# Oregon NW Home Inspections

## Property Inspection Report

1234 NE Anywhere, Anywhere, OR 97777

Date of Inspection: 8/10/2022 Time: 9:00 AM

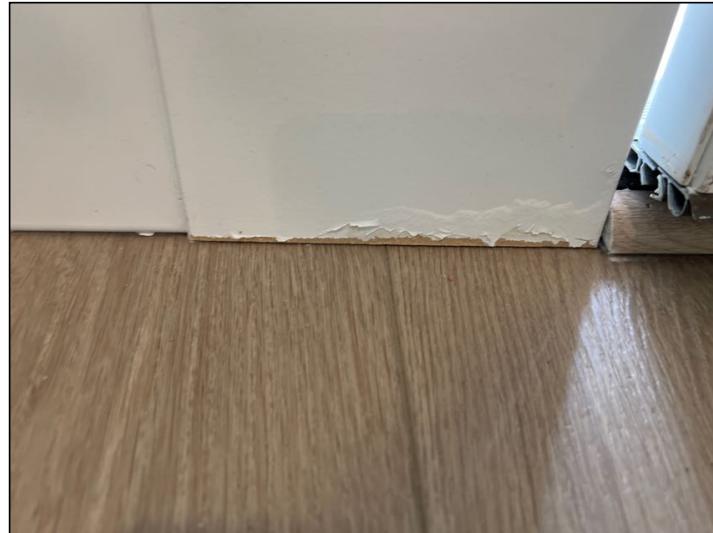
Touch up paint needed in several areas.

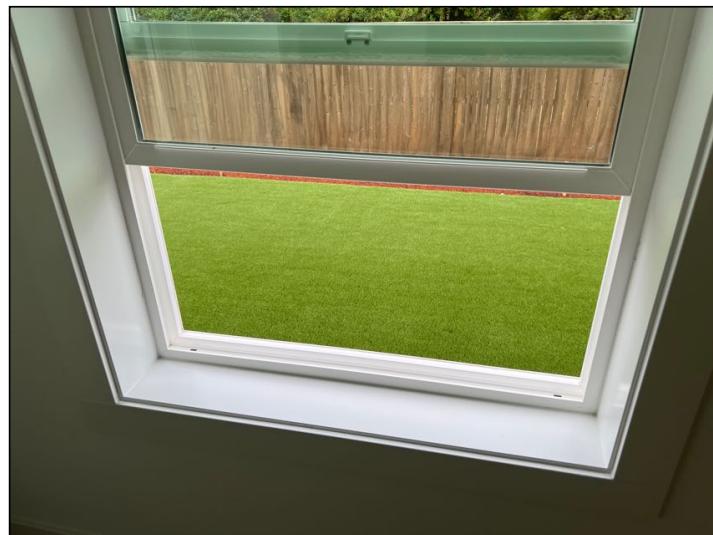
Screens have not yet been installed throughout home.

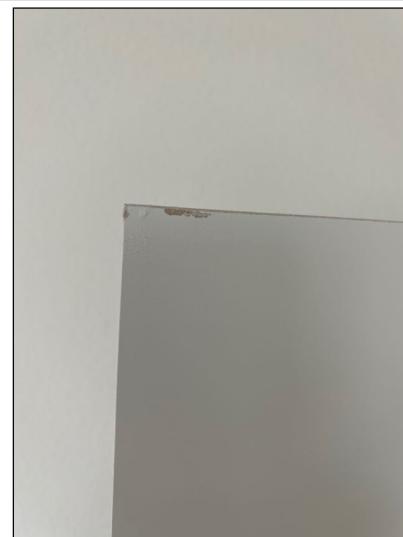
Touch up paint is needed at several doors.

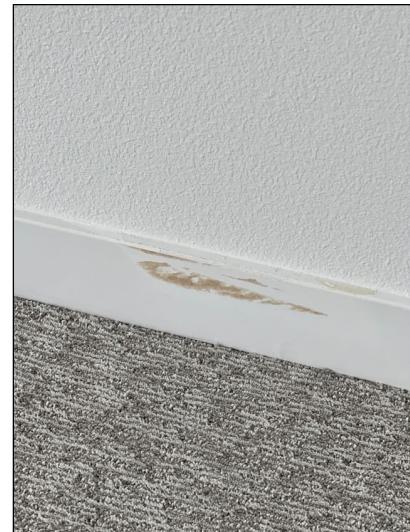
Some areas of minor cosmetic repairs are needed.

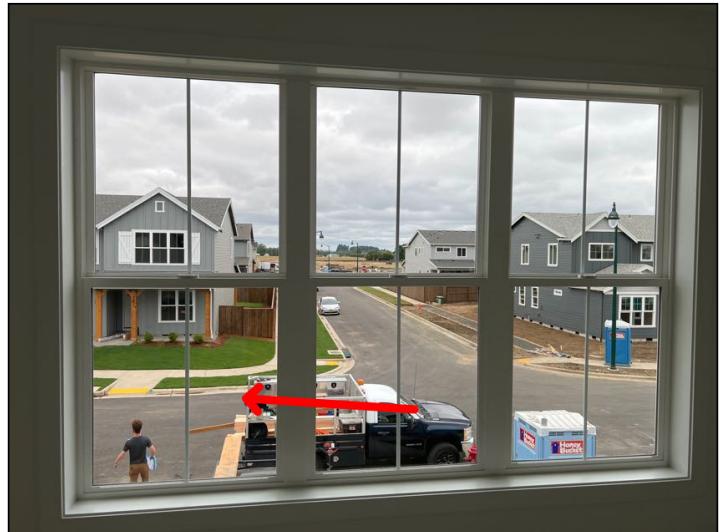
Left side single hung window at upstairs left front bedroom is tight in frame. Recommend adjustment.

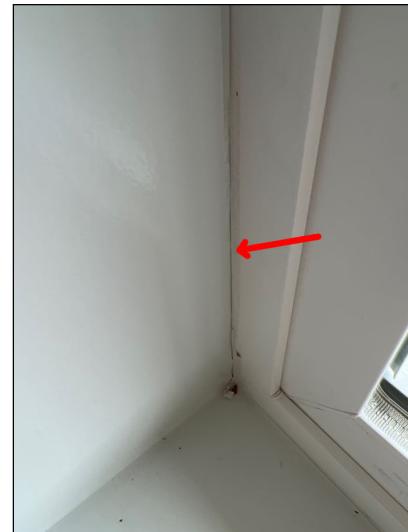
Re caulk at bedroom windows as needed.

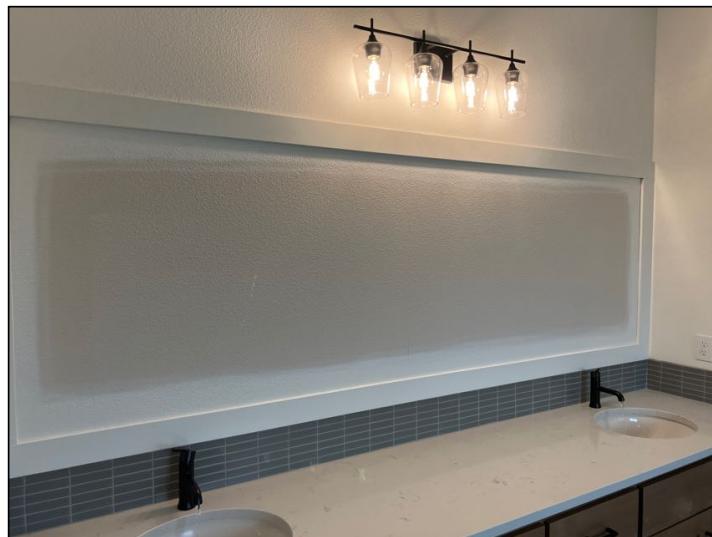
Mirrors have not yet been installed.

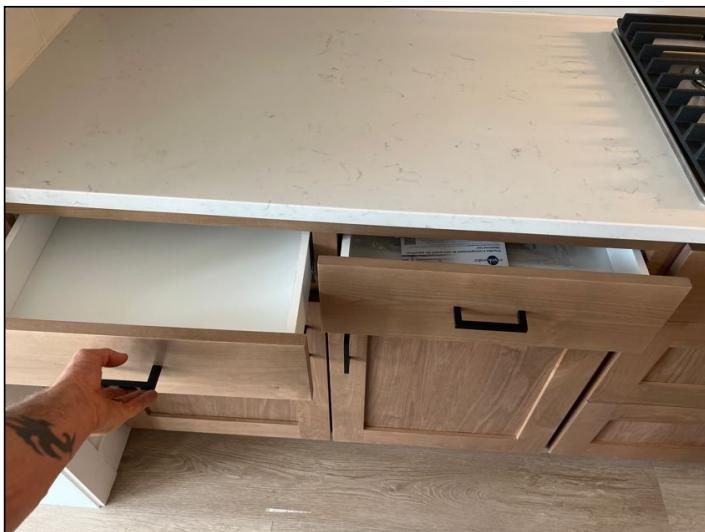
Cabinet drawers appear to be off track and need adjustment- left of cook top and bottom right of sink.

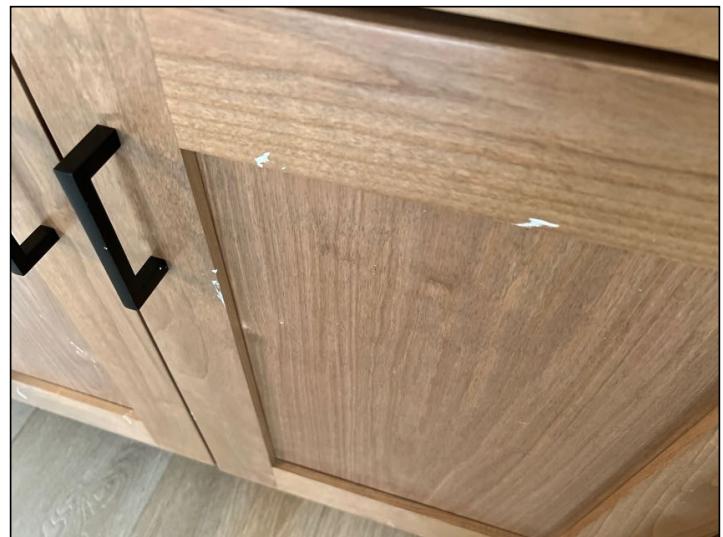
Minor cosmetic damage observed at some cabinets. Recommend repair.

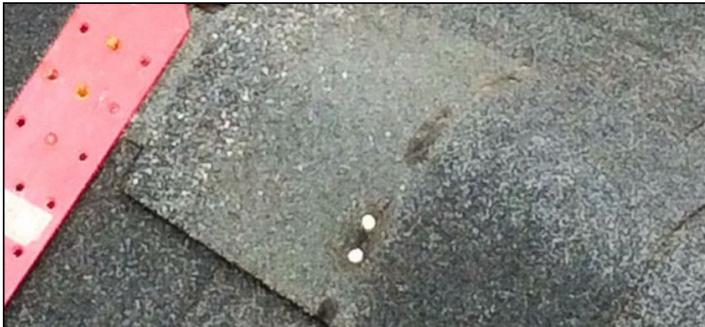
Missing/Damaged shingles at Ridge.  
Recommend repair by a licensed roofing contractor.

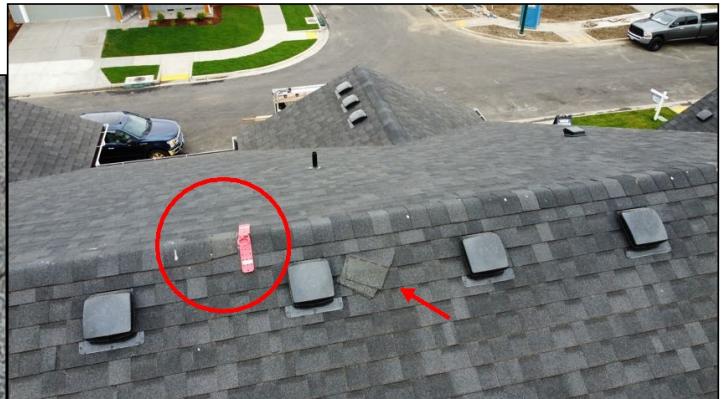
Missing/Damaged shingles at Ridge.  
Recommend repair by a licensed roofing contractor.

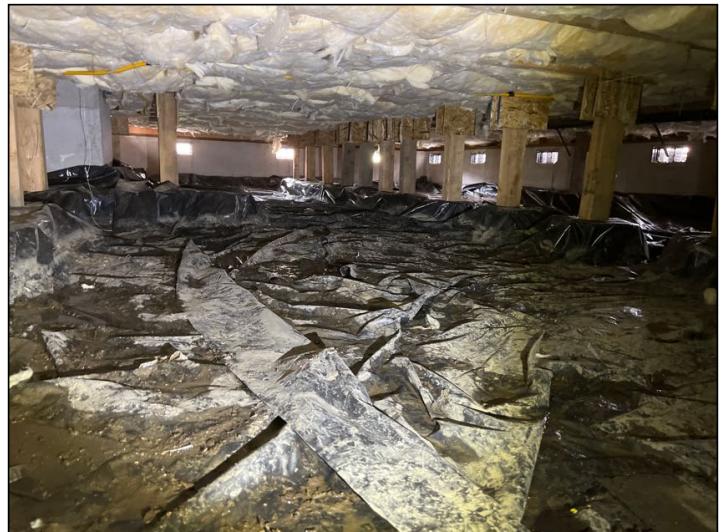
Standing water noted in crawlspace. May be residual from construction phase. This can lead to mold and other moisture issues within this home. Recommend review by licensed foundation drainage specialist to ensure sump pump is sufficient.

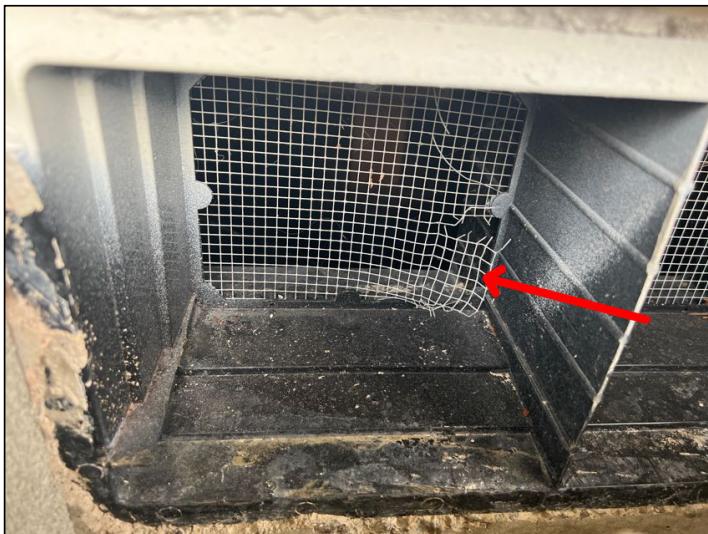
Suggest repair or replacing vent screens.

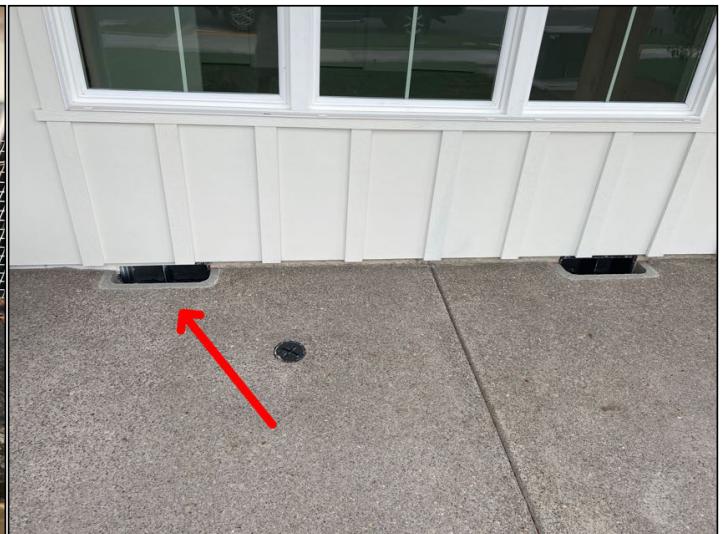
Suggest repair or replacing vent screens.

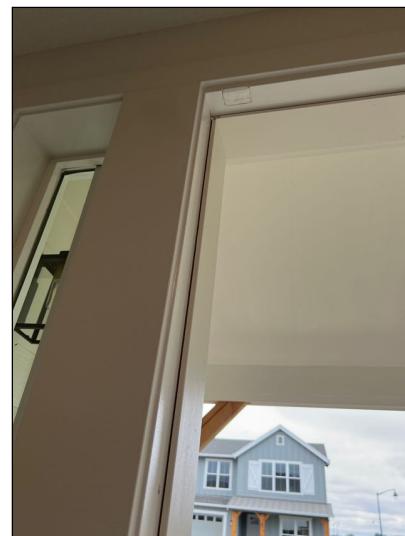
Missing weatherstripping noted at front door.  
Recommend installation.

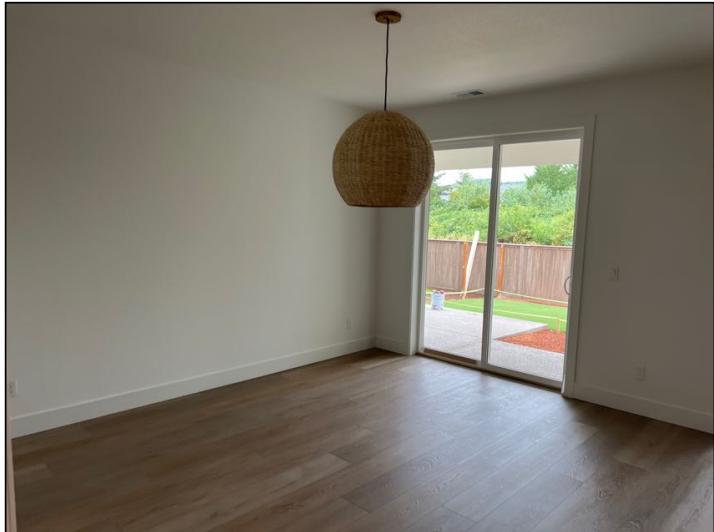
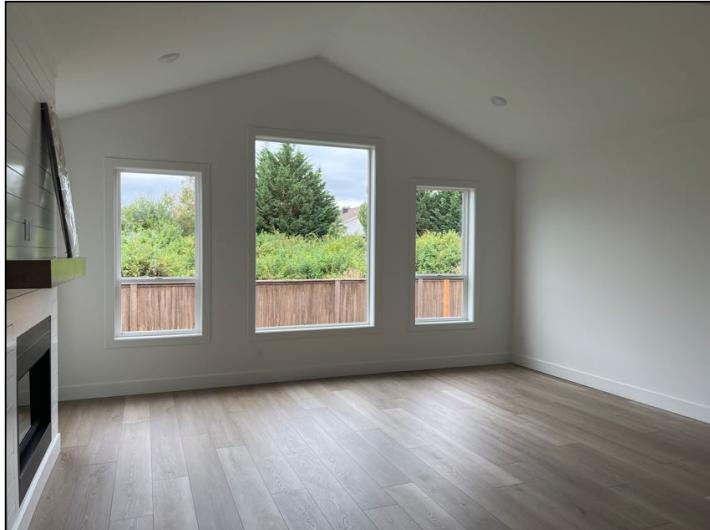
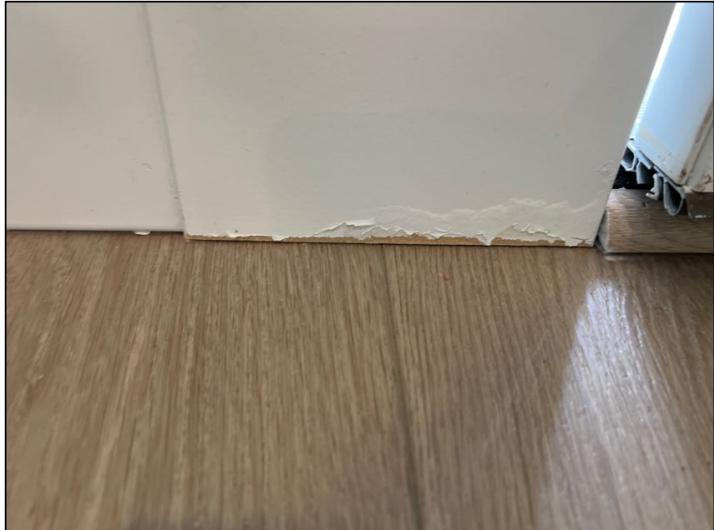
Touch up paint needed in several areas.

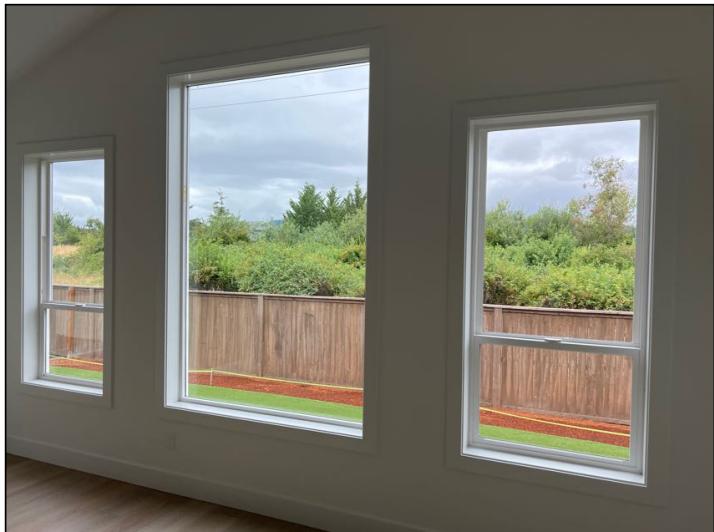
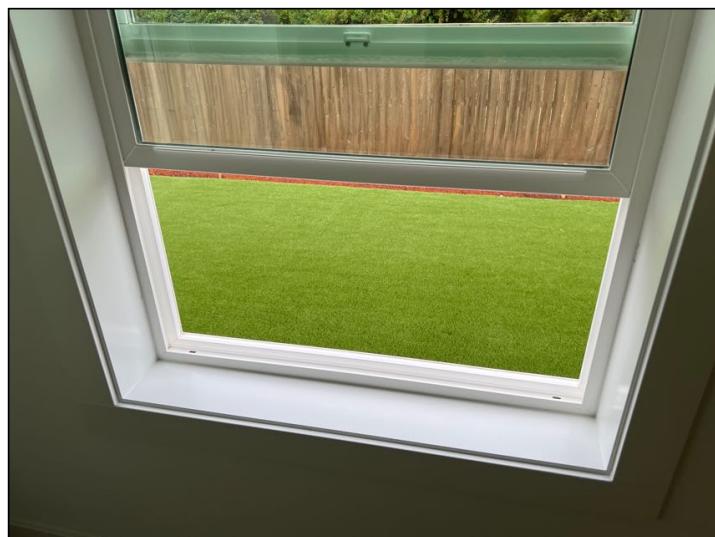
Screens have not yet been installed throughout home.

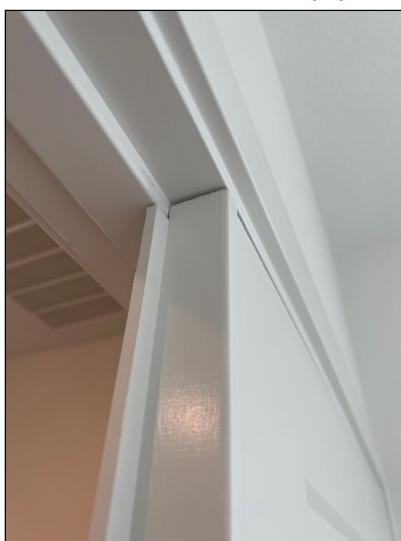
Double door hardware is missing.

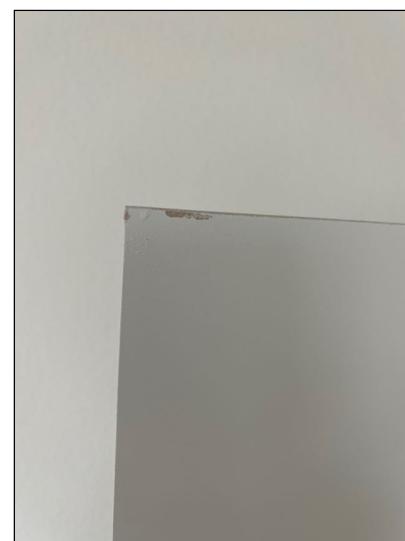
Touch up paint is needed at several doors.

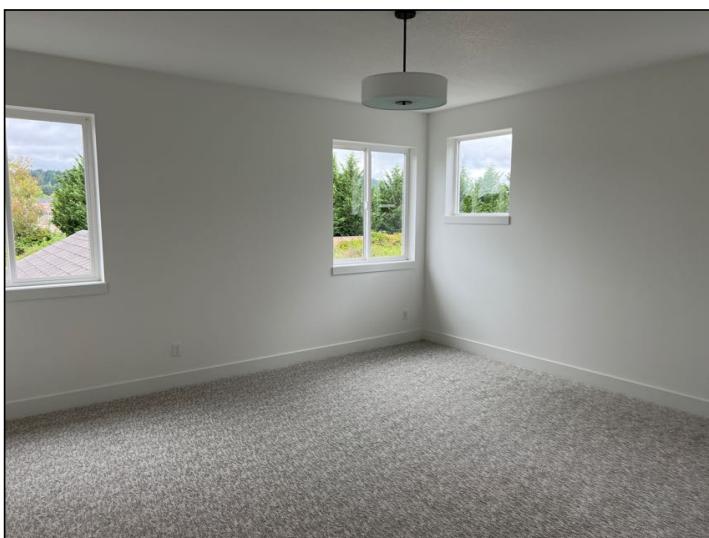
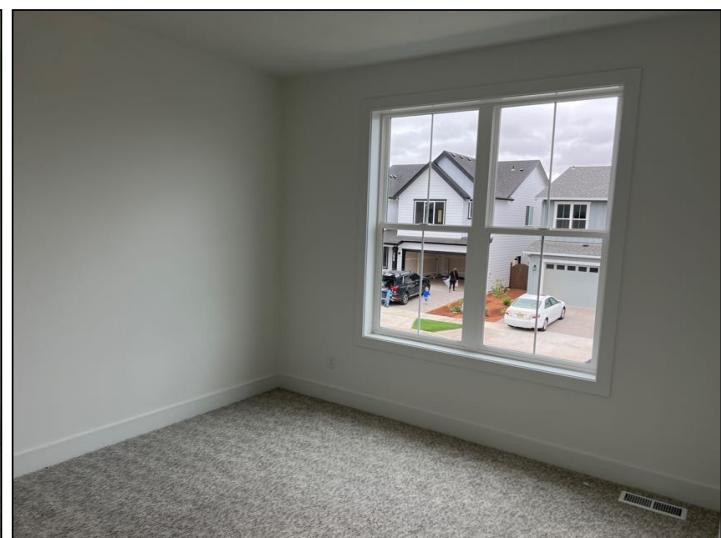
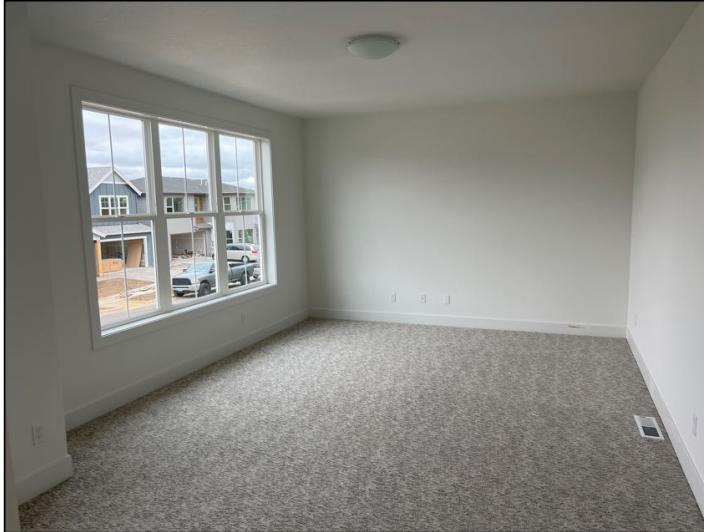
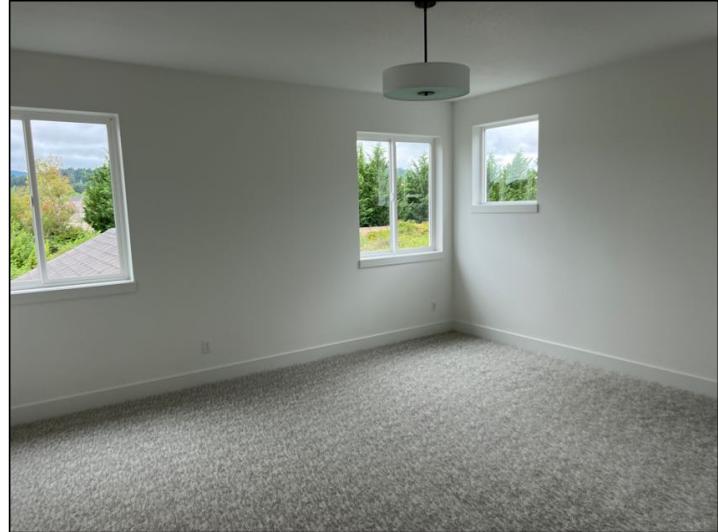
Some areas of minor cosmetic repairs are needed.

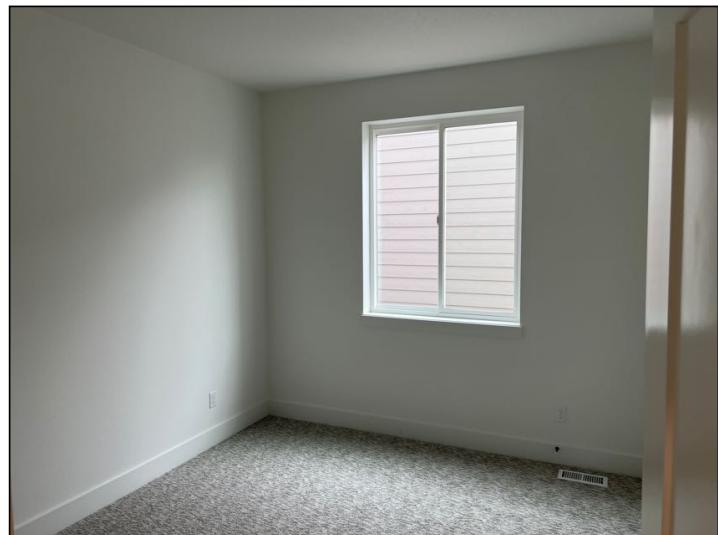
Some areas of minor cosmetic repairs are needed.

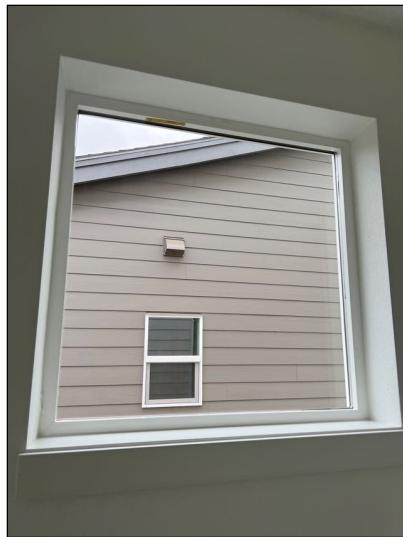
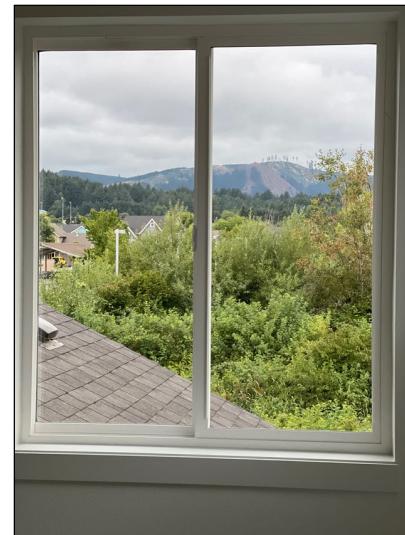
- Re caulk at bedroom windows as needed.
- Right side master bedroom sliding window does not latch properly. Recommend adjustment/repair.
- Left side single hung window at upstairs left front bedroom is tight in frame. Recommend adjustment.
- Right side single hung window at main floor right front bedroom does not latch properly. Recommend adjustment/repair.

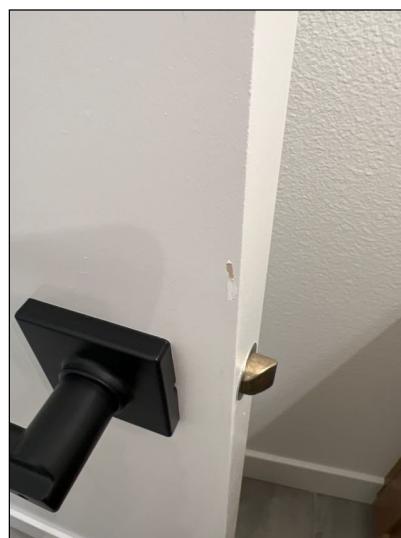
Minor cosmetic damage observed at upstairs hallway bathroom door. Touchup paint is needed.

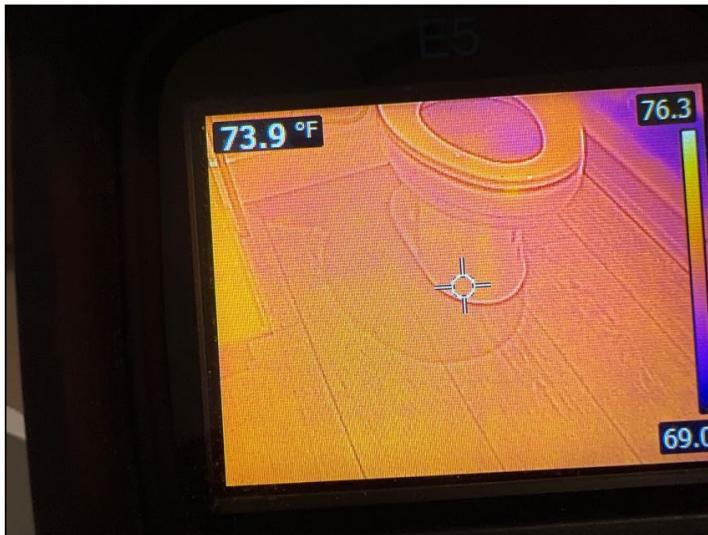
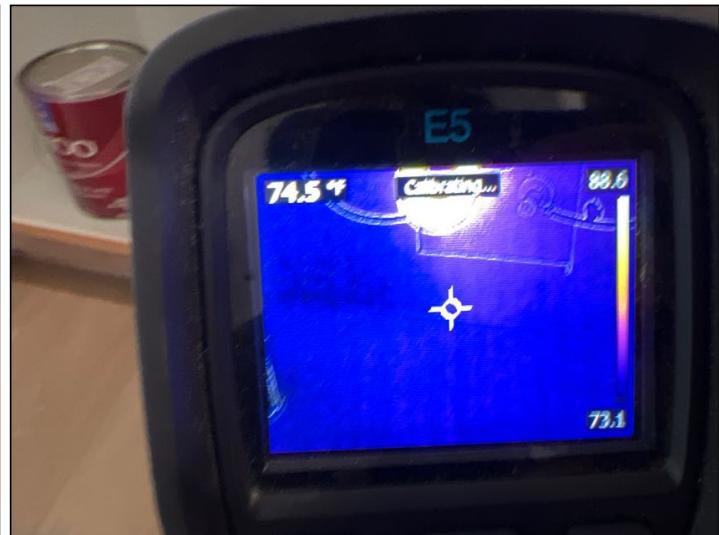
Recommend caulking where the tub or shower meets the floor.

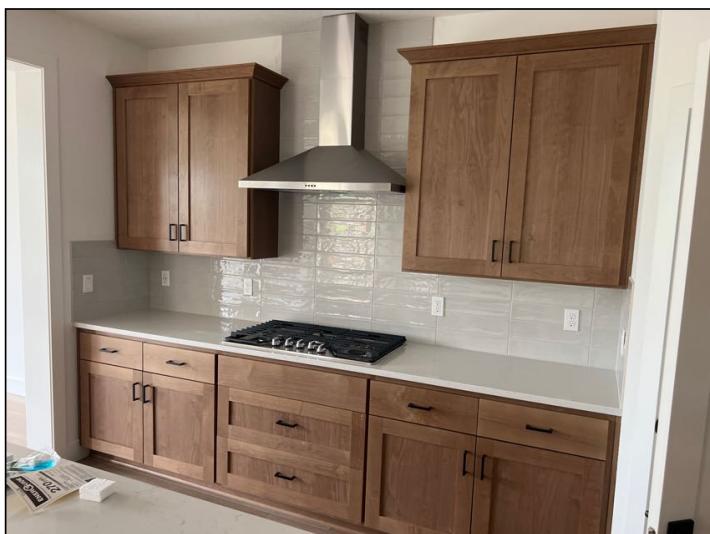
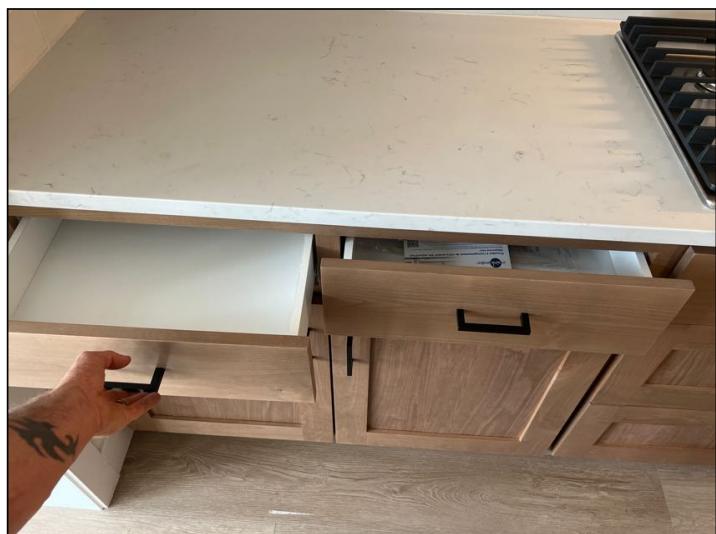
Cabinet drawers appear to be off track and need adjustment- left of cook top and bottom right of sink.

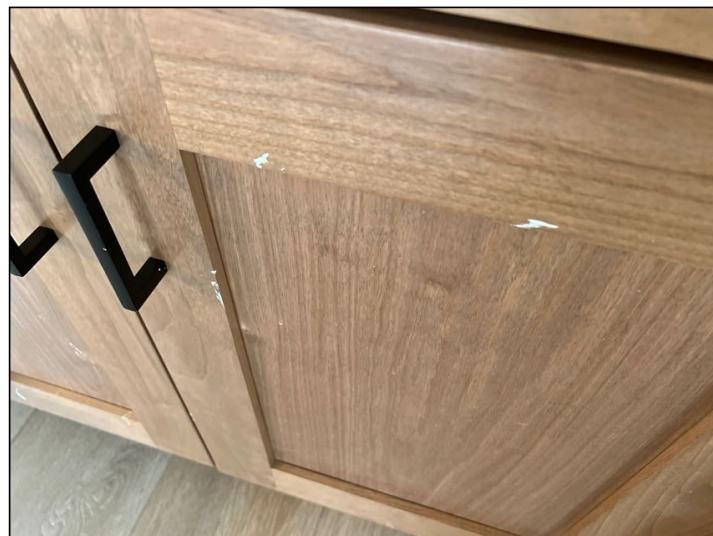
Minor cosmetic damage observed at some cabinets. Recommend repair.

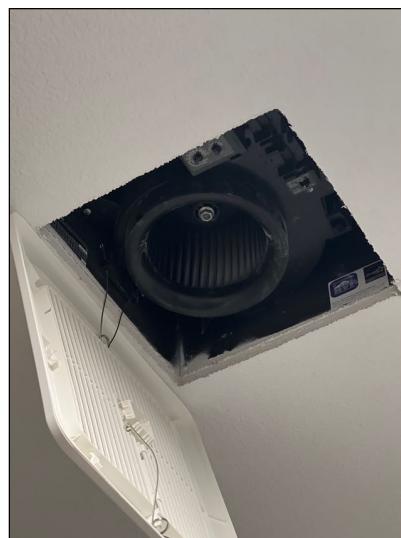
Exhaust fan is inoperable. Recommend repair.

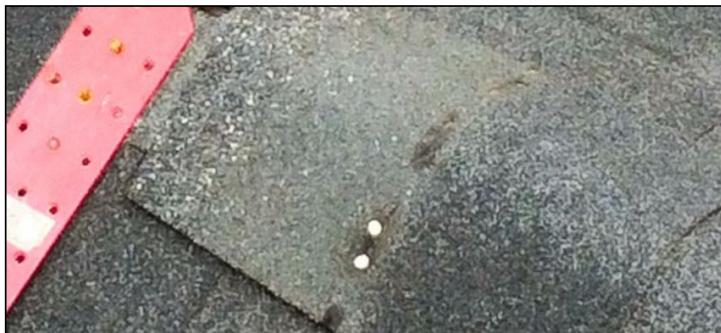
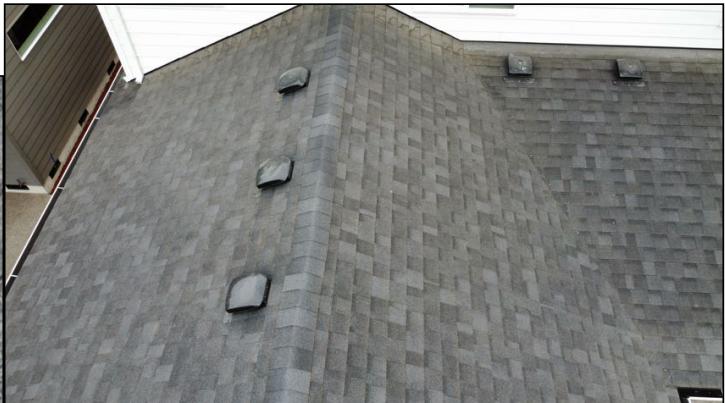
Missing/Damaged shingles at Ridge.  
Recommend repair by a licensed roofing contractor.

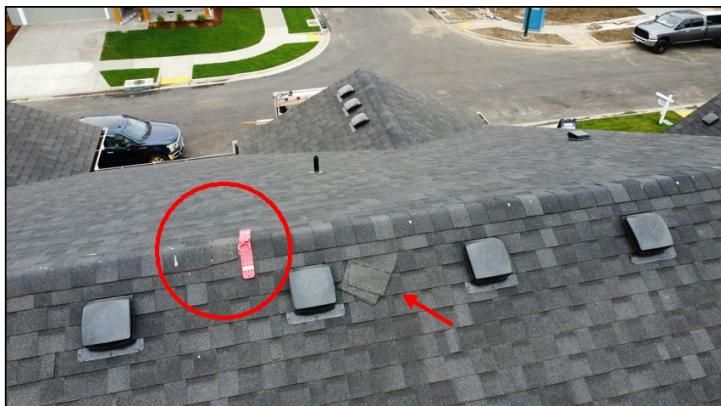
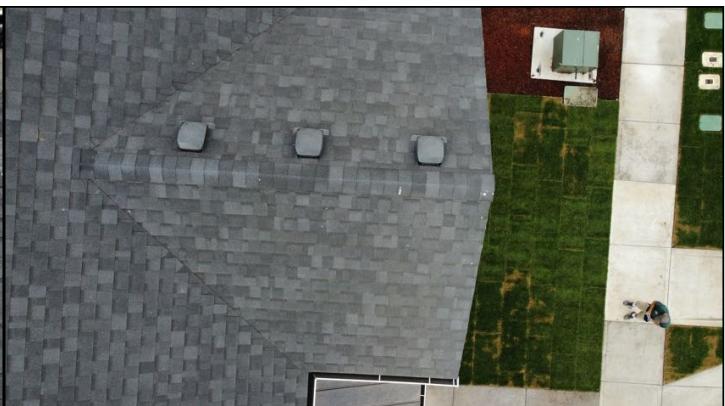
Missing/Damaged shingles at Ridge.  
Recommend repair by a licensed roofing contractor.

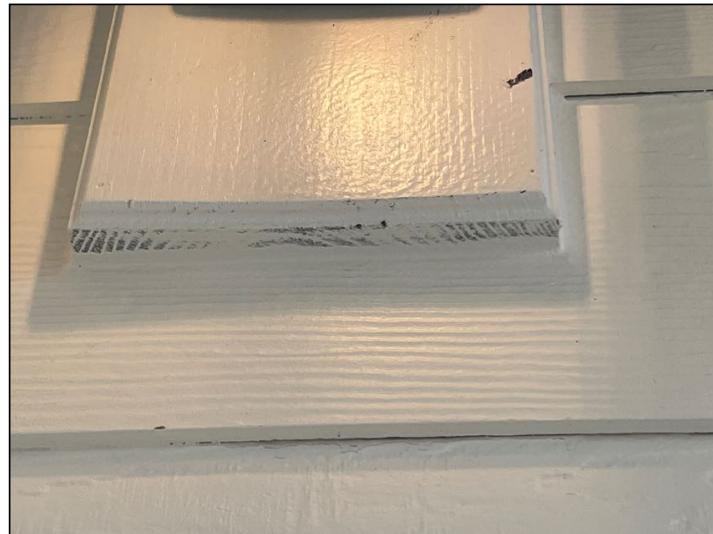
Touch up paint is needed in some areas.

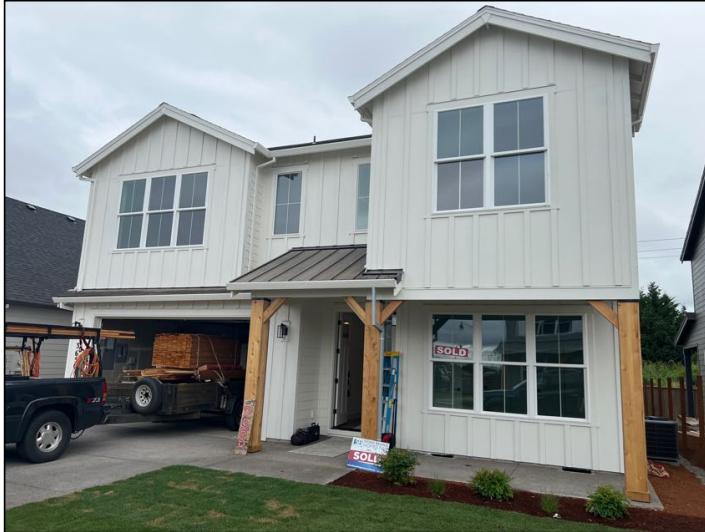
Natural wood trim has some knot holes. Consider caulking or, at the very least, monitoring for the presence of insects, bird damage, or other activity.

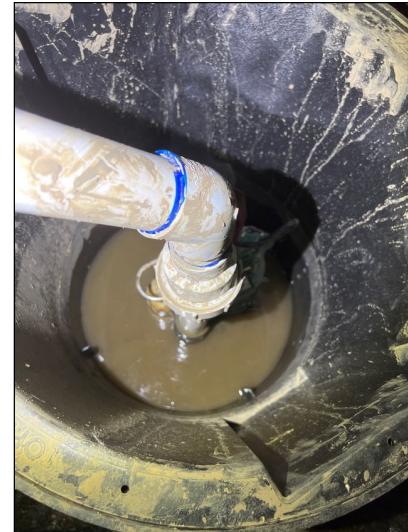
Standing water noted in crawlspace. May be residual from construction phase. This can lead to mold and other moisture issues within this home.

Recommend review by licensed foundation drainage specialist to ensure sump pump is sufficient.

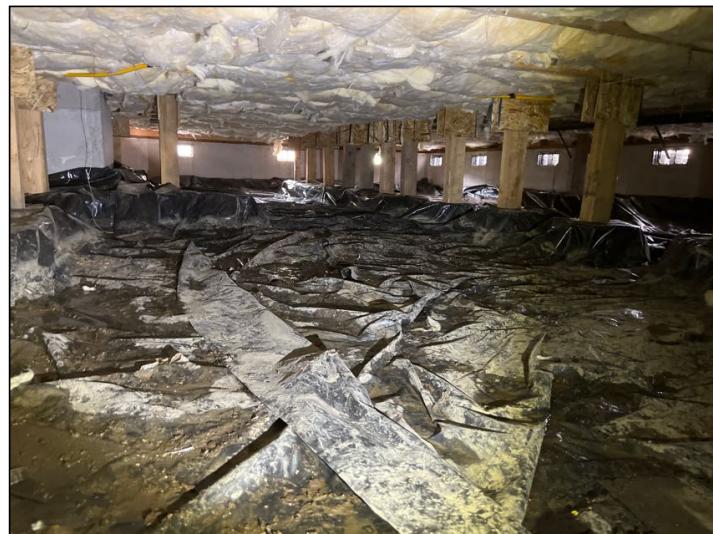
Standing water noted in crawlspace. May be residual from construction phase. This can lead to mold and other moisture issues within this home. Recommend review by licensed foundation drainage specialist to ensure sump pump is sufficient.

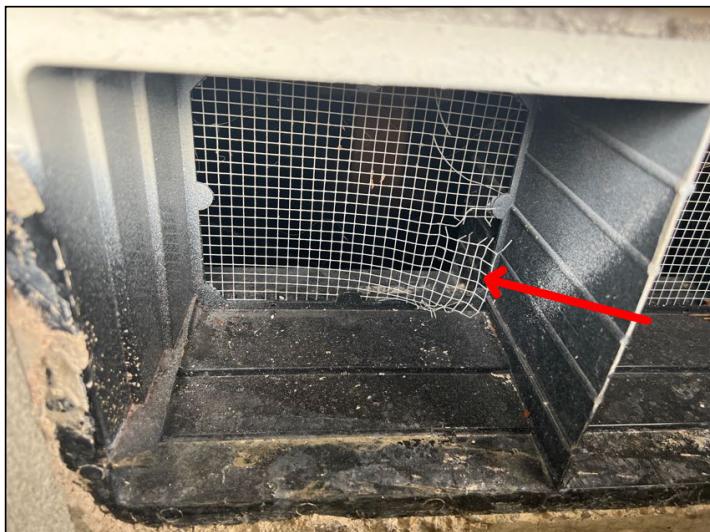
Suggest repair or replacing vent screens.

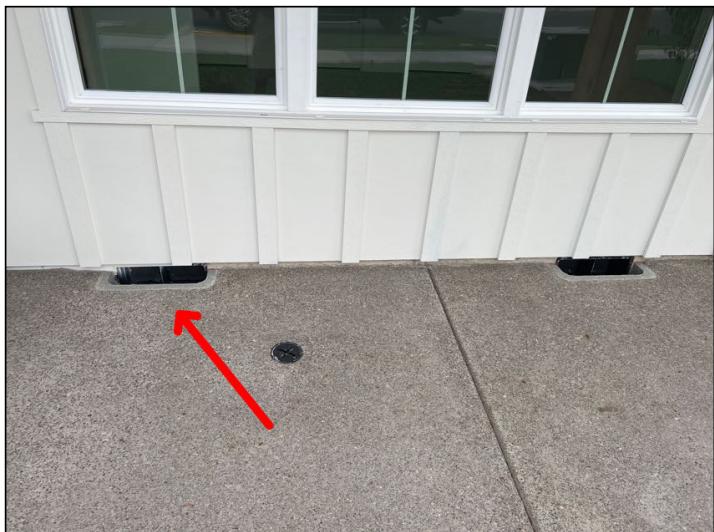
Suggest repair or replacing vent screens.

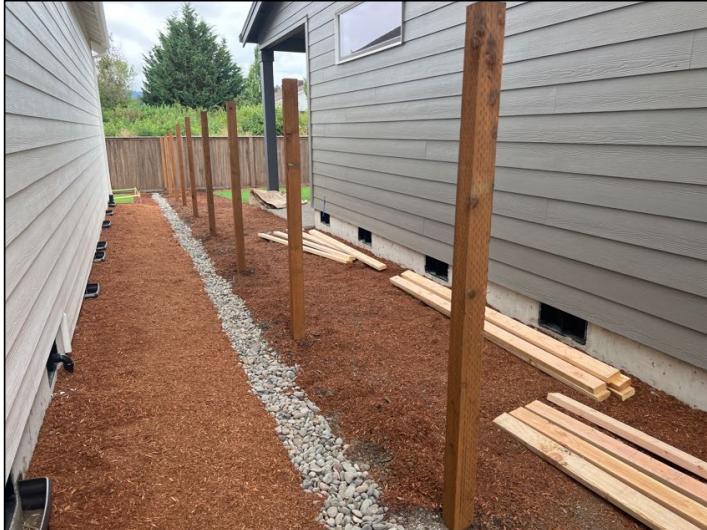
Fence installation is incomplete.

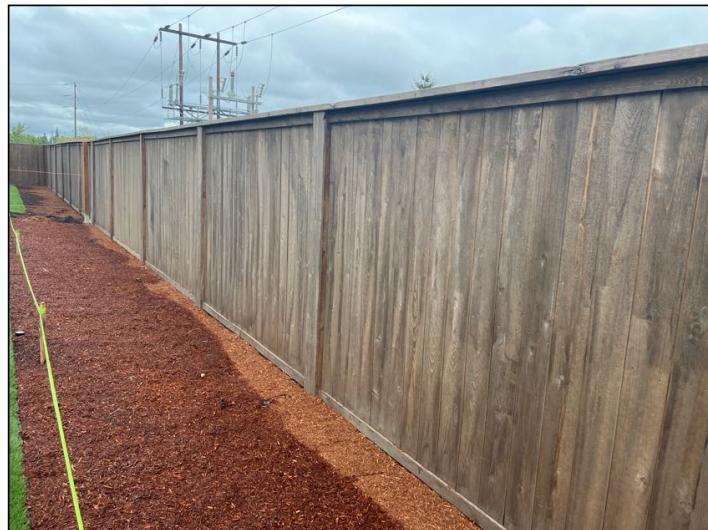
Recommend one inch between soil and fence to prevent decay.
