BUILDING SURVEY & INSPECTION REPORT

[REDACTED]

Building Survey & Inspection Report

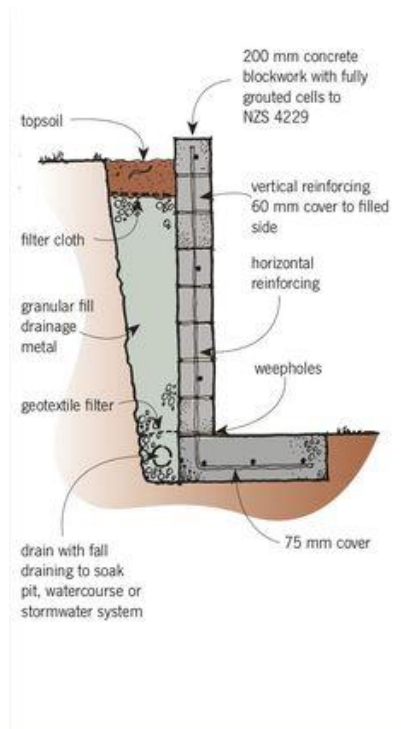
Structural Engineer to verify the design suitability of the retaining walls, at the Rear. We would have expected something more Robust, something similar to the below sketch as a typical construction subject to SE design calculations, we did not see weep holes or solidity of the structure being suitably effective, over many years. This could potentially become a Health and Safety Risk.

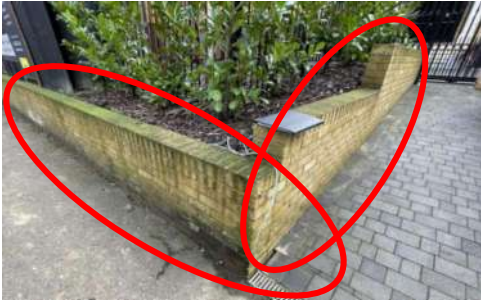
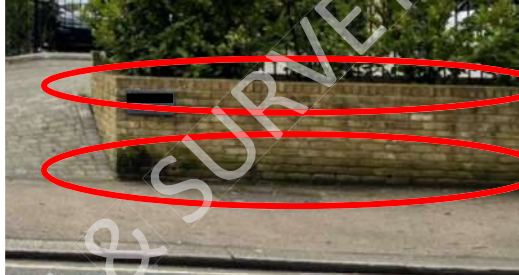
FRONT COMMUNAL DRIVEWAY	
1.1	1.1

Item No.	Contents	Action Recommended
	EXTERNAL	
1.00	Communal Entrance / Driveway	
1.1	Brick Dwarf Wall presents with efflorescence / moss / stain. Damp stains. Damp was evident.	Dampness to be prevented. Rendered plinth is possible solution with a DPM
1.2	Damp was inspected at the Entrance Brick Piers	Dampness to be prevented.
1.3	Exterior Lights cannot be tested. Maybe it is not connected, or not working.	To be tested

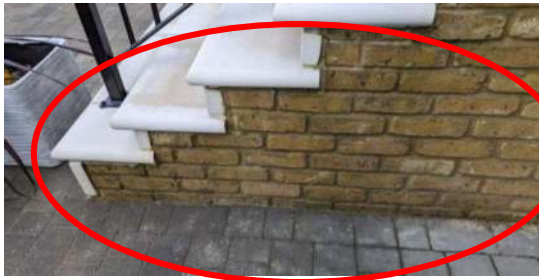
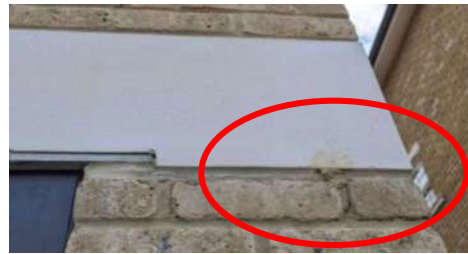
2.3	2.4

2.00	Front Main Building Façade	
2.1	Side Pedestrian Gate (Front Entrance Gate) Space is available but appears. not Installed. No ' <u>Pedestrian only</u> ' access.	This is only an observation: Whether this was intended or not is not known.
2.2	Walls (Dwelling) dampness was evident at the base.	Dampness to be prevented. Rendered plinth is recommended.
2.3	Brick wall - efflorescence stains & cobbling.	Observation only
2.4	Lintels above garages have mortar marks/splatter.	Some, making good, is necessary and recommended.
3.0	Garage	
3.1	Uneven floor finish.	Ideally should be a level sloping floor.

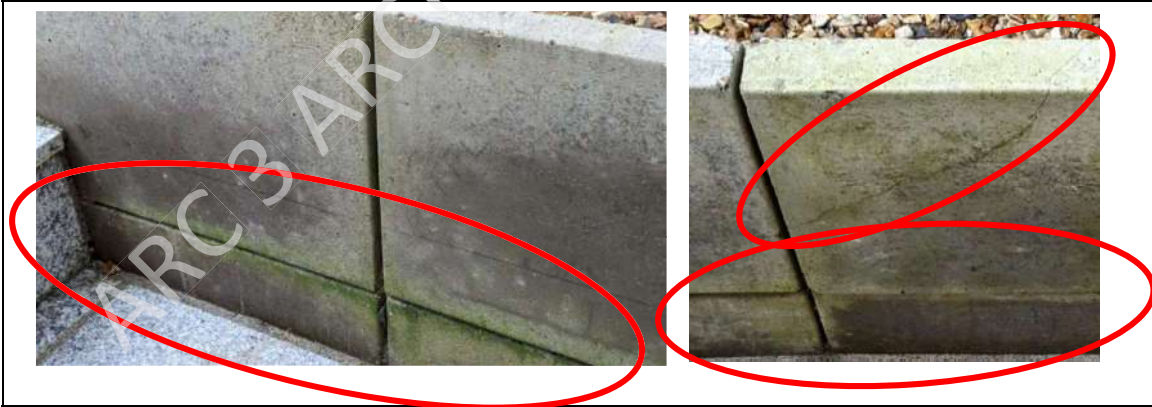
5.15	Side boundary concrete panel blocks wall also presents efflorescence/ moss and damp stains.	Damp prevention recommended.

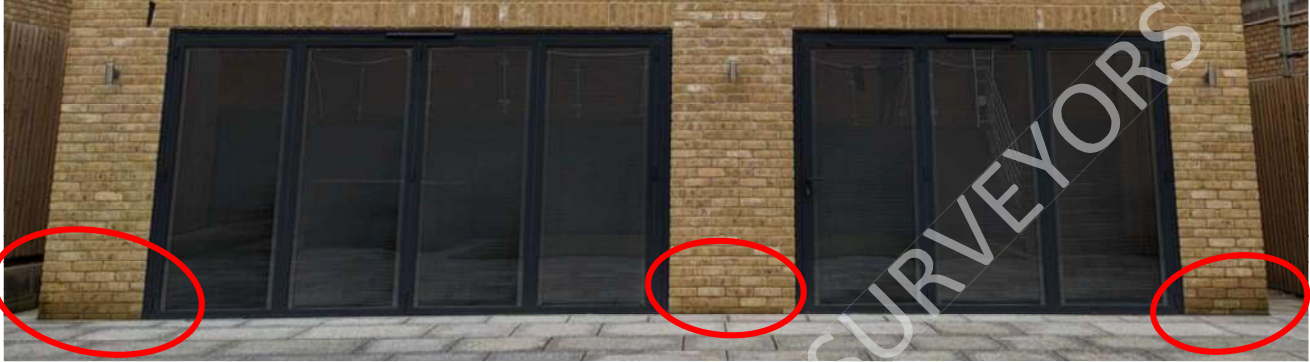
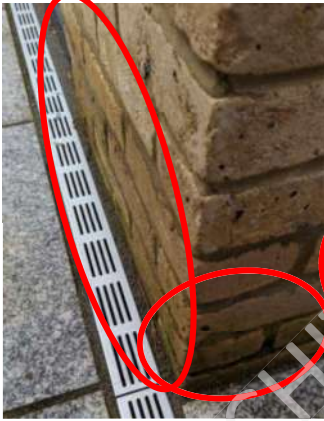
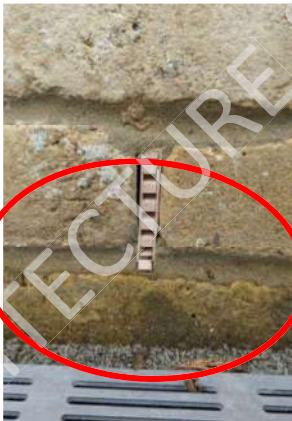
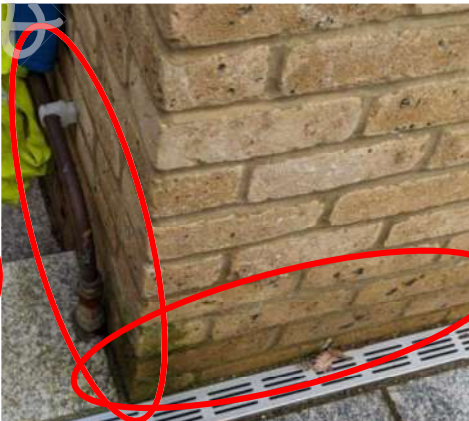
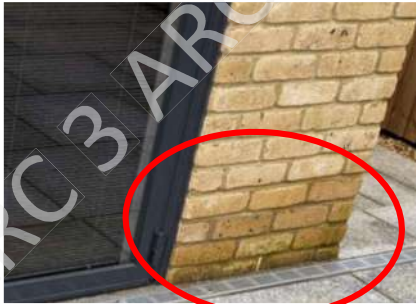
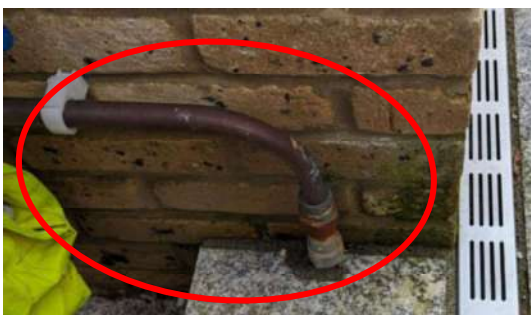
REAR FACADE	
6.1

6.0	Rear Main Building Façade	
6.1	Wall is damp. Green marks evident.	Rendered plinth is recommended.
6.2	External water tap pipe is not installed.	Recommended to be installed / commissioned.

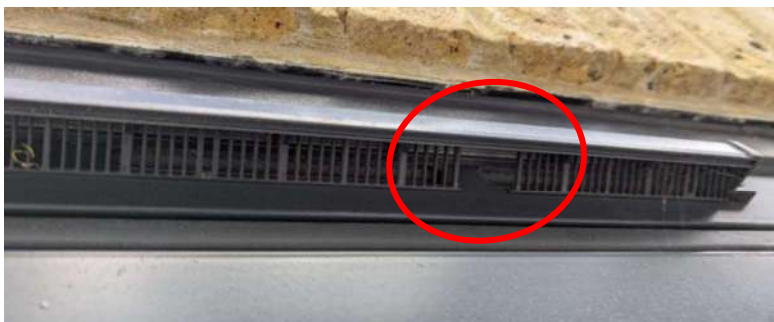
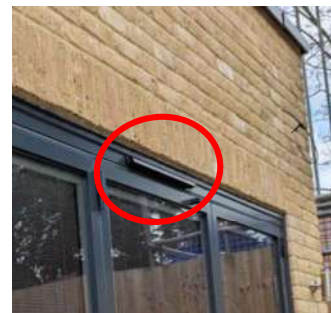
6.5 (same as Item 12.6)

6.3	Loose CCTV cable.	To be installed/ commissioned.
6.4	Wall Lights could not be tested – not working or not connected.	Requires making good.
6.5	The 3-door panel bifold has the ventilation grill broken.	Requires service and making good.

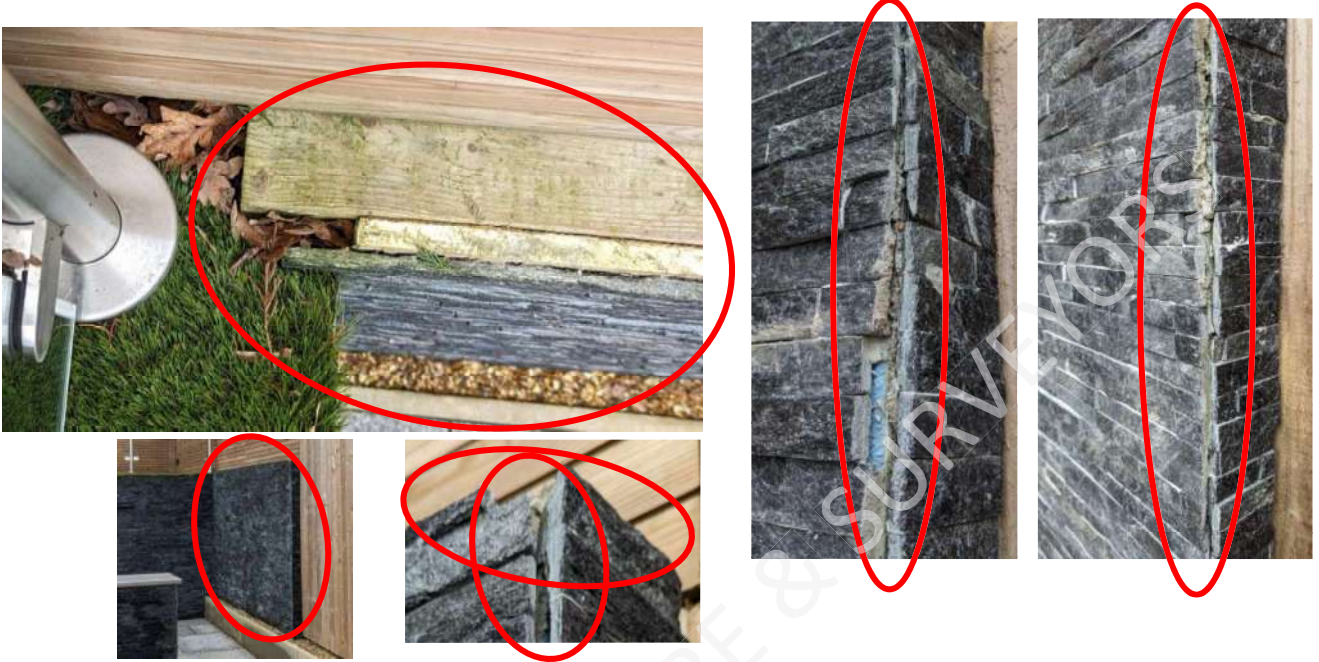
REAR GARDEN		
7.1

7.0	Rear Garden	
7.1	Parapet boundary wall has moss growth.	Ideally requires coping detail.
7.2	Uneven gravel channel. Exposed second level retaining wall.	Making good recommended.

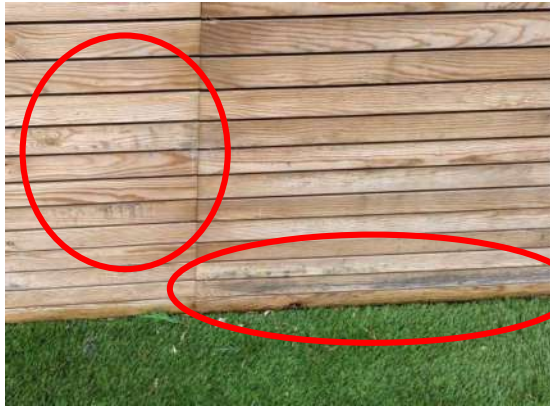
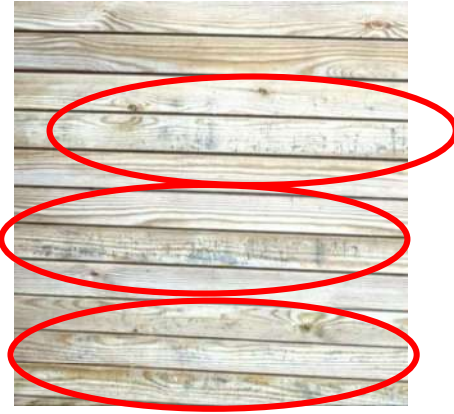
7.17	Moss/damp stain can be observed on the timber panels walls in the upper garden level (only able to access the first level)	ladder access and damp prevention recommended.
------	----------------------------------------------------------------------------------------------------------------------------	------------------------------------------------

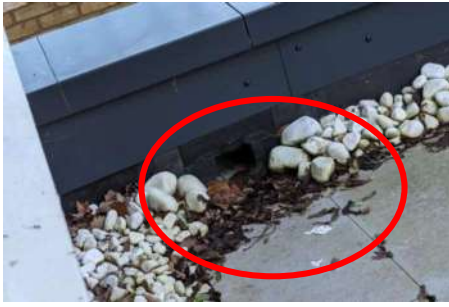
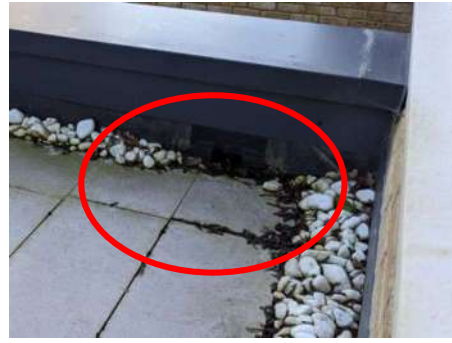
FLAT ROOF
8.1 & 8.4
8.2

8.0	Flat roof - Above Kitchen / Living	
8.1	Misaligned placement of tiles.	Observation.
8.2	2 x side drains are blocked by leaves.	Ideally should have leaf guard. Will require regular maintenance.
8.3	No visible RWP. Discharge of water system to be further investigated or installed.	observation
8.4	Moss overgrown	observation
8.5	Aluminium coping has an approx. 50mm gap. Stain on the side of the coping, potentially mortar or water stains from the flat roof overspill.	Recommended to be infilled to prevent vermin / bees / wasps. Some cleaning and making good.

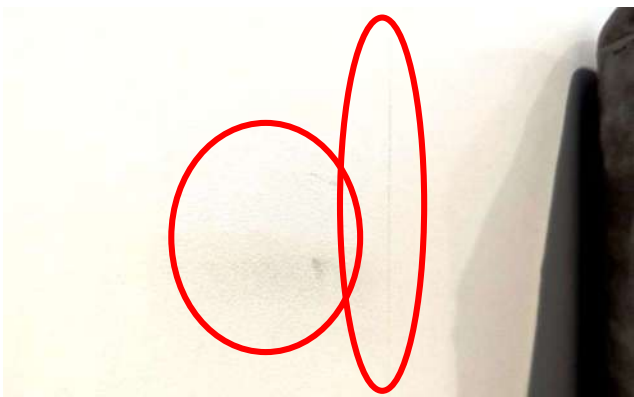
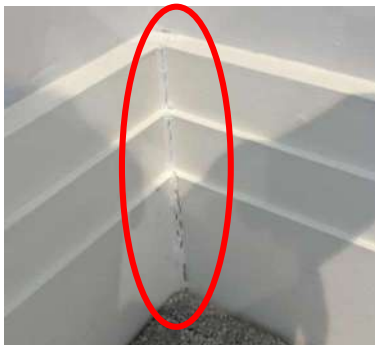
BEDROOM 2	
18.3 & 18.4	18.5

18.3	Scuff mark next to bed.	Requires making good
18.4	Hairline crack next to bed wall.	Requires making good
18.5	Skirting board does not have a uniform scribe and mitre joints.	Requires making good

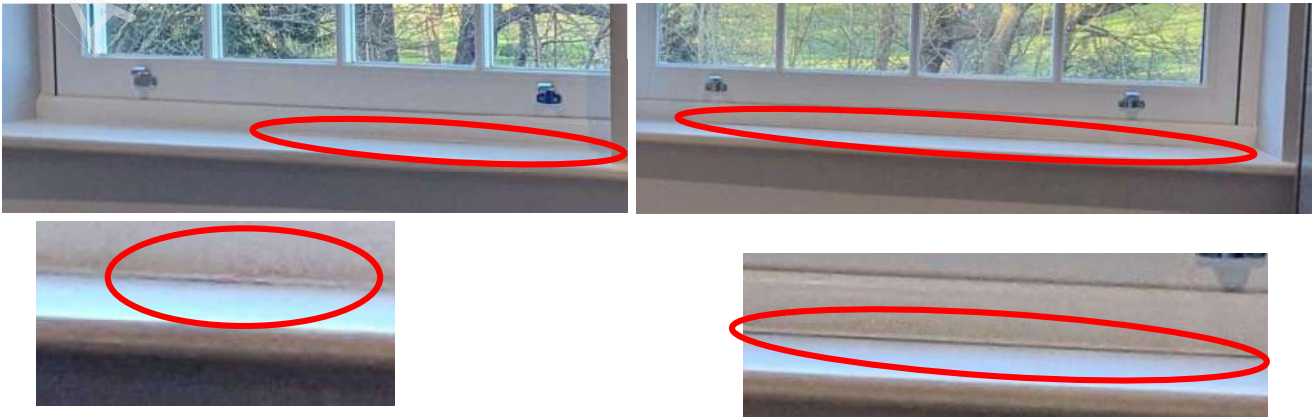
22.0	Bedroom 4	
22.1	Door lock not working.	Requires adjustment or service and/or action
22.2	Both windows require sealant to be fixed.	Requires making good

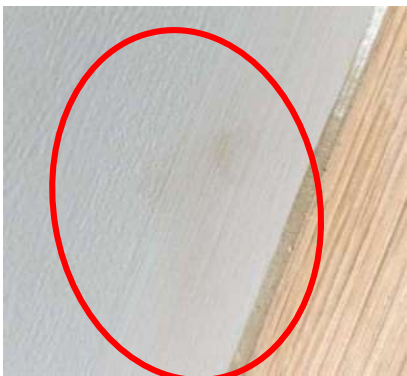
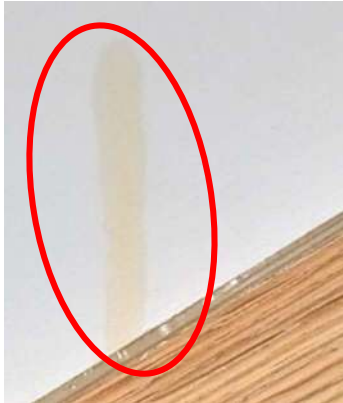
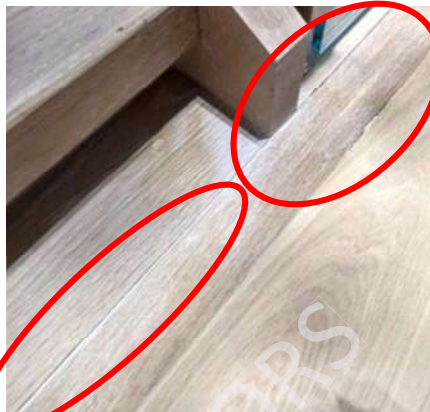
STAIRCASE HALLWAY	
24.1	24.2

24.0	Hallway	
24.1	Paint/stain scuff mark on the staircase wall.	Requires making good
24.2	Uneven finish of sealant of timber floor. Visible gaps between timber boards.	Requires making good
24.3	Steps can be potentially slippery.	Needs review.
