# HOME INSPECTION REPORT

<address removed>, Lafayette, LA  
22 November 2022

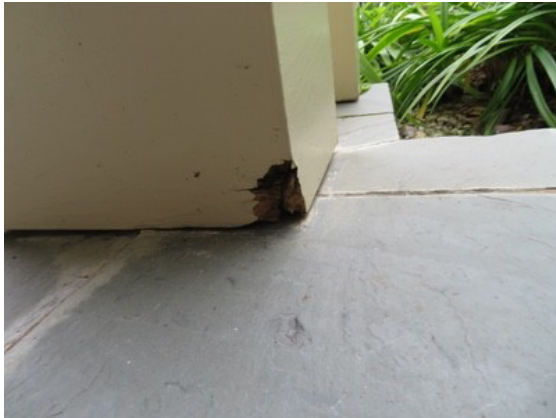
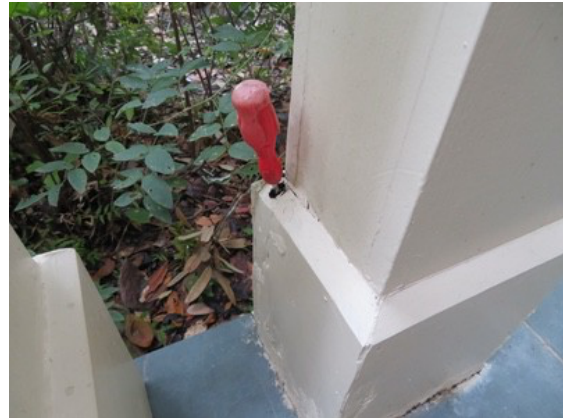
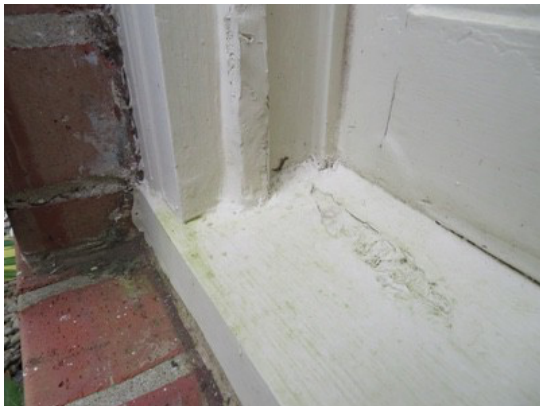
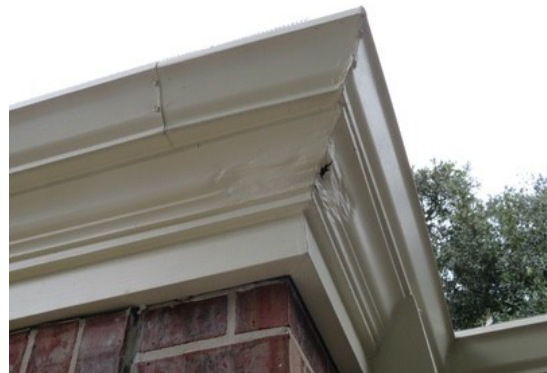
1. There are a significant number of mostly small areas of rotted wood in the cornice, columns, door, and window frames of both house and garage. Most of these areas are filled with caulk then painted, which is not a manufacturer supported use of their caulk products. Proper repair of these areas of rot can be done either by epoxy repair or by replacement of rotted members. Repair by replacement is very labor intensive. Repair by use of epoxy fillers is likely the best solution of many of these areas of rot. Where the area of rot is too large for epoxy fillers, repair by replacement is the only remaining solution.

**Get a carpenter, preferable experienced in epoxy wood repair, to repair all rotted areas by either epoxy repair or by replacement of rotted members. If you cannot find anyone with experience in epoxy repair, ask any carpenter willing to learn a new skill as epoxy wood repairman.**

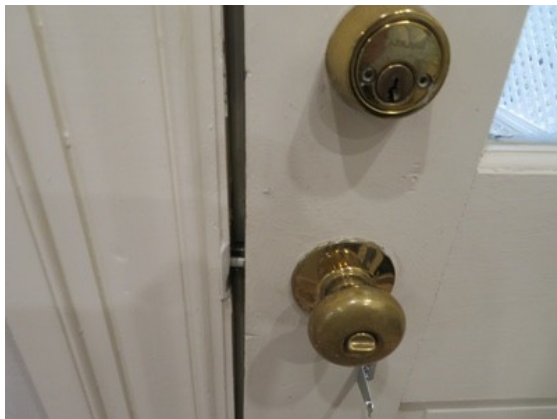
3. The exterior entrance door in the kitchen is badly misaligned with the door frame. The gap between door and frame, at the doorknob, is so wide that the doorknob barely latches onto the frame. **Get a carpenter to re-align this door. This generally entails the removal and re-installation of the entire door/frame assembly.**

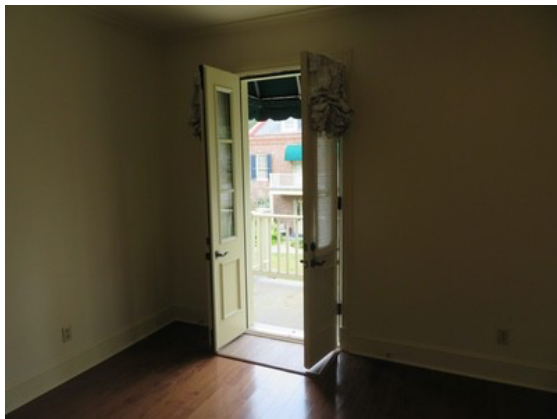
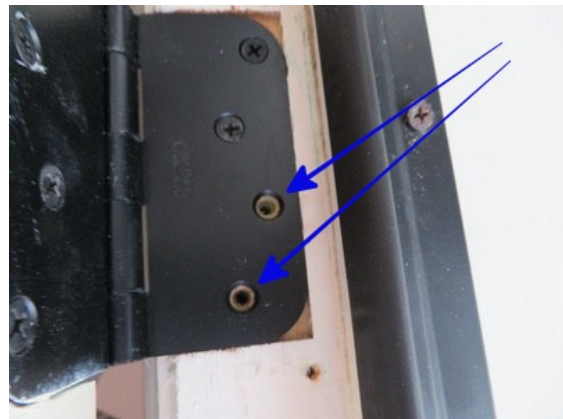
4. About half of the hinge screws on the upstairs balcony doors are missing.

**Get a carpenter to fix them.**

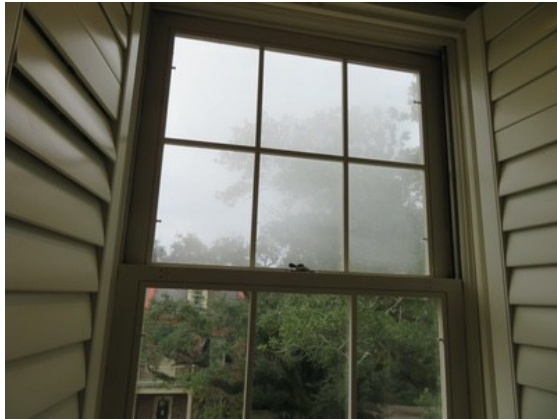
6. Several windowpanes are fogged. These are insulating glass units – two layered glass panes with argon gas at a reduced pressure in between. When the seals on these glass units leak, moisture gets inside and fogs the surfaces between the panes. This issue is cosmetic only, not a hazard. They cannot be fixed without replacement of either the glass unit or the entire window. **Contact a window sales/service company and inquire about replacing these failed glass units.**

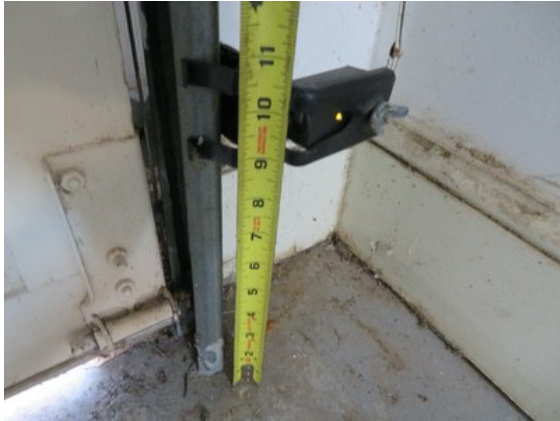
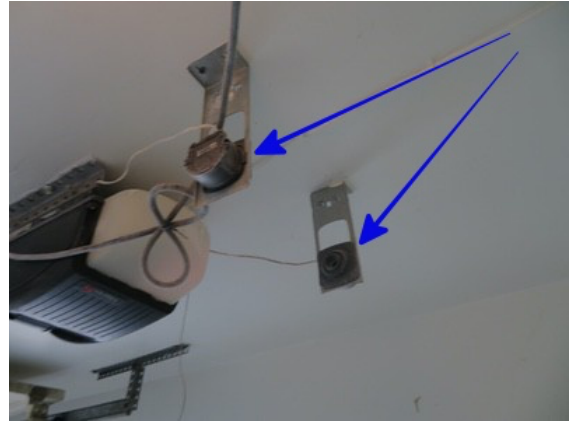
The electronic beams and sensors for the garage doors are both installed too high to function properly. They should be installed between 4 and 6" from the floor. One of them is almost 10 inches off the floor, the other is just below the ceiling.

I tested the pressure reverse feature of both garage doors. One of them did not function at all. It likely just needs an adjustment.

**Get a garage door sales/service contractor to service both garage doors.**

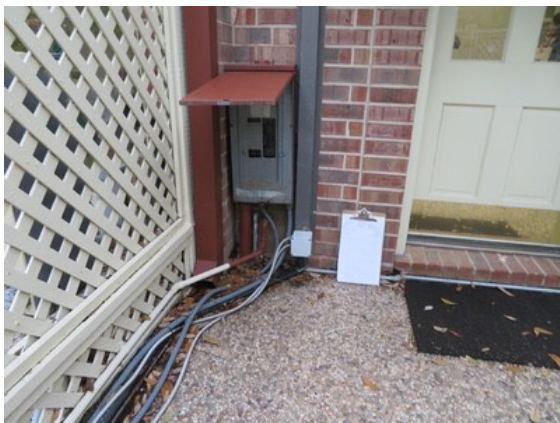
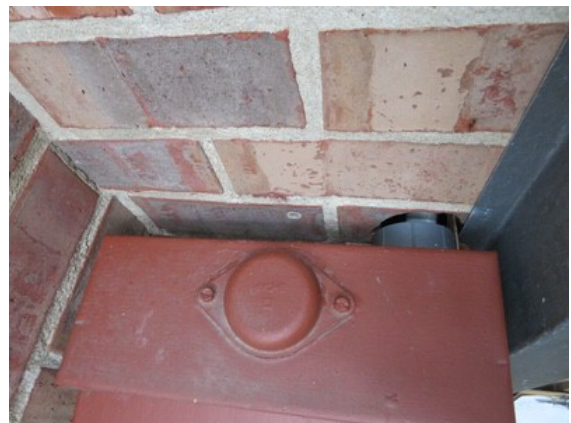
**10.** The main panel has come loose from the brickwork. Rainwater is now able to breach the brickwork via a large hole in it behind the panel. This may result in moisture/water intrusion issues (mold growth and decay of building material) in the kitchen near the exterior entrance door.

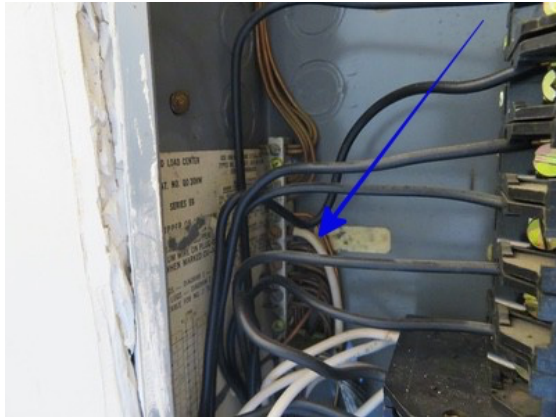
**11.** A few neutral wires are connected to the ground bus, instead of the neutral bus, in one or more of the circuit breaker panels. Such connections introduce neutral currents in the ground

wires. It's an issue because ground wires are smaller and not intended to carry neutral currents. Ground wires are for protection only.

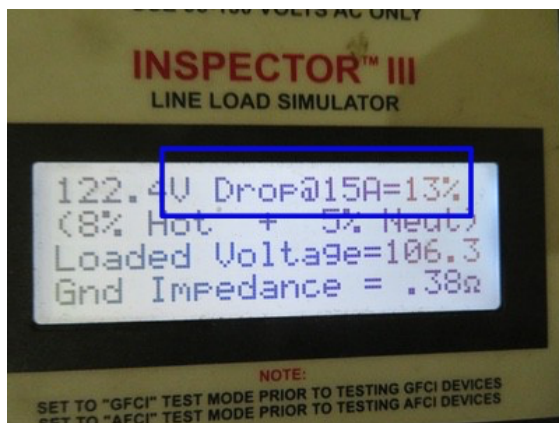
12. I used an instrument to measure a voltage drop of 13% at a stairway receptacle. It shouldn't be more than about 5%. This means that the receptacle has lost too much tension and can no longer provide a good connection. Poor connections may overheat, damaging both the receptacle and prong. Overheating may result in a fire.

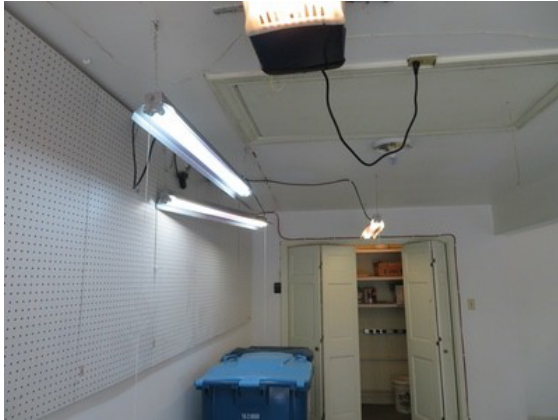
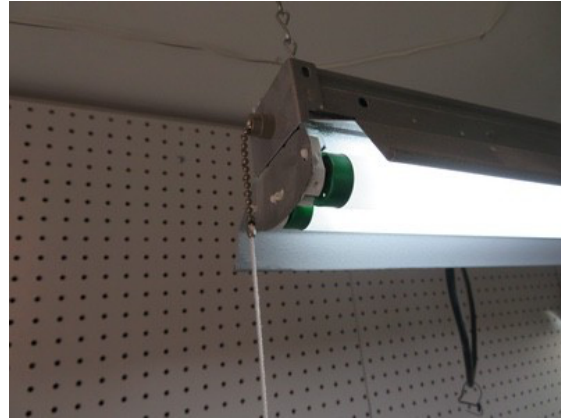
14. In the garage are several fluorescent shop lights suspended from a low ceiling. A high voltage surge is needed to ignite fluorescent tubes. For this reason, they need to be installed

out of reach or covered, especially in a garage with a concrete floor where barefooted persons are in good contact with the earth. Contacting any of the pins on either end of a fluorescent lamp may cause a serious electrical shock.

These fluorescent lights are powered by permanently installed extension cords. The wires in extension cords are much smaller than the wires used to build houses. They may overheat, melt the plastic insulation protecting the wires and throw sparks without ever tripping the breaker.

**Get an electrician to service all light fixtures in the garage.**

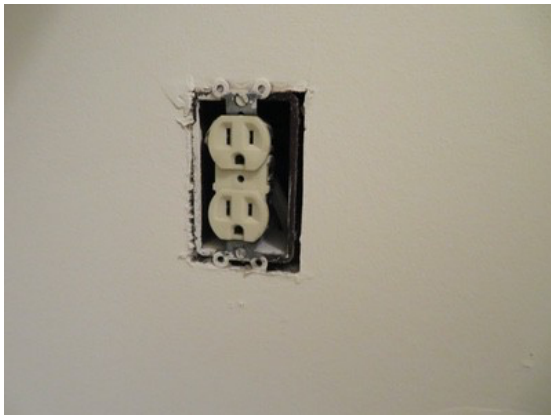
**15.** At least one wall receptacle is without a cover. This one is in a closet where the security system is installed. Energized surfaces are within easy reach when these covers are missing. **Get an electrician to fix it.**

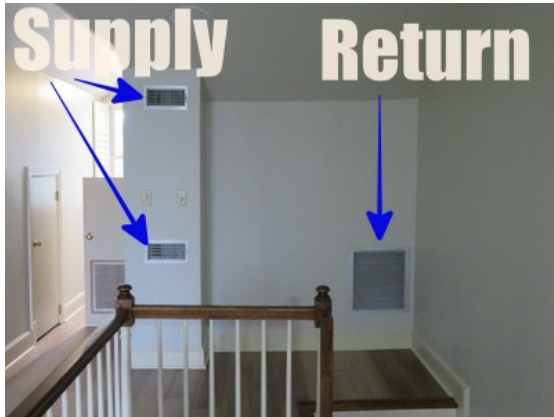
20. On the 3<sup>rd</sup> floor, the air return grill is less than 8' from two air supply registers. Supply and return should be at opposites sides of the room that you're trying to condition so that the conditioned air is forced to cross as much of the room as possible. I can see how doing this correctly would be difficult in rooms with cathedral ceiling, but the mistake was made in choice of system. A ductless mini-split would have been a better choice for the 3<sup>rd</sup> floor, along with a multi-zoned mini-split for the 2<sup>nd</sup> floor.

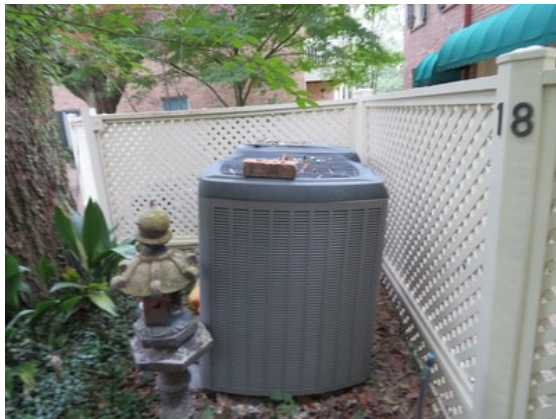
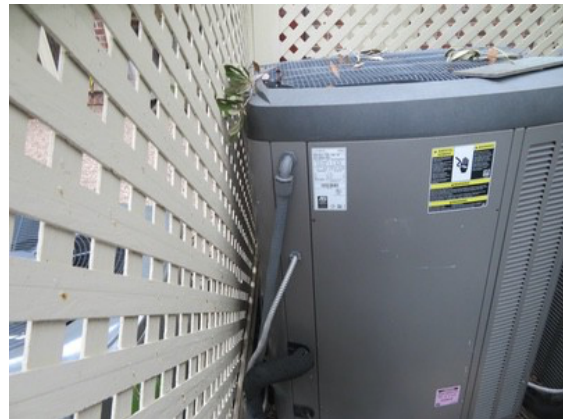
**21.** The two AC outdoor sections are far too close to each other and to a fence, to allow for some types of service work, such as cleaning the coils. As an AC serviceman for over 30 years, I can tell you that the only way to clean them properly is to first re-locate them.

**Get an AC serviceman to re-locate the two AC outdoor sections to locations where all four sides of each unit are fully accessible.**

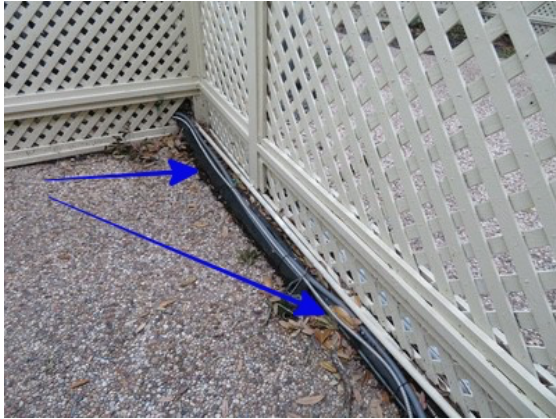
**22.** Four refrigerant lines are laid on the floor of the deck, just outside the kitchen. Two of these lines may be pressurized to over 300 pounds/square inch (PSI). A rupture on either of these two lines may easily cause serious injury as well as an expensive repair.

**Get an AC serviceman to bury or otherwise protect the refrigerant lines.**

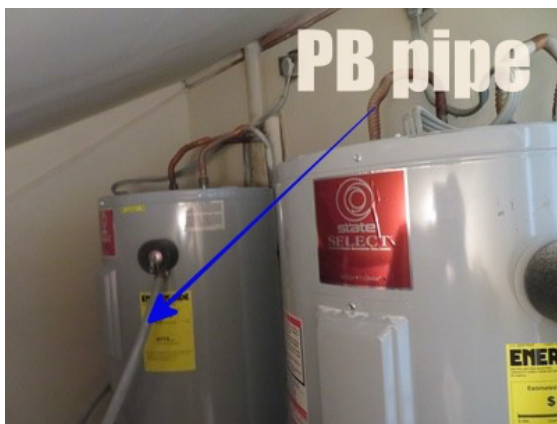
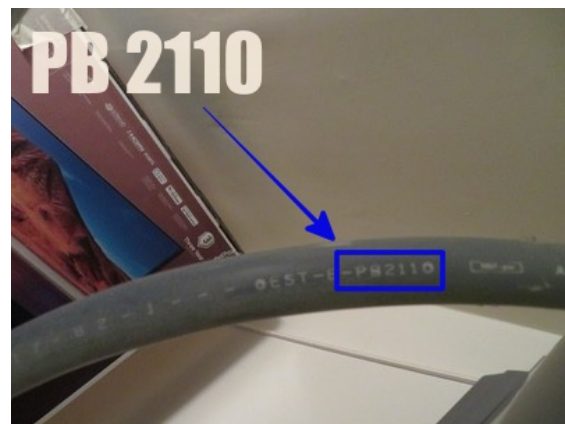
**24.** Polybutylene (PB) pipe is installed as fresh water supply lines on both water heaters. It's well known to frequently fail, in several modes, depending on the nature and amounts of chlorine additives used by your freshwater utility. Even properties served by private water wells have reported some issues. **Ask your plumber to replace it with a better choice of material such as Sharkbite, PEX or copper before a leak causes damage your home and perhaps personal property.**

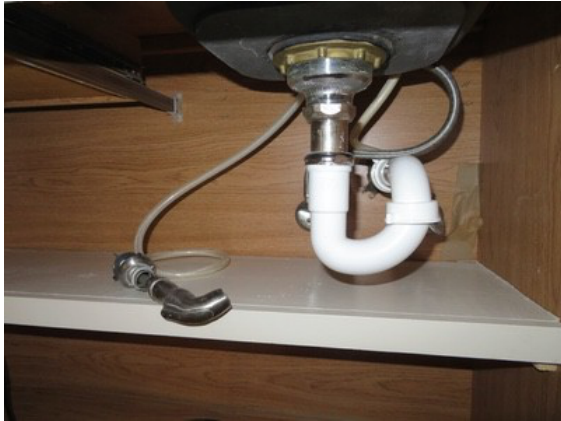
**25.** A lavatory on the 3<sup>rd</sup> floor has a spray attachment within the lavatory cabinet. Should it ever leak or accidentally open, the damage could reach all the way down to the 1<sup>st</sup> story master bedroom.

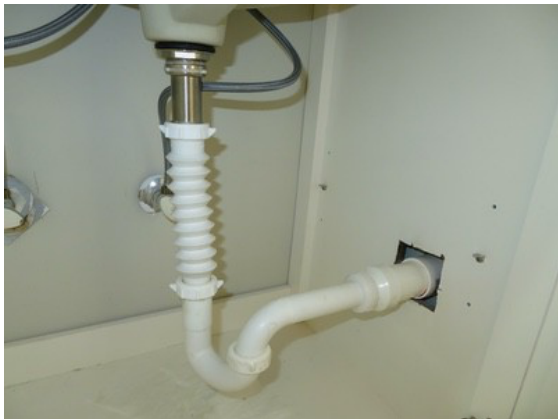
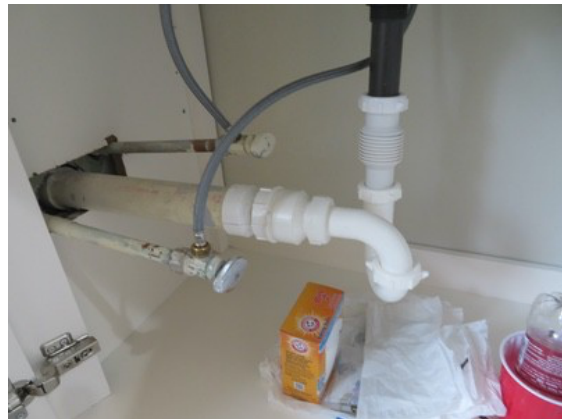
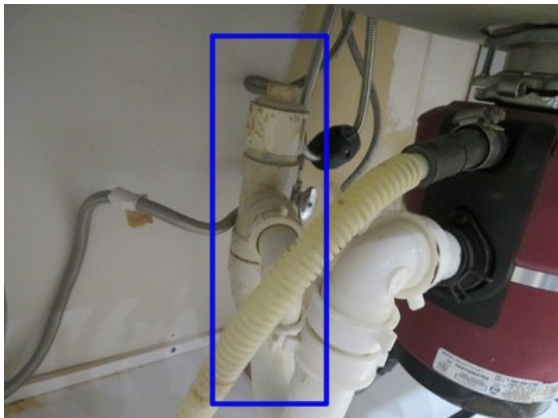
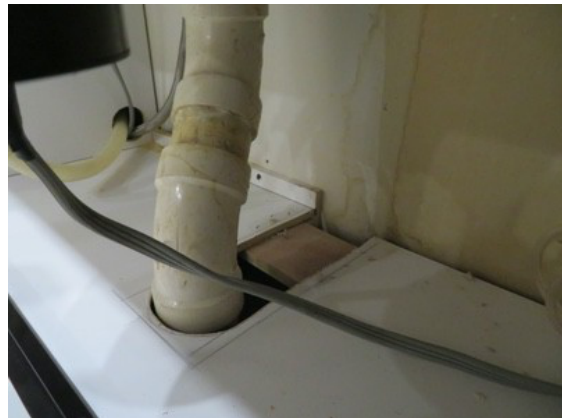
26. Corrugated drain line is installed on a bathroom lavatory. Lavatory drain lines should be smooth to reduce the chance of a clog. A licensed plumber would never make this mistake. Neither would he leave big gaping holes in the cabinet walls. Also, the drain plumbing on the kitchen sink is unvented. I don't anticipate major issue with any of these mistakes. The issue here is that an unqualified person did this work, which raises the possibility that the major renovation recently done on this house was not permitted/inspected by the local building code authority.

Contact the Lafayette Parish Metro-Code Authority (337 291-8461) and ask if there are any permits on file for this address. If there is, confirm with them that the work was inspected and passed. Often times, a permit is secured by the contractor, but the authorities are never contacted regarding the inspection.

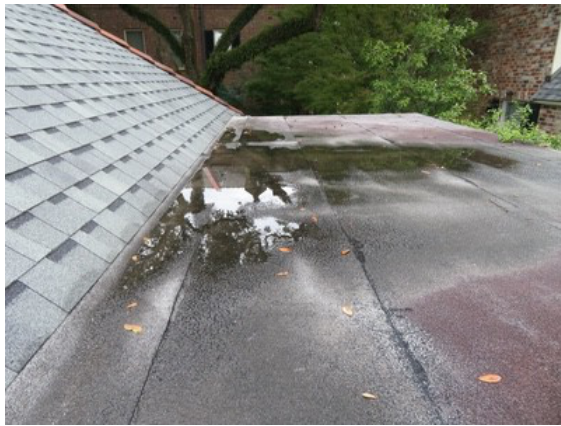
27. The roof over the right-side garage is flat with a slope in the wrong direction. It slopes upwards towards the edge instead of downward. Flat roofs should never be entirely flat but should slope slightly as pooled water can shorten the life of roofing membranes. Pooled water can escape only by evaporation, which can take days, or via a roof leak. I did not observe any active leaks in this roof. Just so you know that it may require more frequent replacement.

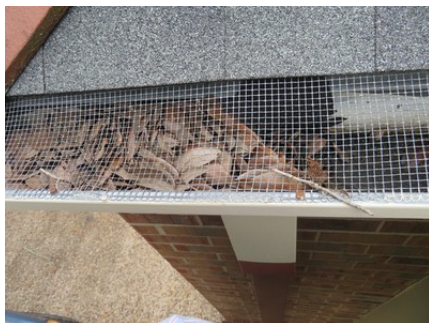
28. The roof gutters on the garage are clogged with leaves. Leaves may cause the gutter to overflow, resulting in erosion at the ground level. They also retain moisture, accelerating the corrosion of steel gutters and downspouts. The leaf filter shown in the photo suggests it was installed without clearing the gutters. **Get someone to clear all gutters.**

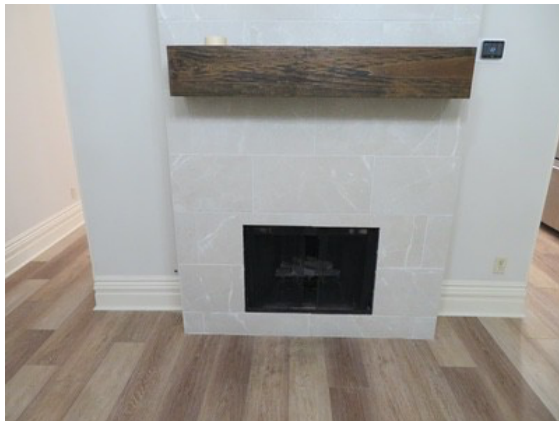
30. I've concerns that combustible building material is too close to the fireplace opening. I'm also unsure whether it is a wood-burning or gas fueled fireplace.

**Get a chimney sweep, certified by the Chimney Safety Institute of America (CSIA), to examine and correct this fireplace installation. The nearest one is in Port Allen, but I suspect that a certain local practitioner was once certified and has been in business since 1986 (Steven Comeaux Chimney Sweep).**

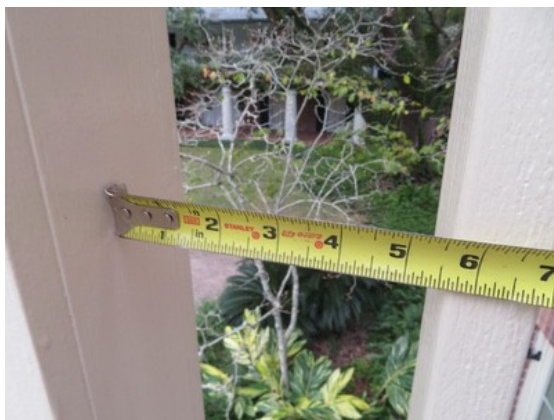
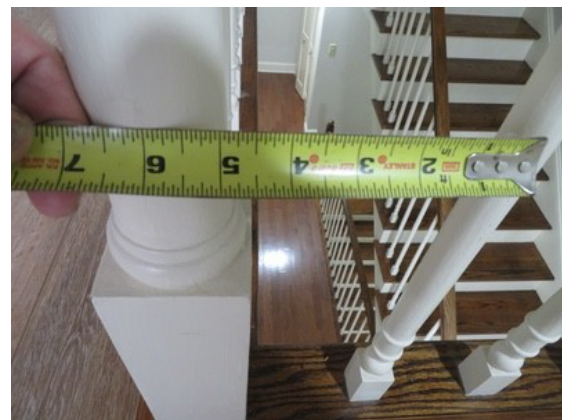
Some of the balusters are too far apart. To protect small children from falling through, the balusters should be close enough to prevent a 4" diameter sphere from passing through.

**Because of the risks of a fall, both stairway railings and all balcony guard rails should be either serviced or replaced with designs that are compliant with current building code requirements. Ignore any contractor who tells you that the house is exempt for current requirements because it's older. This isn't about code requirements, but safety.**

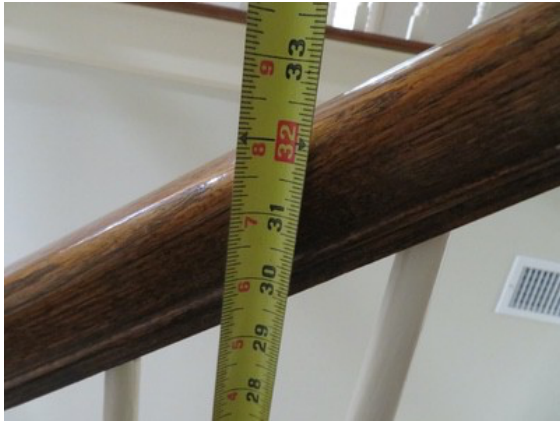
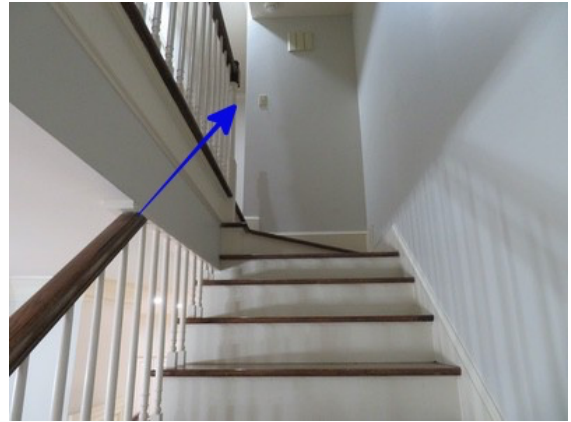
The handrail on at least one of the stairways is too low. It's about 32 inches but should be at least 34 inches. Another rail does not reach to the top of the stairs.

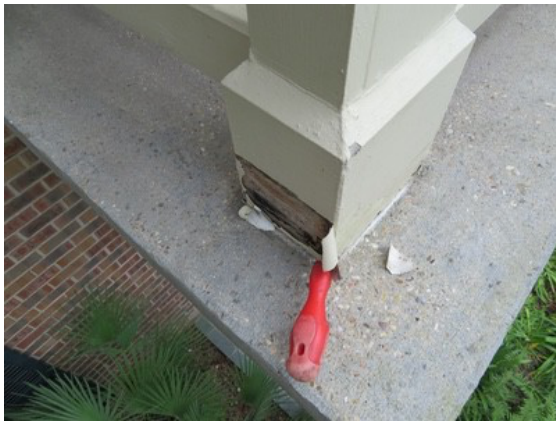
There is rot on at least one balcony rail.

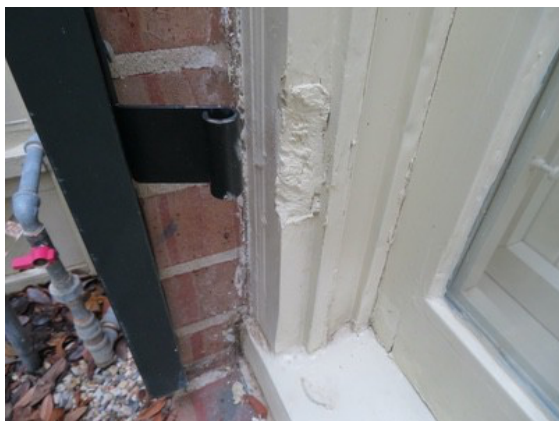
32. At least one of the shutter hinges are missing (kitchen window). These are functional shutters but they're not hurricane rated.
