Westinghouse Hanford Company

Sitewide Lessons Learned

Number: 96I032

FAILED OPEN STEAM TRAPS CAUSE WATER HAMMER

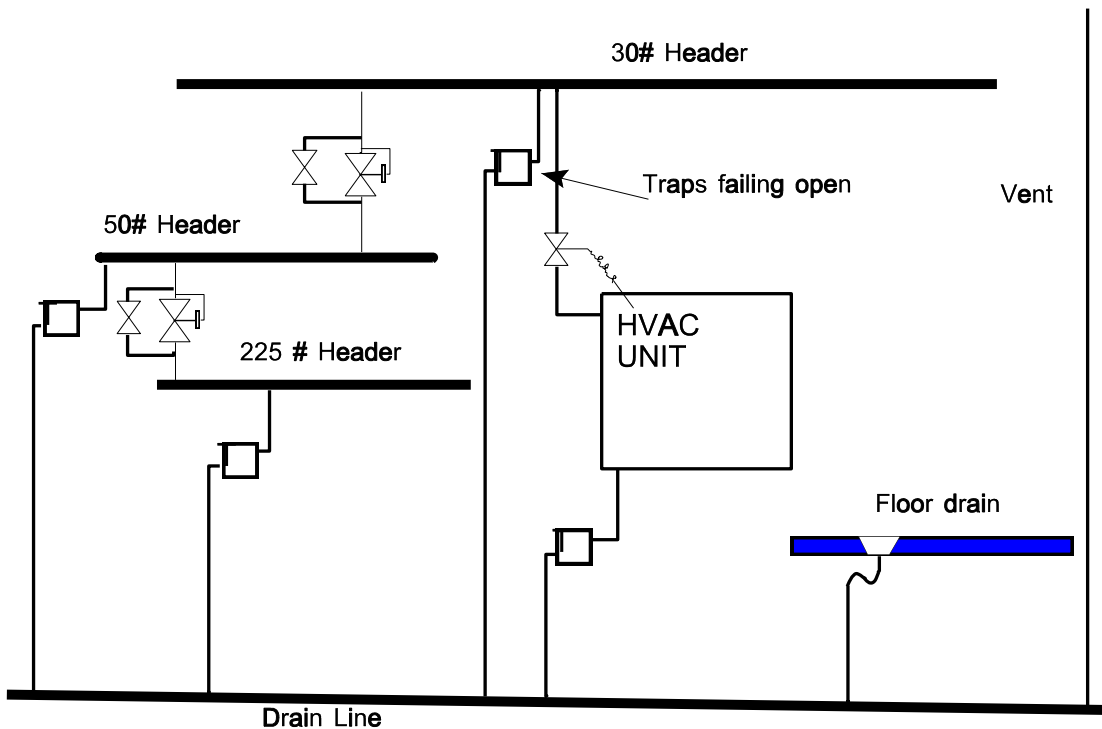
Steam Headers and Drain System Arrangement

Frequent pressure transients on a 30 psi steam system caused inverted bucket traps on that system to lose their prime and fail open. This allowed steam to pass into a drain line, causing water hammers and allowing steam to escape through vent lines and floor drains. No significant damage or personnel injuries occurred.

On March 28, a water hammer was noticed at two 45 degree elbows located just upstream of where the 30 psi main steam header end trap discharges into the building drain line. See Item 4 (trap T-2235-22D) in the drawing below. Pressure transients in the drain line caused water to backslash out of a nearby floor drain and a roof vent. Trap T-2235-22D was found to have failed open. This trap was isolated which stopped the water hammer and splashing of water from the floor drain and vent.

The next day another water hammer occurred farther downstream. Steam was seen coming out of all drain line vents and water was being blown out of some floor drains. Steam to the 30 psi header was secured to stop the hammering and

Low pressure differential across inverted bucket steam traps or sudden or frequent drops in steam pressure can cause the traps to lose their prime and fail open. Traps should be checked regularly for proper operation. Failed traps should be repaired expeditiously.
