Inspection Report

Property Address:

1111

Brighton MI 48114

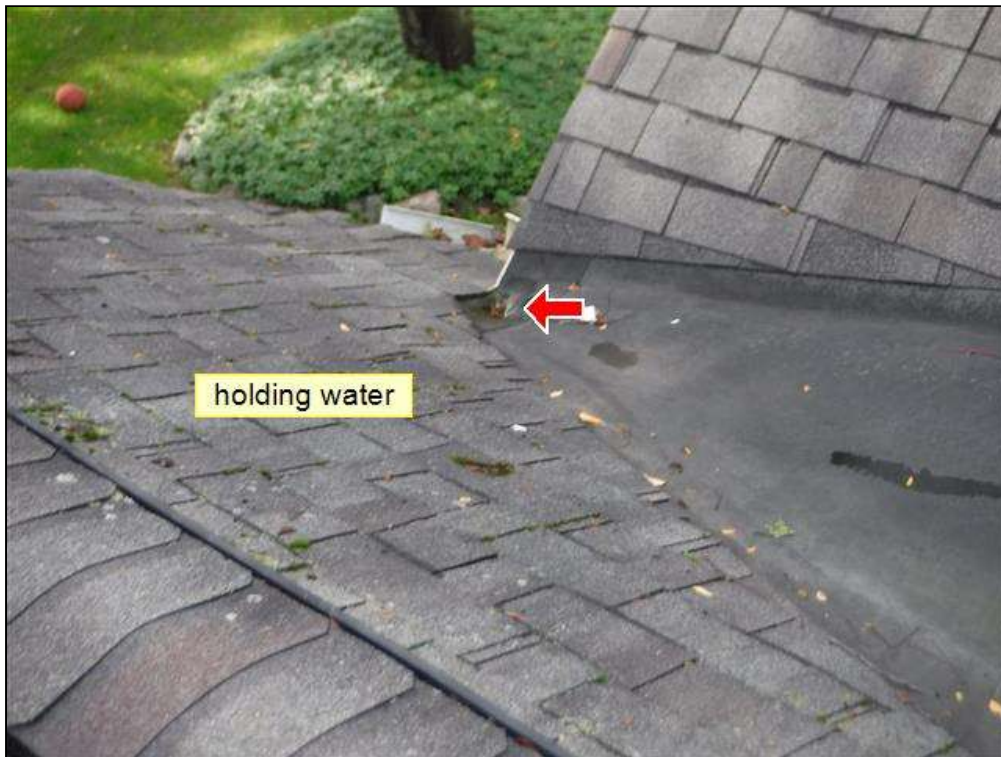
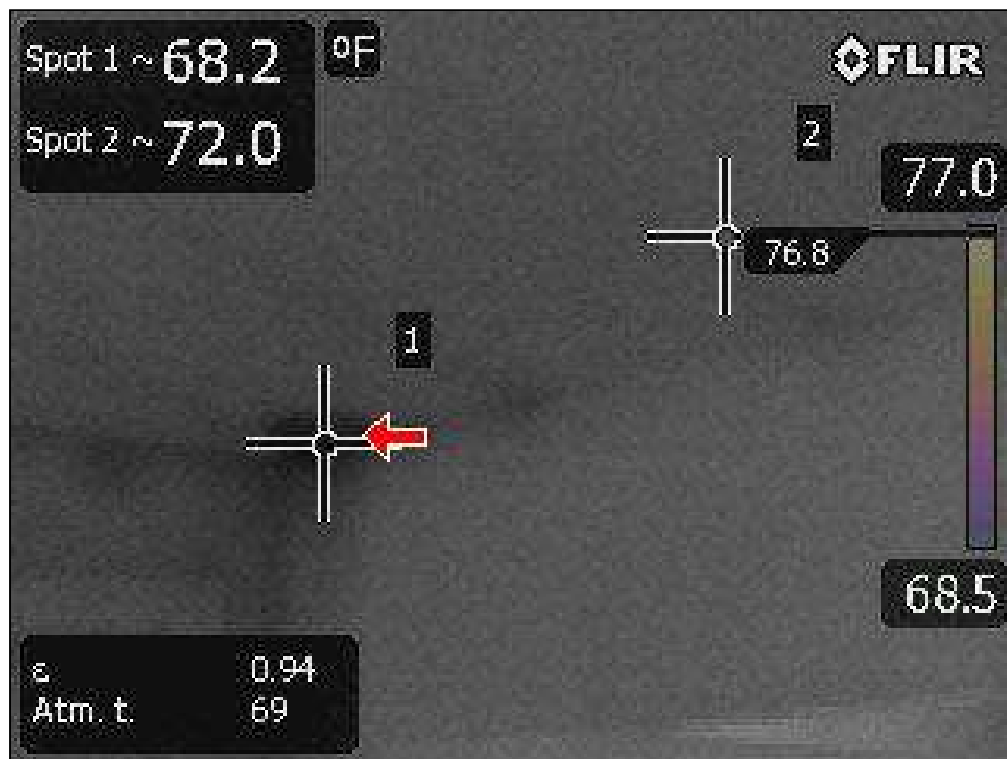
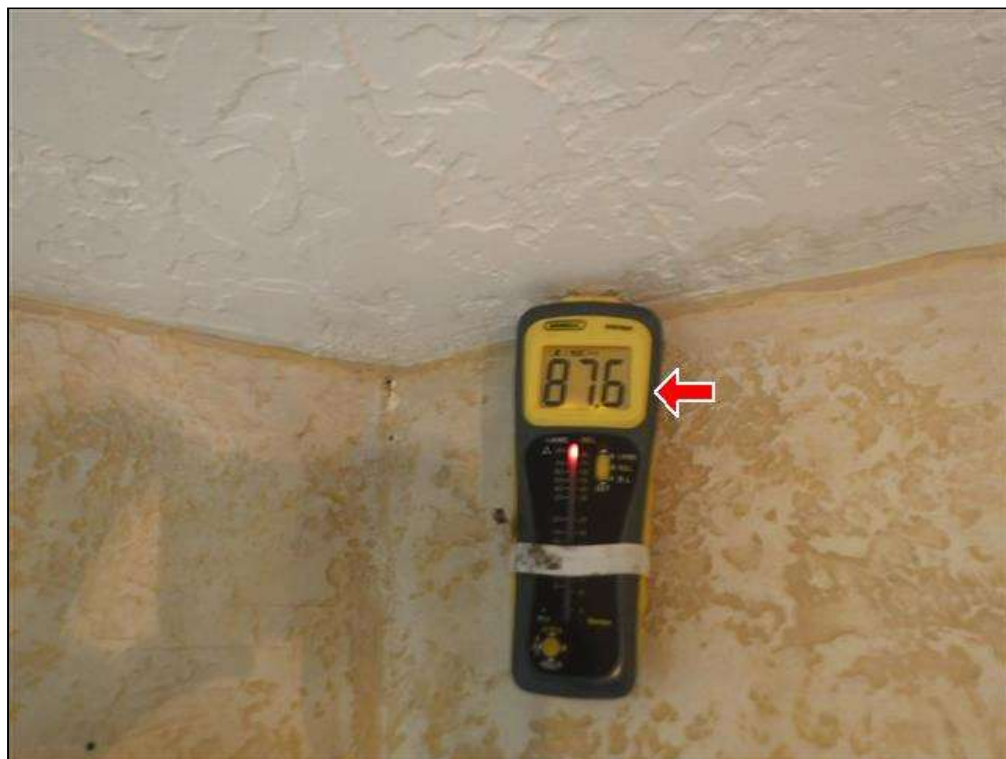
1.0 Rolled rubber is holding water, at indicated location. Current condition has resulted into moisture entry at indicated area of ceiling below. This was observed with a thermal imaging camera and confirmed with a moisture meter. Recommend repair as needed

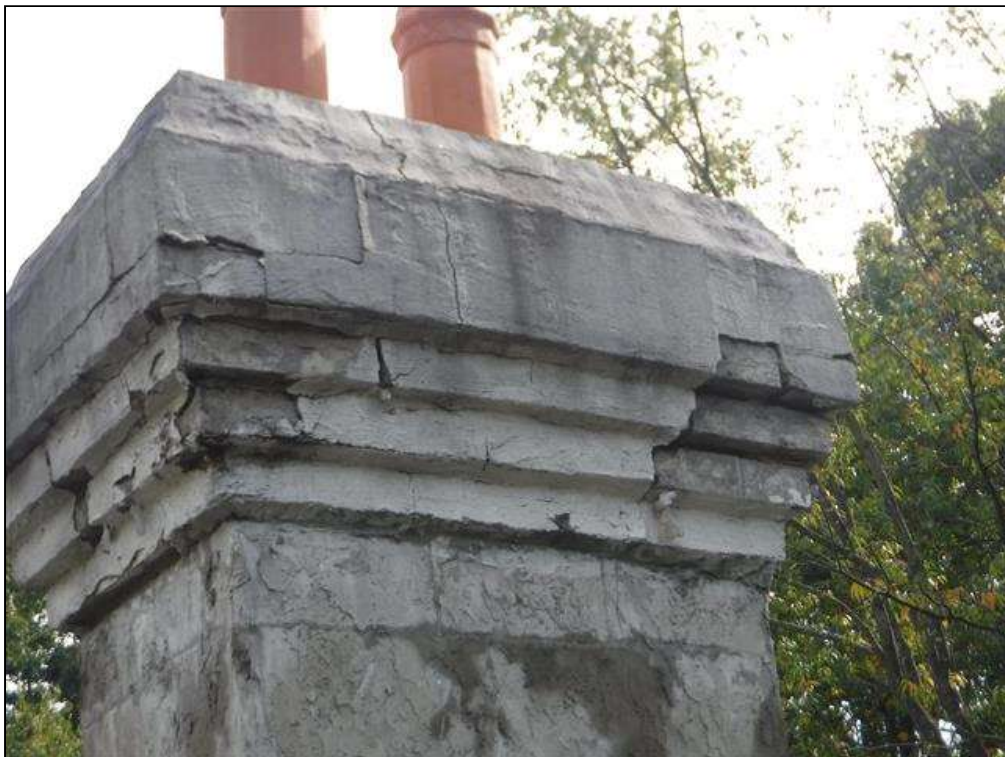
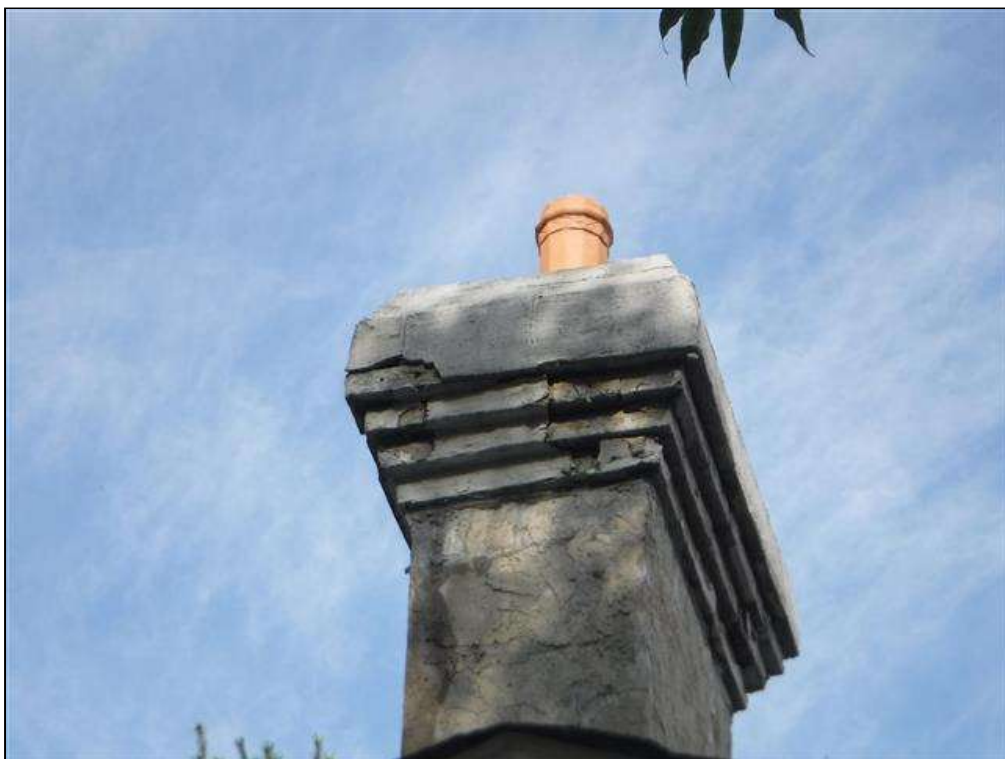
1.1 Severe deterioration to chimney masonry, at all chimneys. Recommend further evaluation by a qualified contractor to assess and determine cost of relative repairs.

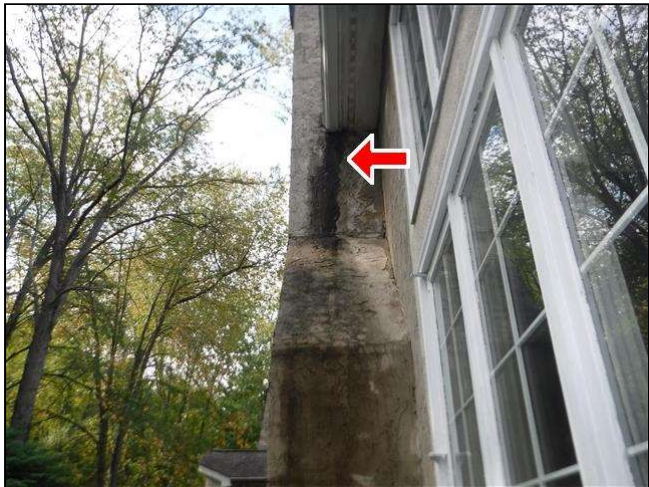
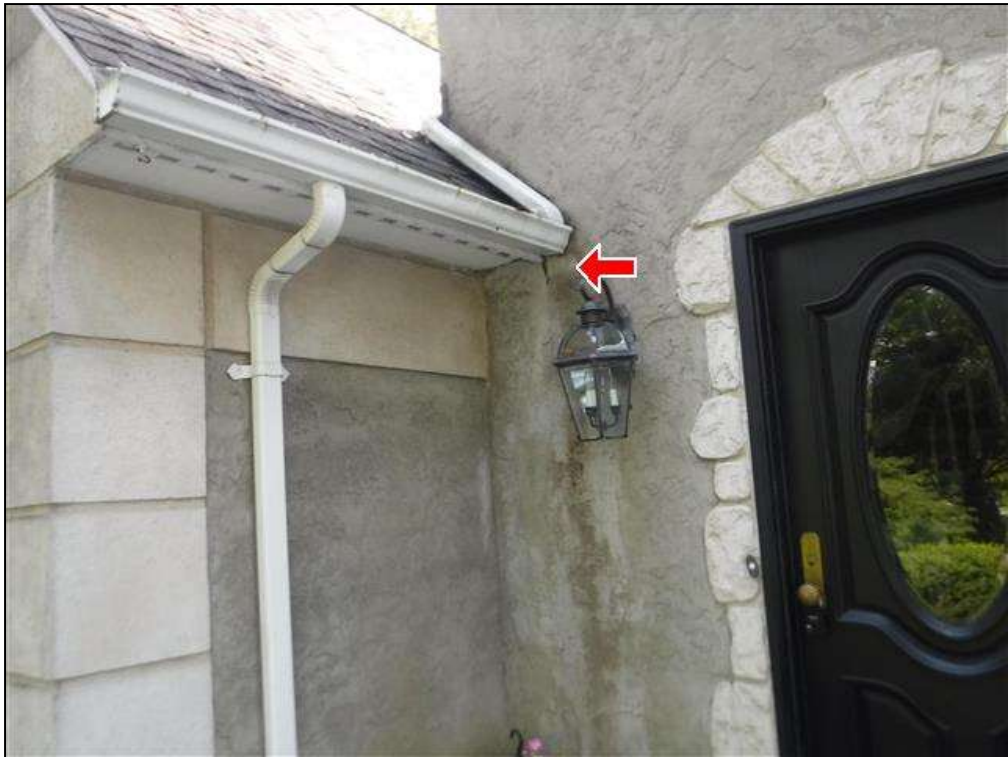
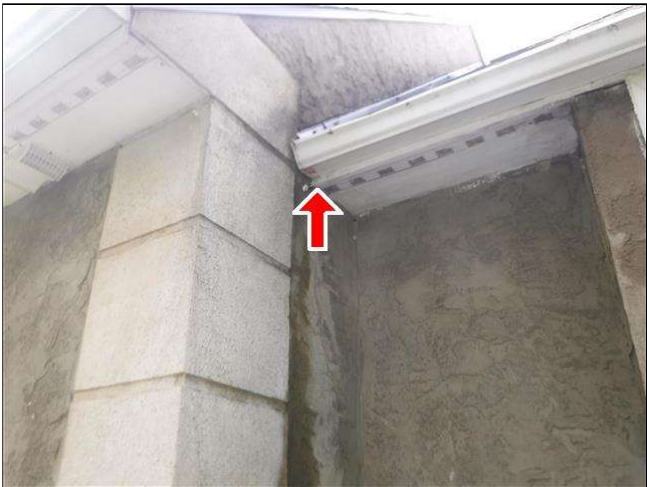
1.5 Gutters appear to be leaking/overflowing at multiple areas. Recommend repair as needed for improved water control.

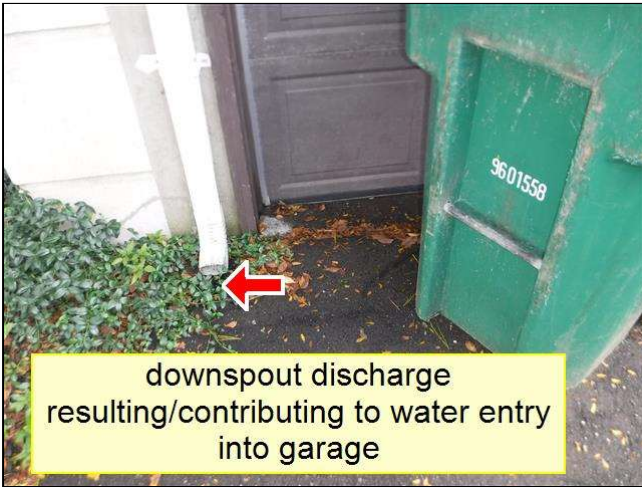
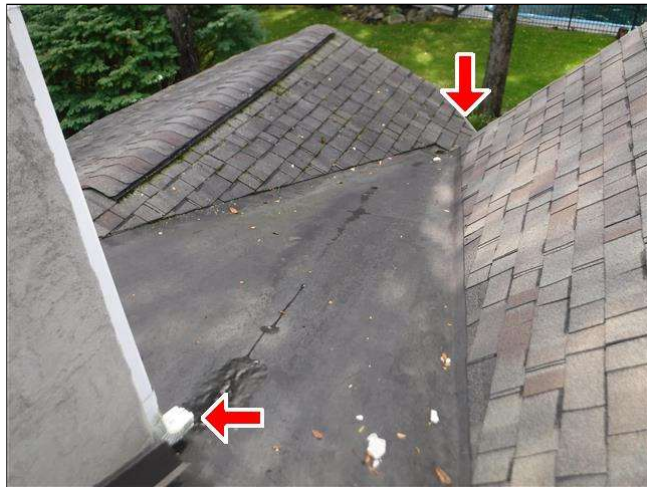
1.6 No/missing extensions. Recommend extending downspouts to drain water away from foundation.

Recommend reconfiguring discharge location of extension indicated. Current configuration is resulting/contributing to elevated moisture levels at the adjacent area in the garage.

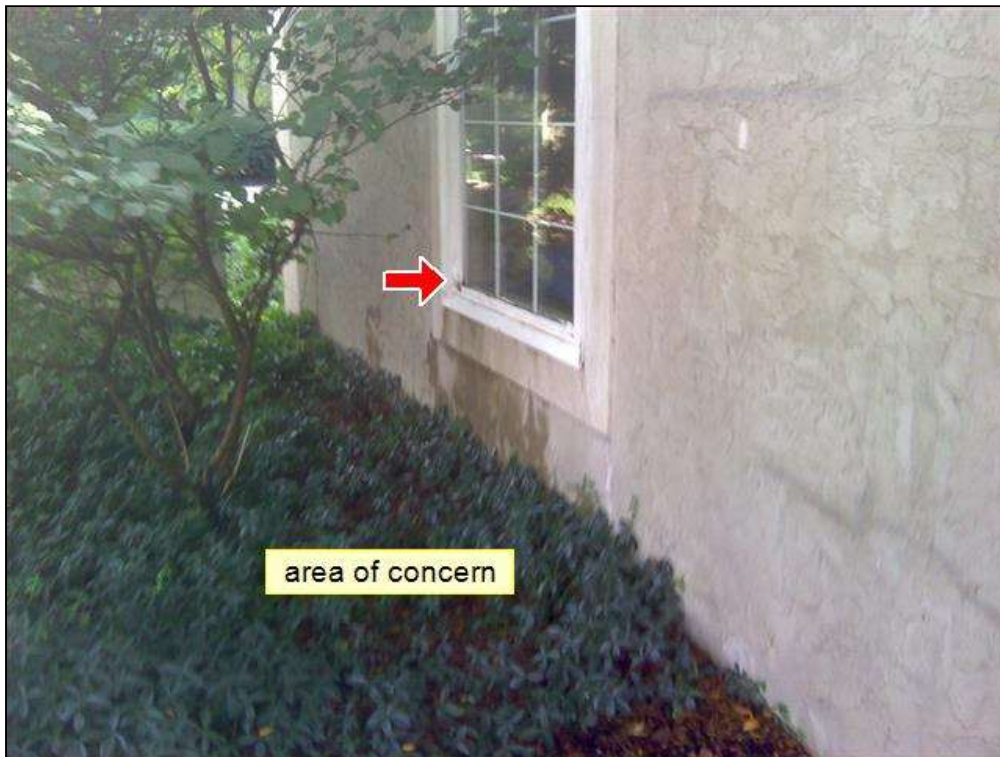
2.0 Item 1(Picture)

area of concern

2.0 Rotted trim at indicated area resulting in elevated moisture levels to wall cavity. Recommend repair as needed.

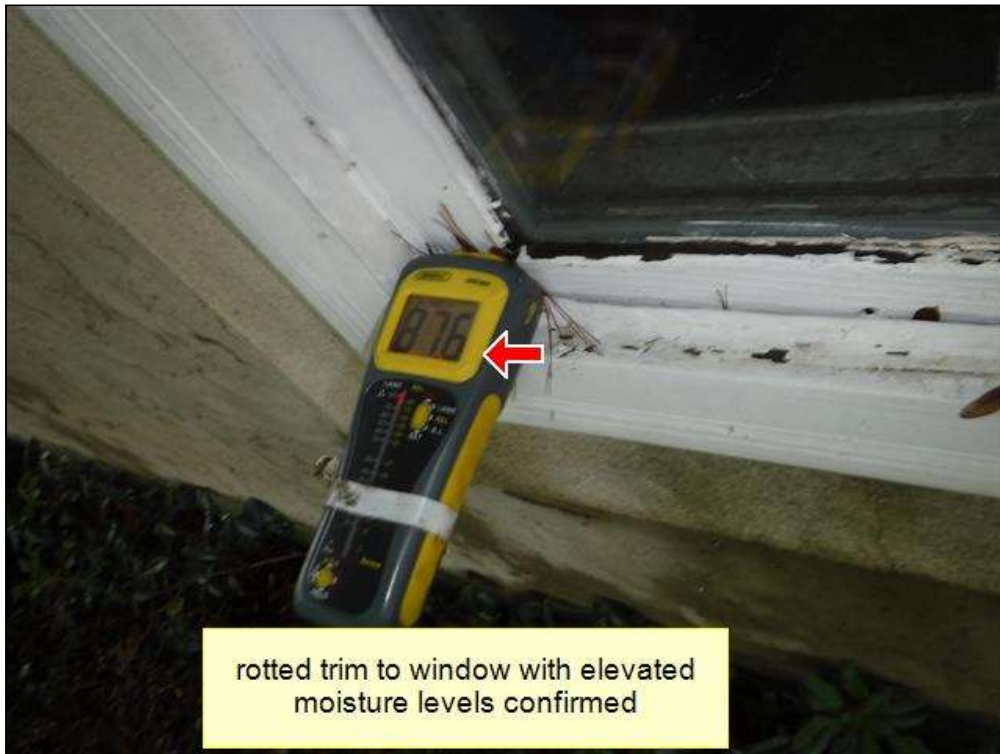
2.0 Item 2(Picture)

rotted trim to window with elevated
moisture levels confirmed

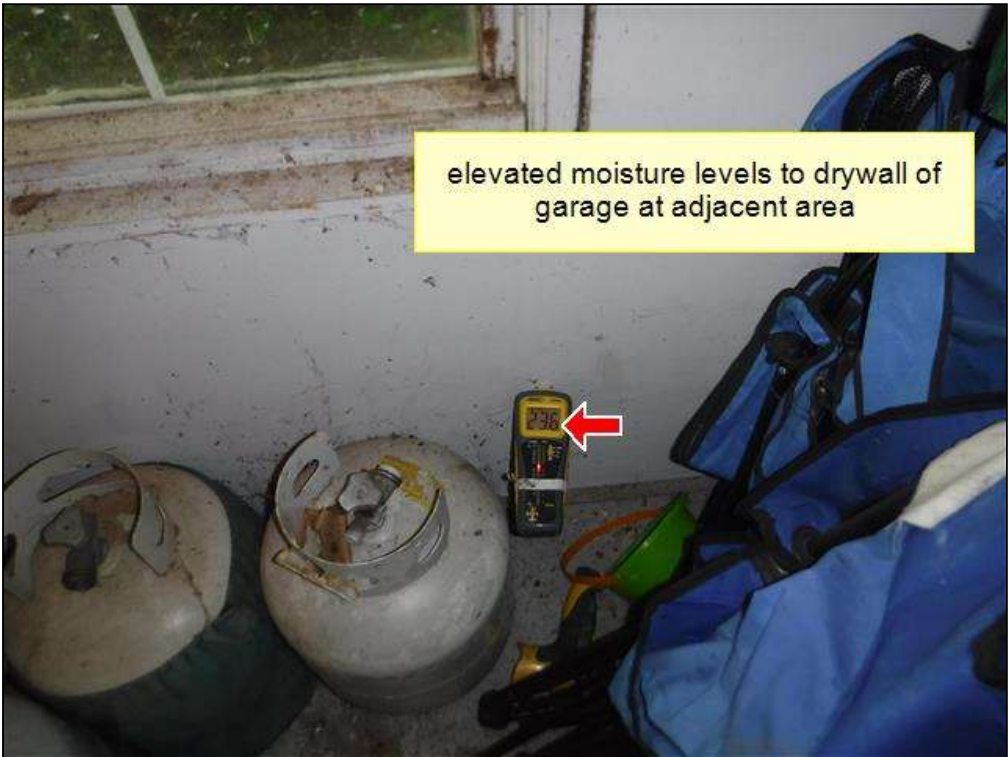
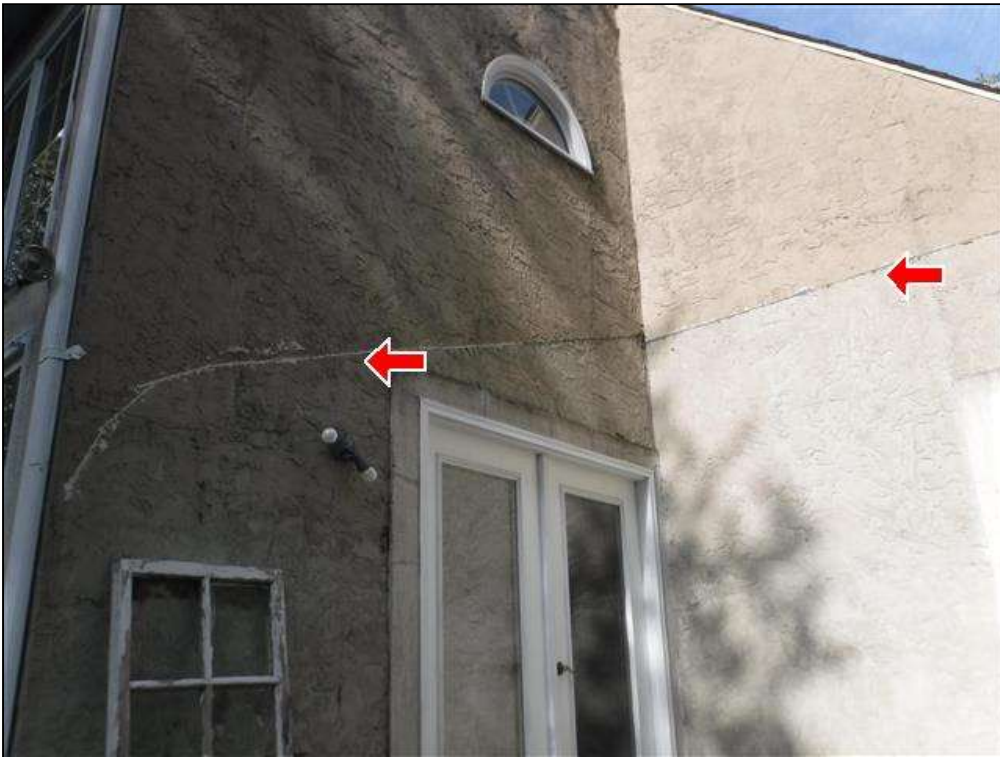
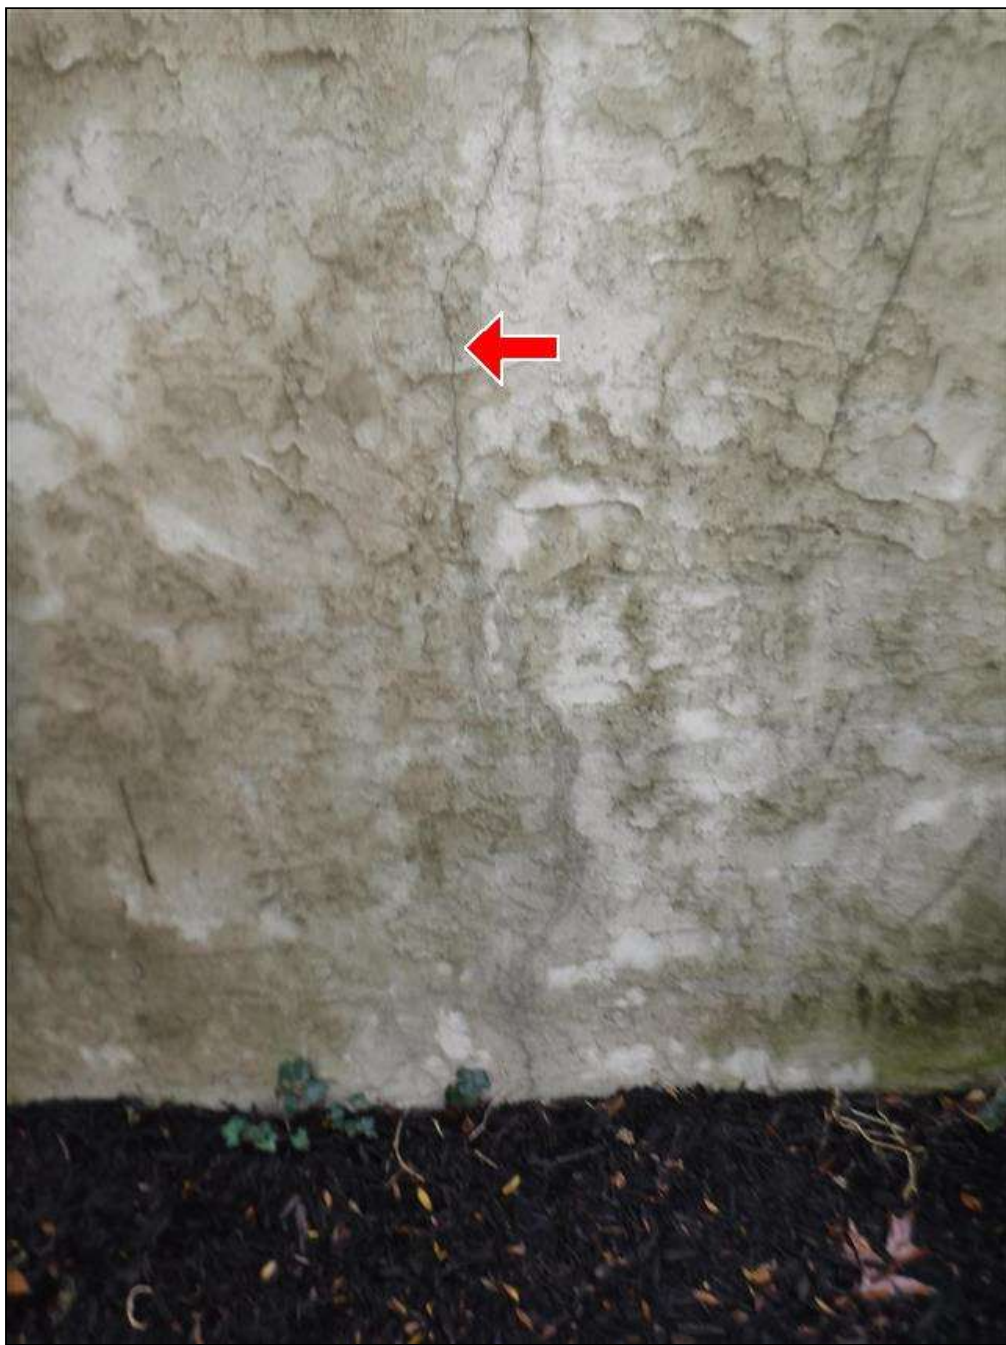
Monitor and maintain seal to fissures of stucco as needed. Recommend trimming all vegetation away from contact with home.

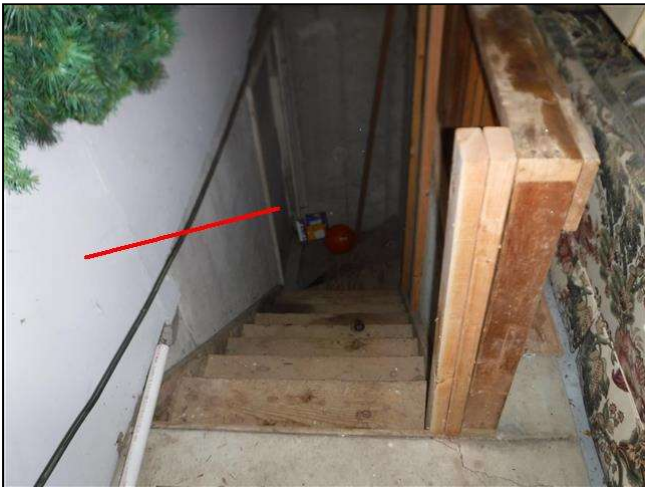
2.6 Item 1(Picture)

2.6 Install a graspable hand rail to steps, as desired for improved safety.

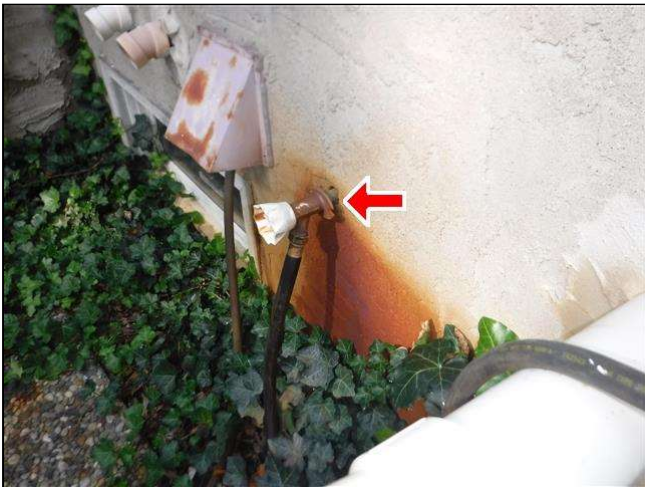
2.7 Item 1(Picture)

2.7 Recommend securing/adhering hose bib to home to prevent stress to plumbing components.

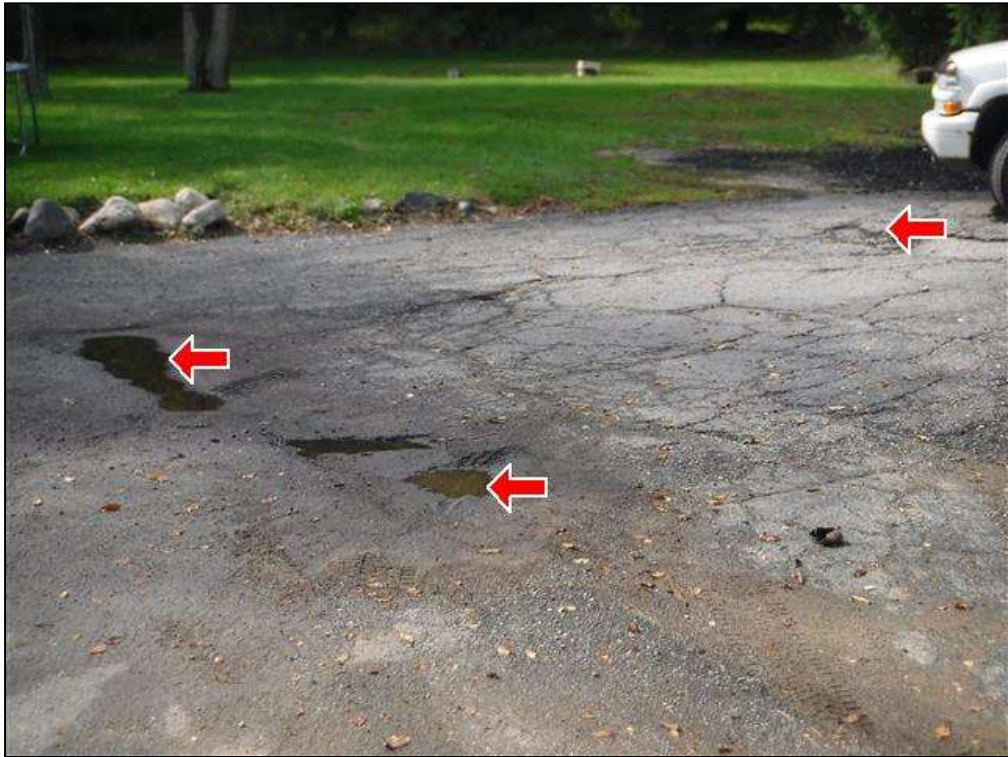
3.1 Item 1(Picture)

3.1 Soil under driveway has settled to the extent of causing depressions in asphalt of the driveway. Due to fact that the soil has settled to this degree, the only corrective action for this drive would be the removal of all asphalt, compacting the soil, and then applying new asphalt. If repairs are desired seek further evaluation by a qualified contractor to assess.

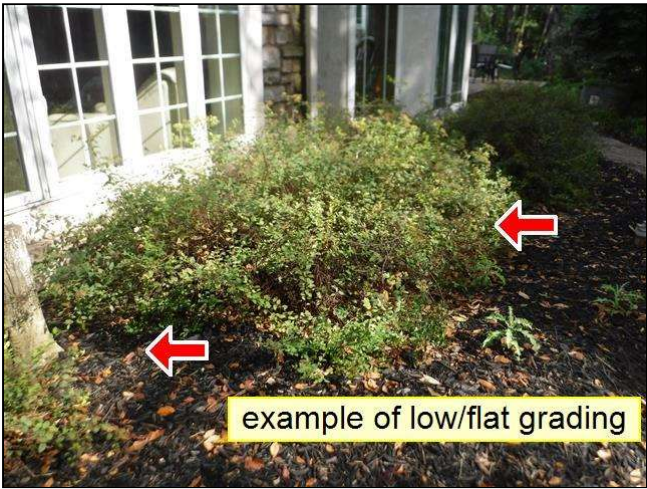
3.3 Item 1(Picture)

3.3 Negative/flat grade in multiple areas, build up around house as needed to divert water away from foundation and minimize water intrusion concerns.

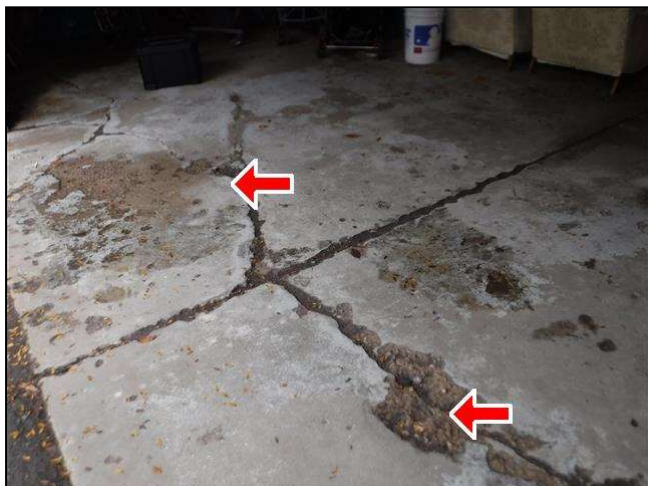
4.0 Item 1(Picture)

4.0 Deterioration to slab at multiple areas. Repair as desired.

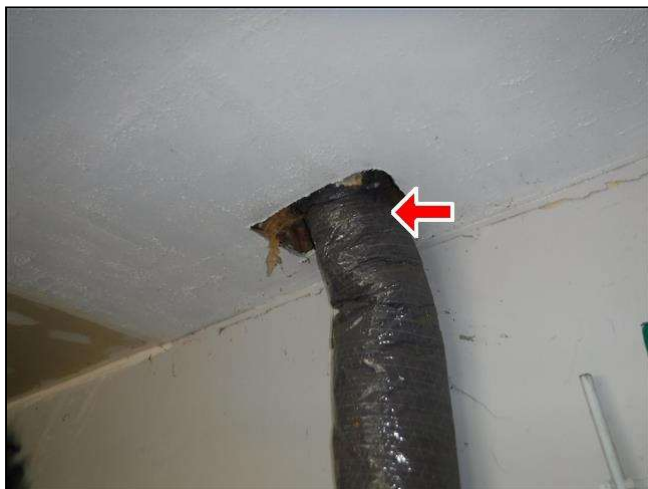
4.1 Item 1(Picture)

4.1 Recommend sealing voids in wall and ceiling to maintain fire barrier to liveable portions of home.

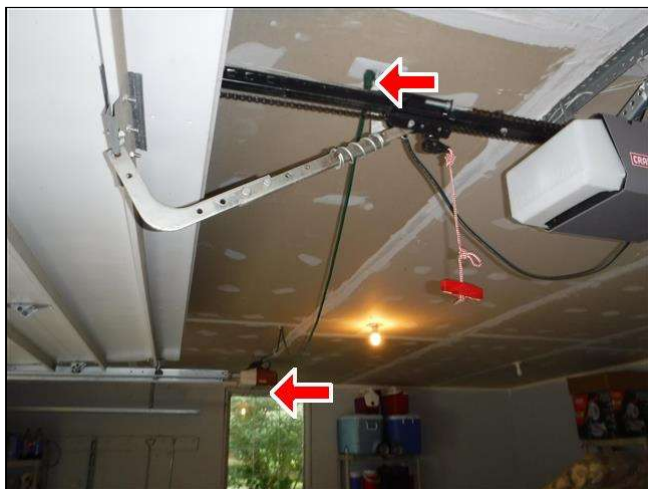
4.3 Item 1(Picture)

4.3 Door is powered using an extension cord. Recommend powering from dedicated outlet.

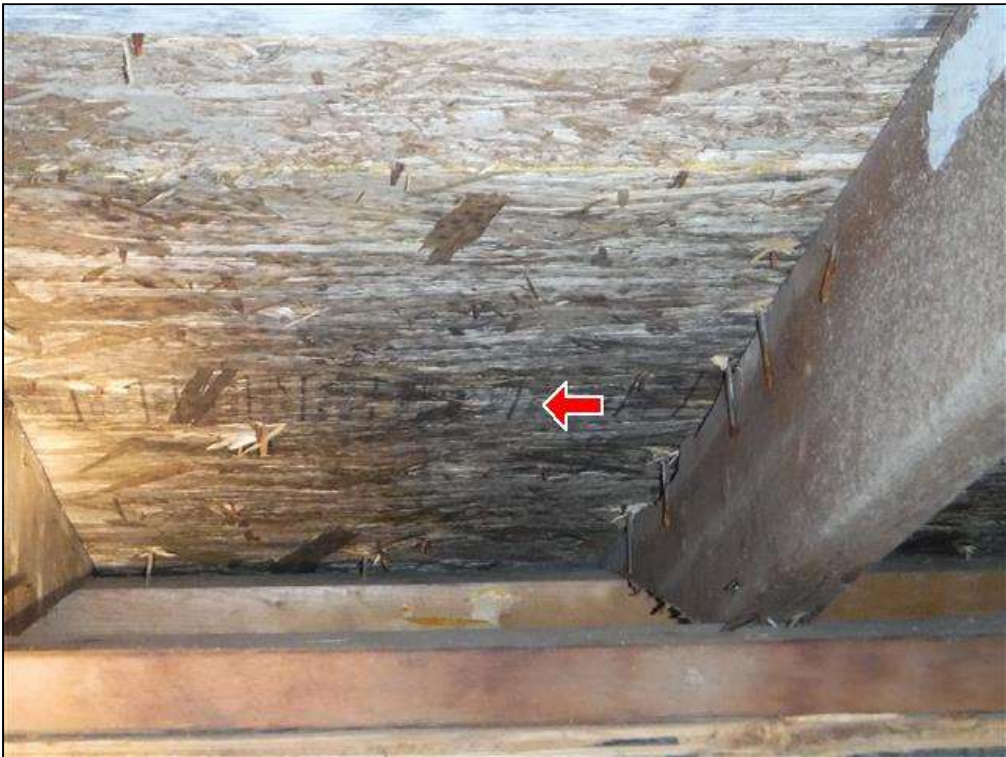
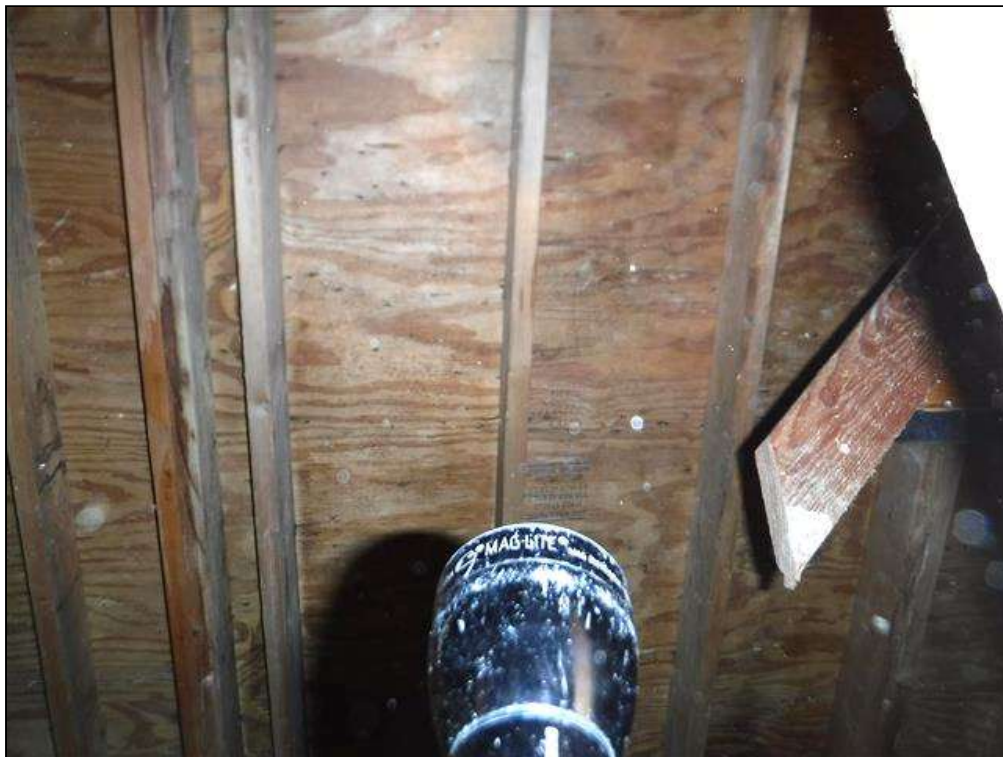
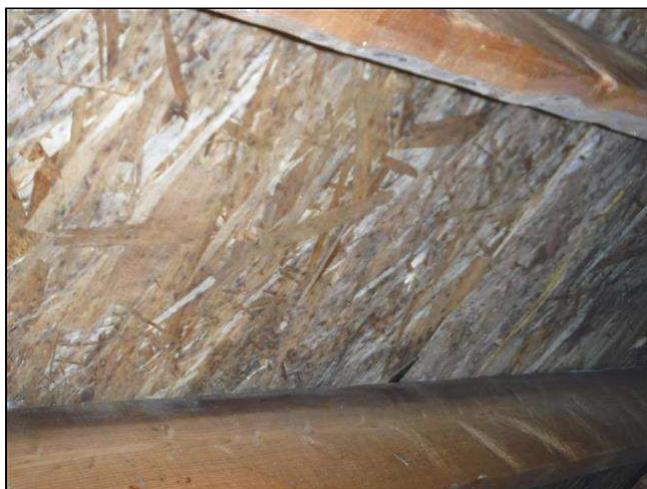
5.2 Fungal/Microbial growth observed on sheathing to attic space over master bathroom area. This is generally caused by restriction of air flow in attic. This condition can allow mold/mildew spores into home and become air born which could have health affects on person(s) prone to allergies. Further evaluation by a mold remediation contractor is recommended to determine cost of sanitizing effected areas and increasing ventilation provisions to the attic space and roof system.

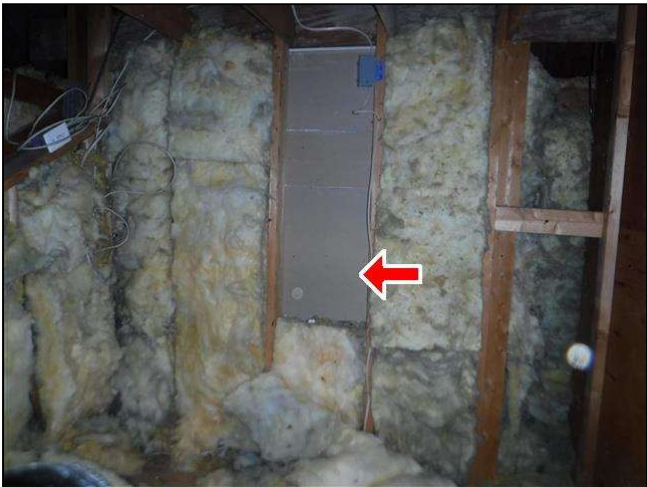
5.3 Item 1(Picture)

5.3 Replace fallen insulation off walls and missing insulation to attic entry hatches for improved efficiency.

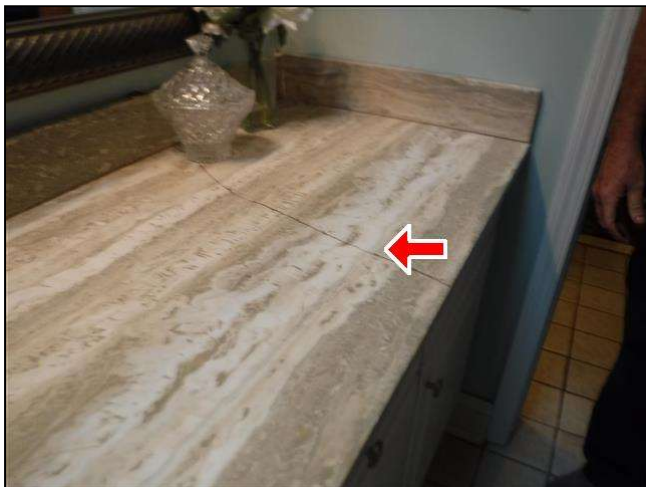
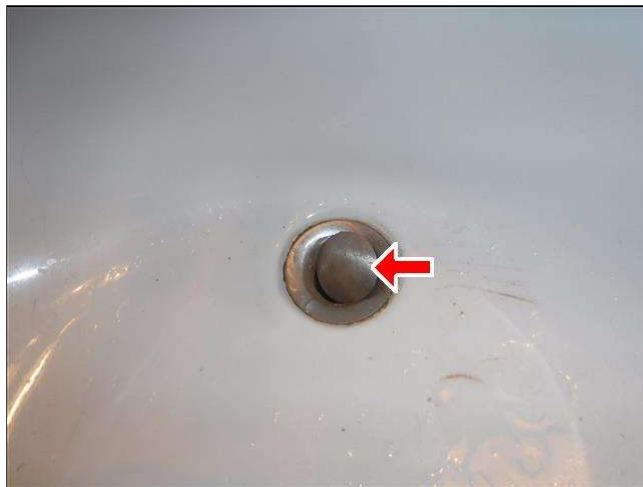
6.0.A Repair damaged countertop as needed/desired.

valve for drain stop mechanism does not create a seal. Repair as desired to hold water in sink.

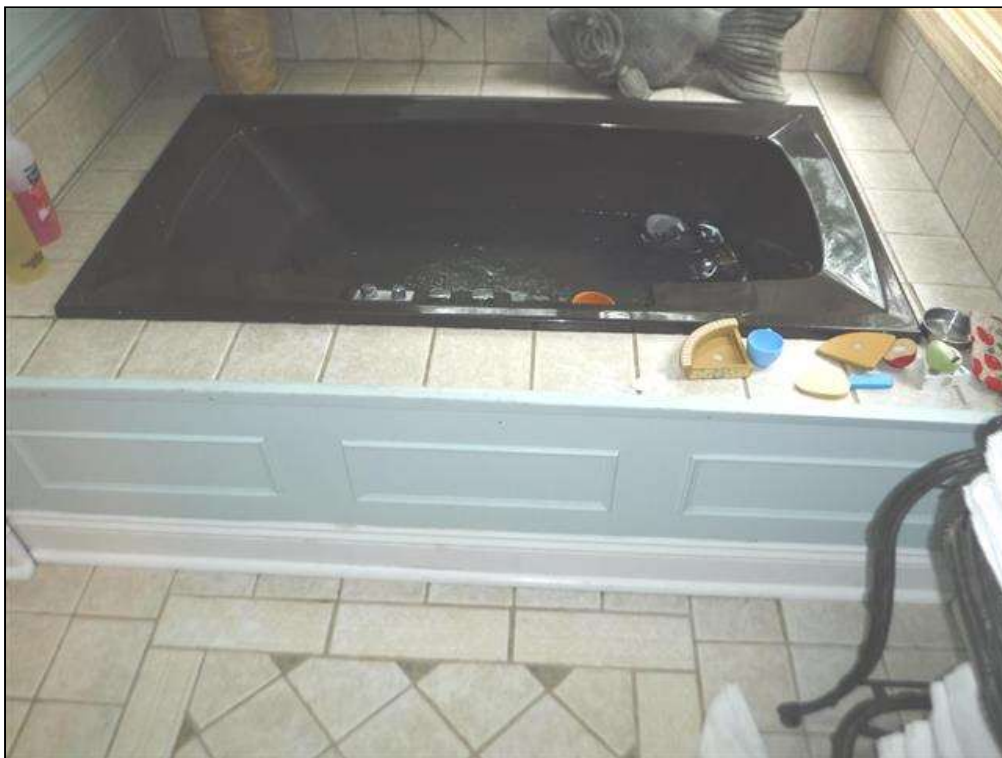
6.2.A Item 1(Picture)

6.2.A Multiple jets did not fire, further evaluate as needed to determine corrective actions.

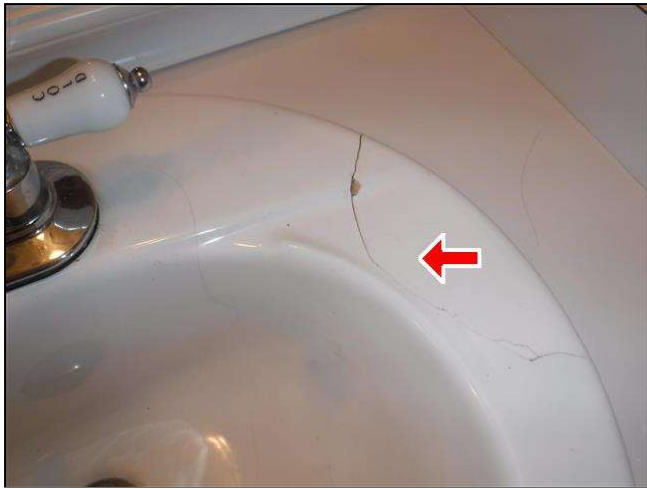
6.0.B Item 1(Picture)
6.0.B Recommend repair/replace of damaged sink, as needed.

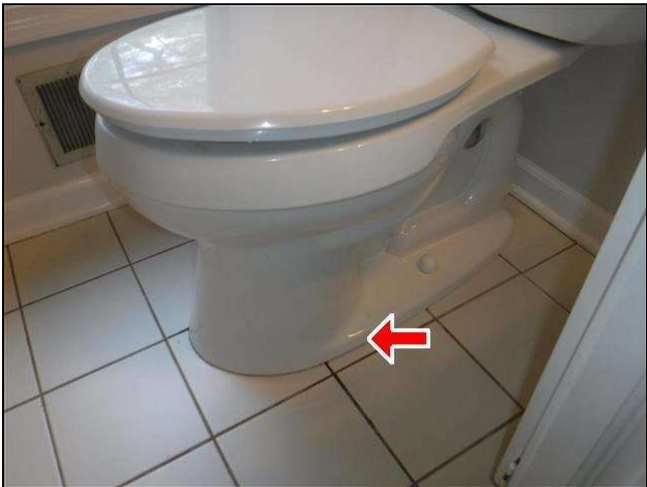
6.1.B Item 1(Picture)

6.1.B Toilet is loose at the flange, tighten/seal with new wax ring, as needed to prevent leaking when toilet drains.

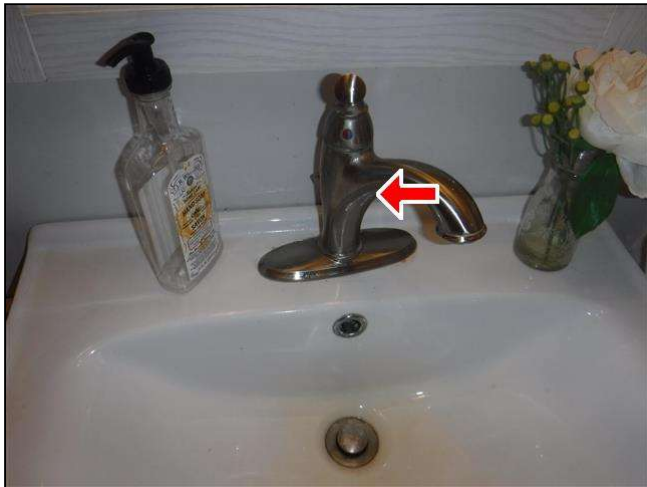
6.0.C Item 1(Picture)

6.0.C Fixture is loose. Repair/secure as needed to prevent stress to plumbing.

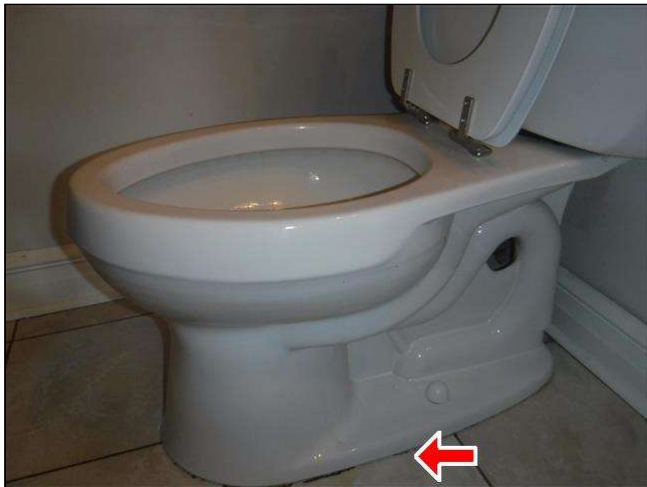
6.1.C Item 1(Picture)

6.1.C Toilet is loose at the flange, tighten/seal with new wax ring, as needed to prevent leaking when toilet drains.

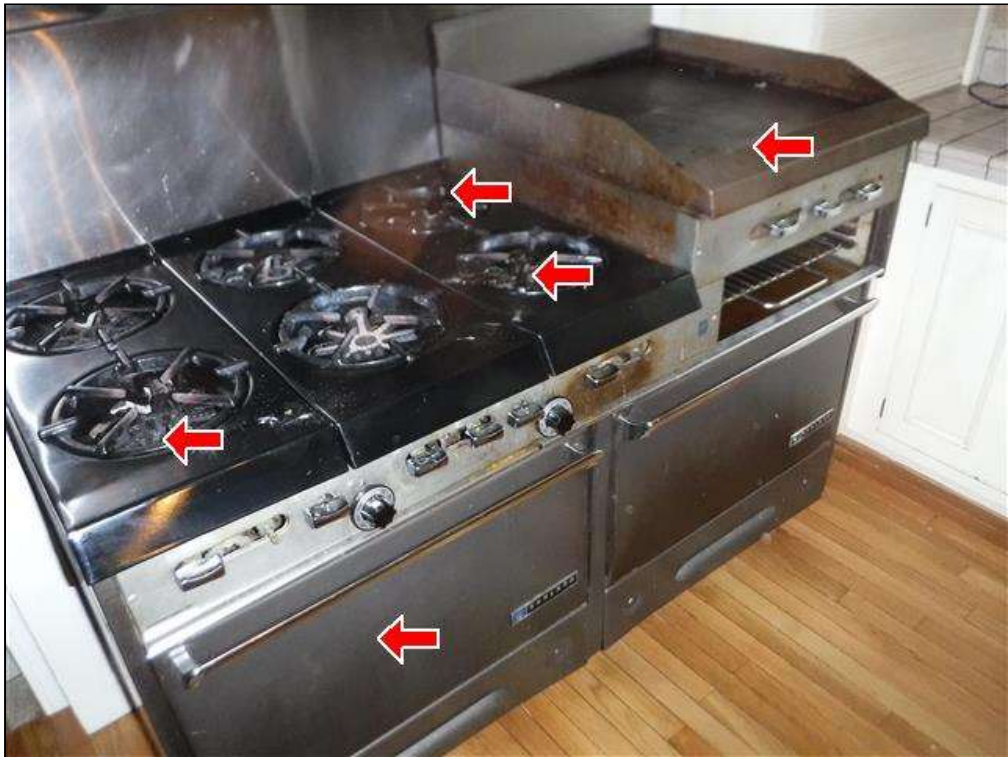
7.3 Item 1(Picture)

7.3 Burners indicated did not fire using normal operating controls. Repair as desired for proper function of the unit.

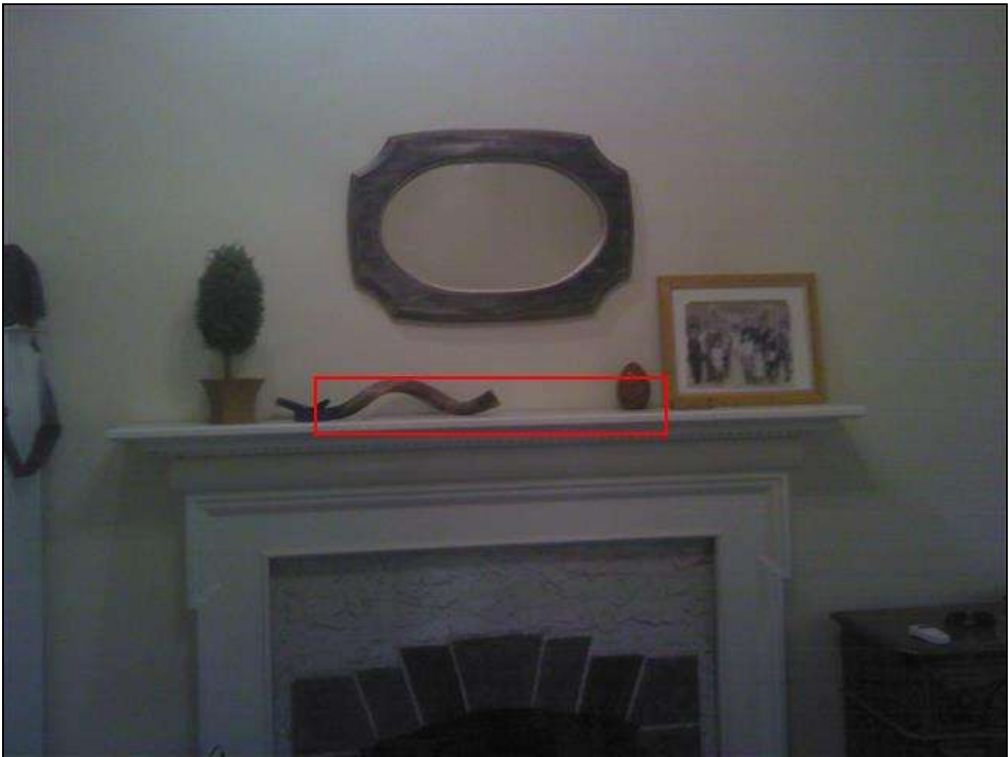
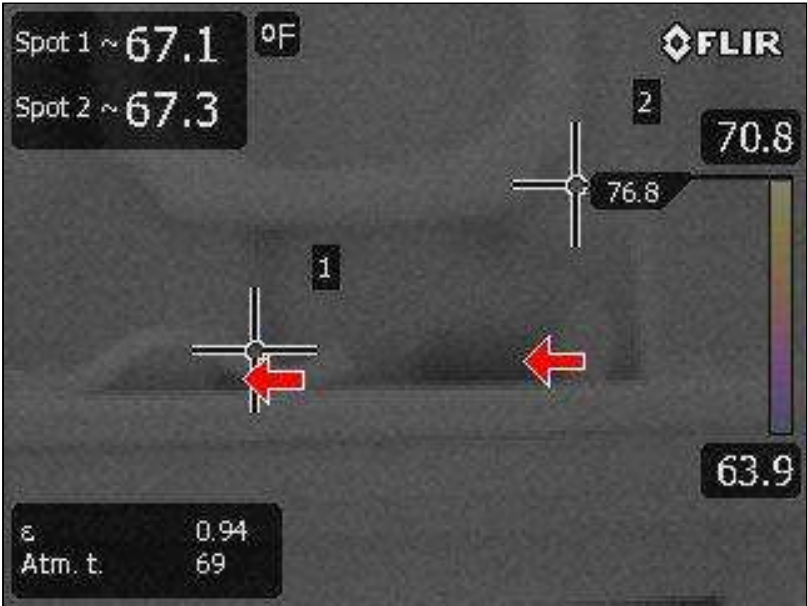
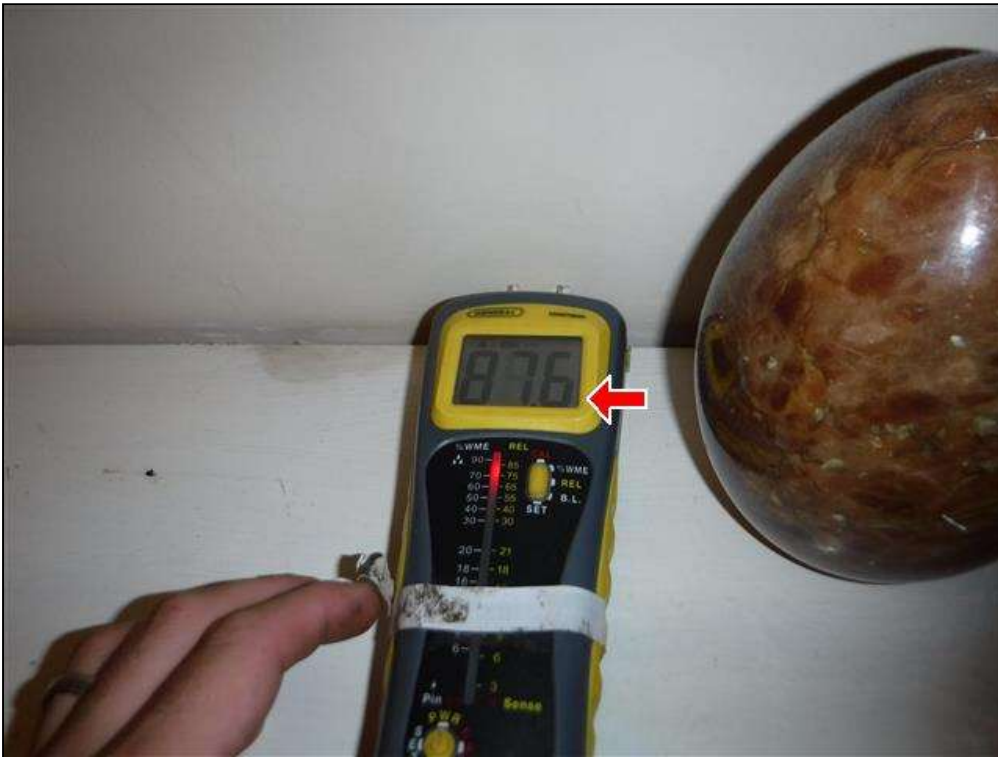
8.1 Ongoing moisture entry to wall cavity over master bedroom fireplace adjacent chimney. This was observed with a thermal imaging camera and confirmed with a moisture meter. Recommend further evaluation to assess and determine corrective actions necessary.

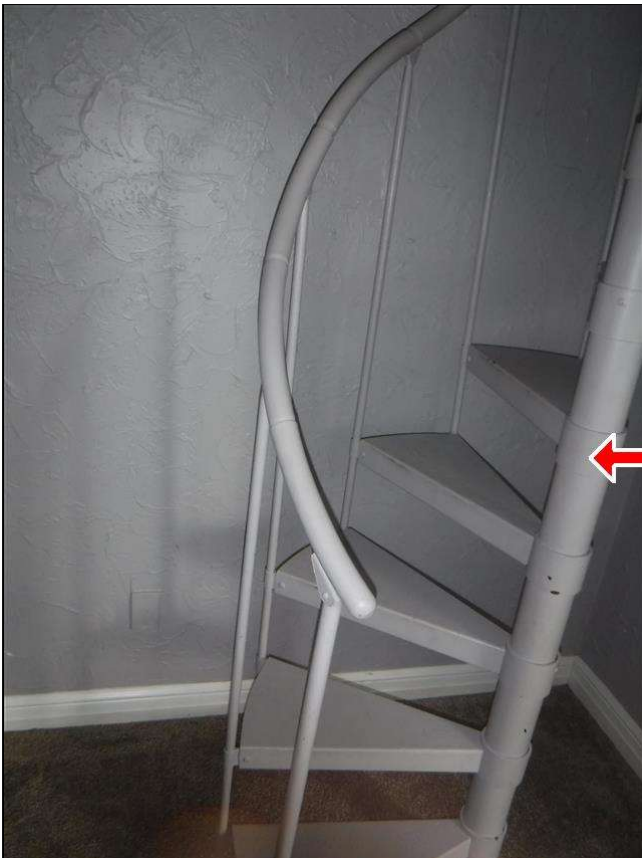
8.3 Item 1(Picture)

8.3 Spiral staircase is slightly loose. Secure as needed for improved safety.

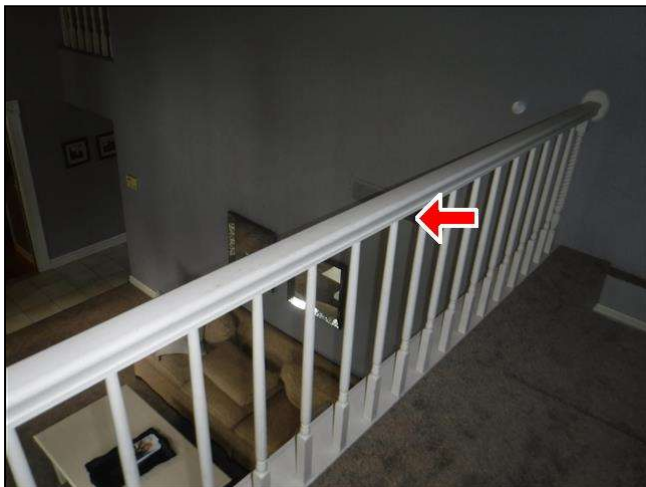
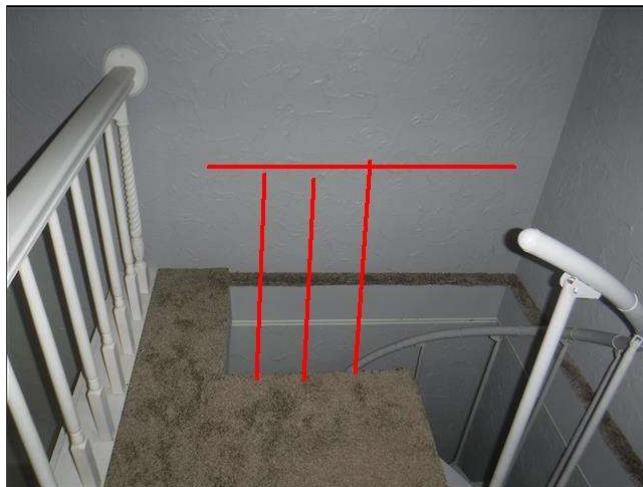
8.4 Railing(s) indicated are loose and should be secured more adequately for improved safety/proper function. Recommend installing a balustered guard rail to indicated areas to prevent fall hazard during use of steps.
