Inspection Report

Property Address:

1111

Brighton MI 48114

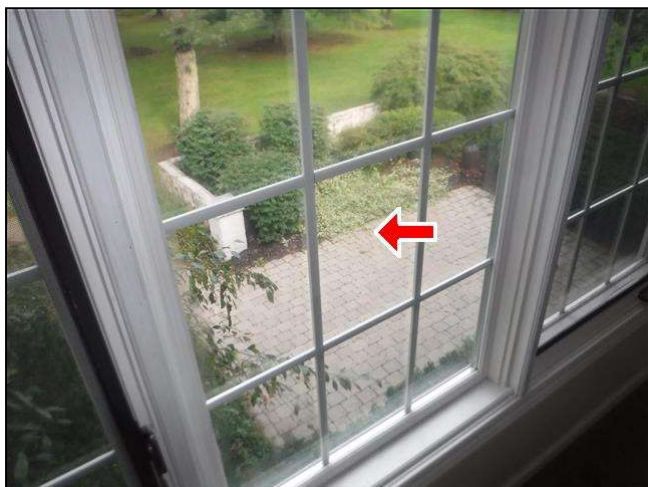
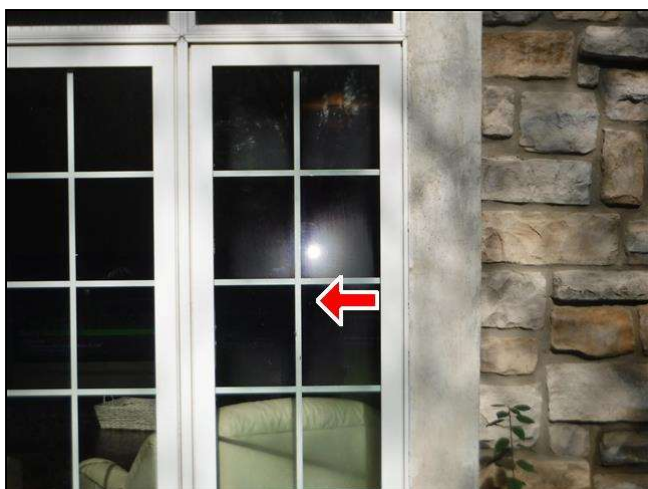
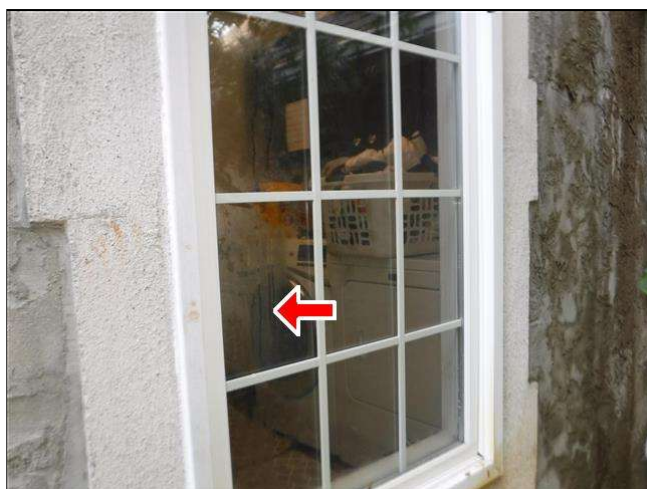
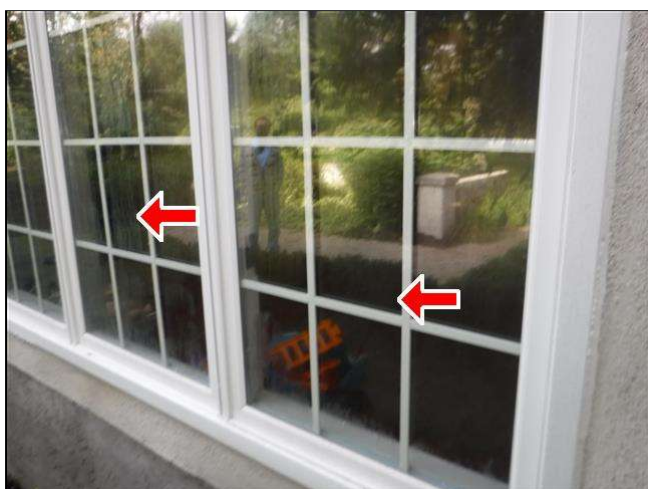
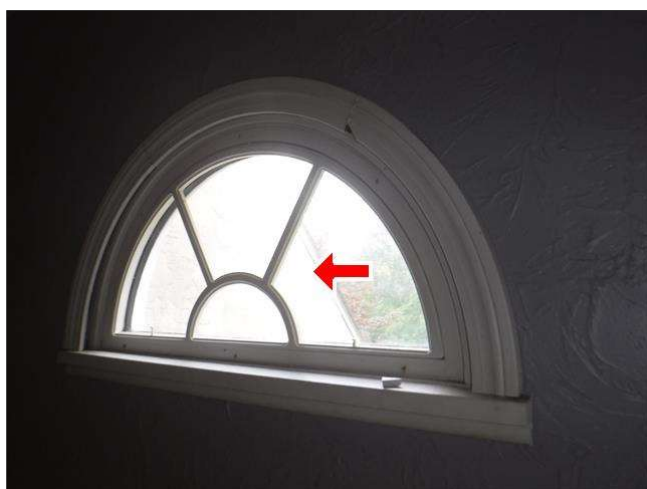
8.5 Broken seals to multiple window panes. Although double-paned windows appear to be stable, they actually experience a daily cycle of expansion and contraction caused by thermal pumping. This process occurs when sunlight heats the air space between the panes and causes the gas there to heat up and pressurize. Expanding gas cannot leave the chamber between the panes, and causes the glass to bulge outward during the day and contract at night to accommodate the changing pressures. This motion acts like the bellows of a forge, pumping minute amounts of air in and out of the air space between the panes. Over time, the constant pressure fluctuations caused by thermal pumping will stress the seal and challenge its ability to prevent the flow of gas in and out of the window chamber. Often when the seal is compromised and if

it is cold enough, incoming humid air has the potential to condense on the window's surface. Repair as needed/desired for proper function of the window/improved visibility.

Due to the amount of the repairs, the inspector recommends further evaluation by a qualified contractor to assess all windows and determine cost of relative repairs.

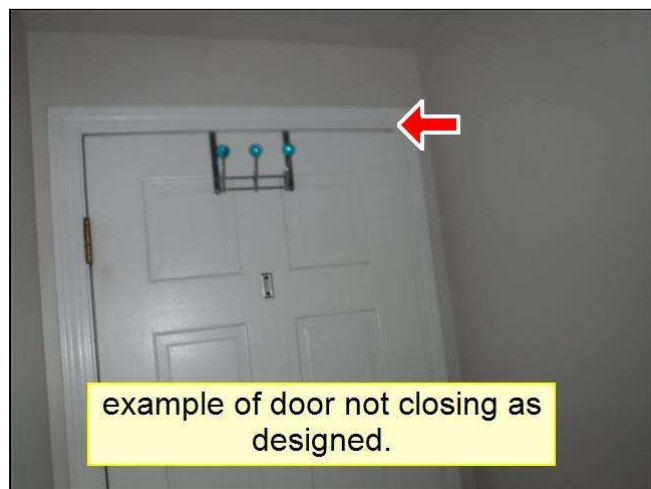
8.6 Item 1(Picture)

8.6 multiple doors rubbing jambs. Repair as needed for proper function.

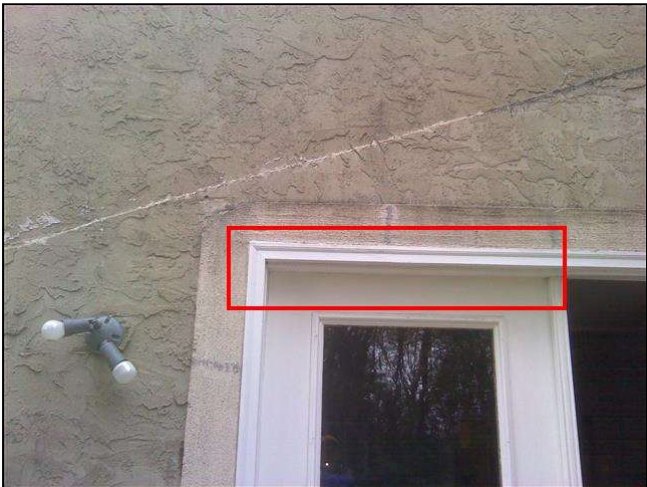
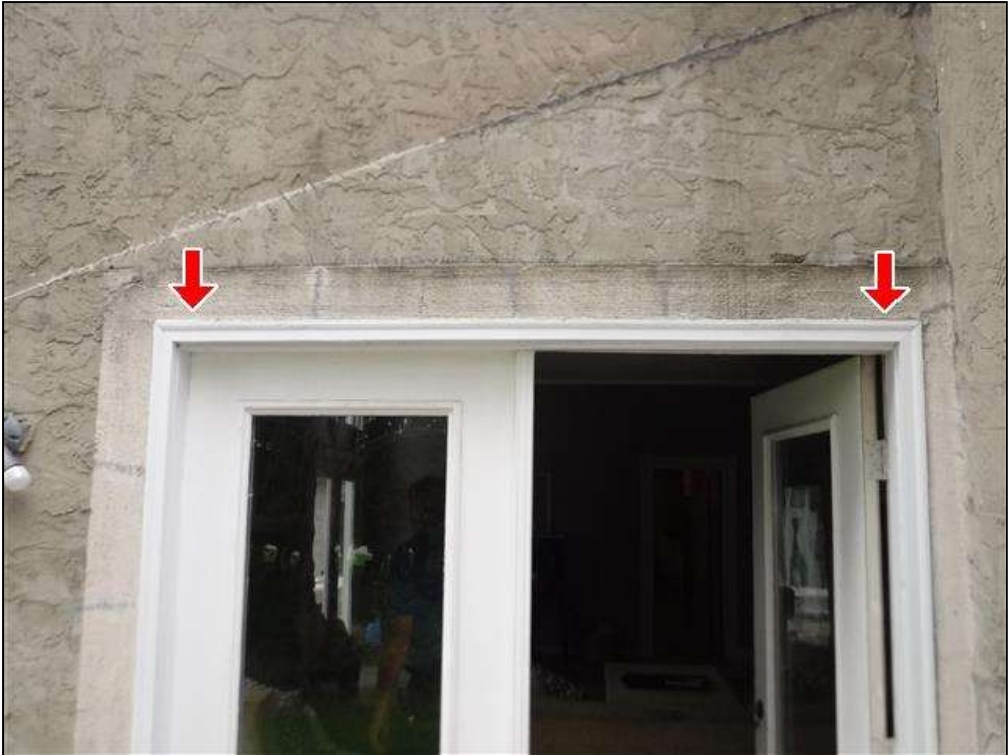
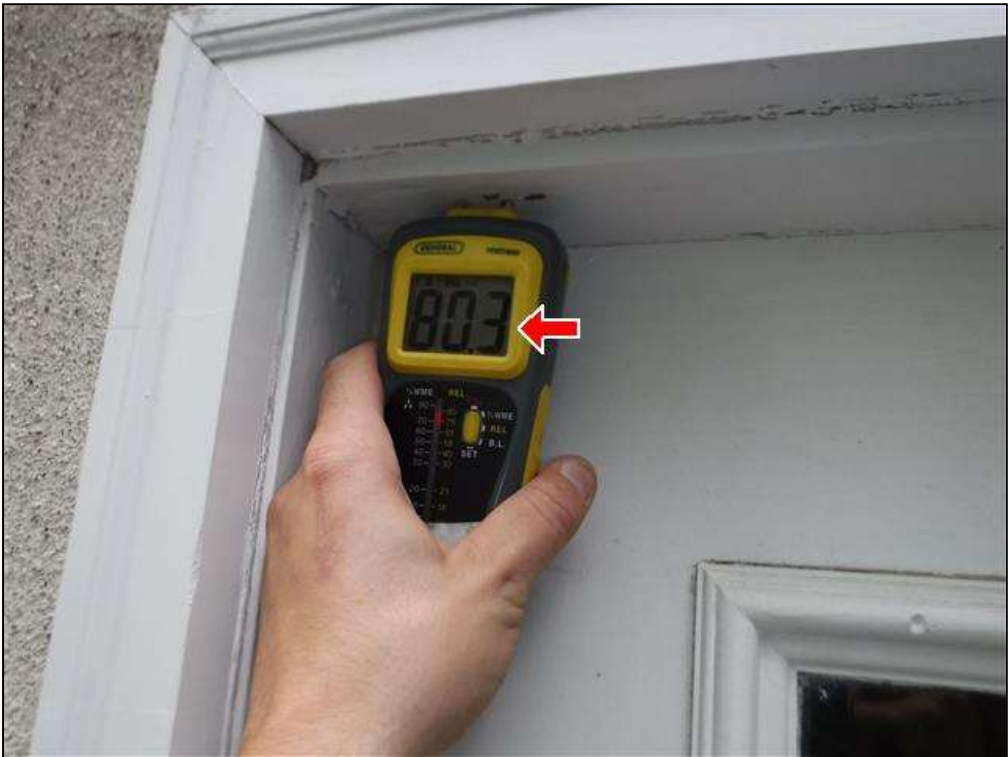
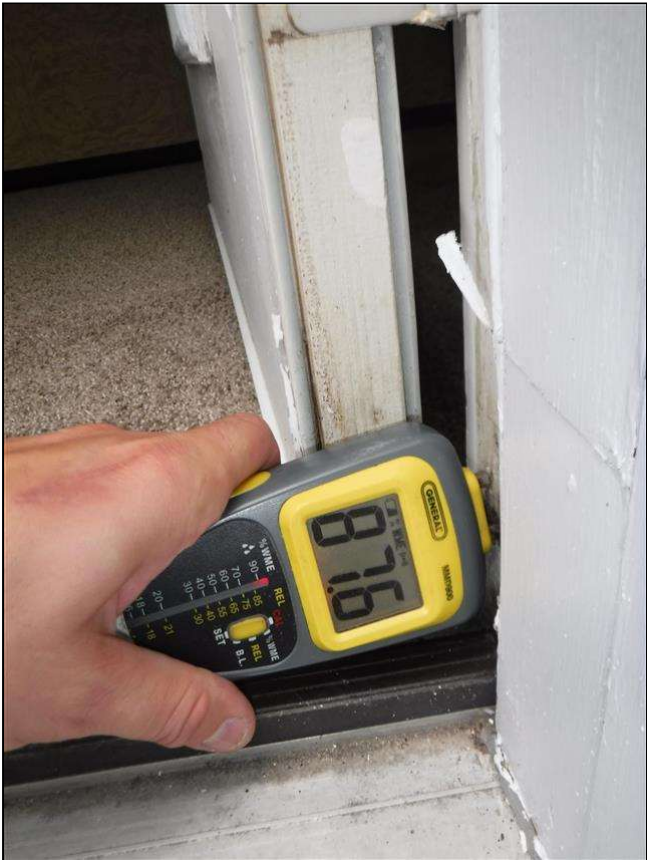
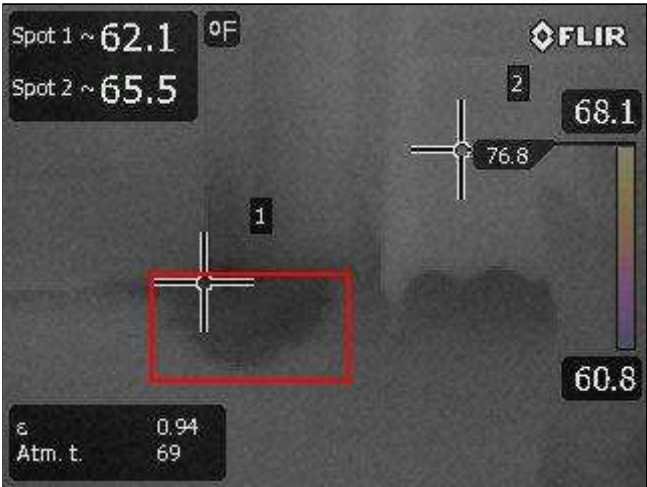
8.7 Patio door indicated is leaking at multiple areas, resulting in elevated moisture levels and moisture entry into structure. This was observed with a thermal imaging camera and confirmed with a moisture meter. Recommend repair as needed.

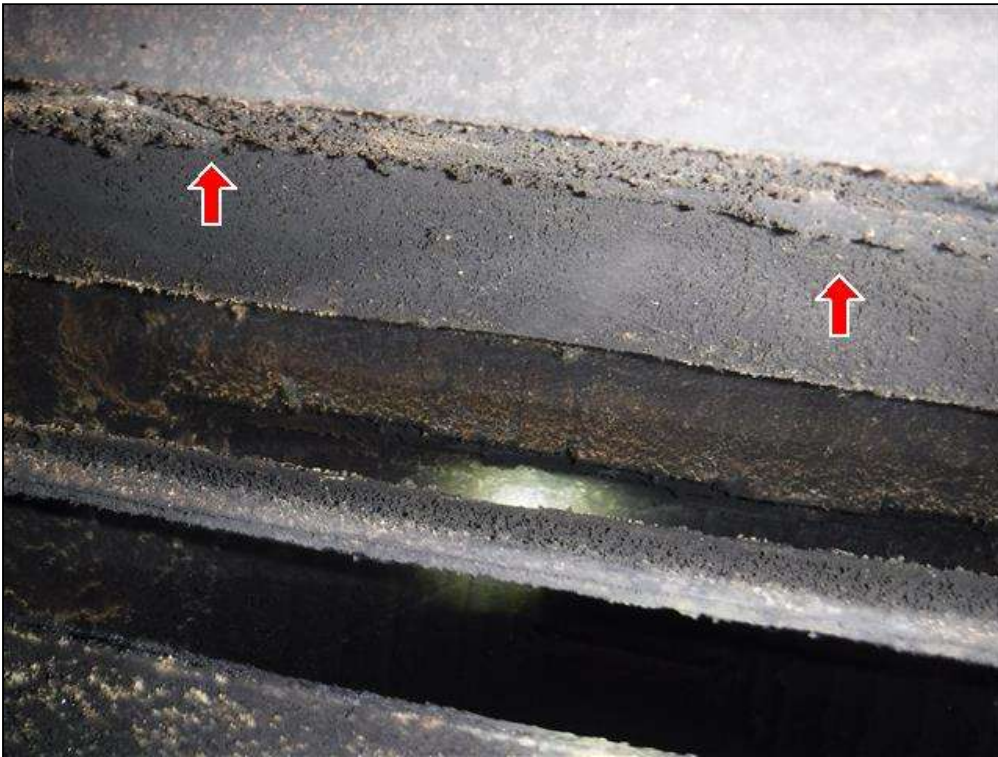
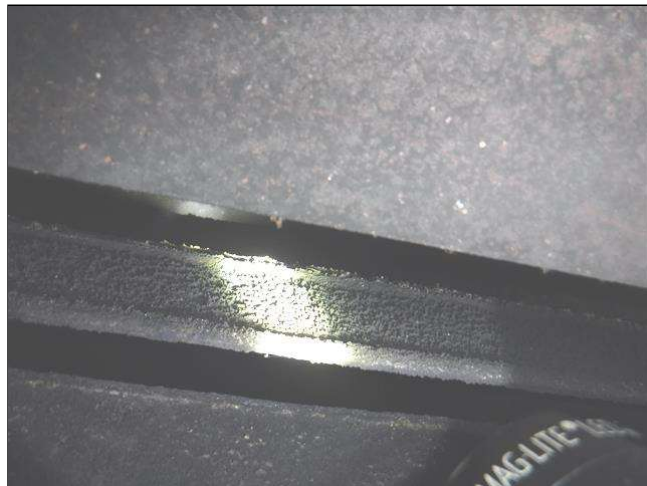
8.8 Creosote build up on liner/flue components to dining room fireplace. This condition presents a fire hazard, to the chimney, as creosote can be ignited by extreme heat from a fireplace. This condition can also conceal any potential defects to flue components. Recommend a full cleaning and inspection by a qualified contractor.

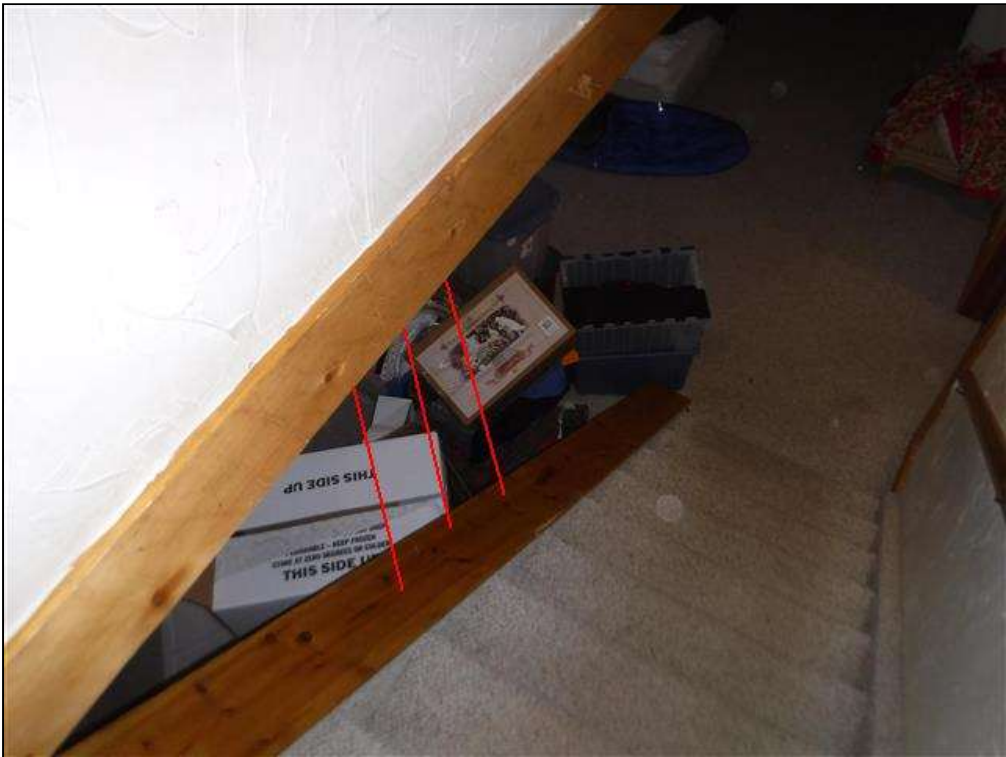
9.0 Item 1(Picture)

9.0 Recommend installing a balustered guard rail to indicated opening to prevent a fall hazard, improving safety during use of the stairs.

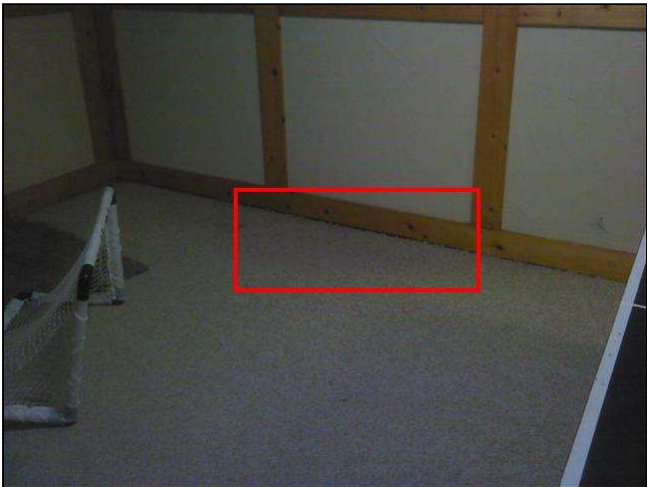
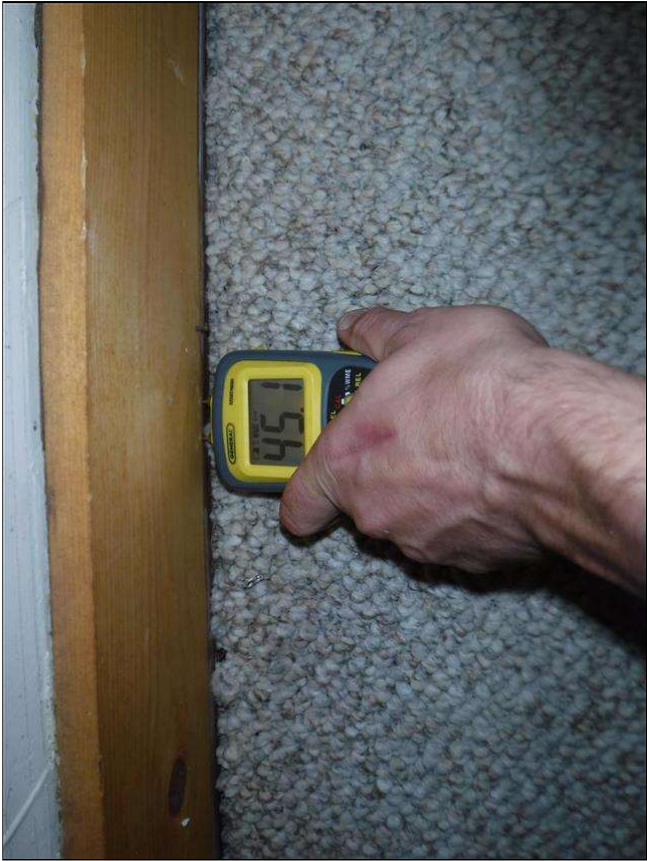
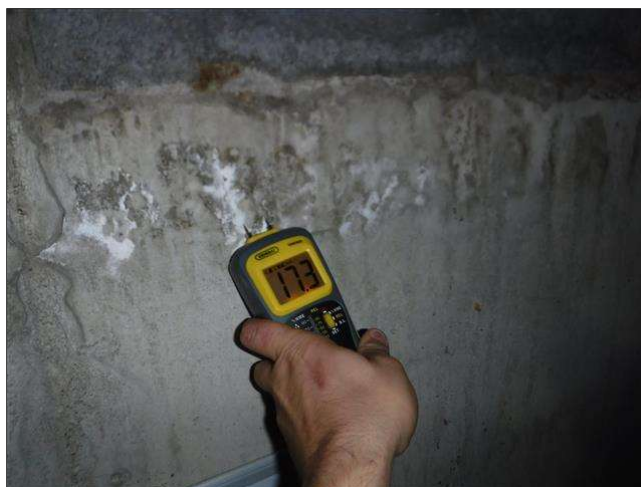
10.1 Ongoing moisture entry at indicated areas. As signs of water entry in this fashion usually can be attributed to water control outside the home, inspector recommends assessment of exterior water control adjacent any water signs inside and improving as needed (gutters, extensions, grading etc). Sump pump float system is not triggering pump to come on at an adequate water level. This condition is contributing to the elevated moisture levels. Recommend repair/adjustment to sump pump and improving water control exterior the home. Recommend further evaluation to determine potential residual effects to finish materials in relative areas and if any remedial efforts are needed.

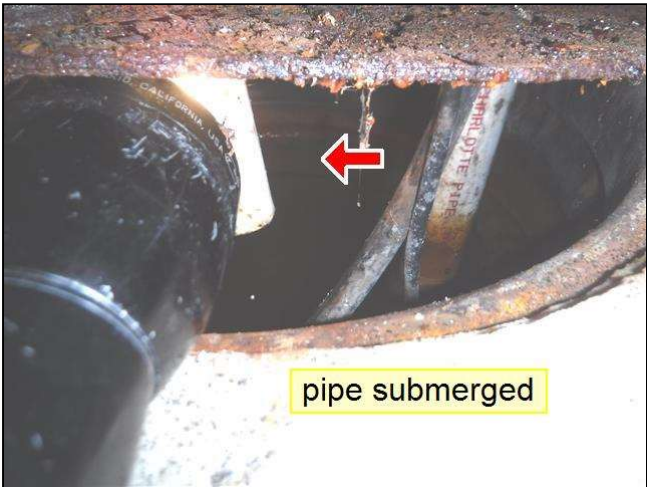
10.2 Item 1(Picture)

10.2 Water level at/over drain inlet pipes. This is an indication of the float mechanism not triggering the pump to come on at a sufficient time/water level in the pit or the pump being defective. Recommend further evaluation by a qualified contractor to assess and determine if repair is sufficient or replacement is necessary.

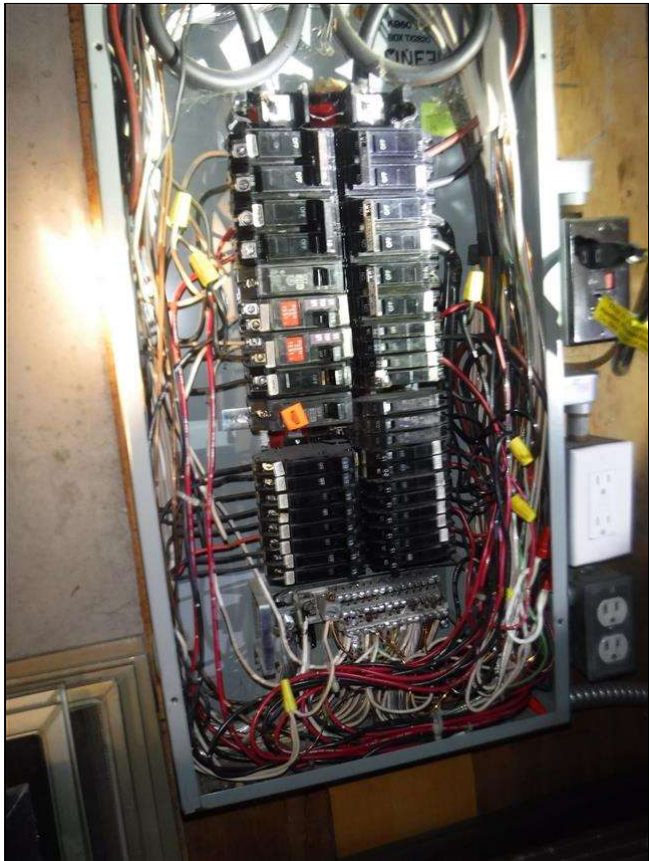
11.2 Item 1(Picture)

11.2 Panel is at full capacity. Upgrading service size or sub panel installation should be considered/may be required.

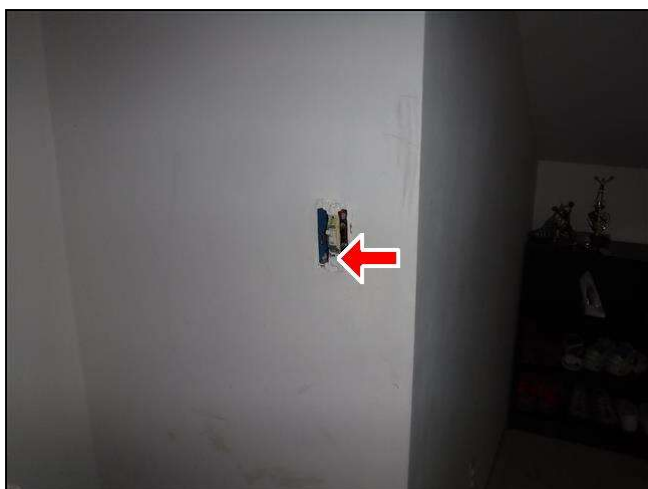
11.5 Item 3(Picture)

11.5 Recommend covering all exposed outlets/receptacles for improved safety.

Recommend securing loose outlets/boxes as needed.

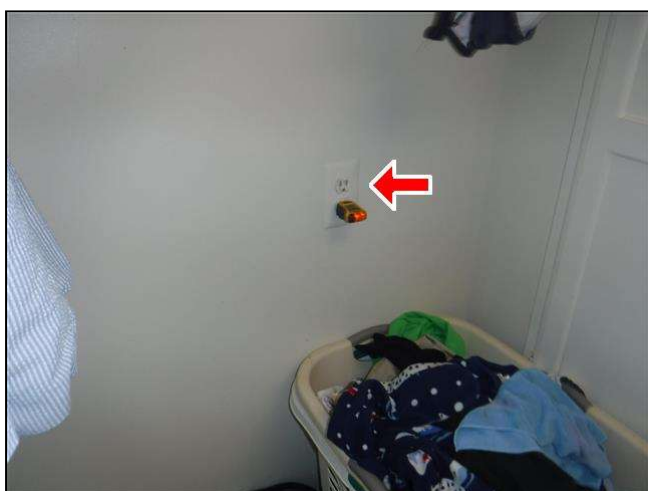
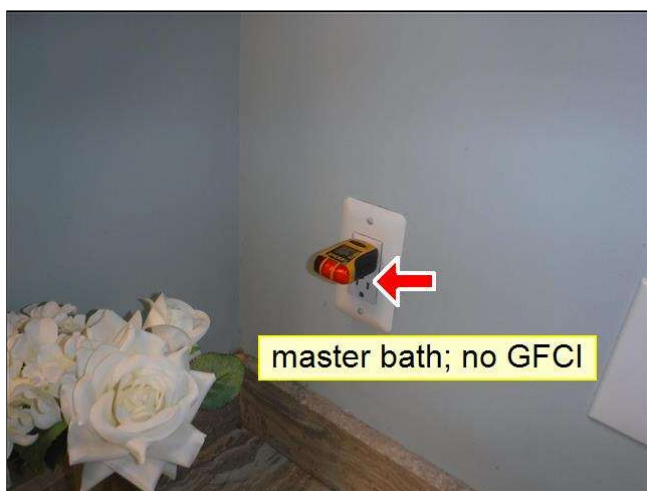
11.7 Recommend GFCI protection to laundry mechanical outlet(s) for improved safety.

Recommend GFCI protection to bathroom outlet(s) pictured for improved safety.

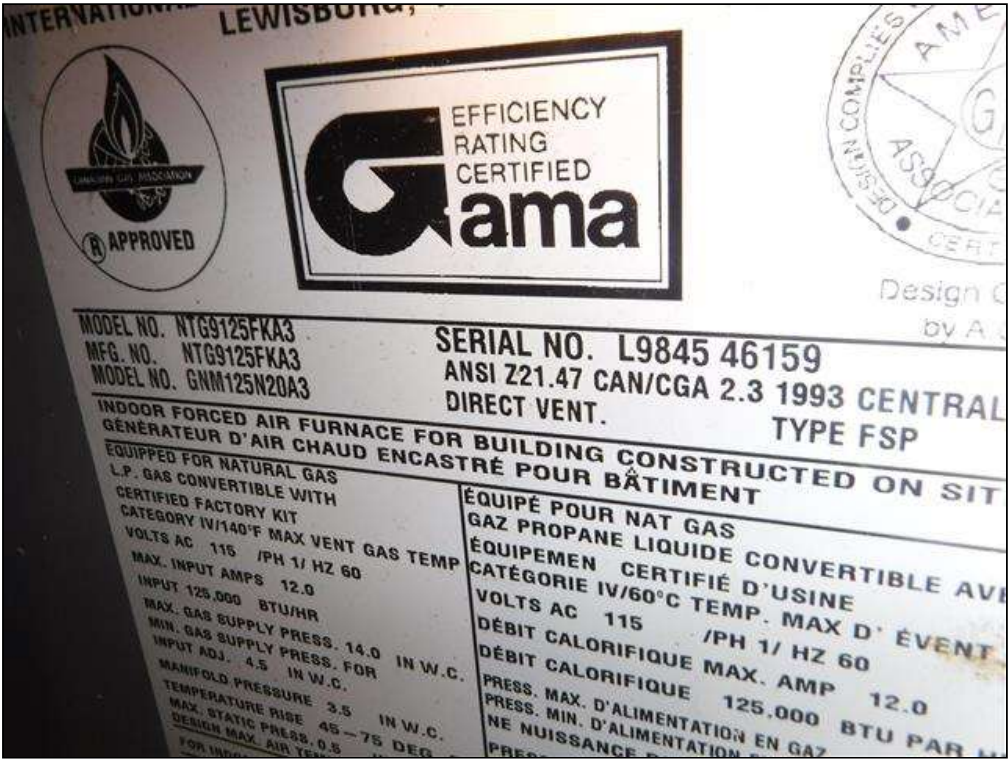
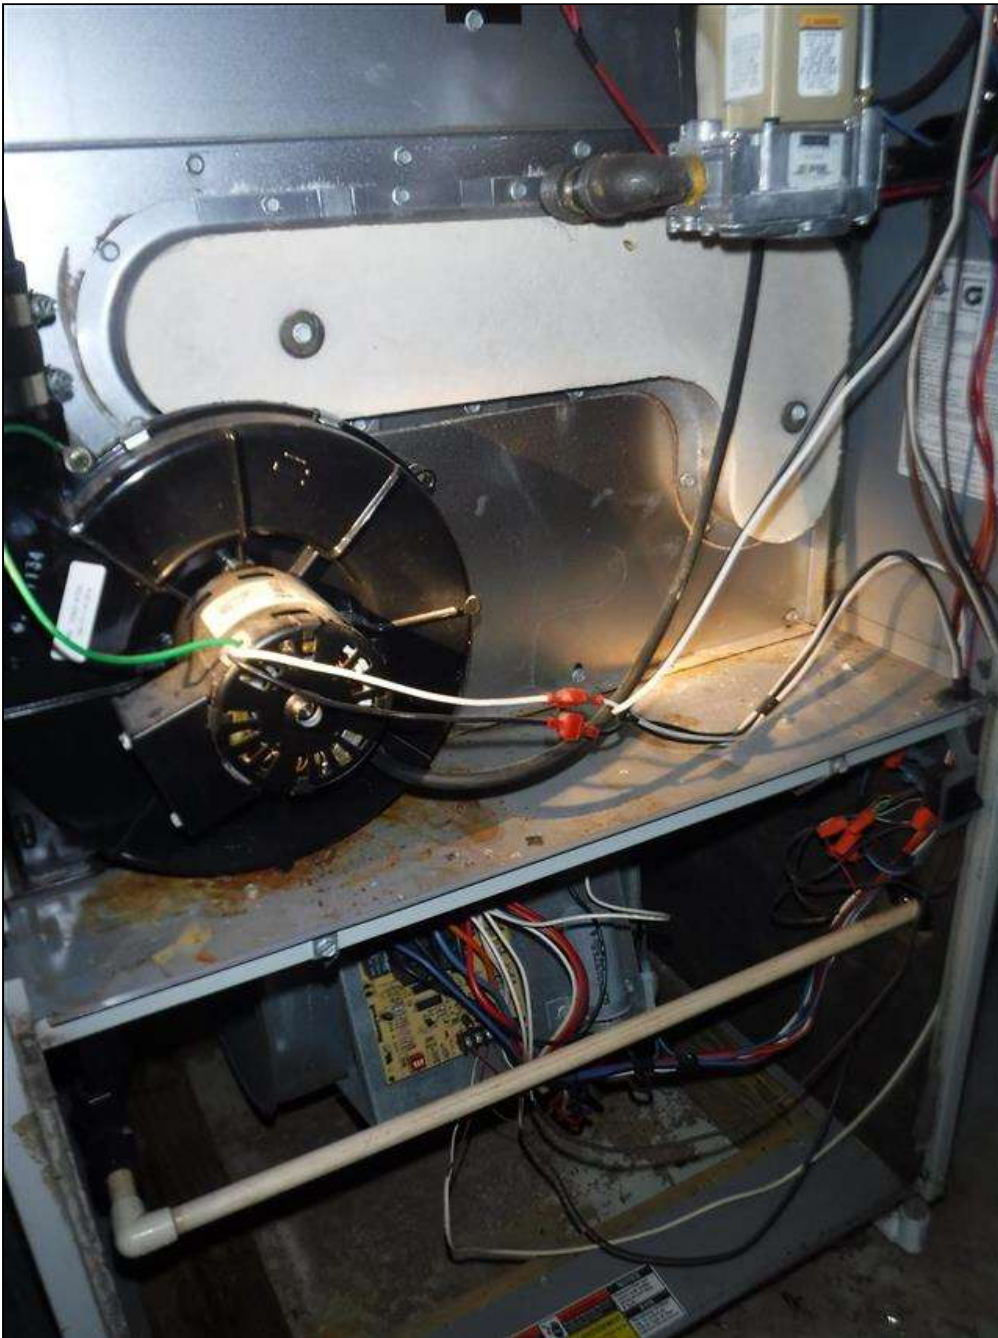
13.0 Evidence of prior condensation leaking (rusting) to interior of cabinets. No leaking present during inspection, after running unit. Monitor and repair as/if needed.

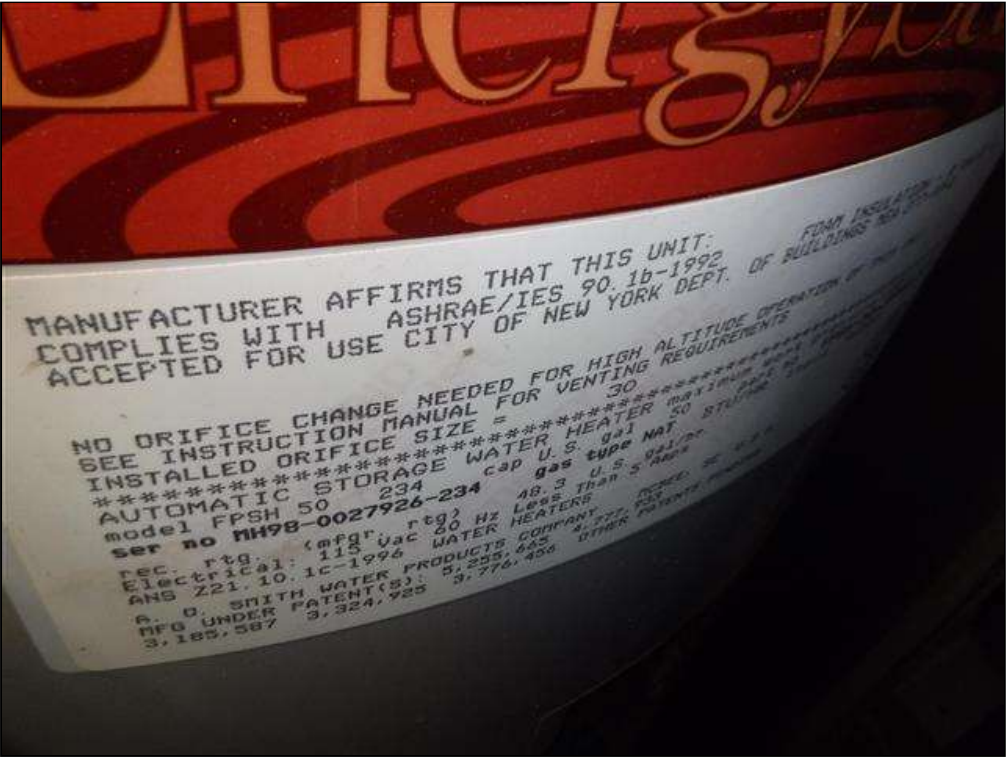
15.0 Item 1(Picture)

15.0 Aged unit functioning at inspection, expect limited life remaining

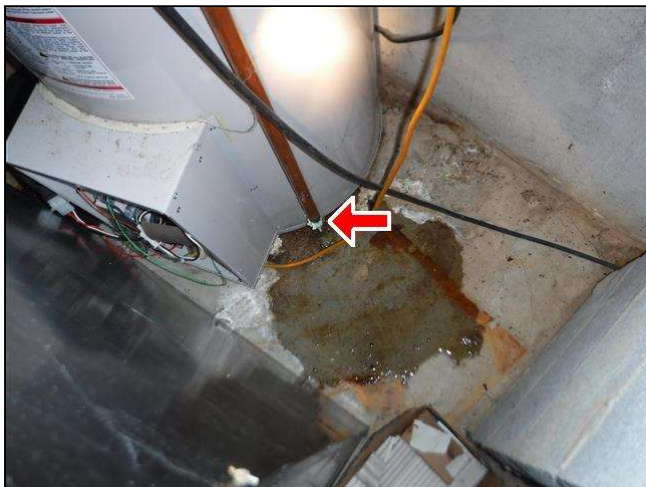
15.3 Item 1(Picture)

15.3 Valve has active leaking. This may be attributed to the valve operating as intended (pressure/temperature too high) or the valve may be defective. Further evaluate/monitor as needed and correct if needed.
