# Insight Home Inspections

## Home Inspection Report

**8195 North Park Dr**

Inspected on Wed, Oct 17 2018 at 2:14 PM

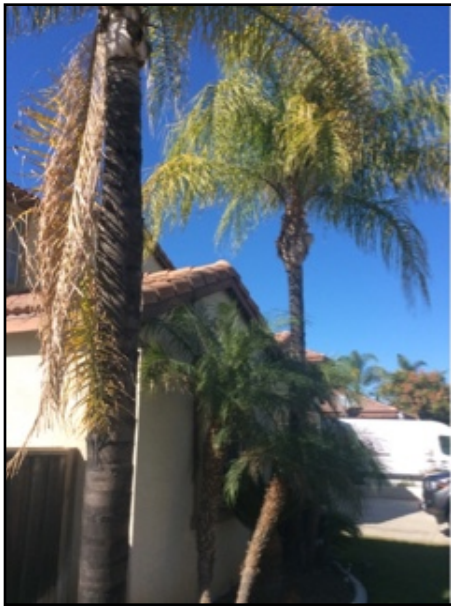
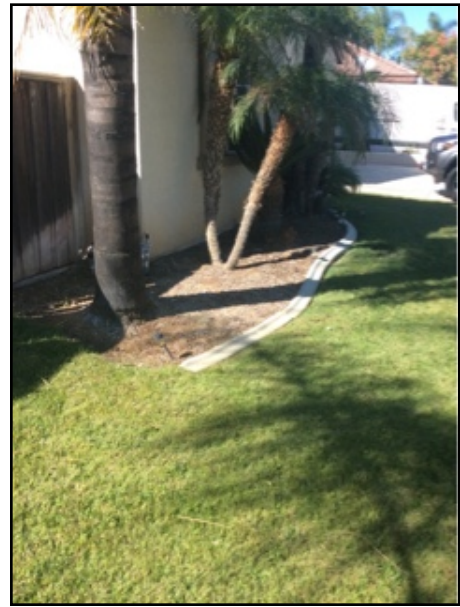
Palms in front of property are within 6 feet of structure and growing against structure. This may lead to structural damage. Recommend removing larger palms and trimming away from structure.

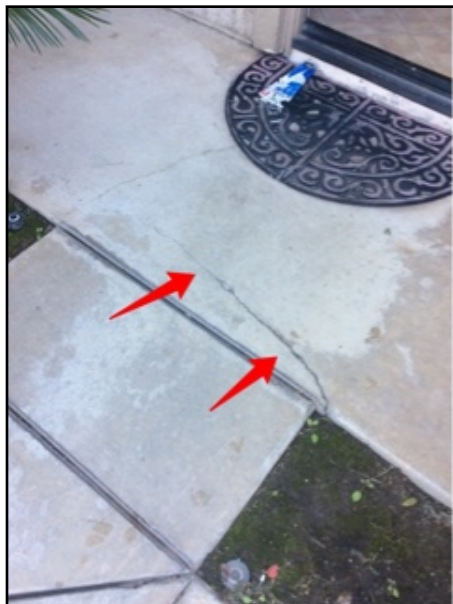
Figure 2-1

Slight crack in in entryway concrete. This may shift and become a trip hazard in future. Recommend repair.

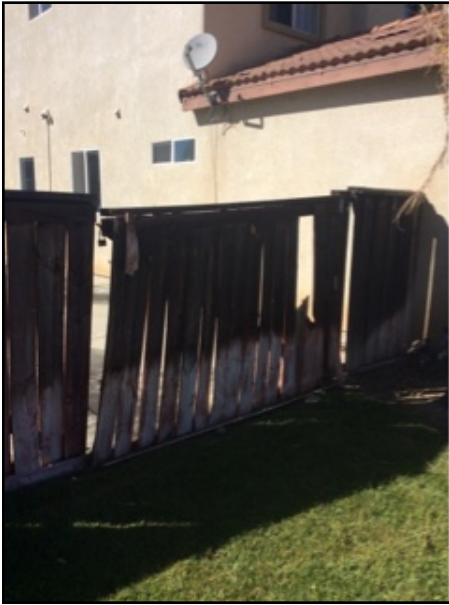
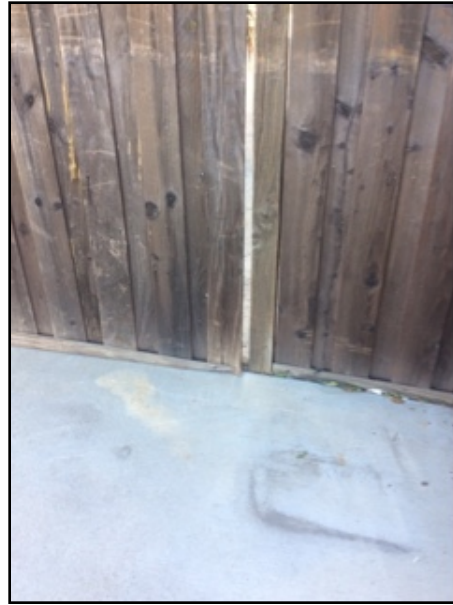
Comment 3:  
Both side gates are not functioning properly due to natural break down of material.  
Recommend repair.

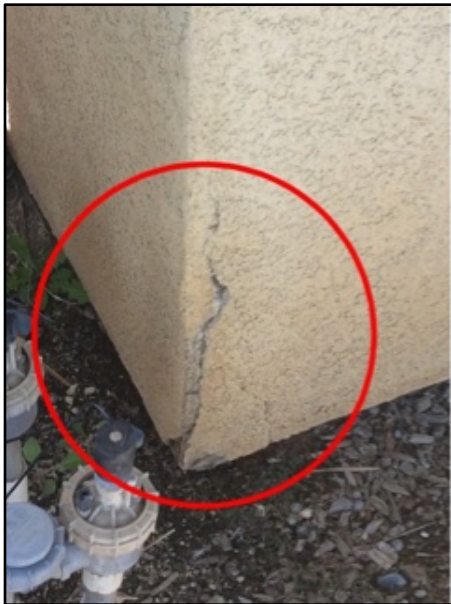
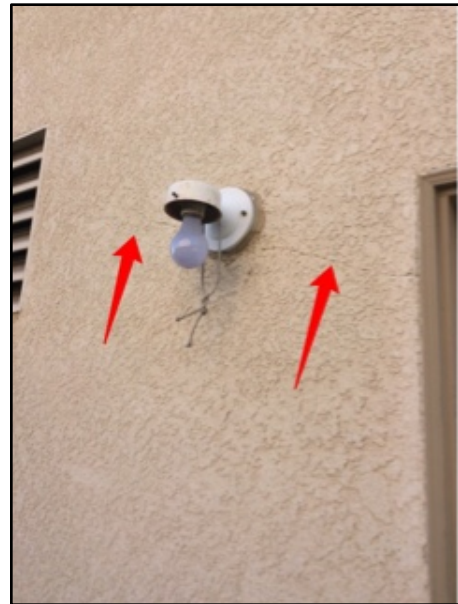
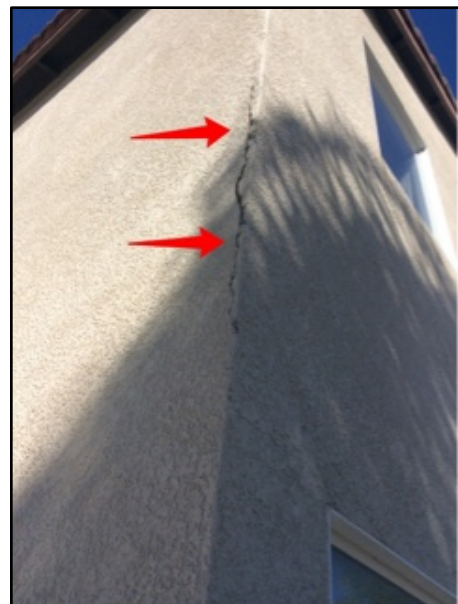
Multiple areas of cracked and failing stucco. Does not appear to be structural. Recommend repair to prevent water intrusion.

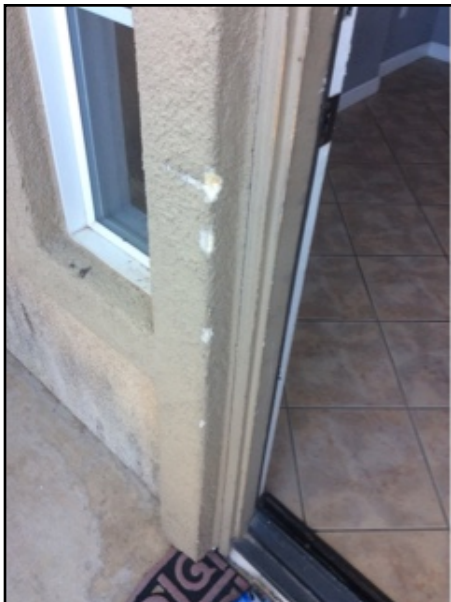
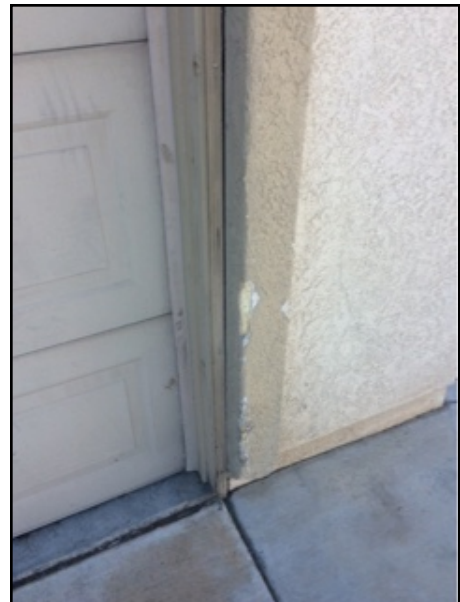
Exposed foam from failing stucco. Recommend repairing to prevent water intrusion.

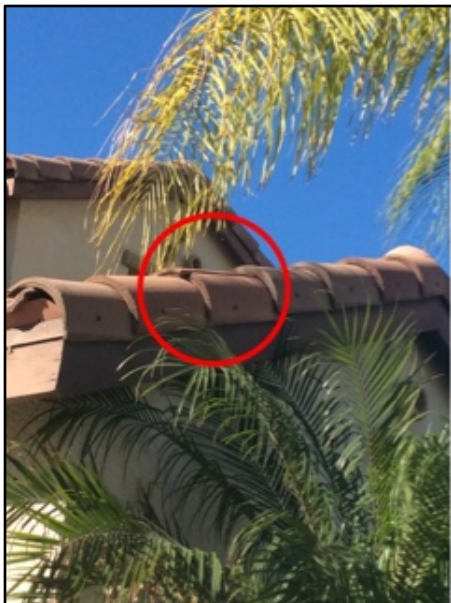
Figure 8-1

Improper end tile. Separation in tile will allow moisture to penetrate into wood fascia. Recommend replacement.

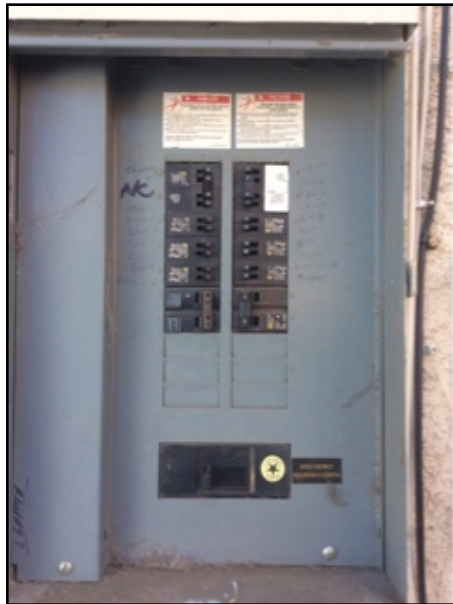
Figure 9-1

Comment 9:  
Labels are needed for all breakers.

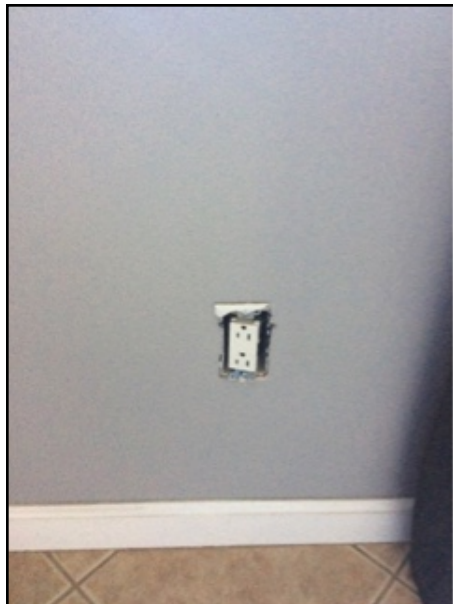
Figure 10-1

Comment 10:  
Multiple outlets are missing face plates. This exposes "hot" connections.  
Recommend repair.

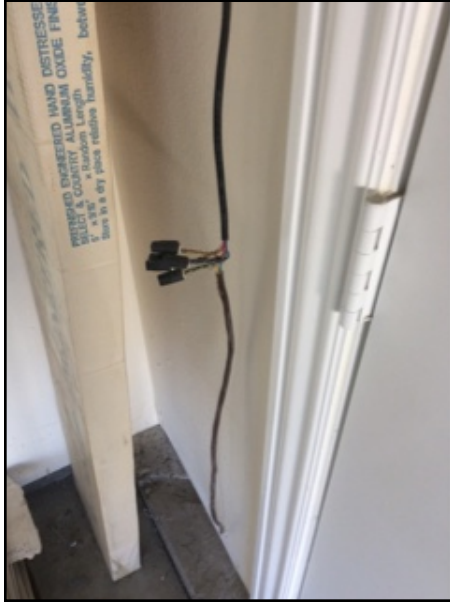
Figure 11-1

Recommend proper junction box for sprinkler wire. Wires need to be mounted properly.

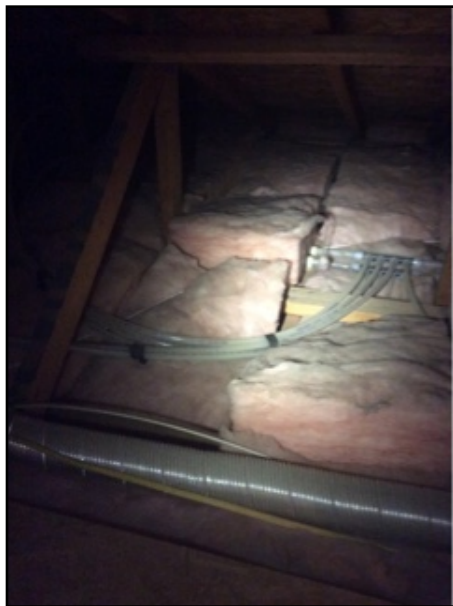
Figure 12-1

Comment 12:  
Pex supply lines are running through attic space.

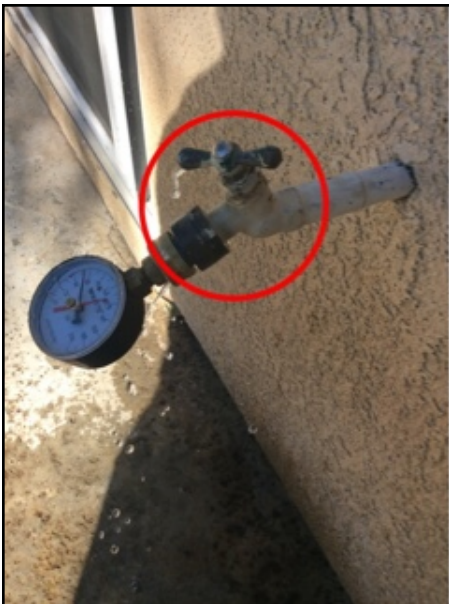
Figure 14-1

Comment 14:  
Hose bib valve is leaking when opened under pressure. Recommend replacing.

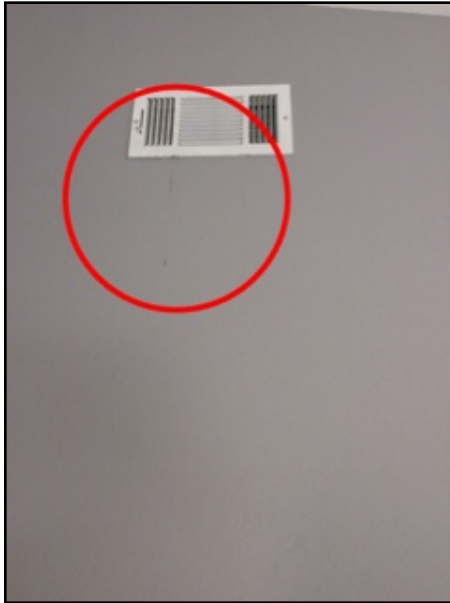
Figure 16-1

Yellow water drips from vents typically indicate condensation drainage stoppage or multiple issues caused by a clogged air filter. Recommend further evaluation and service by a HVAC technician.

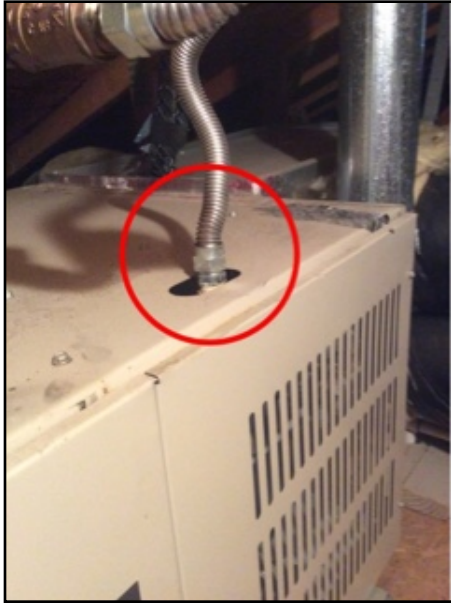
Figure 17-1

Comment 17:  
Possible slight gas leak at supply line. Recommend further evaluation.

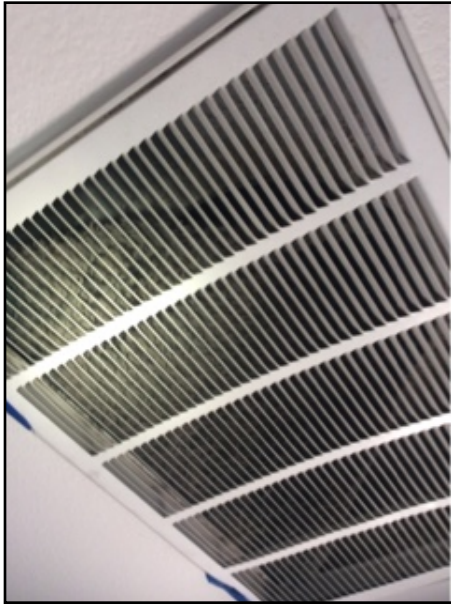
Figure 18-1

Comment 18:  
Air return filter is extremely dirty and needs to be replaced. Recommend replacing filter every 3-6 months.

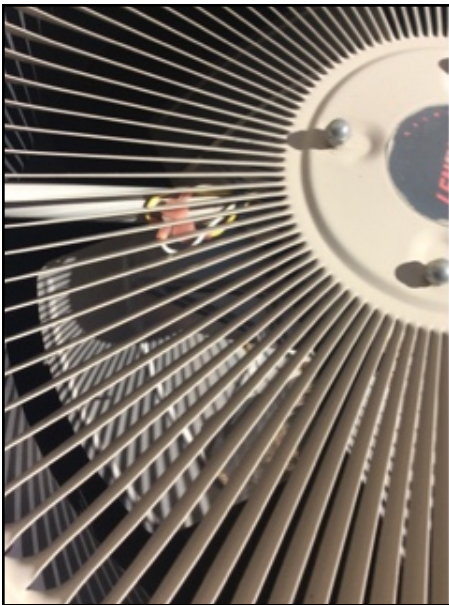
Figure 19-1

Wiring in condenser indicates motor has been replaced or a "quick start" may have been installed. Recommend further evaluation.

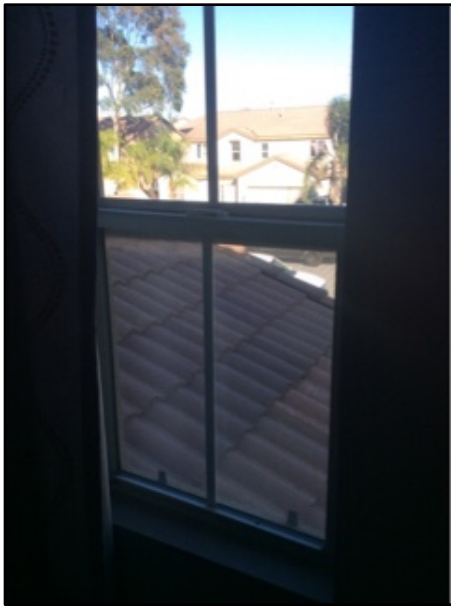
Figure 20-1

Single hung window in upstairs bedroom is not staying open. Recommend repair.

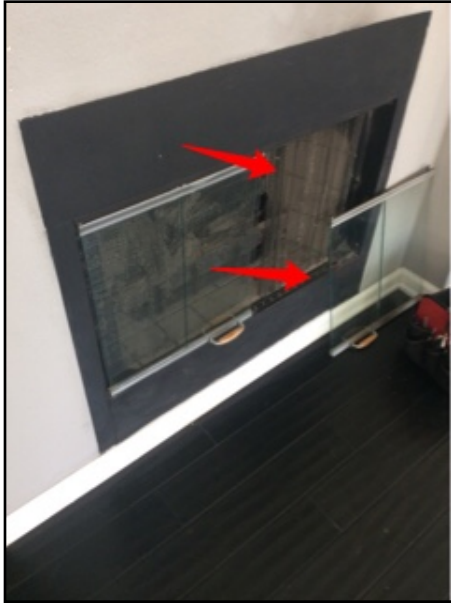
Figure 21-1

Comment 21:  
Fire place door is off hinge. Recommend repair.

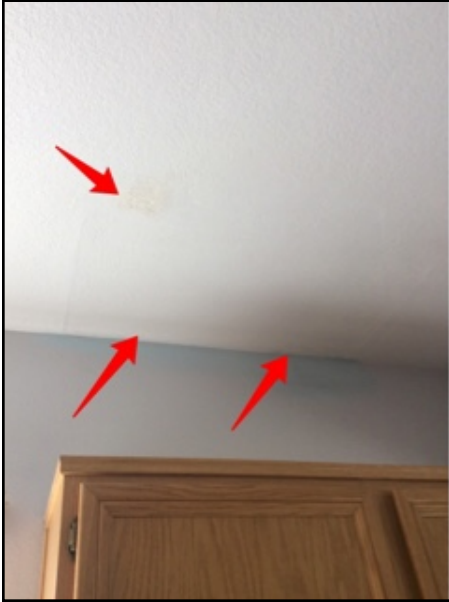
Figure 23-1

Ceiling patch in kitchen indicates previous leak from above shower. Moisture not present at time of inspection.

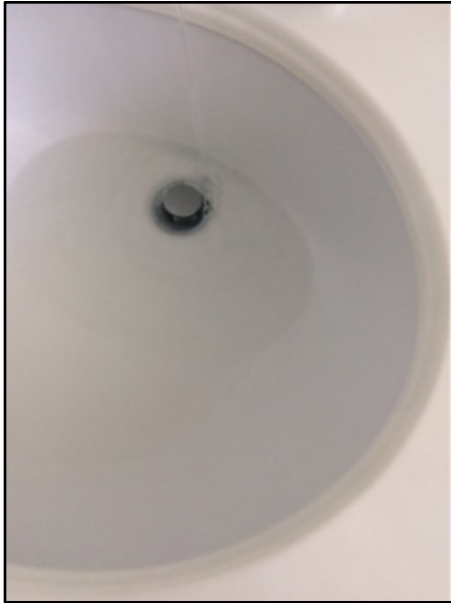
Figure 24-1

Sink is not draining at a satisfactory rate. Recommend repair.

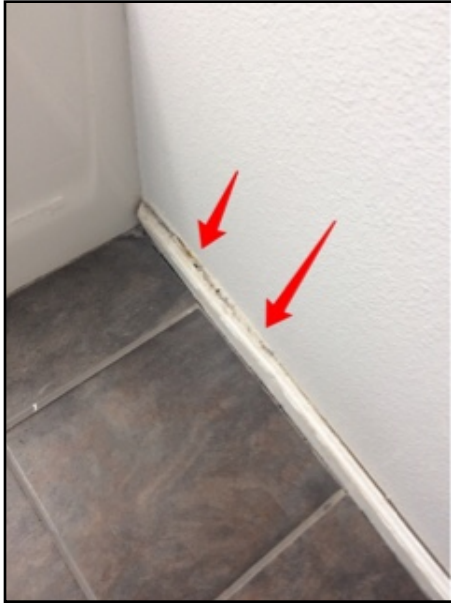
Figure 25-1

Baseboard is warped due to moisture exposure from the shower.

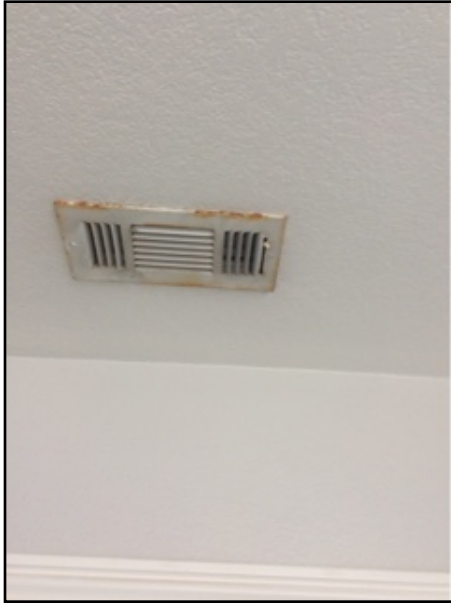
Figure 26-1

Comment 26:  
Rusted vents are indications of poor ventilation.

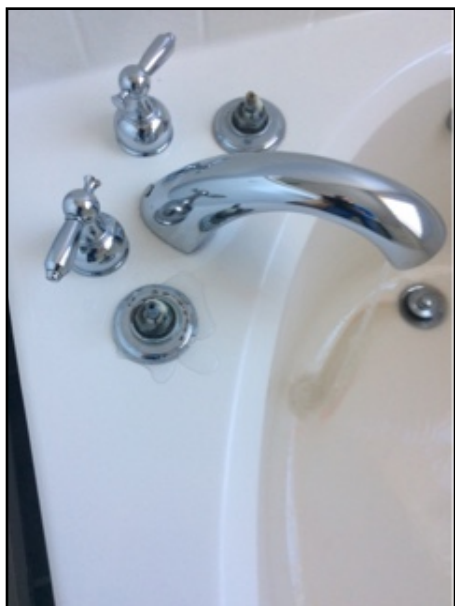
Figure 27-1

Comment 27:  
Tub fixture handles are not properly mounted and are leaking from valve and spout. Recommend repair.

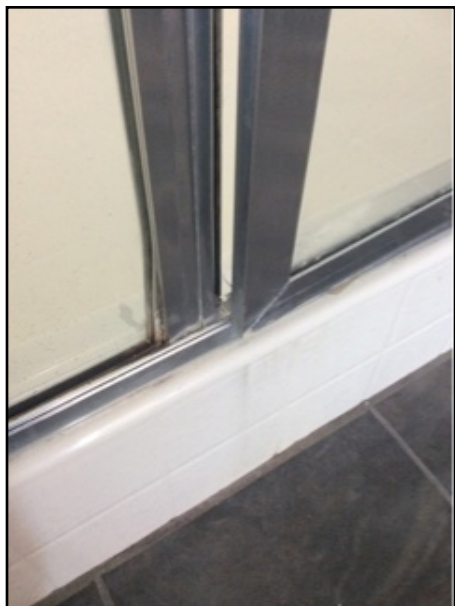
Figure 28-1

Shower door is not hanging even on hinge causing door to get stuck on frame. Recommend repair.

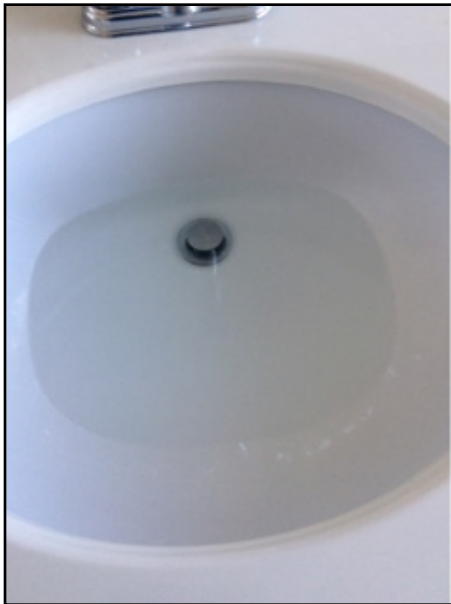
Figure 30-1

Comment 30:  
Sink is not draining at a satisfactory rate. Recommend repair.

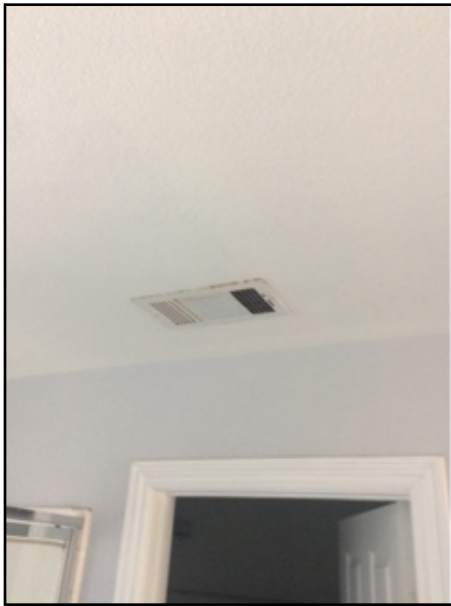
Figure 31-1

Comment 31:  
Rusted vent indicates poor ventilation.

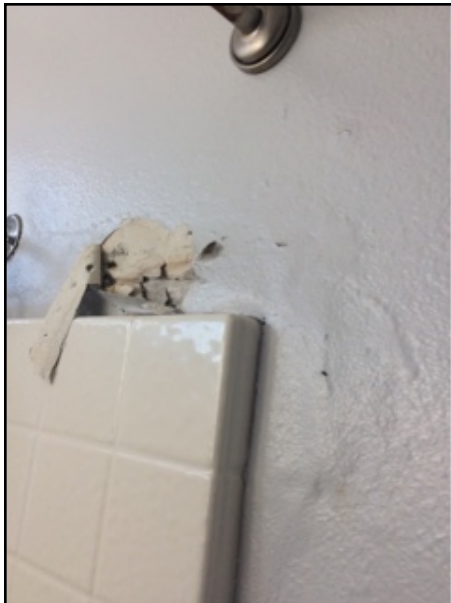
Figure 32-1

Water damage and possible fungal growth above shower walls. A direct sample of possible growth was taken and sent to Lab for analysis. Proper mold remediation will be needed if lab analysis come back as mold growth.

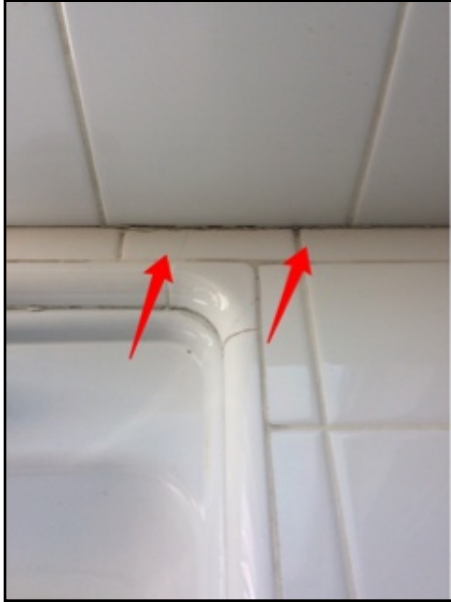
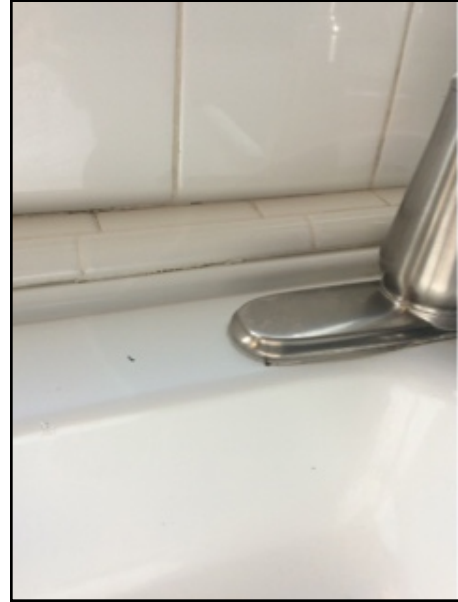
Failing grout along counter and backsplash. Recommend repair to prevent moisture intrusion.

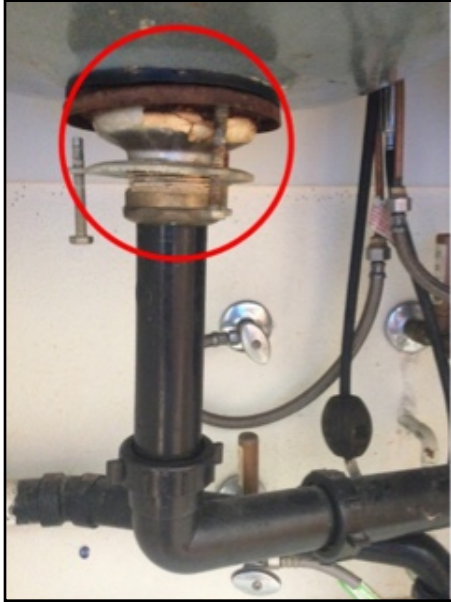
Figure 34-1

Comment 34:  
Strainer body, gasket and lock nut are all heavily corroded and rusted.  
Recommend repair p.

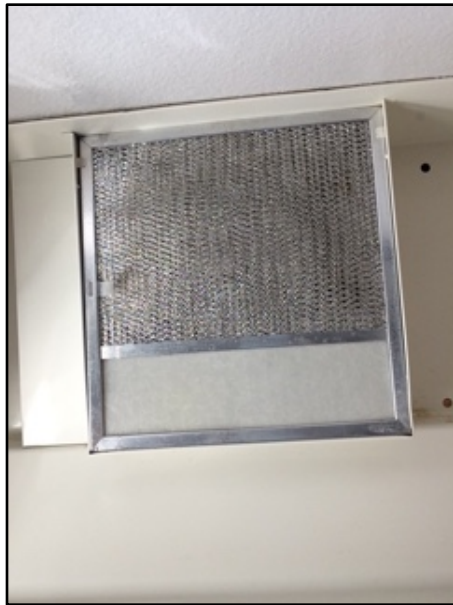
Figure 36-1

Comment 36:  
Hood light is not functioning. Recommend replacing light bulb.
