# Comprehensive Pre Purchase Building Report

**WA Buildinspect**

**Medina**

Report/Agreement #	2212250941091015
Inspection Date:	22 Dec 2025
Inspection Time:	09:30 AM

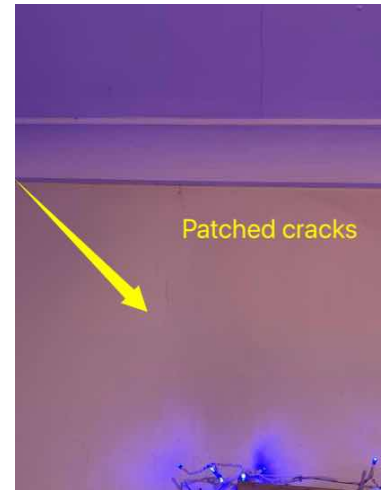
Settlement Cracks Noted. These are typical and generally patch and paint will suffice. To avoid repeating the same defect not all examples of cracking to the property are shown in this report.

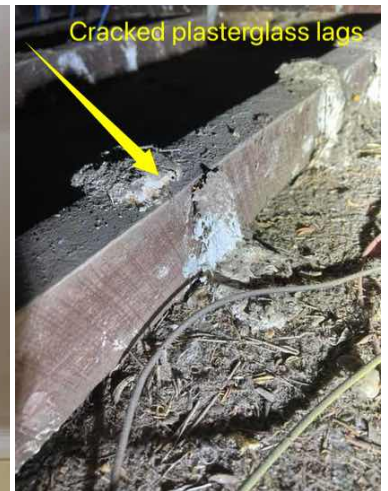
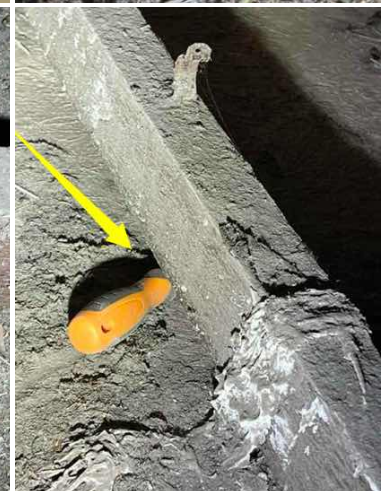
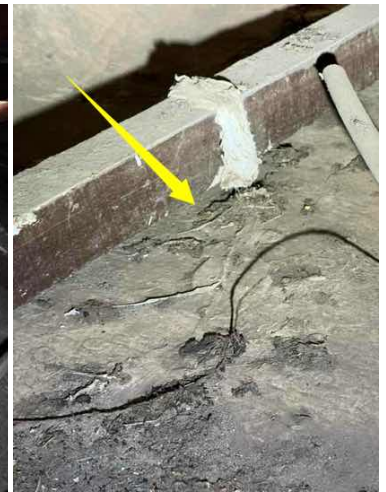
The ceiling lining is sagging in areas due to failure of fixings including plasterglass lagging. This has resulted in the ceiling lining detaching from the underside of the ceiling joists in areas. A ceiling contractor is to further assess all the ceiling lining in the roof void and repair where necessary.

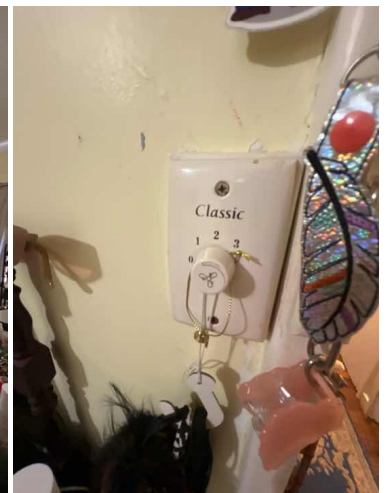
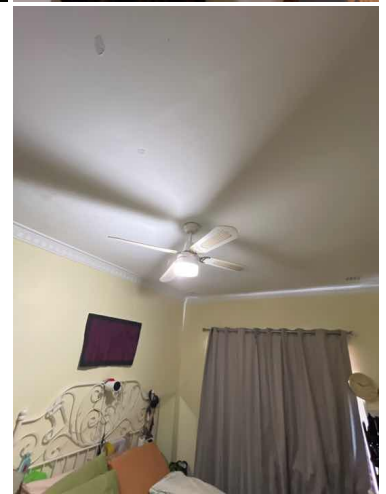
**Bedroom 2**

This Bedroom is in serviceable condition with no notable structural defects sighted. The ceiling fan is not working. Recommend electrician further assess.

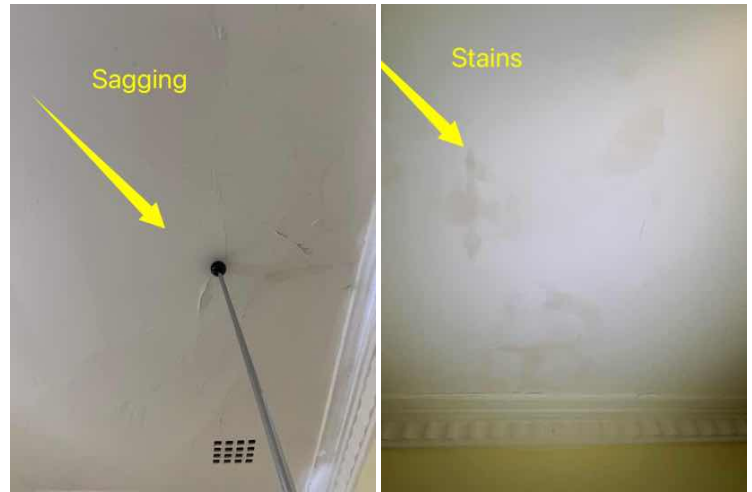
See bedroom 1 for ceiling lining sagging comments.  
Ceiling stains - No moisture readings obtained.  
Recommendations: These may have been repaired, however, you will need to monitor after a prolonged period of rainfall - If leaking persists, a roofing contractor should be engaged for advice and recommendations.

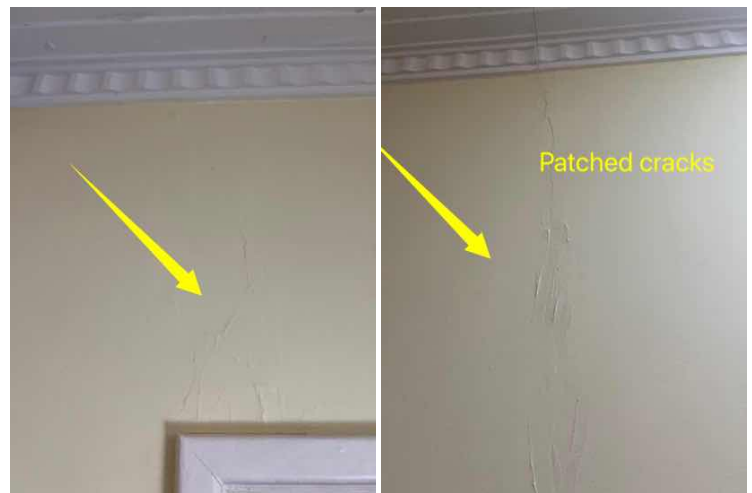
Patched wall cracks visible. I am unable to guarantee that these patched areas will not re-open in the future. Monitor.

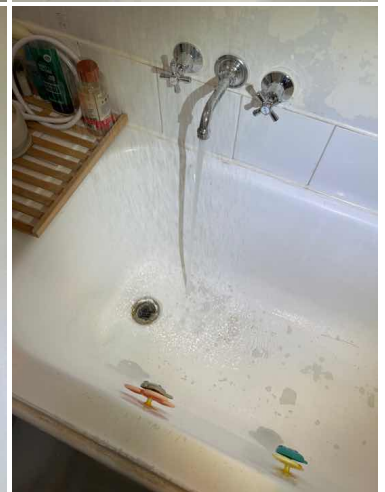
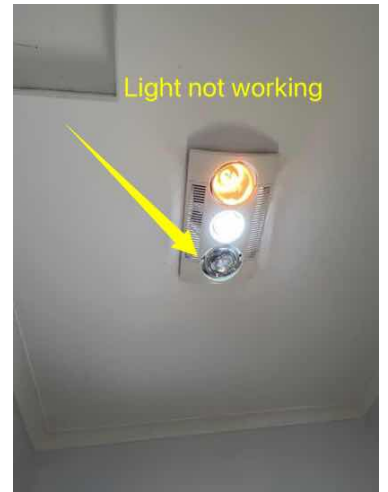
Sink - The hot water tap in the sink continues to rotate and does not flow any water. Recommend plumber repair.

One of the heat lamps is not working. Recommend change globe to ensure light fitting is in good working order.

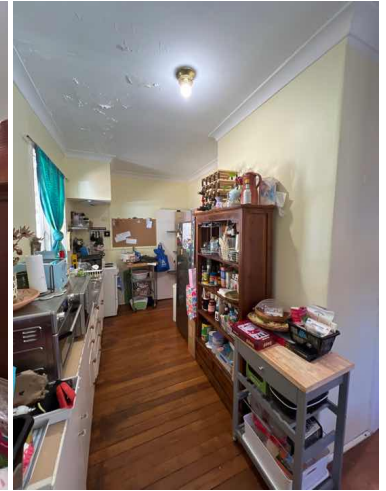
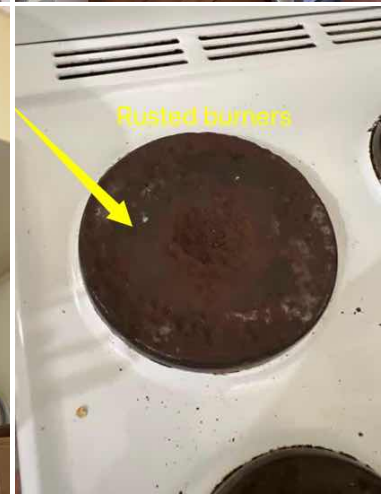
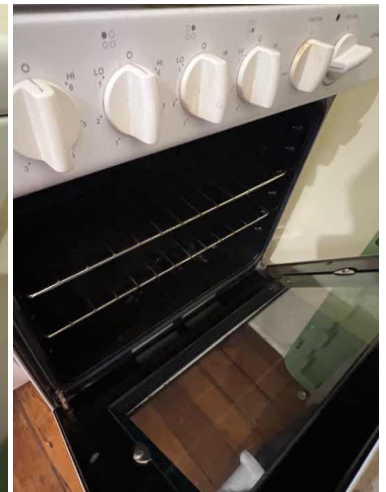
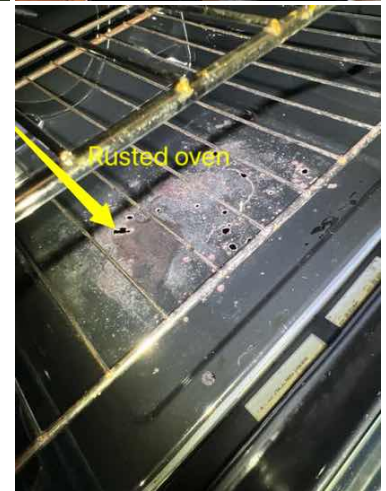
The fan and lights above the oven were not operating.

Recommend electrician further assess. Although the oven was operating there is excessive rust to areas of the appliance, including the cooktop burners. Recommend repair/replace oven.

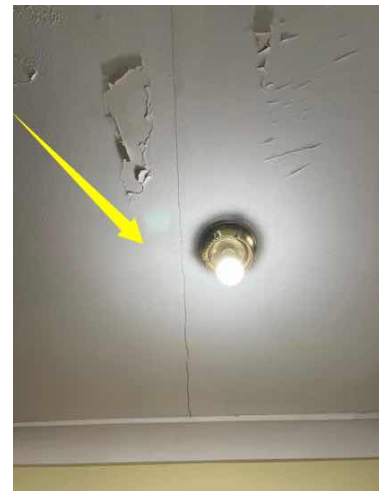
Settlement Cracks Noted . These are typical and generally patch and paint will suffice.

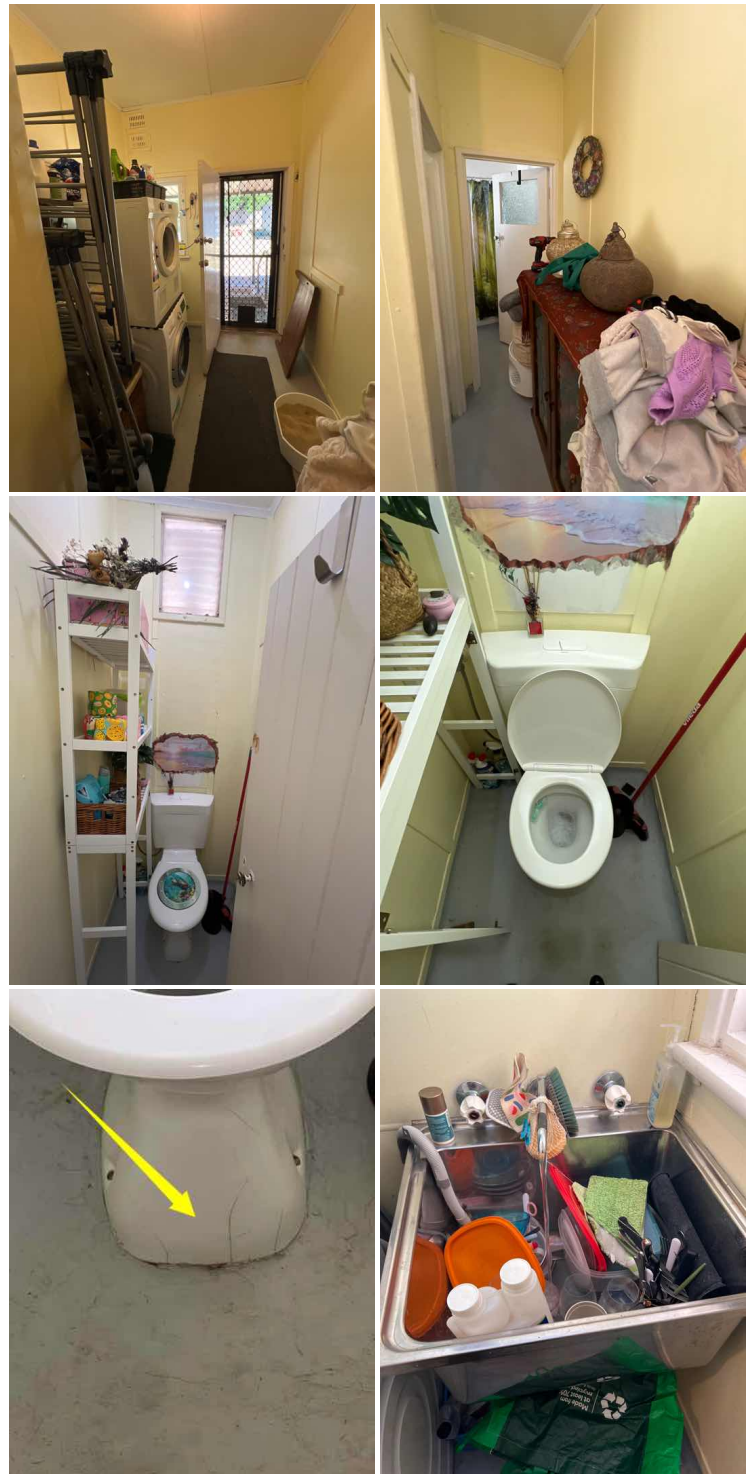
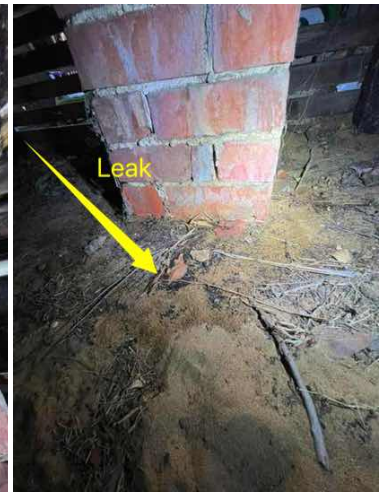
The cistern continues to leak water into the pan when the flush cycle is completed. In addition, there is cracking visible to bottom section of ceramic pan. There is also a drip/leak below the Wc/laundry area visible in the subfloor. Recommend plumber further assess and repair.

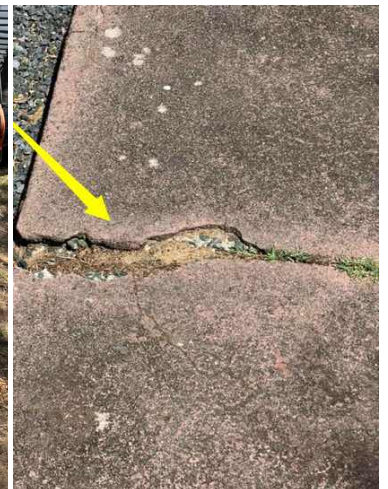
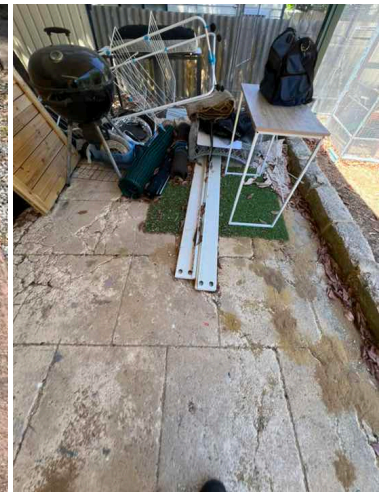
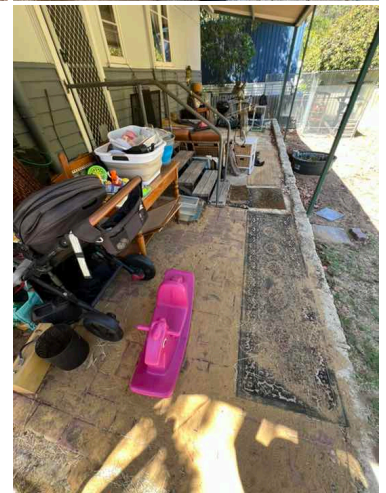
Common cracks/damage were observed on paths. Recommend repair where required.

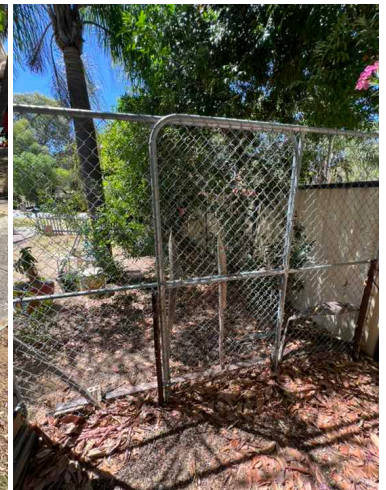
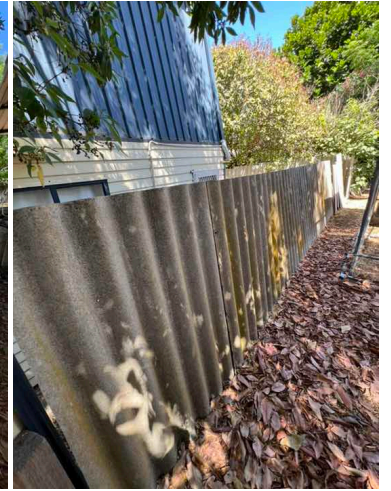
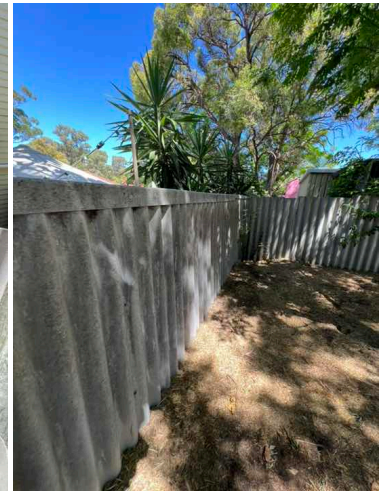
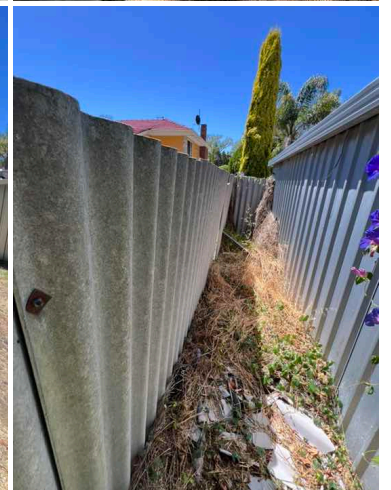
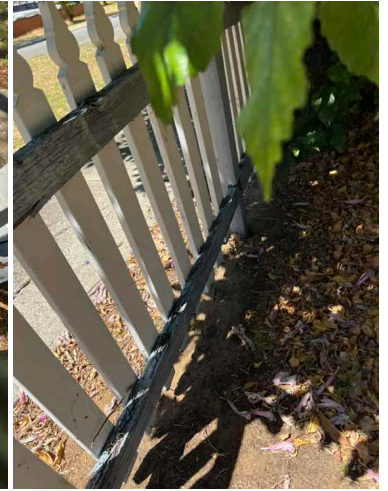
There are sections of the fencing that may contain asbestos fibrous cement sheeting. It is also cracking and leaning in areas. Recommend a fencing contractor further asses.

The front timber fence has timber rot and is damaged in areas. Recommend carpenter repair/replace fence.

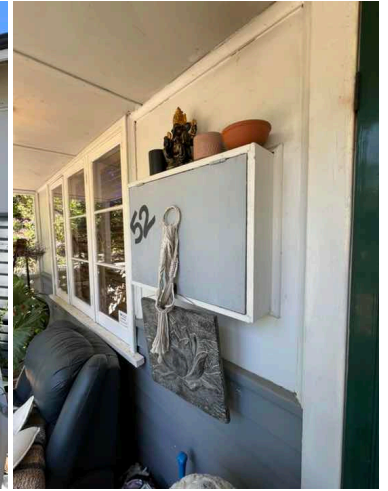
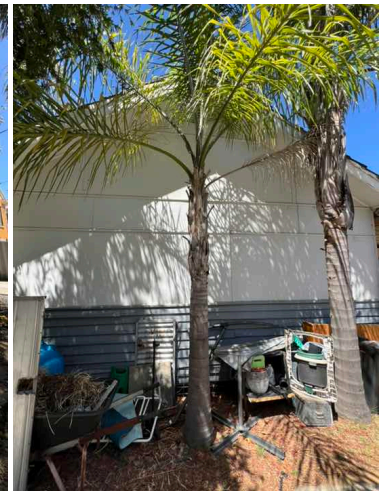
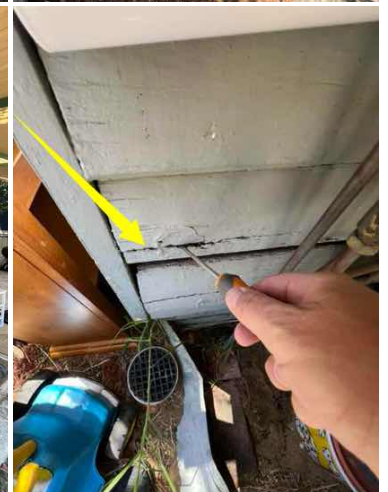
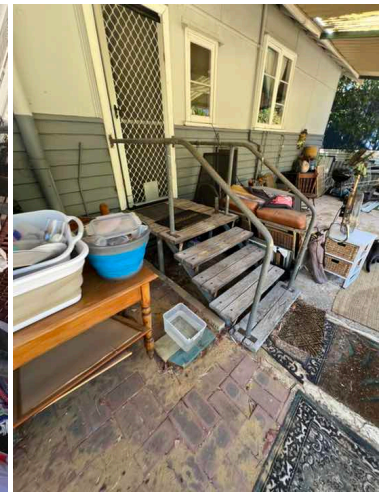
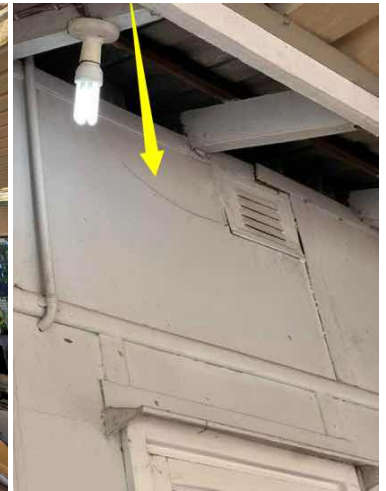
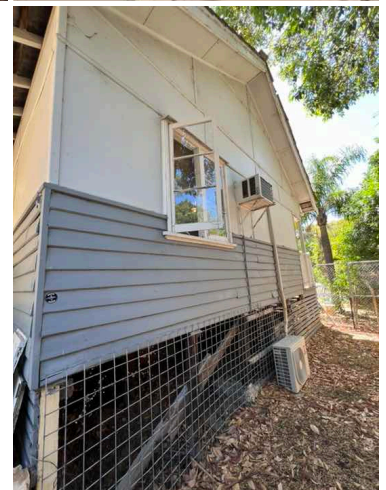
Minor damage and cracking visible to areas of the external cladding. Recommend repair where required.

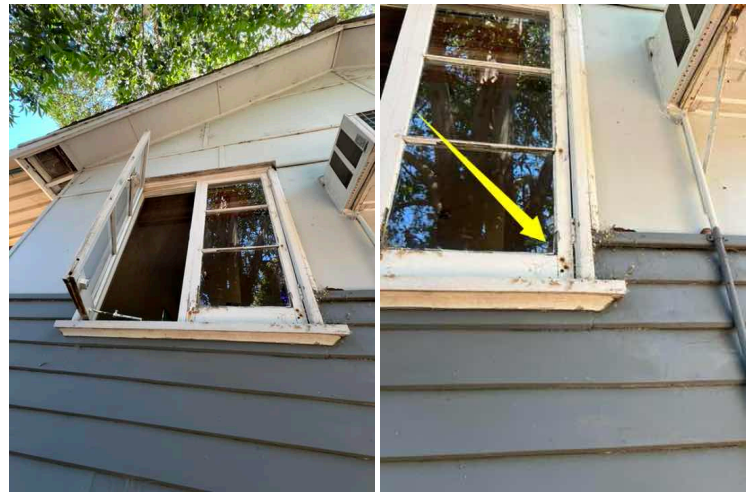
Sections of the external windows have paint deterioration - Engage a painter for repairs.

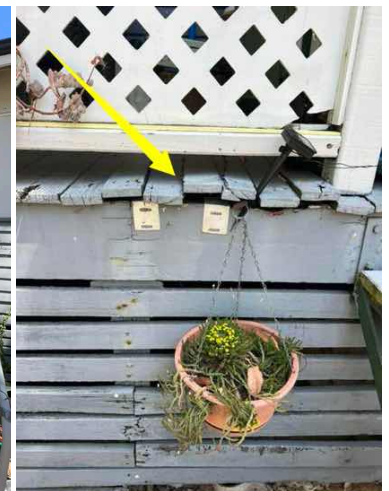
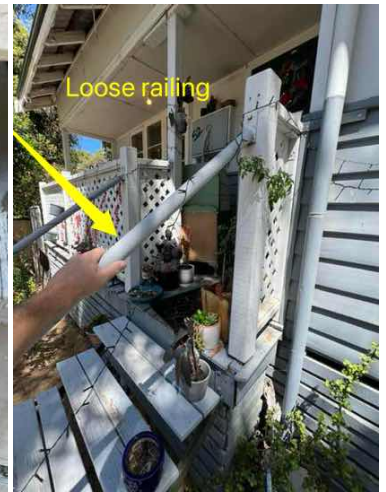
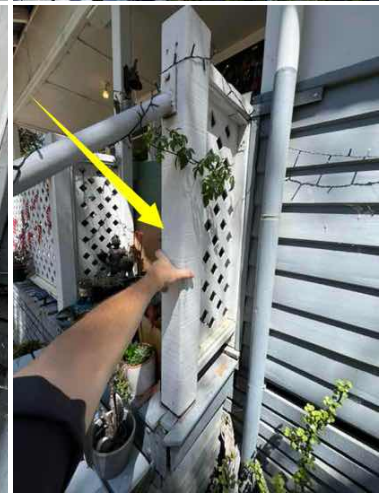
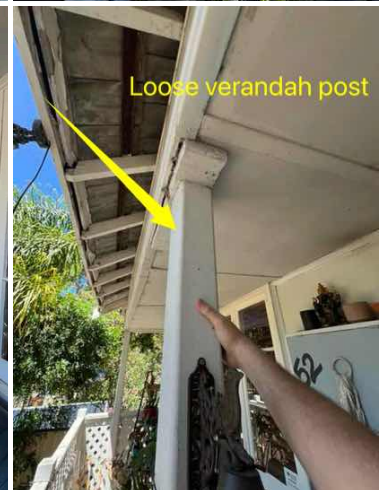
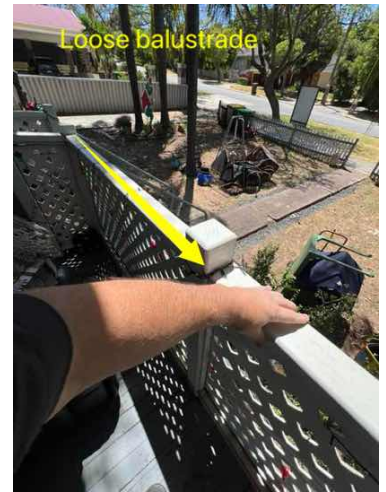
The floor boards to the verandah are loose/damaged in areas with timber rot visible. The balustrade is also loose in areas. Recommend carpenter further assess and repair where required.

Major Structural Defect - The verandah post in front of the meter box is loose at ceiling level. This post is a structural component and requires refixing to verandah ceiling framing by a carpenter.

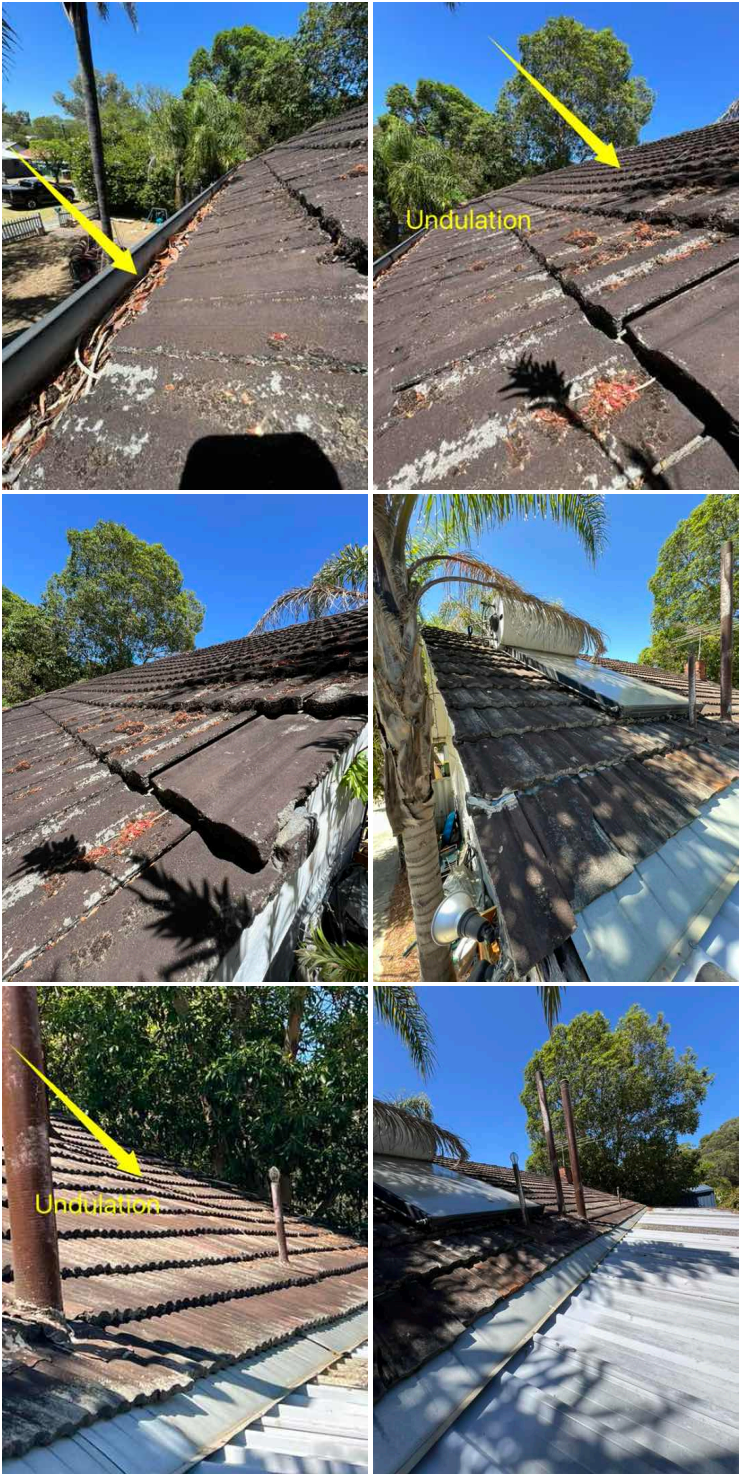
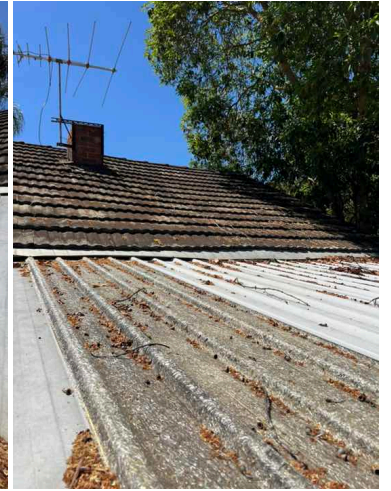
Recommend maintenance be undertaken to roof cover including repair minor timber rot visible to ends of barge boards and remove debris from guttering to prevent blockages.  
 Excessive undulation/sagging visible to roof cover. See roof void defects for further comments and repairs.

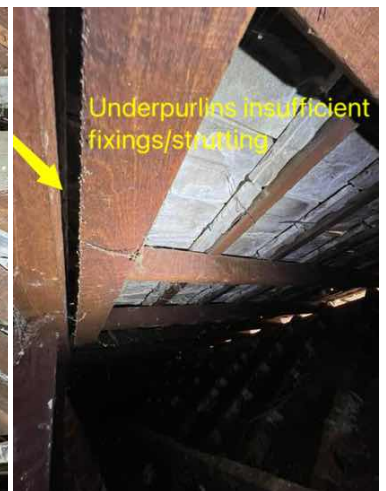
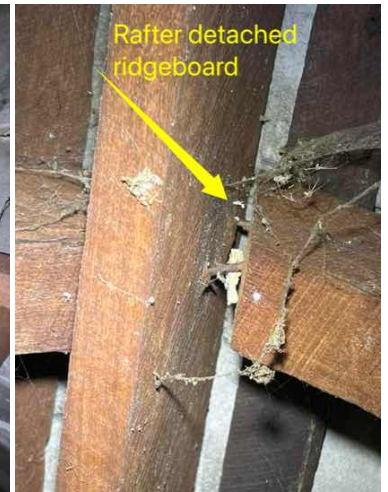
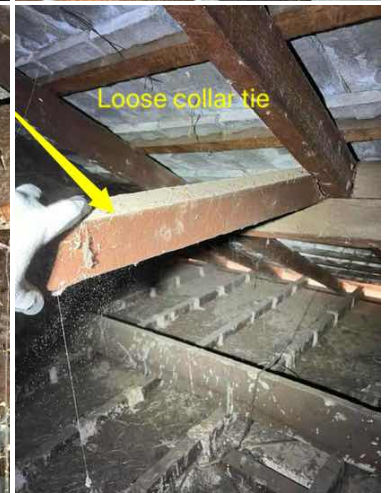
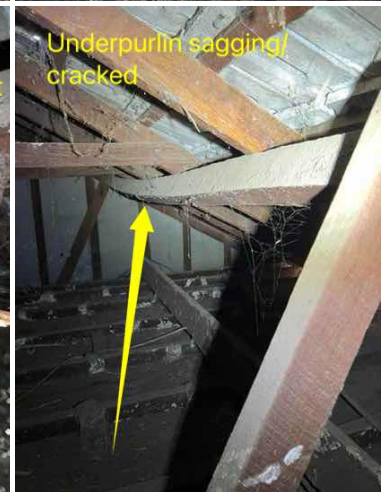
Major Structural Defects - A roof carpenter is required to further assess and repair structural defects visible in the roof void area and prevent further sagging. Although some undulation can be typical of a property of this age, Major undulation is visible to the roof cover in areas as a result of failed/insufficient strutting to rafters/underpurlins. The underpurlin joint laps are insufficiently bolted/strutted. Other structural defects that require repair include a detached rafter at ridgeboard connection, loose collar ties that require retightening of bolts and a ridgeboard connection that requires refixing such as adding a fishplate.

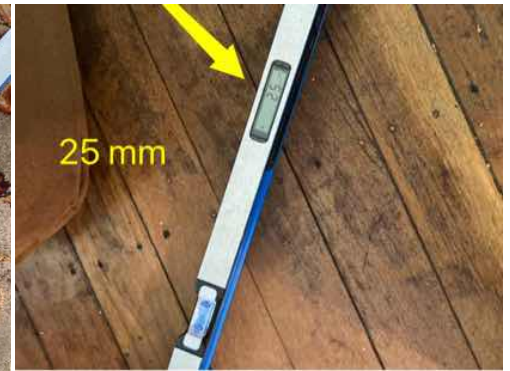
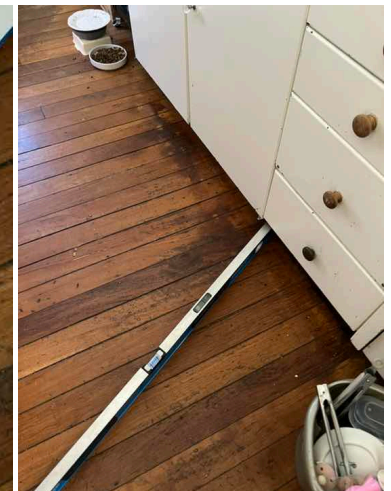
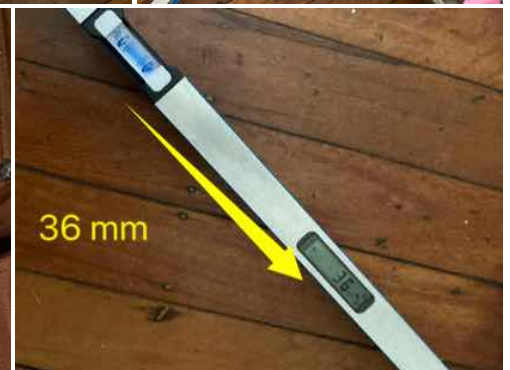
The house floor boards are out of level upto approx 40 mm in areas. Undulation of floor boards can be typical of properties of this age, however subsidence of stumps is a possible cause. See subfloor comments for further details.

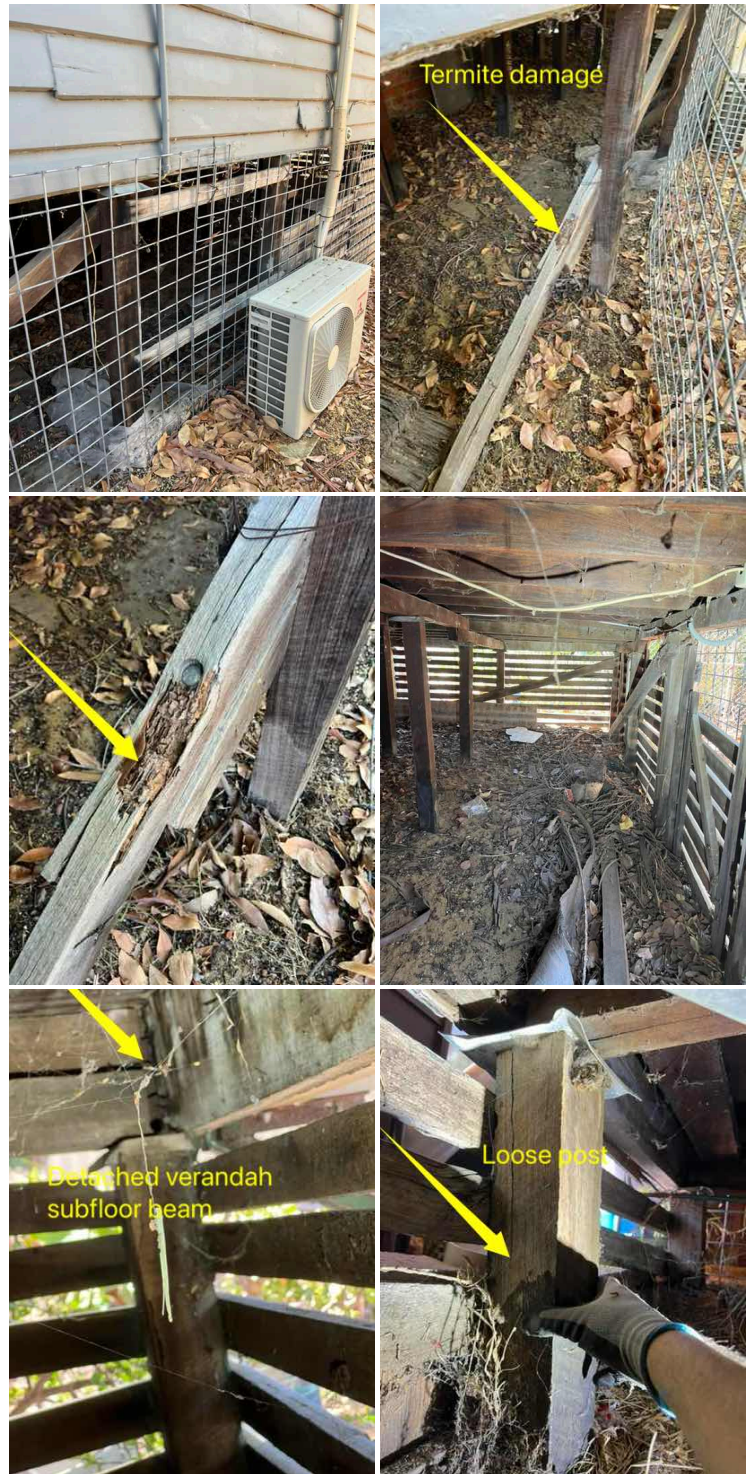
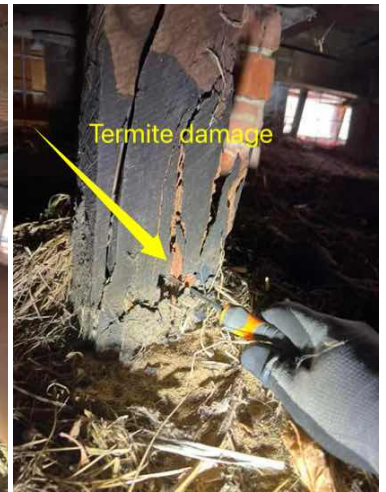
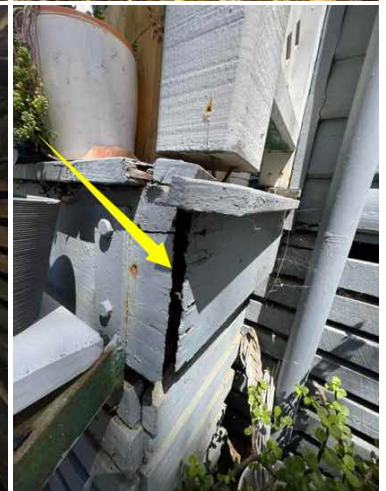
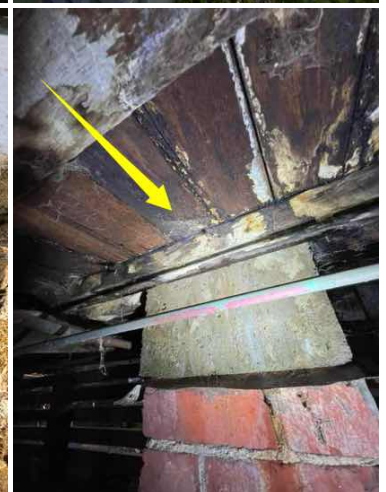
Major Structural Defects - Major structural defects visible to subfloor in areas and require further assessment and repair by a stumping contractor/ carpenter. These structural defects include timber rot visible to Several stumps and floor boards (under bathroom/laundry areas), termite damage to stump under bathroom area/bracing timber to subfloor entry, possible subsidence of several posts (particularly around perimeter) due to floors being out of level upto approx 40 mm and detached verandah outer beam at corner joint location.
