DRAINAGE SYSTEM MAINTENANCE INSPECTION REPORT

Date: December 14, 2022

Client: EAST LAKE WOODLANDS COMMUNITY ASSOCIATION

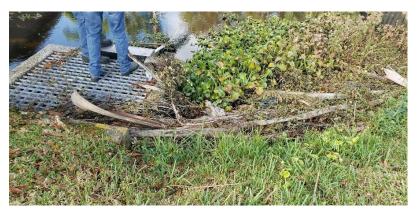
6CC NEW 365 Holly Hill-debris needs to be removed from grate. \$_____

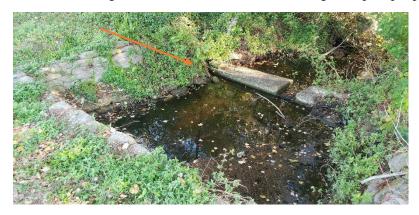
7CC NEW 10th green south course-erosion at drainage sump. Rip rap is needed. \$
