Revised
FULL RESERVE STUDY
East Lake Woodlands
Community Association, Inc.

Oldsmar, Florida
Inspected - February 22, 2021
Revised - July 9, 2021

East Lake Woodlands Community Association, Inc.
Oldsmar, Florida

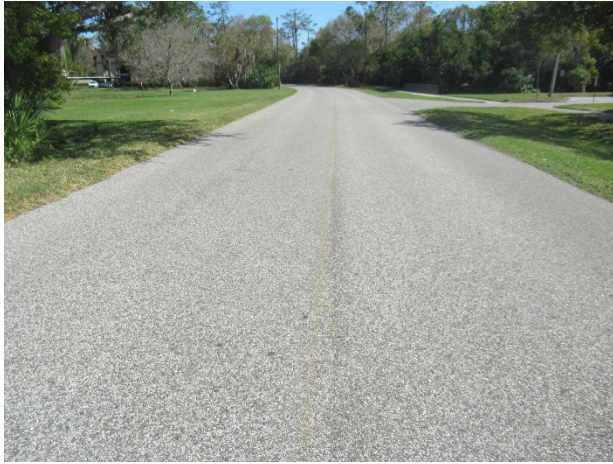
Asphalt pavement – replaced in 2008 – raveling evident

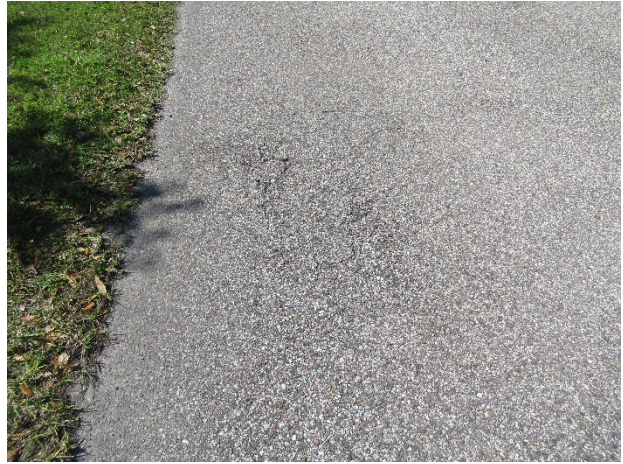
Asphalt pavement – replaced in 2008 – deterioration evident

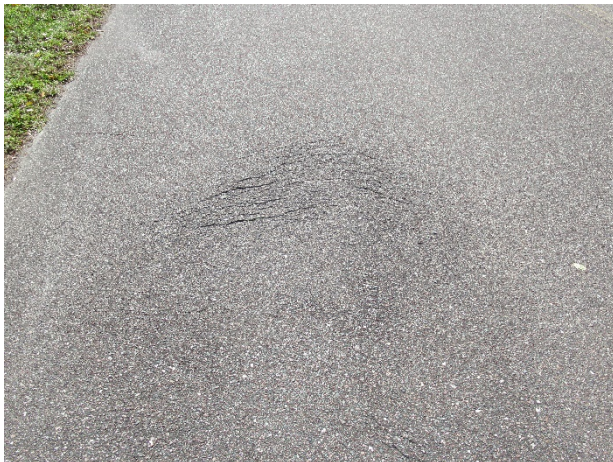
Asphalt pavement – replaced in 2008 – slippage cracks evident

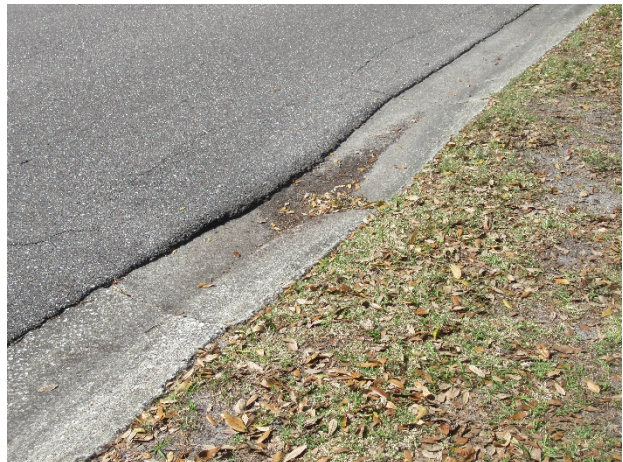
Asphalt pavement – replaced in 2011 - settlement evident

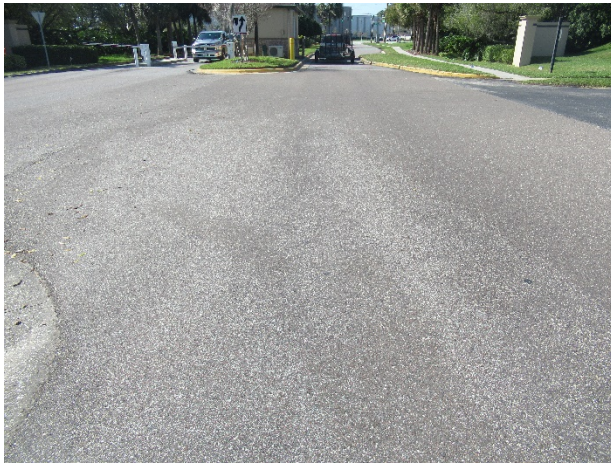
**Asphalt pavement – replaced in 2012 – raveling
evident**

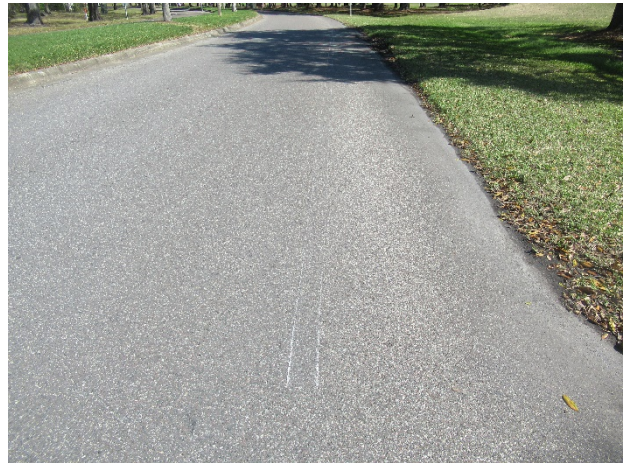
**Asphalt pavement – replaced in 2012 –
deterioration of the striping evident**

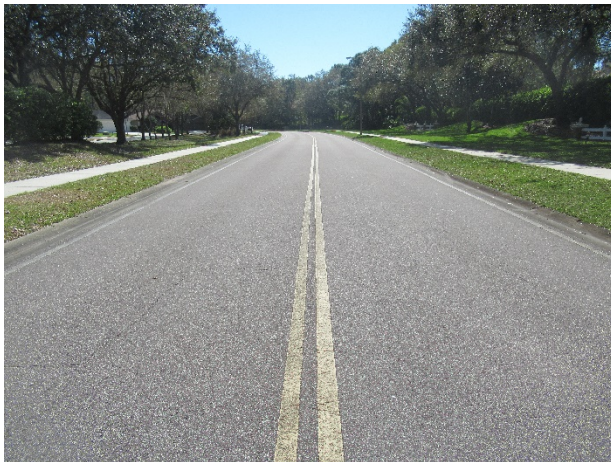
**Asphalt pavement – replaced in 2013 – cracks
evident**

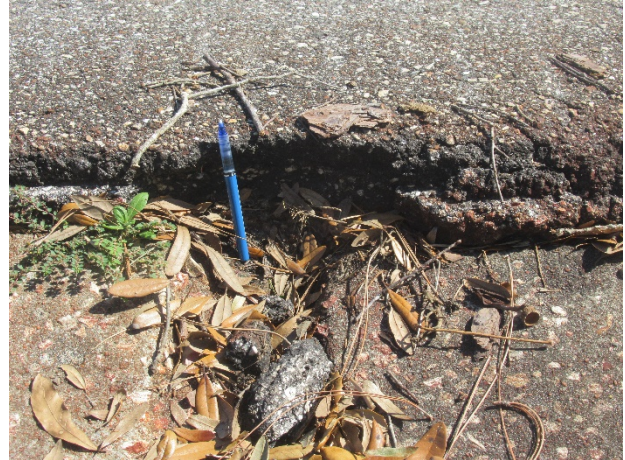
Asphalt pavement – replaced in 2013 - settlement evident at catch basin at Turtle Creek Trail

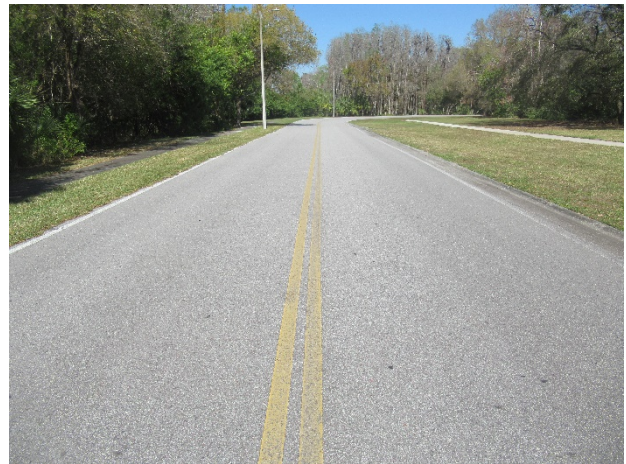
Asphalt pavement – replaced in 2015 – deterioration of the striping evident

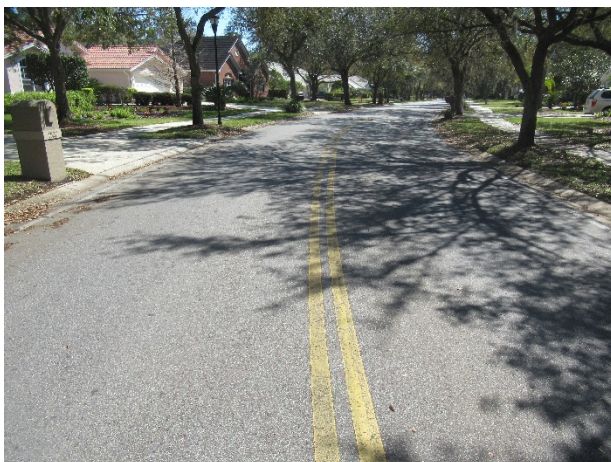
Asphalt pavement – replaced in 2015 – deterioration of the striping evident

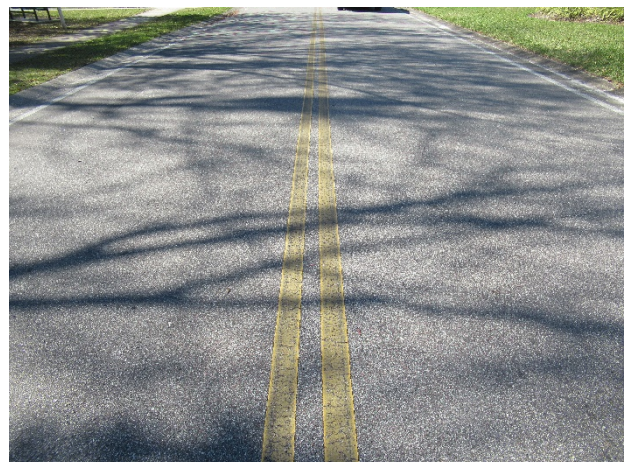
Asphalt pavement – replaced in 2016 – deterioration of the striping evident

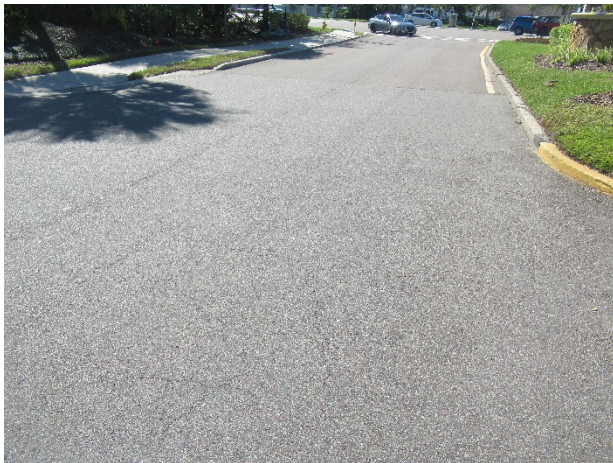
Asphalt pavement – replaced in 2017 – north gate entrance – cracks evident

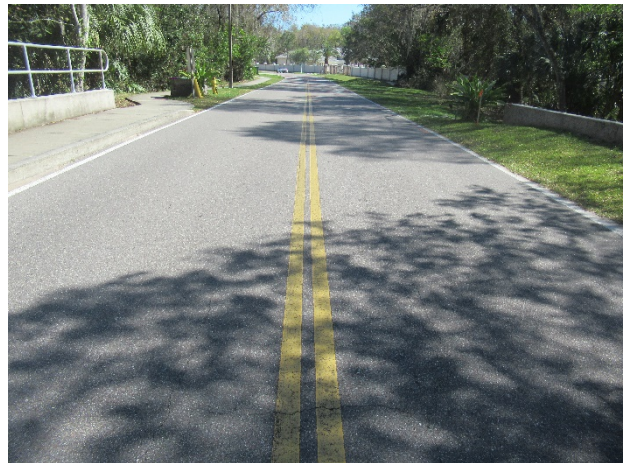
Asphalt pavement – replaced in 2017 – cracks evident

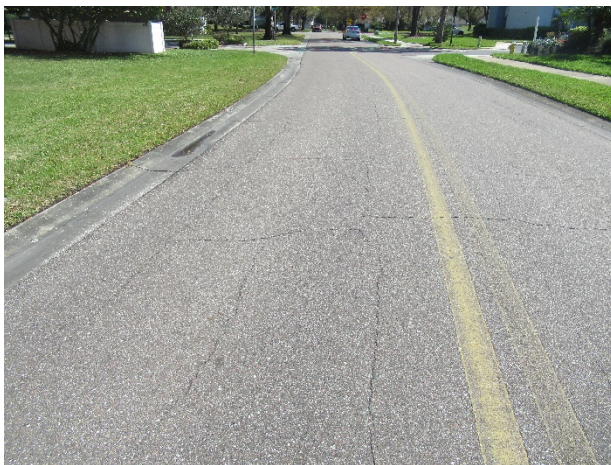
Asphalt pavement – Woodlands Drive – box cracks evident

Useful Life: 15- to 20-years with the benefit of timely patching with the exclusion of the roads at Woodlands Drive. At the request of the Board as well as due to the conditions noted during our inspection, we have reduced to useful life to repaving every 12 years for the Woodlands Drive section of asphalt pavement.

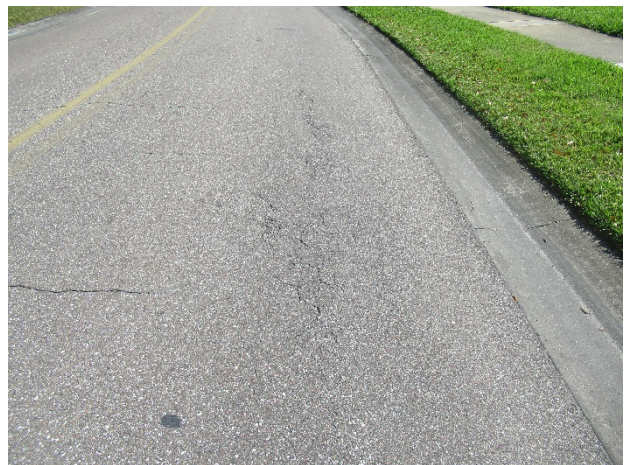
Asphalt pavement – Woodlands Drive - cracks evident

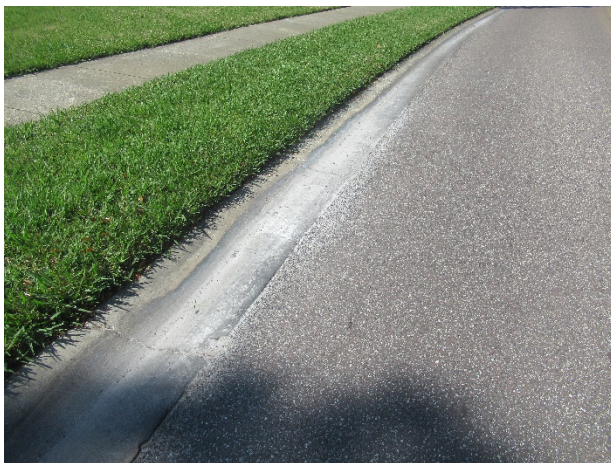
Asphalt pavement – Woodlands Drive – sediment in the gutters evident

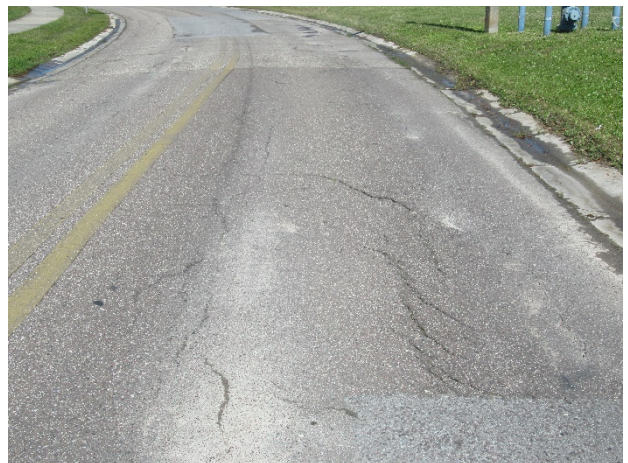
Asphalt pavement – Woodlands Drive – slippage cracks and base seepage evident

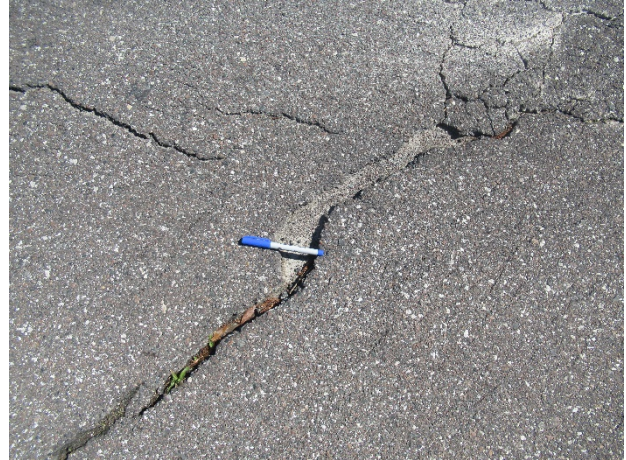
Asphalt pavement – Woodlands Drive – longitudinal cracks evident

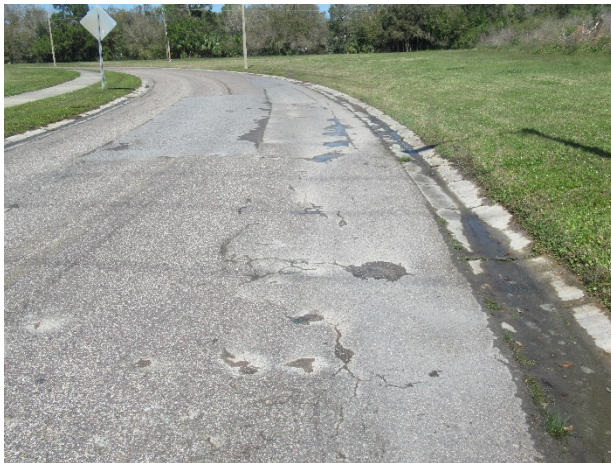
Asphalt pavement – Woodlands Drive – cracks and base seepage evident

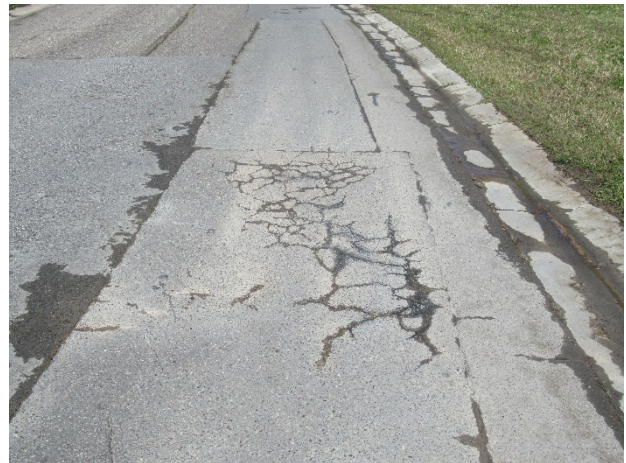
Asphalt pavement – Woodlands Drive – alligator cracks and base seepage evident

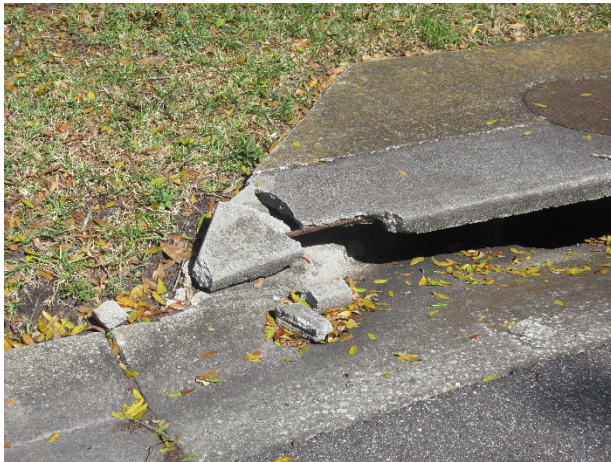
Condition: Fair overall with settlement and deterioration of the concrete evident throughout. Additionally, we noted multiple locations with damaged concrete and exposed rebar during our inspection.

Catch basins – damaged concrete and exposed rebar evident

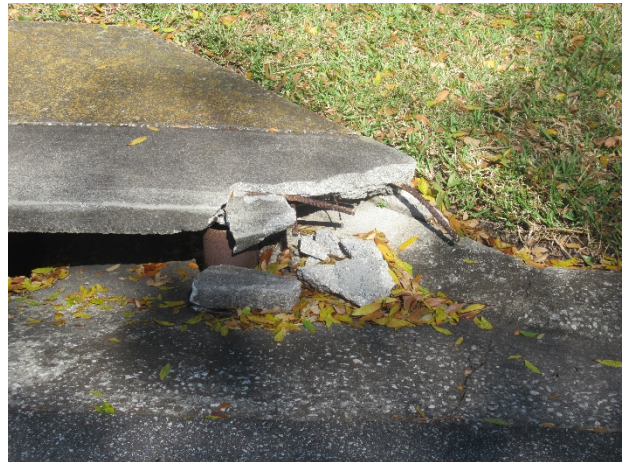
Catch basins – damaged concrete and exposed rebar evident

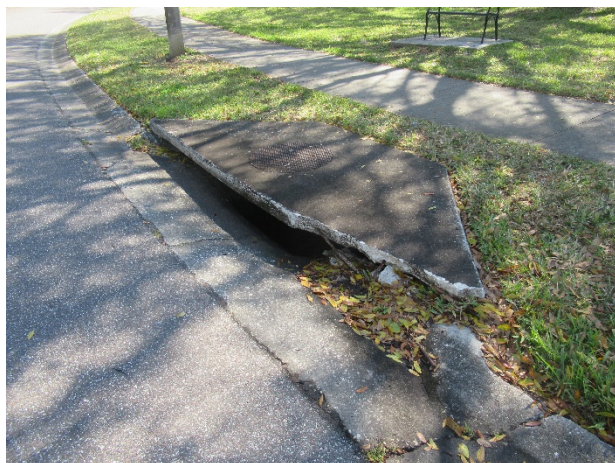
Catch basins – damaged concrete and exposed rebar evident

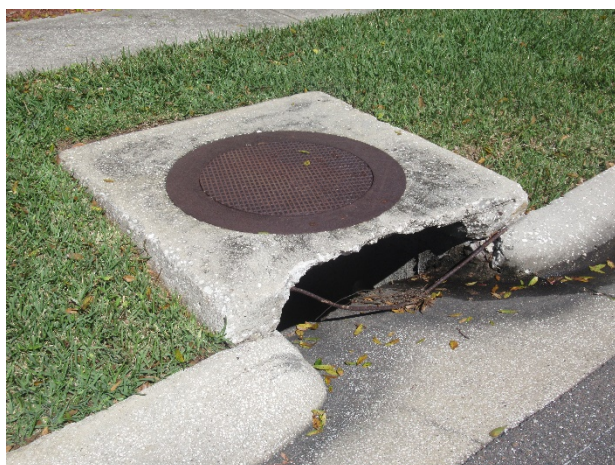
Catch basins – damaged concrete and exposed rebar evident

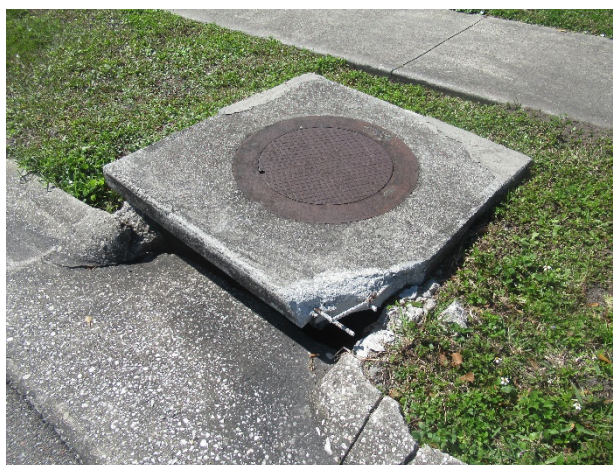
Catch basins – damaged concrete, exposed rebar, and displacement of the cap evident – near Walmart gate entrance

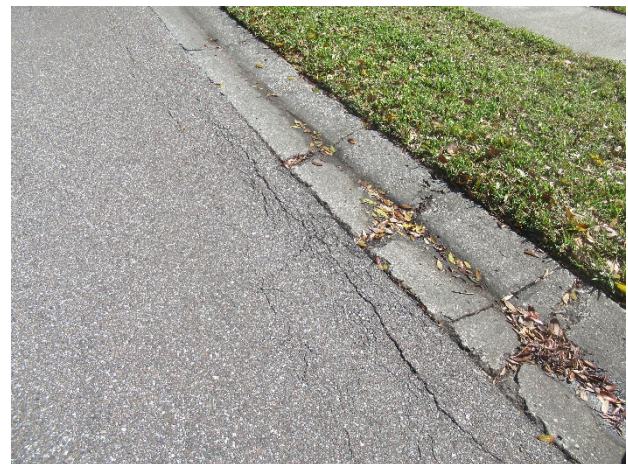
Concrete curbs and gutters – cracks evident

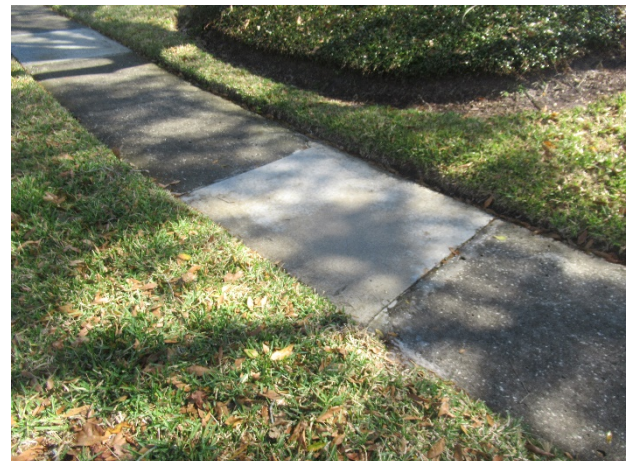
Concrete sidewalks – partial replacements evident

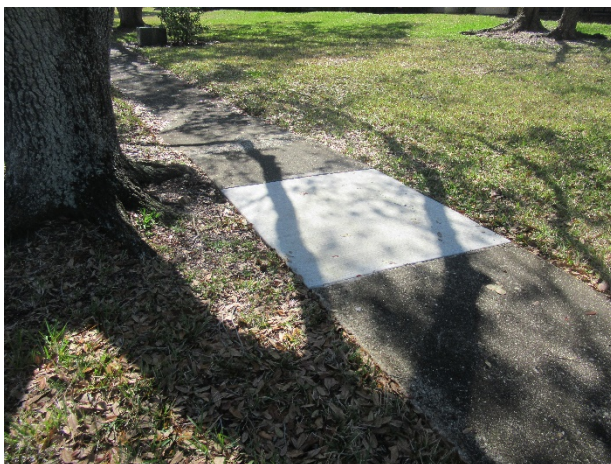
Concrete sidewalks – partial replacements evident

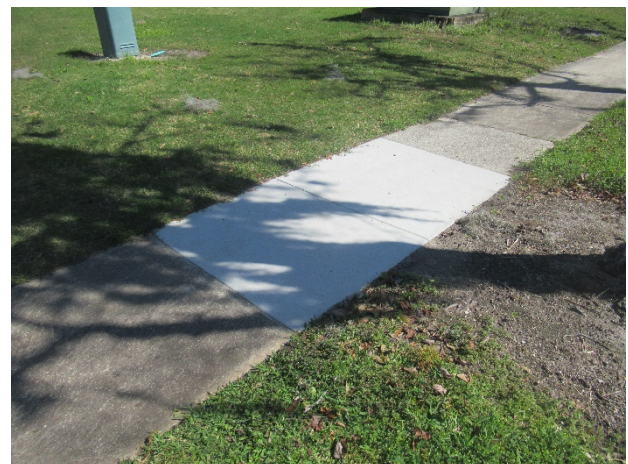
Concrete sidewalks – partial replacements evident

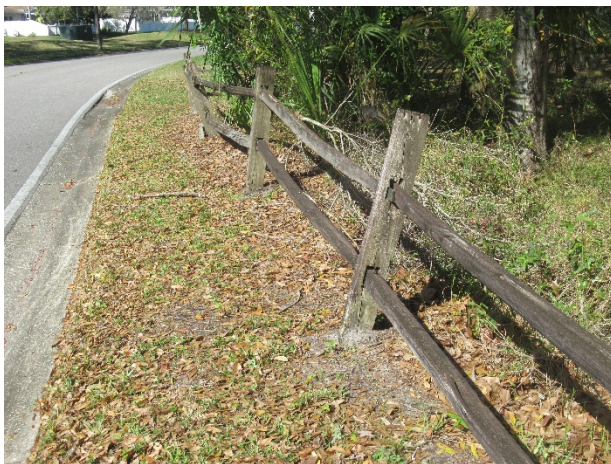
Condition: Good to fair overall with minor wood rot and leaning sections evident

Split rail wood fences – leaning sections evident

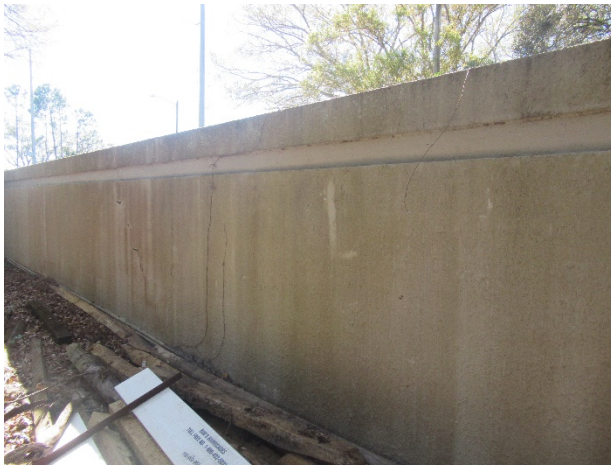
Condition: The walls are in fair condition overall with deterioration of the stucco coatings evident as well as deterioration of the wood fences at the perimeter wall on Sunflower

Perimeter walls – deterioration of the stucco coatings evident - Sunflower

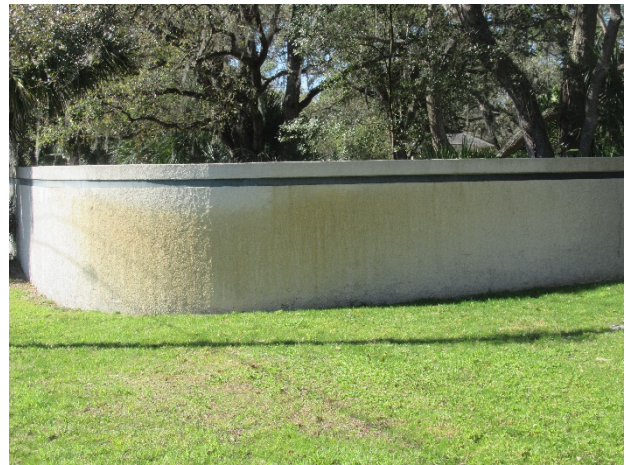
Perimeter walls – deterioration of the paint finishes evident - Sunflower

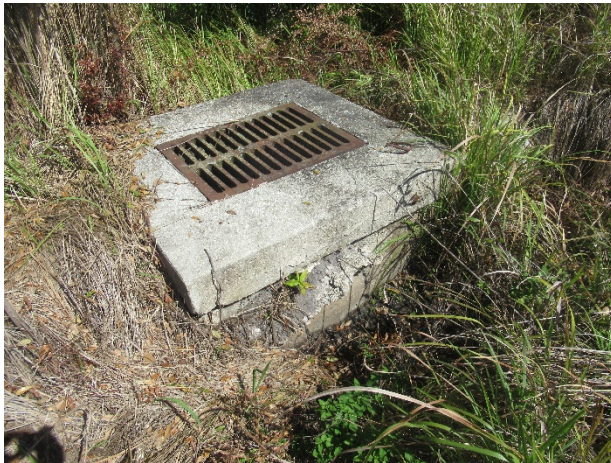
Condition: There have been a history of leaks as well as settlement at the pipes. We are informed that both of the sections of pipes will be televised in 2021 in order to determine if there are any obstructions.

Elkway – control structure

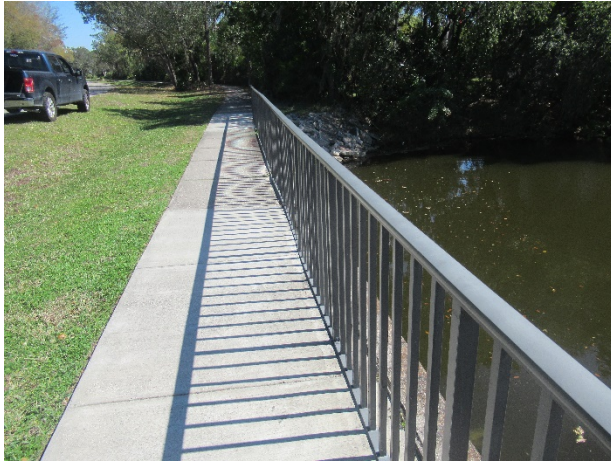
Condition: Good to fair overall with minor deterioration of the paint finishes evident

Metal railings – deterioration of the paint finishes evident

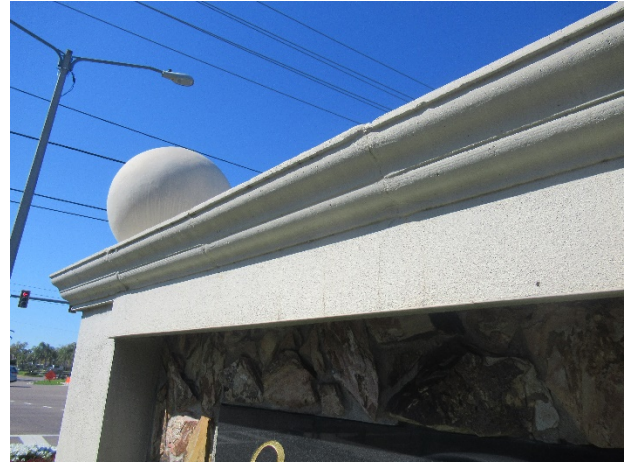
Condition: Fair overall with deterioration of the paint finishes evident.

Entrance monument signage – deterioration of the top cap evident – north gate house

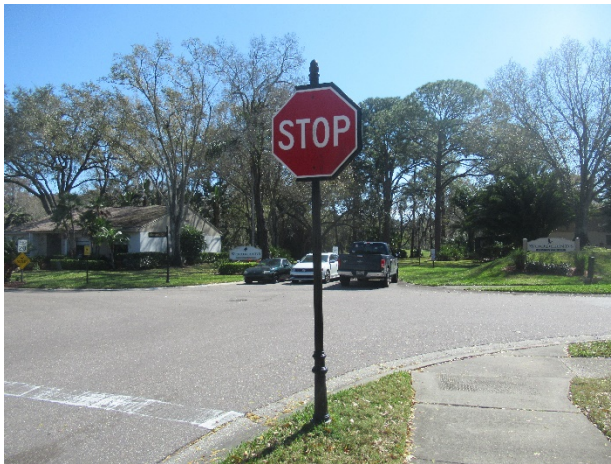
Condition: Good to fair overall with deterioration of the paint finishes on the decorative posts evident as well as deterioration of the sign frame evident

Street and traffic signage – deterioration of the sign frame evident

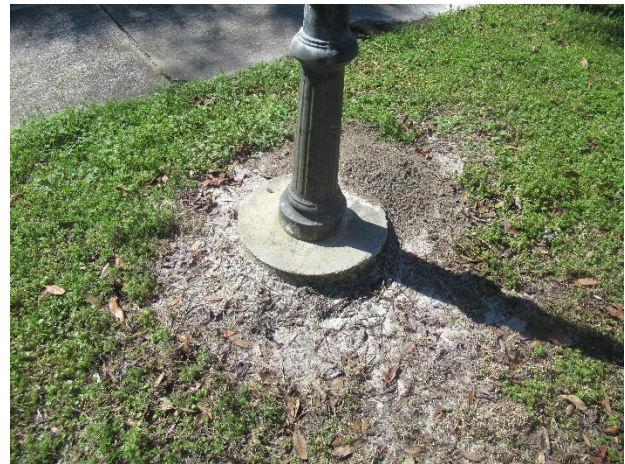
Sign and traffic signage – deterioration of the paint finishes on the post evident

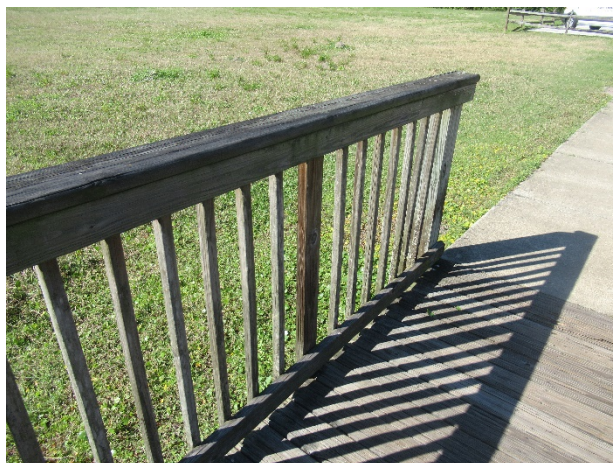
Condition: Good to fair overall with previous repairs evident

Wood walkways – partial replacements of the wood evident
