#### DRAINAGE SYSTEM MAINTENANCE INSPECTION REPORT

Date: March 29, 2021 Inspection #7

Client: EAST LAKE WOODLANDS COMMUNITY ASSOCIATION

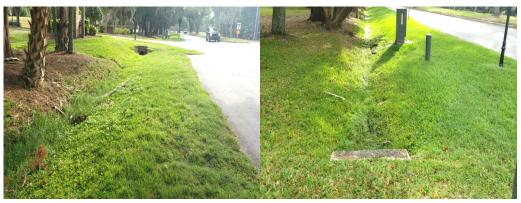
1) Woodlands Parkway at Holly Hill (Woodland Estates)- clear ditch 70' in each direction from inbound and outbound headwalls. **\$2,800.00**

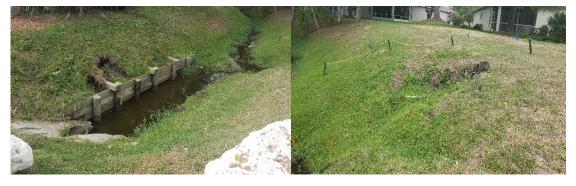
11) Woodlands Blvd creek that runs between Cross Creek and the Preserve-soil has run out from under retaining wall on the Preserve side and the soil has eroded on the Cross Creek side. \$\_\_\_\_\_

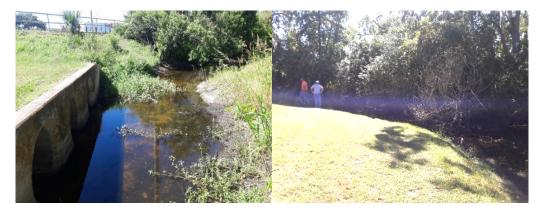
15) Moccasin Creek along Tampa Road- clear vegetation on both side of creek behind #15 south tee box. **\$22,850.00**

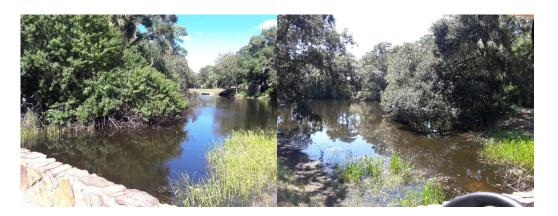
23a) #15 south tee box from bridge
Remove low hanging tree limbs **\$2,590.00 for both pictures**
