DRAINAGE SYSTEM MAINTENANCE INSPECTION REPORT

Date: May 28, 2020 Inspection # 5

Client: EAST LAKE WOODLANDS COMMUNITY ASSOCIATION

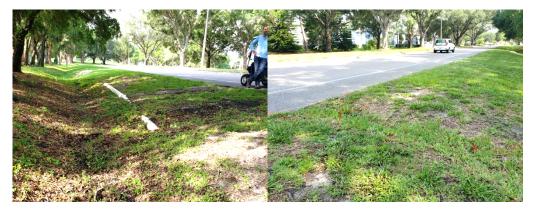
9) East Lake Woodlands Parkway inbound along golf course- there are several locations where concrete flumes need to be constructed. They are marked with orange paint. There is also a larger eroded area which will need a flume as well as rip-rap and sod.

Price for standard flume \$_2,695.00

Price for larger eroded area with flume \$_5,600.00_

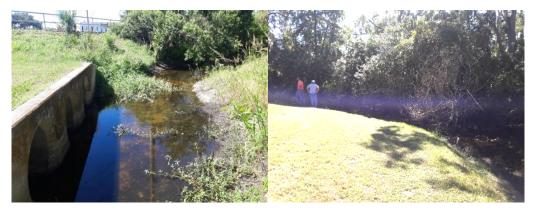
12) Moccasin Creek along Tampa Rd-clear vegetation on both side of creek behind #15 south tee box. **\$22,850.00 NOT COMPLETED**

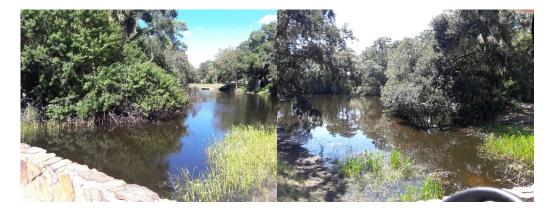
October 2018 October 2018

Initial Date		
Initial Date		
Initial Date		
20a) #15 ^t south tee box	x from bridge	20b) #15 ^t south tee box from bridge
Remove low hanging t	tree limbs \$2,590.00	for both pictures NOT COMPLETED
