**FA-ST**.co.uk  
Filtration Analysis Services Technology Ltd  
How clean is your oil ?

| Objective of Analysis & Tests Performed | Debris material extracted on 1st filter wash |
| <p>Filter submitted for analysis from a marine engine filtration system following a lube oil pump failure to determine the cause of failure. Client commented that engine had only recently been overhauled 3 weeks prior to failure and the lubricant was from a reputable supplier. An unused oil sample was provided from the IBC used to refill the system to establish if the oil in the filter was consistent with the oil in the machinery at time of failure.</p> <p>Analysis included a mixture of organic spectral chemistry, elemental analysis and wet chemistry techniques to determine the nature of the material and failure mode.</p> | |

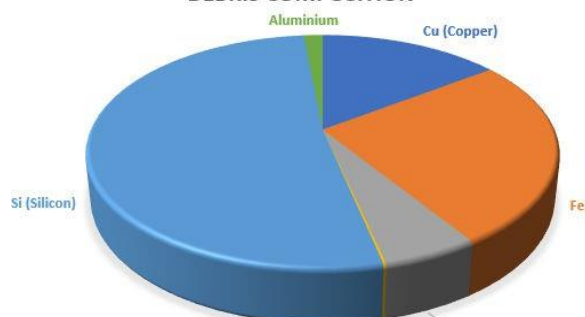
Each field view represents 1cm in size. The picture to the left shows significant ingress of sand particles, whilst the right picture shows a large long and curved cutting wear particle.

The particle composition shown on the left showed significant crystalline particles consistent with sand and the predominant wear type as cutting wear with sliding and fatigue particles. The elemental composition of the material was predominantly Silicon consistent with sand and copper, lead, tin and iron consistent with the pump material failure.

The findings show the failure mode has severe cutting wear, which is likely linked to the abrasive silicon based crystalline material observed. The Silicon source is most likely sand rather than cat fines or dirt because of the low Aluminium content detected. The Copper, Lead and Tin are consistent with bearing material and the iron is most likely additional material from the failure.

Advise to prevent failures such as this in future, inspect machine for sources of ingress such as storage tank breathers. Also review lubricant handling procedures from the point of transferring the lubricant from the IBC.

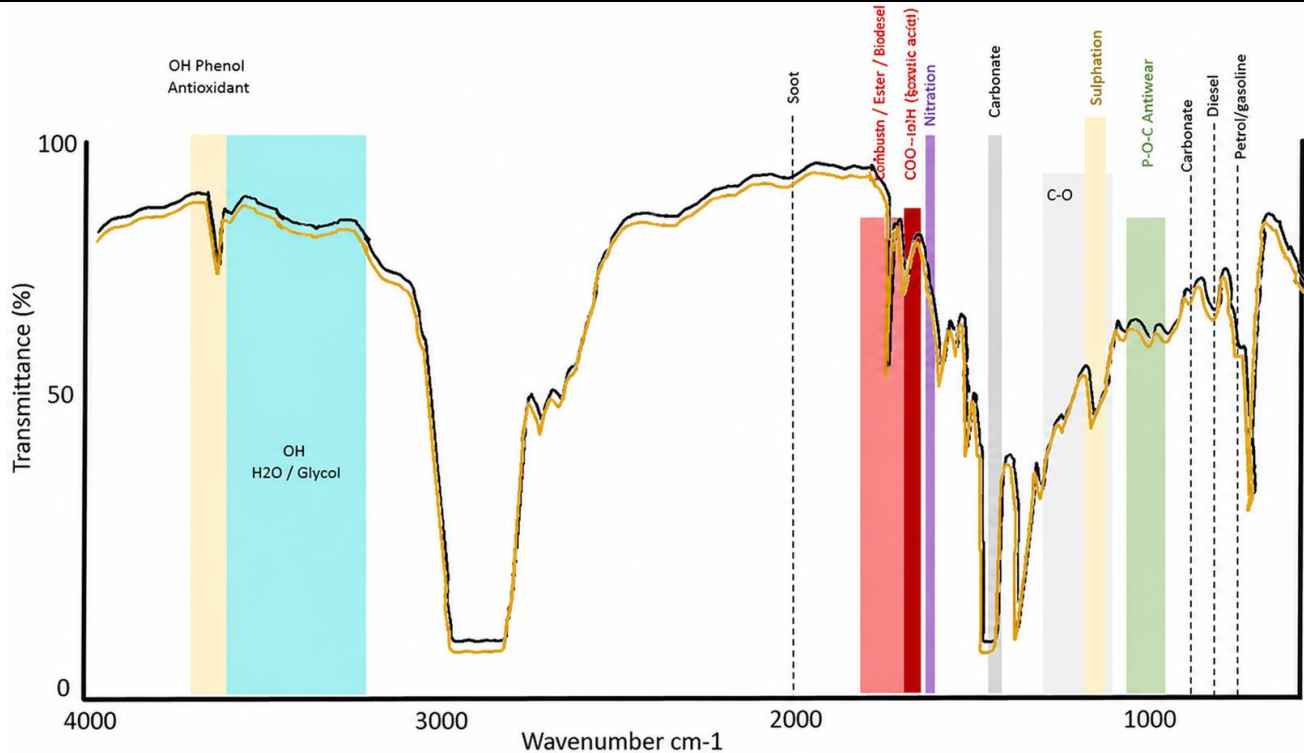
### FTIR Findings

Comparison of new reference oil (yellow line) and used oil (black line) traces shows the two oils to be the same product. Both oils show significant remaining anti-oxidant suggesting the oil is in a near new condition.

The submitted reference oil for comparison shows by FTIR they are the same product, which suggests the clients fear the oil may not have been changed during the overhaul or the incorrect oil was used is unfounded. The IBC sample showed very little evidence of sand ingress, suggesting the contamination did not occur prior to arrival.
