# Inspection & Contra-Charge Report

A detailed structural inspection report prepared for Plot 329, – a two-storey new build dwelling. The inspection was carried out by A&S Contractors Ltd following reports of persistent creaking, cracking and unusual noises emanating from the first-floor structure and the ceiling below.

Foxwood,

329

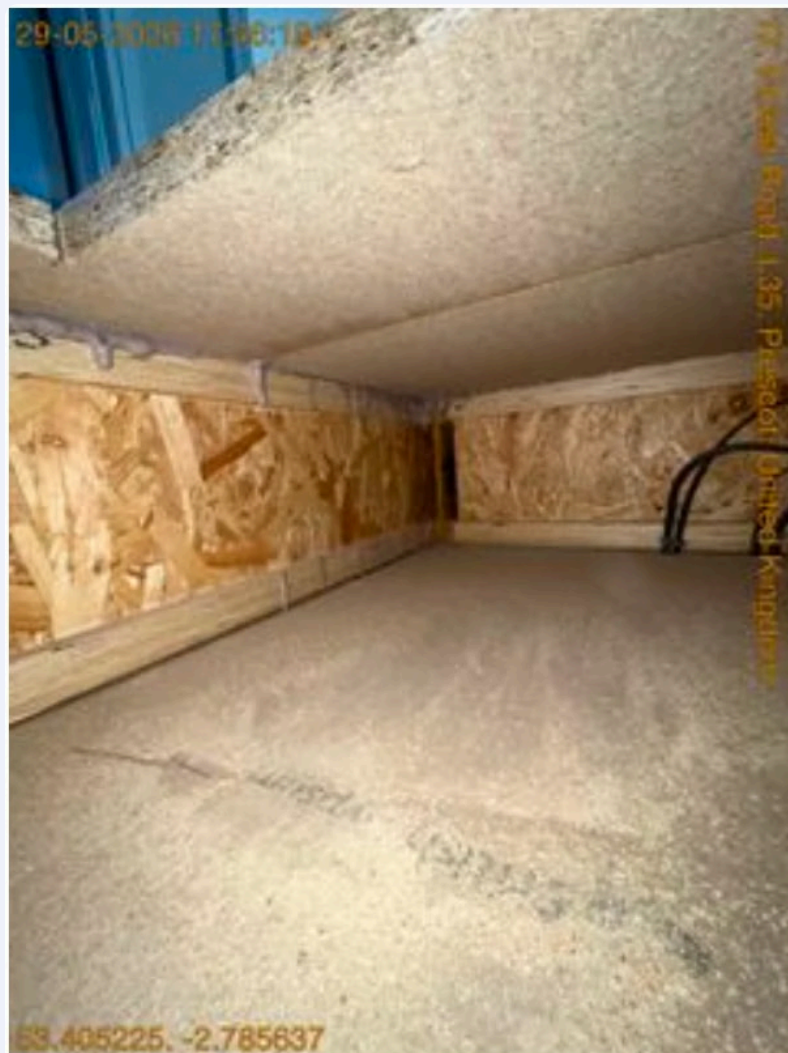
Inspection of the ceiling lining revealed that the plasterboard sheets were **not fixed tightly** against the underside of the supporting floor structure. Visible gaps were noted between the plasterboard and the lower flange/supporting elements in several locations. The lack of mechanical contact between the plasterboard and the timber beam allows movement to occur under normal floor loading conditions, generating cracking, creaking and friction-related noises.

PLASTERBOARD NOT TIGHT TO THR TIMBER JOIST

Installation of timber firing peices and glue and fix to both the plasterboard and joist in 4no rooms. remove sections of ceiling if required.

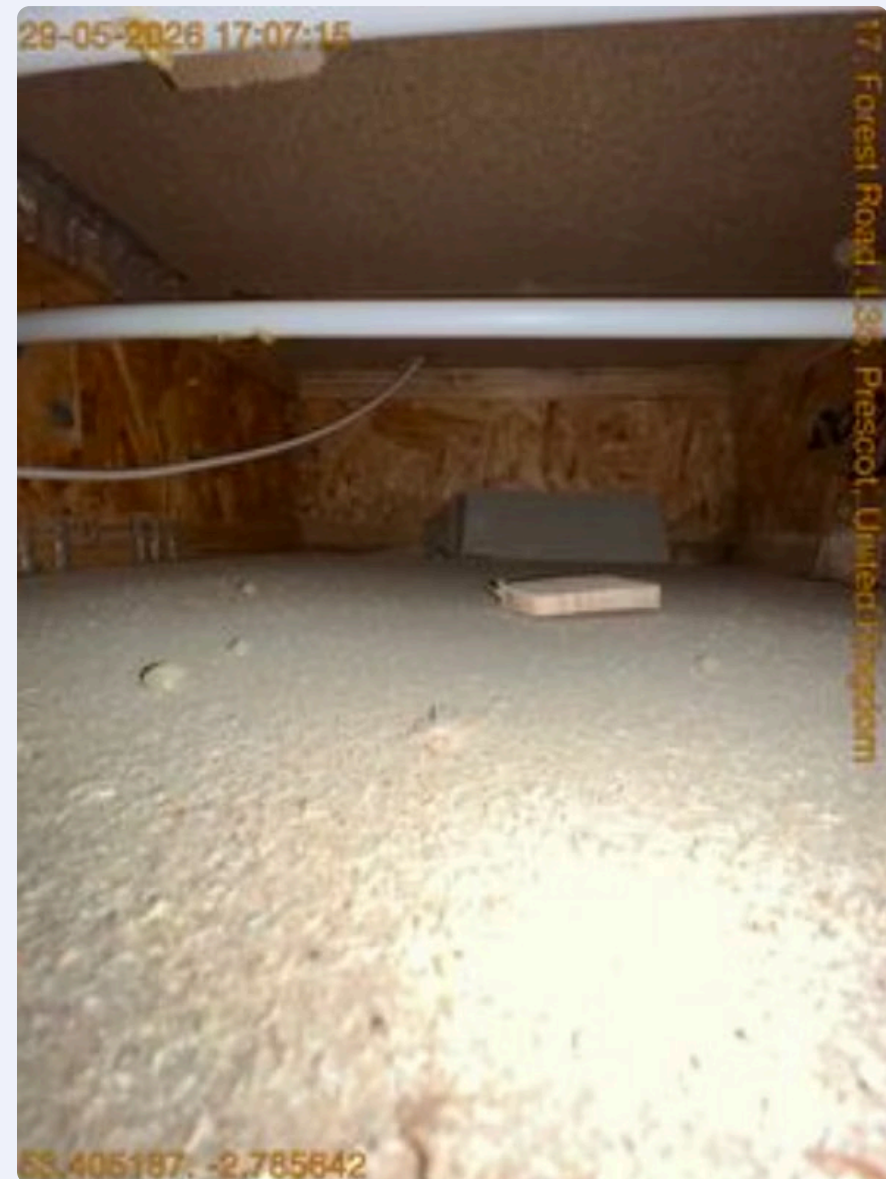
Inspection of the exposed floor structure identified noggings incorporated within the floor construction. The bottom flange nogging assembly had been installed in a **vertical orientation** rather than in accordance with the approved design details and construction drawings. This orientation differs from the expected arrangement.

VERTICAL NOGGING

The floor structure and steel beam arrangement appear inconsistent with the intended construction detail and approved drawings. Subject to confirmation against the structural design information, this may indicate an installation issue attributable to the joinery or structural installation phase. The incorrect vertical orientation of the I-beam lower flange is the primary concern.

Obtain and review the approved structural floor drawings and manufacturer installation details for the I-beam arrangement to confirm the intended lower flange orientation.

Verify whether the lower flange orientation as installed complies with the approved design. Undertake further opening-up works where necessary to establish the full extent of the installation issue.

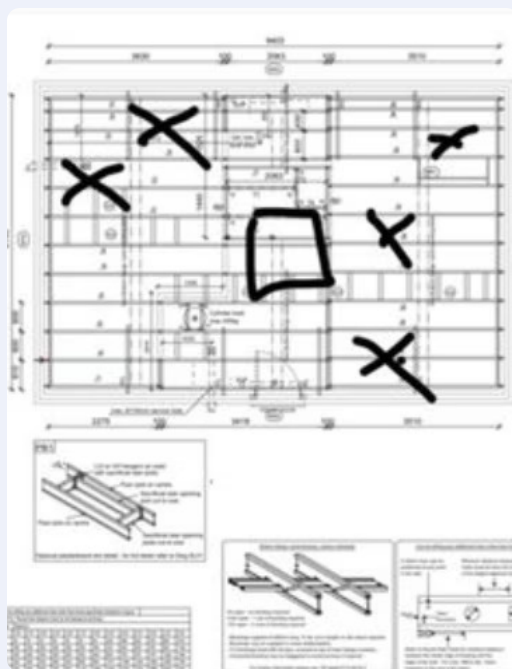
Locations of main noise concern:

The most significant creaking and cracking noises were identified within the first-floor landing area adjacent to the staircase. Movement was observed to coincide directly with loading of the floor structure above the inspected ceiling area, confirming a clear relationship between foot traffic and the reported noise.
