**REPORT**

**Potential Dam-barrier  
objects for  
removal/mitigation  
to support wild Baltic  
salmonid populations  
in Estonia**

**March 2021**

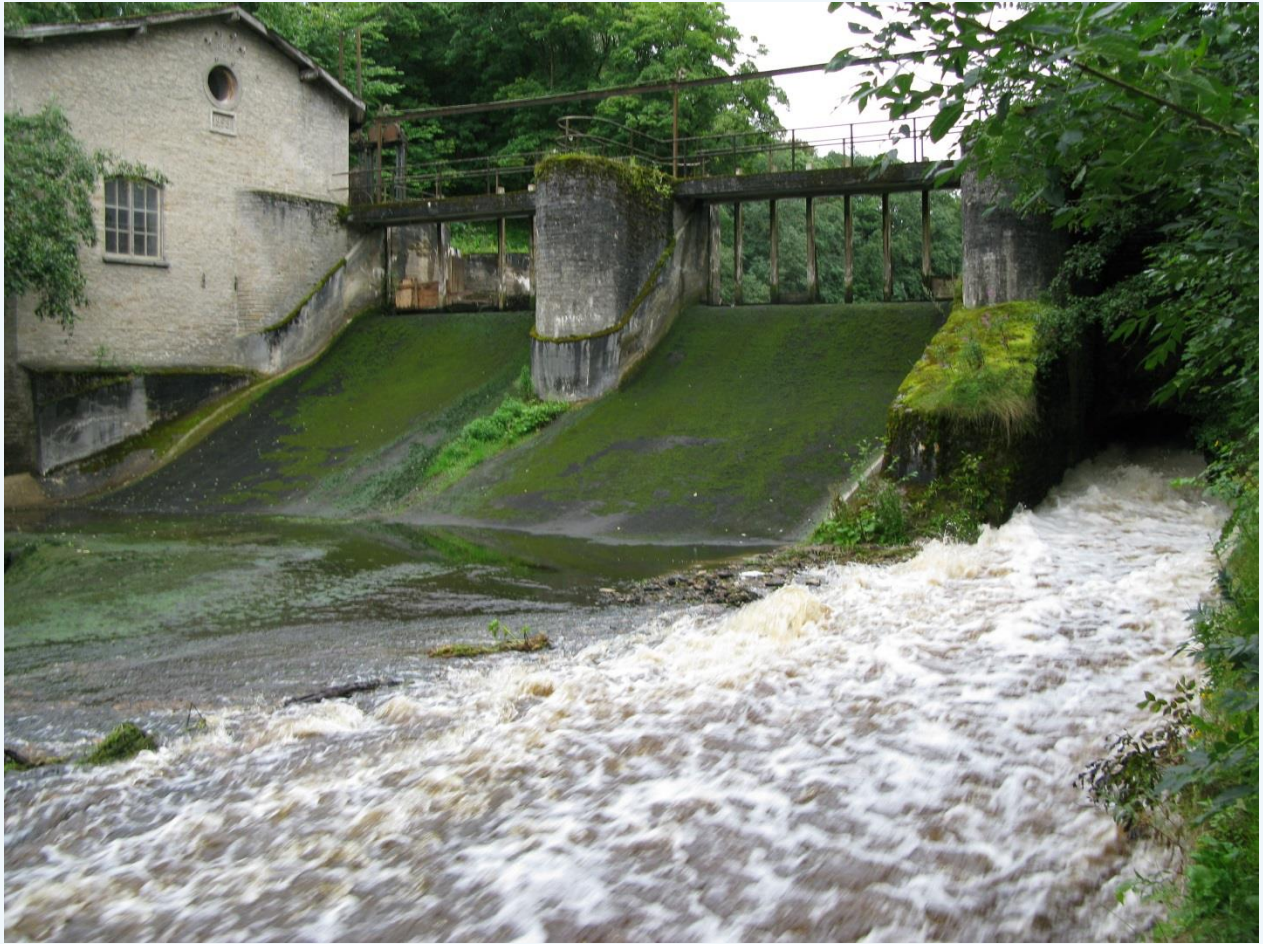
The hydroelectric power station was built in 1893 and it is cultural heritage site. Presently the power station is not operational and it has no water permit. Designed height of the dam is 9.3 m, however the wooden parts are gone and the height as it presently stands is approximately 6.5 m (Photo 1 and 2). The dam is located 2.3 km from the river mouth and it is migration obstacle for all fish. The private company owns the dam and wishes to restore the power station and produce electricity. Local county also supports the plan. However it is unlikely that the dam gets a water permit as it is not able to meet many environmental requirements. The environmental inspectorate issued a decree to fully open the spill gate and to remove the impounded lake. This would restore the spawning areas that are presently flooded, however fish can pass the spill gate only in low numbers and only during in optimal conditions. Long term solution is to remove part of the dam to provide satisfactory fish passage and to retain culturally valuable features of the dam as much as possible. In INTERREG RETROUT project, three alternatives to provide free passage were devised. The construction of a new river channel around the left side of the dam, while retaining all of the cultural values was estimated to cost 2 666 862 euros. The demolition of the concrete body of the dam was estimated to cost 1 038 147 euros. In this alternative cultural values are only partially kept. Third alternative was demolition of all parts of the dam and the estimated cost was 1 125 234 euros. None of the cultural values would be kept in this alternative.

Photo 1. Lower Kunda hydroelectric power station. Note that the upper wooden parts of the dam are missing and all water is (M. Kesler 29.09.2016).

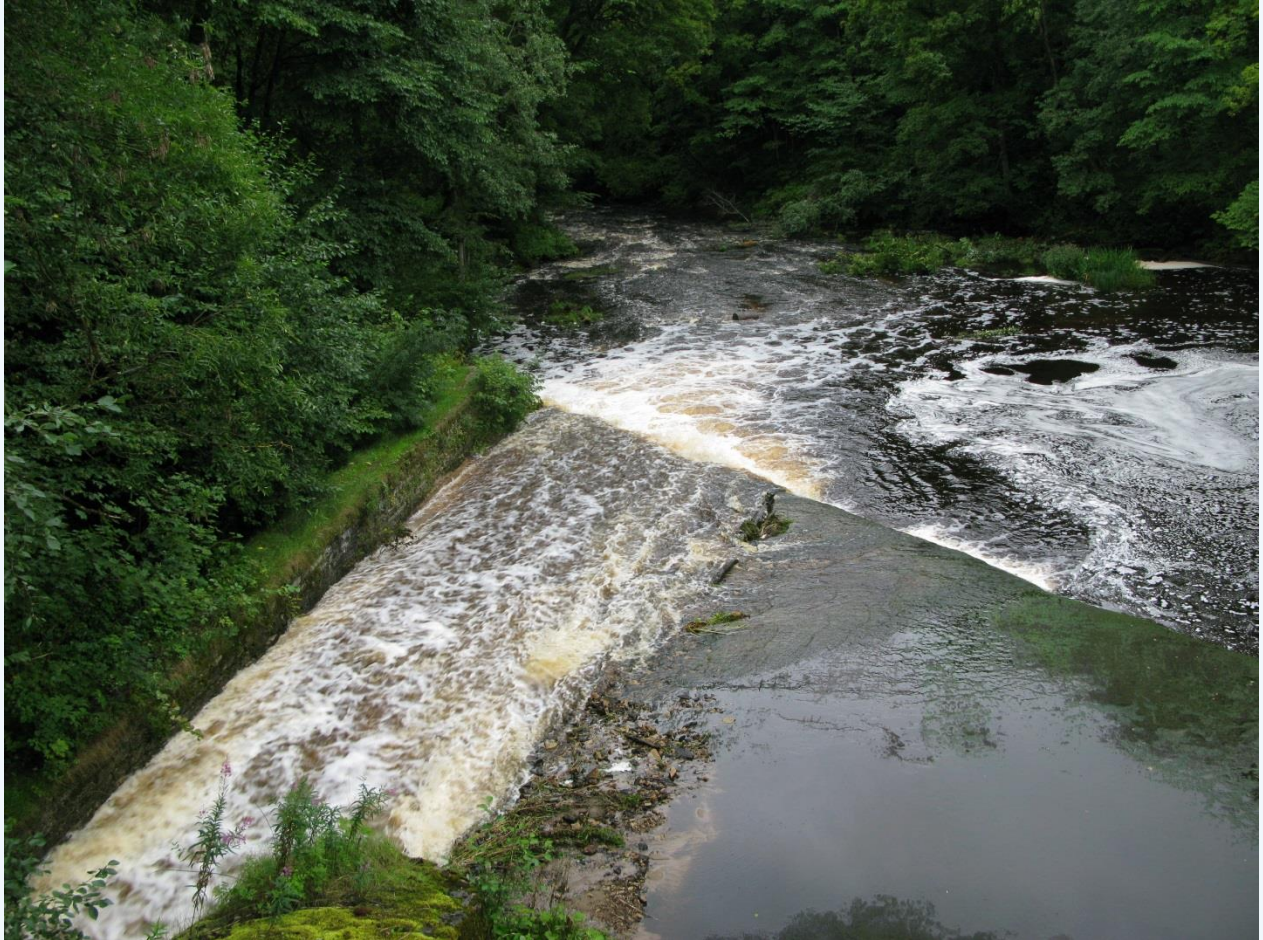
Photo 2. View downstream from the lower Kunda hydropower station (M. Kesler 09.06.2019).

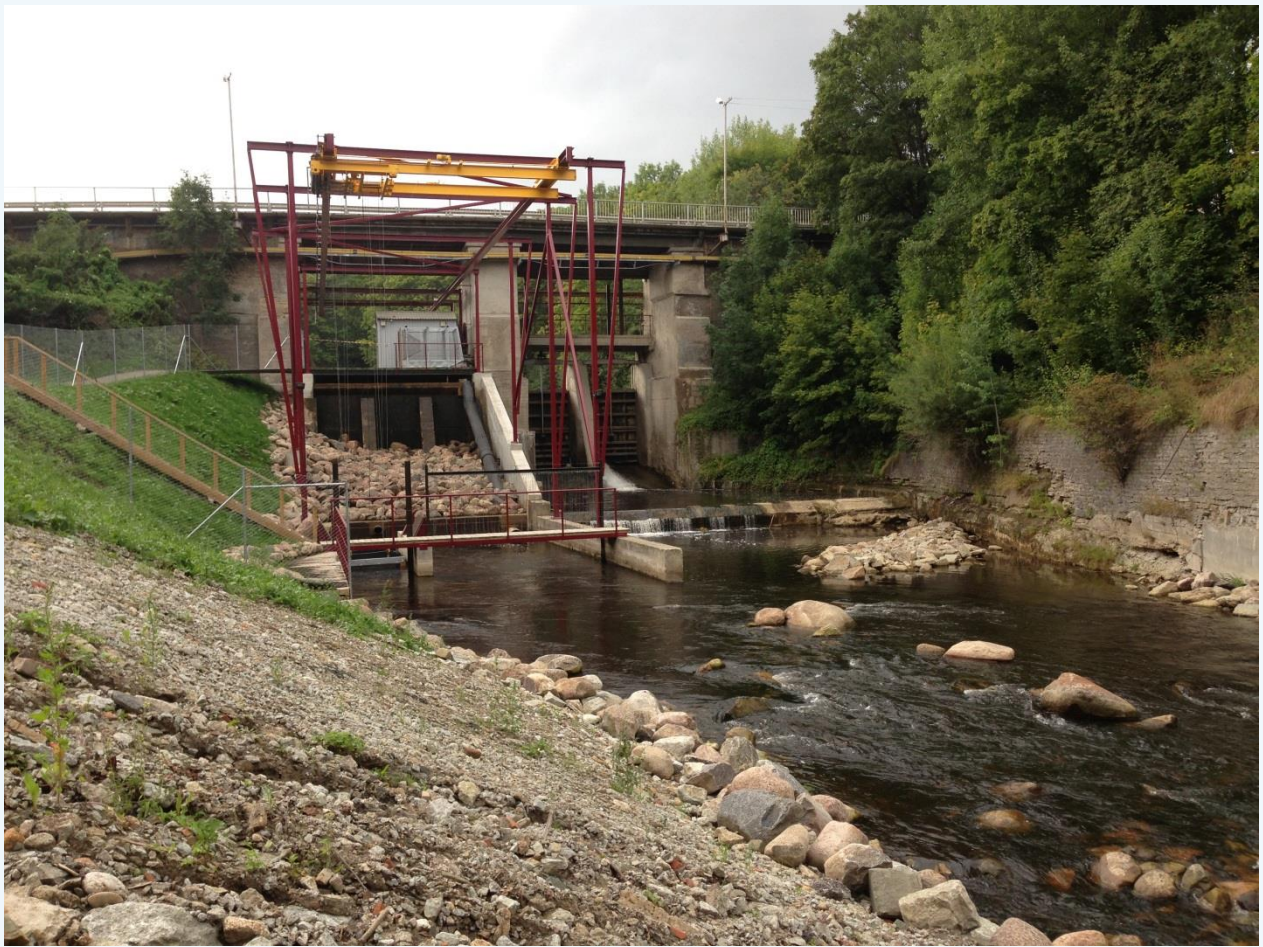
The hydroelectric plant was built in 1870 and rebuilt in 2003. The height is 6.4 m and it is located 2.8 km from the river mouth. The dam has no water permit and therefore not operational. A Fish elevator was built in 2013 to provide passage to fish, however it is considered not adequate (Photo 3). The private company owns the dam and wishes to restore the power station and produce electricity again. Local county also supports the plan. Long term objective is to remove at least part of the dam to guarantee good passage (both upstream and downstream) to fish and at least partially restore the salmon spawning areas at the impounded part of the river. Presently there are no cost estimates of such work.

Photo 3. Kunda second Hydro hydroelectric power station has a fish lift that is considered not to provide sufficient passage.

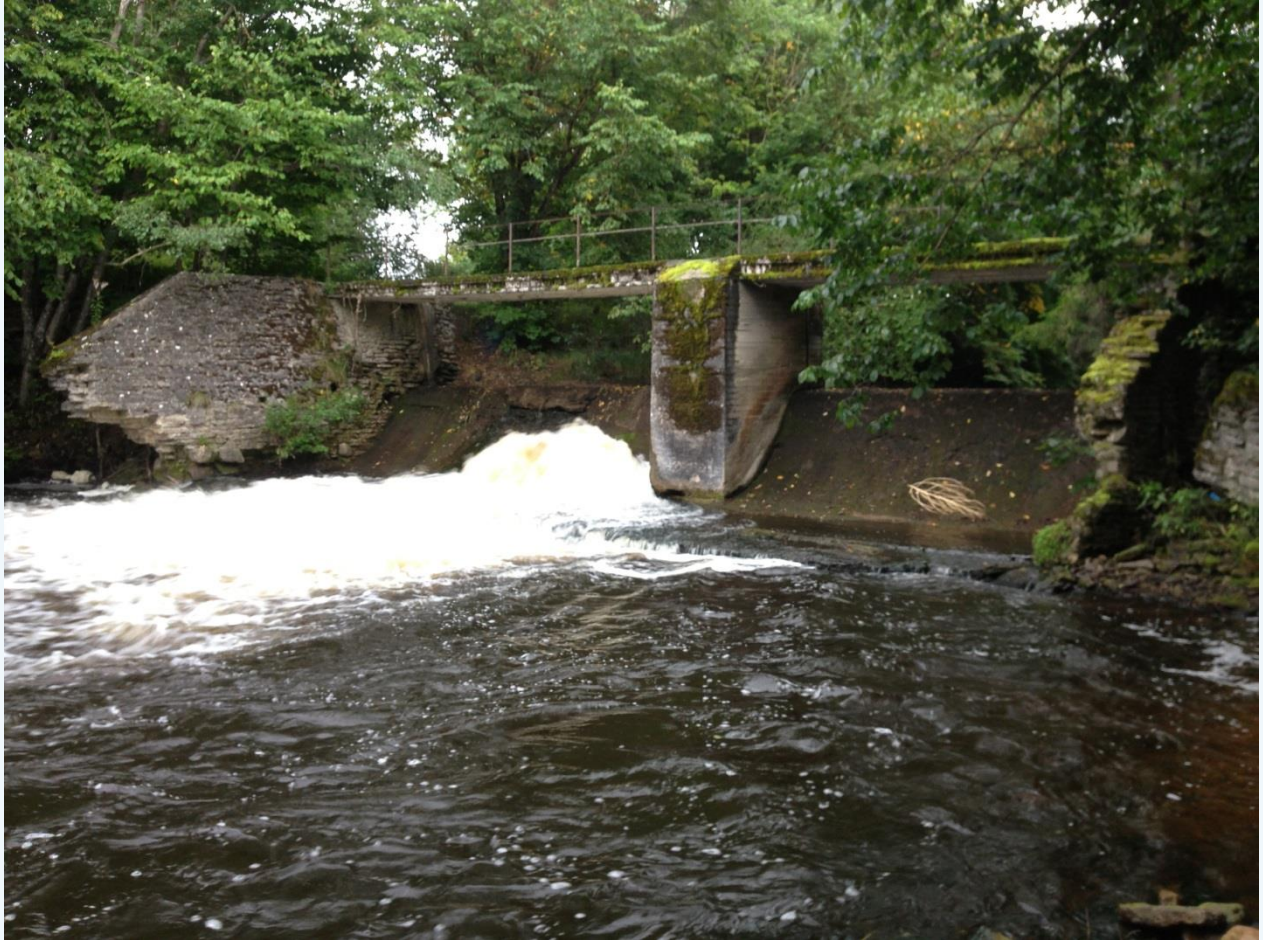
The mill was built in 1870 and the original height was 2.7 m. Only the concrete lower part of the dam remains and the bottom spill gate is open (Photo 4). All water flows through the spill gate during low flow periods, however it is still a migration obstacle. The dam has no water permit and negotiations over the solution with the dam owner (private company) and the Ministry of the Environment are ongoing. Environmental agencies long term goal is to remove the dam. Estimated cost of the dam removal is 104 148 euros.

Photo 4. Old Kunda manor mill has no function, is very bad technical condition and is a migration obstacle for fish. The best option is to demolish it (26.07.2019 M. Kesler).

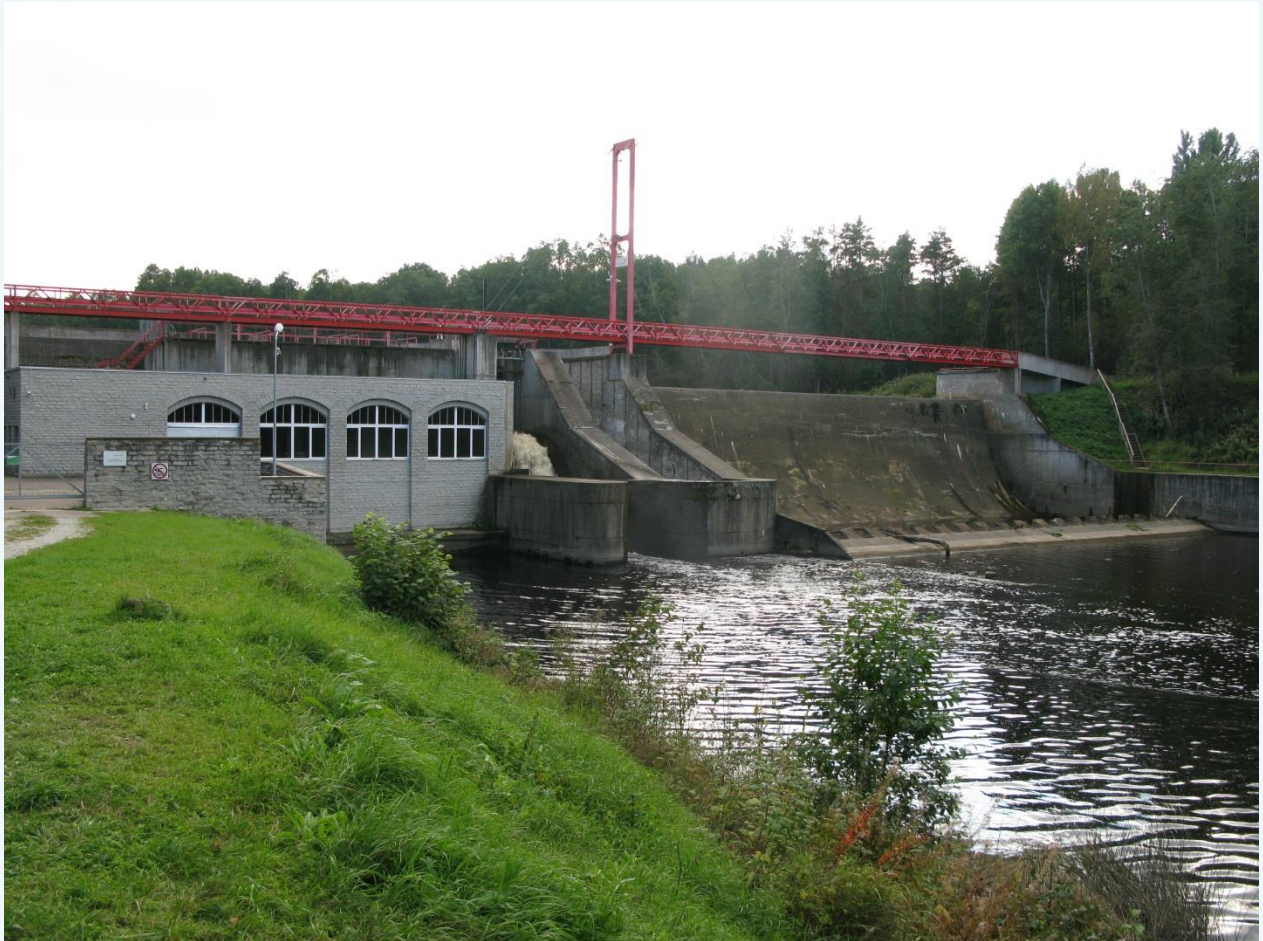
**Linnamäe hydroelectric** power station was built in 1924 and it is cultural heritage site. The dam was deliberately partially destroyed in 1941 and was restored in 2002. Since then it is operational hydroelectric power station with a capacity of 1.1 MW. The height is 11.8 m and (Photo 5) and it is located 1.5 km from the river mouth. The private company owns the dam and wishes to continue to produce electricity. Local county also supports this plan. However the dam has a temporary water permit and an obligation to ensure the good status of Jägala Natura 2000 areas conservation values. The main values are river habitat and salmon. The Linnamäe dam was declared to be culturally valuable site in 2016. The future of the Linnamäe dam is a source of heated debate between the dam owners, county, cultural heritage experts and environmental agencies. Long term solution is to remove part of the dam to provide satisfactory fish passage and to retain culturally valuable features of the dam as much as possible. The construction of a new river channel around the left side of the dam, while retaining all of the cultural values was estimated to cost 6 777 045 euros. The demolition of the

Photo 5. Linnamäe dam on river Jägala is the principal cause for the lack of migratory fish in the river.

concrete body of the dam was estimated to cost 2 169 750 euros. In this alternative cultural values are only partially kept. Third alternative is demolition of all parts of the dam and the estimated cost is 2 391 246 euros. None of the cultural values would be kept in this alternative.

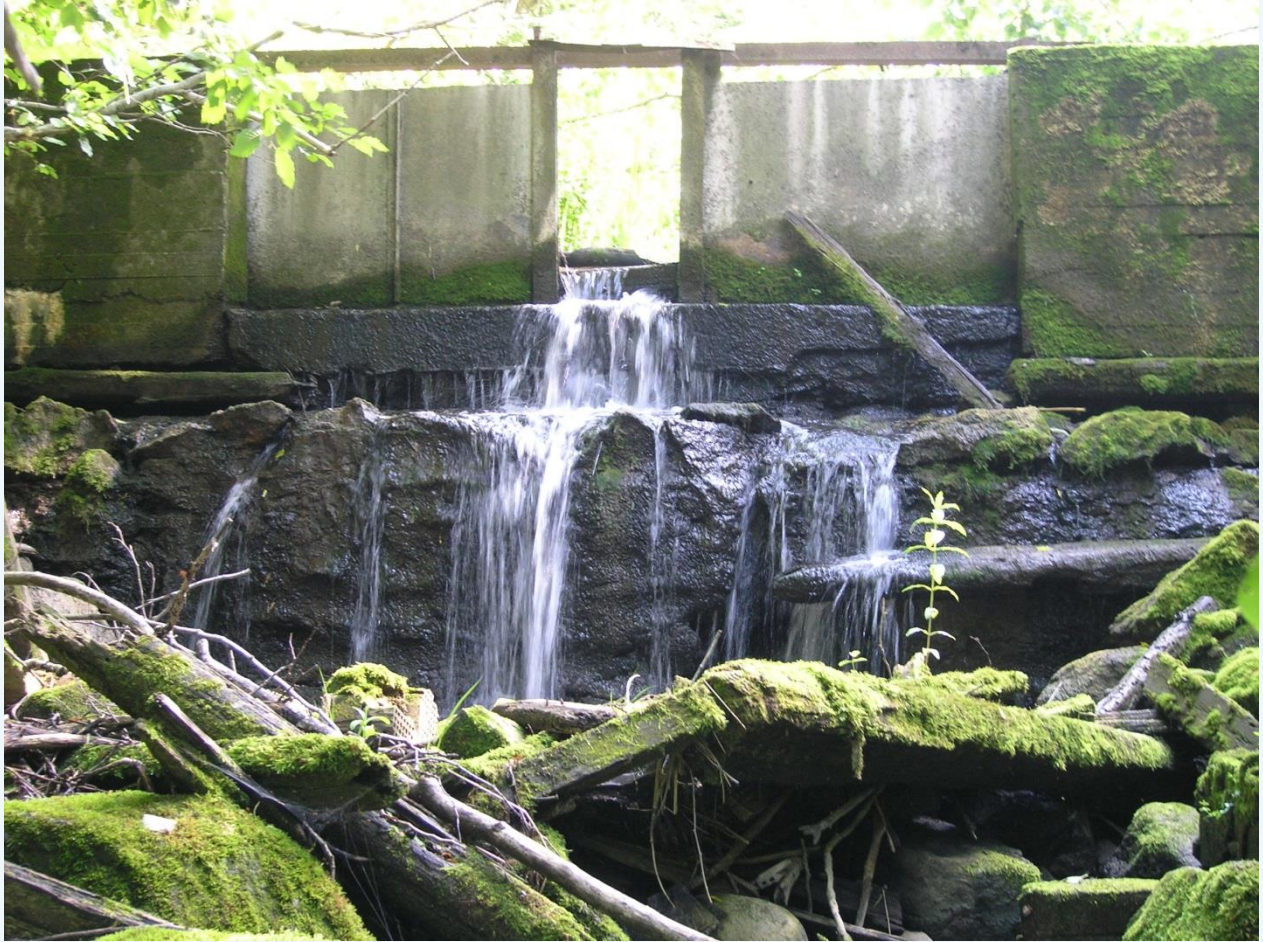
summer base flow due to many springs. The lower 1.4 km long part of the brook is very suitable for sea trout spawning and parr rearing (Photo 6 and 7). The brook has a dam 320 m from the sea, it is 1.9 m high and unpassable for all fish (Photo 8). In 2006, the trout parr density below the dam was 59 parr/100 m<sup>2</sup> and no trout was found upstream from the dam. River lamprey, three-spined stickleback, nine-spined stickleback and minnow also inhabit the river. Based on the size of the habitat in the brook, it was estimated that the part downstream from the dam could potentially produce 150 sea trout smolts annually and the upstream part could produce about 500 smolts annually. The dam has no water permit or any use, therefore removing it is best option and easy to do.

Photo 8. The 1.9 m high dam on Udria brook prevents access to about 75% of the potential sea trout spawning areas.

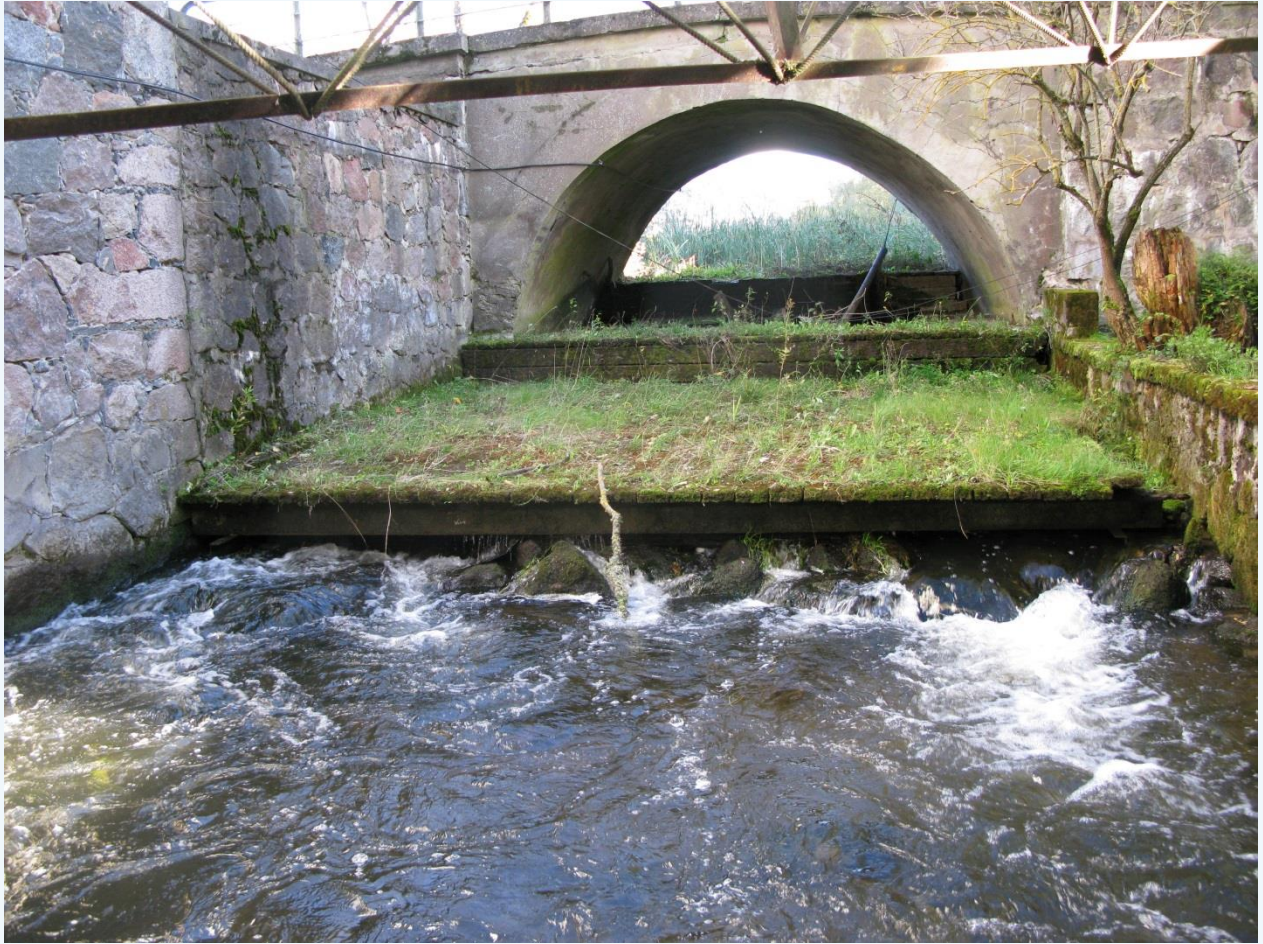
**Undla mill** has been rebuilt several times however the construction year is not known. Presently the dam has no function and it has no water permit. It is located 49.6 km from the river mouth and is 2.2 m high. It is not culturally valuable and has no recreational value since the impounded lake is mostly filled with sediments. The dam is part of the bridge construction and therefore it may not be possible to entirely remove it. The road and the bridge with the dam belong to Estonian Road Administration. The upper wooden part of the dam is in a very bad condition and most of the water flows under the wooden construction (Photo 9). Otherwise the wooden parts of the dam should be very easy to remove.

Photo 9. View to Undla dam at r. Loobu. Note that all water flows underneath the upper wooden components of the dam. The dam is located beneath a bridge and that may complicate the full removal of the dam.

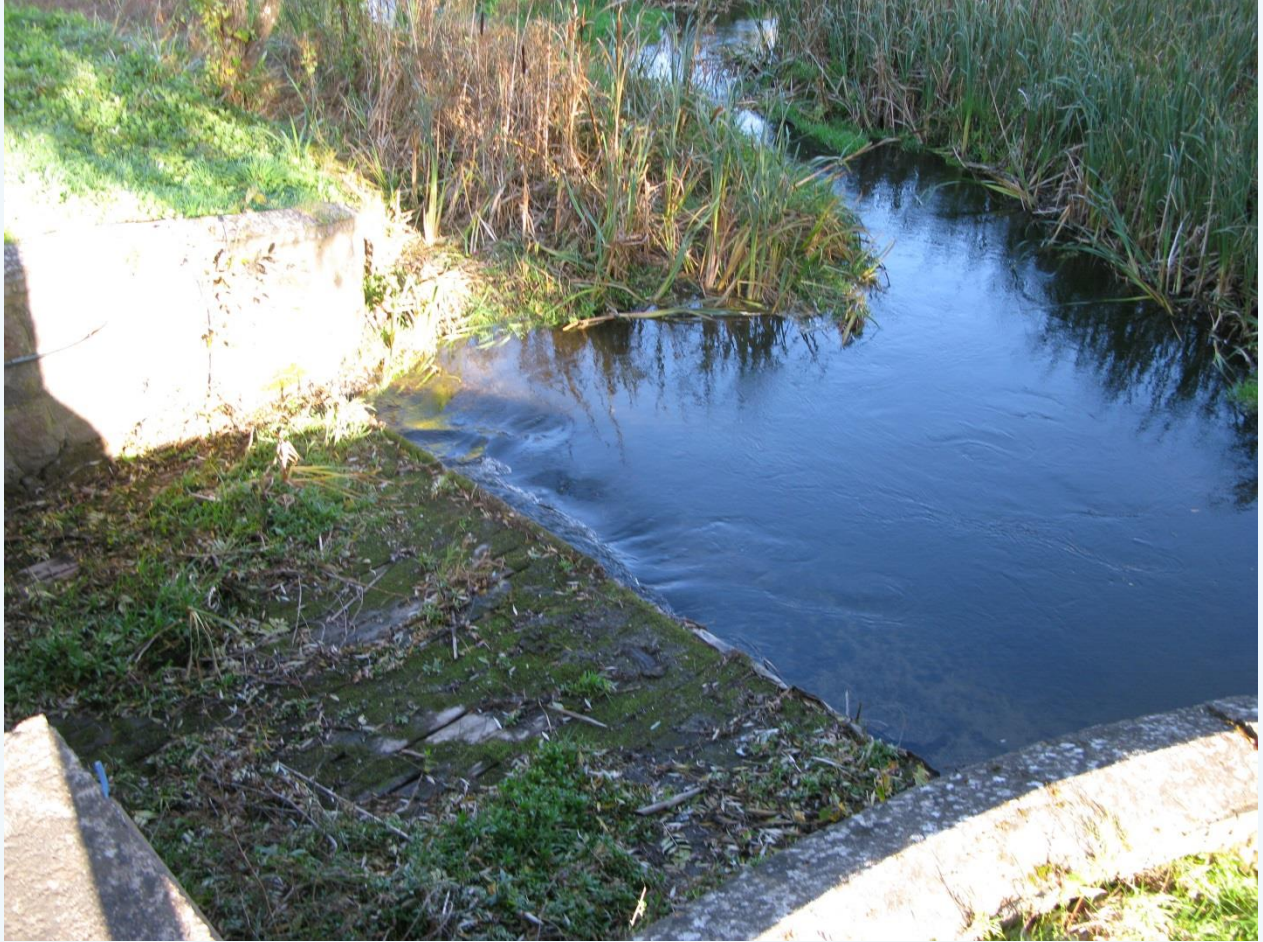
Photo 10. View to the upper part of the Undla dam.

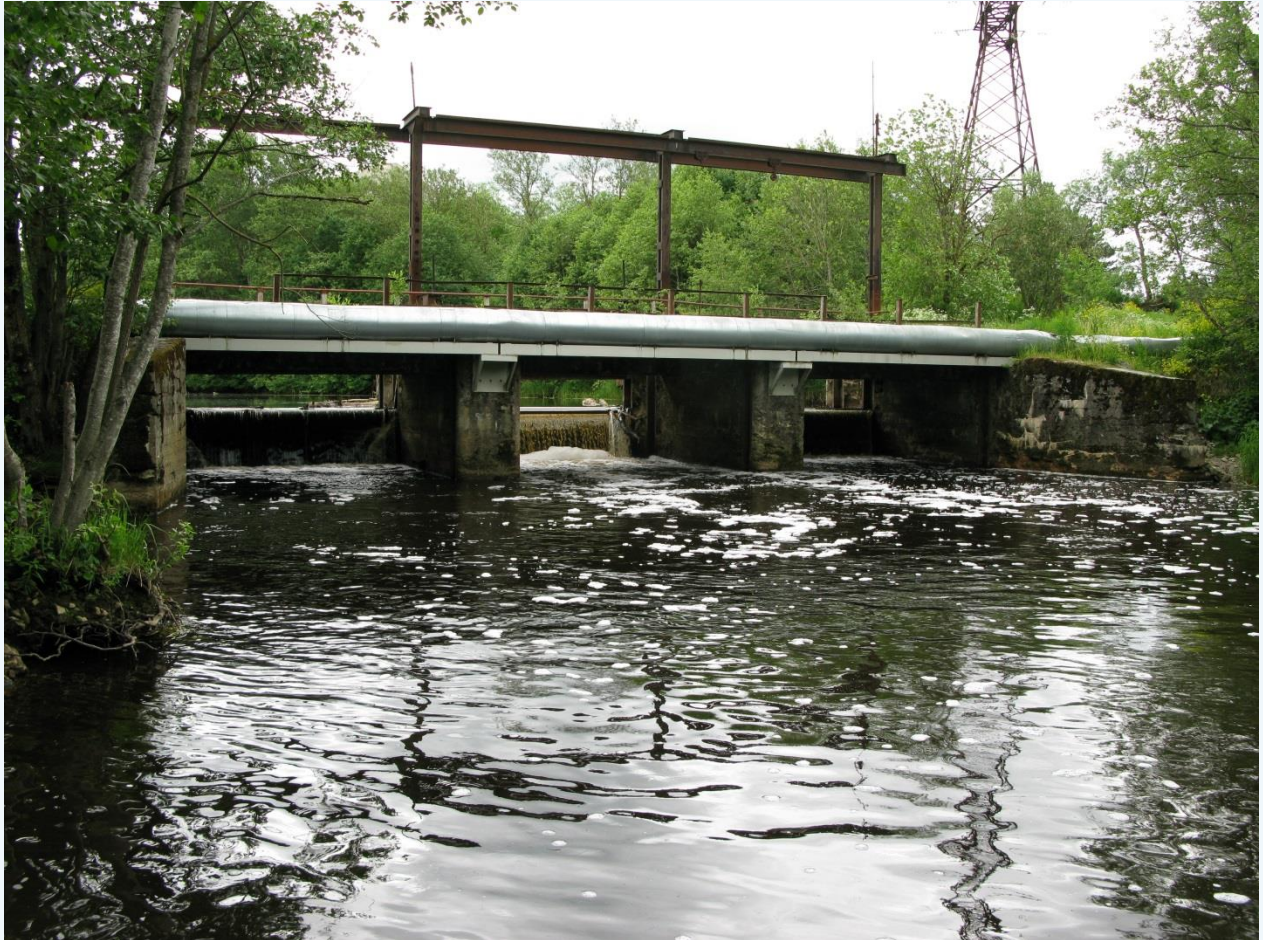
The 1.5 m high Püssi dam was built in 1970s to provide water for a plywood factory (Photo 11). The dam has water permit, however the plywood factory is closed and there is no need to for the dam. So far the company is reluctant to give up the right to abstract water and operate the dam. The company has an obligation to ensure fish passage and the renewal on the water permit necessitates the plant to provide passage. Most cost effective option for the future would be the dam removal and reconstruction of the water uptake facility, if that is still necessary.

Photo 11. View to the Püssi dam on r. Purtse.

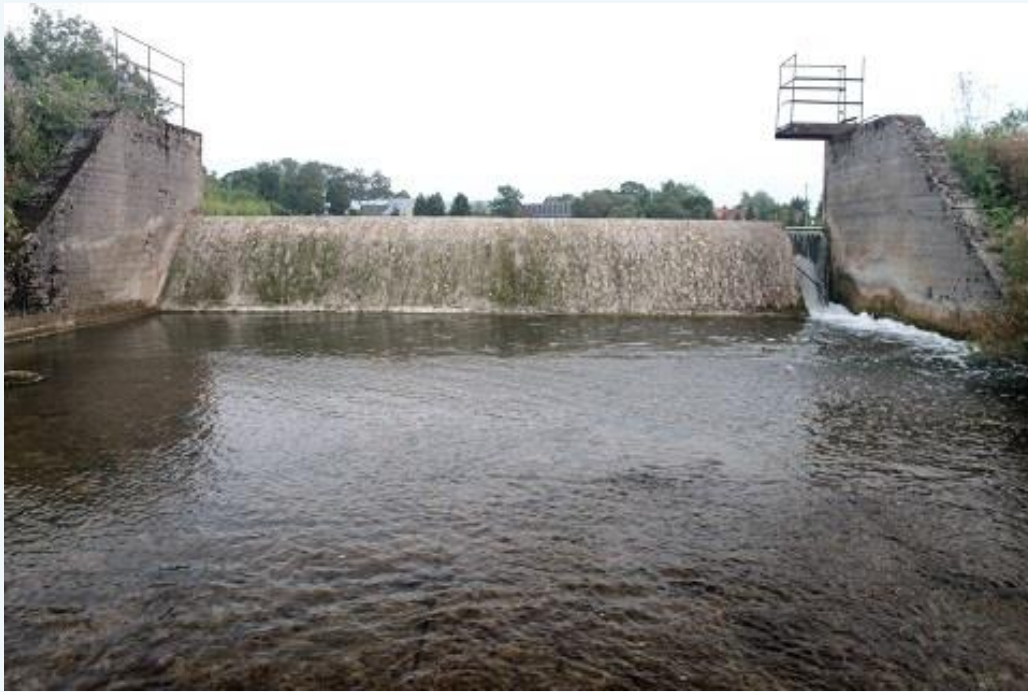
The Ruila dam is 1.6 m high and is located 32.5 km from the sea. The dam was built in 1984 as a part of irrigation system. The dam no longer serves that function and it has no water permit. The dam is not a culturally valuable. However it forms a 1.4 ha pond that for the locals may be seen as a valuable landscape element. Local municipality owns the dam and is presently

Foto 12. Presently the 1.6 m Ruila dam is the first definite migration obstacle for fish (G. Lauringson, 29.07.2013).

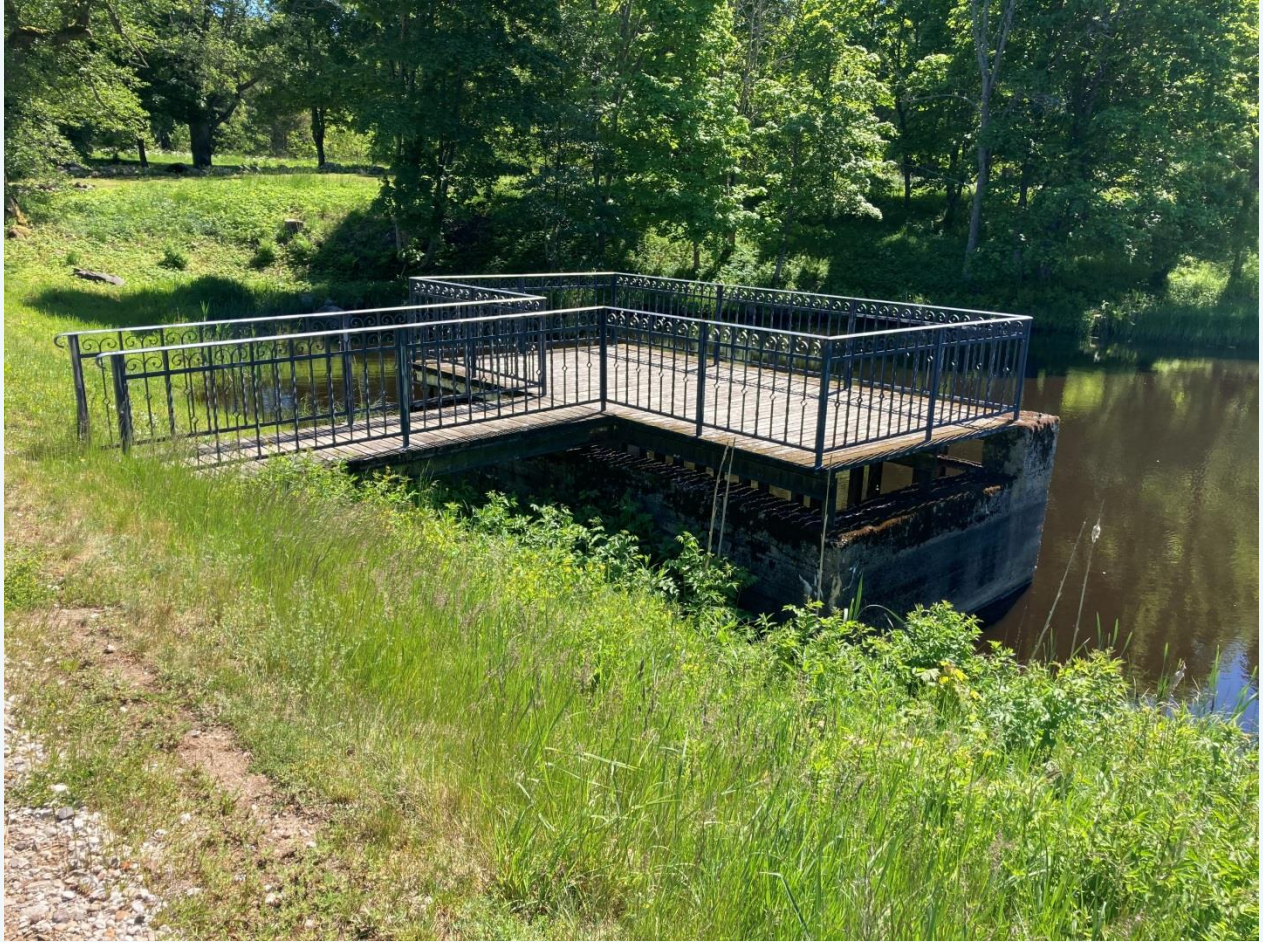
**The Oandu dam** was built in 1975 to the old mill site for recreational purposes. The dam has no water permit and it is not culturally valuable. The lake has some limited recreational value. The designed height was over 4 m, earth embankment of the dam has eroded and the water level is kept at 2-3 m level during past decade. The dam has several private owners and has no water permit. The concrete regulator is built just in front of the embankment that has a culvert. The embankment also acts as a road. Therefore there is almost no room to build a fish pass. Most sensible is to remove the regulator and to smooth the stream bottom below the culverts for easier passage. Dam removal cost calculation is not available.

Photo 13. Oandu dam regulator, note that the designed water level is at least one 1 m higher than it is presently maintained.

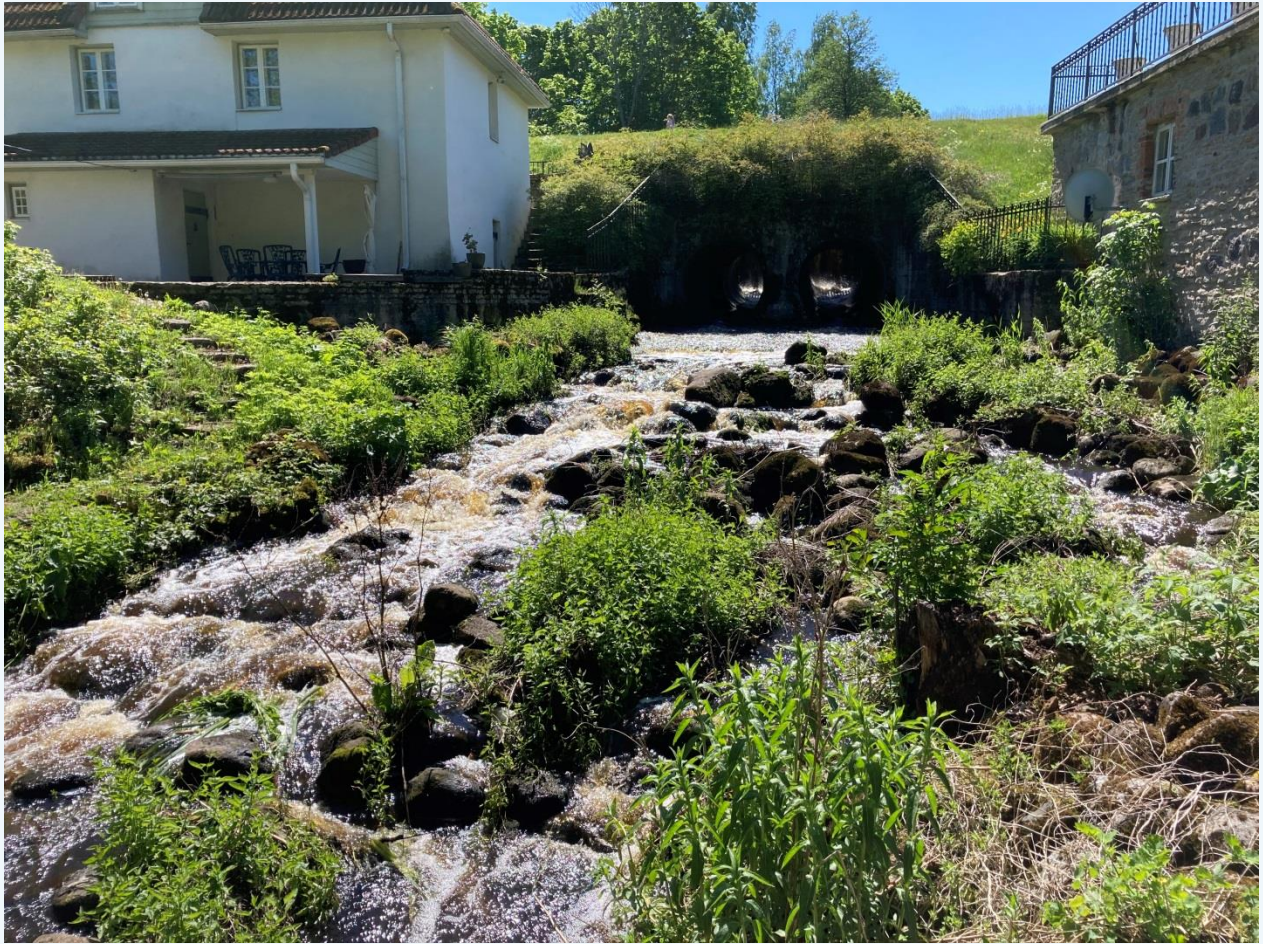
Photo 14. The two culverts below the regulator are in a steep angle and somewhat difficult to pass.

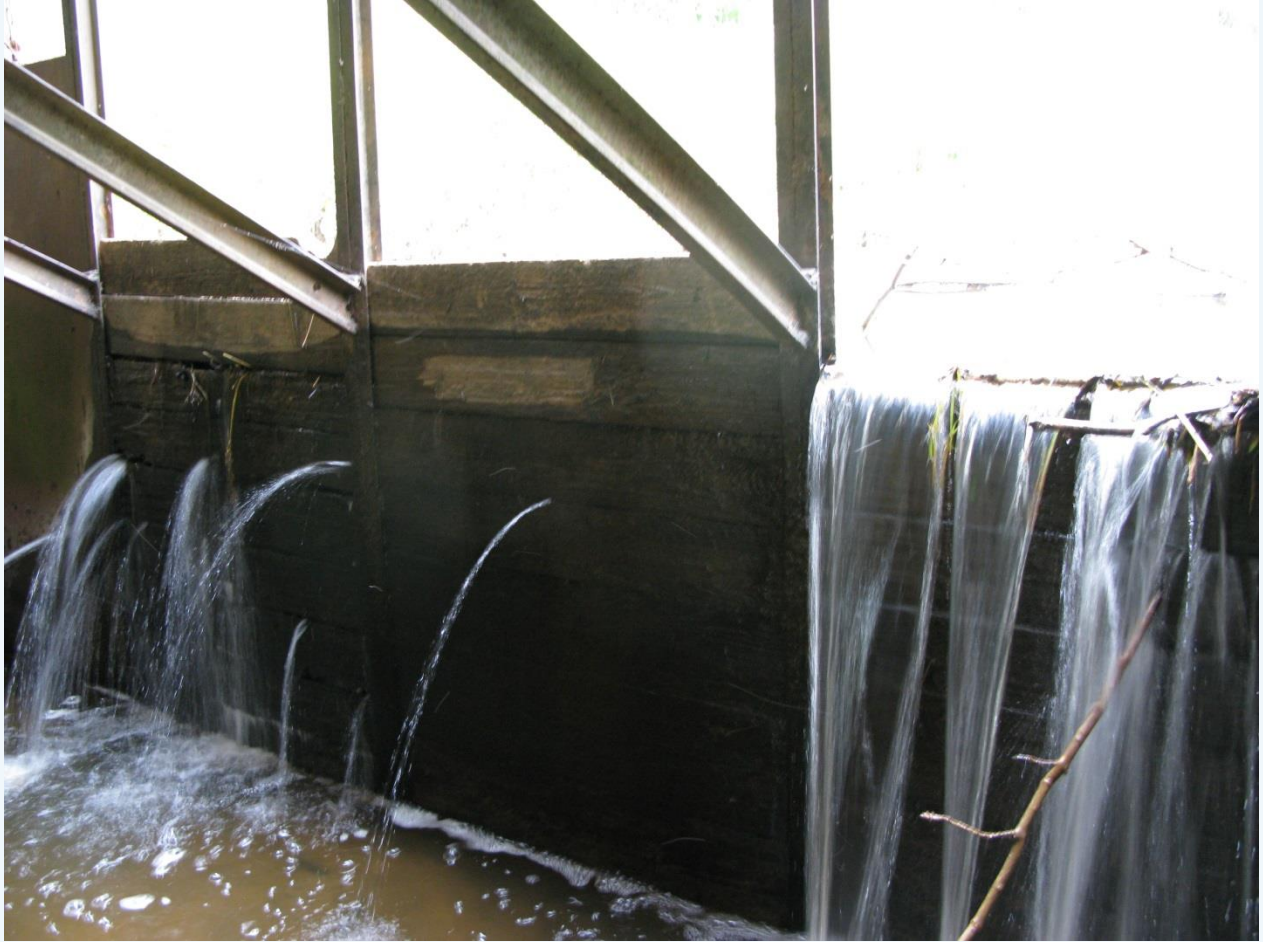
The construction year of the Kopli dam is not known. The dam was part of irrigation system; however it is no longer in use. Presently the dam less than 1 m high and does not need a water permit because the river is not designated as salmonid bearing river. Nevertheless it is still impassable to fish. The dam is in front of a culvert and is owned by the local municipality. It has no cultural or recreational value. The dam is maintained by nearby household. The household is fears that the further lowering of the water level at the dam will affect the water

Photo 15. The Kopli dam as a simple metal frame that holds wooden blanks. Removing this structure is very easy.

level in their well. Most sensible solution is to completely remove the dam and assisting the nearby household with their water supply issues.
