# *Certified Home Inspection, LLC*

## Property Inspection Report

Inspection prepared for:  
Date of Inspection: 11/18/2021

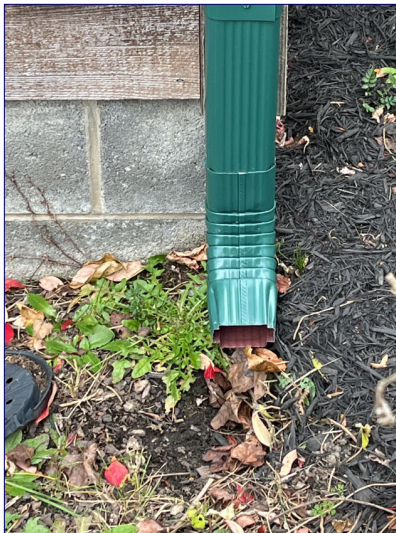
- *One or more downspouts discharged roof drainage next to the foundation. This condition can effect the ability of the soil to support the weight of the structure above and can cause damage related to soil/foundation movement. Recommend the installation of downspout extensions to discharge roof drainage a minimum of 6 feet from the foundation.*

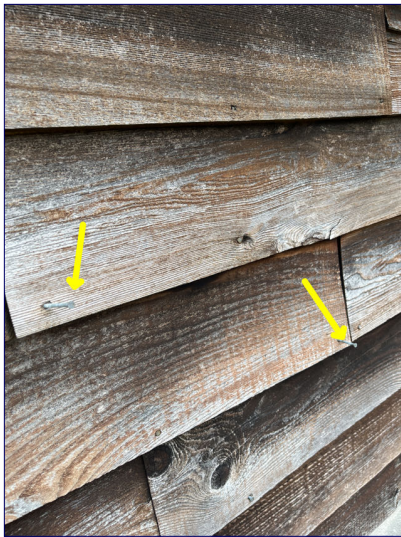
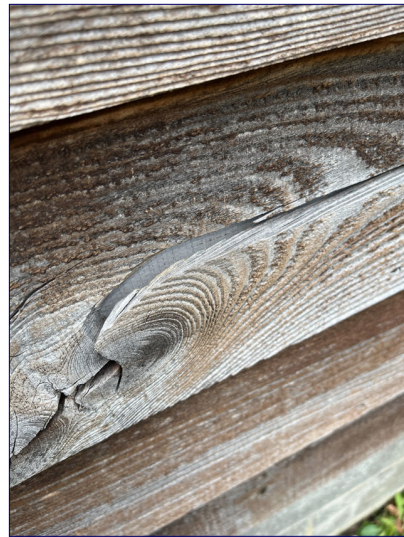
### 1. Wood Siding

- *Wood siding covering the exterior walls of the home exhibited moderate general weathering, and deterioration commensurate with its age.*
- *The siding had areas in which nail heads were protruding. This condition can be caused by long-term expansion and contraction of the wood siding in response to changes in moisture content. The Inspector recommends re-fastening as needed by a qualified contractor.*
- *Wood siding covering exterior walls of the home had areas of advanced deterioration that were cracked allowing moisture intrusion of the wall assembly. The Inspector recommends replacement or repair of siding in any such areas to help prevent damage from moisture intrusion to the home materials and the exterior wall structure. All work should be performed by a qualified contractor.*

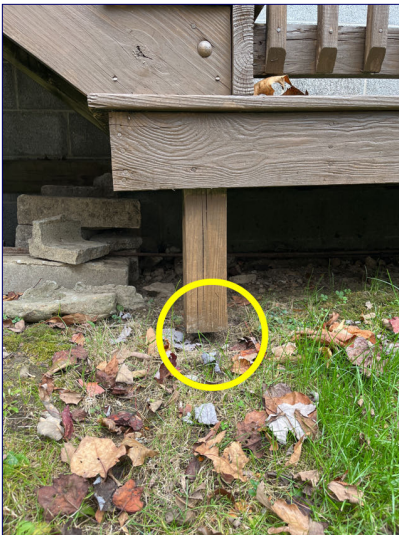
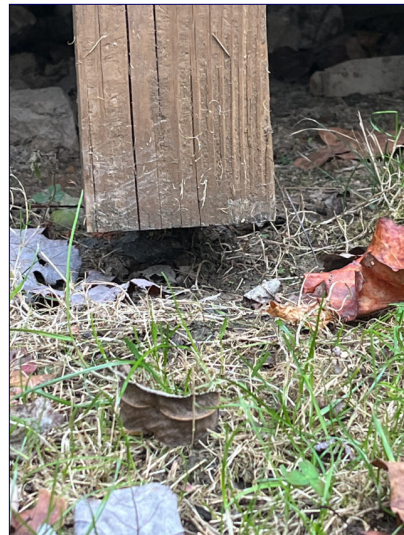
### 1. Deck Foundation

- *Wooden posts supporting the deck have suffered erosion of soil beneath that could eventually cause structural failure. This condition should be corrected by a qualified contractor.*

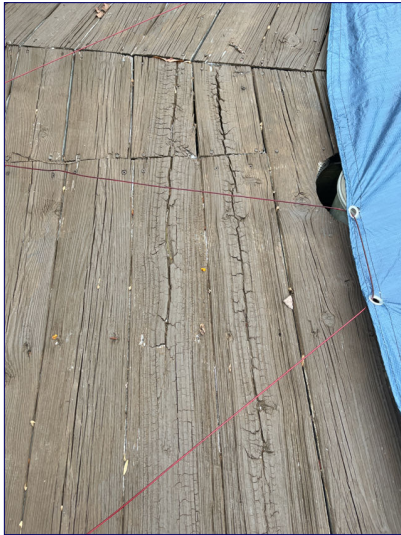
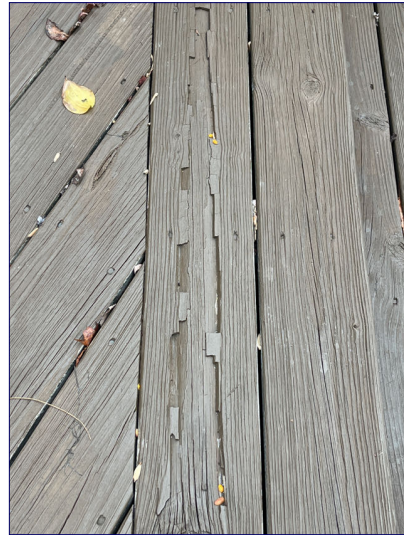
### 2. Deck Planking

- *Deck planking (the walking surface) had moderate wear or deterioration visible at the time of the inspection. Routine maintenance will improve its lifespan.*

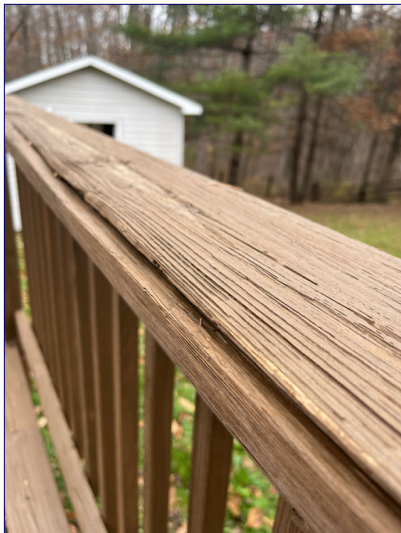
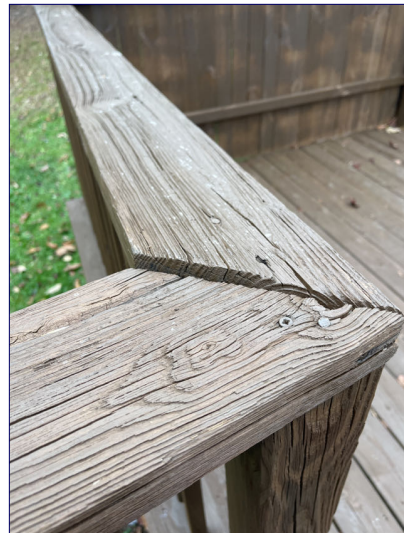
### 3. Deck Guardrails

- *At the time of the inspection, the deck guardrail assemblies exhibited moderate deterioration. Providing routine maintenance will extend the long-term service life of the guardrails.*

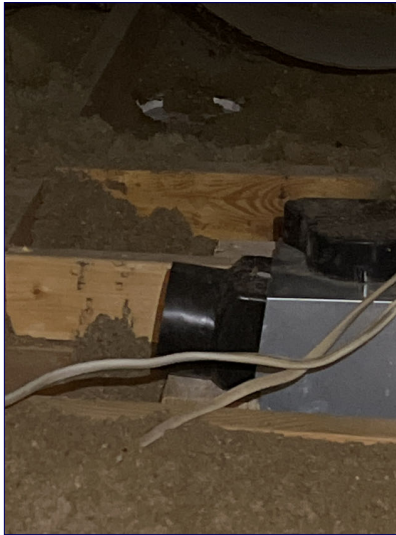
- *A bathroom exhaust vent terminated in the attic instead of at the home exterior. This condition can raise moisture vapor levels in the attic to the point at which home materials are damaged or unhealthy conditions related to mold develop. The Inspector recommends correction by a qualified contractor.*

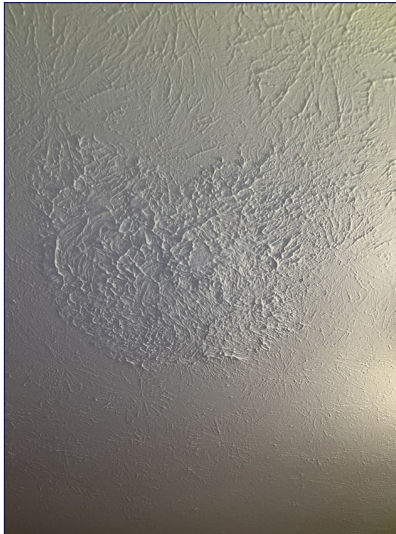
### 2. Ceiling

- *Patching was visible in the ceiling.*

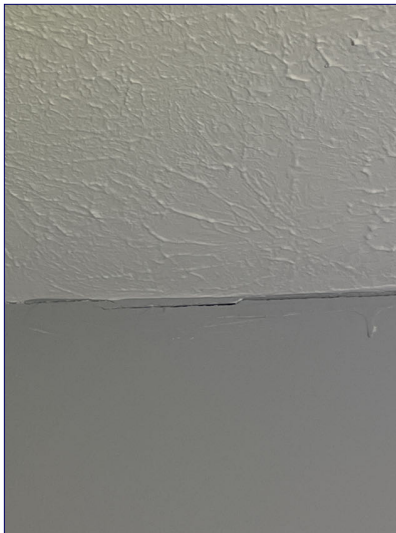
### 3. Walls

- *Minor cracks at the corners of doors and windows in walls appeared to be the result of long-term settling. Some settling is not unusual in a home of this age and these cracks do not appear to be a structural concern.*

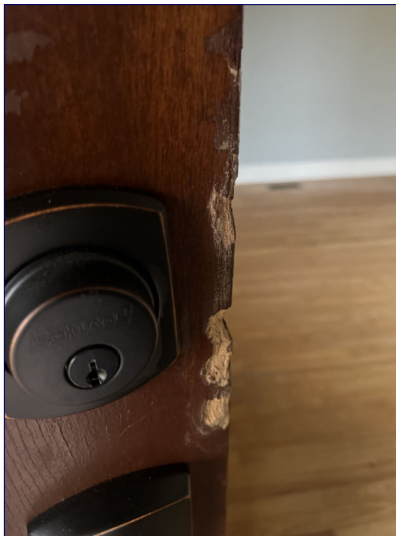
#### 1. Exterior Door Condition

- *A door to the exterior at the front entry exhibited light damage. This damage appeared to be from an attempt at forced entry.*

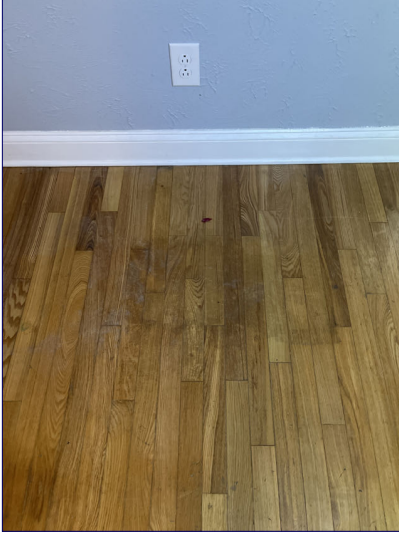
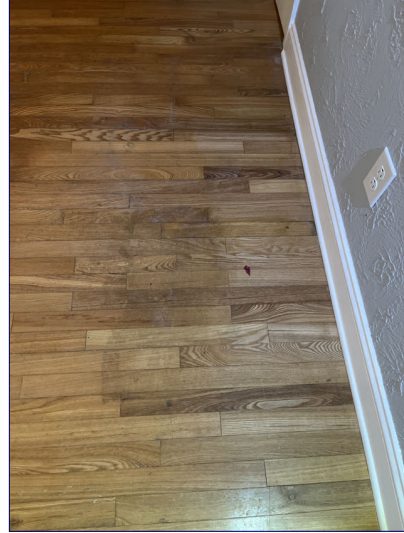
### 1. Wood Floor Condition

- *At the time of the inspection, wood floors in the living room exhibited areas of moderate surface wear. You may wish to consult with a qualified contractor to discuss options and costs for repair.*

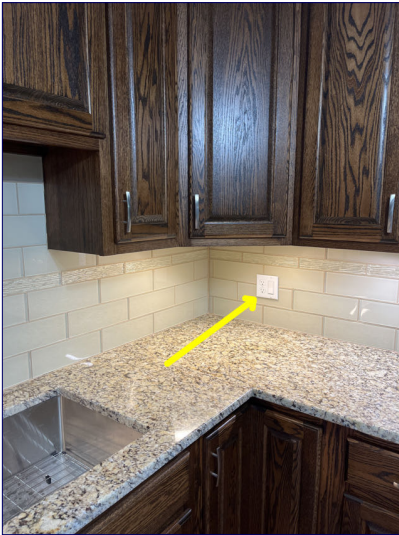
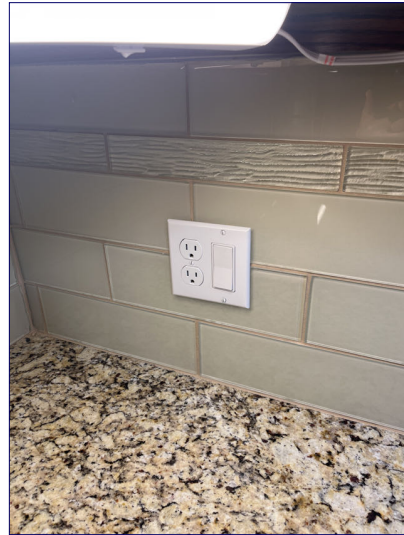
- *No ground fault circuit interrupter (GFCI) protection of home electrical receptacles was provided in the kitchen at the time of inspection.*

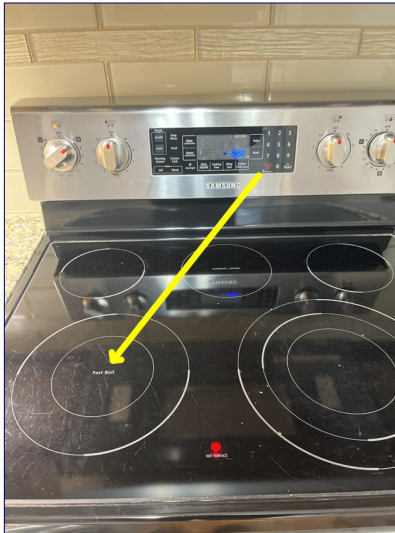
### 3. Range

- *The electric stove had one or more inoperable burners. The Inspector recommends service by a qualified technician.*

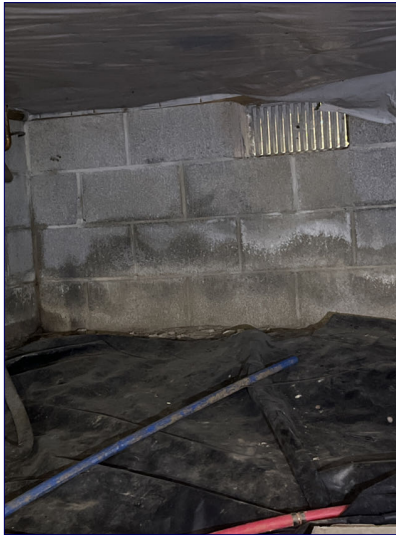
### 2. Moisture Intrusion

- In the crawlspace, moderate amounts of efflorescence was visible at some of the interior surfaces of the foundation walls. Efflorescence is a white, powdery residue left by moisture seeping through the foundation wall and its presence indicates high moisture levels in soil near the foundation. Excessively high moisture levels in soil supporting the foundation can cause various structural problems related to soil movement. The source of moisture should be identified and the condition corrected by a qualified contractor.*

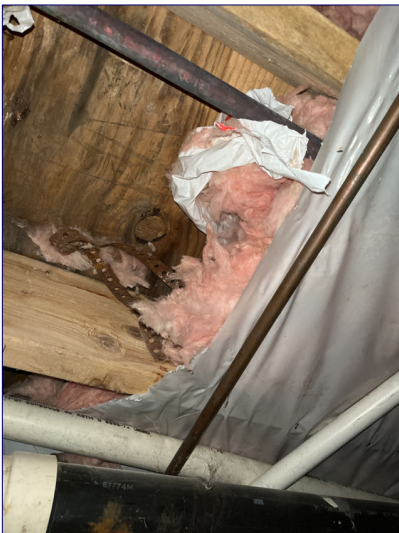
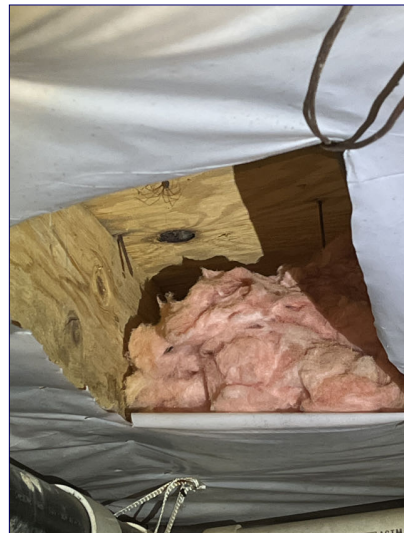
### 3. Insulation

- Thermal insulation was loose or missing. Insulation should be secured properly in place to help reduce heating costs.*

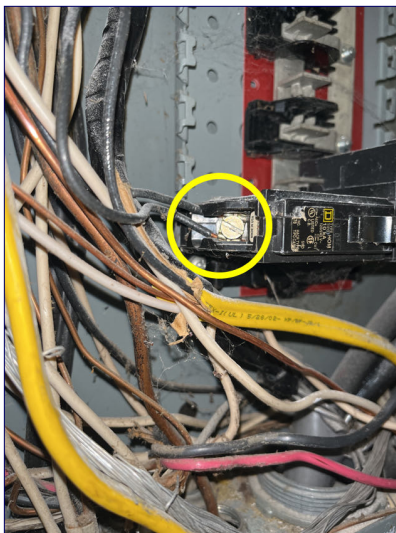
- *In the service panel, two wires were connected to a breaker designed for only one wire. This is known as a "double-tap" and is a defective condition that should be corrected by a qualified electrical contractor.*

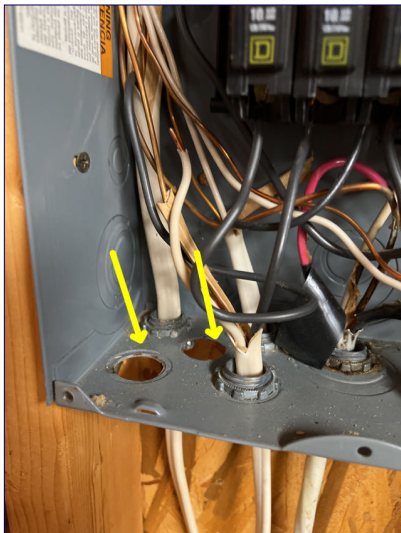
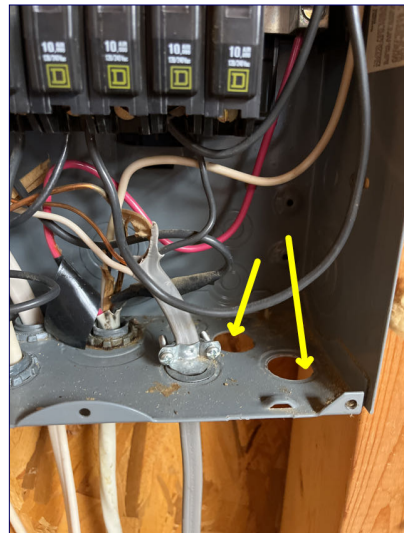
### 2. Cabinet Condition

- *Unfilled holes or knockouts in this sub-panel may allow insect or rodent entry, or allow persons to come into contact with energized electrical components. This condition is a potential shock/electrocution hazard and should be corrected by a qualified electrical contractor.*

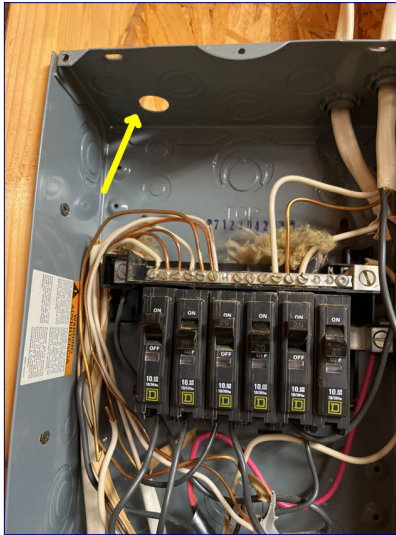
### 3. Bonding

- *The sub-panel was not grounded. This is a potential shock hazard and should be corrected by a qualified electrician.*

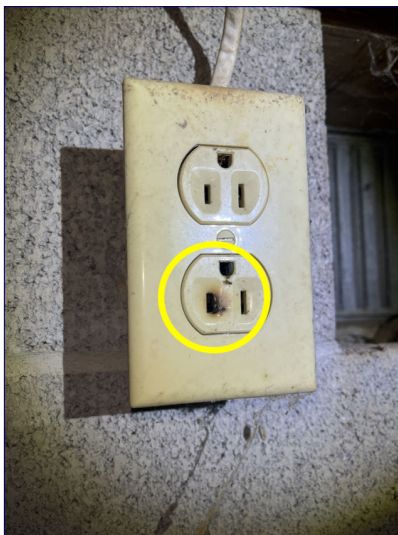
### 1. Receptacle Deficiencies

- *An electrical receptacle in the crawlspace exhibited visible scorching. This condition is a potential fire hazard and should be investigated and any repairs made by a qualified electrical contractor.*
