Inspections by Bob, LLC

Home Inspection Report

Frederick, MD 21702

0273-2015-12-29-WBS

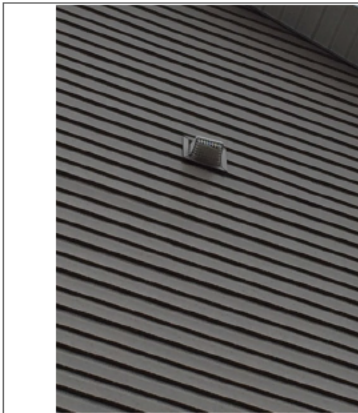
One or more of the vent covers on the outside of the house is damaged. This can create gaps that could allow water and/or vermin to enter the property, and can also prevent the vent from operating properly. The affected covers should be repaired or replaced by a qualified contractor.

Damaged vent cover

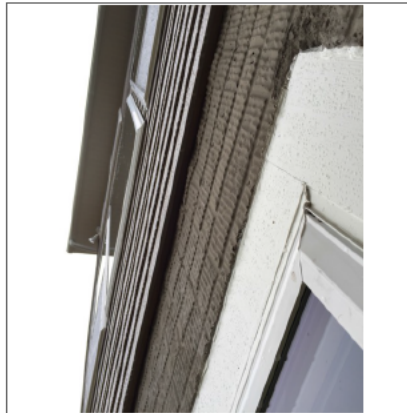
Comments There are gaps between the bottom course of siding and the foundation wall on the rear side of the house. This exposes the wood to possible damage from water and/or vermin. The gaps should be sealed with foam to prevent damage.

Gap under living room siding

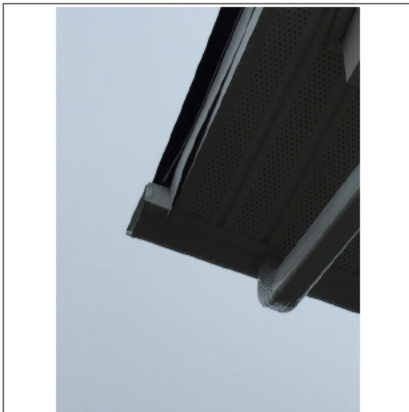
Comments One or more areas of fascia board is damaged. This can allow water to enter the structure and cause damage to the framing and insulation. It can also create holes or gaps for animals to enter, such as birds or squirrels. The fascia board should be repaired or replaced as soon as possible to prevent further damage.

Fascia damaged over porch corner

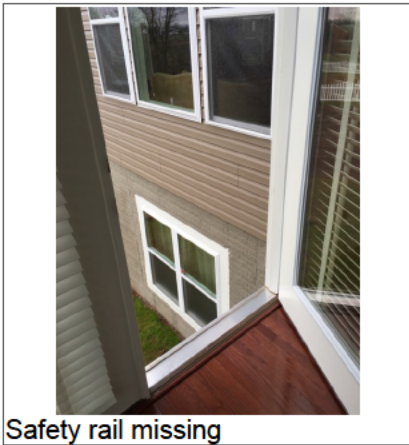
Comments One or more exterior doors is missing a safety railing. These railings are necessary at any operable door above ground level that does not have any connected landing surface or stairs. Without safety rails, it is possible for occupants to be seriously injured from falls. A safety railing should be installed as soon as possible by a qualified contractor.

Safety rail missing

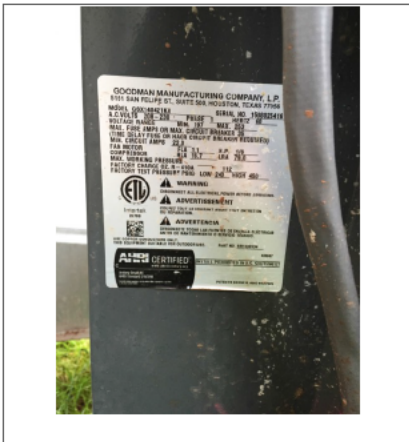
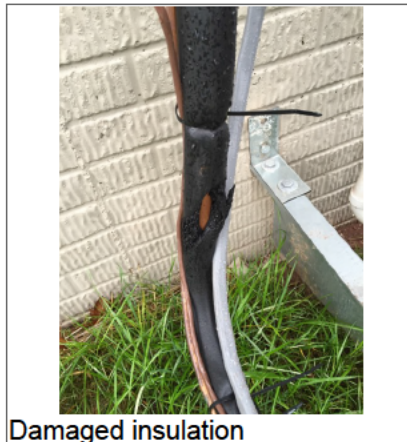
Comments The insulation on the refrigerant lines is damaged or missing. This insulation helps the system operate at optimum efficiency by preventing unwanted condensation of the refrigerant. The insulation should be replaced by a qualified HVAC contractor.

Damaged insulation

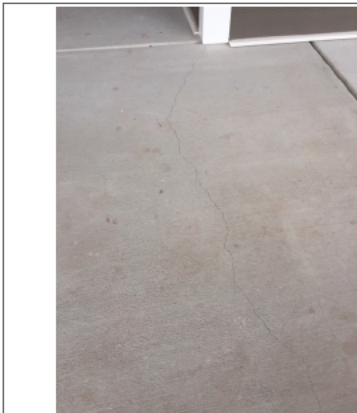
The cracks on the front porch (one on the porch slab, one on the east side where the porch meets the house) should be monitored for any future movement. While these are likely shrinkage cracks, any widening could signal an issue with the porch, especially the southeast corner.

Shrinkage crack

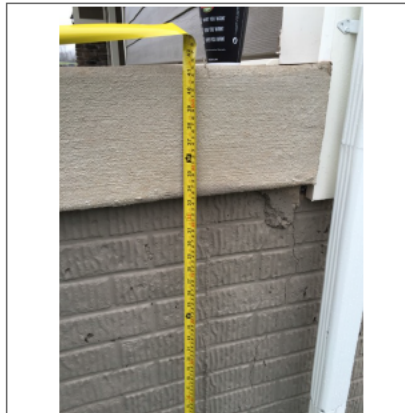
Porch is missing guard railings. Railings are required when there is more than a 30 inch drop from the surface of the deck to the ground. Appropriate railings should be installed by a qualified contractor.

Porch height 41". Needs guard rail.

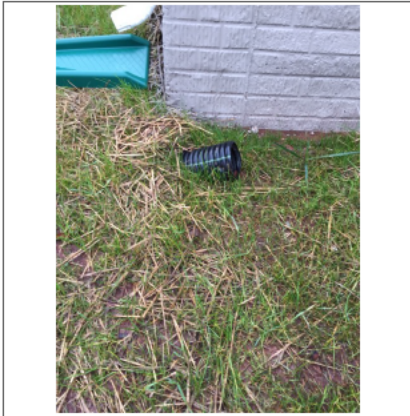
Comments One or more foundation drains does not maintain a constant downhill slope. This will affect the drain's ability to efficiently drain water from the foundation perimeter. The drain slope should be corrected by a qualified contractor.

Foundation drains go uphill at ends

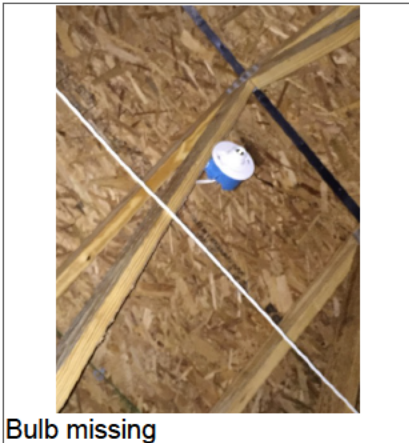
Inspection of the attic was limited to viewing from the access due to the lack of a safe walking surface. Light fixture missing light bulb.

Bulb missing

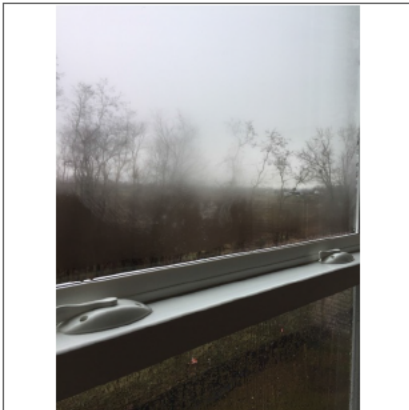
Comments One or more windows has a failed seal in the dual glazing. This allows water to enter the space between the panes and condensate, leaving a mineral film behind that blocks visibility. The affected panes should be replaced by a qualified contractor.

Fogged window breakfast room

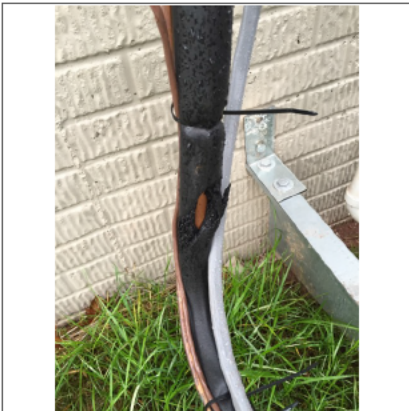
Location Location: Side yard
Description Brand Name: Goodman Model No.: GSX140421KA
Configuration Split System Approx. Tons: 3.5 240 volt
Condition Serviceable Not tested; temperature below 65 degrees
Refrigerant Lines Defective Insulation damaged
Condensate Lines Serviceable
Thermostat Location: Family room Serviceable Digital type
Comments The insulation on the refrigerant lines for the air conditioning system is damaged or missing. This will affect the efficiency of the unit, resulting in increased energy costs and lower comfort. The insulation should be replaced by a qualified HVAC contractor.

Damaged insulation on outside refrigerant line

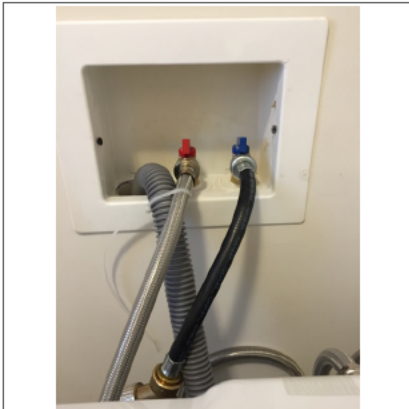
Comments The water supply hoses for the washing machine are rubber. These hoses are always under pressure, and are known to bulge and fail, causing potentially catastrophic water damage. The hoses should be replaced with braided steel hoses, which are much more durable.

Rubber hose on cold water line

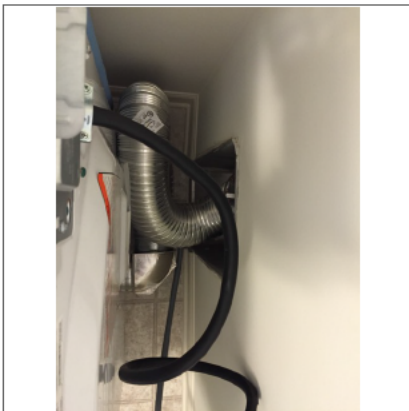
Comments The dryer vent pipe is too long. This can lead to a buildup of lint, which is a fire hazard. The dryer vent should be repaired or replaced to ensure proper ventilation to the exterior.

Recommend shortening vent pipe

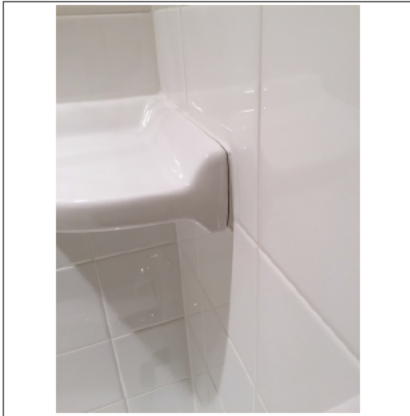
Location : Jack and Jill 2nd fl
Sink(s) Marginal Counter needs caulking
Sink Comments The joint between the countertop and the backsplash needs caulk. Gaps in the counter can allow water to penetrate behind the cabinets and cause damage. The gaps should be caulked by a qualified contractor.
Toilet Serviceable
Bidet N/A
Bathtub N/A
Whirlpool N/A
Shower N/A
Tub/Shower Combo Marginal Enclosure walls need grout
Tub/Shower Combo Comments The soap tray in the corner is not securely grouted to the enclosure walls. This may lead to the tray detaching from the wall and falling into the tub. The tray should be securely re-attached to the enclosure walls.
Ventilation Serviceable

Soap shelf needs grout
