**Accredited Snagging**

1 Sample Street  
Sample Town  
SA1 2BC

January 15th 2024

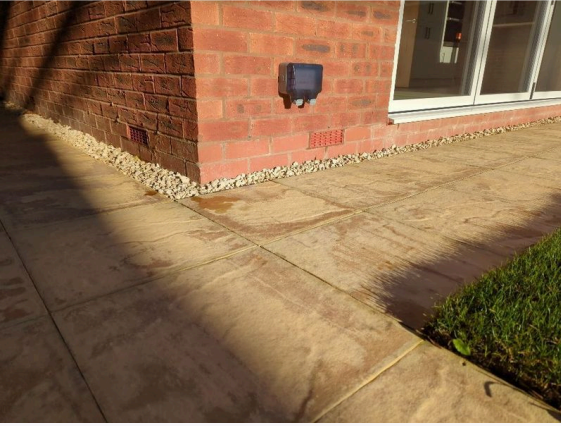
Ref # 3.2

Ref	Location	Condition	Condition Rating
3.1	General Condition	The overall condition of the exterior and grounds was found to be of a good standard.	GREEN
3.2	Damp Proof Course	The ground level appears to have been set correctly in relation to the DPC. This is critical to ensuring there are no problems with rising damp to the property over time.	GREEN

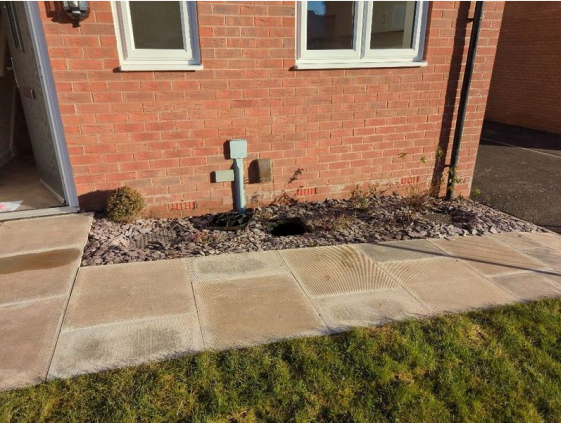
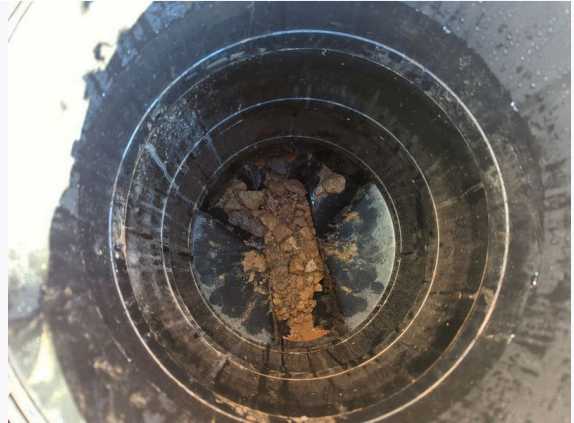
Ref # 3.3

An inspection chamber was examined and the foul drainage channel was found to be blocked with debris. All should be checked and cleared as necessary prior to handover.

RED

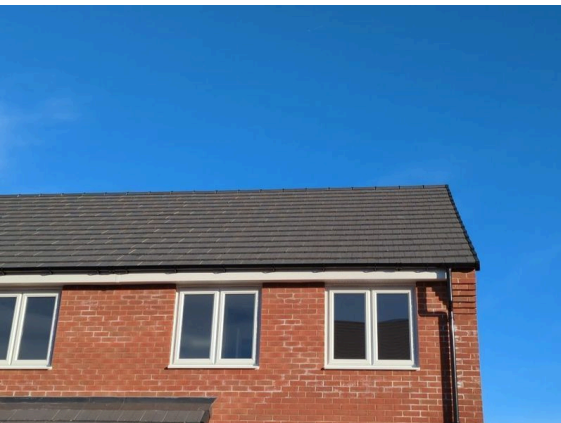
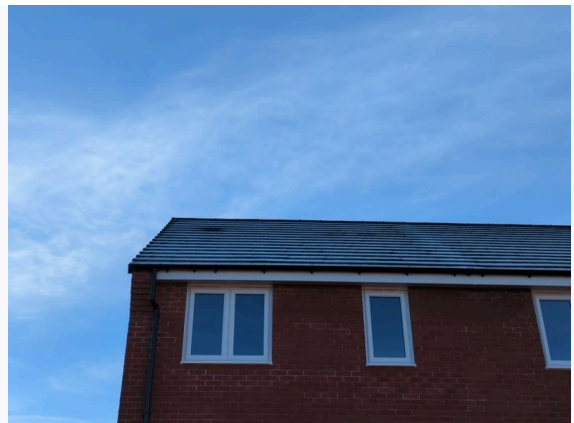
Ref # 3.4

Tiling to the roof is in good order.

GREEN

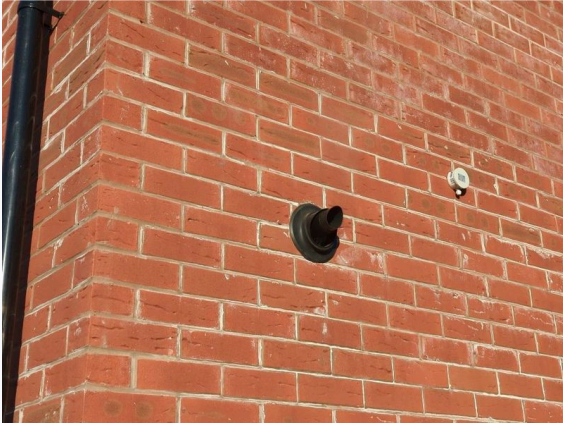
Ref # 3.5

The boiler flue appears to have been sealed in place correctly. This is critical to ensuring that dangerous gases are properly expelled from the property.

GREEN

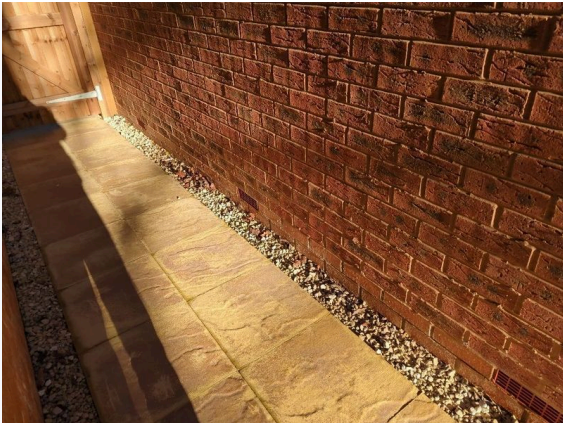
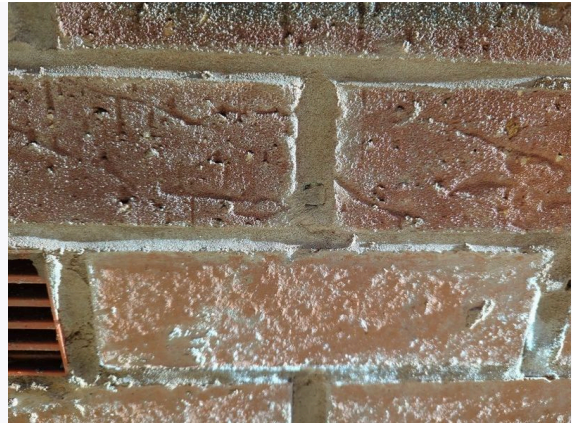
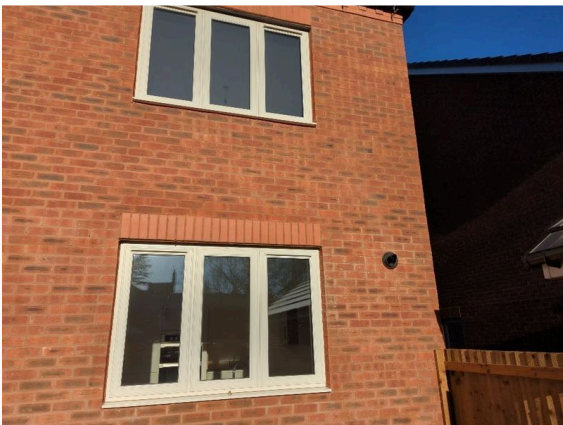
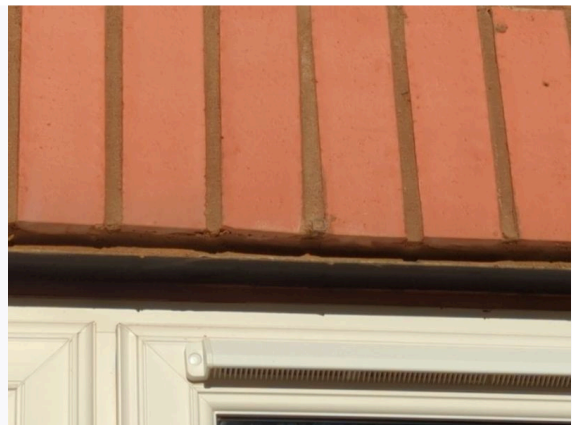
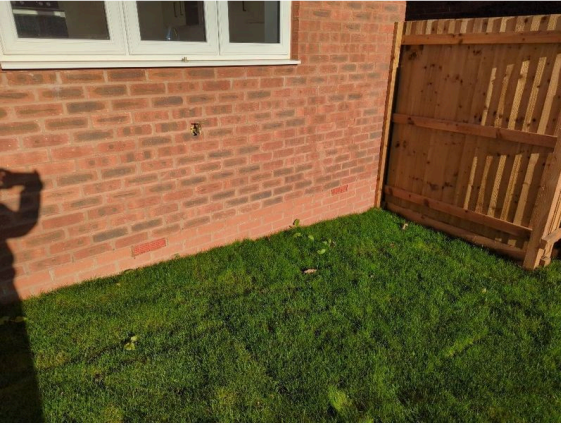
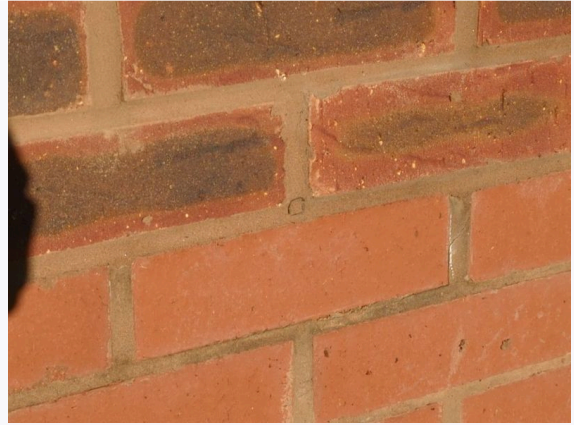
Ref # 3.6

Several blocked weep vents identified. Weep vents are critical to ensuring correct airflow and drainage of condensation to the structure. All should be checked and cleared of any blockages prior to occupation.

RED

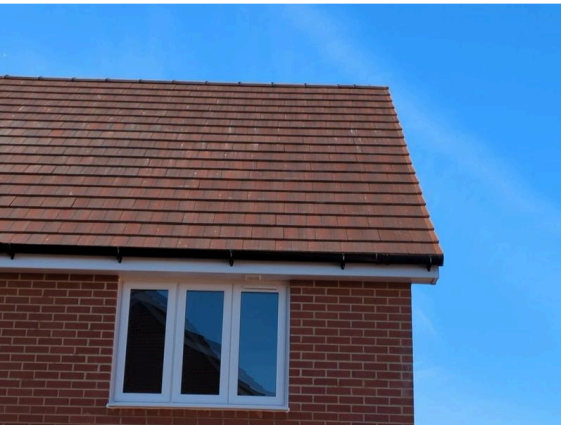
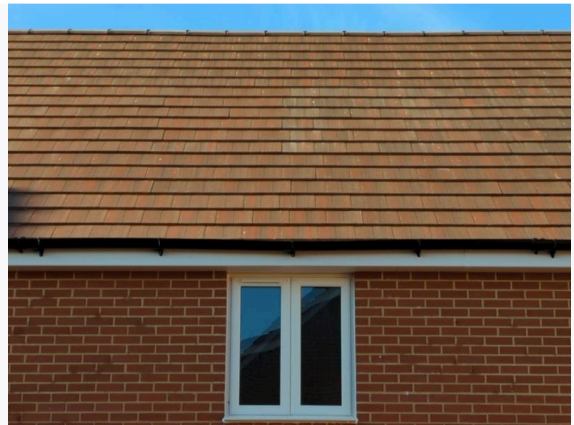
Ref # 3.7

Guttering to the rear elevation does not fall consistently towards the downpipe, with notable dips at the left elevation side and in the centre. Pooled water was evident during the survey, which will promote vegetation growth and consequently blockages, and/or overflow during heavy rainfall.

AMBER

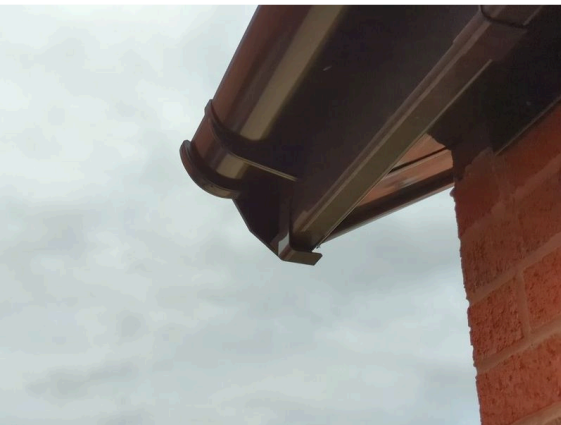
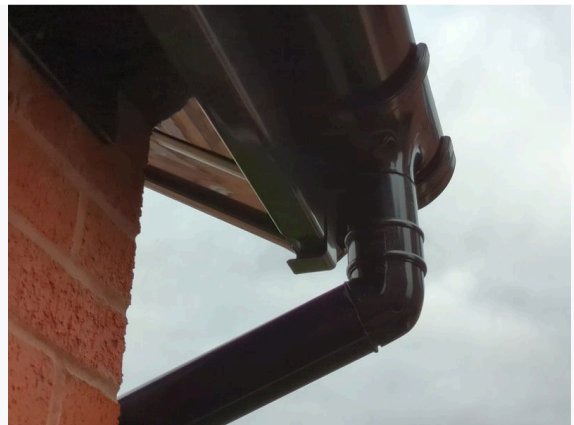
Ref # 3.8

Poor alignment to fascia trim pieces.

AMBER

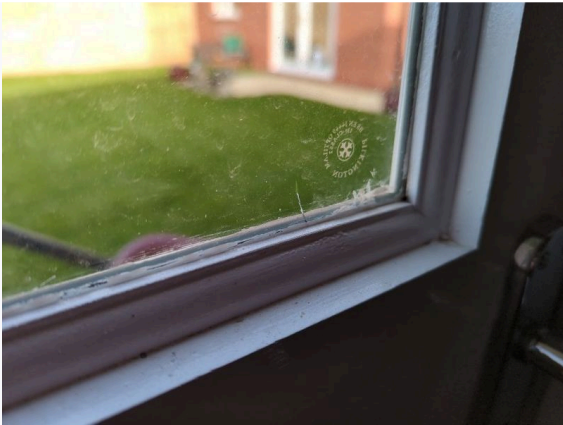
Ref # 3.9

Cracked glazing to the garage personnel door.

RED

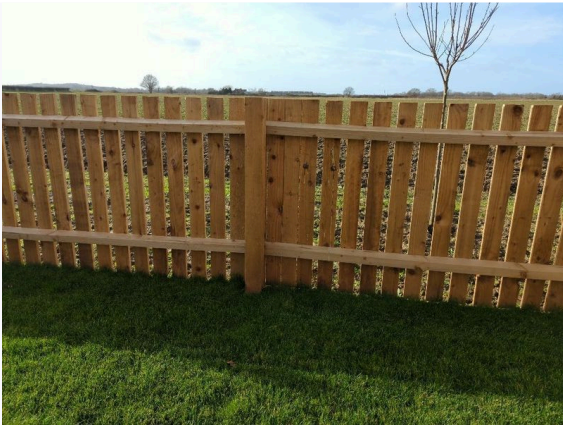
Ref # 3.10

3.10	Garden	Inconsistent arrangement to fence pickets.	AMBER
------	--------	--	-------

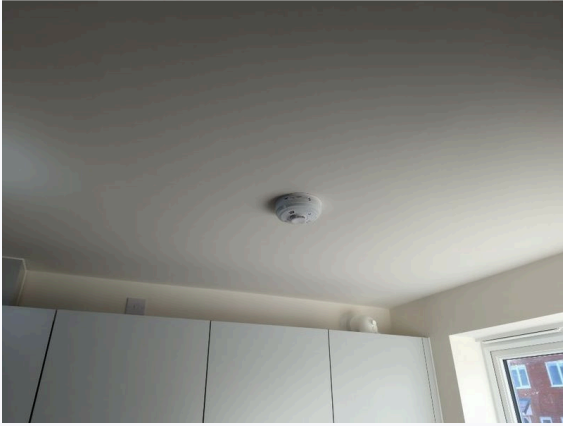
Ref # 4.2

Ref	Location	Condition	Condition Rating
4.1	General Condition	The overall condition of the interior was found to be of a good standard.	GREEN
4.2	Smoke Alarms	A test of the smoke alarms confirmed that all units sound an alarm upon an alert from one.	GREEN

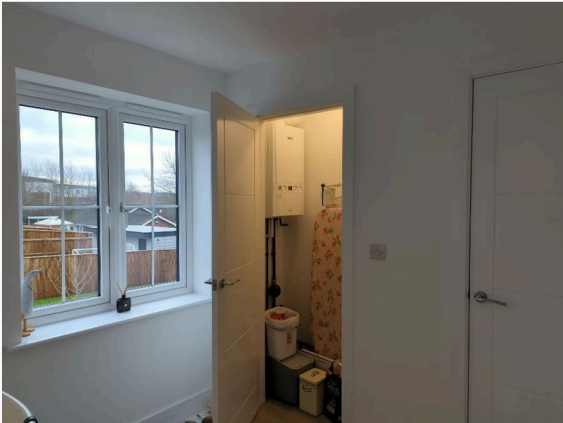
Ref # 4.3

Building Regulations Part J requires that a carbon monoxide alarm is installed within an appropriate proximity to the boiler.

RED

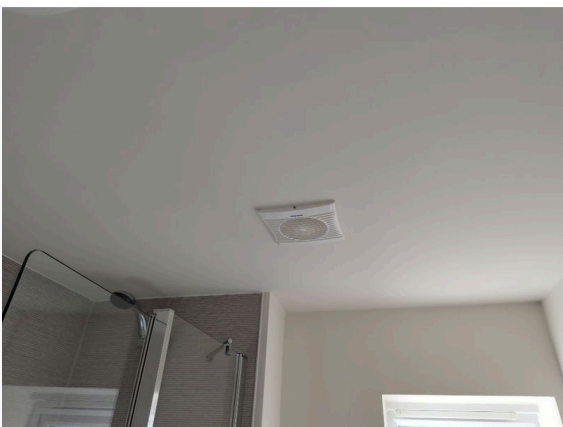
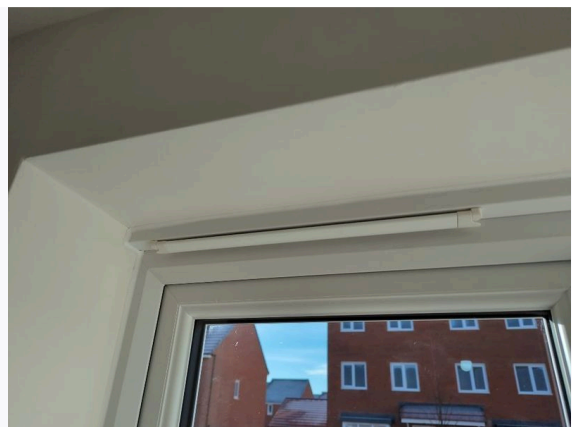
Ref # 4.4

The property is seen to have extract and background ventilation systems in accordance with building regulations.

GREEN

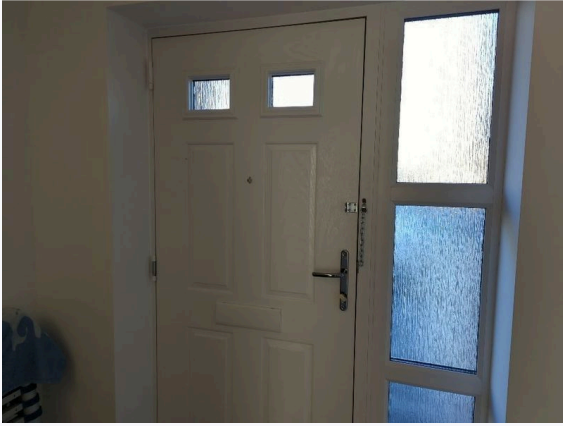
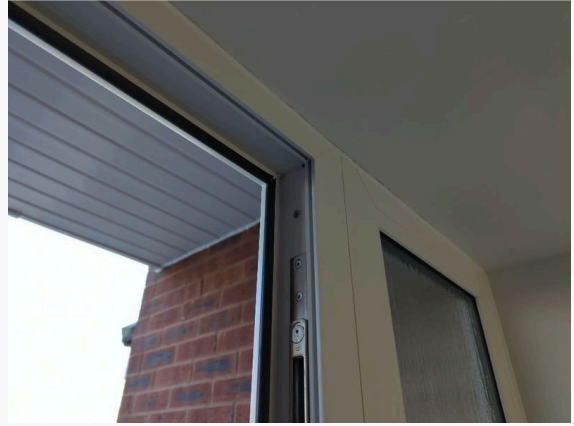
Ref # 4.5

Draught brushes missing to front door frame.

AMBER

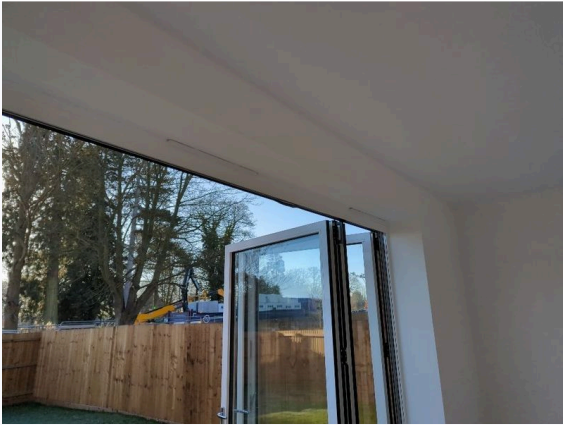
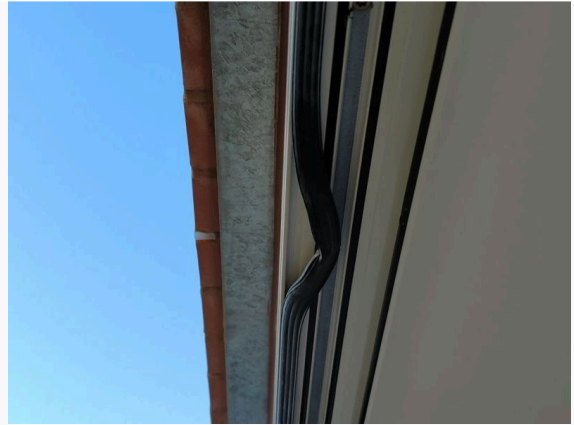
Ref # 4.6

Failure to the patio bi-fold door seal.

AMBER

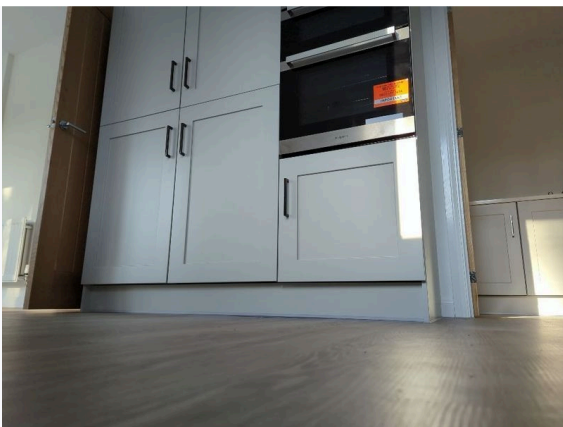
Ref # 4.7

Most integrated fridge freezer and oven towers require a vent to the plinth for sufficient airflow to the appliances. Please can the builder confirm whether this installation has been completed to the manufacturer's specification, or remedy.

AMBER

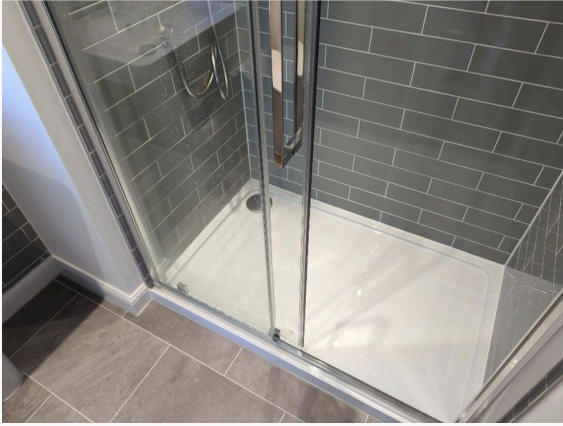
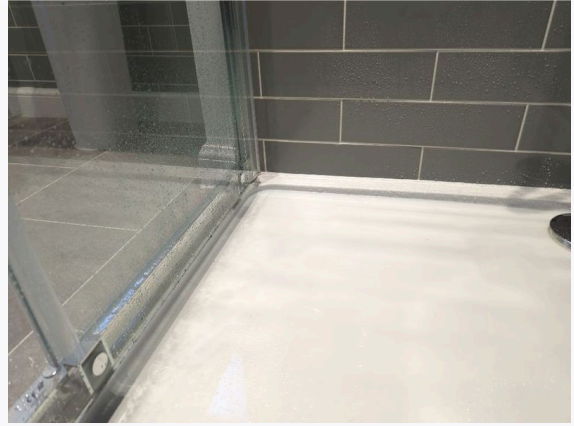
Ref # 4.8

After use, water remains pooled to the left hand side of the shower tray.

AMBER

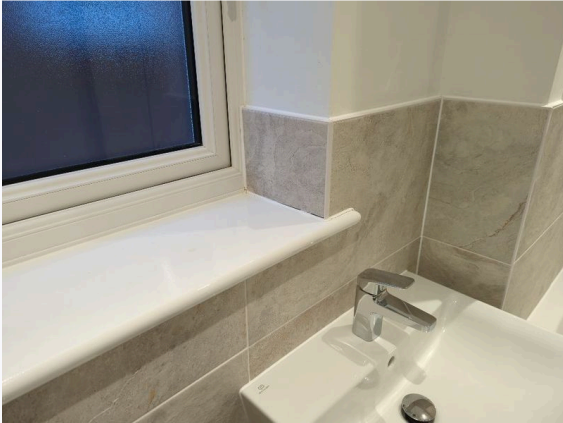
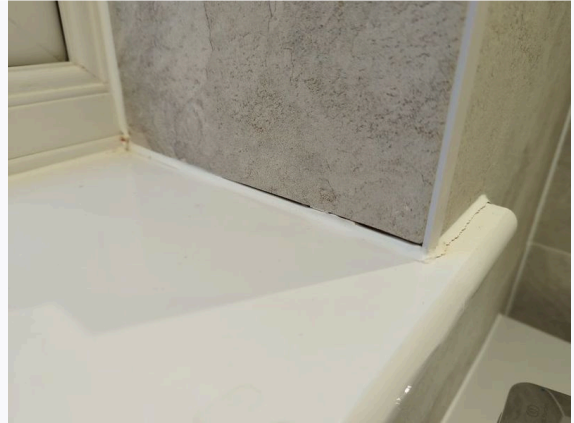
Ref # 4.9

Excessive gap between tiling and window sill, leading to failure of the seal.

AMBER

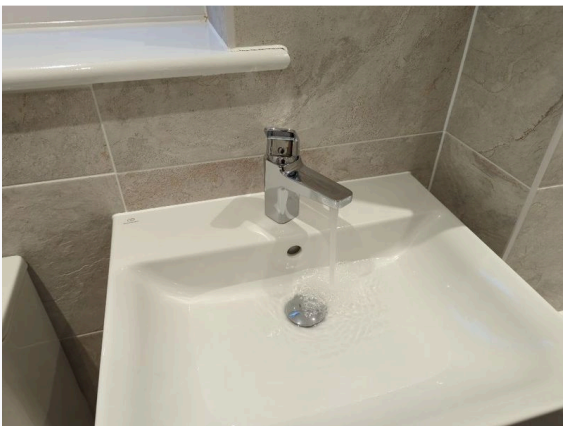
Ref # 4.10

Insecure installation to basin tap.

AMBER

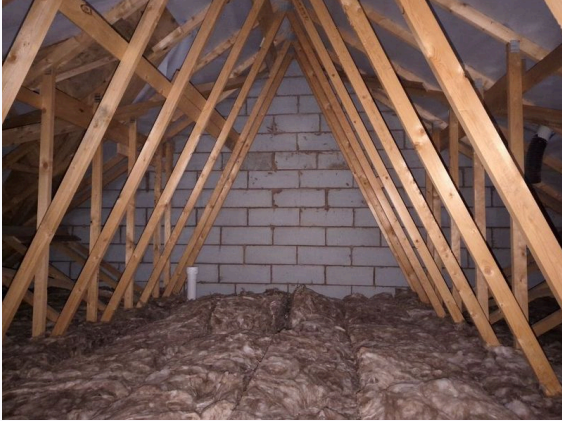
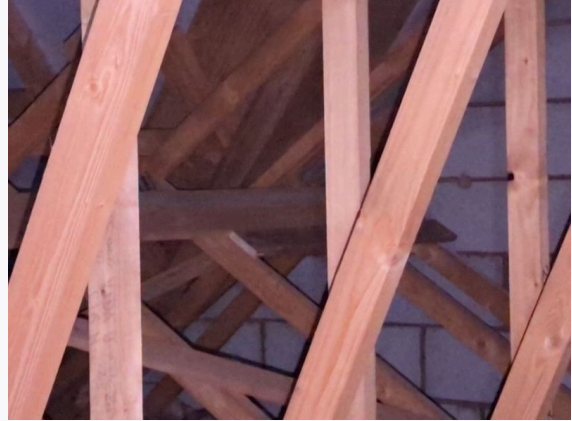
Ref # 5.1

Ref	Location	Condition	Condition Rating
5.1	Restraint Straps	It is unclear whether there is a lateral restraint strap installed at a central point to the gable end, in order to meet the 2m spacing required by NHBC Standards. Restraint straps can be seen to both sides of the rafters, but these are further than 2m apart.	RED

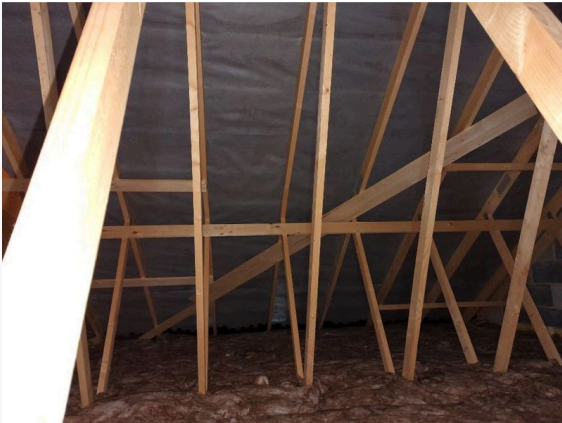
Ref # 5.2

5.2	Timbers and Felt	All visible areas of the timbers and felt were found to be free of damage.	GREEN
-----	------------------	--	-------

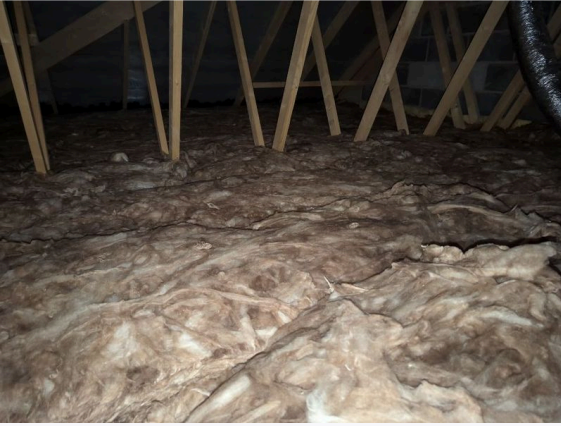
Ref # 5.3

5.3	Insulation	The insulation has been laid evenly throughout the loft space.	GREEN
-----	------------	--	-------

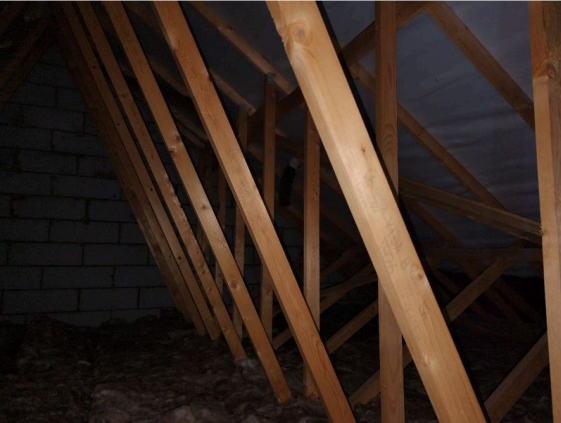
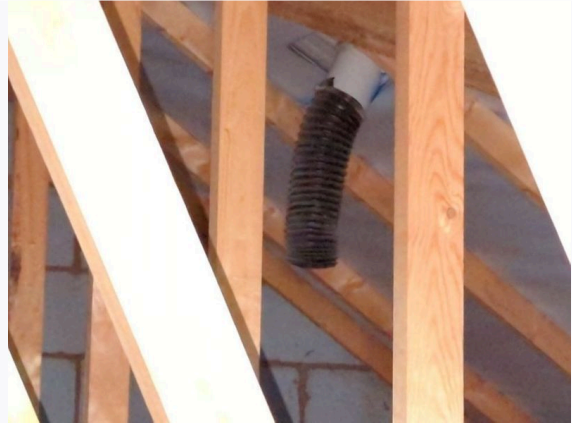
Ref # 5.4

5.4	Ventilation	Unconnected ducting for extract ventilation.	RED
-----	-------------	--	-----

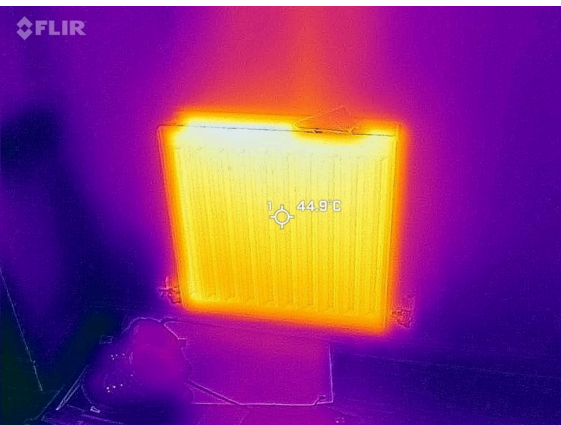
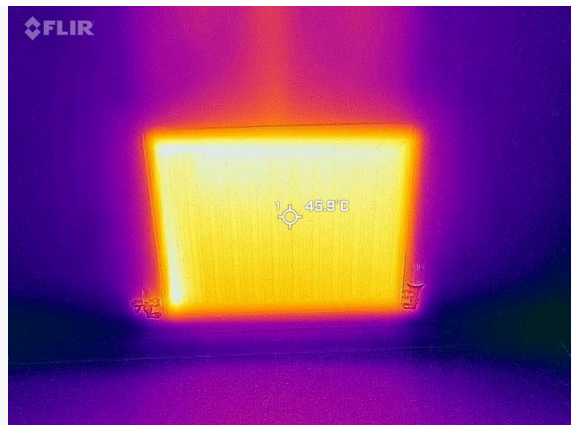
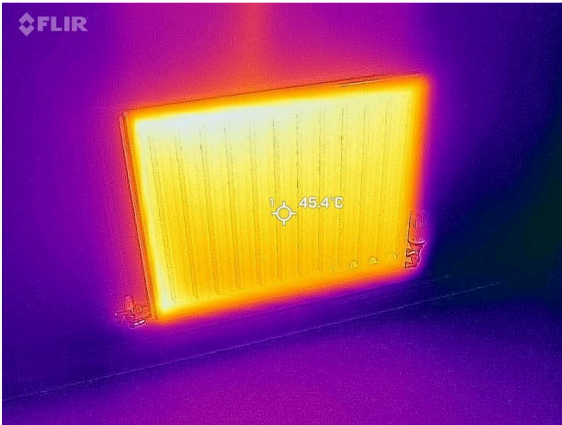
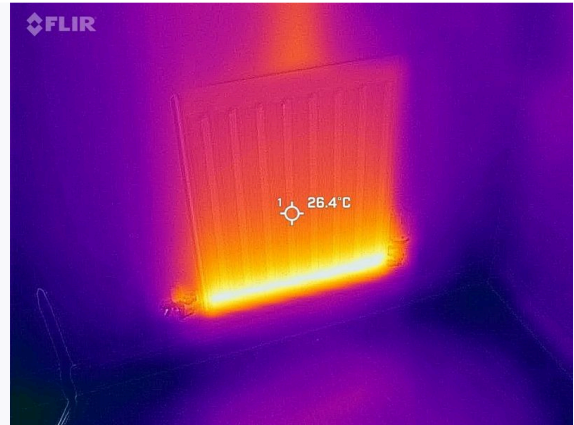
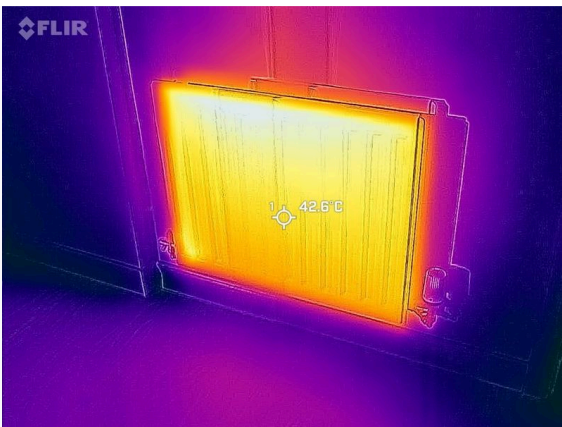
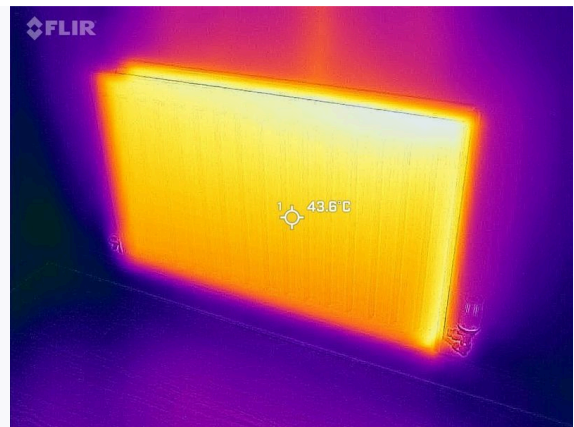
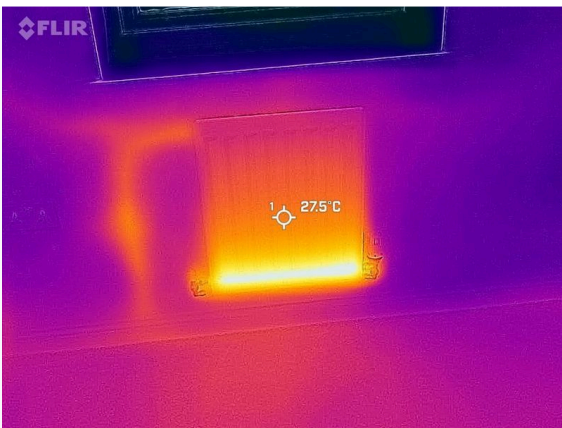
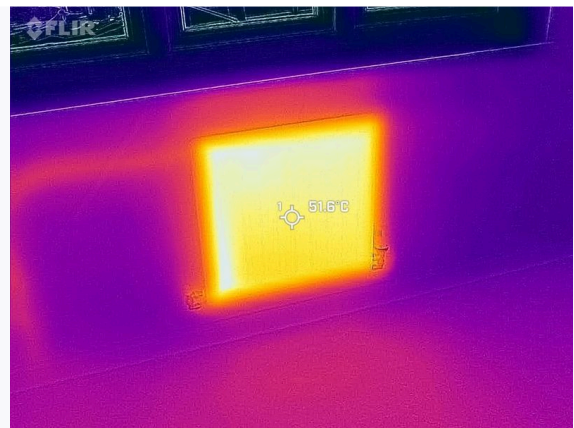
Ref # 6.1

Ref	Location	Condition	Condition Rating
6.1	Thermal Imaging	Thermal imaging of the radiators. Uneven heat distribution identified to the landing and rear right bedroom radiators.	AMBER

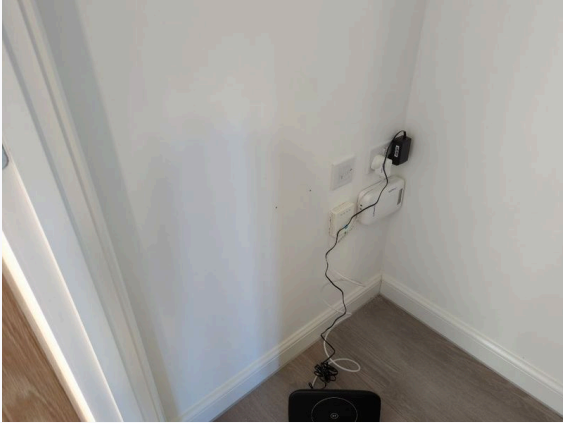
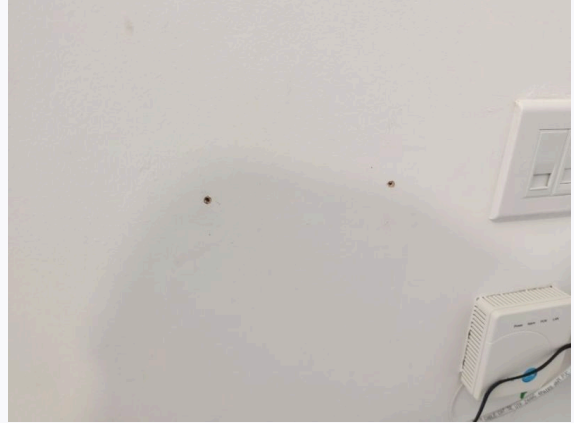
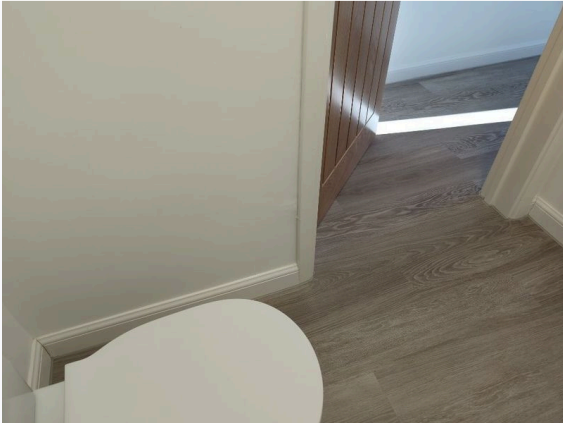
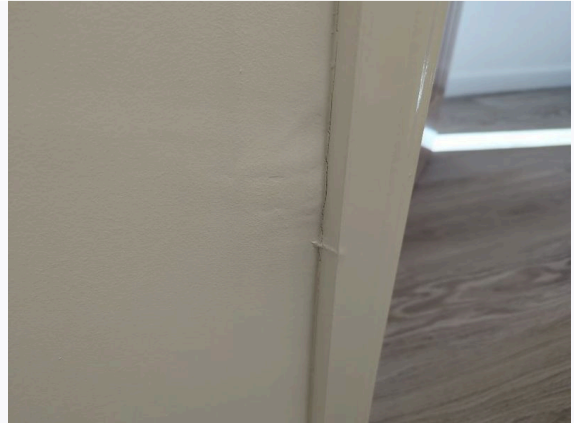
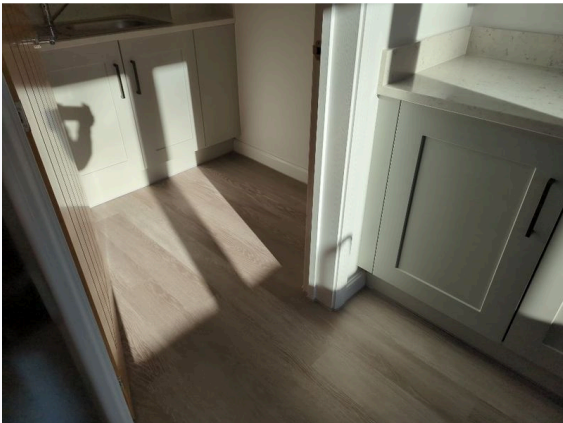
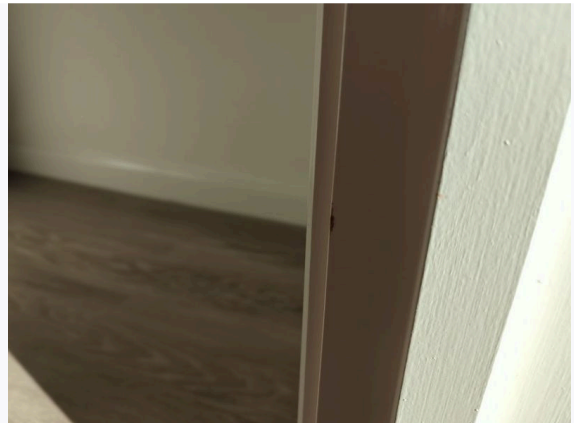
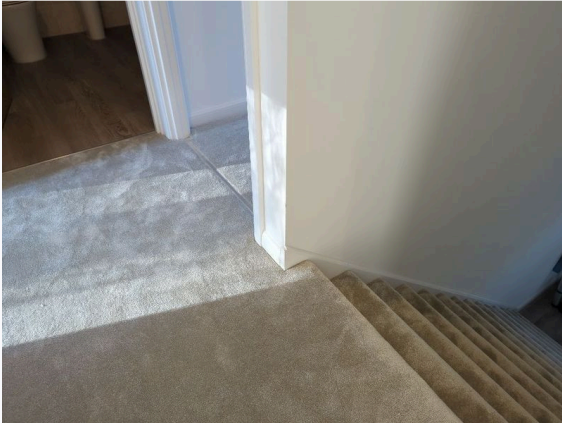
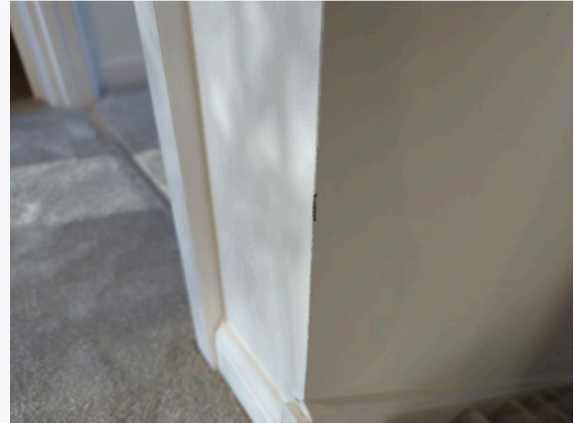
Ref # 7.1

Ref	Location	Condition	Condition Rating
7.1	Interior Decor	<p>Pictured are several examples of minor cosmetic defects and imperfections. All are within the tolerances set by the warranty or generally accepted workmanship standards for new build properties.</p> <p>As such, these items are classed as beyond the professional inspecting standards we adhere to, however they can be easily remedied.</p>	<p>GREEN</p>

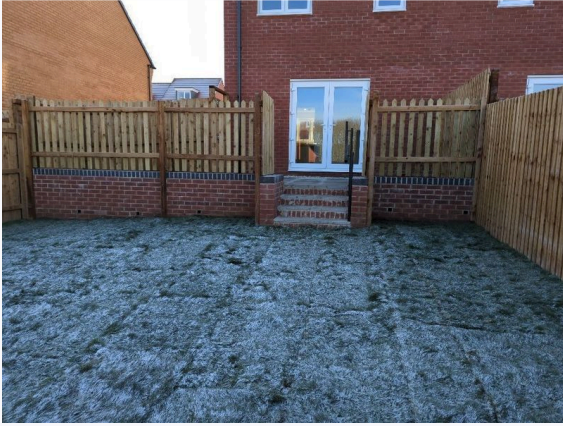
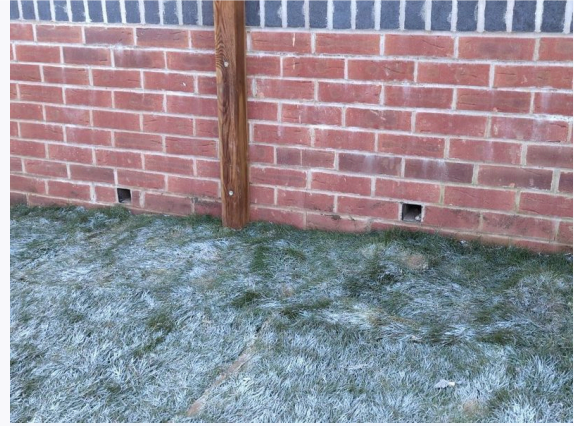
Ref # 8.4

8.4	Any issues evident with boundaries?	Yes	<p>Land Registry title documents rarely indicate responsibility for maintaining, repairing, or replacing a particular boundary fence or wall. Typically this is decided between neighbours unless specifically mentioned in the title documents.</p> <p>It is important that you are aware of any requirements for proper maintenance of the retaining walls that border the property, as these are critical to the overall structural stability of the plot.</p>
