# RICS Home Survey Level 2 (Survey Only)

12 Sample Street, London, SE11  
1AA, United Kingdom

July 11th 2023

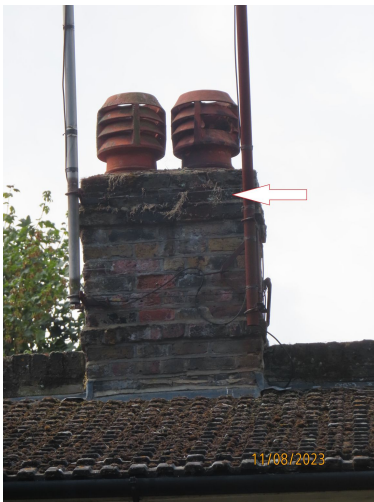
The property has three chimney stacks. Two to the front and the other to the rear. The rear stack has been fitted with a hood-type cowl which cannot be used for an active fire. Louvre-type cowls are fitted to the right chimney stack and the left has been capped off and cannot be used for an active fire. There is an increased risk of nesting birds within chimney pots as no bird guards have been fitted to the open flues. The brickwork to all chimney stacks was showing signs of wear with some spalled brickwork, worn pointing, moss and vegetation growth. Moisture meter readings taken internally showed a high level of dampness around the chimney breasts which is most likely a result of poor ventilation to the chimneys with capped pots and water ingress through the worn mortar joints. However, it must be noted that there were no visible signs of dampness internally although this could be due to the recent renovation work concealing the effects of any dampness. The flashings (waterproof covering around the base of the chimney) appear intact and in a serviceable condition although mortar around the flashings require repointing.

*Vegetation to chimney stack*

**Advice:**  
The chimney stacks should be regularly monitored for any indications of damage, instability or other defects. You should carry out a thorough visual inspection at least once a year, ideally in the Spring, and ideally at roof level, to identify and repair any damage that could have been caused by winter weather. Missing, loose or defective mortar should be repointed as necessary.

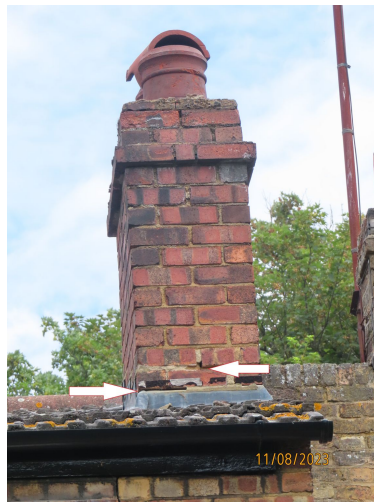
*Worn pointing to mortar joints*

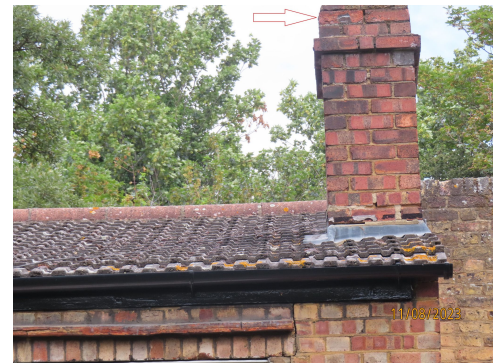
*Evidence of spalled brickwork*

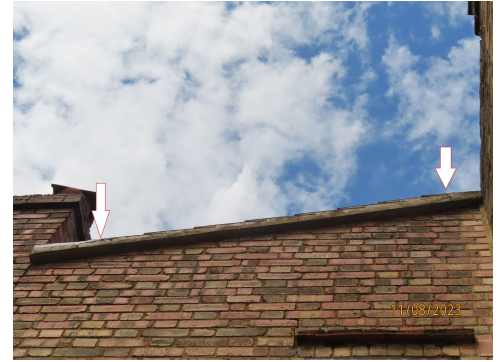
The roof coverings and ridge tiles are constructed of concrete. The verges at each gable are made up of mortar. General unevenness to some tiles was noted which is common in a property of this age. Some moss and lichen growth was noted on the roof but is not considered to be excessive. The parapet wall section to the left elevation requires some repair with spalling to the brickwork and worn mortar joints. Some light cracking was noted around the mortared verges which may require attention in the short to medium term. The roof was likely recovered when the property was rebuilt around 1947. This means the coverings could be around 75 years old. Typically concrete roof tiles have a lifespan of around 60 years and although no obvious signs of defect were seen you should be aware that defects may develop.

*Light cracking to mortared verge*

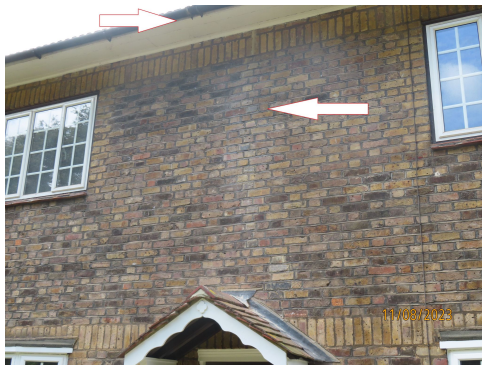
As it was not raining at the time of inspection I was unable to see conclusive evidence of any leaks to the guttering. However, staining was noted to the brickwork on the front elevation which could be an indication of a leaking gutter above. The front elevation downpipe is constructed of cast iron and is showing signs of corrosion and leaking around the joints.;

*Staining to brickwork and potential leak to gutter joint.*

Advice: Gutters and downpipes should be cleaned and inspected regularly to ensure that they are free from blockages and leaks. If it is noted during any heavy rain, that gutters or downpipe joints are leaking, then these must be fixed as soon as possible to prevent water penetration to the property and damage to the foundations. Climbing plants are prone to causing blockages in gutters and downpipes and should be removed from the area around the facilities on a regular basis.

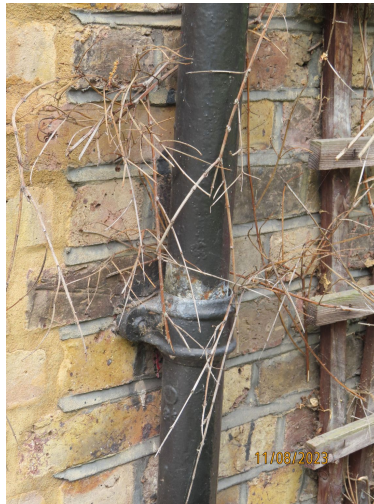
*Corrosion and leaking around downpipe join.*

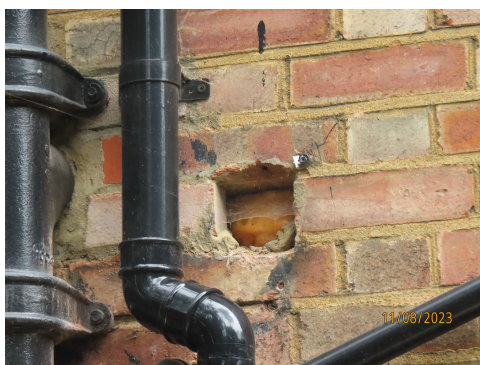
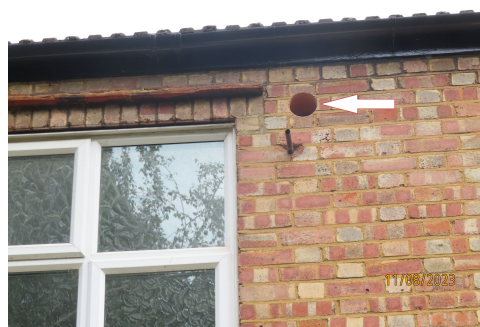
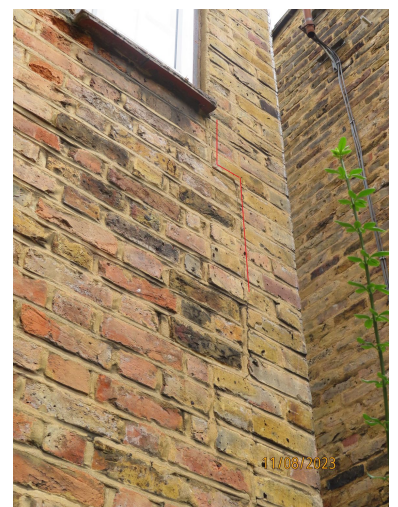
Evidence of recent repointing work was seen on both the left and right-hand side of the front elevation. This corresponds with some elevated moisture meter readings to the internal walls in this area which suggests that some dampness had occurred prior to the repointing works. However, it must be noted that there were no visible signs of dampness internally although this could be due to the recent renovation work concealing the effect of any dampness. Minor cracking was seen to the rear elevation although this appears to be longstanding. Due to the sloping nature of the site, I recommend that this cracking is monitored and investigated further should the severity of the crack worsen. Generally, there are multiple areas where repairs to the brickwork and seals are required such as where penetration holes have been made for services. Additionally, Some movement has occurred around the soldier course of brickwork to the first-floor rear elevation window on the right-hand side. This could have been caused during the window replacement as evidence of repair work was noted. However, it could also be a result of a failed, incorrectly installed or missing lintel. To confirm the cause some exposure work will need to be carried out.;

*Minor cracking to rear elevation.*

Advice: Walls should be examined regularly to inspect for changes in the nature of any cracking or other defects that may become apparent. You should carry out a thorough visual inspection at least once a year, ideally in the Spring to identify and repair any damage that could have been caused by winter weather.

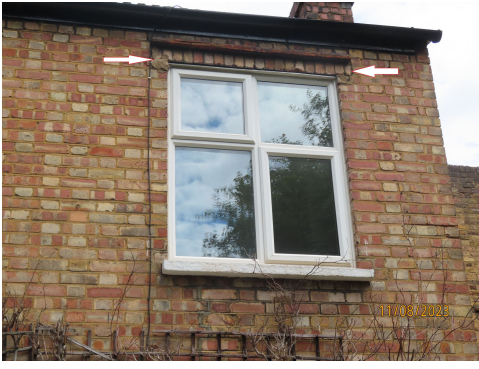
*Movement to brickwork soldier course.*

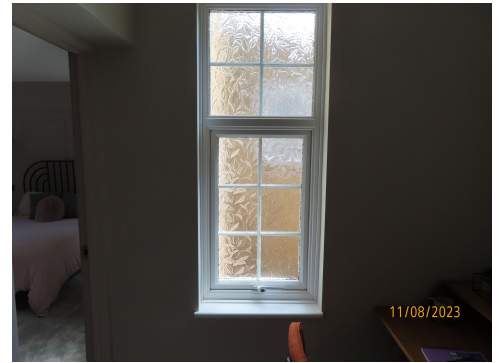
All windows operated as expected and there were no signs of failure noted. There was no evidence of blown double glazing but the external seals around the frames appear worn. This is also the case with the timber framing which will require ongoing maintenance. FENSA certificates were found for the replacement of the windows between 2003 and 2008. Without a copy of the FENSA certificate, there is no way to date the individual windows but typically PVC windows have a lifespan of around 20 years so the ones replaced in 2003 will be approaching the end of their expected lifespan. The two front bay windows have been fitted with mineral felt to the top sections whilst there is currently no indication of failure these sections will have a significantly reduced lifespan (typically 10 years) than that of a lead roof which would be a recommended improvement. Historical images show the bay windows with mineral felt roofs back in 2008 so assuming they have not been replaced then the roofs are likely to require repair or maintenance in the short to medium term. Low-level windows were noted on the first floor to the Landing, Bedroom 1, Bedroom 3 and the Main Bathroom. These windows pose a significant risk of falling and you should consider installing a suitable restrictor prior to occupation. The applied condition rating reflects this potential safety hazard.;

*Low level window to landing*

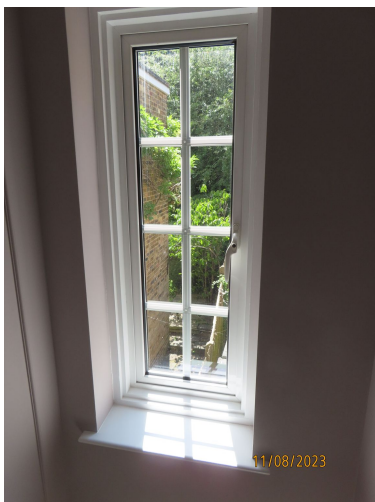
*Low level window bed 3*

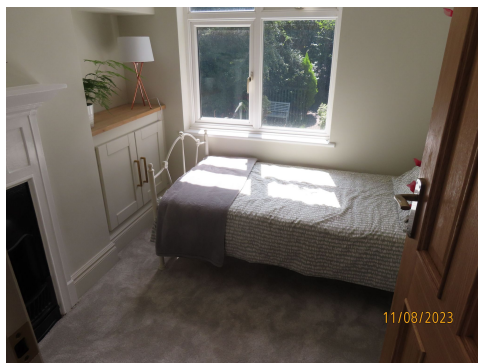
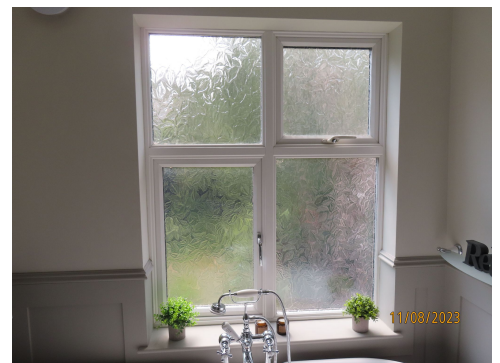
*Low level window main bathroom*

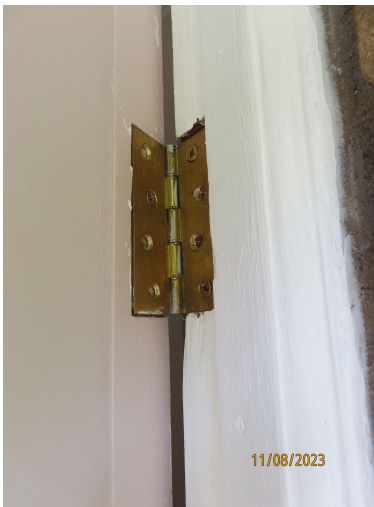
The doors operated as expected and there were no significant defects noted. ongoing maintenance of the timber doors will be required to preserve the integrity of the wood. It should be noted that the timber front door has not been securely screwed onto its hinges. Whilst this is a simple fix, it's important to ensure the security of the front door.

*Missing screws to front door.*

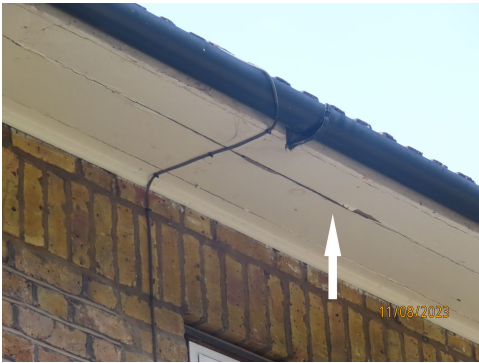
The timber fascias and soffits are showing signs of deterioration and will require ongoing maintenance to preserve the timber. As the guttering is fixed to some of the fascias it is vital that they are maintained to avoid failure of the gutter fixings.

*Timber soffit to front*

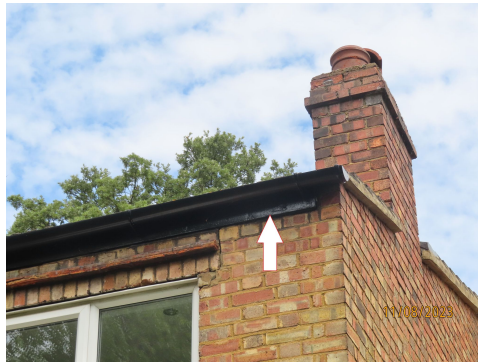
*Timber fascia to rear*

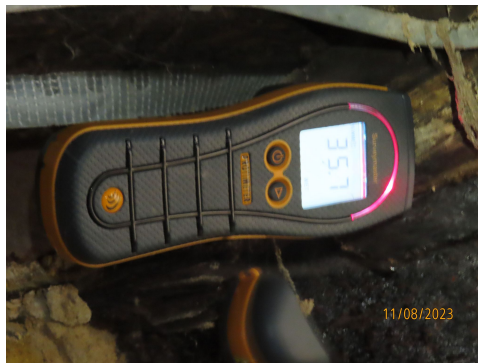
*Timber moisture meter reading 35.7%*

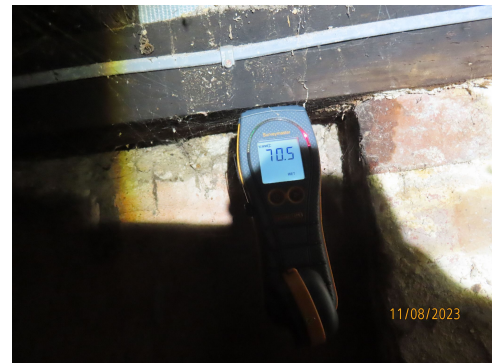
*Timber moisture meter reading 70.5%*

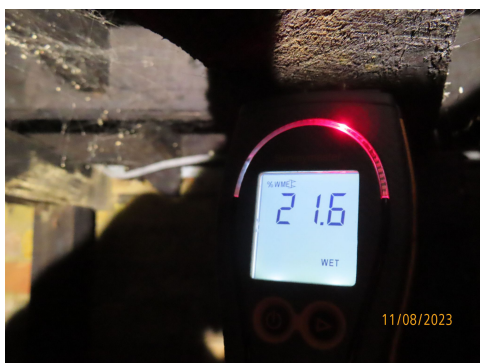
*Timber moisture meter reading 21.6%*

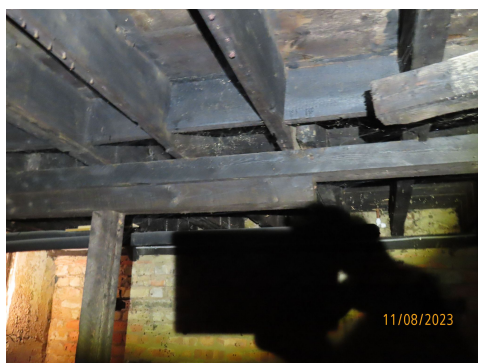
Timber supports have been used as shuttering to support the walls of the basement. These are showing signs of bowing and may be inadequate to hold the ground behind. Furthermore, significant cracking was noted in the retained wall close to the entrance hatch. I recommend a structural engineer is consulted to advise if the timber supports are adequate to hold the weight of the retained ground. The chimney breasts and old fireplaces within the basement are also in poor condition. Deterioration of the brickwork and cracked lintels above the fireplace is evidence of instability which is likely to develop into instability further up the chimney breast unless repair works are carried out. I was also able to use this vantage point to inspect the condition of the ground-floor joists. Moisture meter readings were taken which indicated a high level of dampness within the timbers at between 21 and 70%. Timber is susceptible to deterioration, woodworm and mold growth at around 18%. The floor joists were found to be unstable with rot and mold growth noted. In places, an attempt has been made to reinforce the floor joists with the addition of timber supports. These have failed and are not adequate to support the floor above. Significant repair work will need to be carried out to repair and replace the affected timbers.

*Failed timber supports*

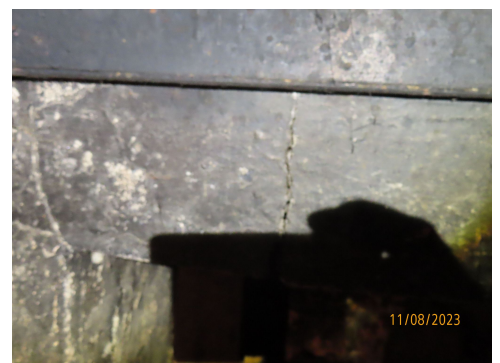
*Cracked lintel support to fireplace.*

As referred to in section D9 other, the fireplaces in the basement are in a poor state of repair with signs of deterioration to the brickwork and structure at their base. This will impact the structure above and it is likely that some rebuilding and supporting work will be required. You should ensure that a competent contractor is used and any structural calculations have been made by an appropriately qualified structural engineer.

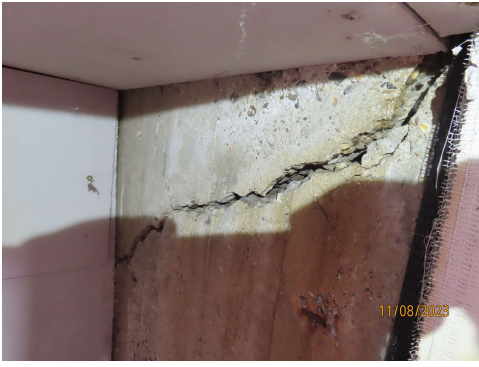
*Crack in retaining wall near access hatch*

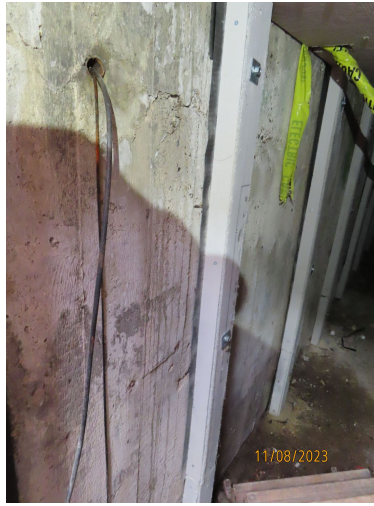
*Timber supports showing signs of bowing.*

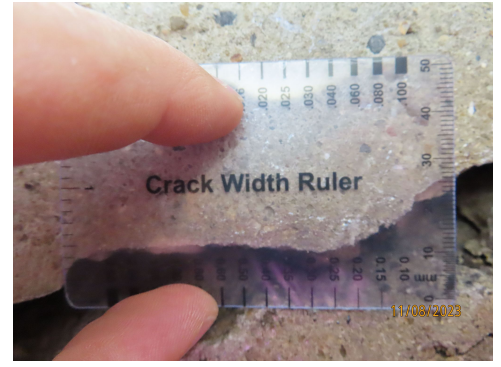
*Width of crack approximately 25mm*

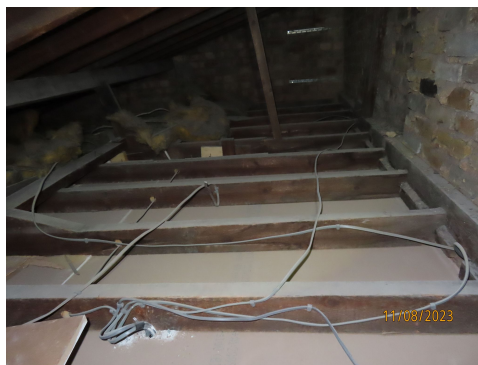
No significant defects were noted during my inspection and the roof was found to be in good condition. There was no evidence of woodworm to the accessible timbers and moisture meter readings indicated that the timbers are dry. A lack of insulation was found within the roof space and this has been discussed in the Energy Efficiency section. I also note a large wasps nest towards the rear of the roof. Although this appears inactive it is evidence that wasps can gain access to the roof space and may return to nest in the future.;

*Lack of insulation to the roof space*

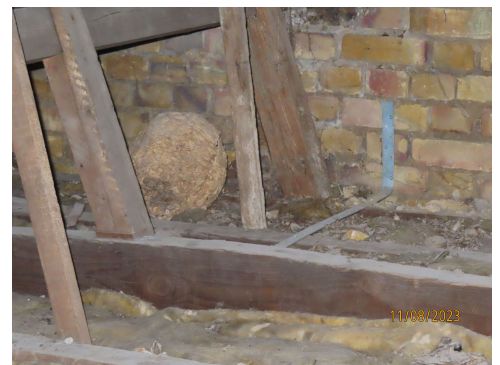
*Inactive wasp nest*

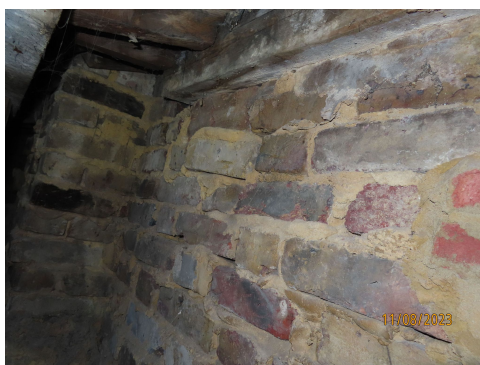
The visible brickwork of the chimney breast within the roof space requires repair to the dislodged bricks and mortared joints. The timbers above this wall also appear to be suffering from some mold growth although when tested with the moisture meter they were dry. It is likely that this has occurred as a result of a lack of ventilation explained below.

*Chimney wall*

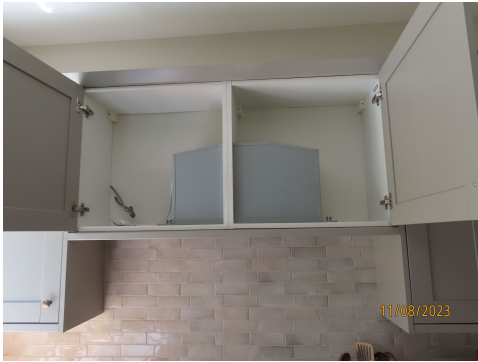
The kitchen appears to have been recently replaced and is in a condition conducive to its age. A kitchen extractor has been fitted above the hob but has not been fitted to an electrical supply or a suitable ducting so that it can vent externally. If used in its current condition there will be an increased risk of condensation within the kitchen. Although not tested given this appliance has been missed it would be a safe assumption that other appliances have not been connected.

*Kitchen extractor not connected.*

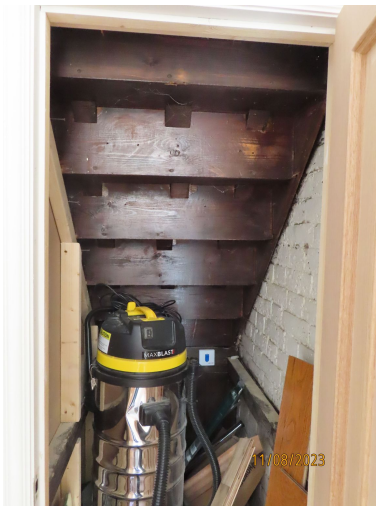
All doors within the property are timber doors. Generally, all doors are in good condition with no binding noted when opened and closed. All doors can be opened and closed with ease. Skirtings and architraves were also in good condition conducive to a recently refurbished property. Upon opening the cupboard within the landing to assess the back of the staircase it was found to have not been plaster boarded. This increases the risk that the stairs will fail in the event of a fire and I recommend plaster boarding the back of the staircase as soon as possible. Furthermore, a secondary hazard exists with the open staircase. No balustrades or banister has been fitted to a right hand side and so there is an increased risk of falling, particularly for the young or elderly. The appropriate condition rating has been applied due to the presence of a safety hazard.

*Lack of fire protection to staircase*

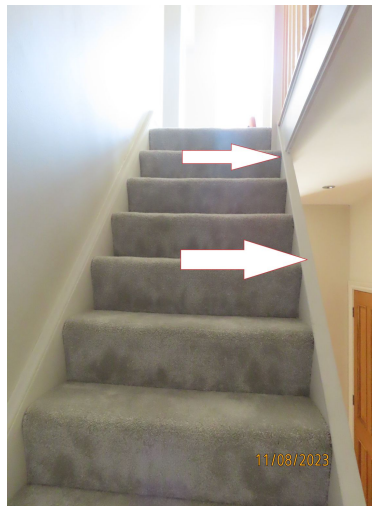
*Lack of banister or balustrades to staircase.*

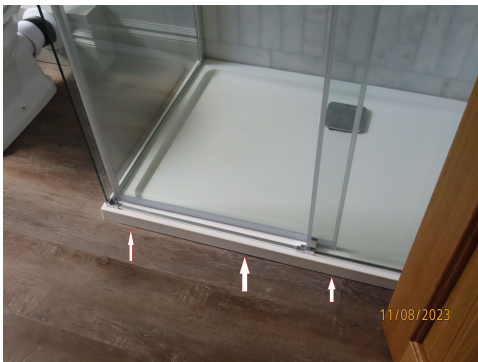
The shower was found to be lacking a mastic seal where the tray meets the finished flooring. This will require fitting to avoid water ingress to the floor below. Given the issues found with the bath and other unfinished work found throughout the property, it is recommended that all bathroom fittings are checked when the boiler is active to ensure their suitability prior to exchange.

*Missed mastic seal to shower tray.*

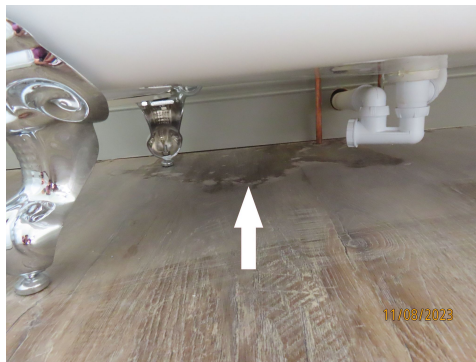
The fittings have been recently installed and their condition is conducive to their age. Basin taps were turned on and the water was found to flow at the expected rate. No hot water was obtained from any outlet due to the boiler being switched off at the time of inspection. The water to the bath appears to have been switched off and there was evidence of a recent leak underneath. This will require investigation and repair by a competent contractor before the bath can be used.

*Evidence of leak underneath the bath.*

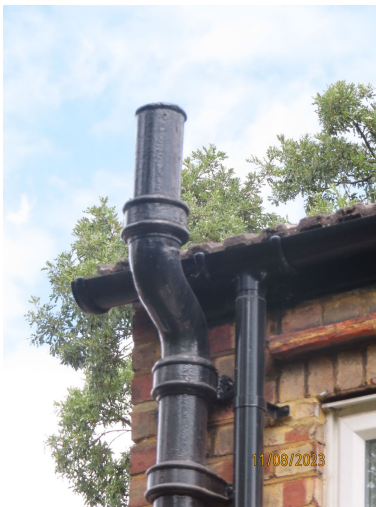
Soil and vent pipe

The soil and vent pipe to the rear elevation is constructed of cast iron. Generally, it is in a serviceable condition although is missing a vented cap to the top. This means that birds can nest and drop material down the pipe which may cause a blockage.

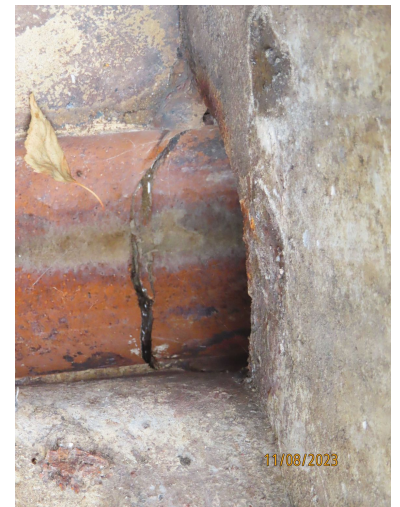
Cracked drain to rear

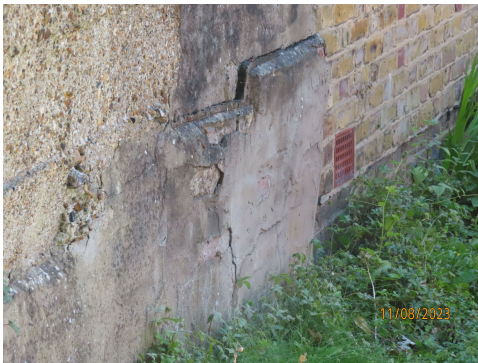
*Bulging and cracking to front boundary wall.*

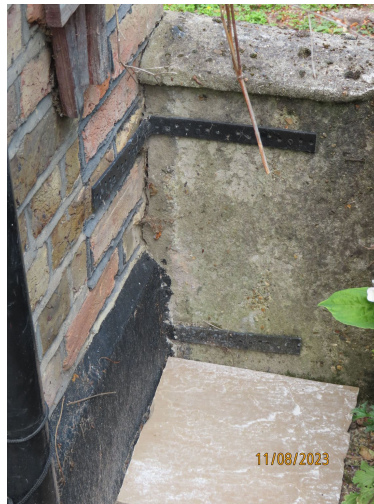
*Restraint straps to front boundary wall.*

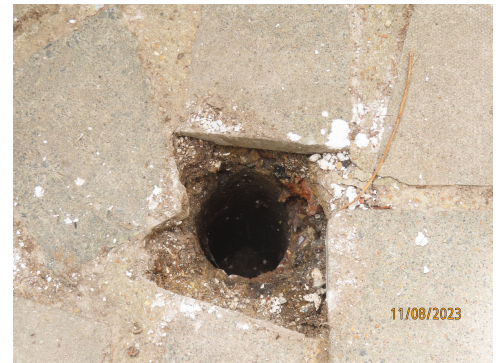
*Hole in paving to rear patio*
