# Inverness Condominiums

## *Milestone Inspection Report*

RE: Phase 1 – Milestone Inspection

Inverness Condos

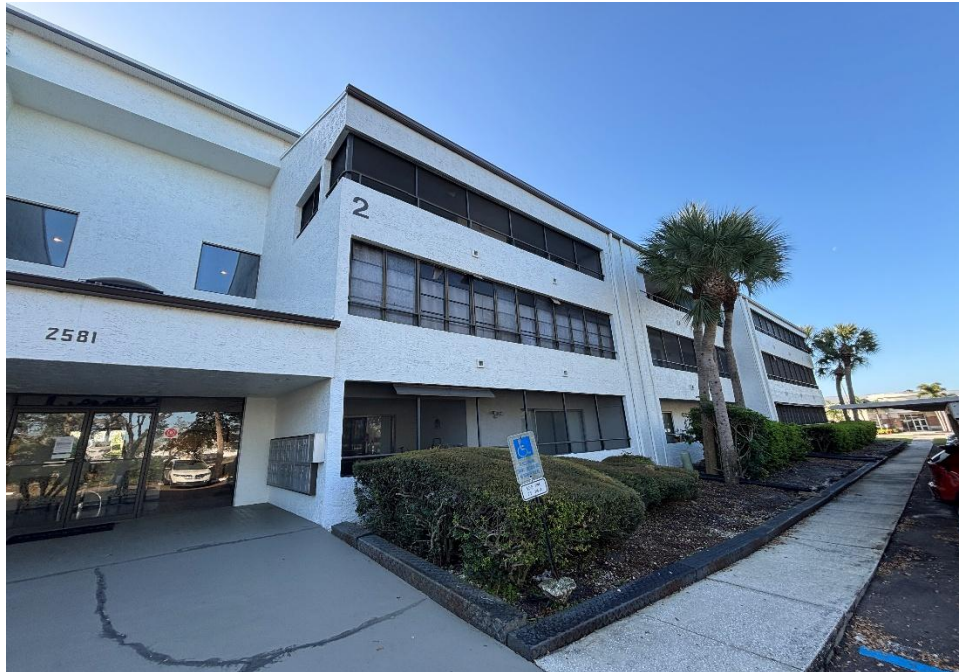
**Figure 1: Typical West Elevation – Building 2  
(No visible structural distress observed)**

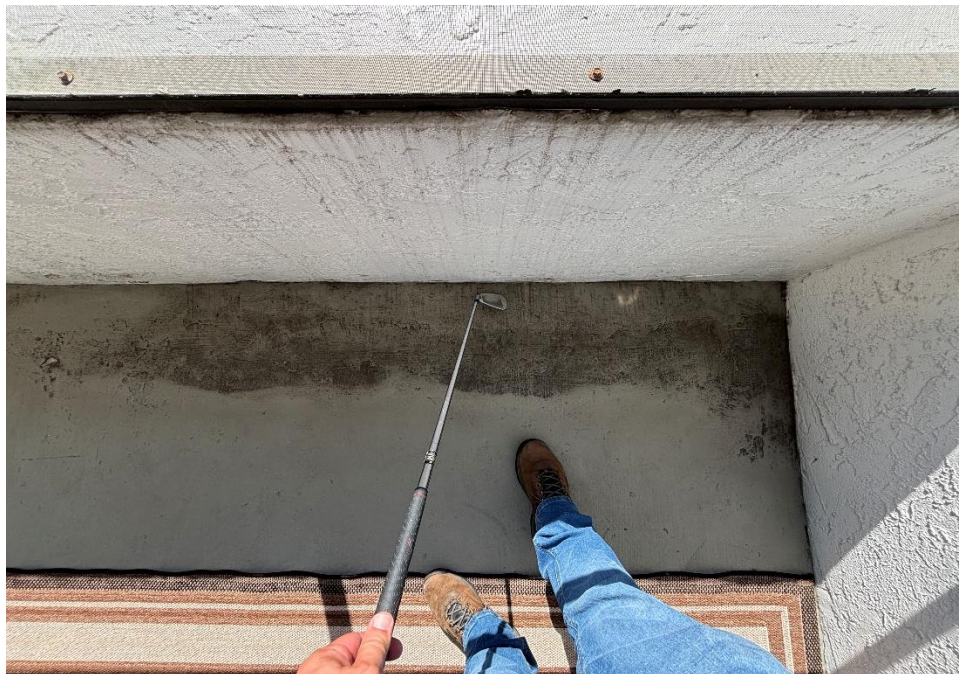
At Unit 209, two (2) localized areas of apparent concrete delamination were observed at the balcony slab, each approximately 1 square foot in size. The remaining accessible areas generally exhibited typical age-related conditions, including minor surface cracking and localized deterioration of protective coatings at balcony slabs.

**Figure 2: Localized apparent delamination at balcony slab, Unit 209  
Building 2.**

1. **Repair, as necessary, of localized areas** of apparent delamination or distress at balcony slabs and soffits, including those noted at Units 209, 301, 208, and 204.
2. **Repair of minor cracks and surface deterioration** at balcony slabs and soffits, as necessary.
3. **Evaluation and repair of moisture-related conditions** at balcony knee walls, including sealing, waterproofing, or drainage improvements as required.
4. **Restoration and maintenance of protective coatings** at balcony slabs to help reduce moisture intrusion and extend service life.
5. **Periodic inspection of balcony slabs, soffits, and associated elements** to monitor for progression of delamination, cracking, or moisture-related deterioration, and to perform repairs as needed.

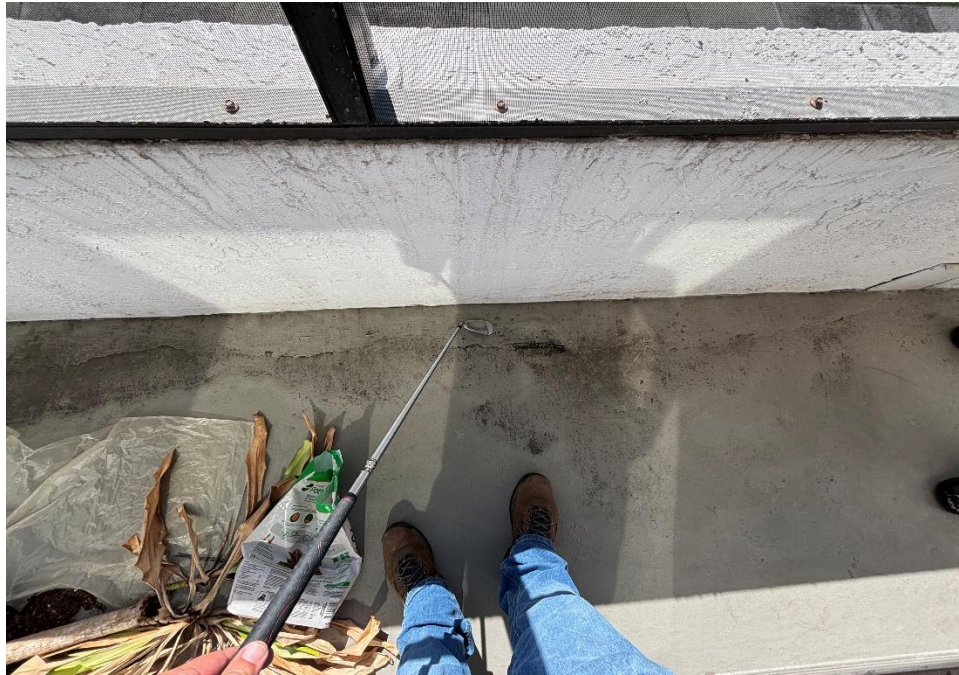
**Figure 3: Localized apparent delamination at balcony slab, Unit 209 Building 2.**

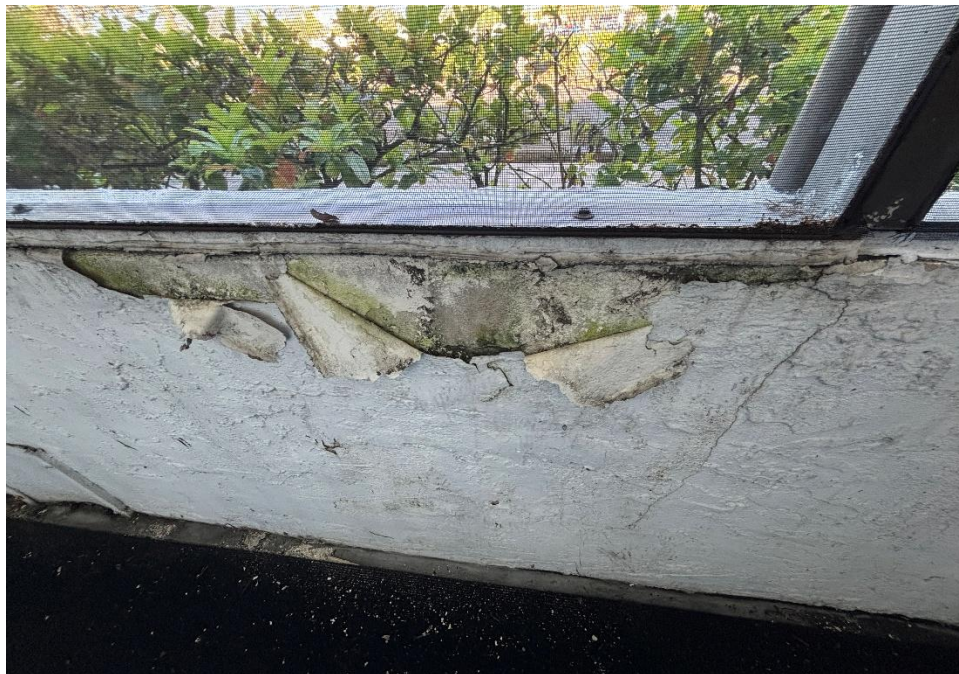
At select first-floor units, visible moisture-related staining and deterioration was observed at the balcony knee walls, likely associated with water intrusion and/or inadequate waterproofing or drainage detailing.

**Figure 4: Moisture-related deterioration at balcony knee wall (typical condition) - Building 2.**

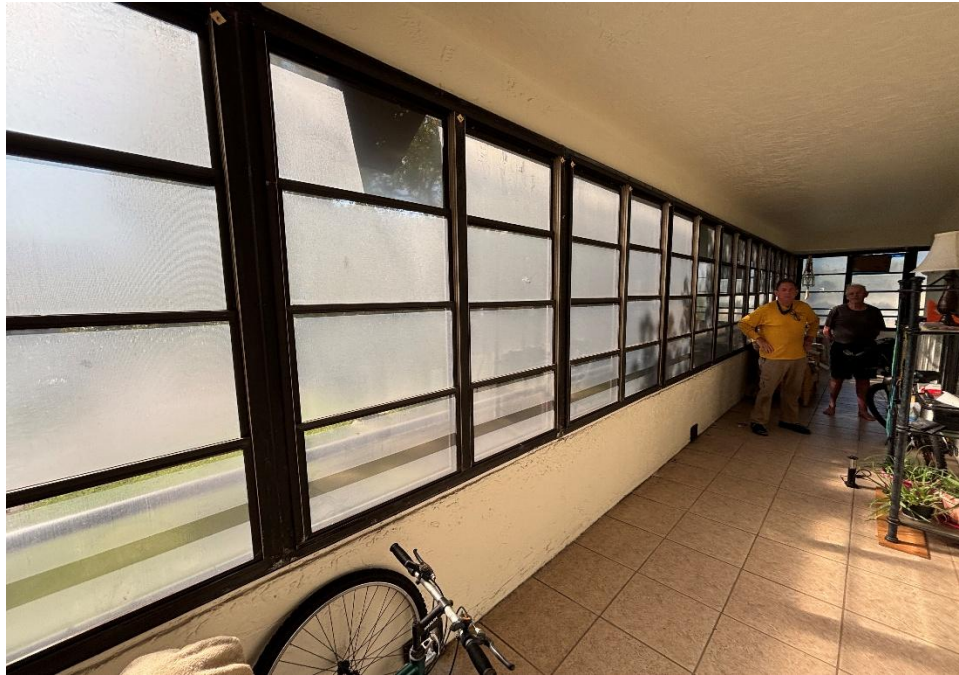
**Figure 7: Typical balcony condition with tile finish, limiting direct observation of the underlying structural slab – Building 2.**

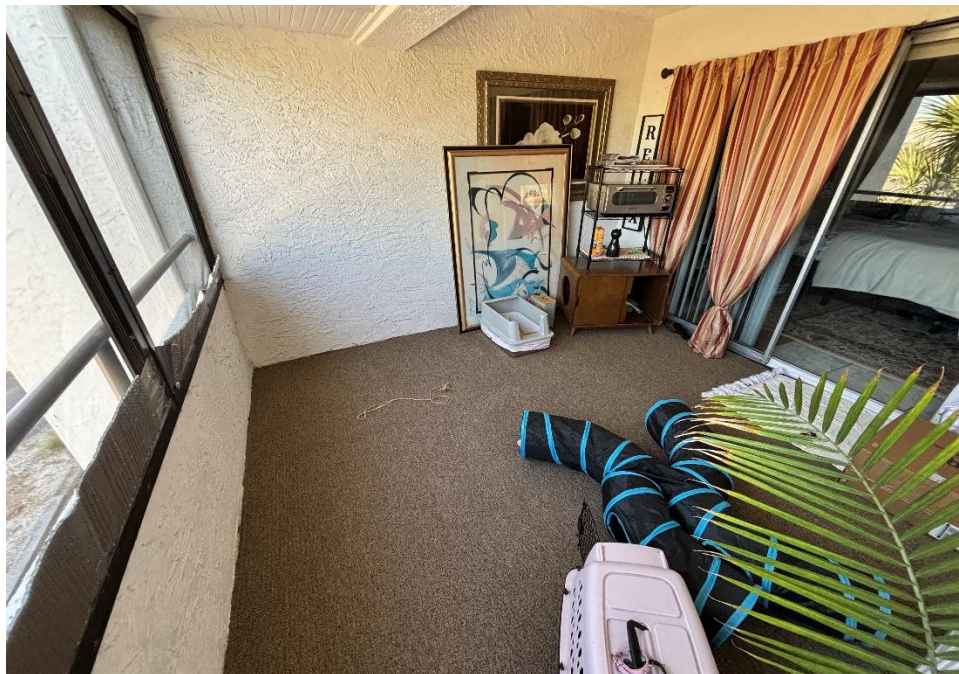
**Figure 8: Typical balcony floor condition with carpet finish, limiting direct observation of the underlying structural slab – Building 2.**

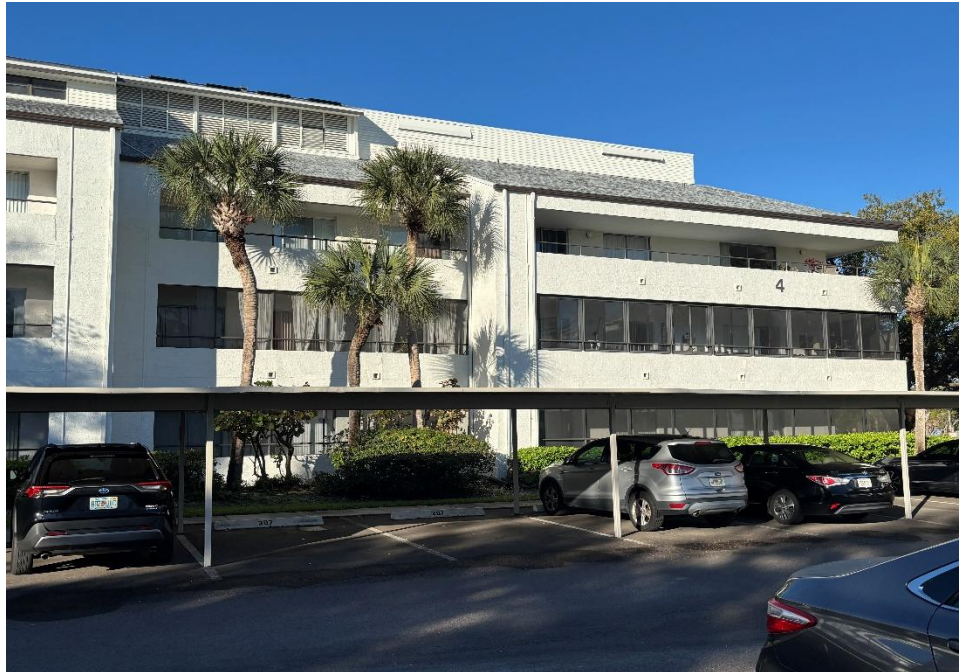
**Figure 9: Typical East Elevation – Building 4  
(No visible structural distress observed)**

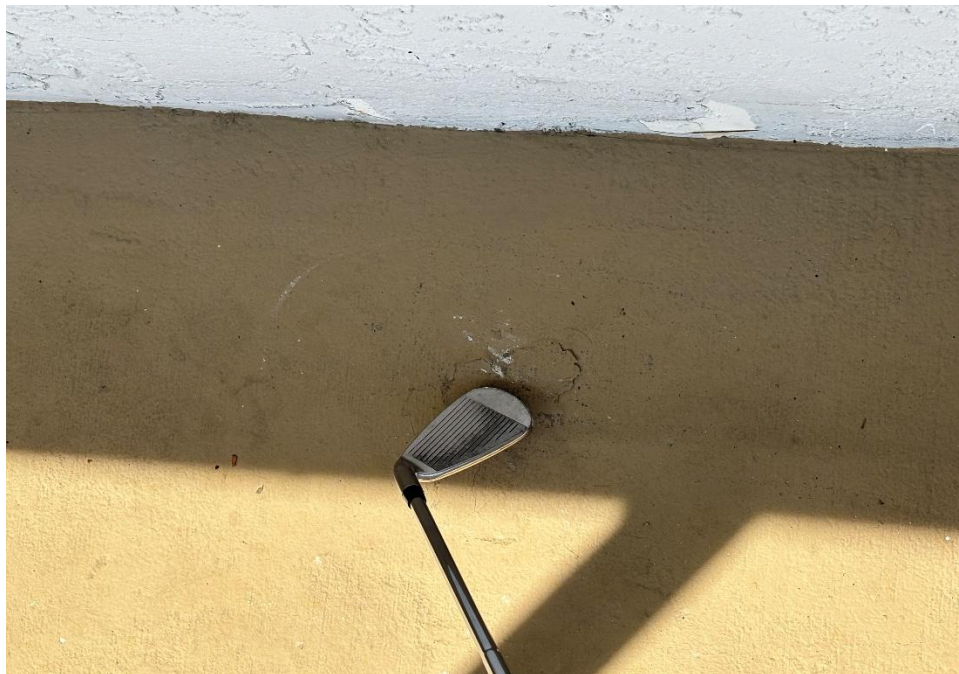
- One (1) area at Unit 301
- Multiple minor areas at Unit 208
- Two (2) areas at Unit 204

**Figure 10: Localized apparent spall at balcony slab, Unit 301  
Building 4.**

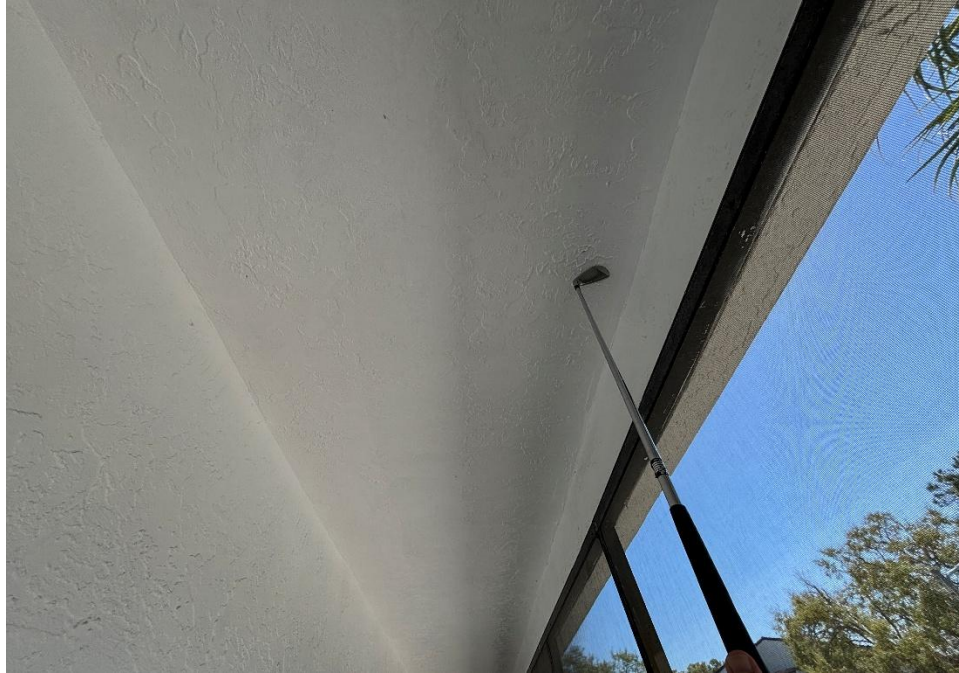
These conditions are considered apparent, as the soffit surfaces have a stucco/textured finish, which may mask or influence the visual identification of underlying concrete distress.

**Figure 11: Apparent delamination at soffit, Unit 204.  
Building 4.**

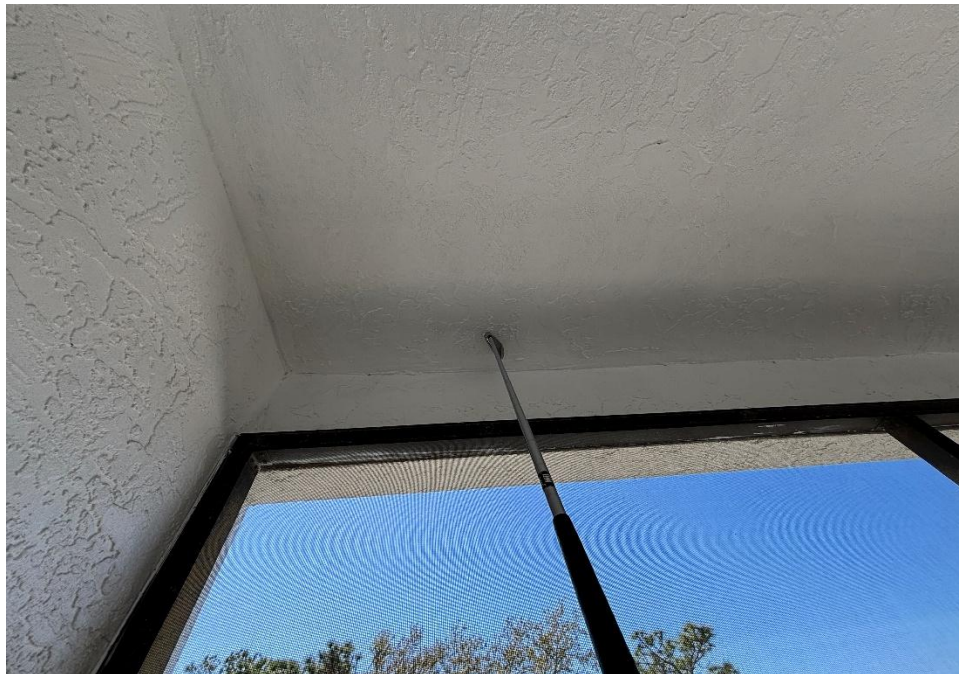
**Figure 12: Apparent delamination at soffit, Unit 208.  
Building 4**

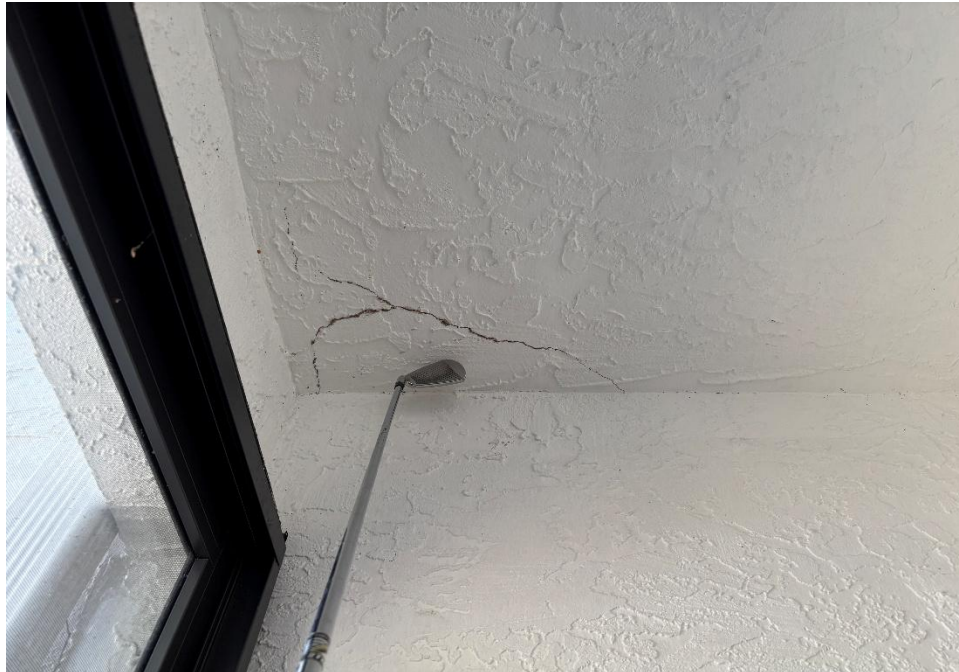
**Figure 13: Minor hairline cracking observed at ceiling, consistent with typical age-related conditions – Building 4.**

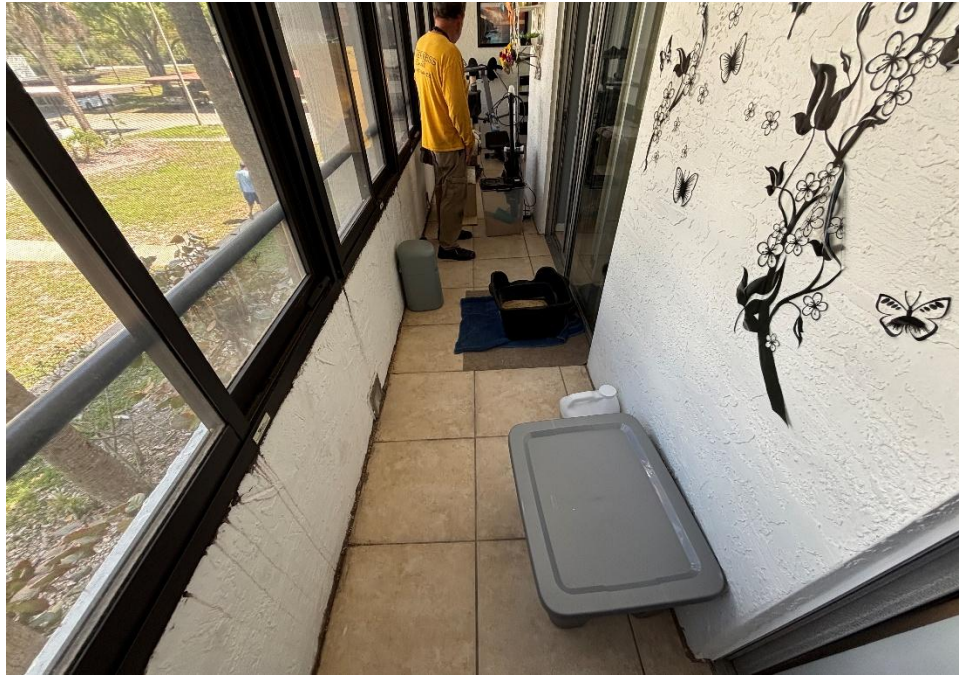
**Figure 15: Typical balcony condition with tile finish, limiting direct observation of the underlying structural slab – Building 4.**

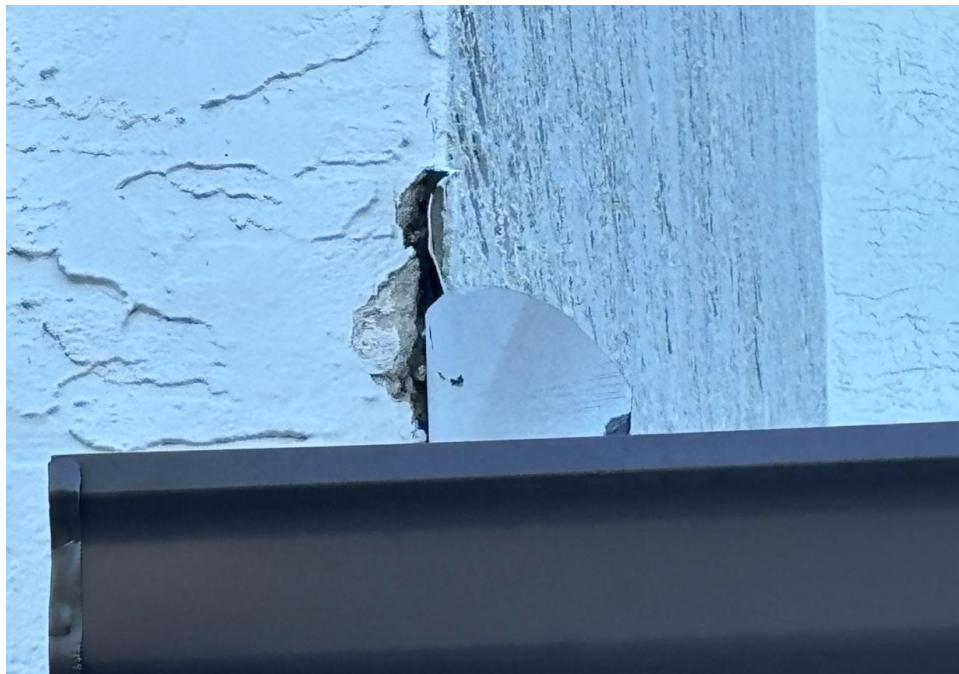
**Figure 16: Localized surface damage with material loss at wall corner at west entrance – Building 2.**

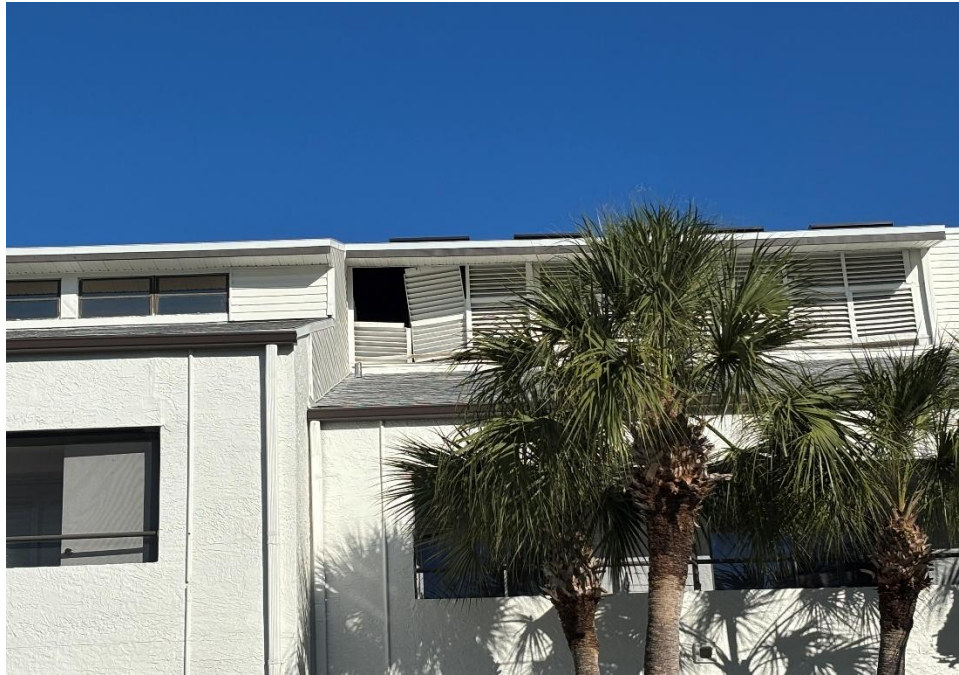
**Figure 17: Displaced or missing louver panel at attic ventilation opening, east elevation – Building 2.**
