PROPERTY INSPECTION REPORT

<u>Mr. and Mrs. Happy Homeowner</u> Name of Client	<u>March 02, 2022</u> Date of Inspection
<u>1234 Happy Trail, Happy Town, TX, 76179</u> Address of Inspection Property	
<u>Bryan Garrett</u> Name of Inspector	<u>21568</u> TREC License #
<u>N/A</u> Name of Sponsor (if applicable)	<u>N/A</u> TREC License #

Prepared exclusively for Mr. and Mrs. Happy Homeowner • Inspected Address: 1234 Happy Trail, Happy Town, USA
By Bryan Garrett TREC #21568 • Hearthstone Professional Inspections PLLC
Mobile: (630) 743-1009 • Email: Bryang@hearthstonepllc.com

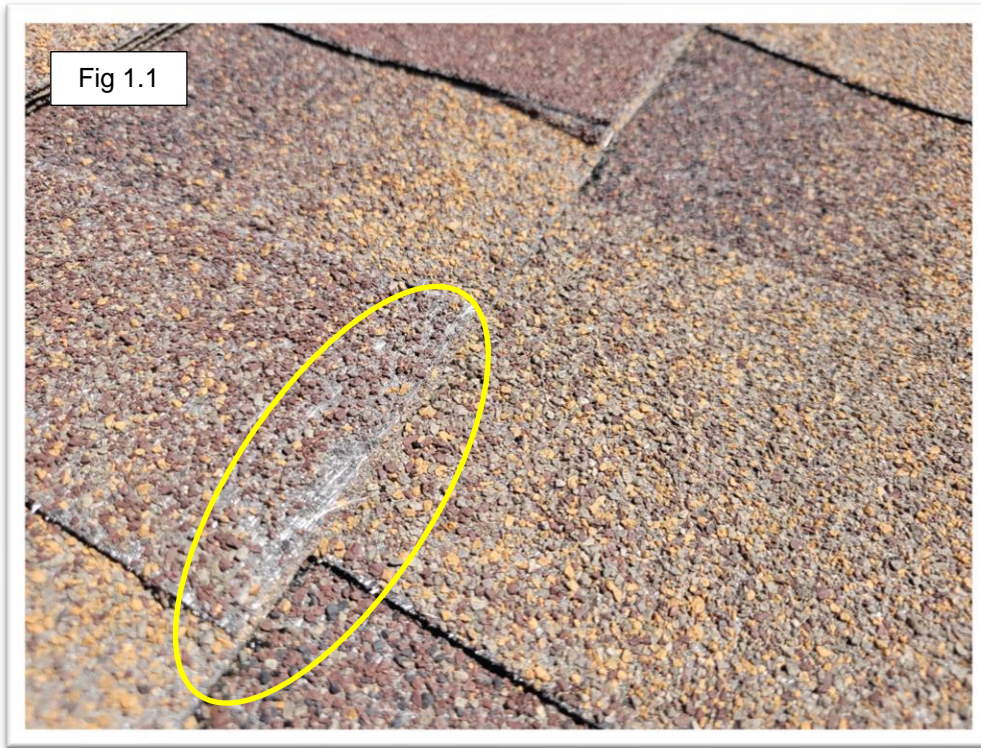
- Some of the shingles edges were showing. This can cause the shingles to prematurely deteriorate. See Fig 1.1 on page 8.
- There was evidence of hail damage on the southwest side of the roof. See Fig 1.2 on page 8.
- The roofing trim, eaves, and fascia board needed painting.
- The PVC vent pipes on the roof had missing paint which can cause them to prematurely deteriorate rapidly, recommend painting them for protection against the sun's UV rays.
- The felt paper was installed under the drip edge which can prevent water from draining.

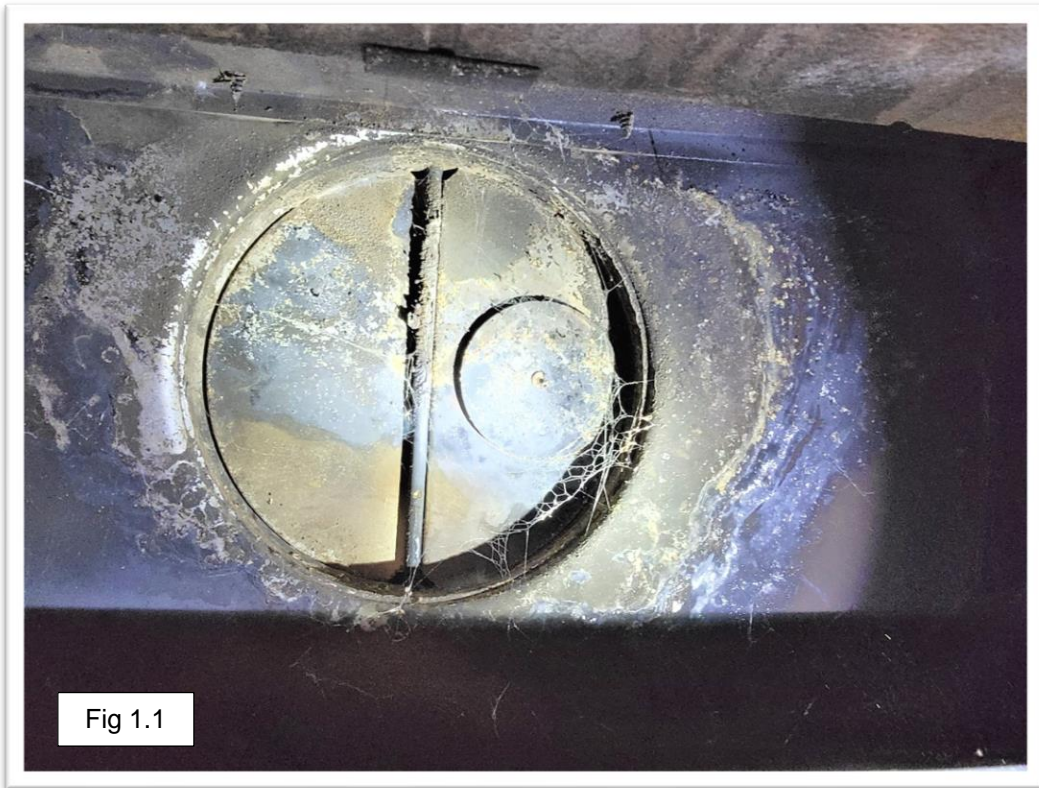
- The damper area was dirty with built up creosote and or dirt which can cause a fire. In the inspector's opinion I recommend that the interior of the firebox, flue and damper area be cleaned. See Fig 1.1 on page 14.
- The mantle was a floating type of unit, and it was loose at the wall. In the inspector's opinion it is recommended that it be properly secured prior to putting items on it.

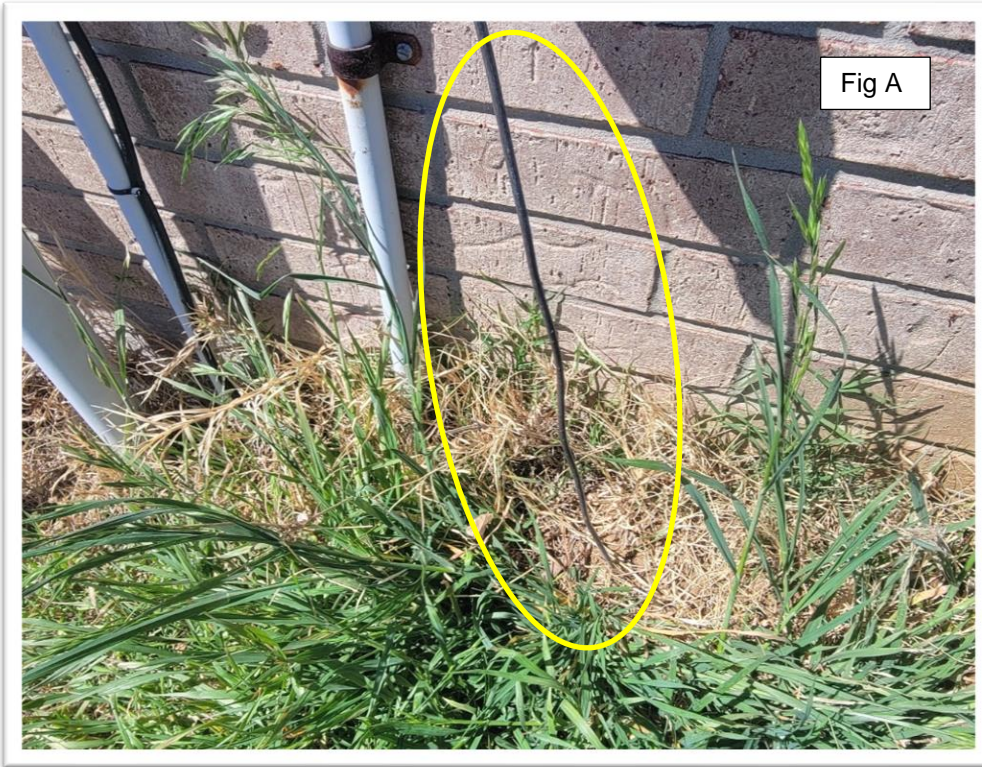
Fig A is a picture of the copper grounding wire leading to the grounding rod which is on south corner of the home.

- Type of grounding electrode type present was a Grounding Rod. See Fig A for your grounding electrode system and a definition on page 16.
- Type of bonding termination was not observed or located.

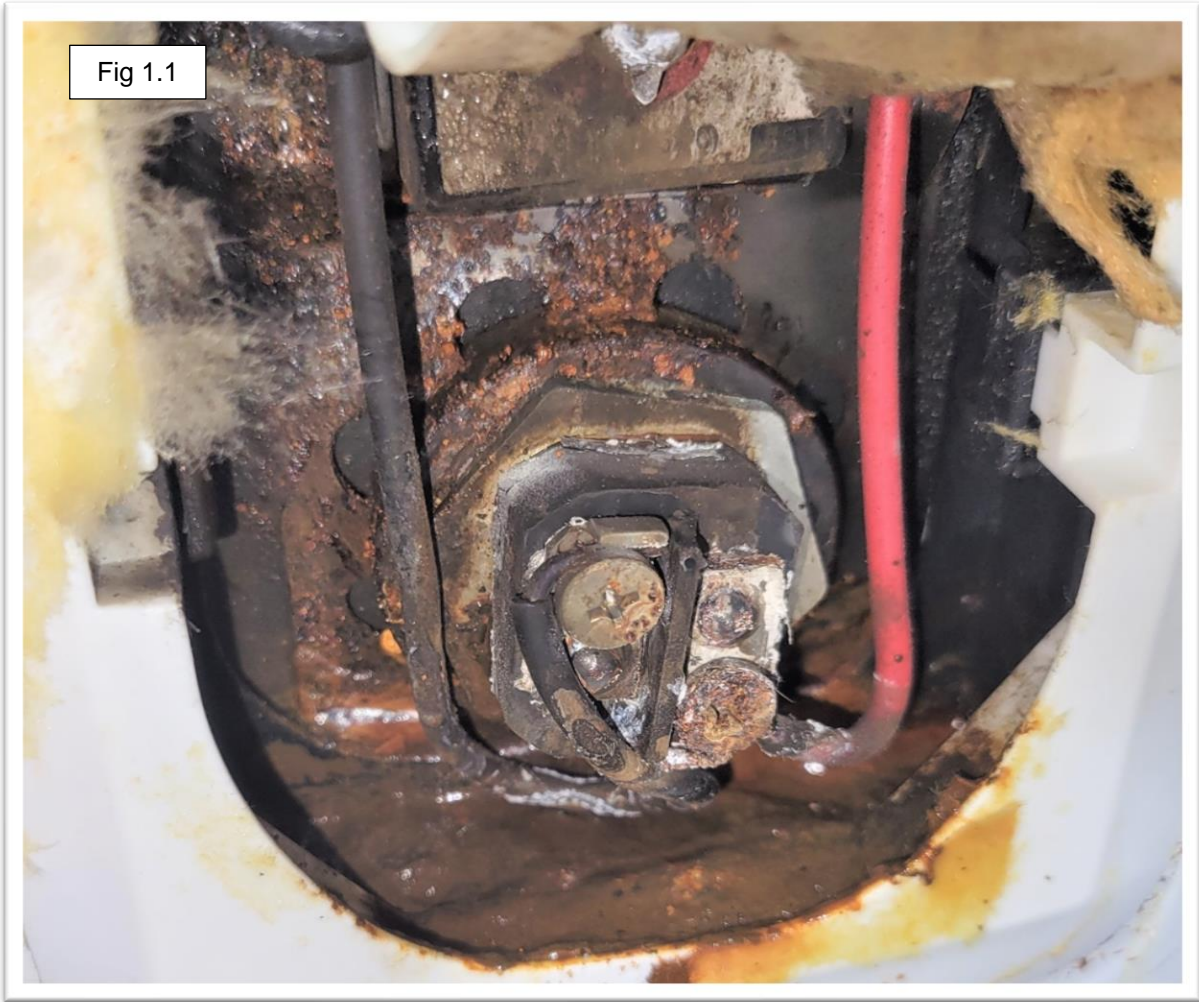
- **Water was leaking from the lower heating element which has caused damage to the tank, the insulation and the back side of the cover door. This will lead to significant damage and in the inspector's opinion it is highly recommended that a plumber inspect the water heating system and make the necessary repairs and or replacements. See Fig 1.1 on page 24.**
- Corrosion was present on the heating elements. Corrosion can lead to water leaks and other damage. In the inspector's opinion it is recommended that a licensed plumber make all necessary repairs.
- The safety pan did not have a drain that terminated to the exterior. This can allow for water damage to the ceilings, walls, floors, and other items.
- The electrical wires that enter the top of the tank were missing a grommet for protection.

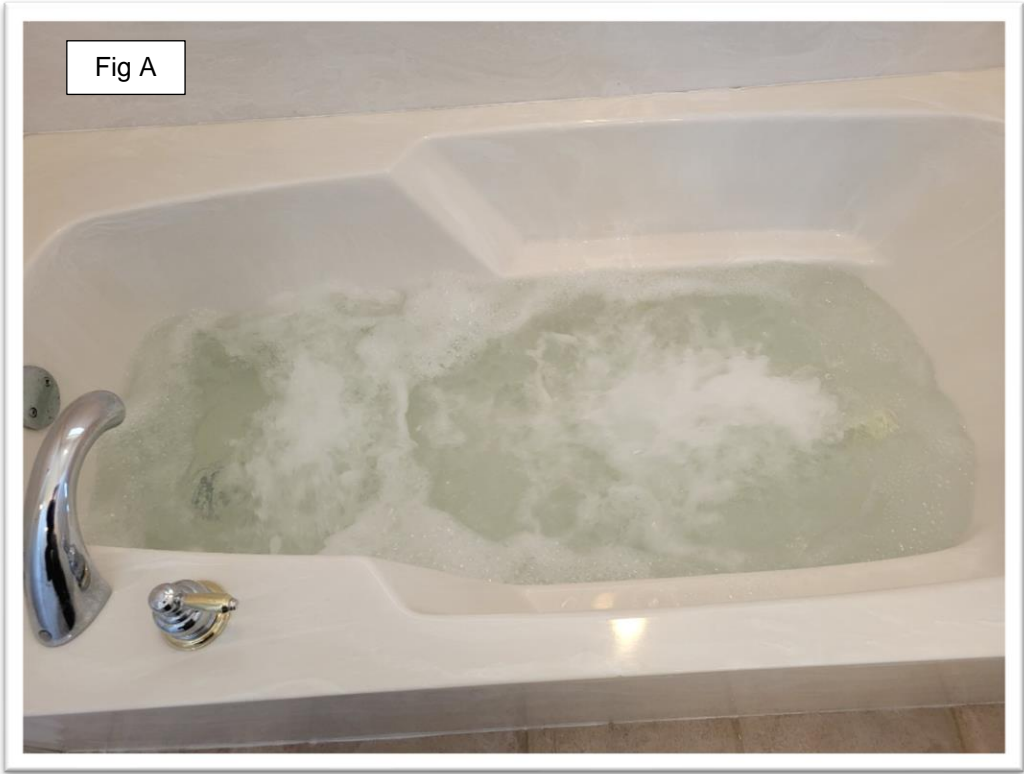
- There was no access to the underside of the tub to perform maintenance on the equipment.
- A GFCI (Ground Fault Circuit Interrupter) receptacle was not present for the tub.

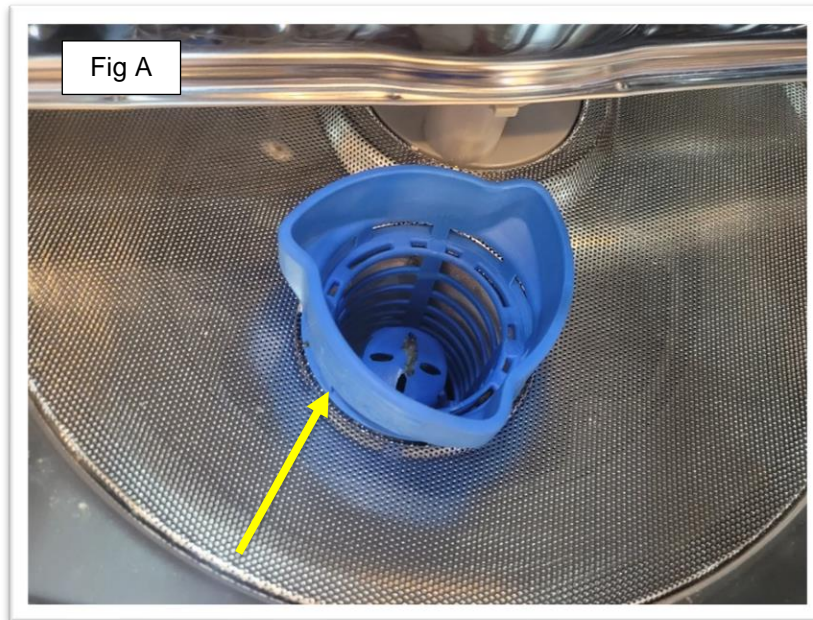
- The dishwasher was powered by the GFCI receptacle to the left of the range/oven. The GFCI also connects the two outlets to the right of the oven/range. In the inspector's opinion this should be separated and put on their own circuits.

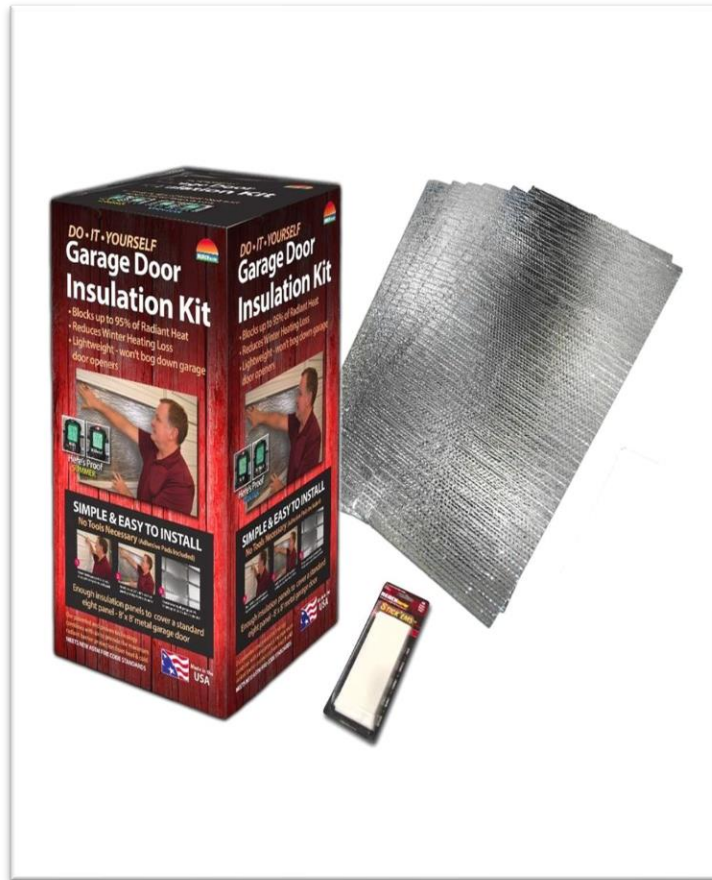
1. There were large bees' nest at the eaves around the perimeter of the home, for safety reasons they should be removed.
2. Insulating the garage door with a product like the product in the picture below will lower the temperature of the garage by up to 30 degrees. (This is not a professional endorsement for this product)
