PROPERTY INSPECTION REPORT

374 Citadella Court, Johns Creek, GA.

May 22, 2021

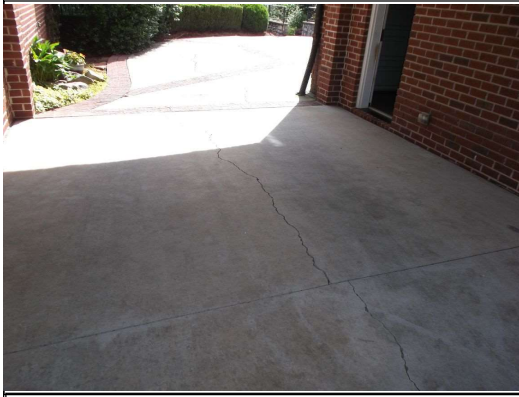
Moderate crack in driveway

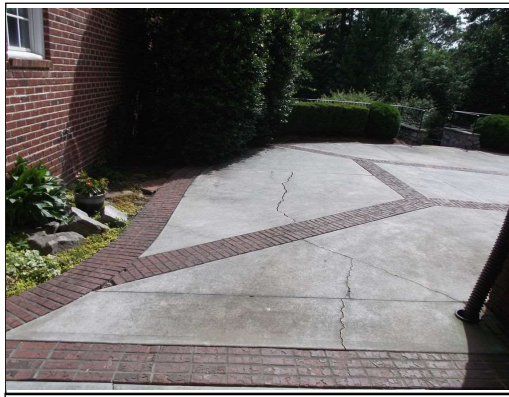
Driveway has moderate crack/slope to house

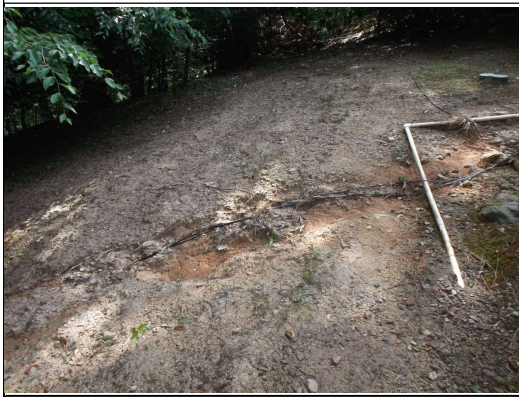
Missing ground cover & soil erosion rear yard

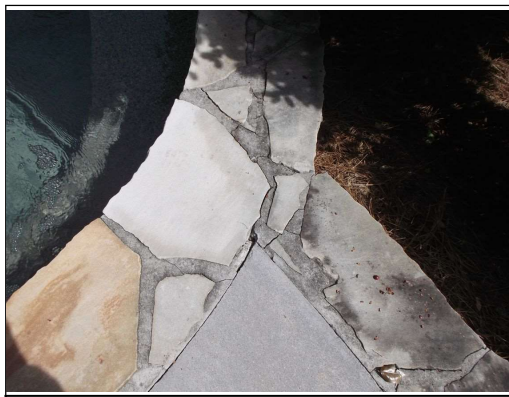
Missing mortar at pool stones

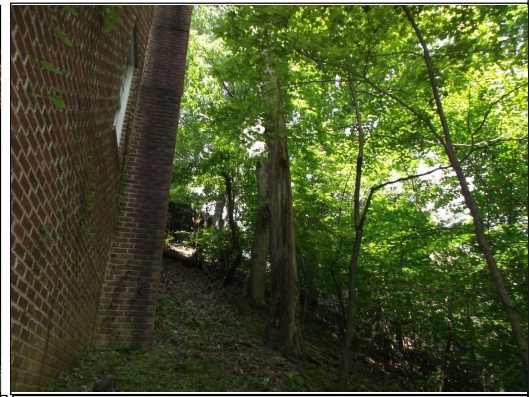
Dead tree left side of house

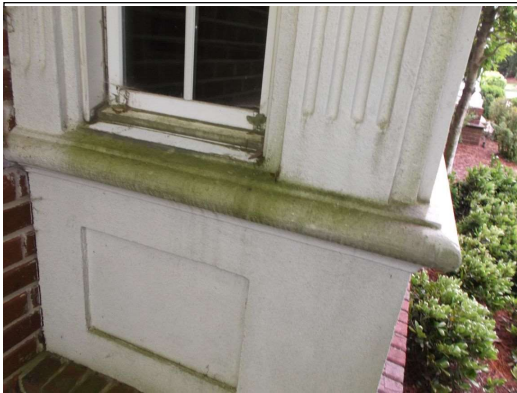
Movement crack/downspout detached/Algae

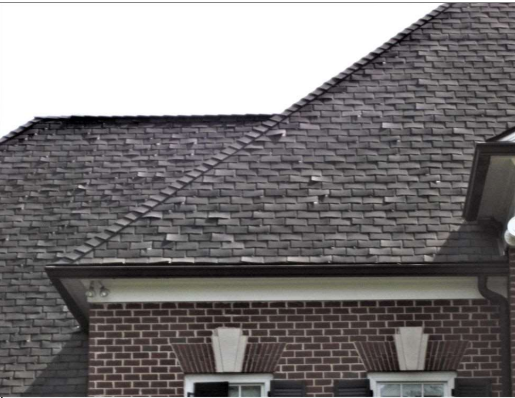
Shingles near end of use

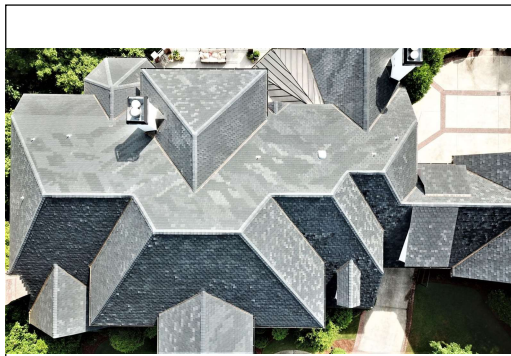
Defective shingles throughout roof system

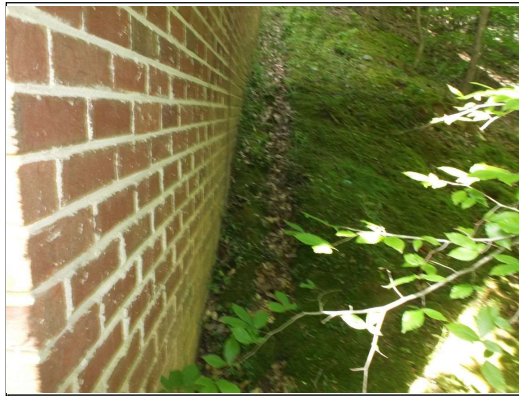
Soil erosion on left side of house no gutter

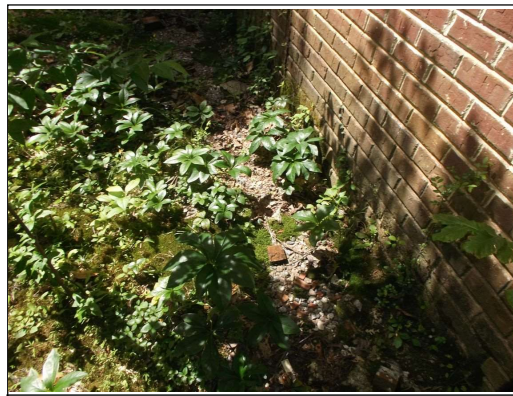
Soil erosion at the rear of the house no gutter

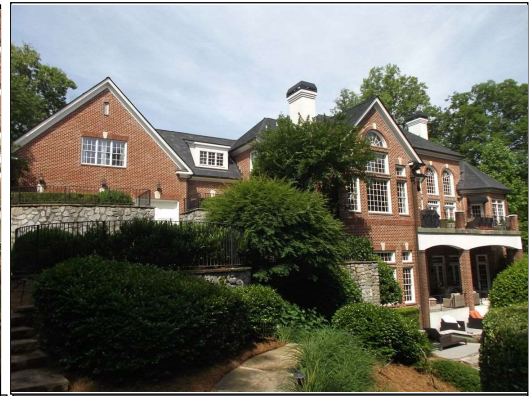
Shingles on rear roof lifting and curling

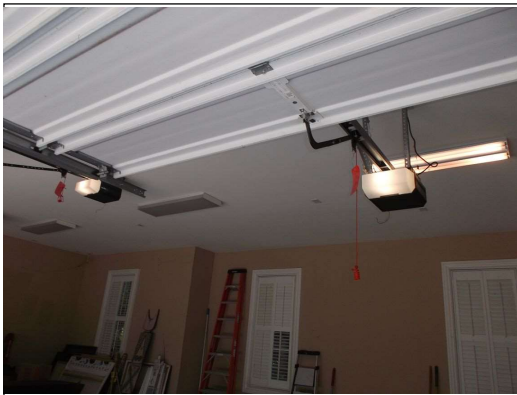
Lights not illuminating garage/globe missing

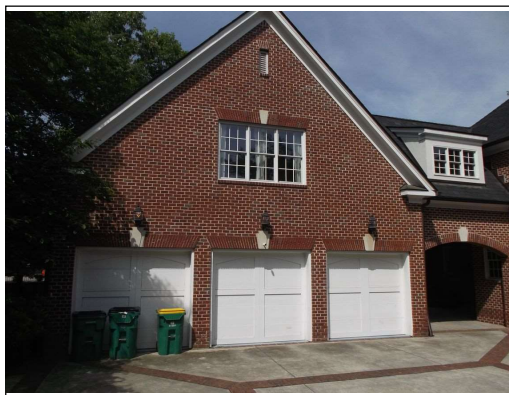
Verify all remote gate and door openers

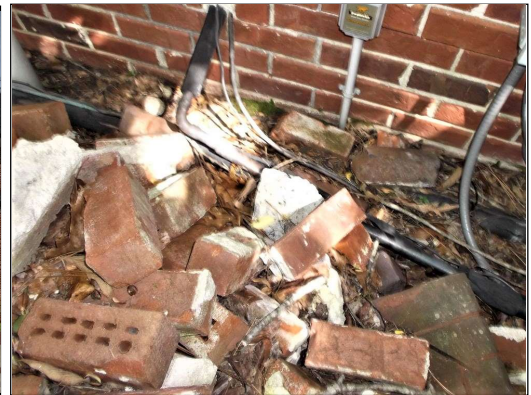
Bricks and debris on the side of the garage

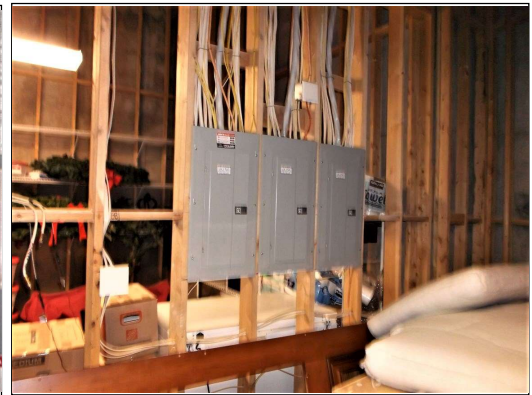
Basement panels blocked by belongings

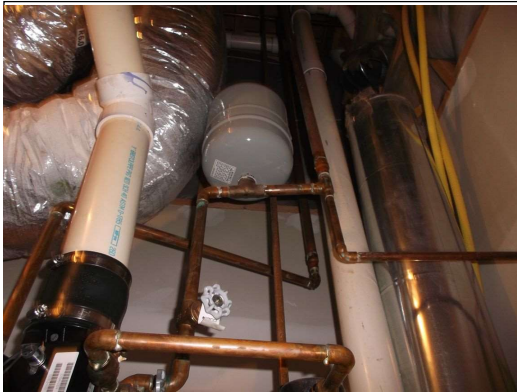
Expansion tank resting on pipe can damage

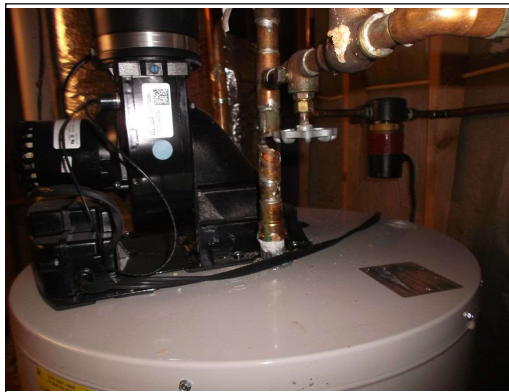
Copper & steel pipe join above water

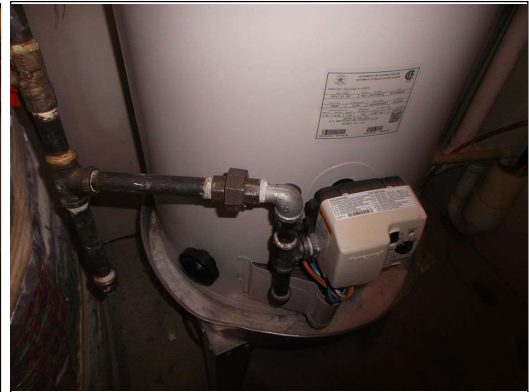
Water pipe elbow in gas pipe @ W/H

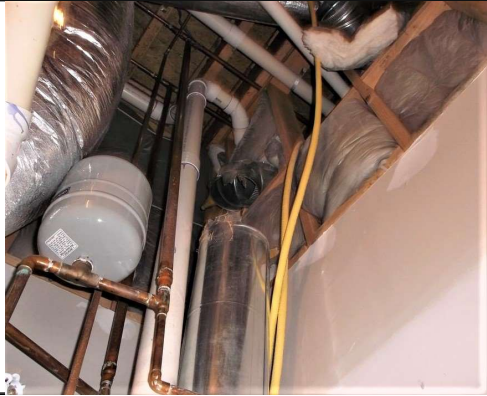
Makeup air duct section disconnected

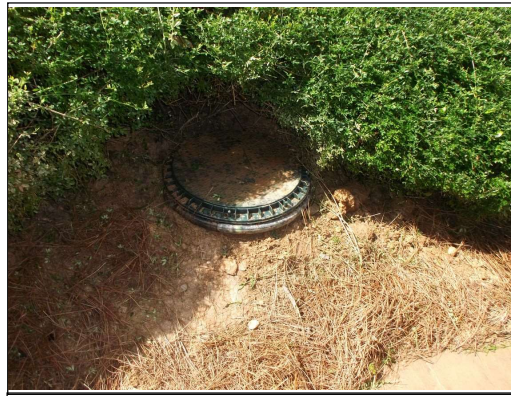
Verify if there is a septic tank at the rear yard

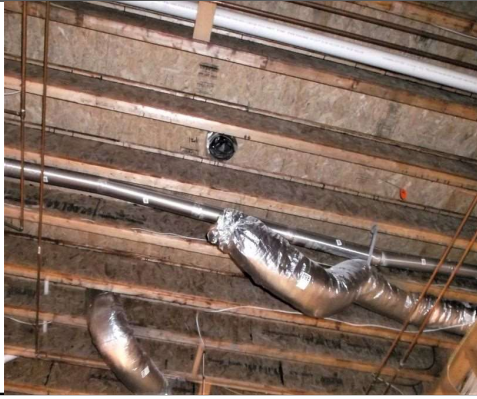
Air duct disconnected in basement ceiling

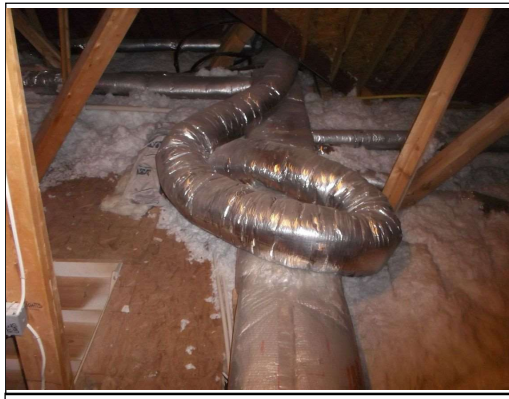
Air duct too long, too many turns

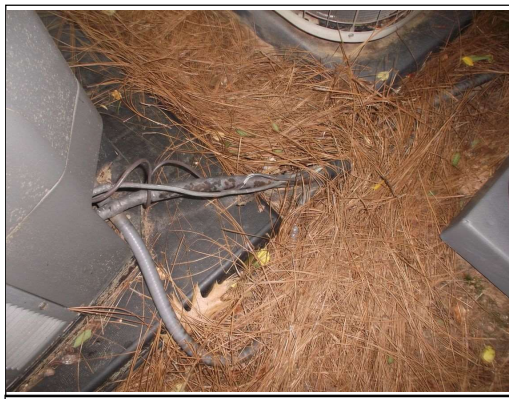
Refrigerant line insulation deteriorated and missing at the exterior at the AC units on the right side of the garage (all damaged, deteriorated and missing refrigerant line insulation shall be replaced);

Refrigerant line insulation missing

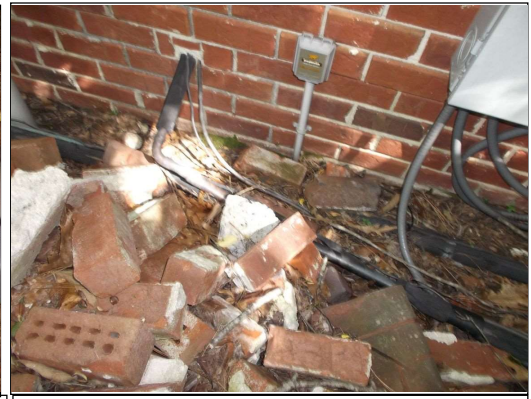
Refrigerant line insulation missing

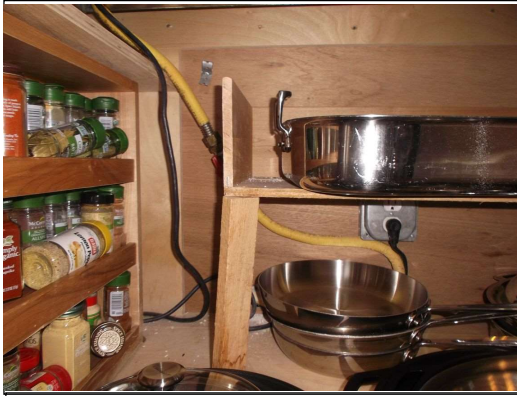
Cannot see a gas regulator valve in cabinet

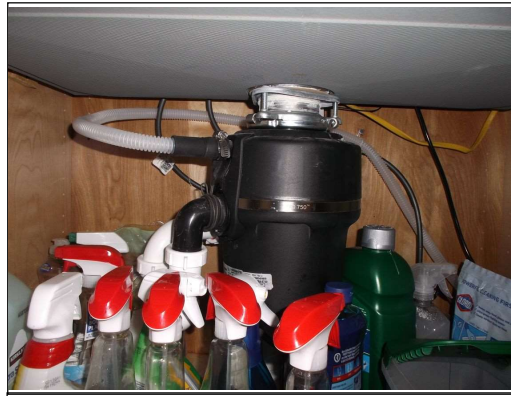
Dishwasher drain pipe not high looped up

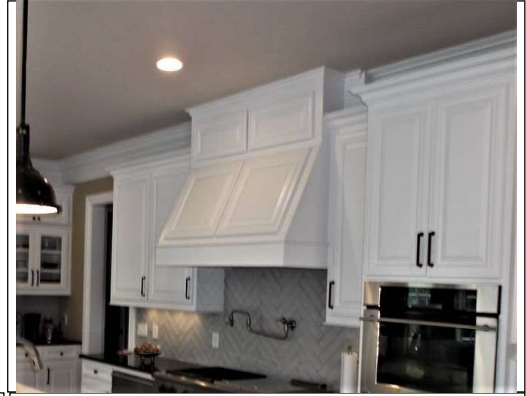
Exhaust hood makes slight mechanical noise

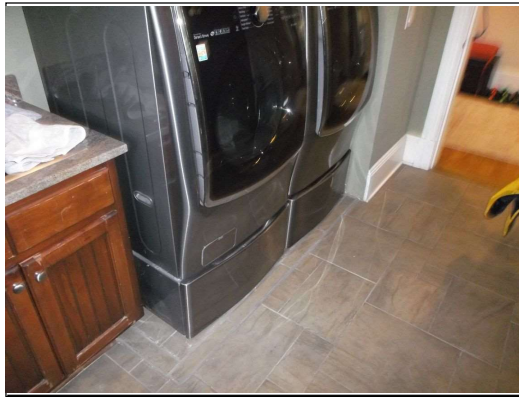
No washer drain pan installed

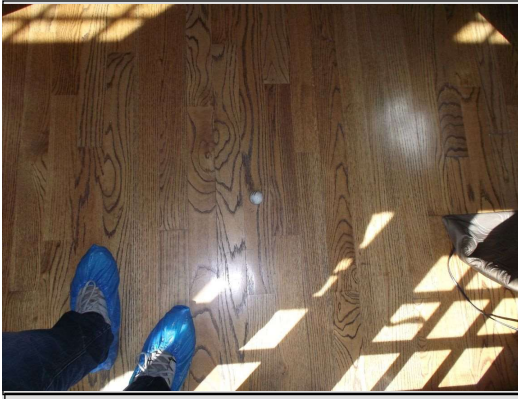
Greatroom floor slopes to the center of room

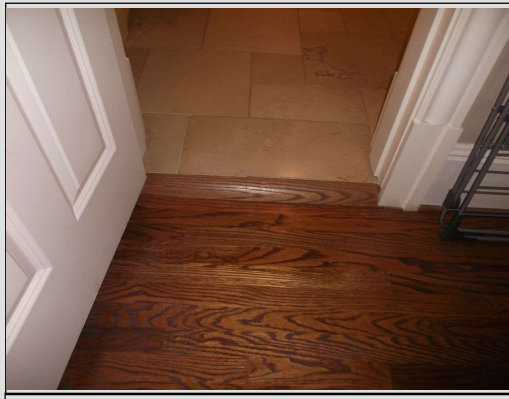
Master closet floor lower than bath floor

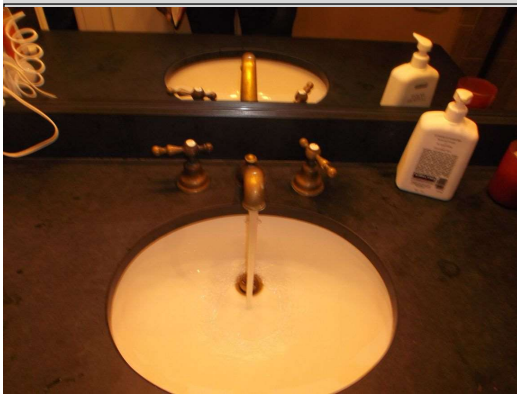
Air noise when water flowing

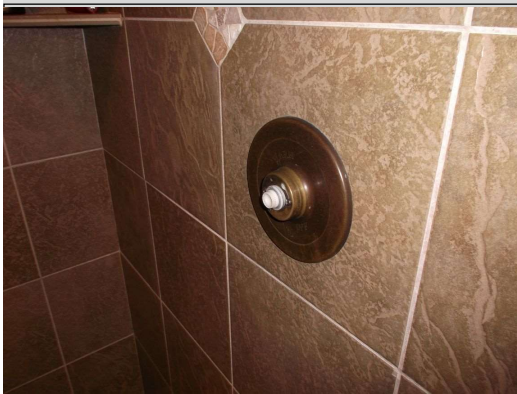
Shower faucet handle and fittings missing

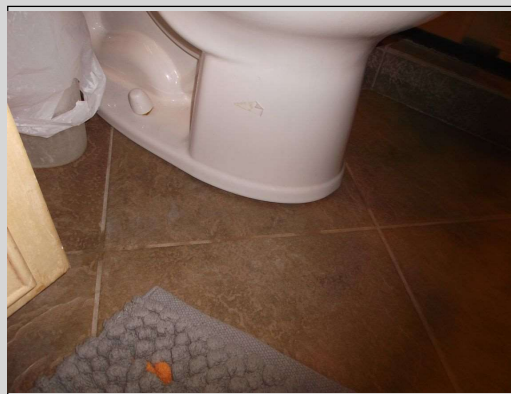
Missing caulk at toilet on the floor tile

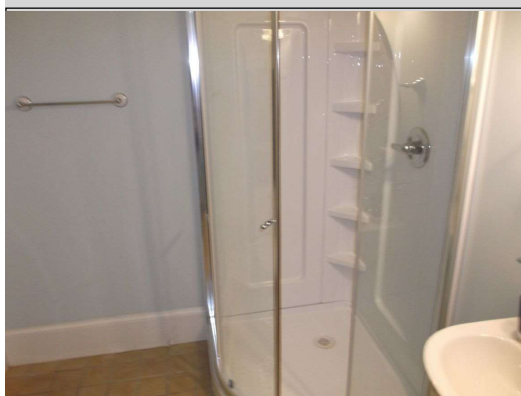
Shower door defective opening and closing

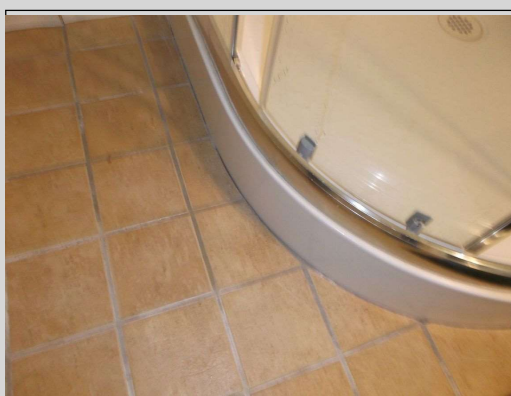
Missing caulk at the shower base and tile

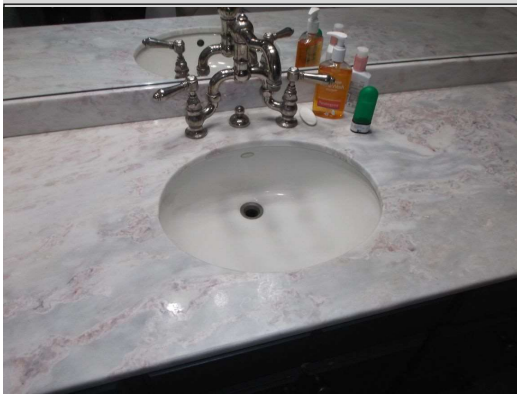
Sink stopper missing

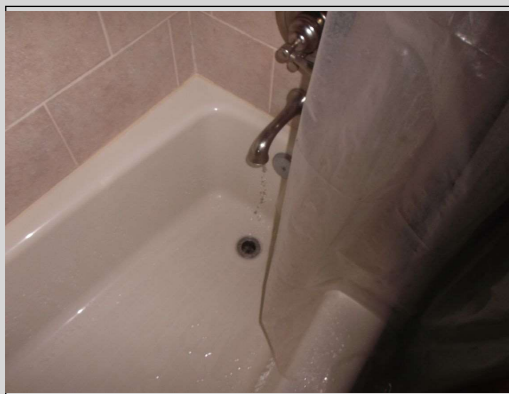
Tub stopper missing

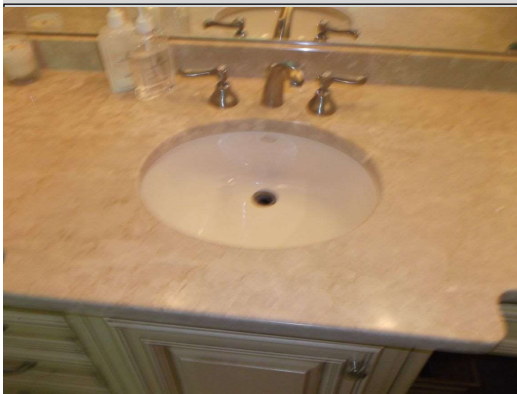
Missing sink stopper at left sink

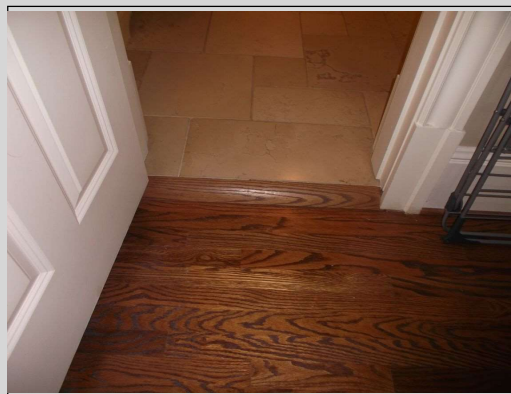
Bath floor higher than closet floor

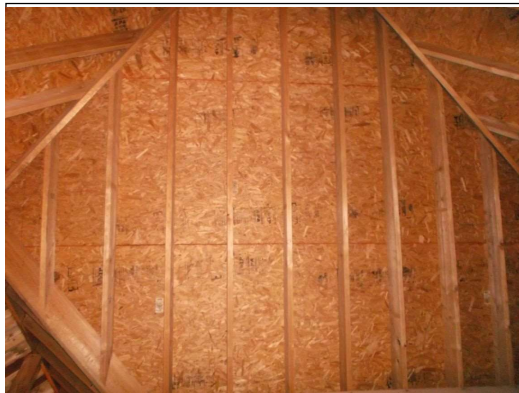
Missing spacer clips between OSB or engineered structural board panels for roof decking (spacer clips create a air gap between each OSB panel for expansion or swelling, where there is no space between panels for expansion panels can push against each other and bulge under certain conditions);

Missing ply board spacer clips between panel

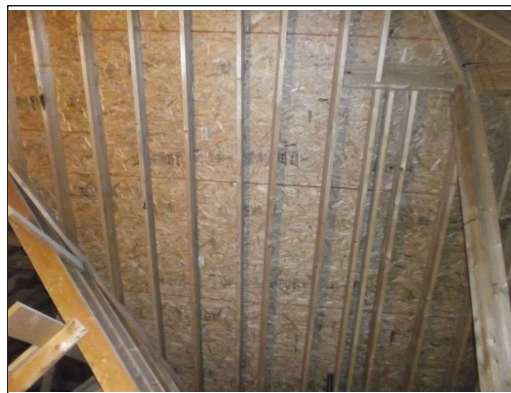
Missing spacer clips between panels

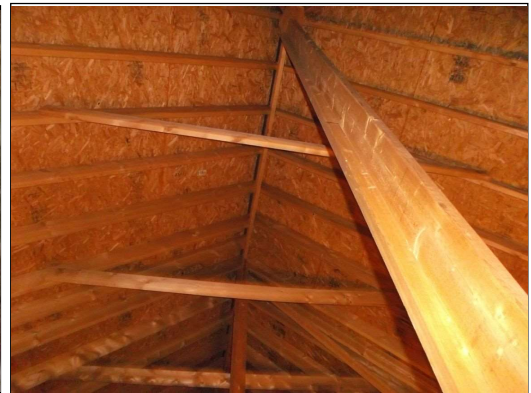
Roof ridge ply board not cut wide enough

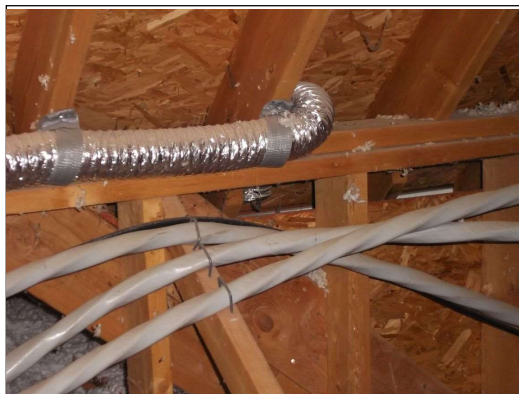
Bath fan duct exhaust into the attic

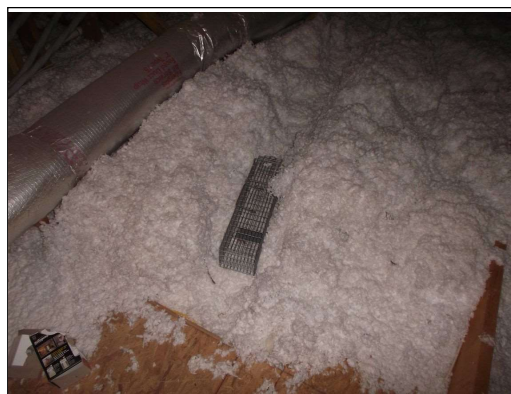
Rodent trap placed in the attic
