# Property Inspection Report

680 Trinity Place, Suwanee, Ga. 30024

Apr 12, 2021

1599

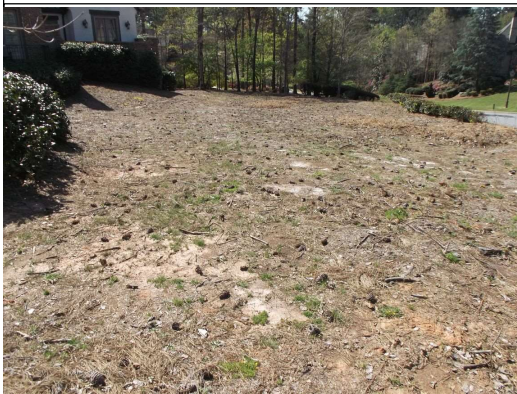
No ground cover soil erosion protection

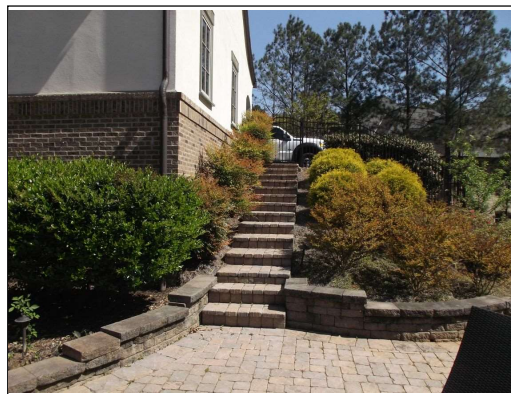
No handrail at rear yard stairs

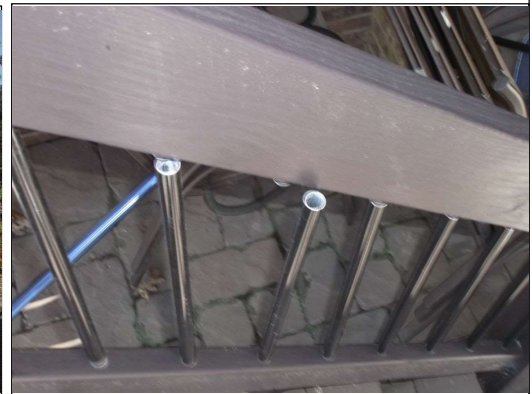
Balusters detaching from stair railing

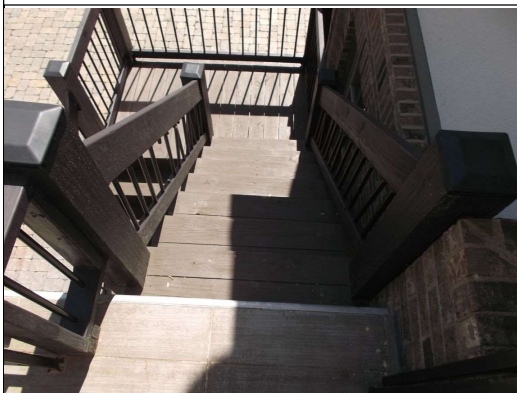
**Comments** Rear deck stairs steep, rear deck stairs poorly bearing on main deck floor, rail guards detaching and missing handrails;

Deck stairs too steep & missing handrails

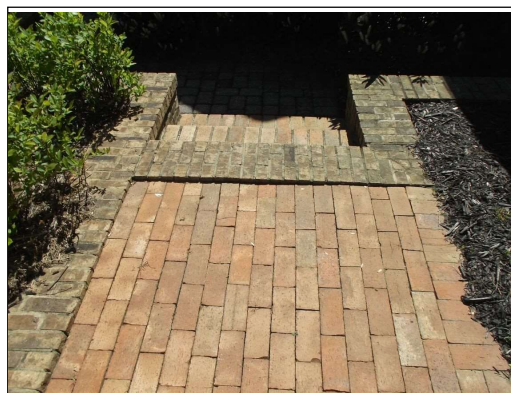
**Comments** The brick pavers at the left side of the house has settle some and have trip hazards where sections meet;

Trip hazard at walkway and steps brick

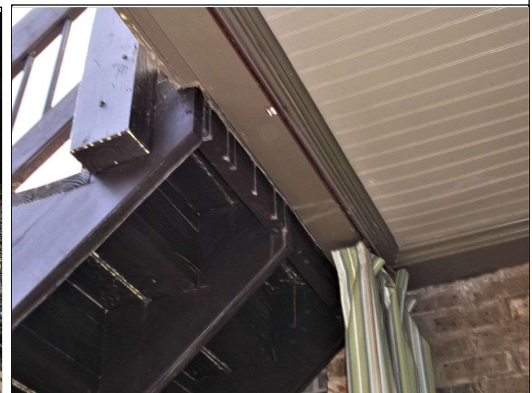
Rear deck stairs are poorly bearing on rim

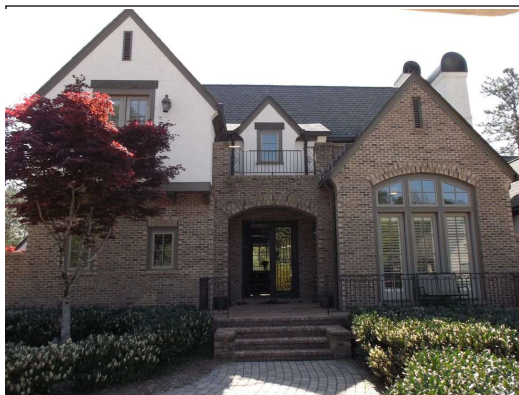
Front balcony settles to the left

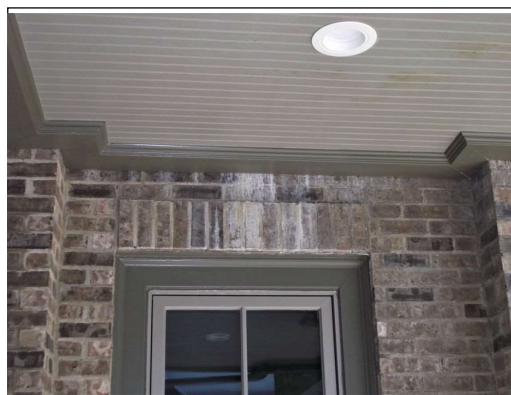
Calcium deposits on brick at lower patio

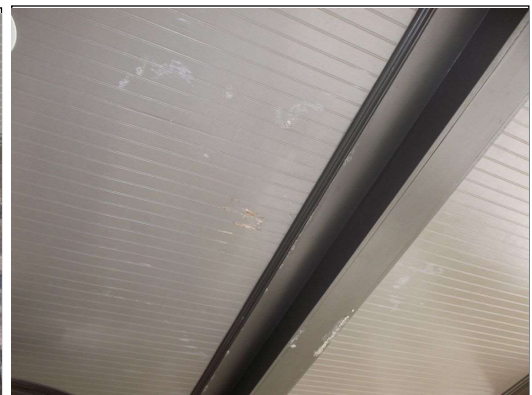
**Comments** Based on stains in the patio ceiling the main deck floor may be allowing water to leak through and onto the ceiling below

Possible water intrusion at patio ceiling

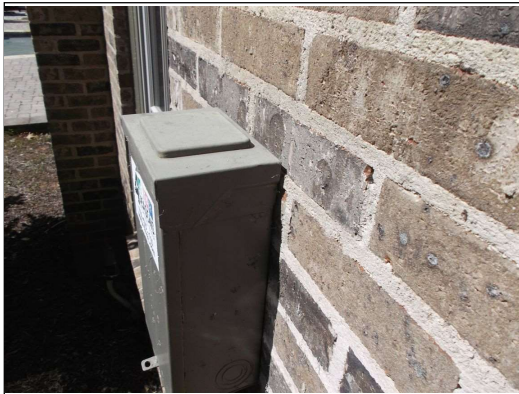
Missing bead of caulk over electrical boxes

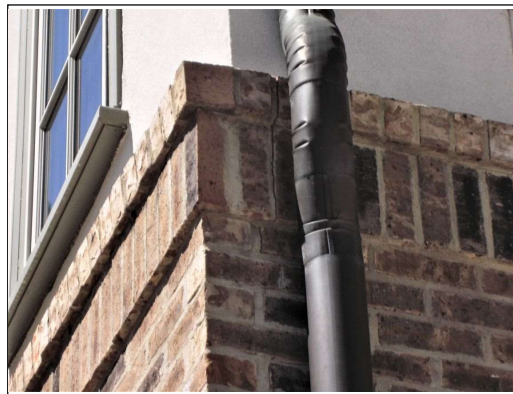
Movement crack at brick at rear brick corner

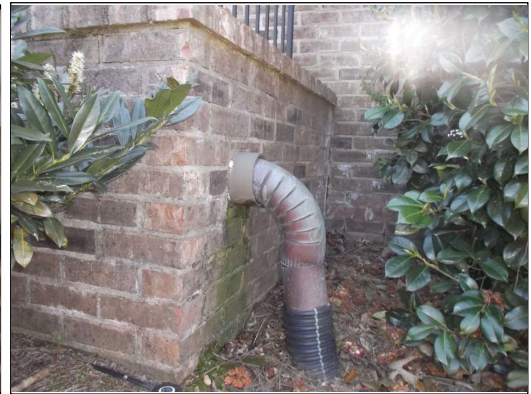
Drain pipe leak at side of front patio

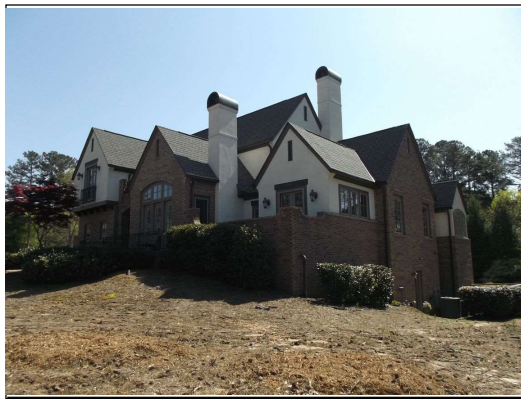
Front chimney leans to the left

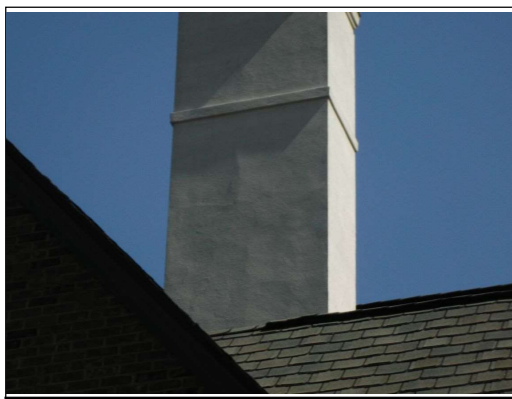
Bulge cracks in chimney stucco

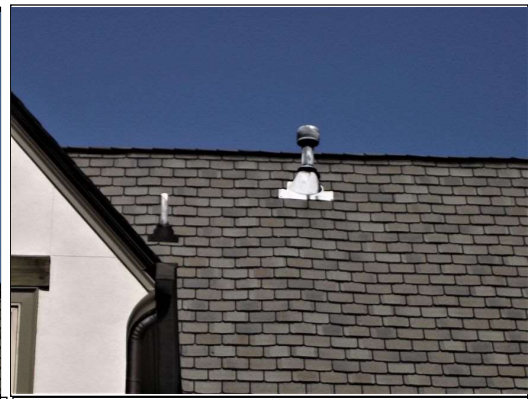
**Comments** Roof humps visible in the roof deck at the rear main roof caused by rising rafters at the humps

Humps in roof deck/pipe flashing face nailed

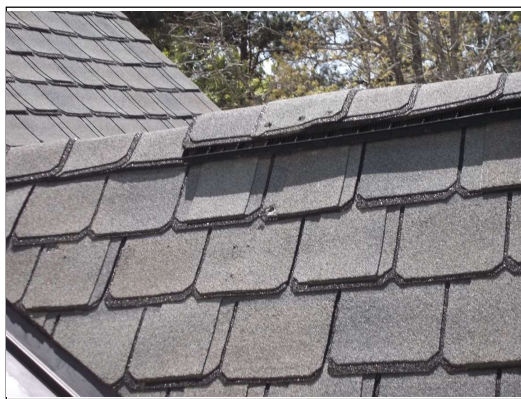
Holes in in roof shingles seen from bed

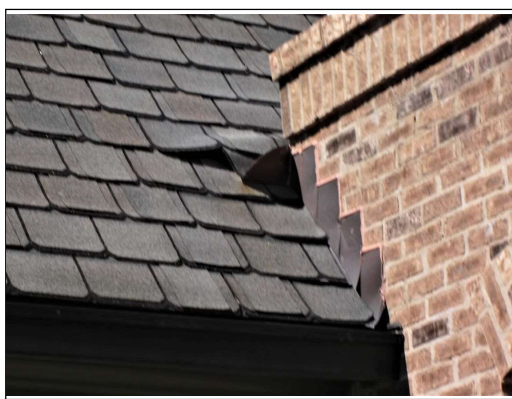
Roof-to-wall flashing lifting at rear of house

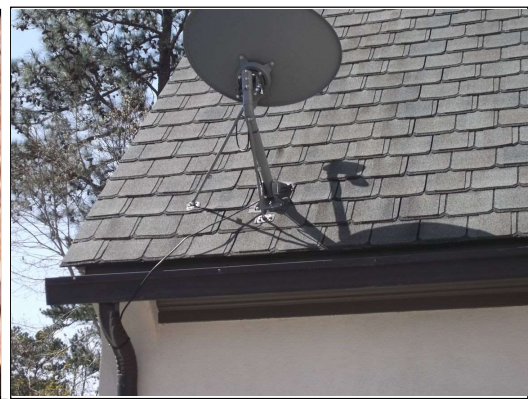
TV dish bolted to the roof at the rear of house

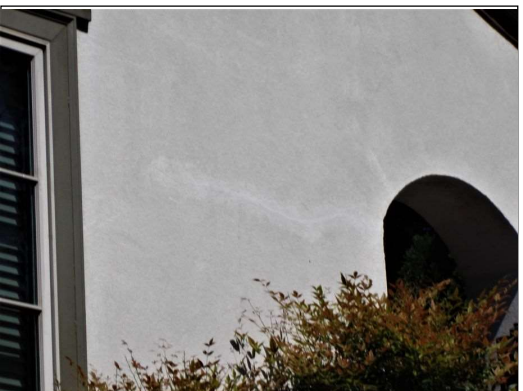
**Item to Monitor:**  
 Cracks in the stucco wall at the right side of the garage (rear yard side);

Cracks in stucco filled and painted

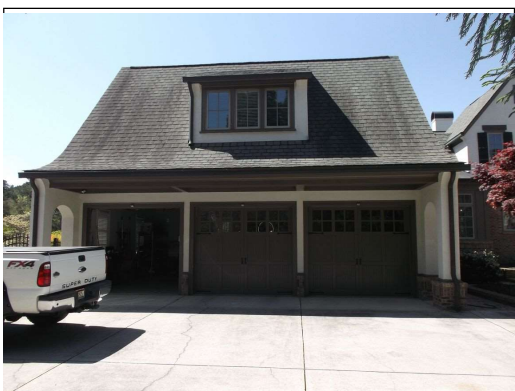
Gutter sagging over vehicle doors

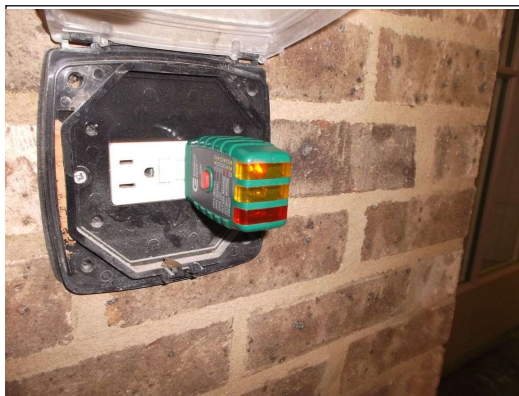
Lower patio ext. outlet tested open ground

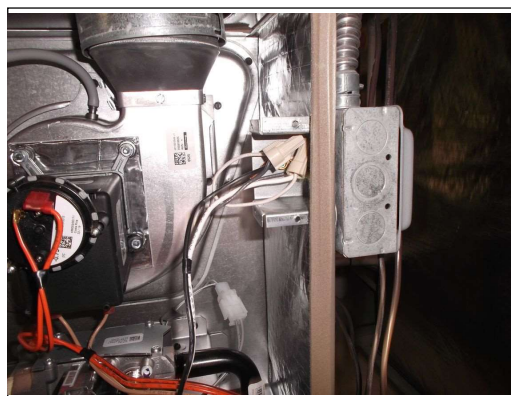
Open junction box in basement furnace

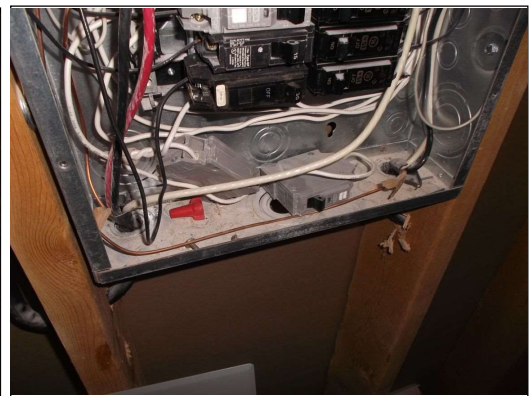
Hole in the bottom of distribution panel

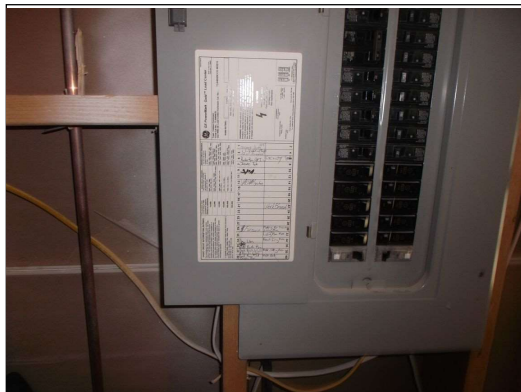
Basement panel directory missing breaker list

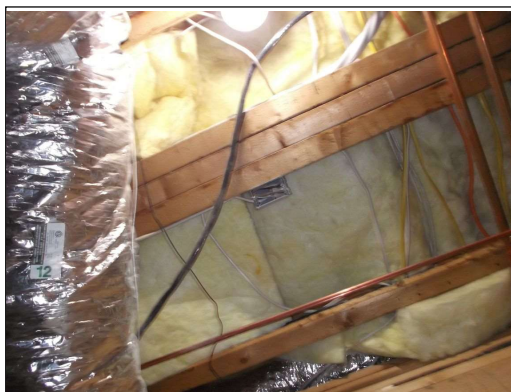
Open junction box in utility room ceiling

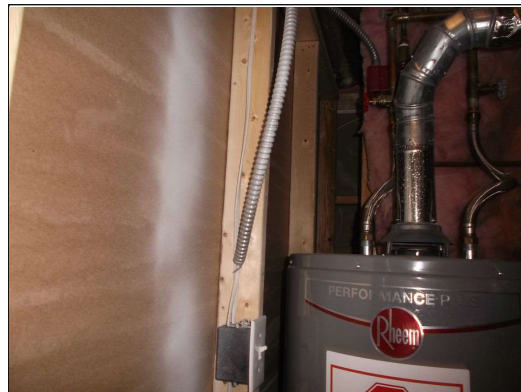
Electrical cable stapled instead of conduit

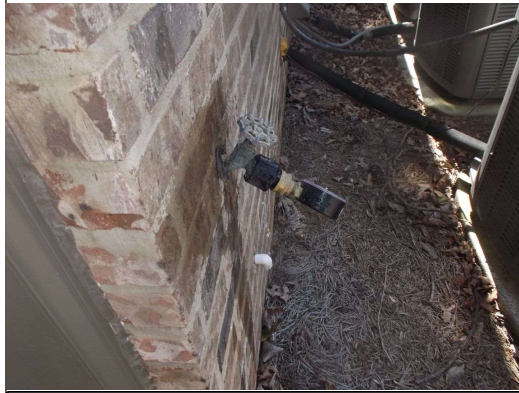
Hose faucet at right side leaks at handle

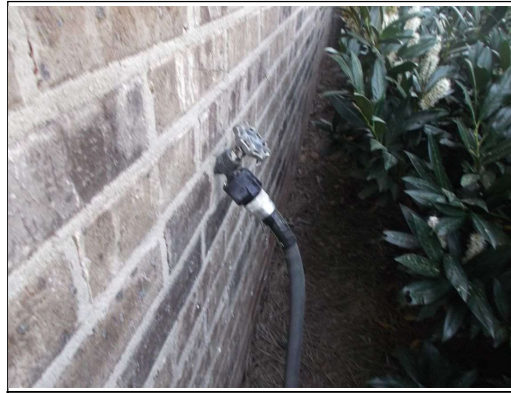
Hose faucet leaks at handle left side of house

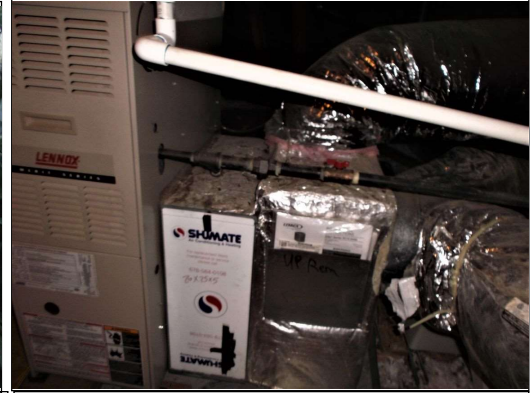
Improper sediment trap @ gas pipe to furnace

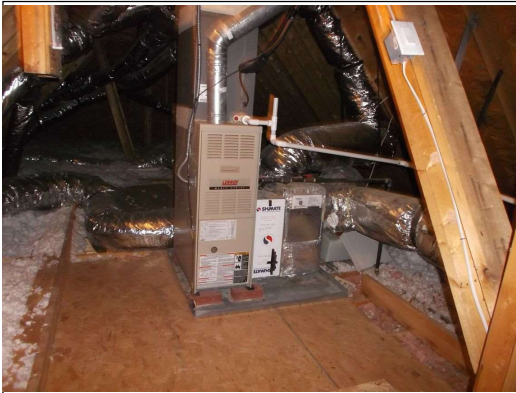
Attic furnace older model

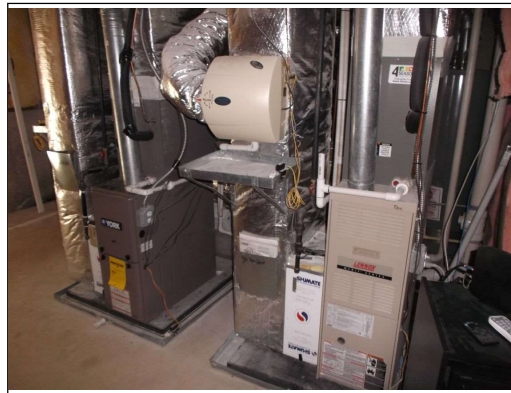
Utility room furnaces one older model

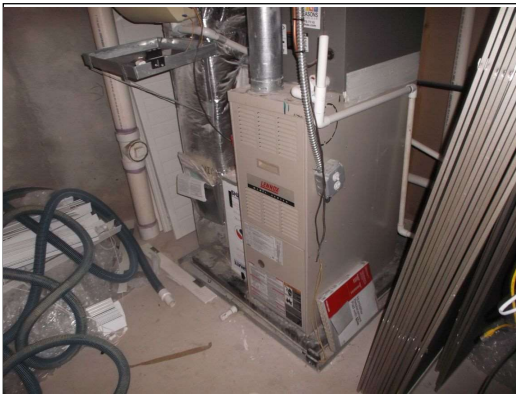
Other utility room furnace older model

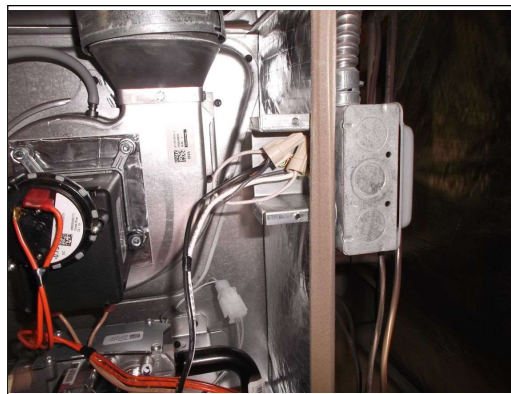
Open junction box @ 2nd utility room furnace

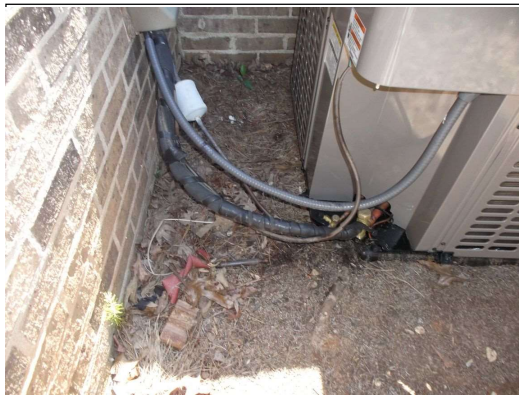
Refrigerant line insulation deteriorated

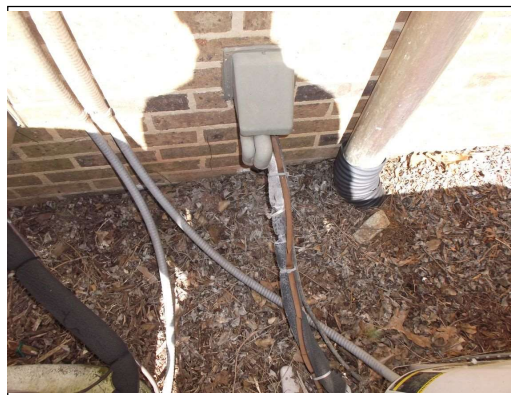
Condensate pipes pour at foundation

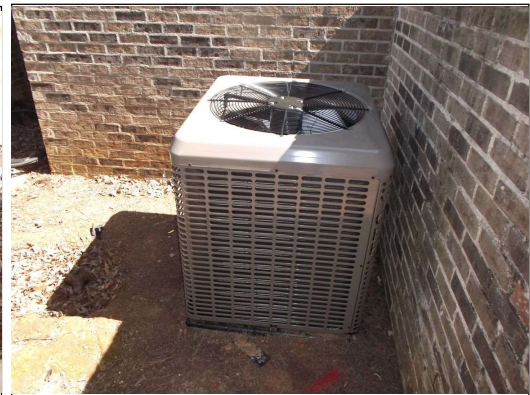
Poor clearance around at AC

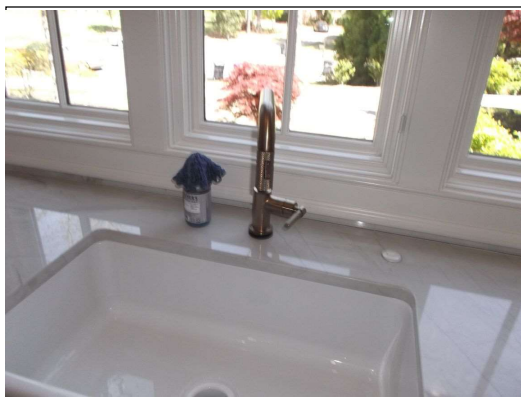
Sink faucet loose at the base

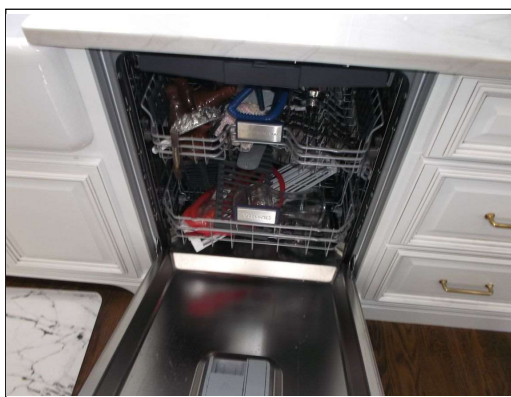
Belongings in dishwasher/not operated

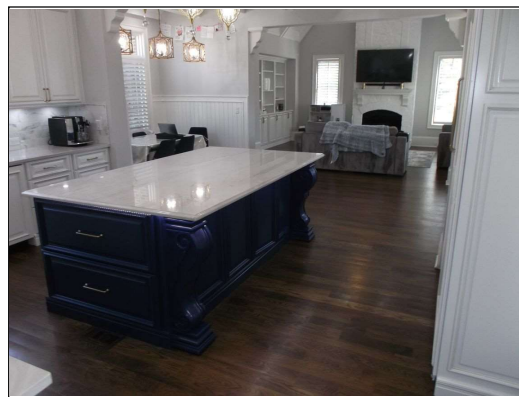
Kitchen floor settling at island

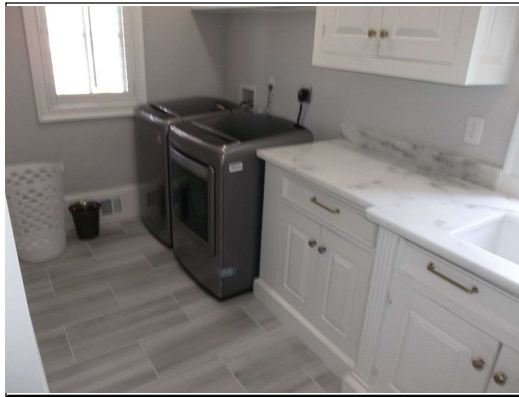
No washer drain pan installed

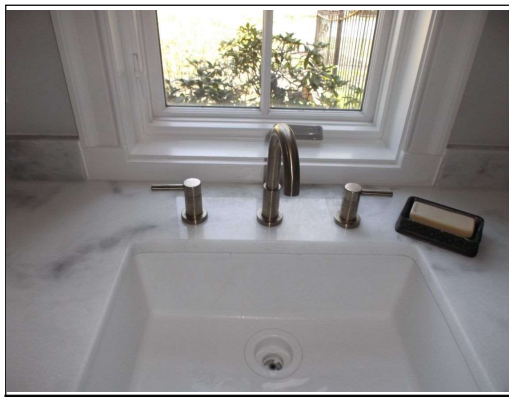
Sink faucet loose at the base

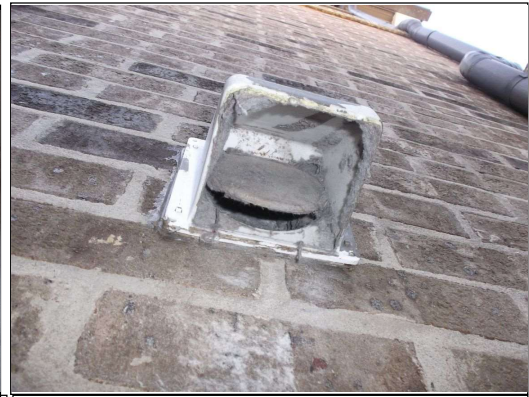
Dryer terminal door stuck open &amp; lint debris

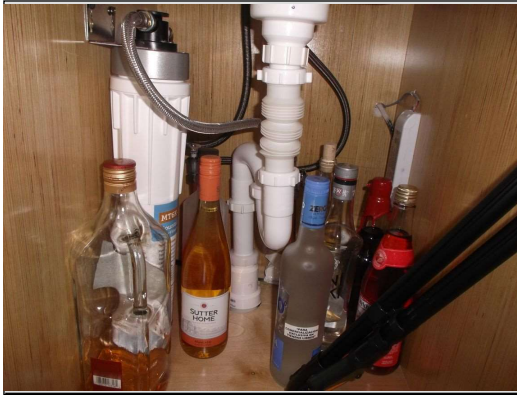
S-Trap under bar sink

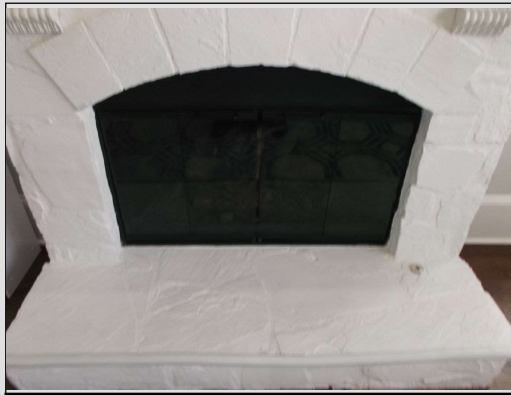
Fireplace doors defective

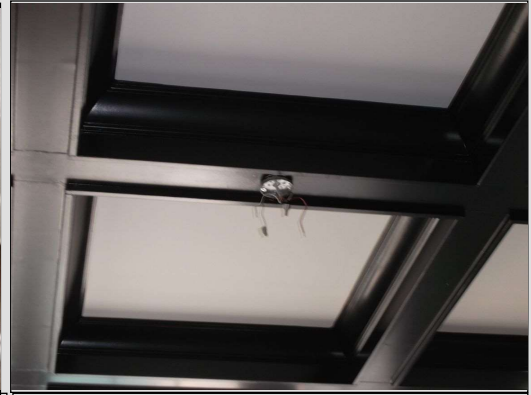
Missing light fixture at parlor

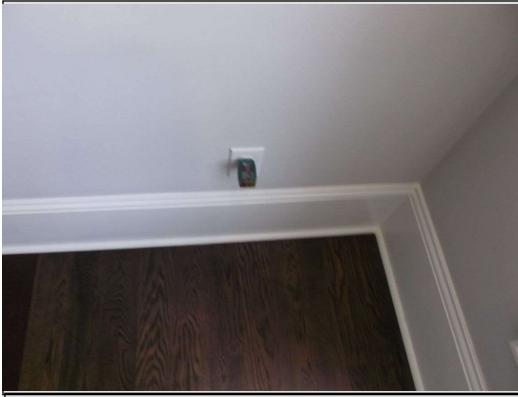
Outlet not energized at the stairwell

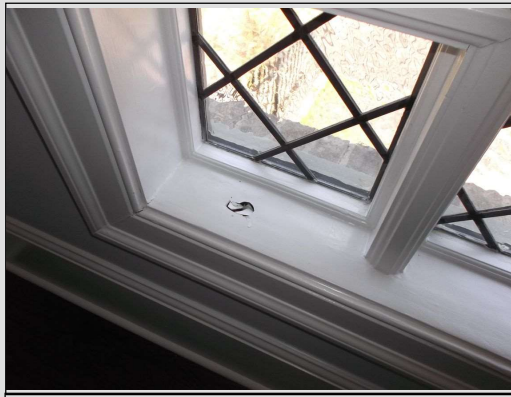
Window seal dry rot, water damage, termite?

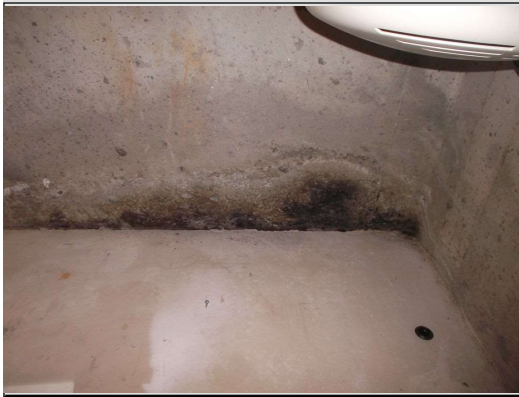
Stains on wall at utility room side of house

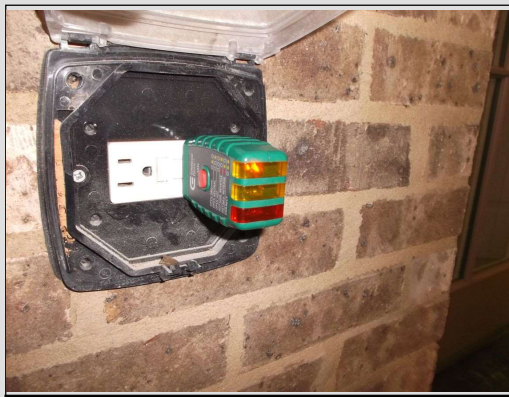
Basement patio outlet tested open ground

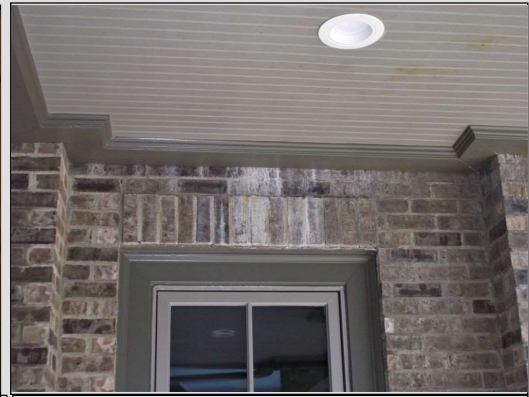
Calcium deposits on basement patio brick

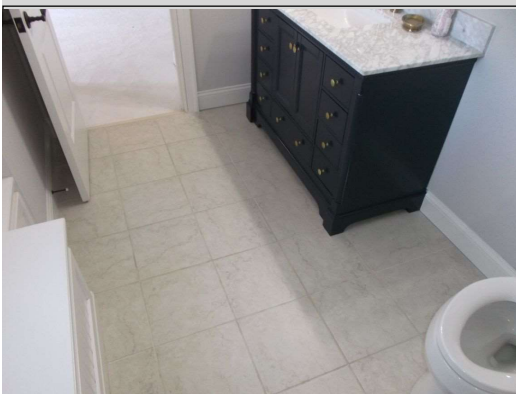
Baby bedroom bath floor slopes to the sink cabinet;

Baby bed bathroom floor slopes to sink

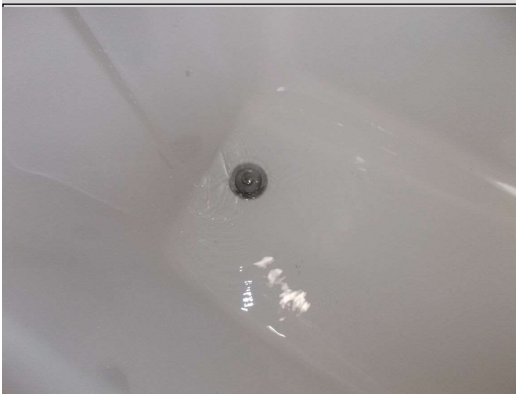
Tub drain outlet has corrosion

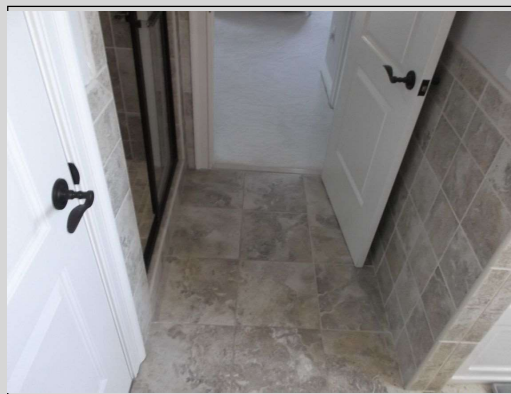
Bath floor slopes to doorway

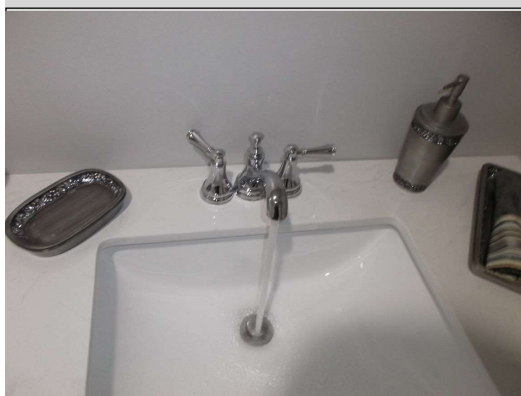
Sink faucet handles keep turning

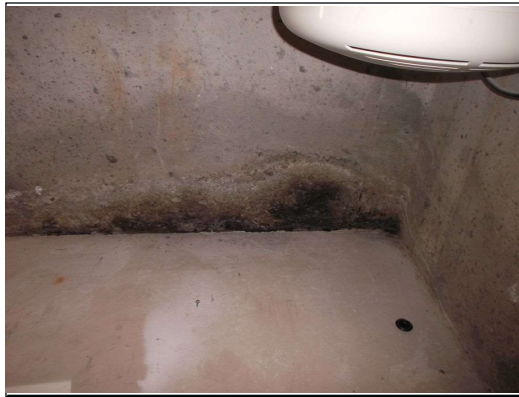
Stains inside the basement wall

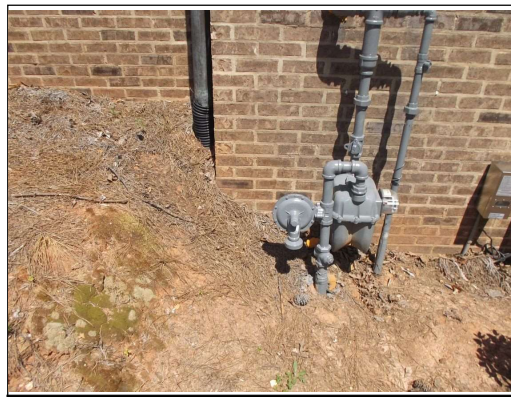
Area outside the basement wall near stairs

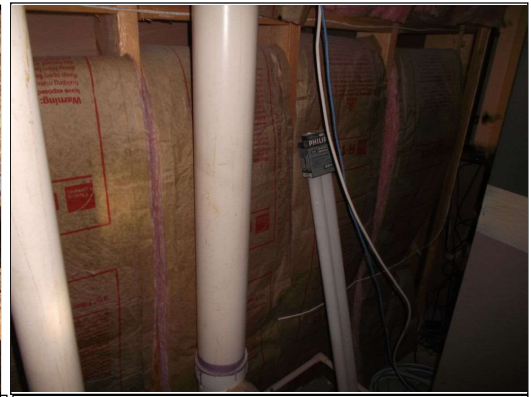
Insulation installed backwards at utility room

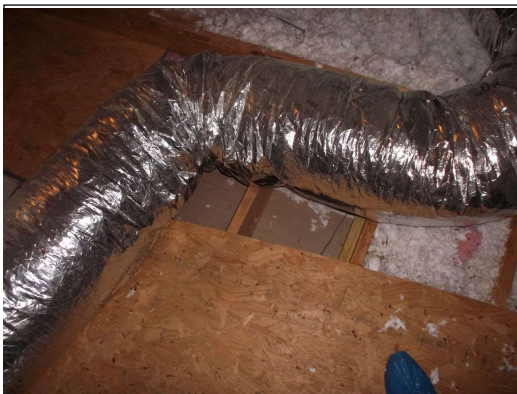
Missing ceiling insulation behind furnace

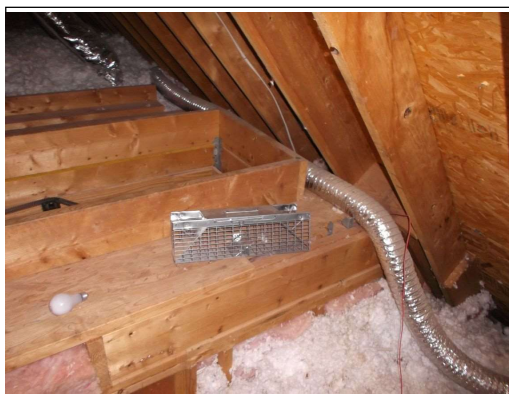
Rodent trap in attic

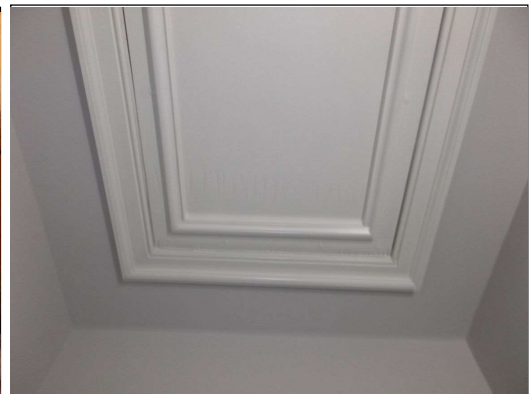
Paint blistered at pulldown attic door
