PROPERTY INSPECTION REPORT

1372 Gates Cir. SE. Atlanta, GA

May 25, 2021

1599

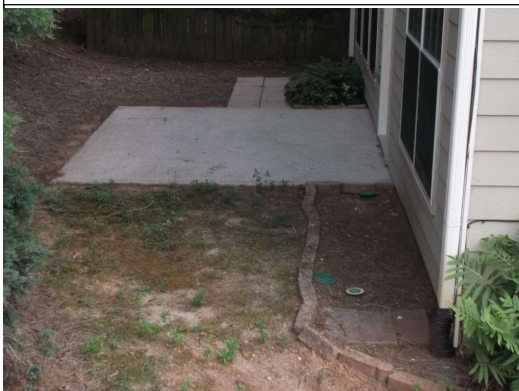
Soil has poor slope away from the rear of the building and at the utility room door entry may cause standing water and water to pond during heavy rain and long rain (soil grade should have a grade slope of 6 inches away for the first 10 feet away from the foundation on all sides); excessive bushes growing into the rear yard usable area;

Poor soil away from the foundation

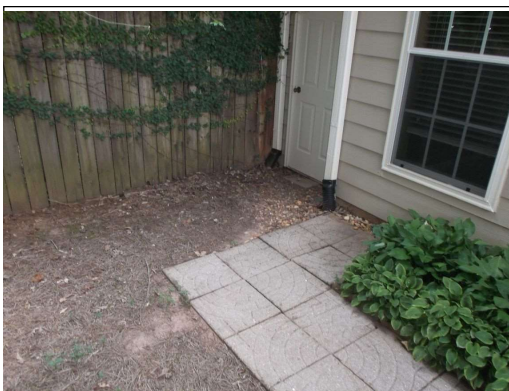
Poor soil slope away from the utility room

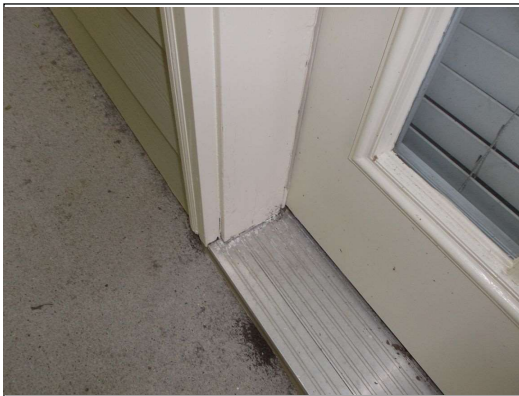
Water damage to rear door frame

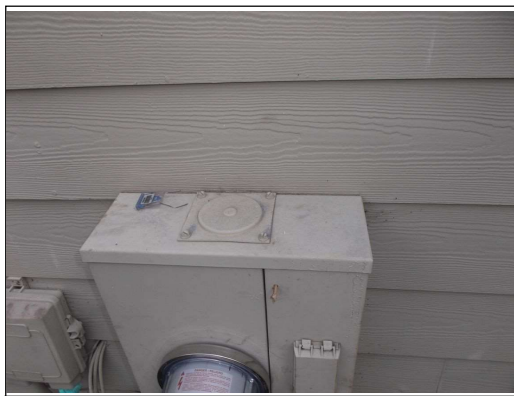
Missing bead of caulk over electrical boxes

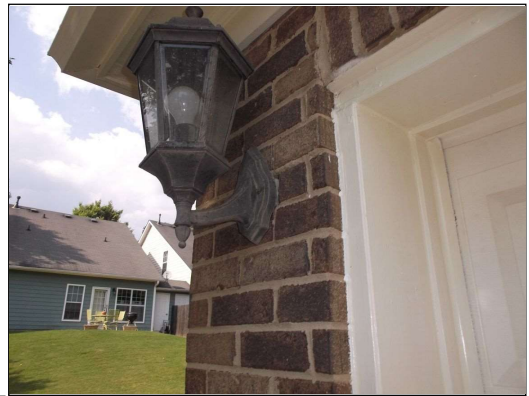
Missing bead of caulk around light on walls

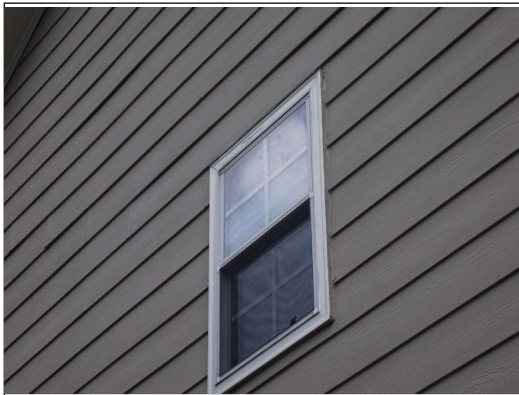
Window fogged at the left side of house

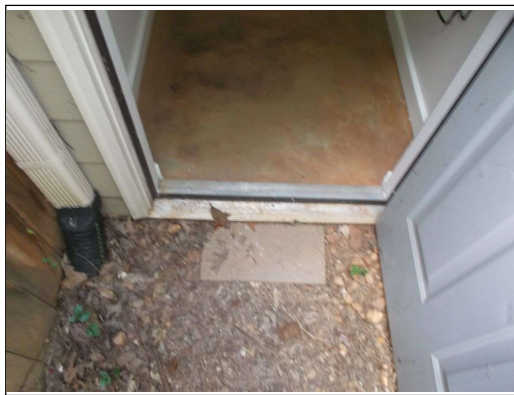
Utility room door threshold not supported

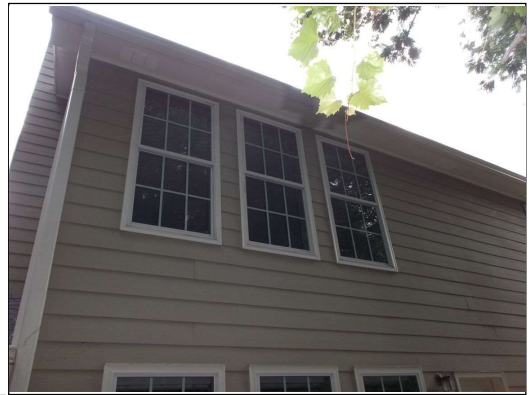
Missing screens at the rear windows

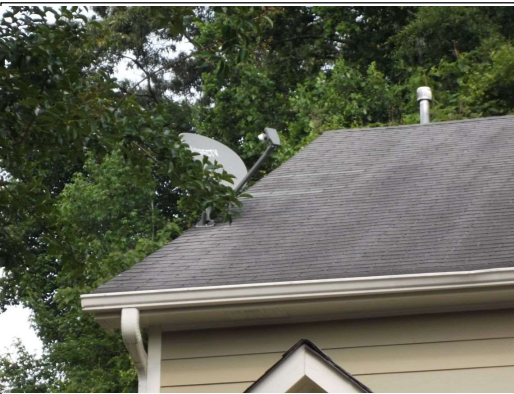
TV dish bolted to roof can cause leaks

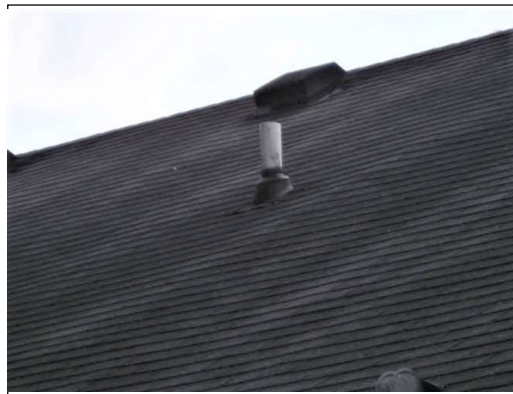
Plastic pipe flashing on top shingles face nailed

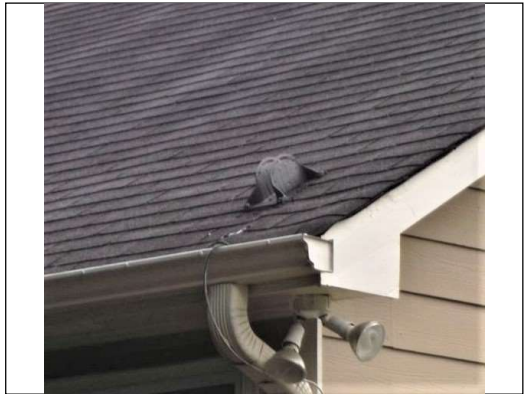
TV dish bracket bolted to the roof

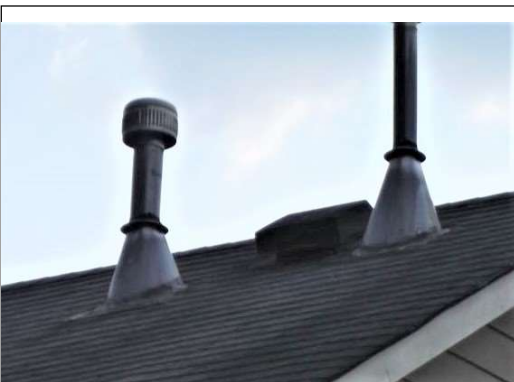
Metal flashing on top shingles face nailed

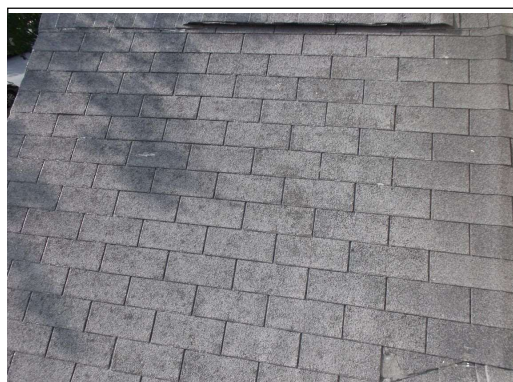
Shingles worn and show deterioration

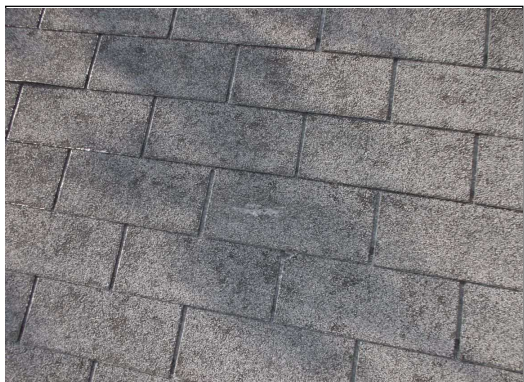
Shingle damage

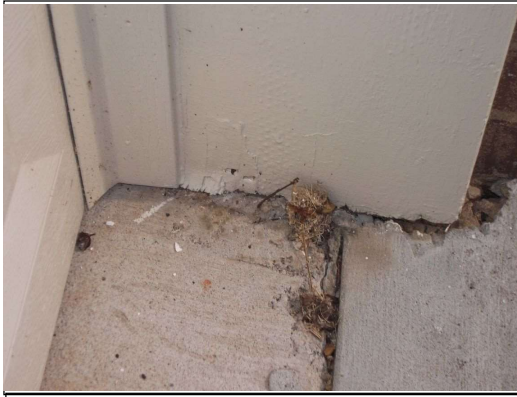
Water damage at the vehicle door frame

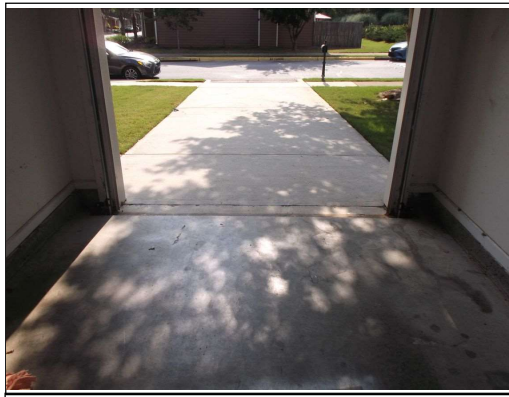
Vehicle door sensors needs adjustment (door would not come down unless hold the wall button, has to press the wall opener button 2 times to let the door up and door stops if the button is released when letting door down); the door opener rear light did not illuminate as the vehicle door was opening; ceiling light did not illuminate when switched on (no bulb in place); water damage to vehicle door frame at the bottom on the left side;

Door not letting up and down properly

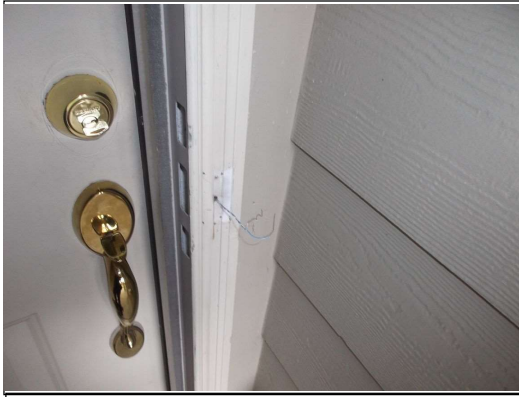
Doorbell button missing

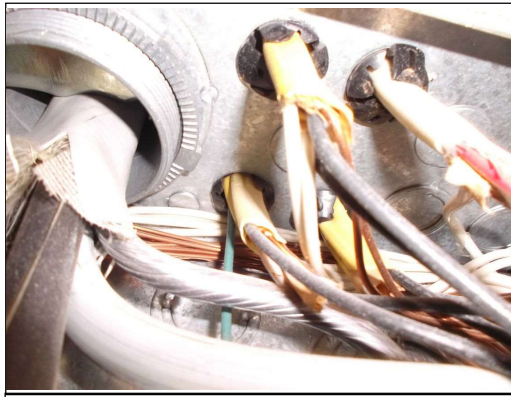
Electrical cable rub sharp metal at hole

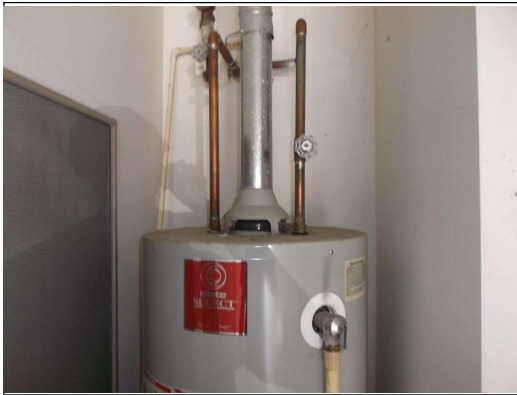
No expansion tank above water heater

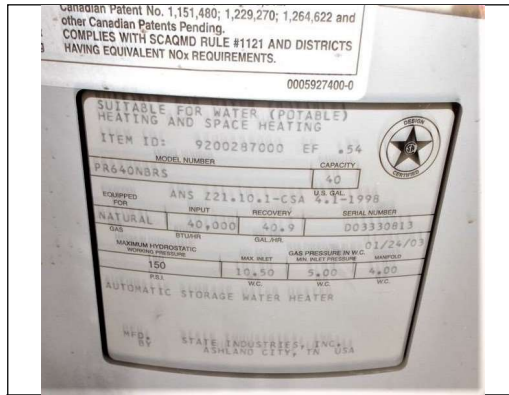
Water heater date 2003

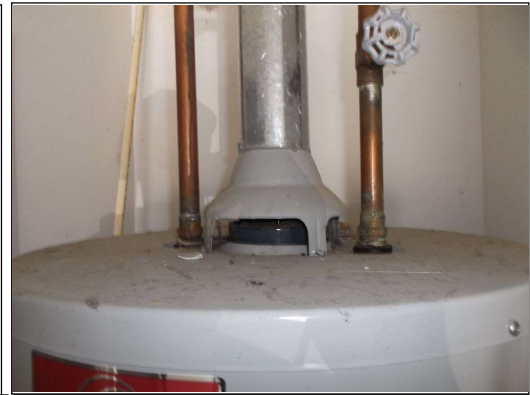
Copper & steel join without dielectric fittings

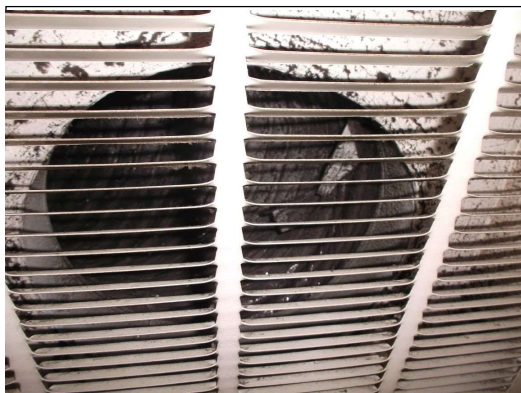
Air ducts dusty

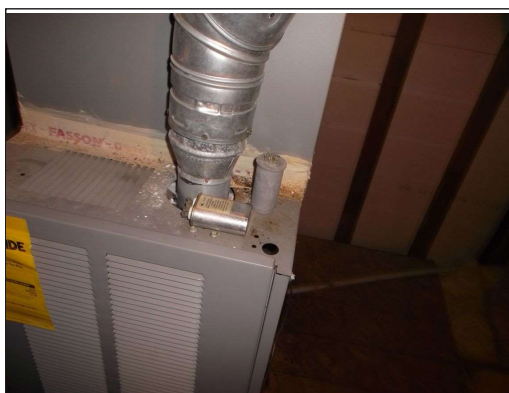
Furnace components have been replaced

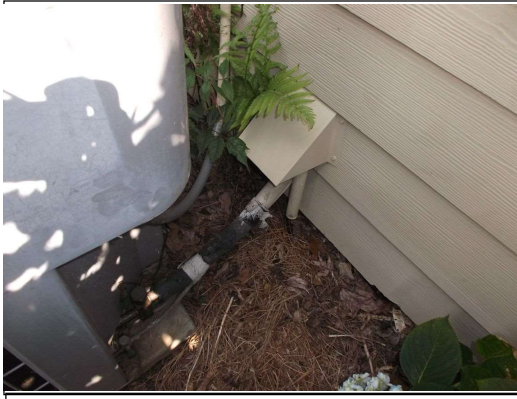
Condensate drain pipe dripping at the foundation;

Condensate drain pipe drips at foundation

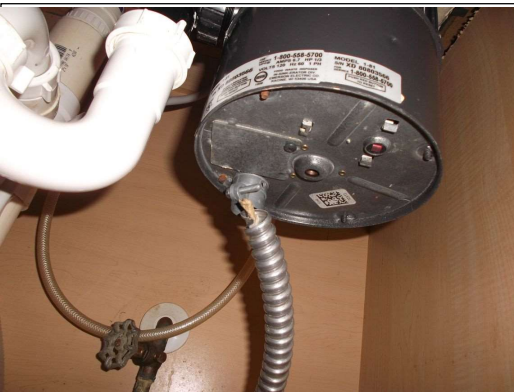
The electrical conduit is detached from the bottom of the disposal is a safety and shock hazard;

Detached conduit under disposal

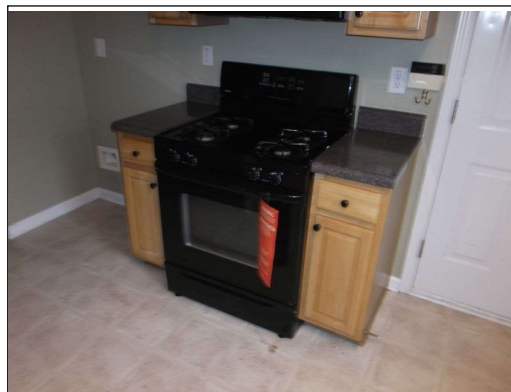
Stove defective

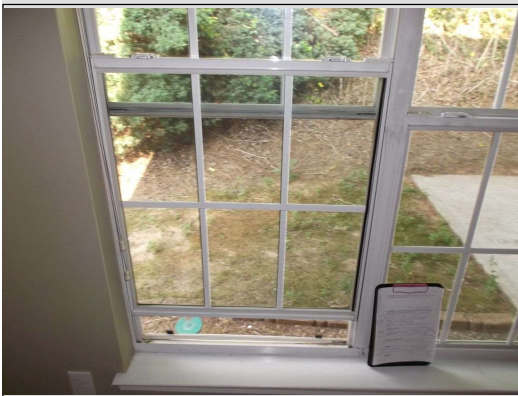
Window restrictive when letting down

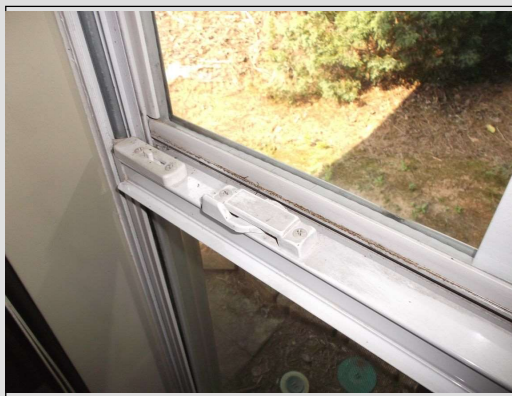
Dining window locks not latching

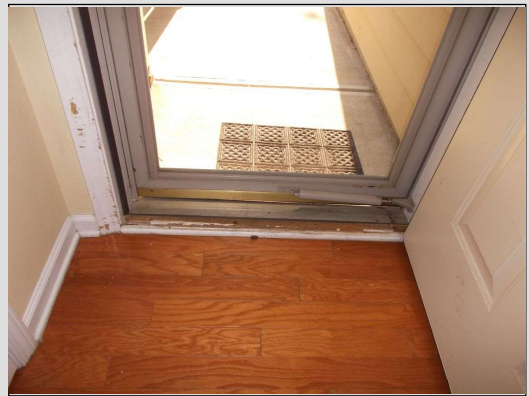
Daylight at the bottom of the storm door

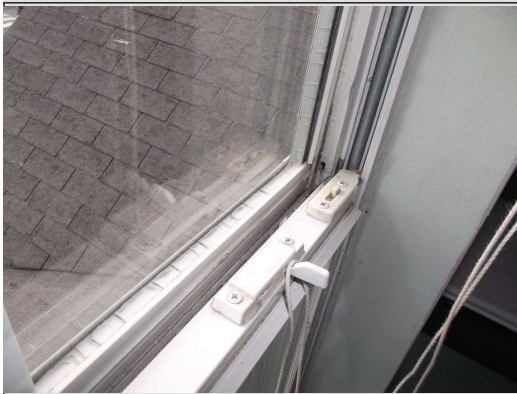
Top glass pushed out of frame

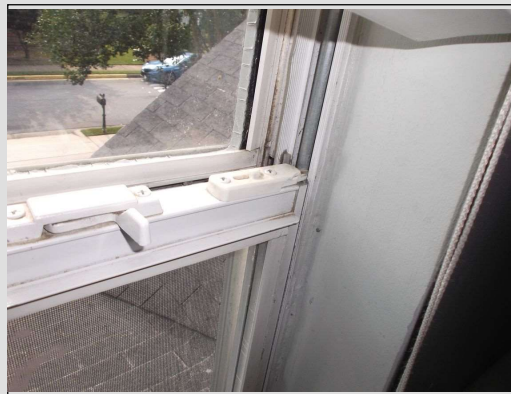
Cracked tilt out latch plastic

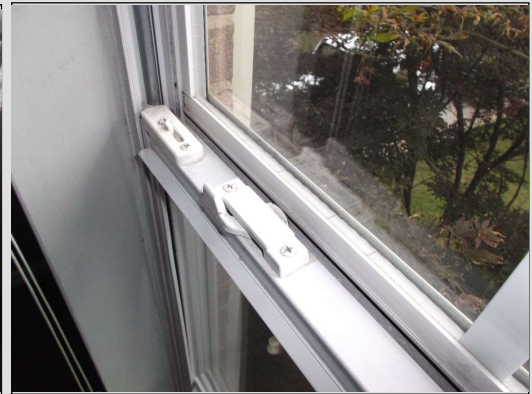
Lock not latching

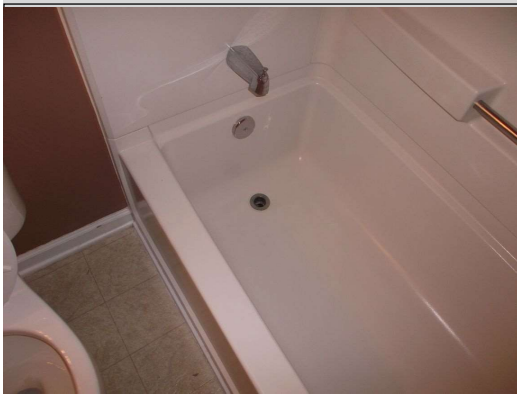
Tub stopper missing

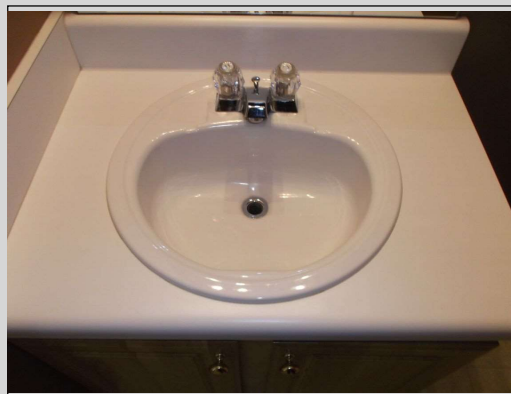
Sink stopper missing

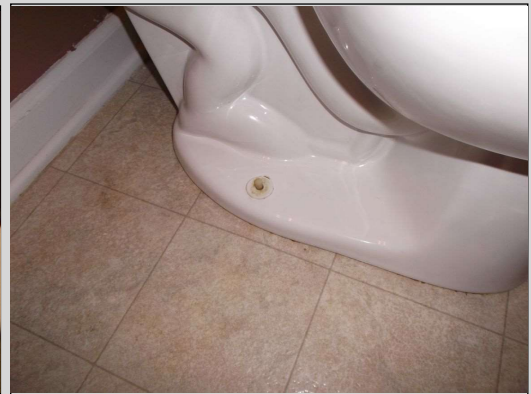
Missing screw and missing caulk at toilet

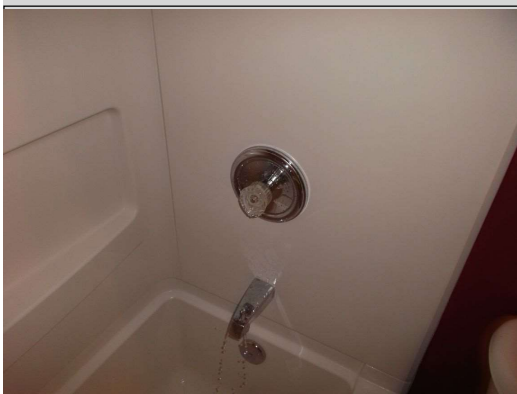
Missing faucet knob cap at tub

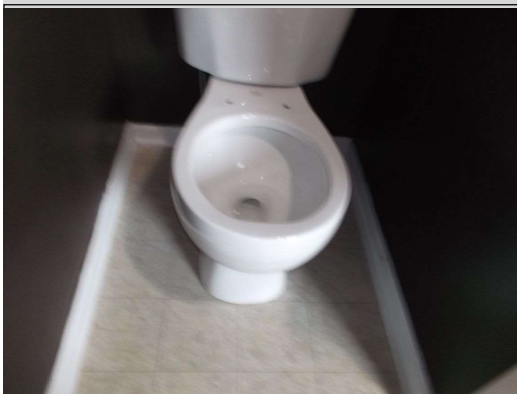
No toilet seat

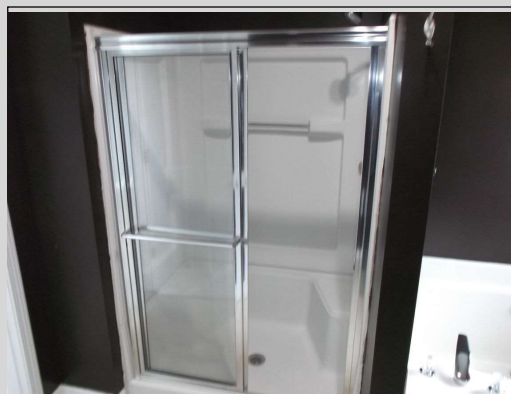
Shower cross bar too low

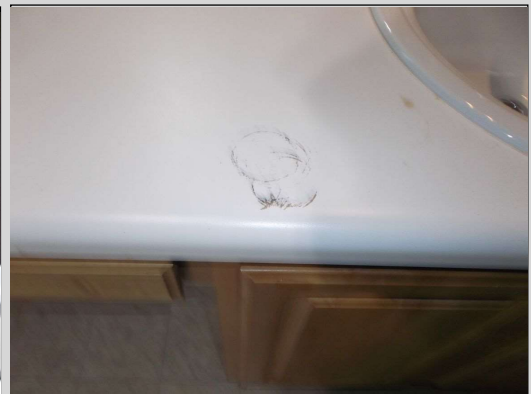
Stains or damage to counter

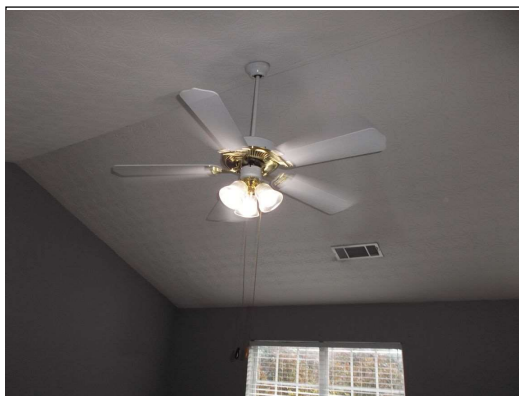
Fan wobbles and popping

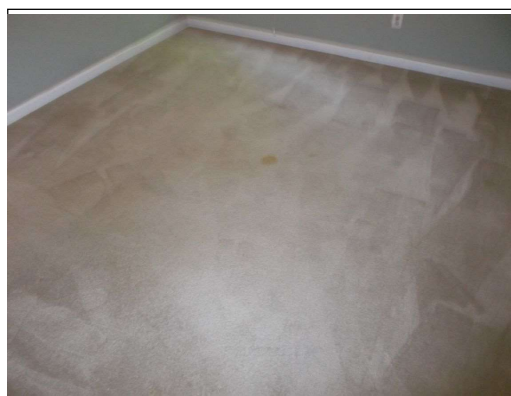
Bed carpet soiled

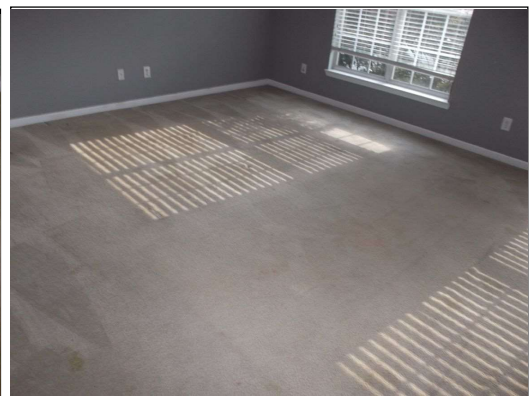
Master bed carpet soiled

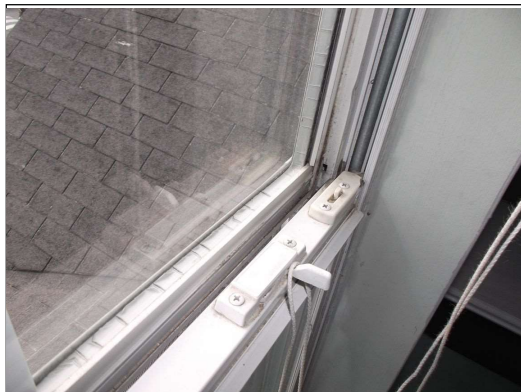
Master bed window pushed out

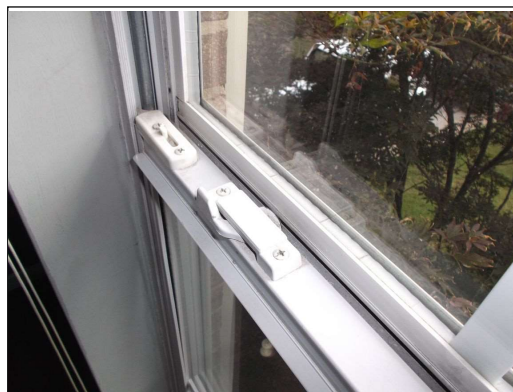
Master bed window lock not latching
