PROPERTY INSPECTION REPORT

141 Greenville St. Newnan, GA. 30263

Dec 8, 2021

1599

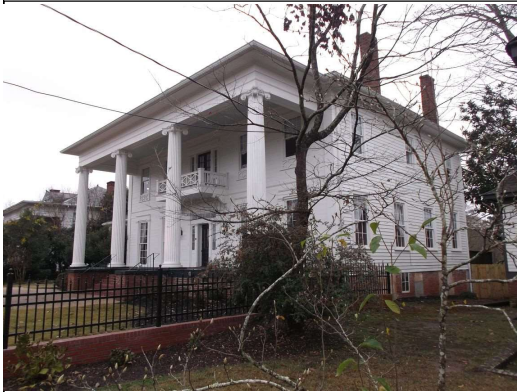
Mailbox damaged. Front upper porch railing too low and guards spaced too wind.

There is a large tree stump remaining at the front yard at the right side of the property. The foundation has a skirt wall leaning outward at the right side of the house near the rear corner.

Tree stump/upper porch unsafe

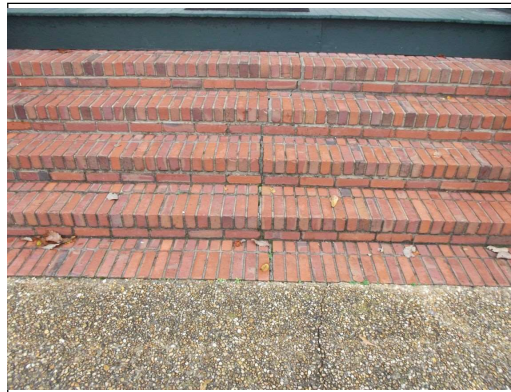
Front porch stairs step up to the front porch too high is a trip hazard. Front porch floor has poor slope away from the building. Front porch floor paint worn. There are cracks in the front brick steps mortar. The front porch column on the left side of the stairs has a putty filler at the bottom of the column.

Crack in front steps/step high at porch

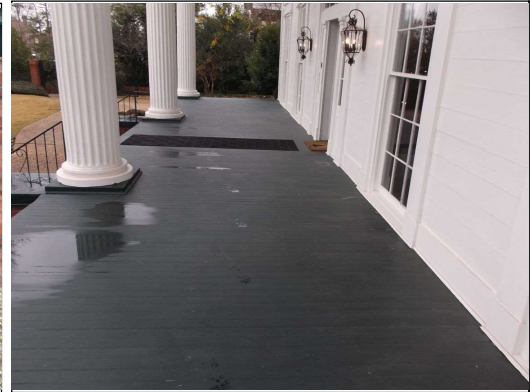
Porch floor has poor slope away

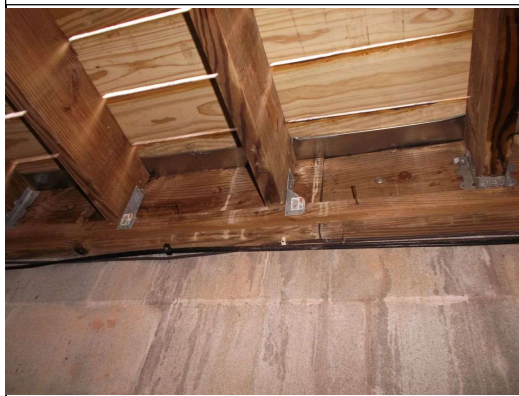
Wood decks posts in the soil, missing joist hangers at some areas, improper flashing at main deck connecting to the house, deck wood in contact with the soil at several areas.

Improper metal for joist hangers

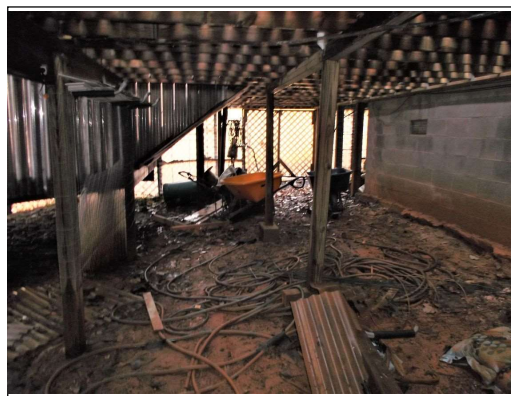
Wood in the soil/improper flashing at house

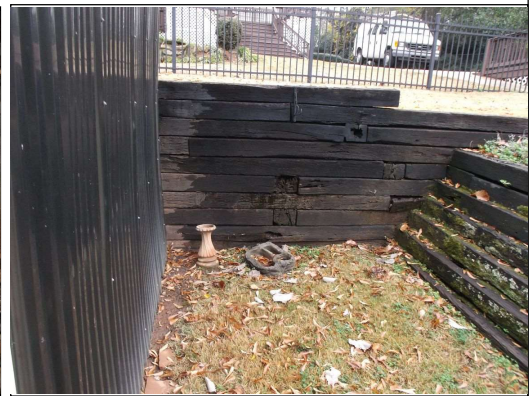
Soil slopes to the pool house floor. Pool house screened porch posts in contact with the retaining wall can rot and attract termites. Pool house screened porch floor has mud on the surface that may indicate water intrusion.

Soil slopes towards pool house floor

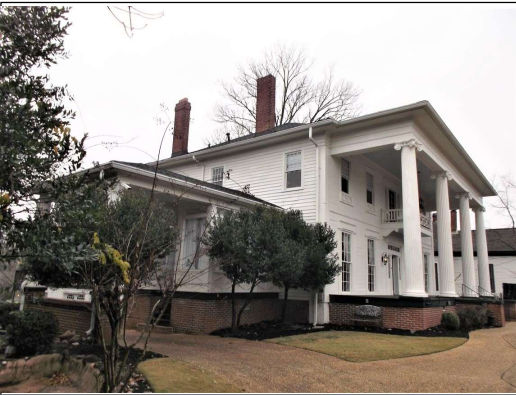
Building will need painting soon

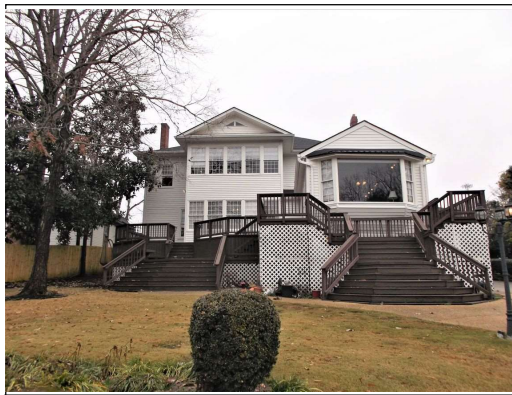
Rear room of kitchen appears to lean

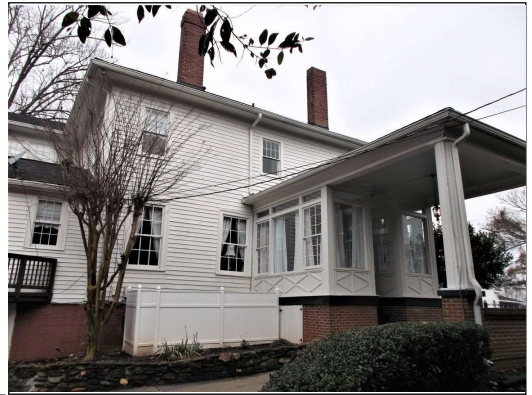
Defective paint some areas

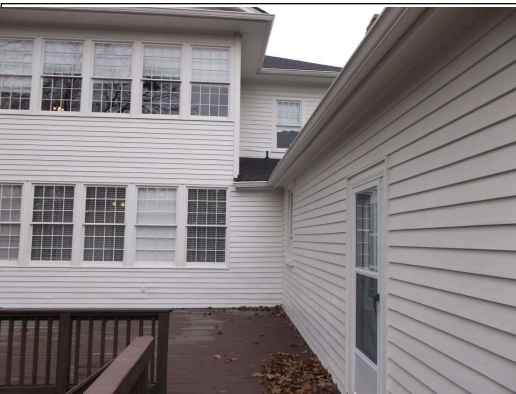
Gutter downspouts missing splash blocks. Rear gutter over the deck area is leaking at the corner and slopes away from the downspout overflows.

Gutter slopes away and leaking at joint

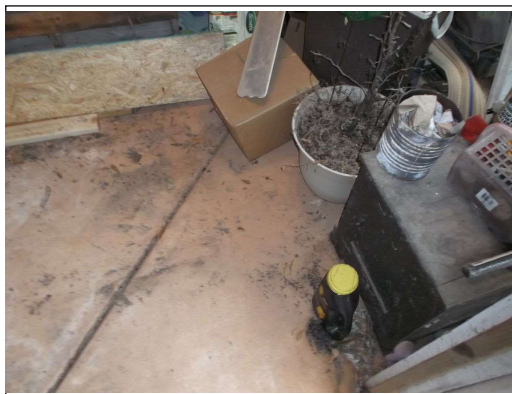
Mud on pool house porch floor

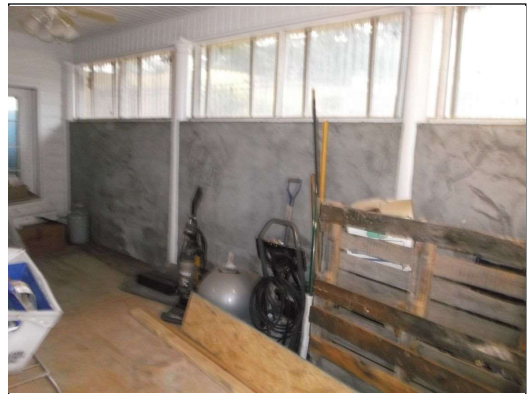
Posts contact concrete.

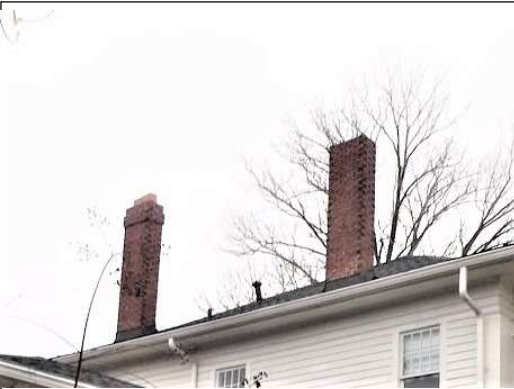
Chimneys missing caps & spark screens

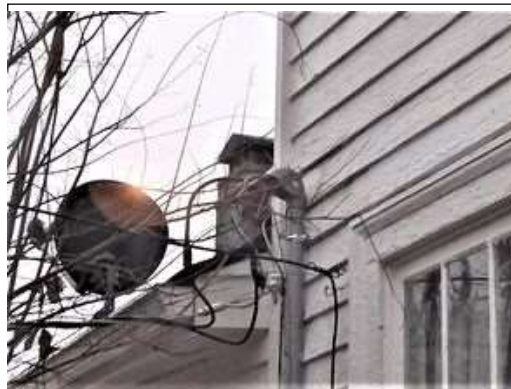
TV dish bolted to roof

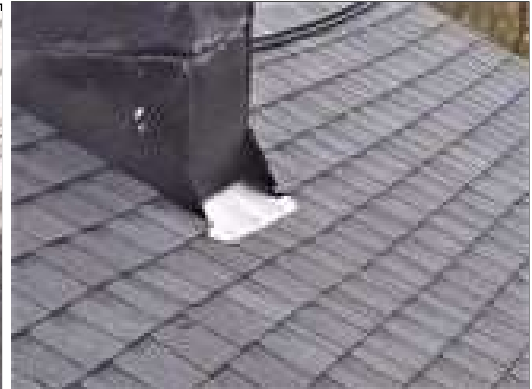
Flashing on top shingles face nailed

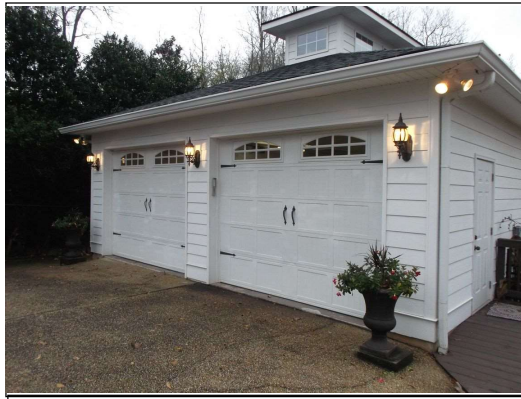
Doors need painting

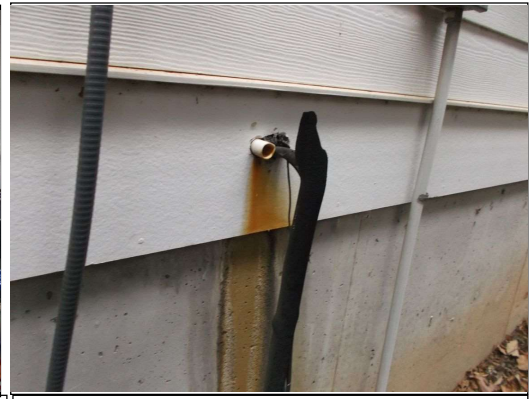
Detached Garage: AC refrigerant line insulation deteriorated and condensate drain pipe is not extended down to the ground and away from the foundation 3 feet (water can get into the wall).

Condensate drain pipe improper

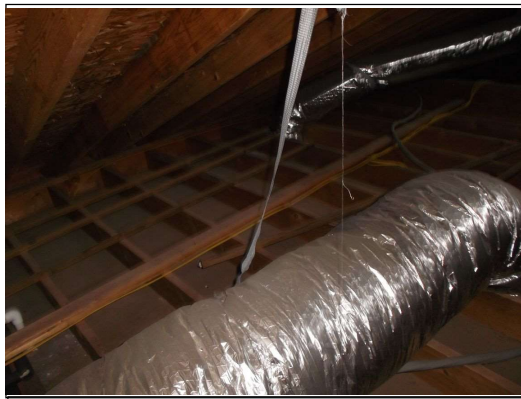
No ceiling insulation

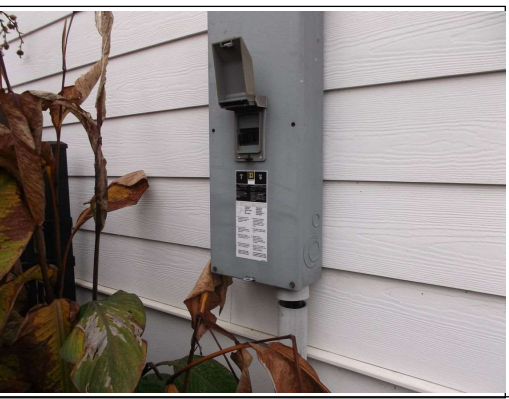
Conduit detached under disconnect panel

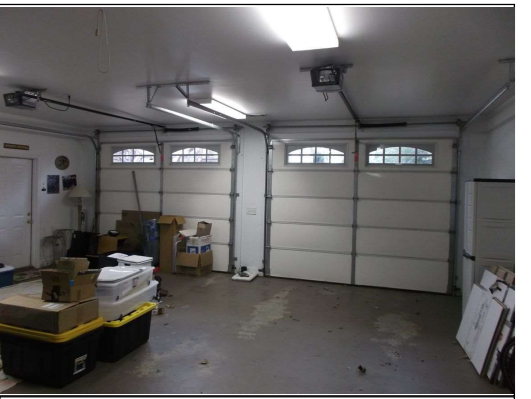
One of the vehicle doors was blocked and did not let up.

Left door was not operated, blocked

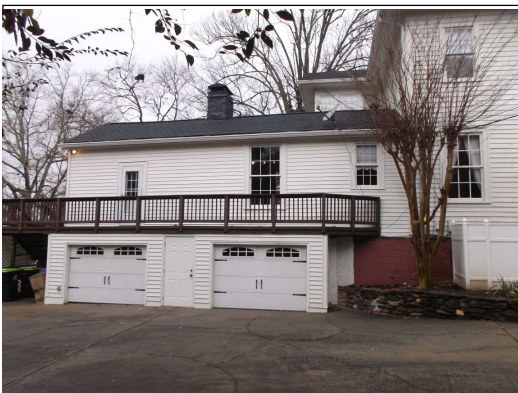
Wood contact concrete

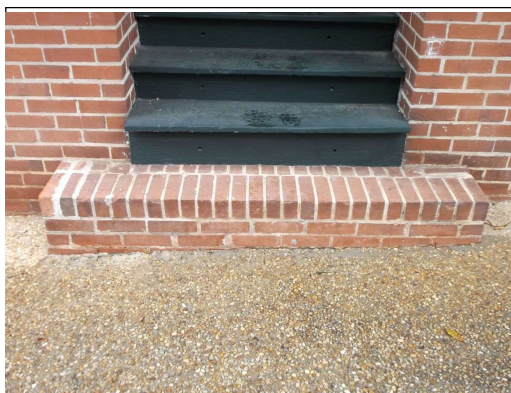
Carport attached to the house steps up to the sunroom are too high and can be a trip hazard.

Carport step too high is trip hazard

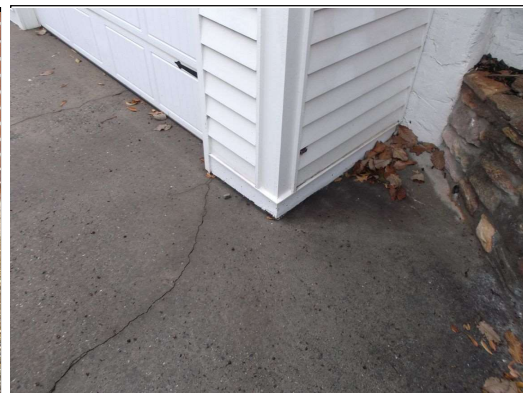
Driveway slopes to garage awll

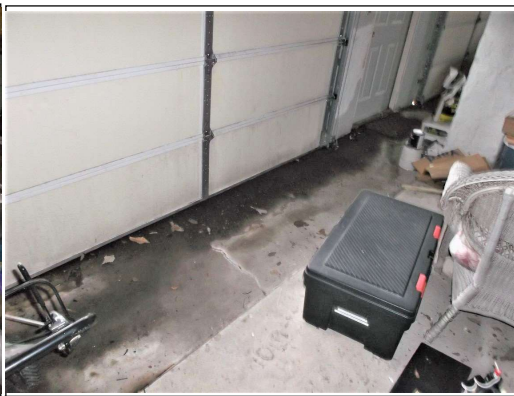
Floor wet at vehicle doors

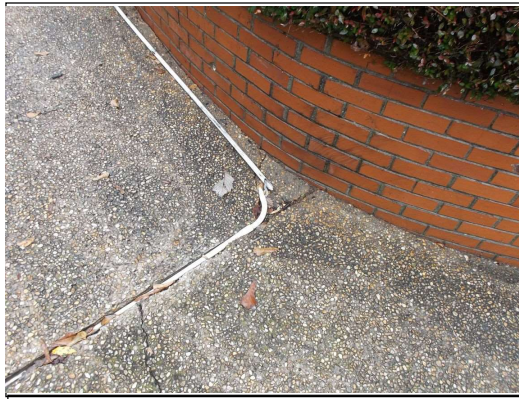
There is a electrical cable crossing the driveway near the street that has broken conduit, improper conduit and electrical cable exposed can be damaged.

Conduit broken, exposed cable

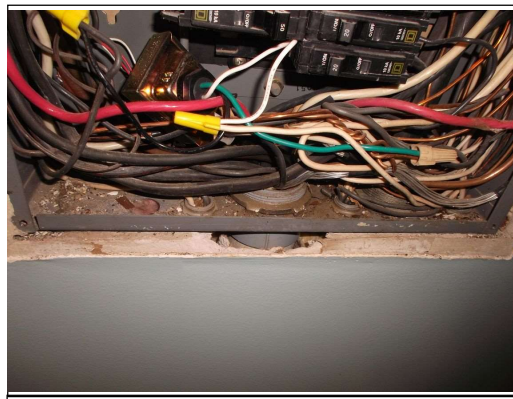
Opening at sheetrock and hole in panel wall

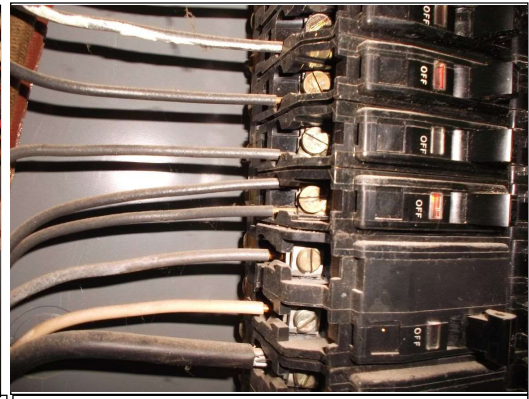
Two hot wires connected to one breaker

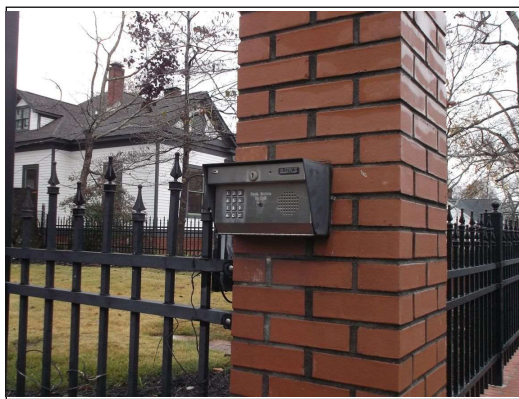
Verify gate and intercom control operate

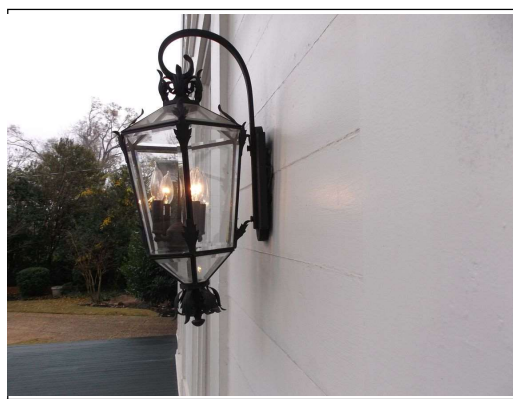
Coach light detached from wall

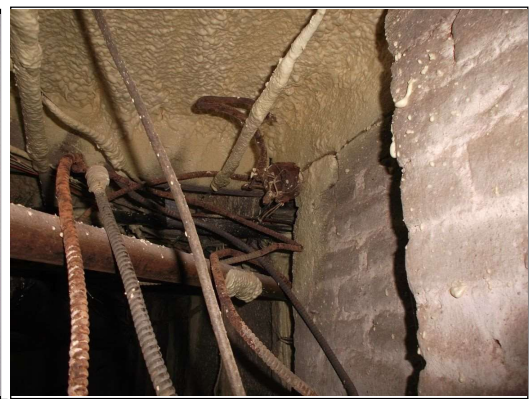
Exposed wire connections in crawlspace?

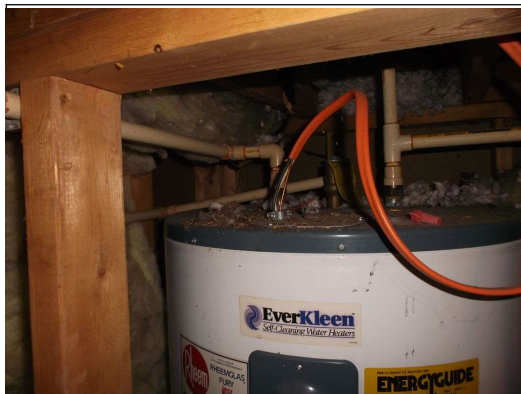
Missing sheathing where wires enter top

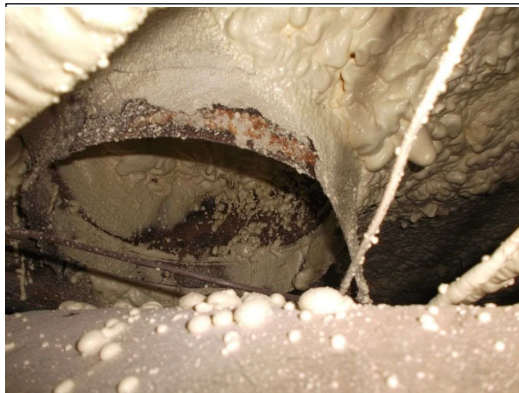
Possible Asbestos tape

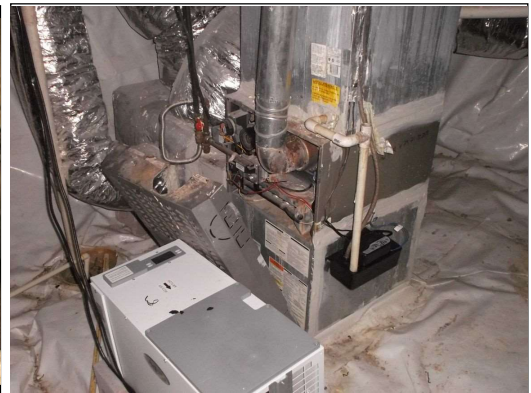
Basement furnace defective

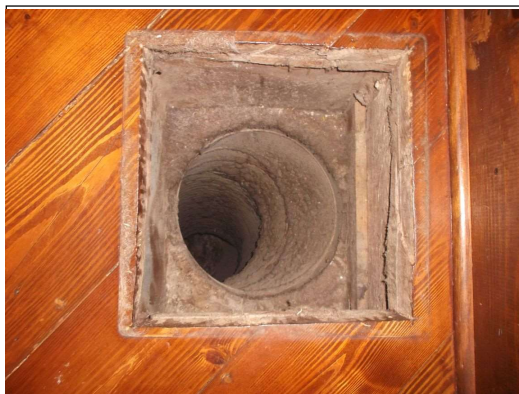
Air ducts very dirty

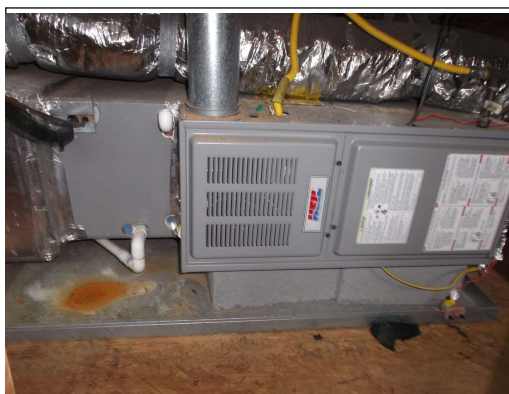
Wrong pipe in furnace, wire in hole, rust in pai

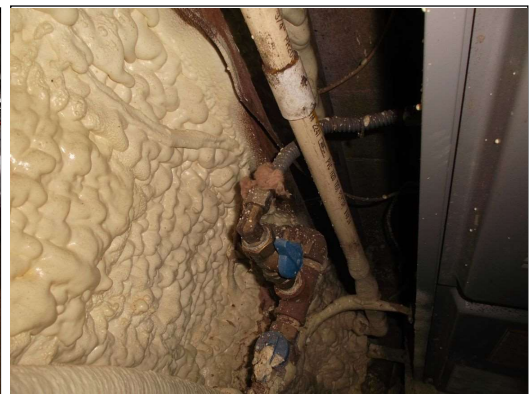
The garage furnace has improper sediment trap in the gas pipe leading to the furnace. Gas appliance connector enter the furnace wall is unsafe. Missing refrigerant line insulation near the furnace. The electrical cable is entering a hole in the bottom of the furnace contacting sharp metal.

Improper gas pipe at furnace in garage closet

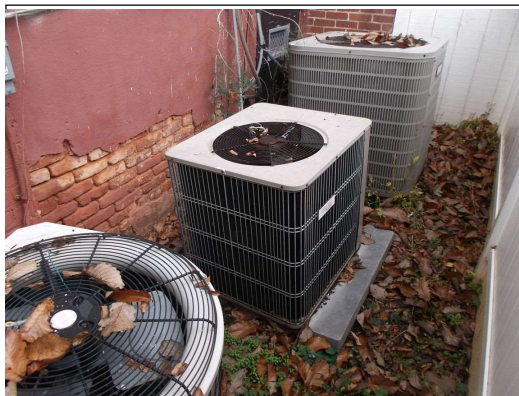
AC units closed in leaning on pads

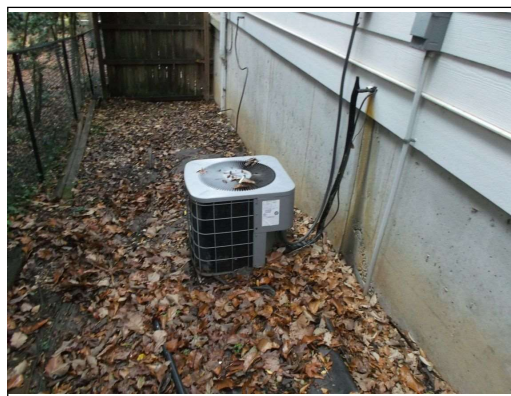
Detached garage condensate drain pipe pours into the siding, refrigerant line insulation deteriorated. There is rust in the air handler drain pan indication condensate dripping. Pool house condensate drain pipe under the leaves and ground cover at the side. Electrical conduit detached from the AC disconnect box at the side of the house.

Condensate pipe drains at siding

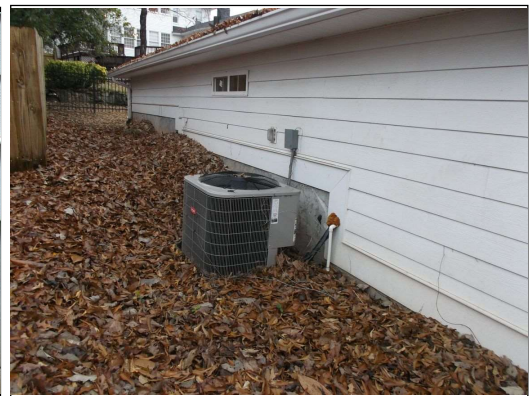
Condensate pipe under debris

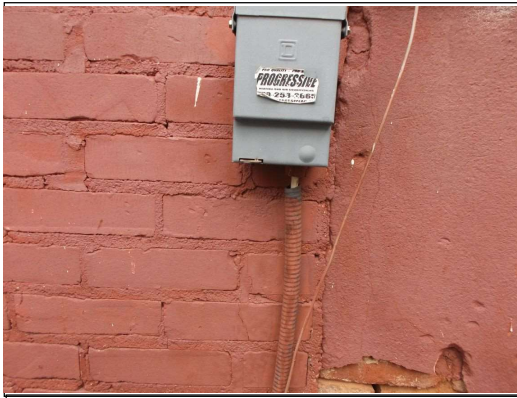
Conduit detached from AC box at house

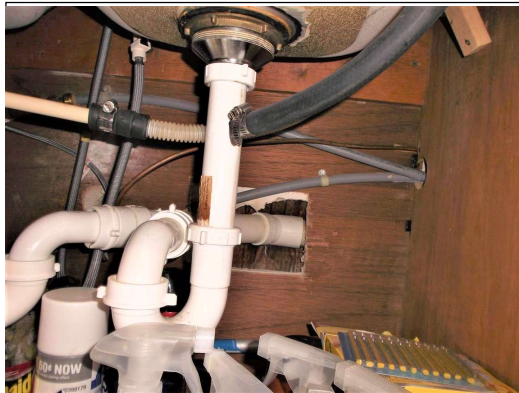
Gray water pipe in sink cabinet/hole in wall

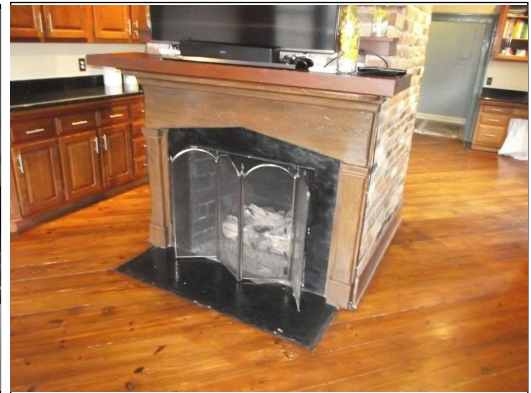
Fireplace brick mortar deteriorated. The fireplace damper was open and did not operate (verify not defective).

Fireplace damper open, mortar deteriorated

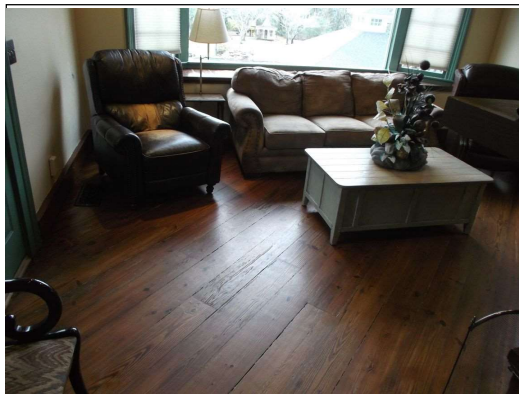
Floor major settling and sloping

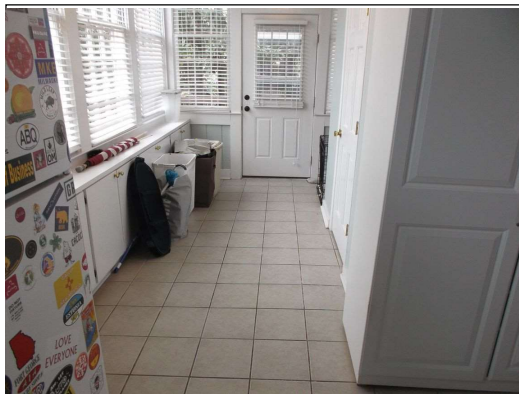
Laundry floor slopes to the left

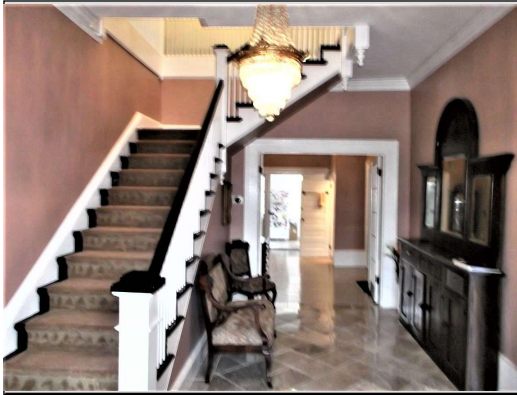
Floors settled/low headroom at stairs

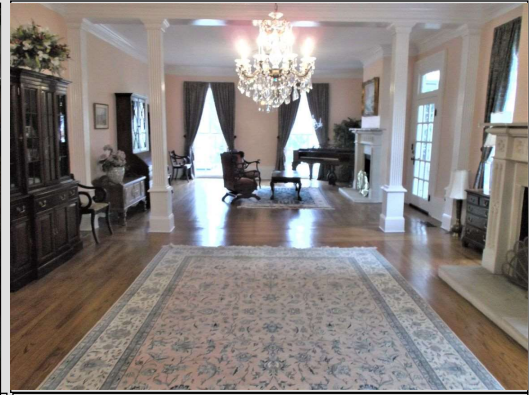
Main Level: The house main level floors settle, sag and slope at several areas (foyer, pool room, office, parlor, living room sitting room...). The french doors between foyer top latch not striking.

Floors settle and sagging

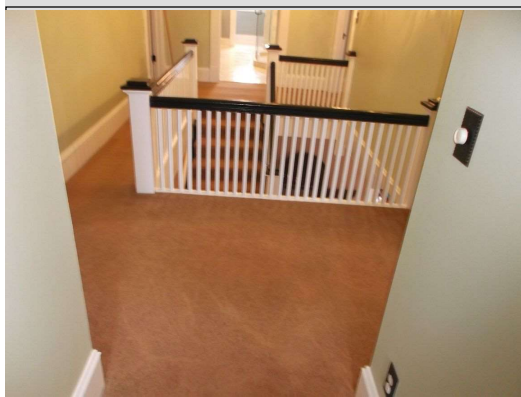
Stairwell to the 2nd level has a ceiling too low can bump head. The guards around the stairwell are too low and can be a fall hazard.

Stairwell guard rails too low/floor settles

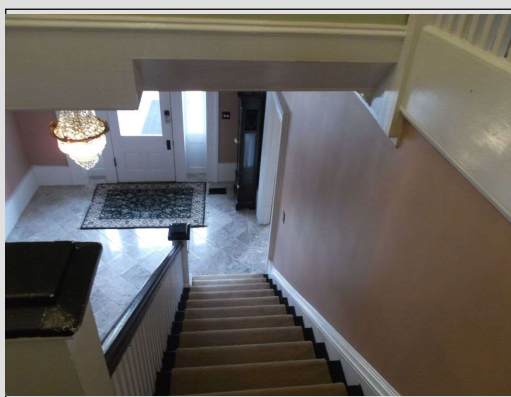
Low head room

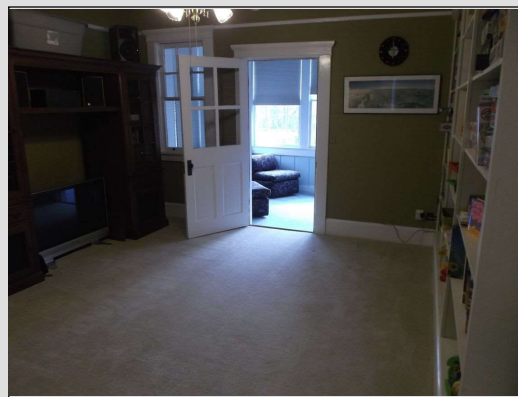
Floors major sloping and settling

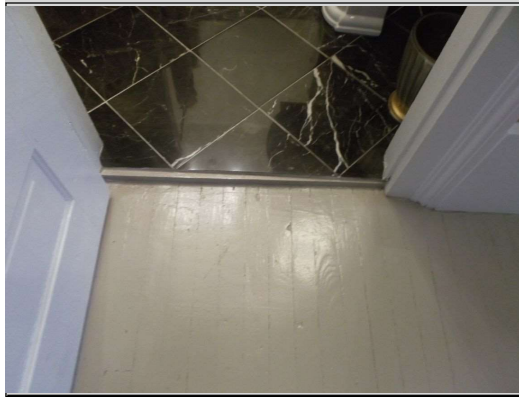
Floor trip hazard

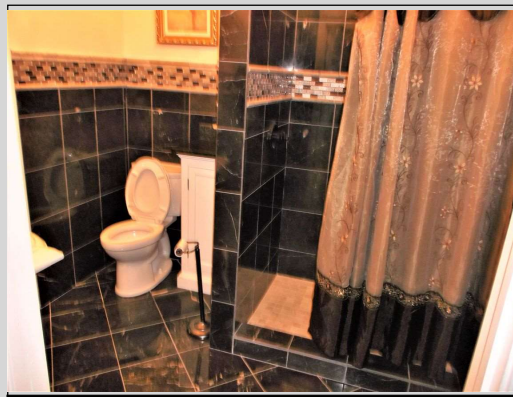
Missing caulk at toilet on floor tile

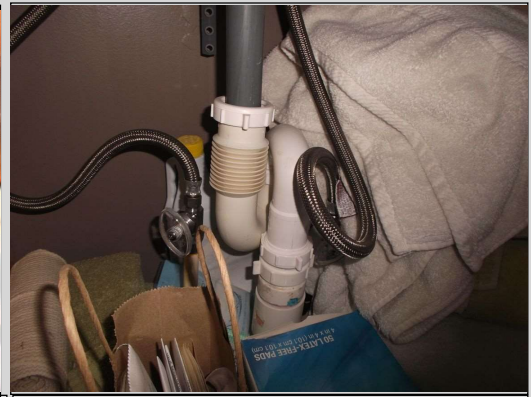
1st floor 1/2 bath toilet missing caulk where it rest on the floor, and outlet tested open ground. Door bump door frame. The sink waste pipe is a S-trap that can let sewer gas back into the house.

1/2 bath drain pipe is S Trap

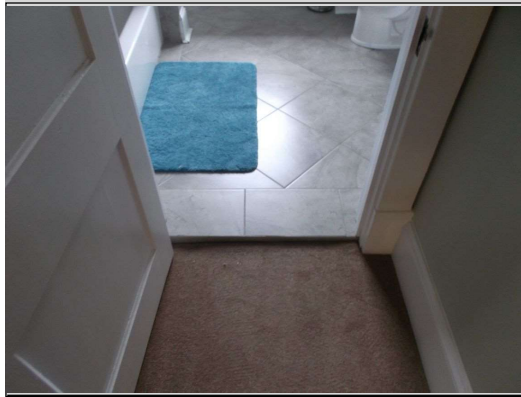
Floor is a trip hazard

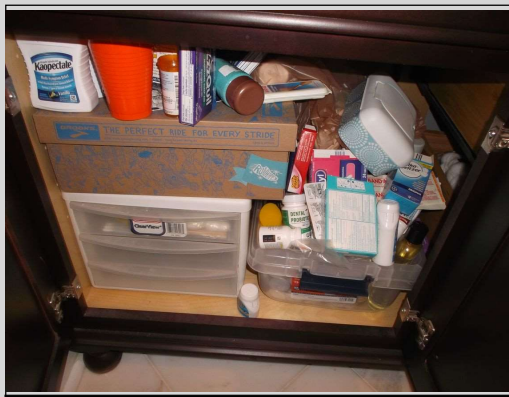
Belongings in cabinets

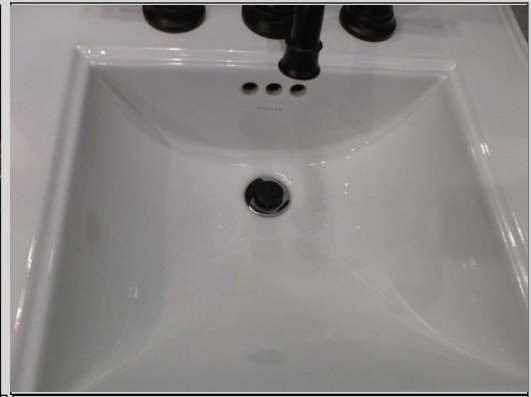
2nd floor hall and bed bath cannot see under cabinets due to filled with belongings, there is no exhaust fan and finish peeling off sink drain out.

Finish peeling of drain outlet

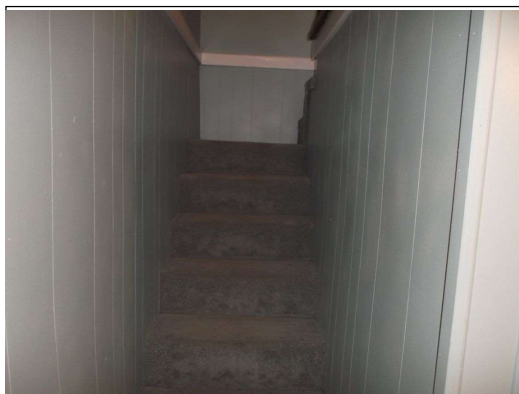
No handrail at basement stairs

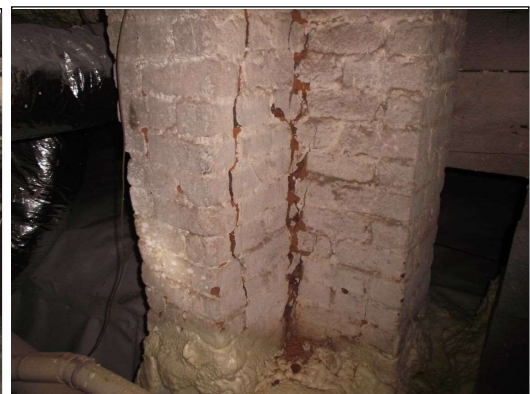
Basement doors were open at the time of the inspection (can let snakes, rats and critters into the basement and crawlspace. There is a brick column in the crawlspace that have cracks

Cracks in brick columns

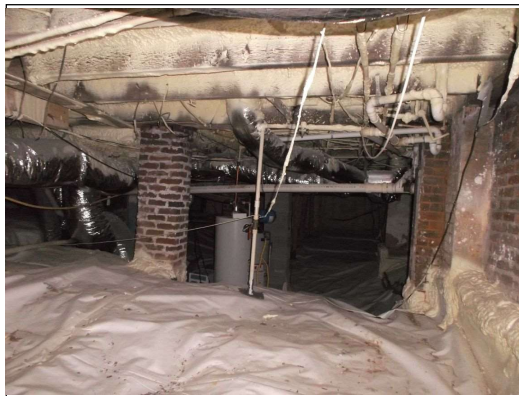
Foam cover floor framing

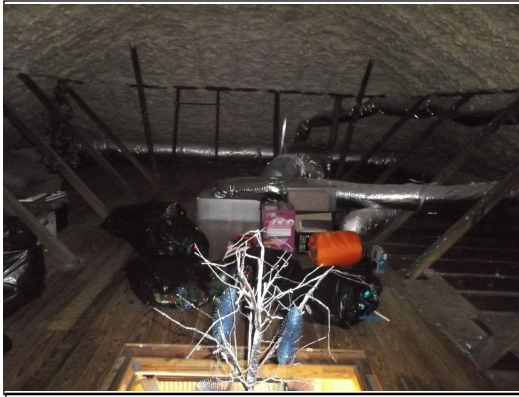
Whole house exhaust fan cannot work due to the attic sealed with foam.

House attic encapsulated with foam insulation

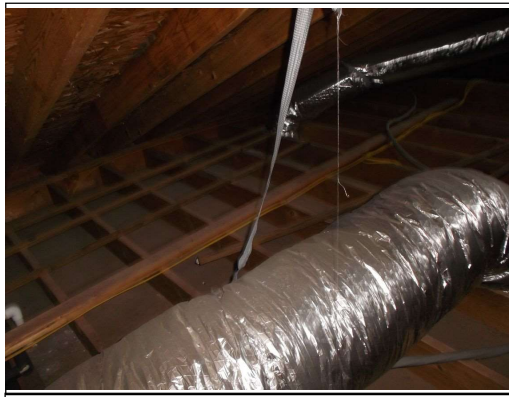
Missing insulation in detached garage attic

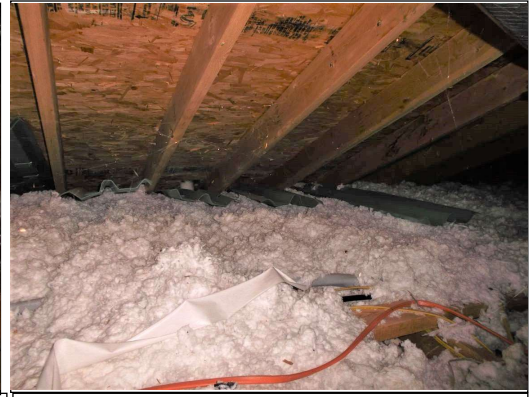
Baffles falling down at the pool house attic

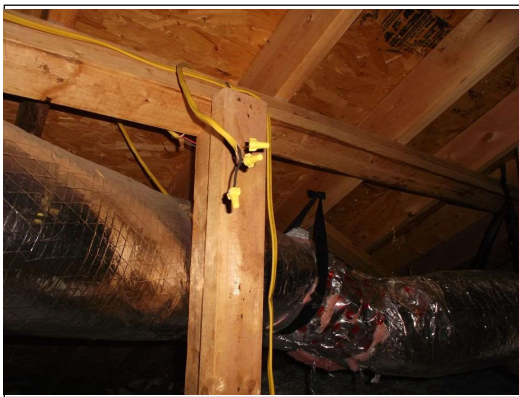
Exposed wire connections in pool house attic

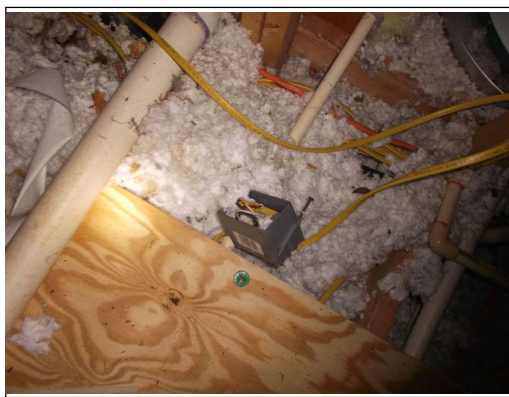
Open junction box at pool house attic
