Property Inspection Report

3161 E Point St., east Point, GA

4-22-2021

Paris Pressley: R-5 Master Residential Building Inspector & State License Residential Building Contractor

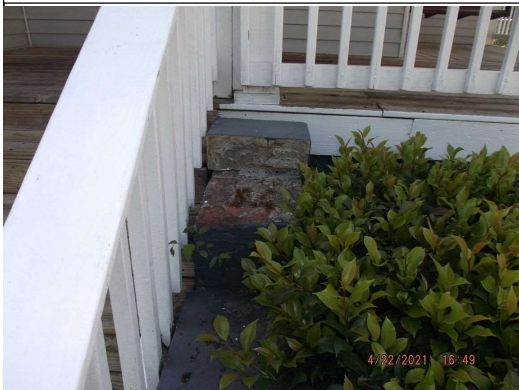
Broken pillar at the front stairs

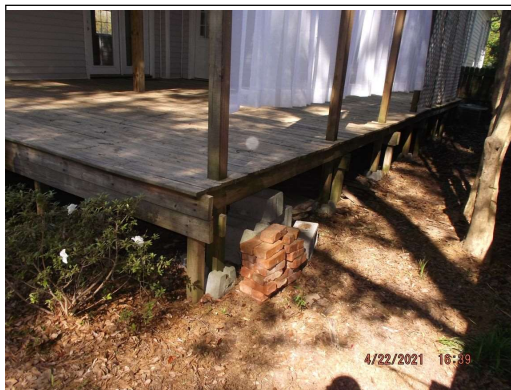
Rear wood deck is installed improperly (improper post supports, deck support posts are not notched and bolted to beams and rim joists, posts contact soil, stairs rest in soil, missing guardrails where deck is more than 30 inches above ground, missing handrails at the deck stairs and cannot verify deck is properly attached to the house; missing handrails at the front stairs;

Deck unsafe and debris under deck

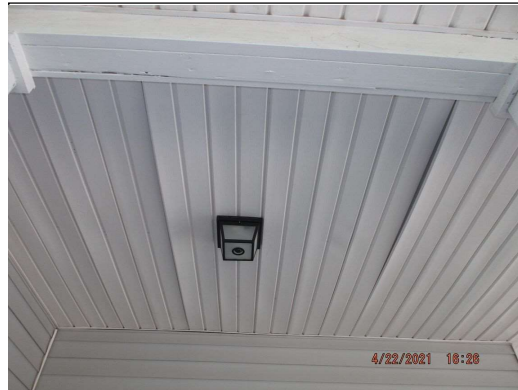
Front porch ceiling coming loose

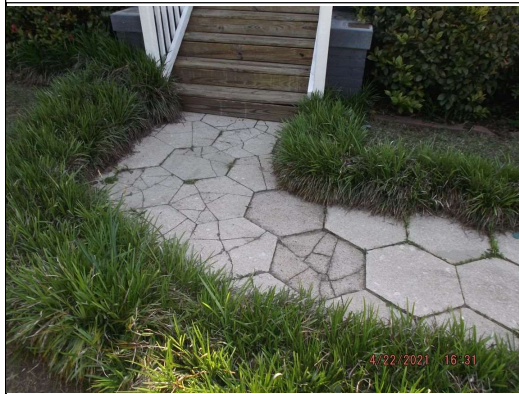
Walk stones broken

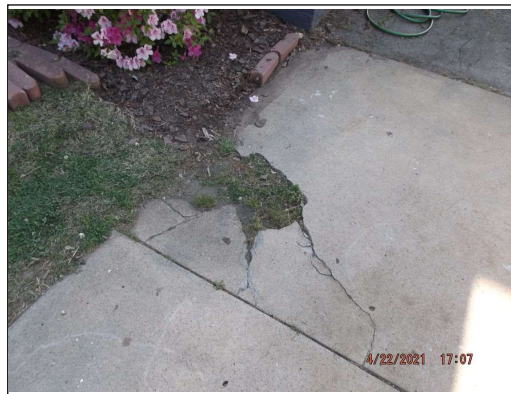
Driveway broken sections and cracks

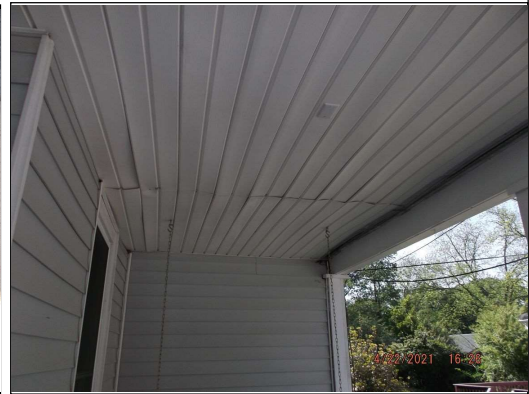
Front porch vinyl defective

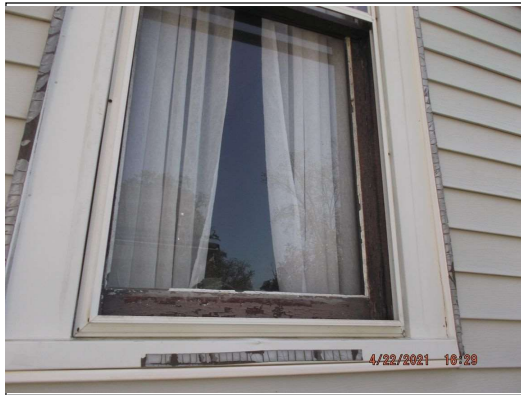
Wood windows need repair or replacements

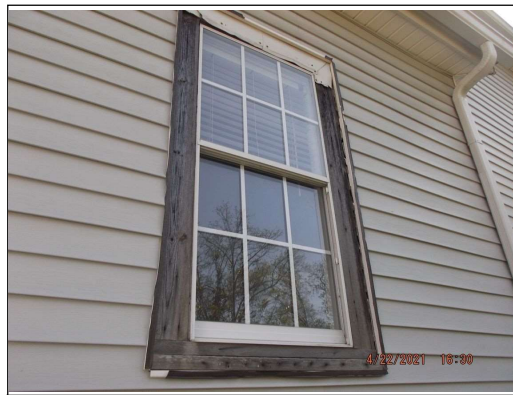
Missing cladding at window side of house

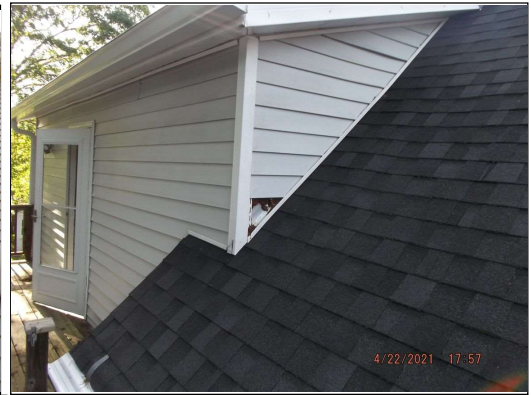
Missing siding panel at 2nd story wall

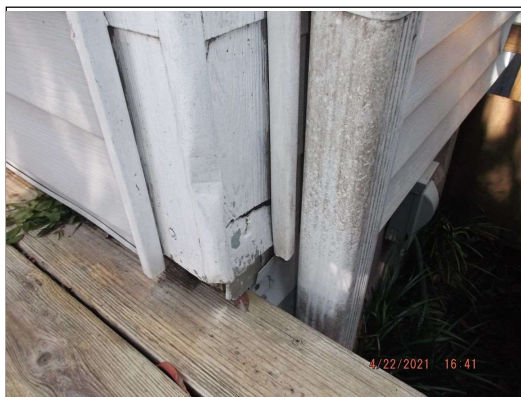
Vinyl siding appears to may have been installed what looks like Asbestos shingles. Where nails have been driven in Asbestos siding they can cause Asbestos material to be damaged, break and cause Asbestos particles and dust.

Possible Asbestos siding under vinyl

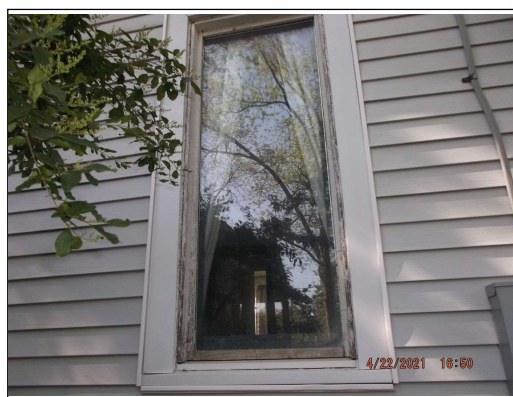
Window needs repair or painting

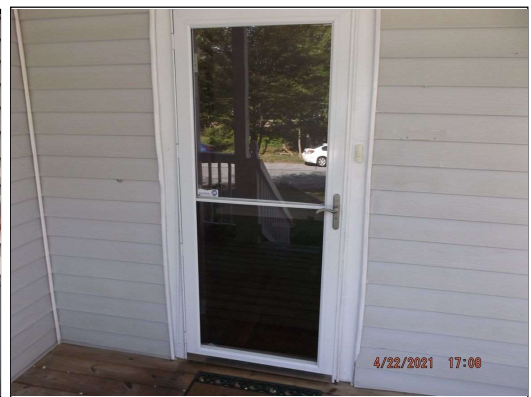
Front porch vinyl has heat damage at door

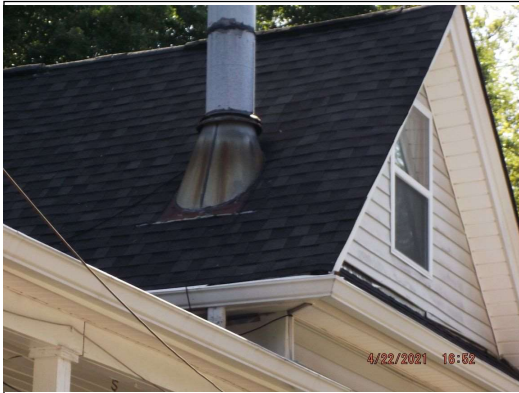
Chimney flashing nailed on top of shingles

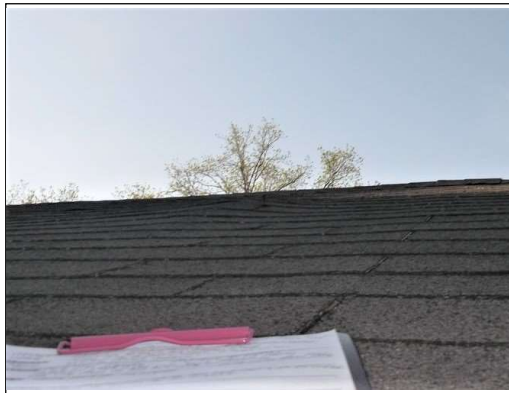
Hump and nail extracting at 2nd level room

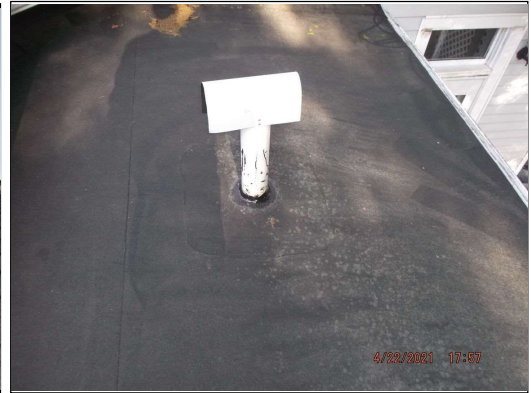
No flashing and boot around vent pipe

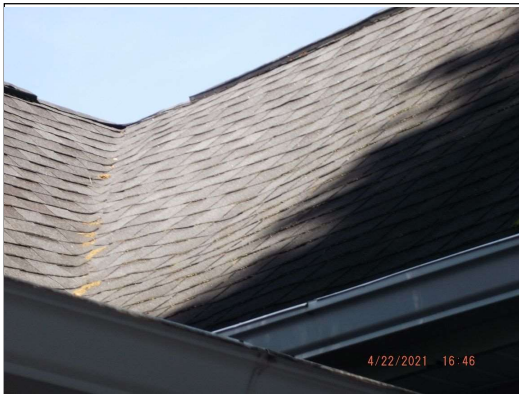
Roof system sagging

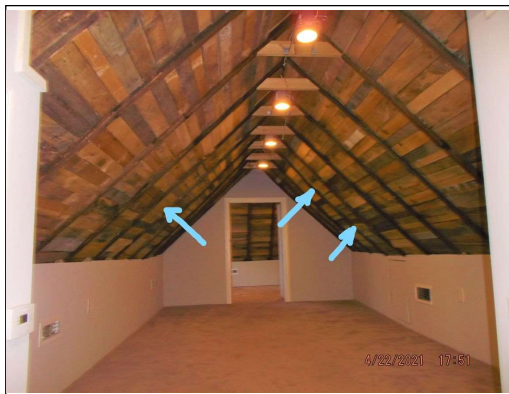
Roof framing sagging/ no braces

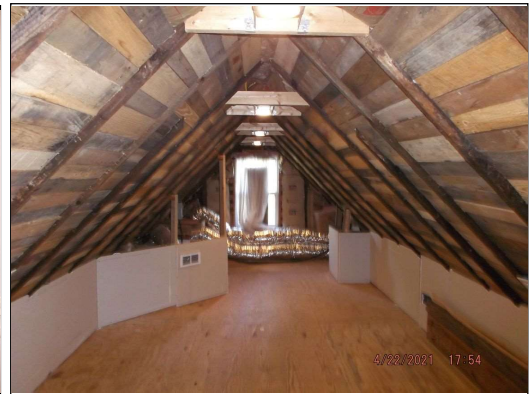
Roof framing sagging/ wrong size rafters

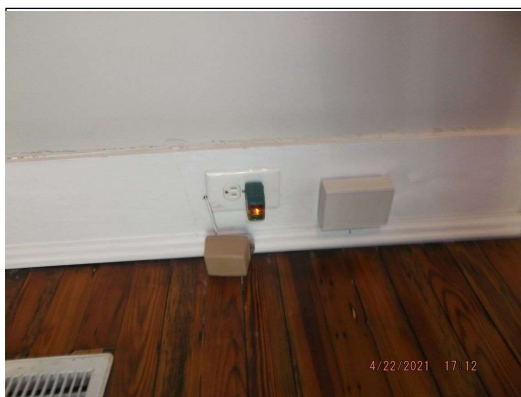
Outlet tested open ground at foyer

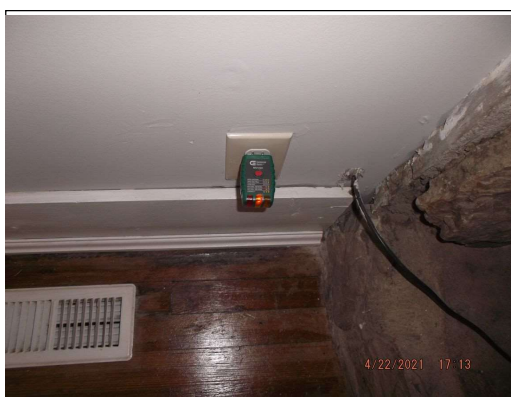
Outlet tested open ground at living room

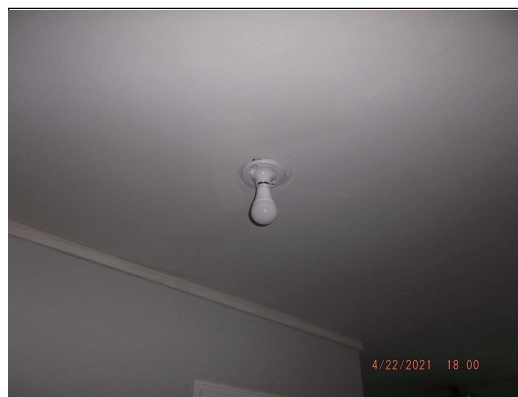
Utility fixtures for light fixtures at areas

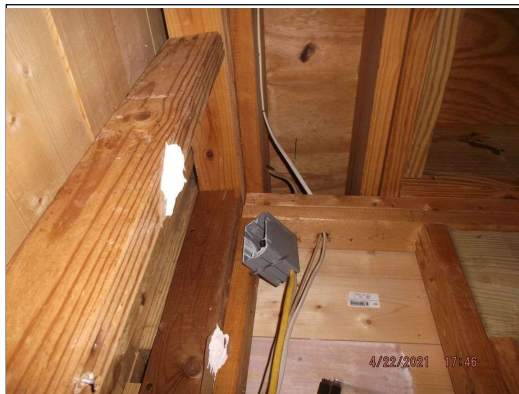
Open junction boxes

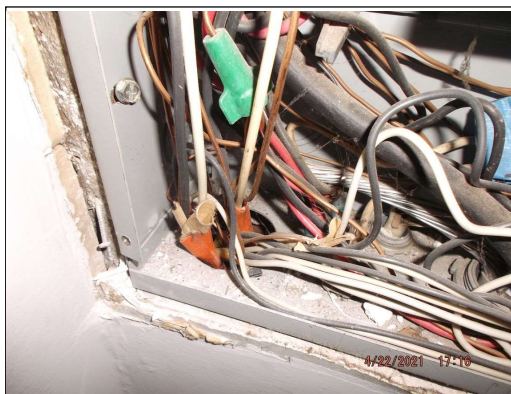
Holes in bottom of panel wires touch metal

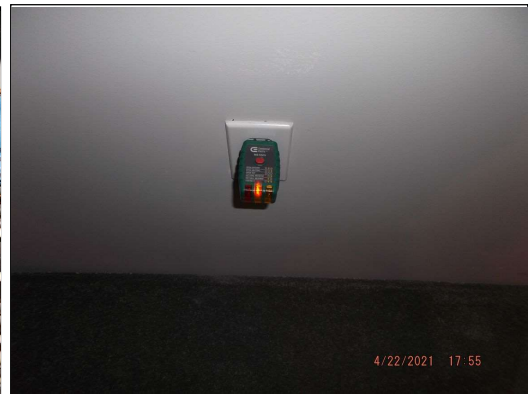
Outlet tested open ground rear room

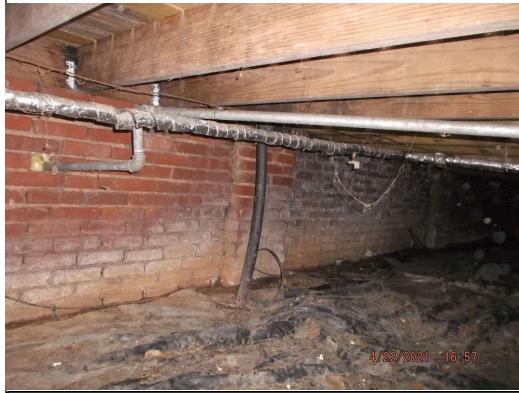
Water pipe used for gas pipe

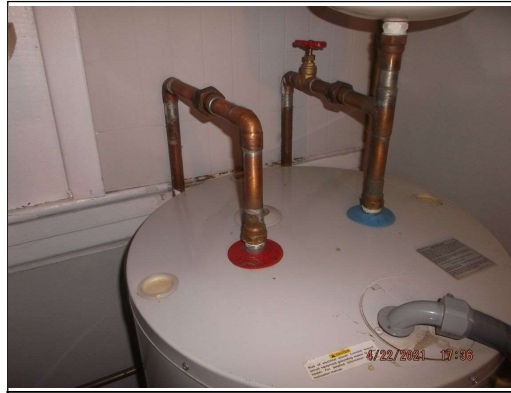
Copper/steel pipe join without dielectric fittin

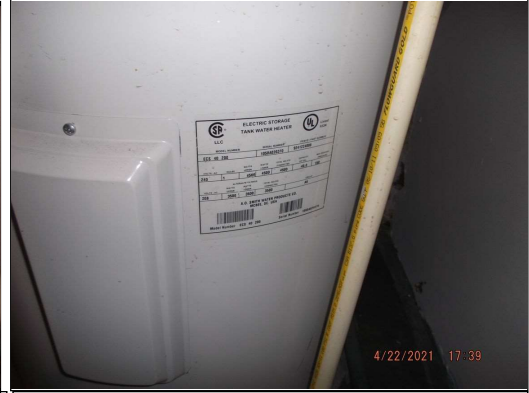
Cannot verify age of water heater

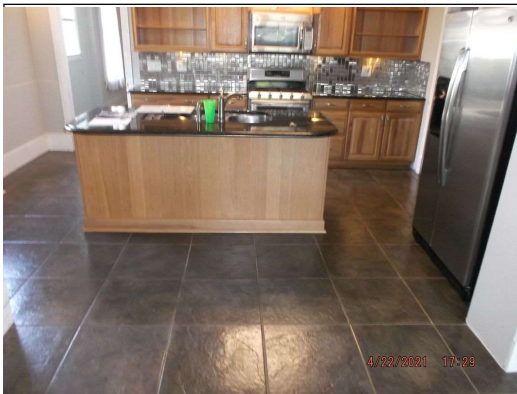
Floor sagging at the island

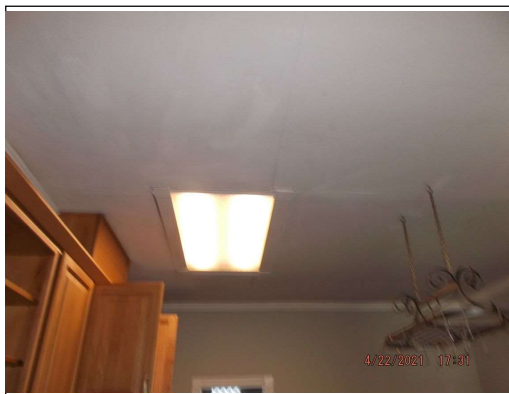
Defective ceiling installation/light installed?

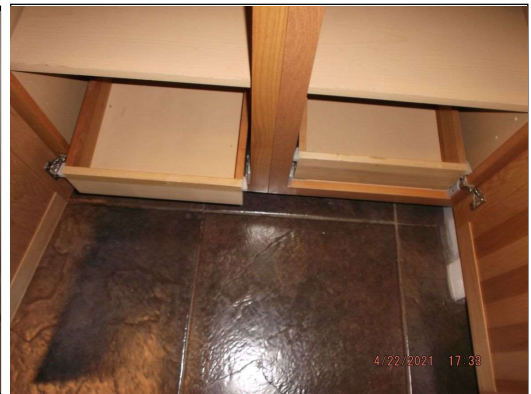
Defective drawer on left

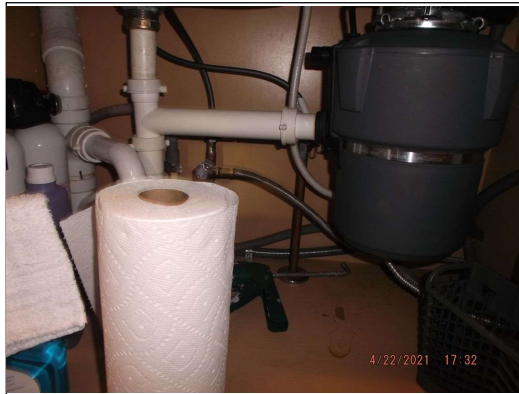
Disposal did not operate from switch

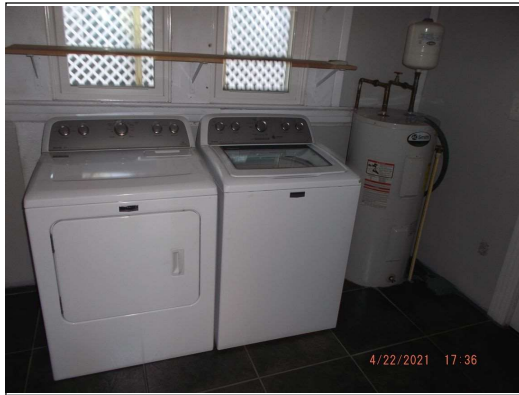
No washer drain pan

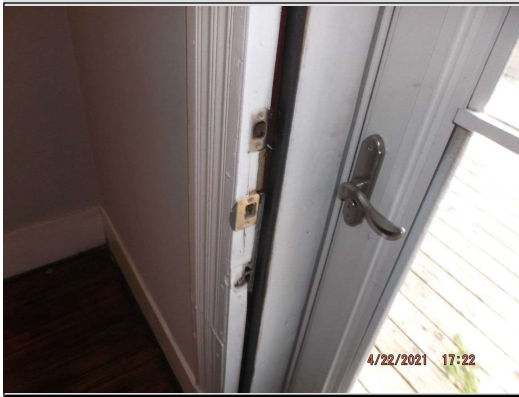
Bed door frame split

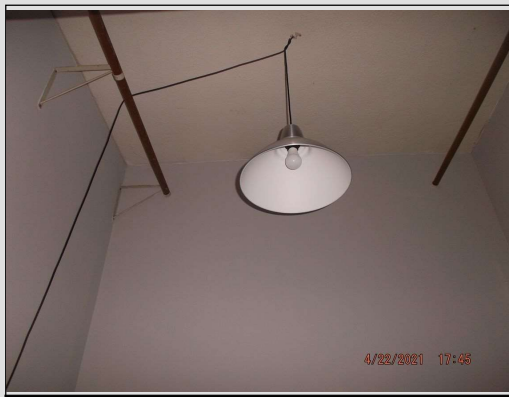
No light switch in bed closet

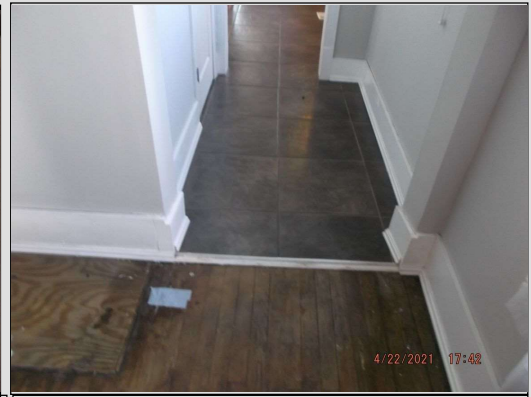
Kitchen floor higher is trip hazard

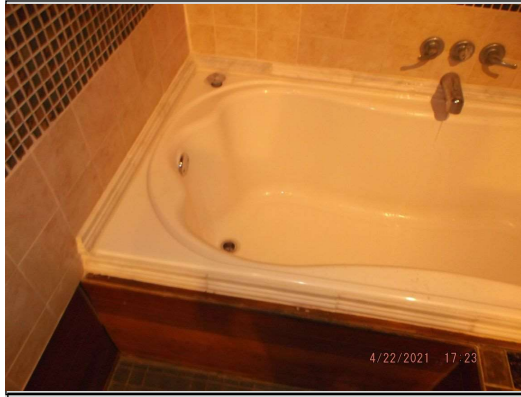
Tub stopper missing

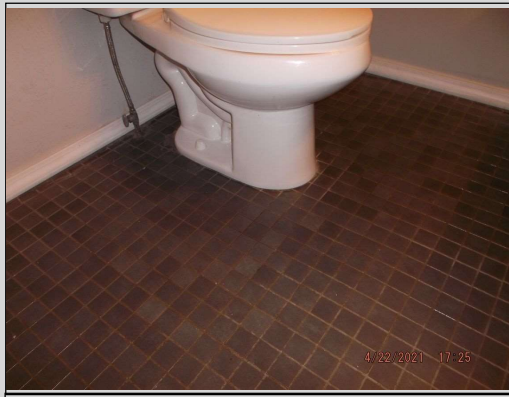
No caulk where toilet rest on the floor

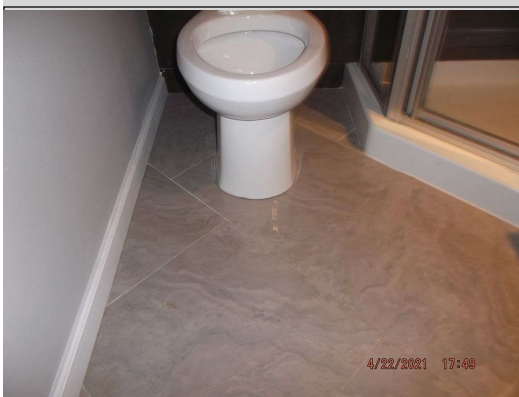
No caulk at toilet on the floor

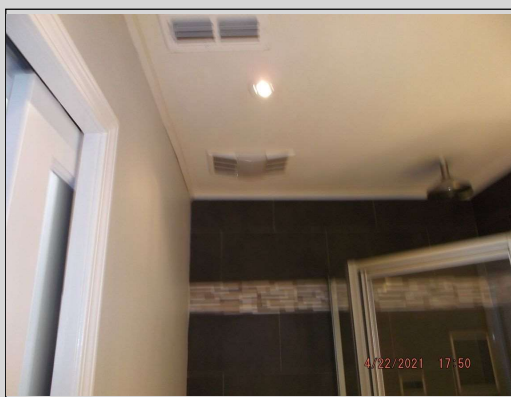
Exhaust fan mechanical noise when operating

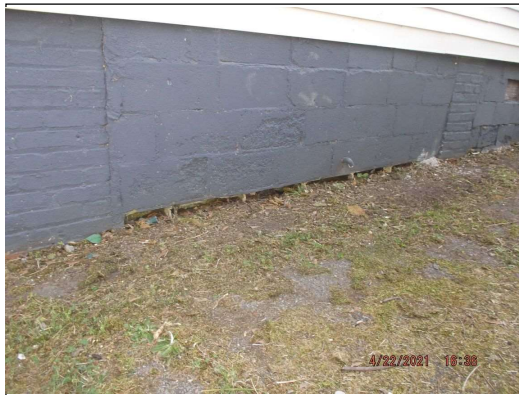
Defective foundation under walls

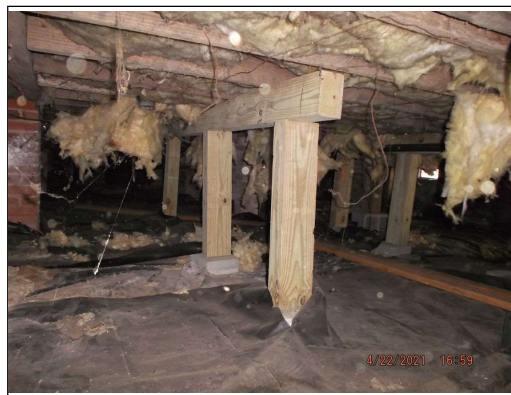
Floor system appears improperly installed and supported with wood posts resting on cap blocks at many areas in the crawlspace. Wood support post supporting the floor are resting on cap blocks that may be unstable at several areas; This home had major floor system replacement and it appears the floor system and beams were not properly installed (floors sagging, settling and sloping in the house);

Many support Posts rest on blocks

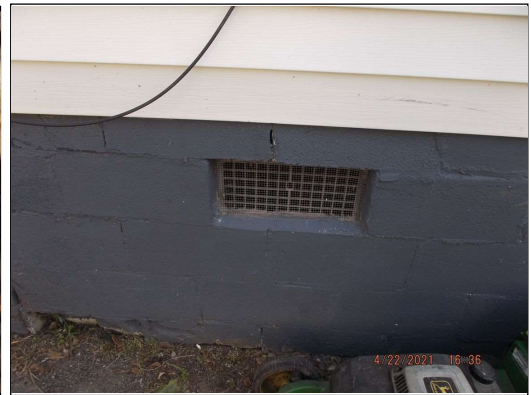
Defective foundation vents

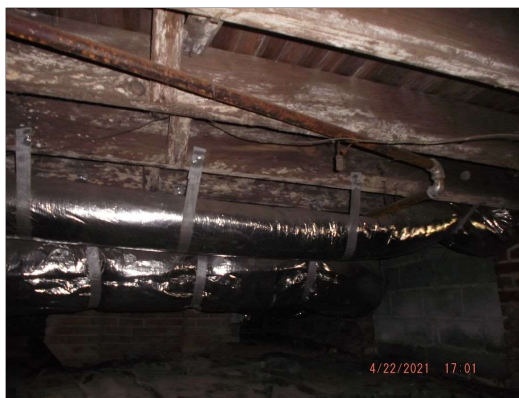
Mold and fungus

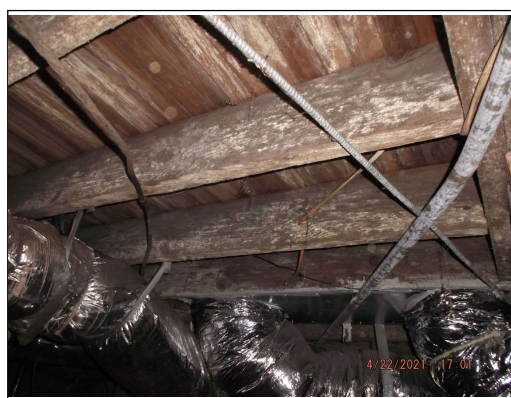
Mold and fungus

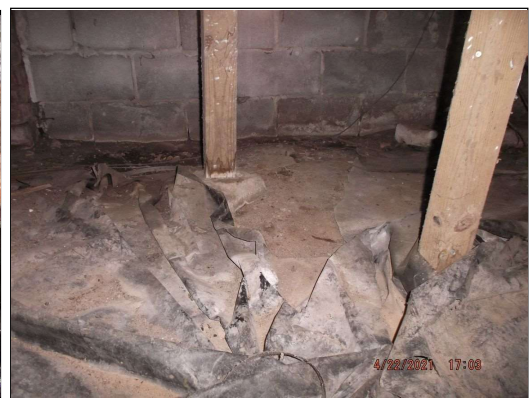
Defective moisture barrier
