Property Inspection Report

61 16th Street N.E. #1, Atlanta GA.

Dec 15, 2020

1599

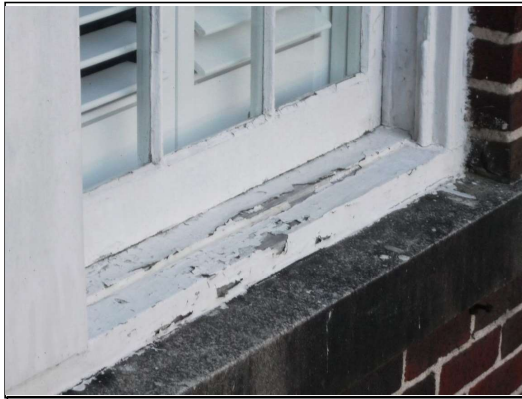
Windows have peeling paint, deteriorating window glass putty some areas, windows painted shut and screens missing. Tree limbs growing close to patio (cut limbs back). Small crack in the brick veneer on the right side over the patio door.

Deteriorating paint at windows

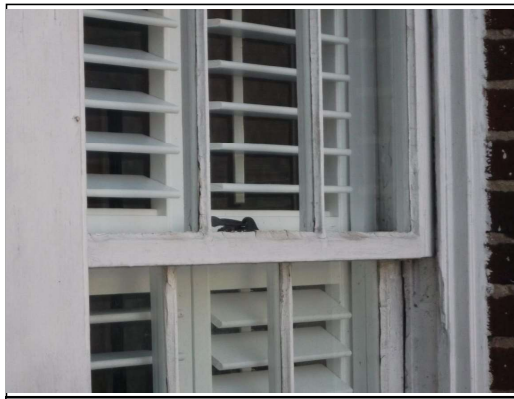
Comments Windows need pressure wash, glass putty replaced some areas and painting;

Deteriorating glass putty some window areas

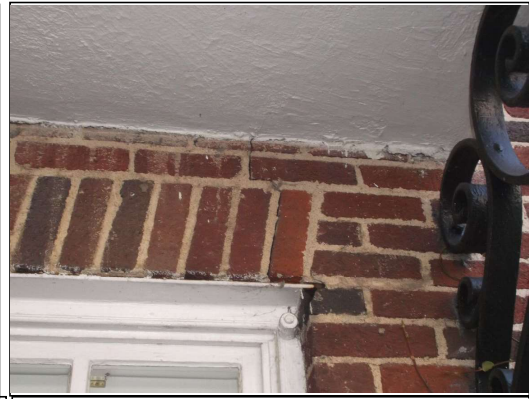
Material Stone Slate Block/Brick Fiberboard Fiber-cement Stucco Wood Asphalt Metal/Vinyl
Condition Satisfactory Marginal Poor Recommend Repair/Painting
Comments Minor crack in brick veneer above patio doorway;

Small crack above right side of the patio door

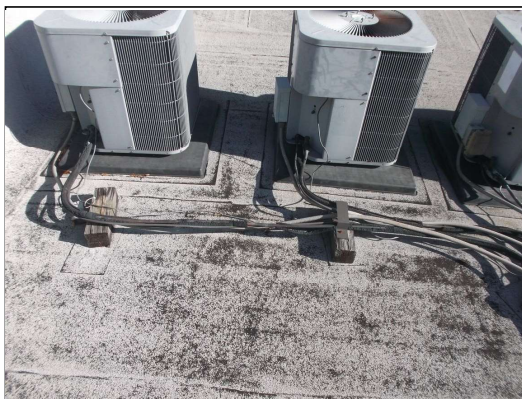
Major Concern: Many AC units on the roof were not properly marked for condo served. Refrigerant line insulation deteriorated at many AC units on the roof.

AC unit poorly marked/insulation deteriorate

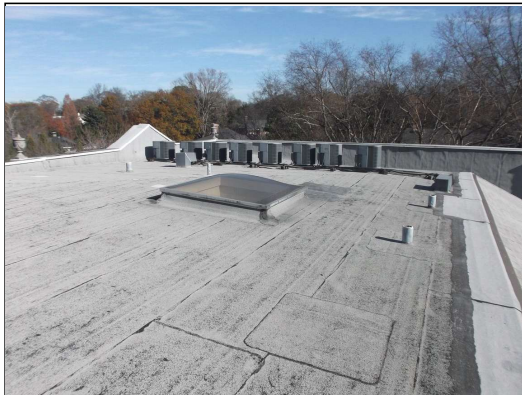
Roofing is aging, asphalt visible and worn. Roof covering in the last years of good use.

Roof covering worn

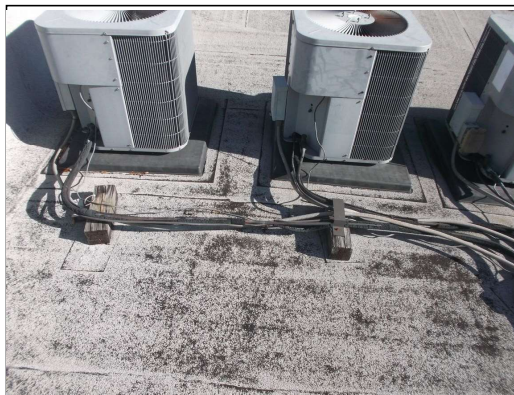
Roof covering deteriorating, asphalt showing

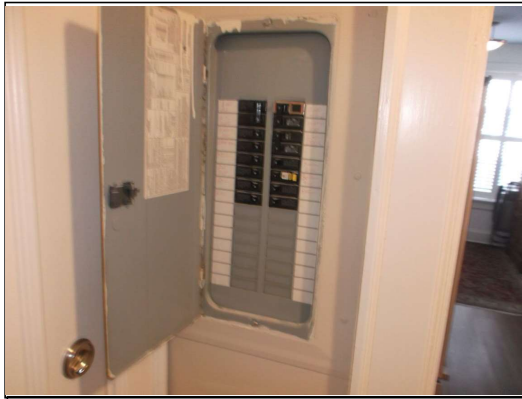
Could not remove distribution panel cover from wall as it was glued to wall with several layers of paint (can damage wall paint and finish if removed). Based on several interior outlets testing open ground it is advised to have electrical system serviced and repaired. Bedroom outlets tested open ground. Exposed electrical cable at the end of the conduit traveling around the bedroom wall. Exposed light bulb in bed closet & no switch (safety/fire hazard).

Could not remove panel cover (paint sealed)

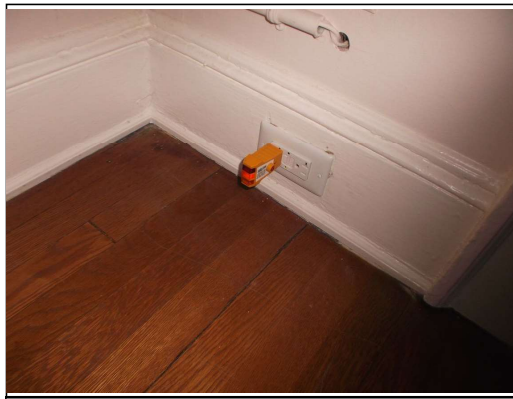
Bedroom outlets tested open grounds

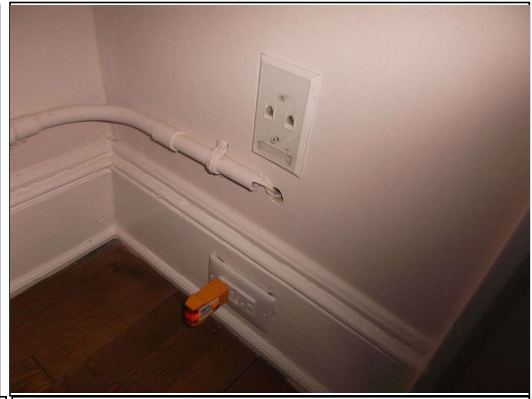
Exposed electrical cable at end of conduit

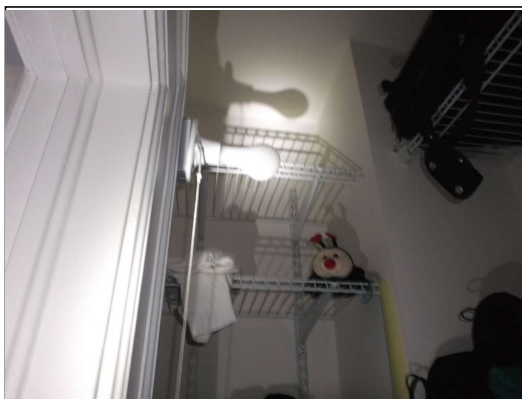
Exposed light bulb, pull chain fire hazard

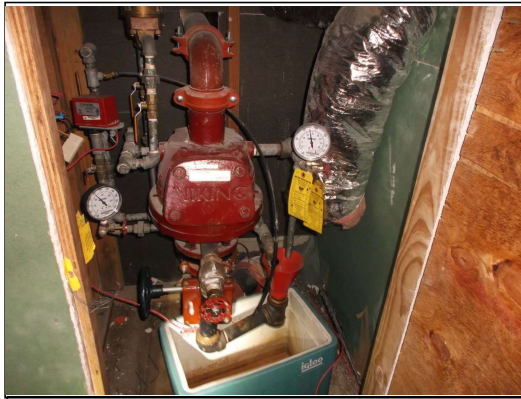
Water pipes in the attic are not wrapped in insulation (could freeze under certain conditions).

Water supply system in the attic

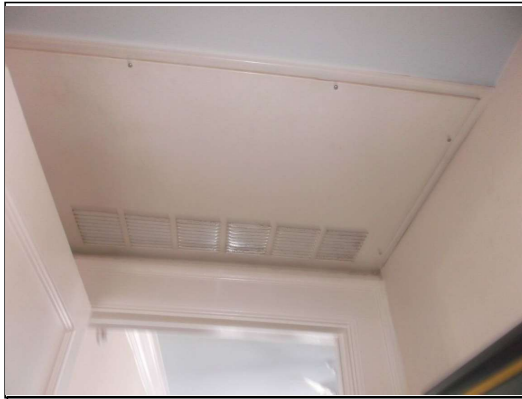
Could not access the inside of the furnace as unit is located in hall ceiling and enclosed with a panel & several screws. Furnaces should be readily accessible without the need for tools and filters should be able to be replaced without tools (tools are needed to replace the air filter). It is advised to have a HVAC technician to check and service the total HVAC system before closing to verify operation and maintenance.

Furnace & filter covered with panel & screws

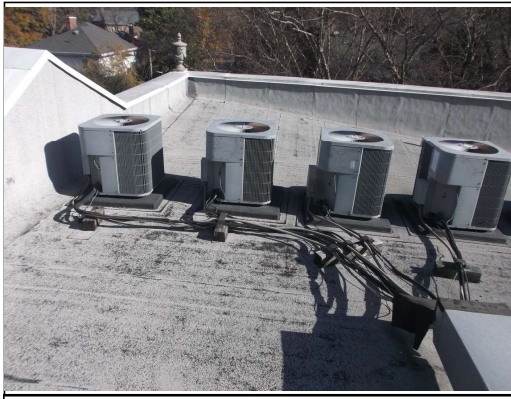
AC units appear not properly serviced

AC unit on the roof appears to have not been properly serviced. AC units are poorly marked and many not marked at all. Could not positively identify the 1st AC unit serves condo #1. AC unit operating during furnace operating in the condo was the first unit on the left on the roof (seller verify which AC unit serves condo #1). Have AC unit and cooling system checked and serviced.

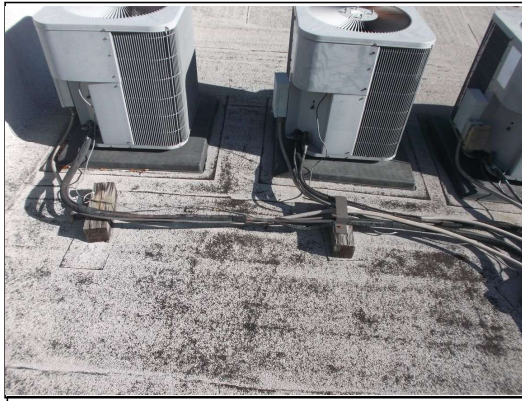
AC unit appears not properly serviced

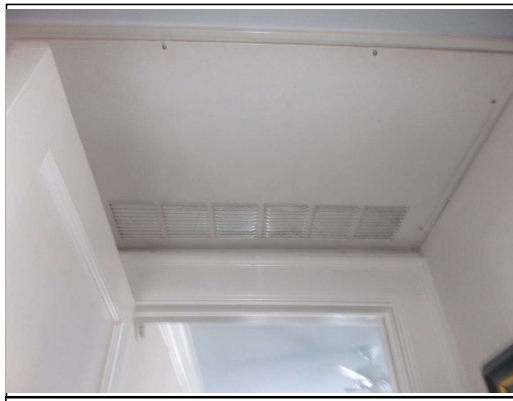
Could not access HVAC in ceiling

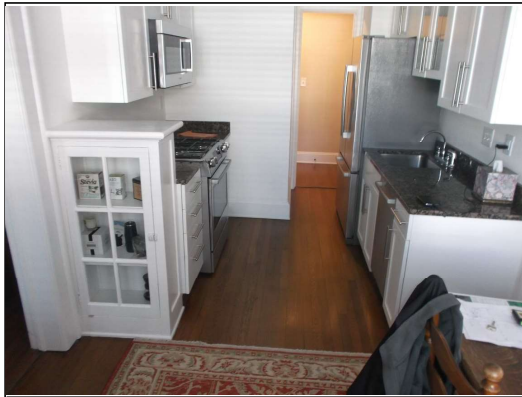
Kitchen floor slopes from the window to the center of the kitchen and kitchen floor slopes towards the stove.

Kitchen floor settling and slopes to stove

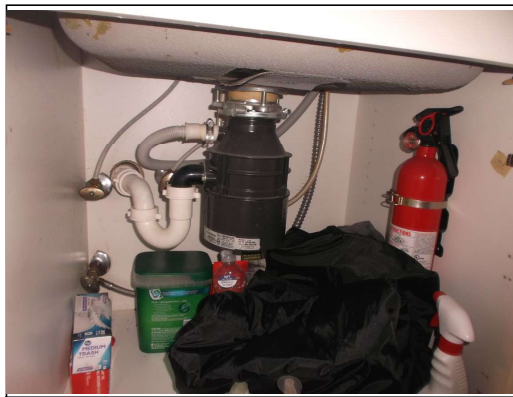
Disposal not operational

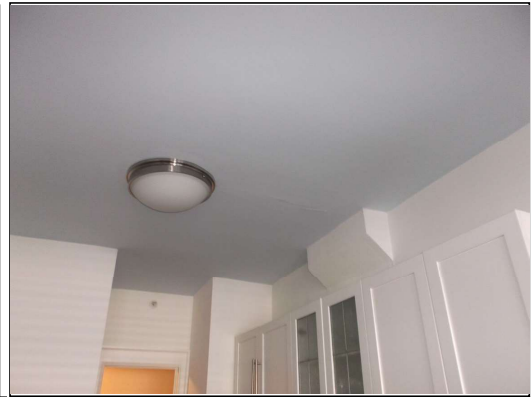
Light not operational

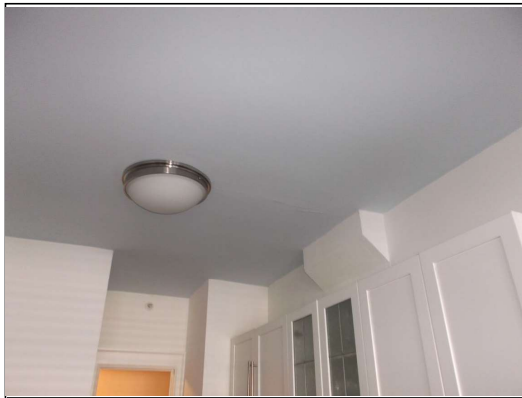
Peeling paint and sagging in kitchen ceiling

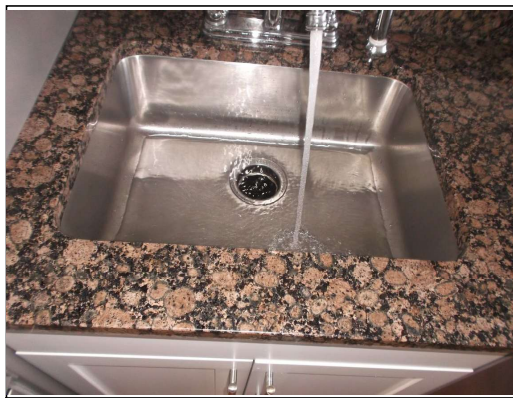
Water slow draining out the kitchen sink

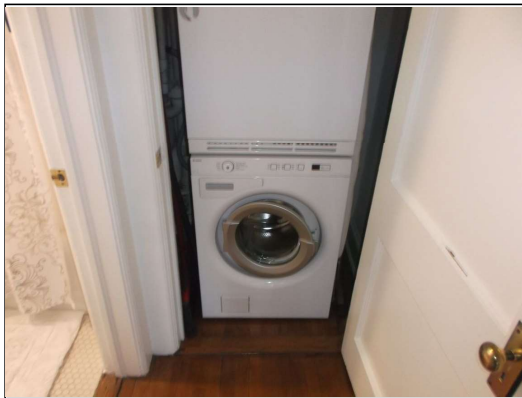
Maintenance:
 There is no washer drain pan installed under the stack unit with a drain pipe extending to the exterior of the building. Could not see the water hookup faucets in the laundry closet. Could not verify the dryer is properly vented to the exterior.

No washer drain pan & pipe to ext. installed

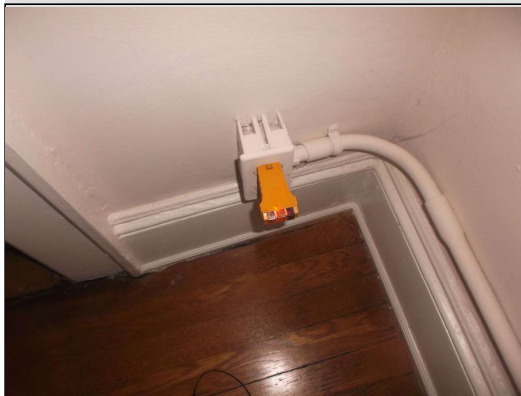
Bed outlet tested open ground

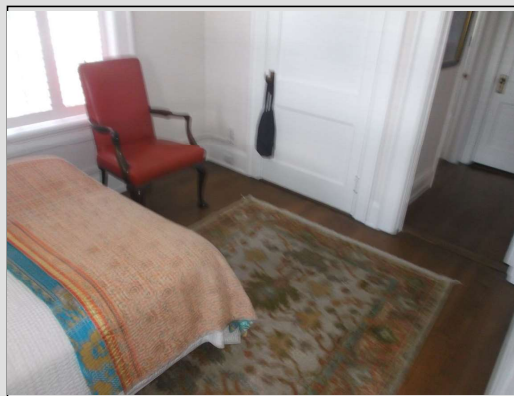
Bed floor slopes to exterior corner

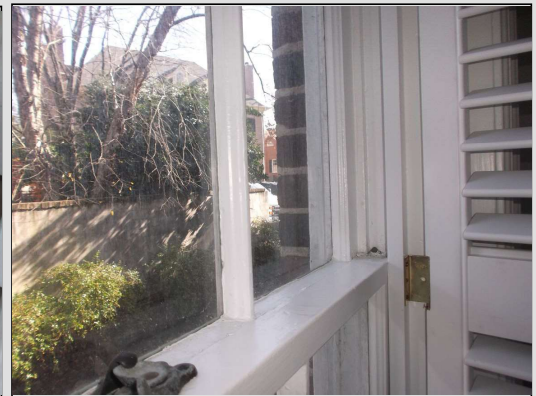
Bedroom windows painted shut, no sash cords

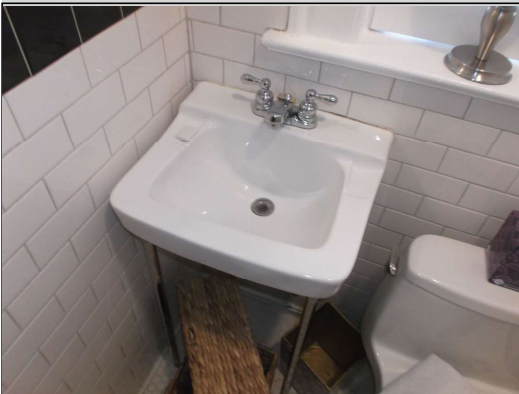
Sink stopper missing

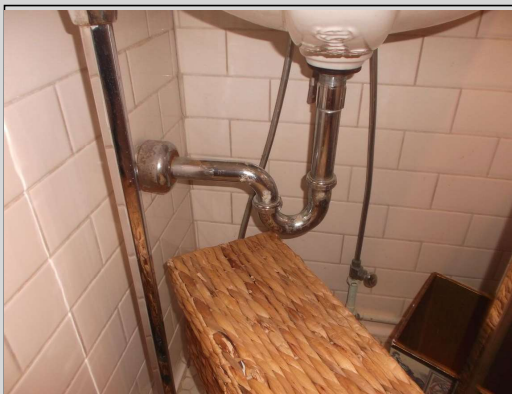
Drain pipe corroding

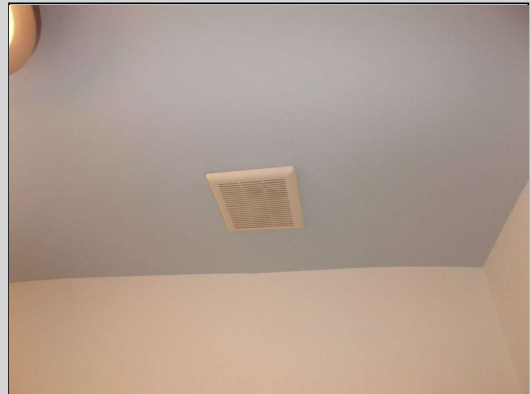
Exhaust fan vibrates and cover dusty

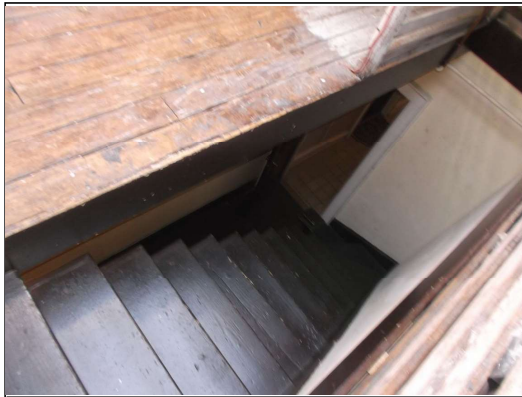
Missing guard rails and handrails at the stairs leading up to the attic and missing guardrails around the the stairwell in the attic can be a fall hazard.

No handrails around attic stairwell & at stairs

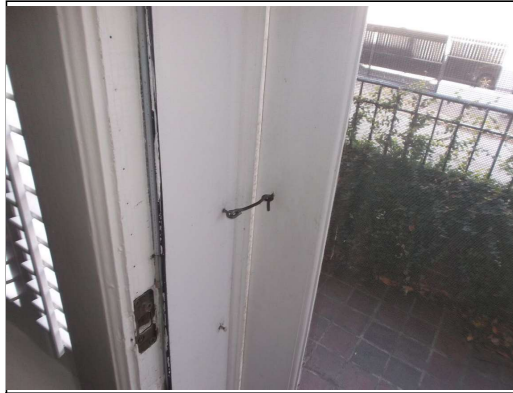
Screen door to the patio door latch or hook not keeping door fully closed.

Hook not closing screen door fully
