PROPERTY INSPECTION REPORT

660 Brownlee Rd. SW. Atlanta, GA.

Oct 25, 2021

1599

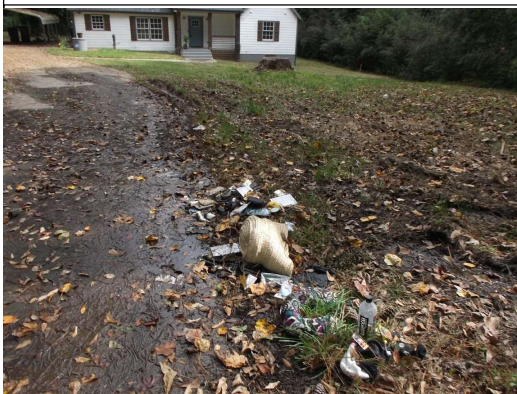
The ground is very wet and water saturated at the top of the front yard, wet ground around the dead tree stump. There is a water leak in the front yard.

Water leak in the front yard

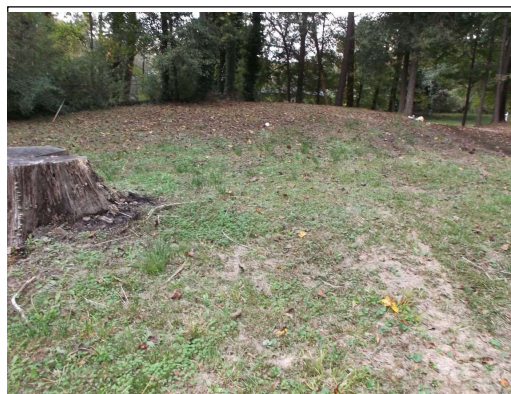
Dead tree stump and soggy soil

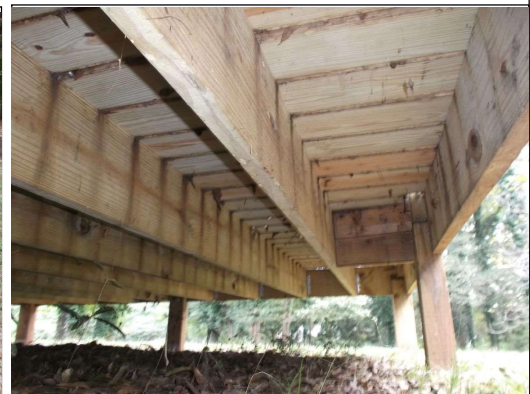
Deck posts are notched but not bolted to rim

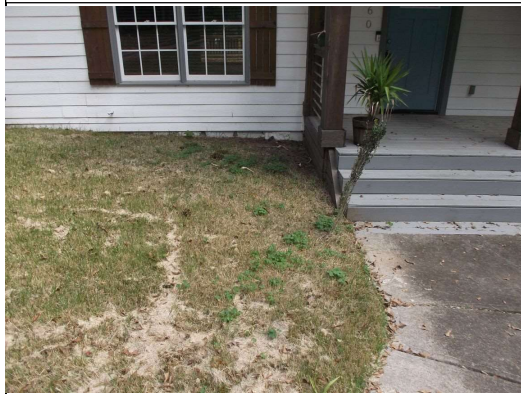
The soil slopes towards the front porch and foundation at the front of the house. Tree at the left rear corner of the house needs limbs cut back (limbs touch roof).

Soil slope to porch and foundation

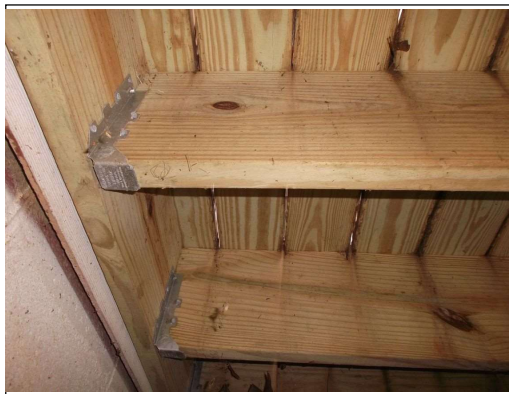
Wood deck missing flashing at house wall

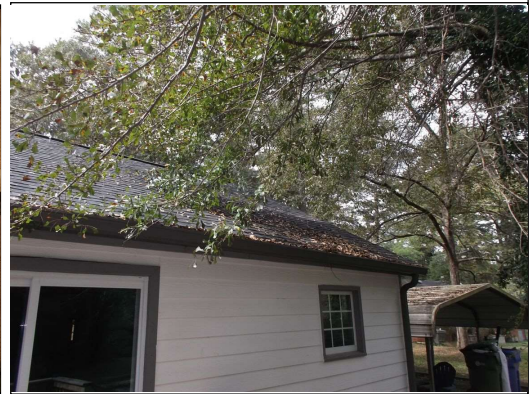
Tree needs limbs trimmed

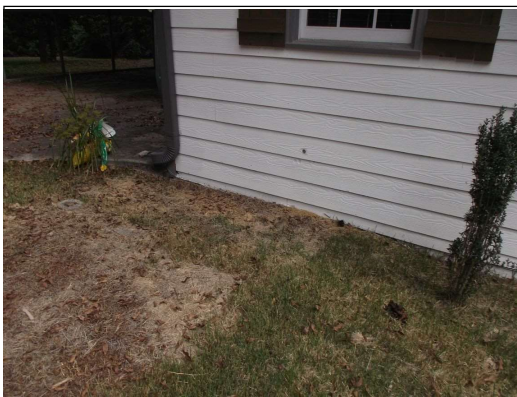
Siding in the soil

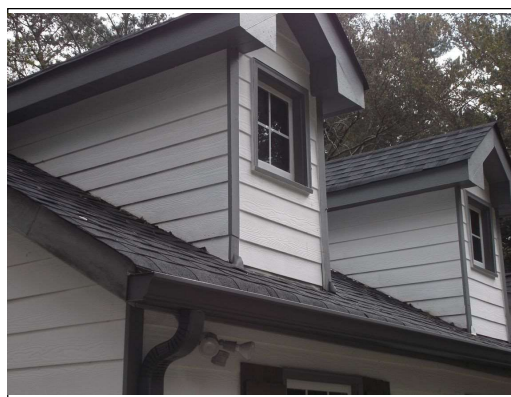
Siding touch shingles

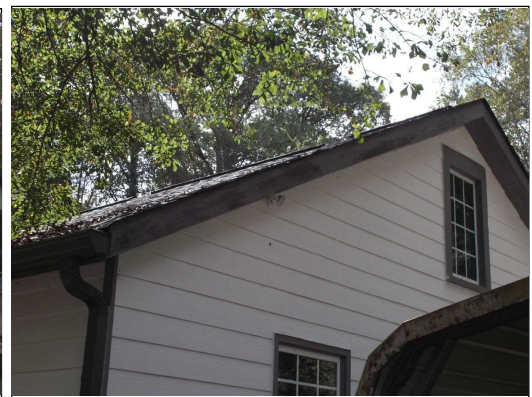
Fascia board is plywood and mold on wood

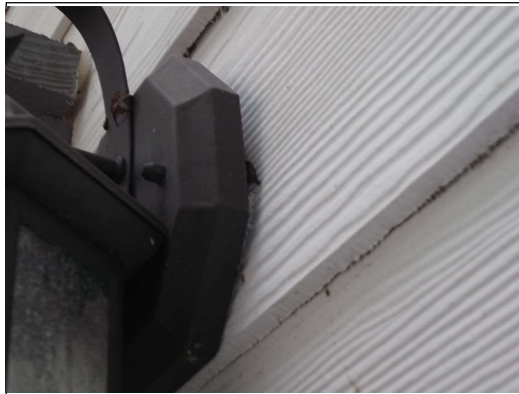
Missing caulk at fixtures on siding

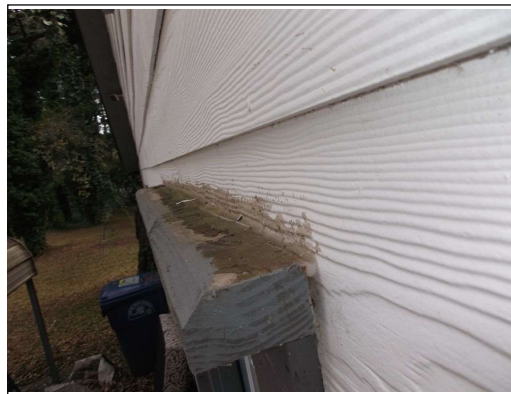
Cannot verify flashing over side door

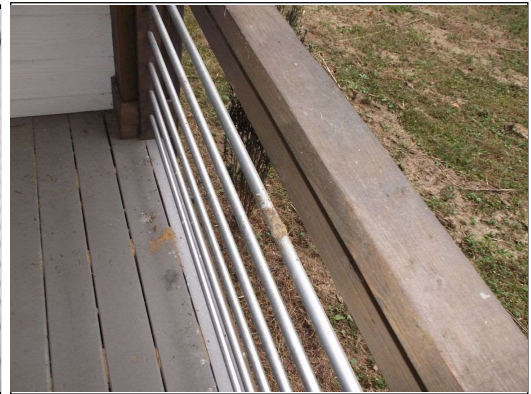
Front porch floor needs pressure wash. Bees eating holes into porch wood railing.

Bees drilling holes in the wood railing

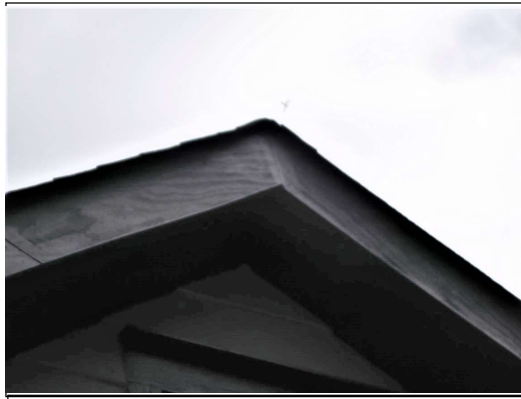
There are no vents cut into the soffit plywood. Tree limbs touch roof. Missing drip flashing on the gable fascia boards. Plywood used for fascia boards is wrong type of wood (should be 1 by 6 or 1 by 8).

Fascia made of plywood/missing drip flashing

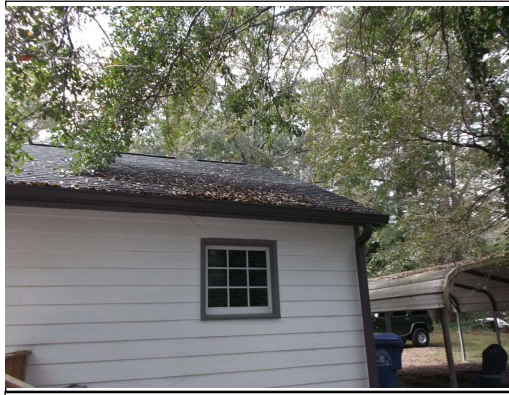
Debris on roof, tree limbs touch roof

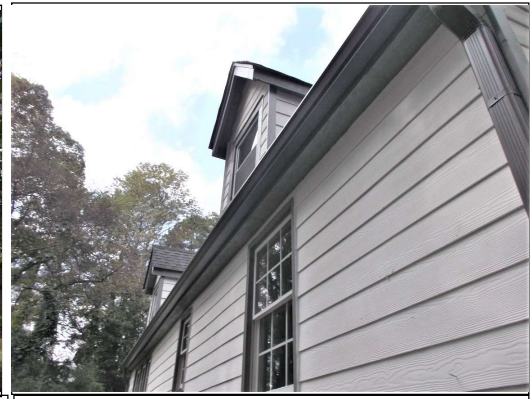
No vents installed at the soffit plywood

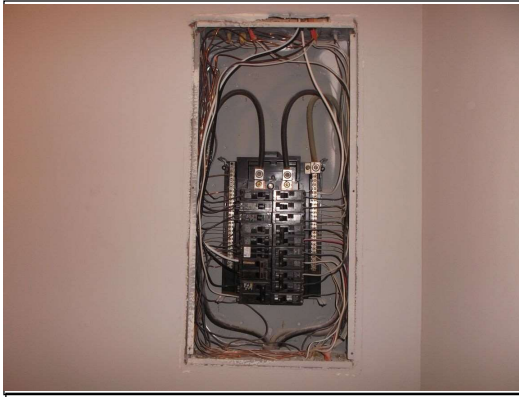
The service cable's from the street mast head was partially covered with the soffit plywood at the driveway side of the house. There is an open space at the top of the distribution panel that can let sparks escape into the wall (fill gap properly).

Gap at the top of the panel can let sparks out

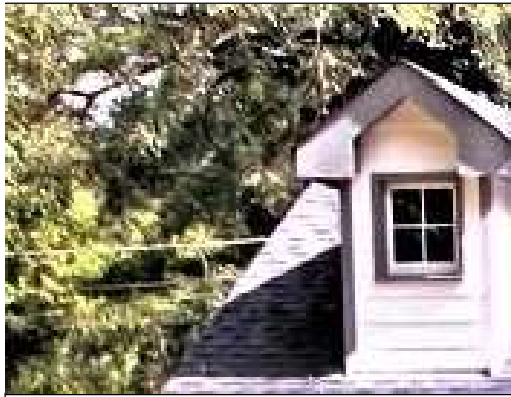
Electrical cables must head under soffit

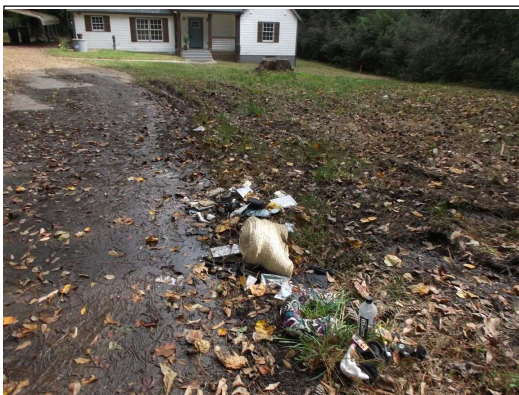
Major water leak in the front yard. Ground in the front yard is water logged from leaking pipe verify all water bills are paid if home is purchased.

Major water leak in the front yard

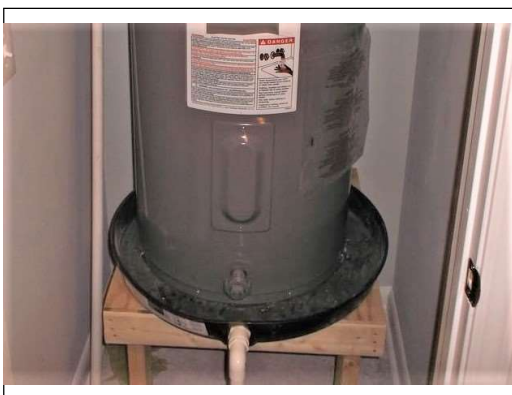
Water heater base poorly built can fail over time

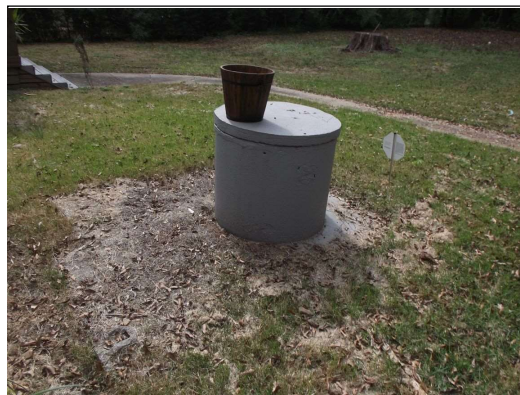
Old well in the front yard

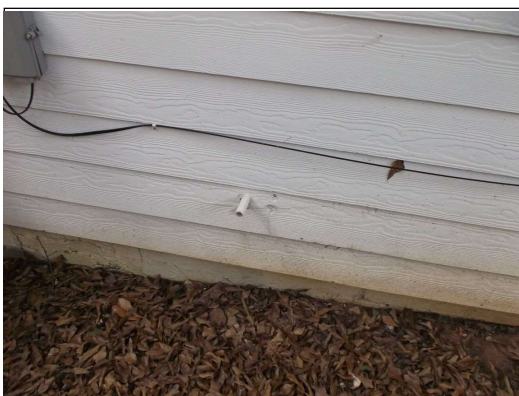
Drain pipe not turned down to the ground

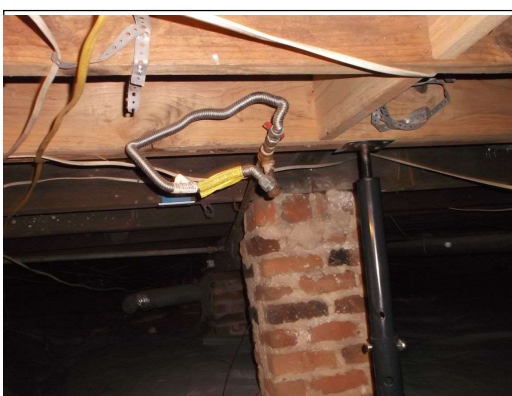
Uncapped gas pipe in crawlspace

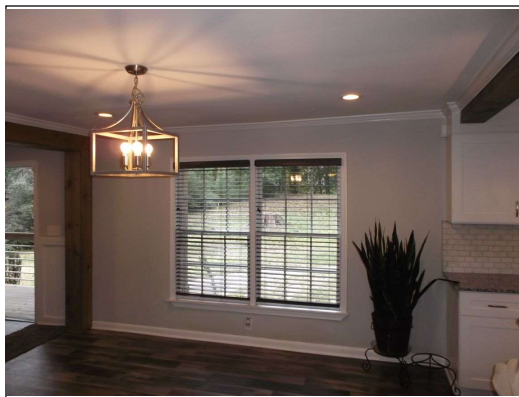
Air vents have been installed in the wrong locations in the ceiling at all rooms. The send air registers are located near the interior walls or center of the rooms. Air sends shall be located at exterior walls over windows or doors. This configuration will cause rooms to not heat and cool properly during the warm and cold months. This type of installation will cause conditioned air to return to the furnace before heating or cooling rooms properly causing higher energy usage.

No air vents at exterior wall

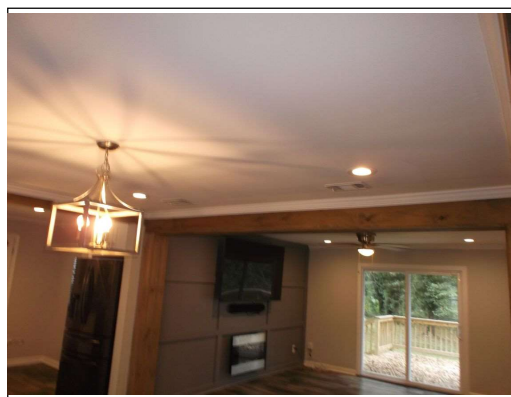
Air vents at center of room

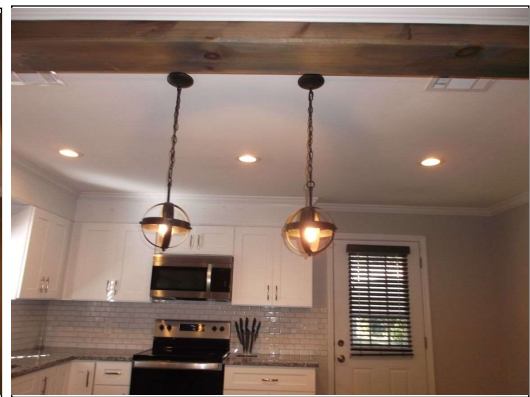
Air vent located near beam wrong place

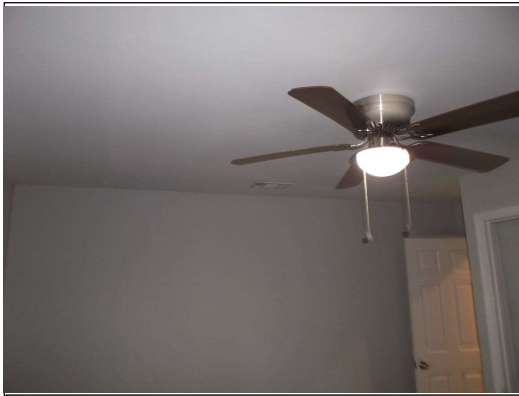
Air vent located near interior wall in bed

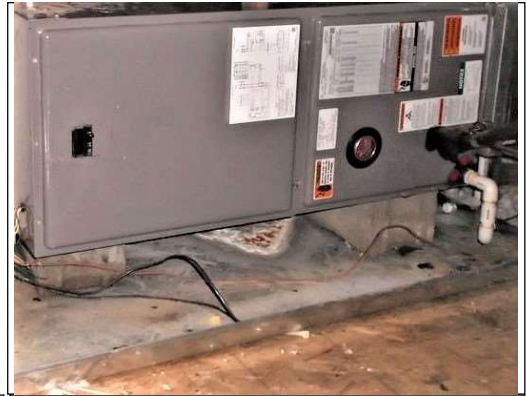
Corrosion in furnace drain pan may indicate condensate issues now or in the past. There are dry water stains on the den ceiling where these may be under the furnace location (verify no leaks at furnace and AC system).

Corrosion in drain pan under furnace

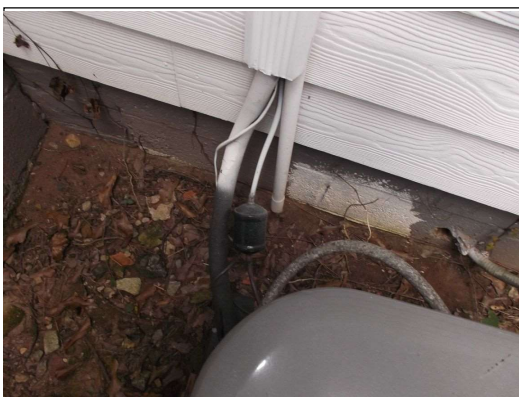
Condensate drain pipe pour at the foundation at the rear of the house behind the AC unit can saturate soil shall be routed 3 feet away from the foundation

Condensate drain pipe pour at foundation

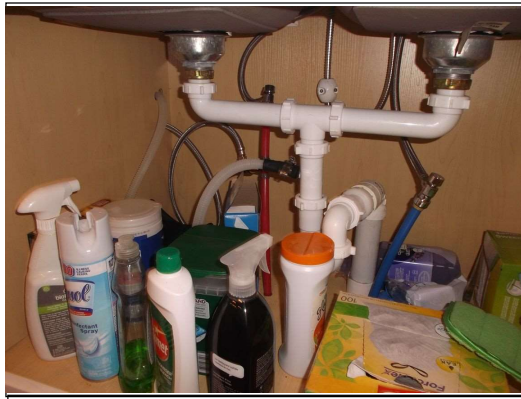
Drain pipe S-Trap

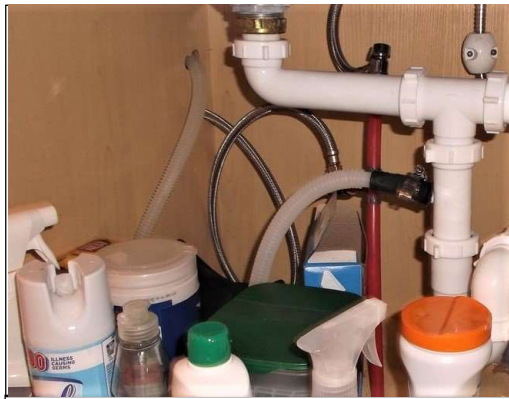
Dishwasher drain pipe not high looped

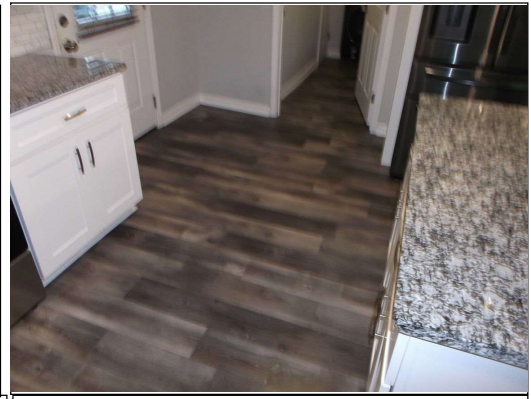
Floor sagging in door area

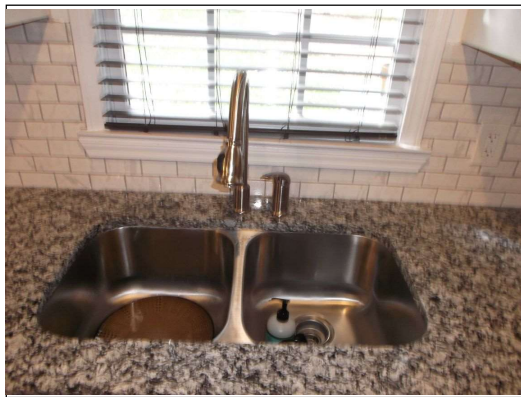
Faucet spout loose at the base

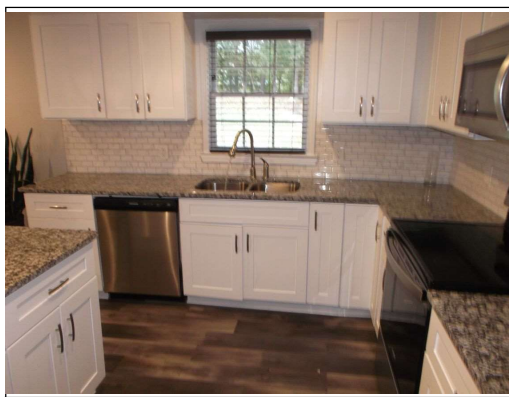
Counter and floor slopes to the left

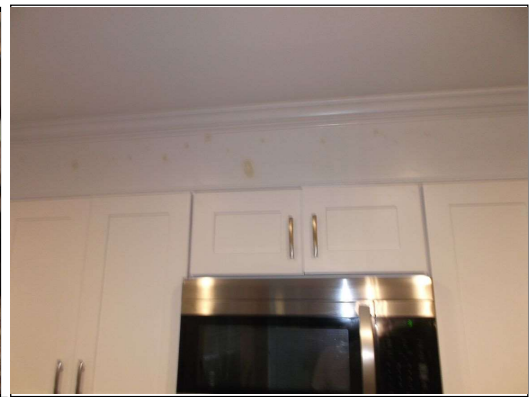
Defective paint above/doors bump

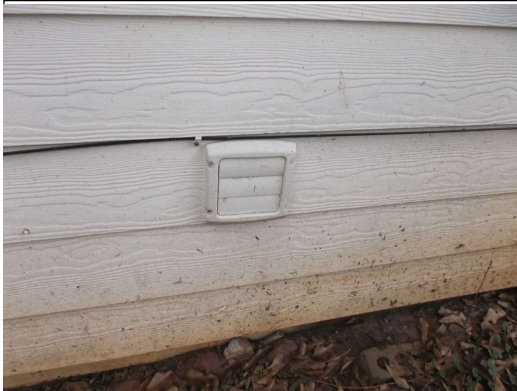
No washer drain pan installed in the laundry room. Improper vent terminal at the exterior wall is a fire safety issue (can block lint discharge and clog) should be a door flap and no grill in vent terminal).

Improper dryer vent terminal (this is for bath)

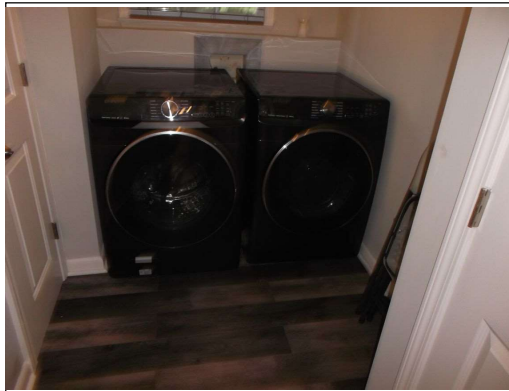
No washer drain pan installed with line

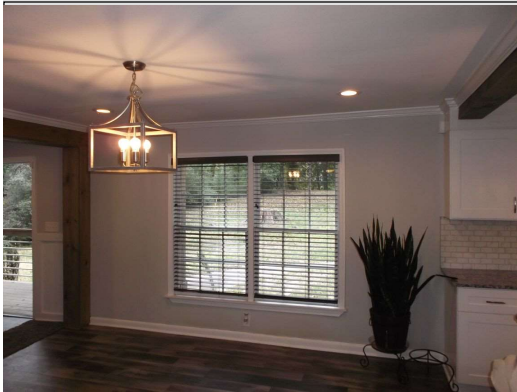
Ceiling sagging over window area

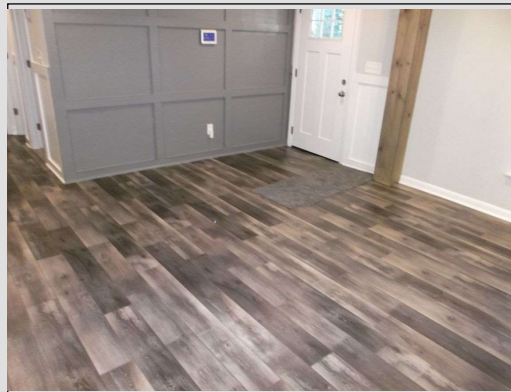
Floor settling at front door area

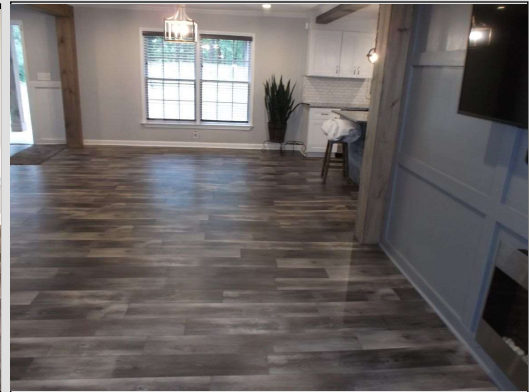
Floor sagging in the center of the room

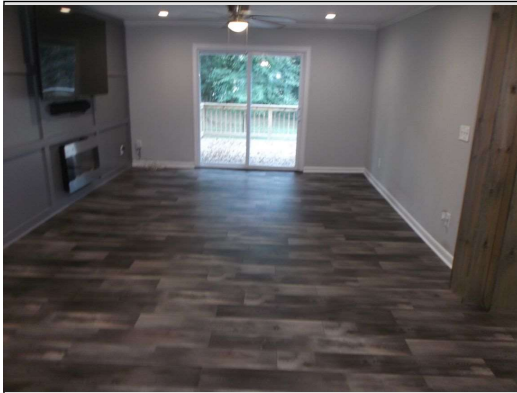
Floor sagging and settling toward S/L door

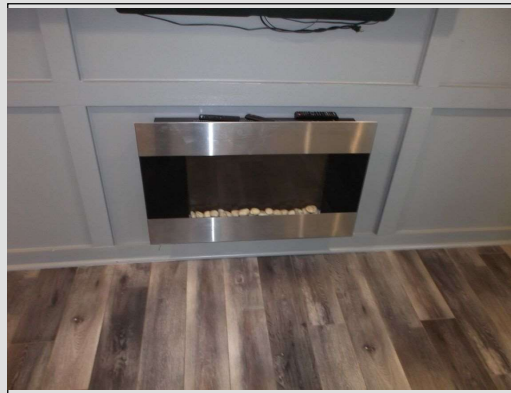
Verify fireplace operational

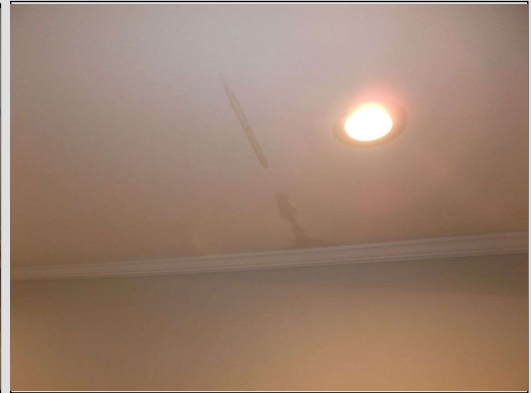
Water stains in den ceiling

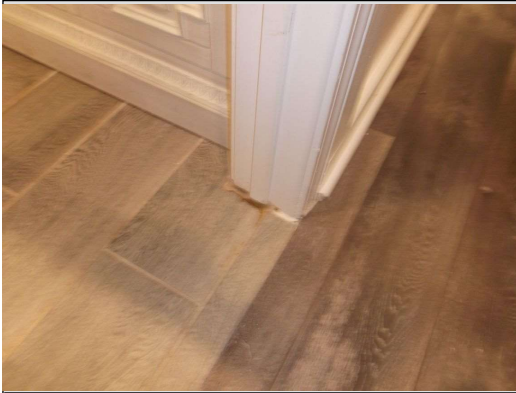
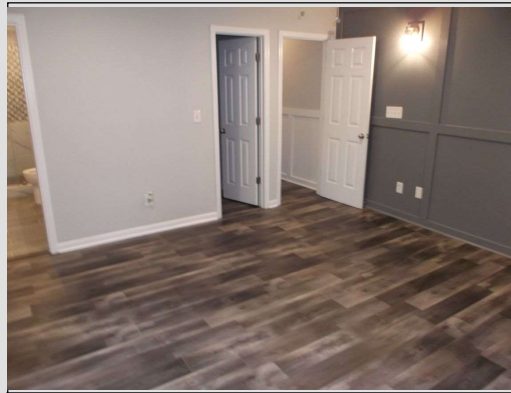
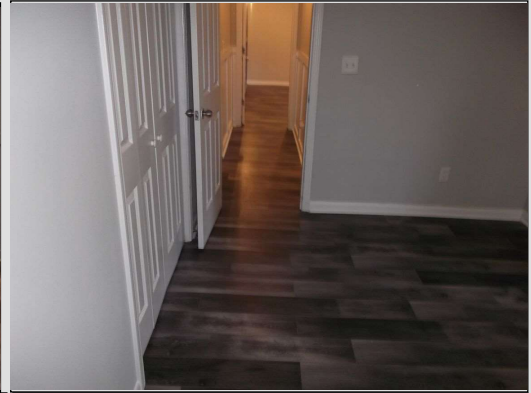
Bedroom Areas: Missing caulk where door frames end at the flooring. Defective finishing at walls and ceilings at some areas. Floors squeak at various areas. Floors rise and settle at various areas at the halls and bedrooms. There is no door at the coat closet.

Floor settles at master bedroom areas

Hall slopes to the right and settles

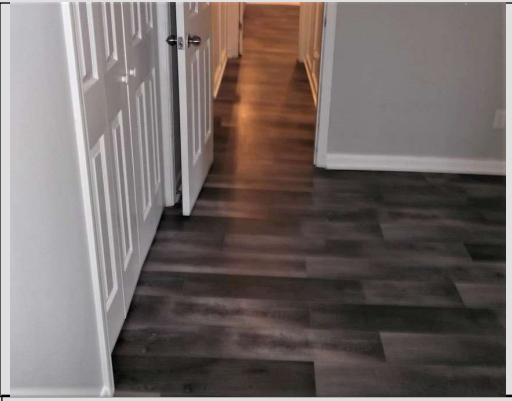
Floor sagging

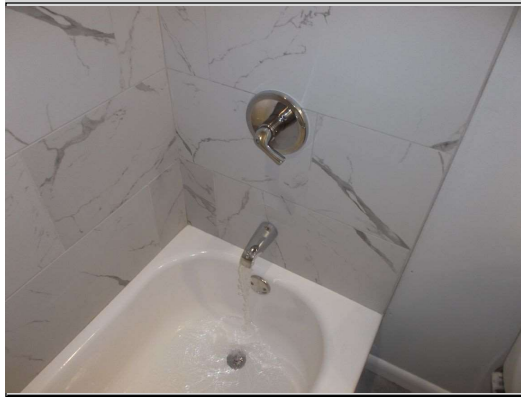
Tub spout and faucet handle loose

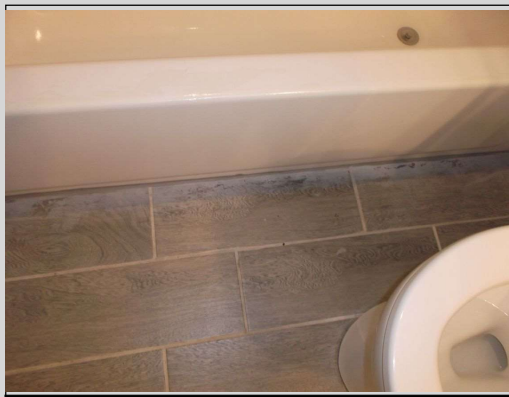
Paint on floor tile

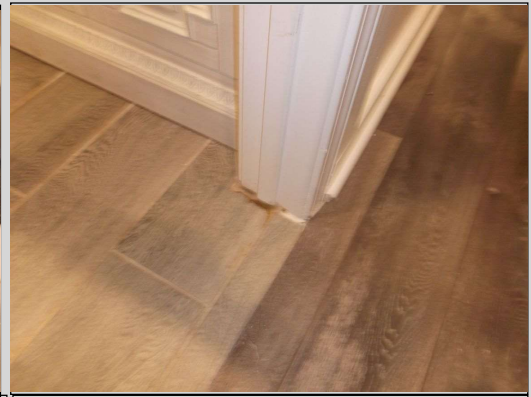
Large gap at door frame and floor

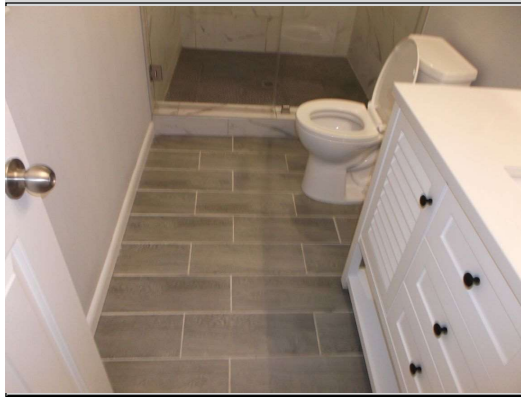
Floor settling near toilet

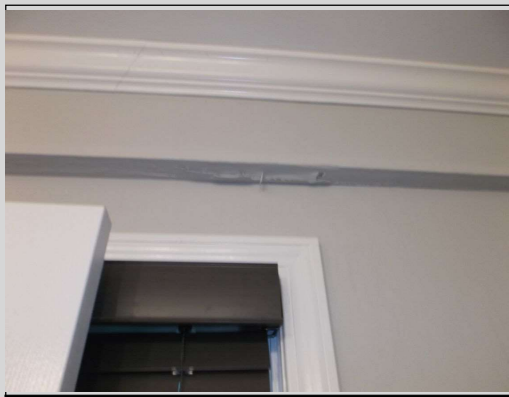
Paint peeling above window

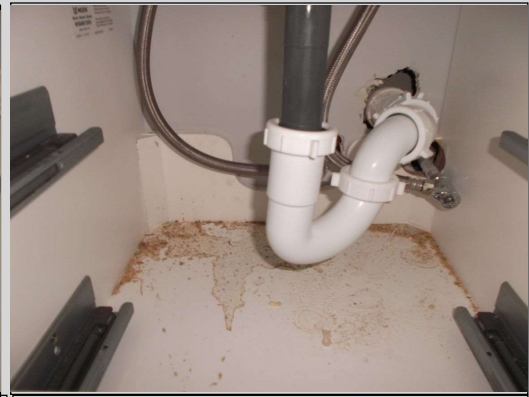
Dry stains on cabinet floor

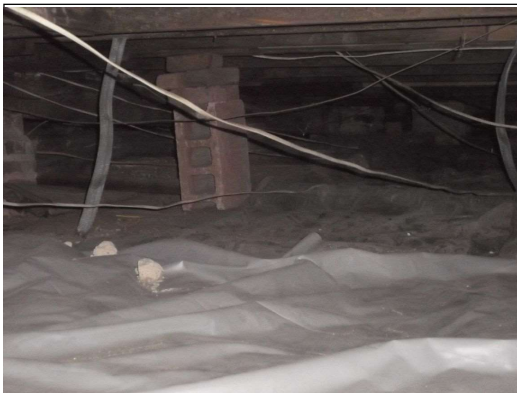
Bricks, blocks stacked and jack posts placed to support floor system at various areas in the crawlspace. This may indicate defective and weak floor system at various areas under the house.

Stacked blocks and bricks

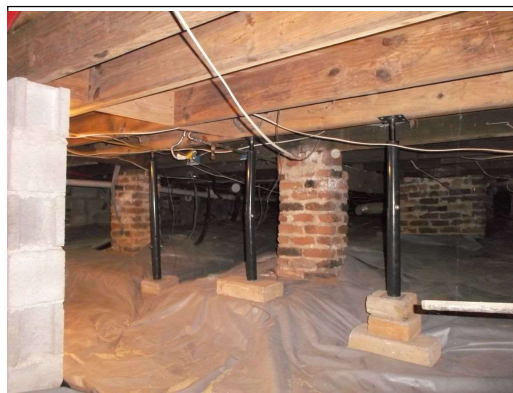
Jack posts placed under floor framing

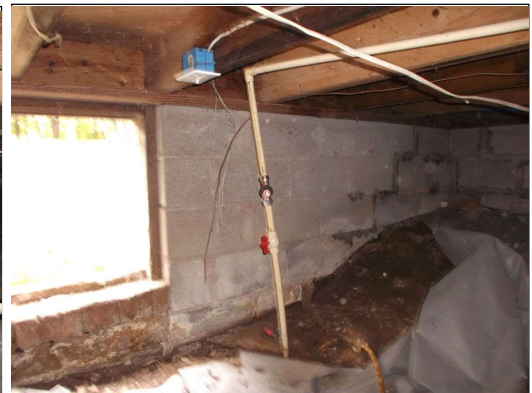
Exposed soil and defective moisture barrier in the crawlspace (poorly placed over soil). Debris in the crawlspace.

Exposed soil in crawlspace

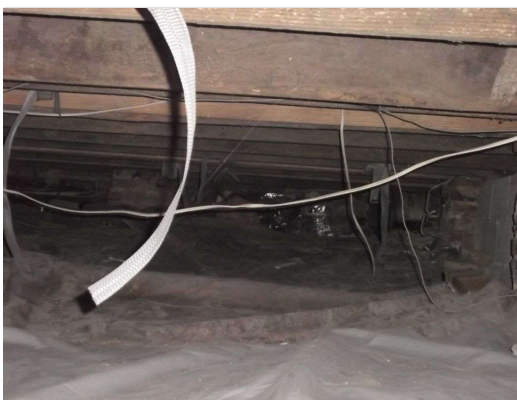
Loose moisture barrier/debris
