PROPERTY INSPECTION REPORT

1350 Carter Rd. Decatur, GA. 30030

Oct 31, 2021

1599

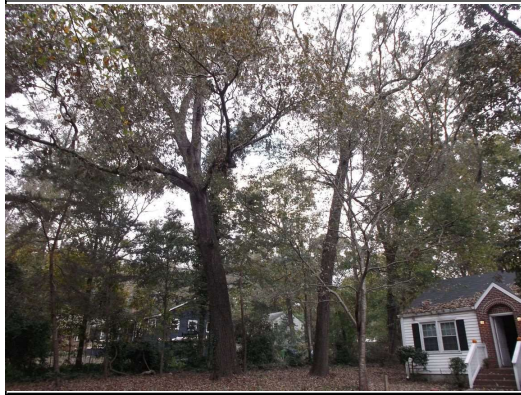
Trees have excessive leaning in front yard

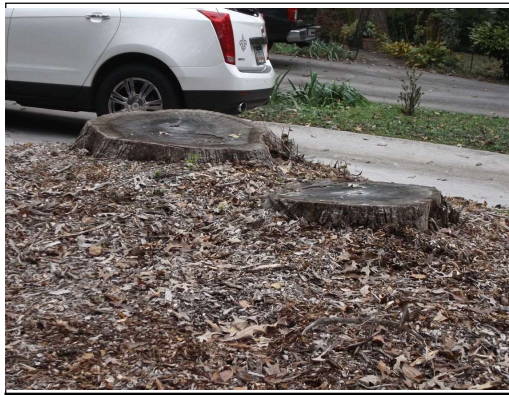
Large tree stumps in the front yard

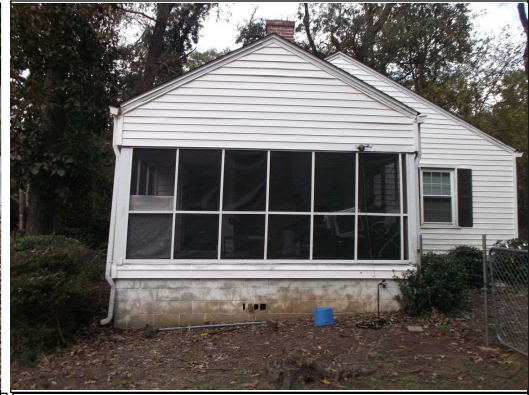
Screened porch framing leaning

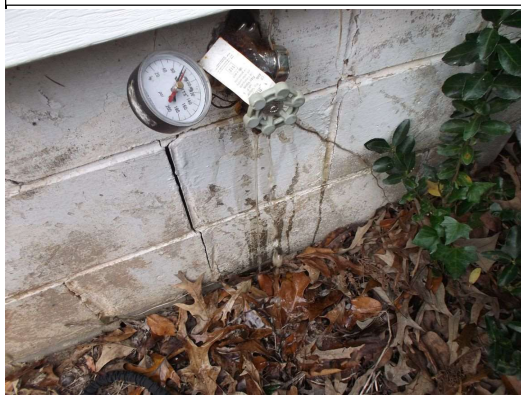
Exterior hose faucet pipes loose in the walls and movement when turning on and off the water can cause damage.

Slight cracks in foundation/faucet loose

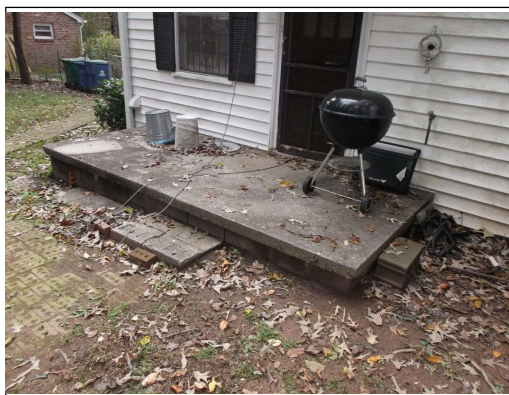
There is no handrail at the front stairs railing, front steps have slight rotation forward. The rear concrete patio has poor slope away from the building (surface water can flow to the house during heavy rains, can cause water damage to floor seals in this area and under the rear door threshold).

Rear patio has poor slope away from house

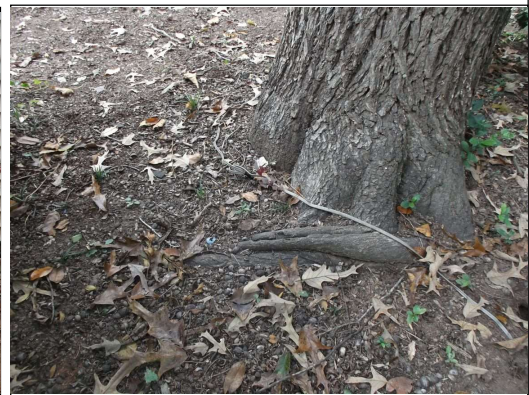
There is an electrical cable leading out of a foundation vent, traveling across the ground and up the tree to a flood light that is not protected from damage and has exposed connections near the tree. The receptacle on the short post in the yard tested on GFCI protection and open or weak ground.

Electrical cable & connections exposed

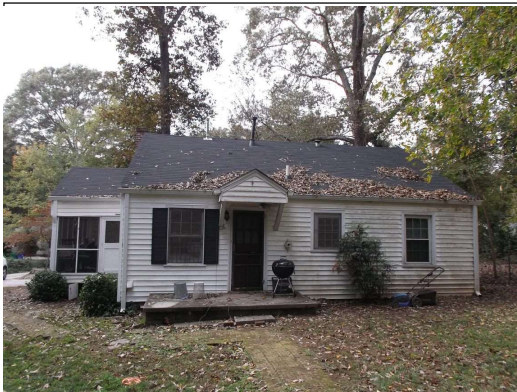
Siding needs pressure wash. Siding in the soil at the rear and the left side can cause water damage and attract termites. Missing caulk where light fixtures are attached to the front porch brick veneer. There are unprotected holes in the siding where AC pipes enter wall at the left side of the house. Some siding panel loose or detaching at some areas around the house.

Siding needs wash & contact the ground

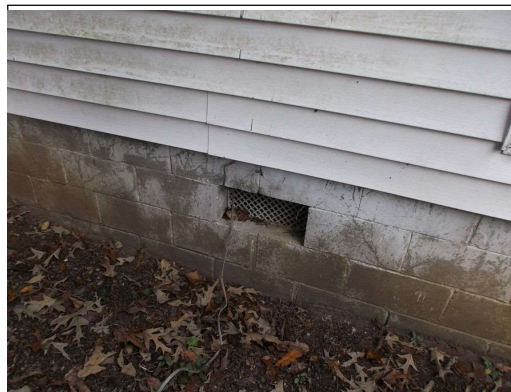
Foundation has missing and defective foundation vents. Can see slight settling cracks in foundation at a few areas. Foundation needs wash and painting.

Foundation vents no screens and no doors

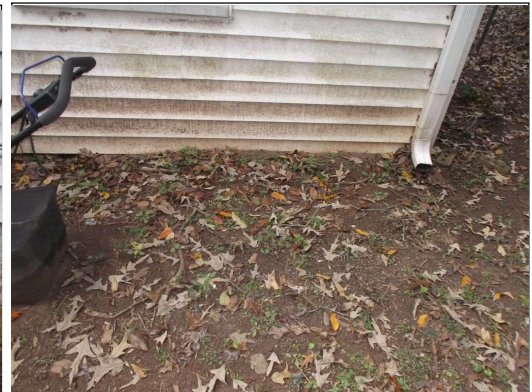
Siding in the soil, needs wash

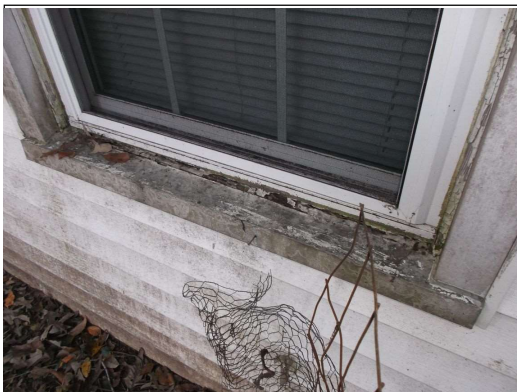
Water damage noted at the window seal on the left side of the house. Some metal cladding at the window seals have poor slope away from the wall and can cause water to drain back to siding and or wall. Rear wood windows original and need repair and glass putty replaced. may be water damage to window seals under medal cladding.

Rot a window seal at left side

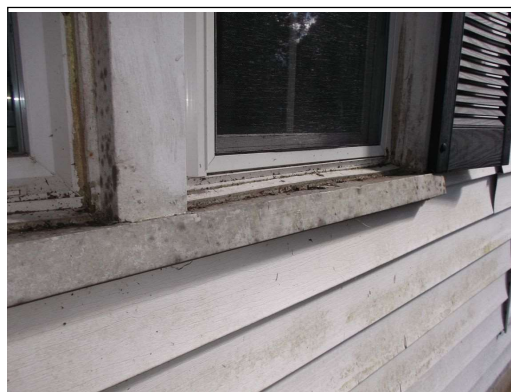
Cladding on seal slope to window

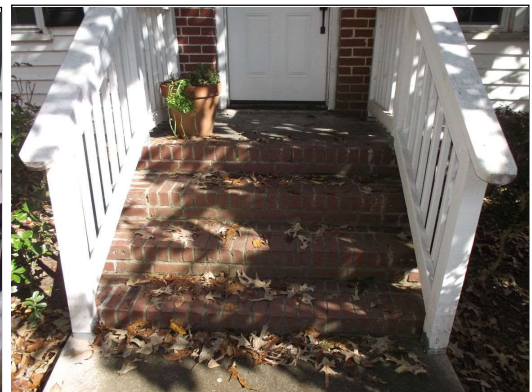
There is no handrail at the front stairs railing, front steps have slight rotation forward. The rear concrete patio has poor slope away from the building (surface water can flow to the house during heavy rains, can cause water damage to floor seals in this area and under the rear door).

Missing handrails at front railing

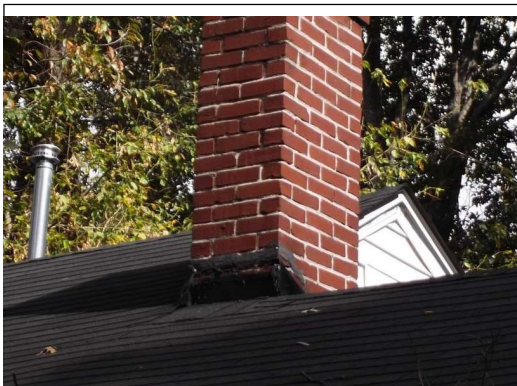
Improper flashing covered with tar

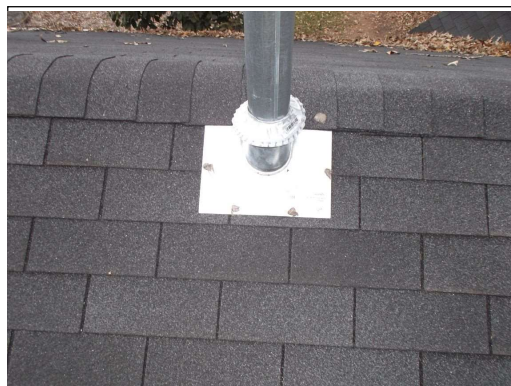
Pipe flashing is installed on top of shingles and face nailed at areas. Pipe flashing not under shingles and lifting at the rear lower roof area. The flashing around the chimney at the roof line appears to not have a tight seal on the brick. There is mold on the trim at the chimney brick seen from the side porch may indicate a leak at the chimney on the roof. Missing rain cap at gas vent pipe on roof.

Flashing on top of shingles face nailed

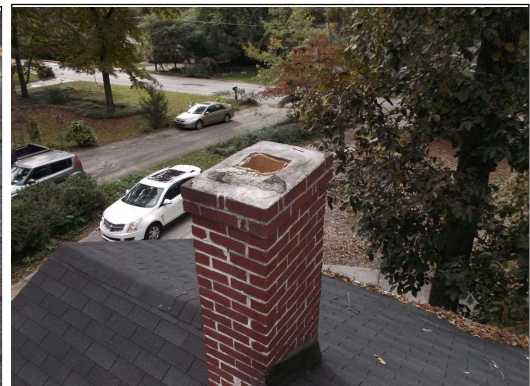
Chimney missing rain cap and spark screen and flue pipe broken off down to the top of the chimney.

Missing chimney cap and broken flue pipe

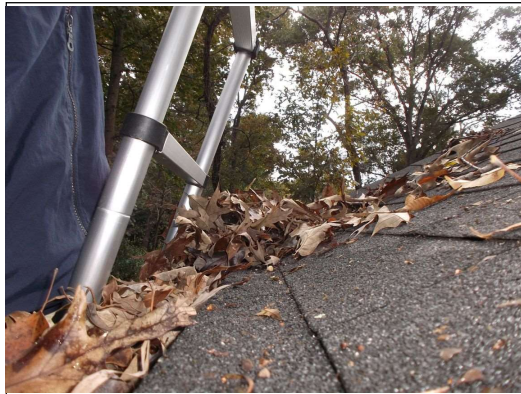
Shingles roll up near gutter

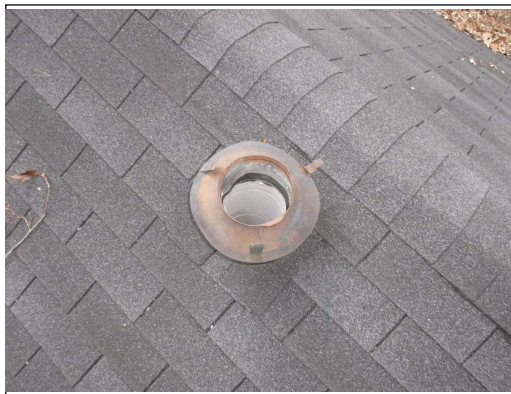
Missing rain cap on gas vent pipe

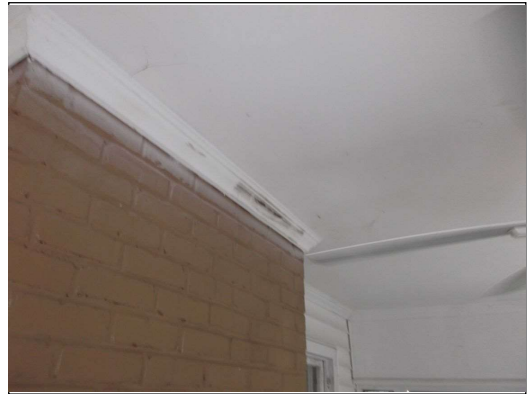
Mold on molding at porch may indicate leak

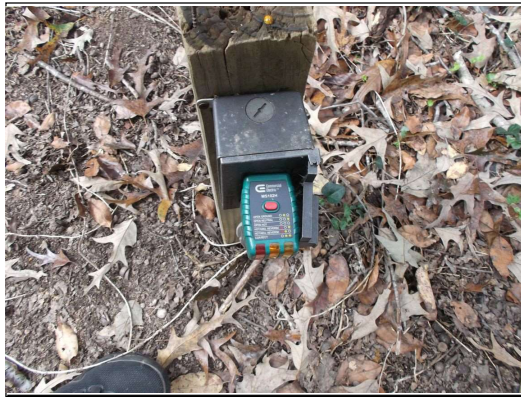
Yard outlet tested open ground/no GFCI

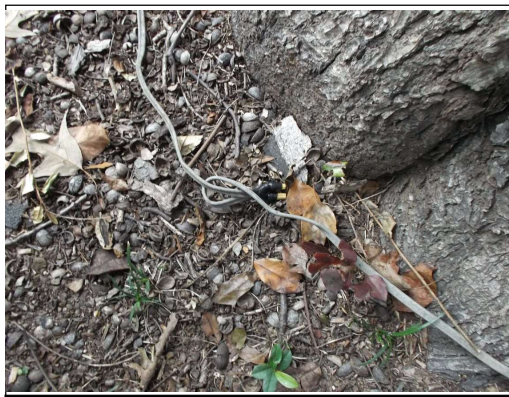
There is a electrical cable leading out of a foundation vent, traveling across the ground and up the tree to a flood light that is not protected from damage and has exposed connections near the tree. The receptacle on the short post in the yard tested on GFCI protection and open or weak ground.

Exposed cable and wire connections

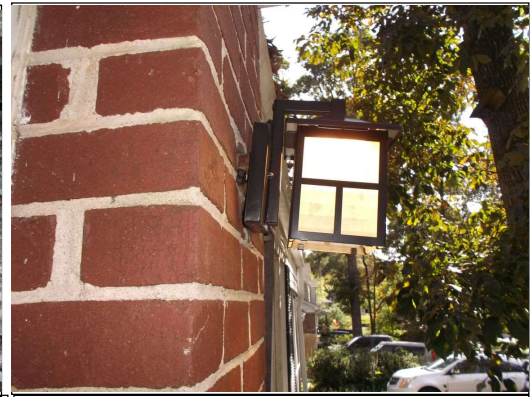
The exterior light fixtures attached to the brick at the front porch appears to be loose in the wall and missing a caulk seal around the fixture on the wall to prevent water entry into the holes in the wall. There is a screw missing in the distribution panel cover in the hall closet.

Loose light fixtures on brick veneer

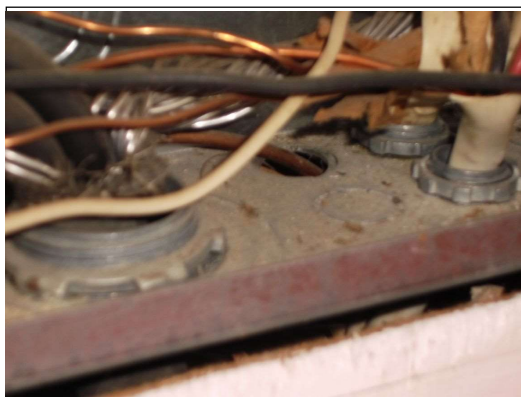
Open hole and gap at bottom of panel

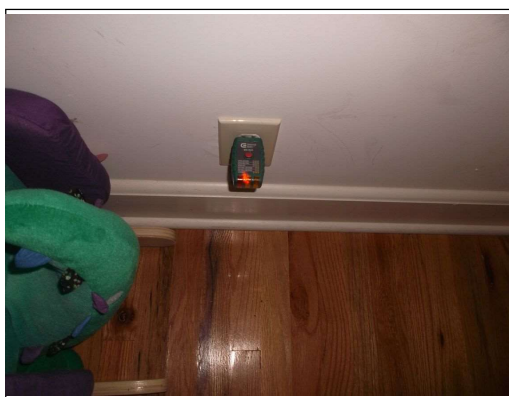
Outlet tested open ground

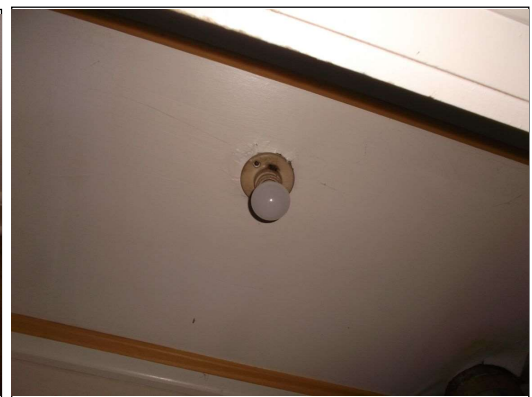
The lights in the closets are utility fixtures without globes can be a fire hazard (lights in closets should have globes).

Exposed light bulbs in closets

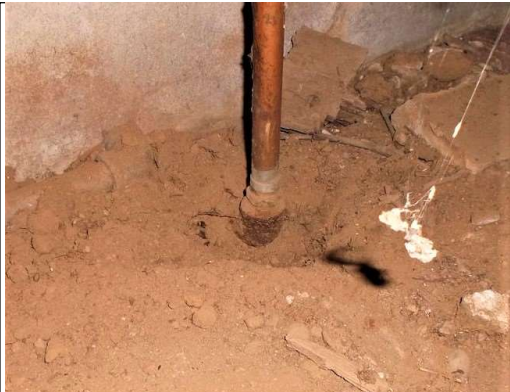
Main water pipe appears to be steel

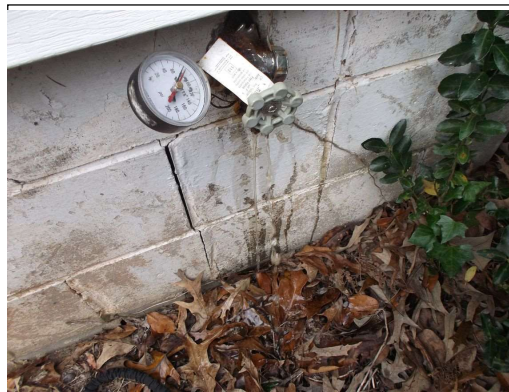
Verify hose faucets leaking at the handles

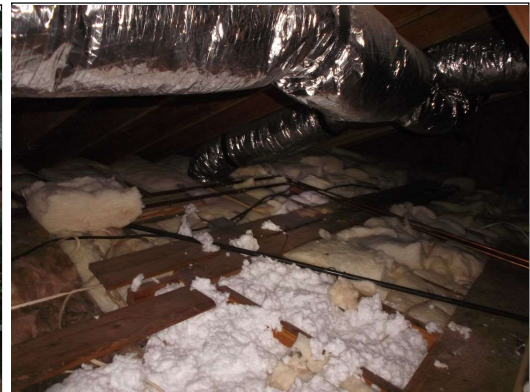
The water pipes in the attic are not wrapped with pipe insulation (can freeze and burst if there is no heat in freezing weather for an extended amount of time). Seller verify the water heater is properly supported with the ceiling joists or extra support has been installed under the water heater in the attic. Water pipe used for gas pipe seen in the crawlspace. Copper and steel pipe join above the water heater can cause corrosion and rust in the pipes. Expansion tank supported with the water pipe can damage the pipe.

Water pipes in attic not wrapped in insulation

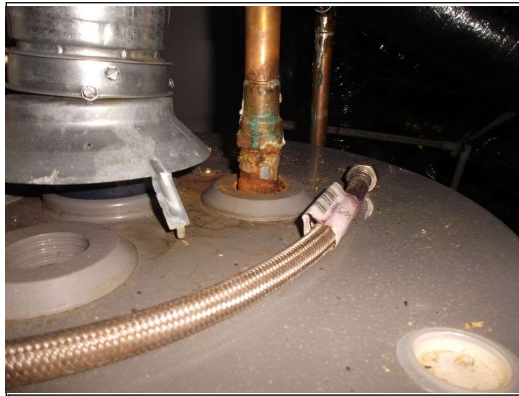
Copper and steel join causing rust & corrosior

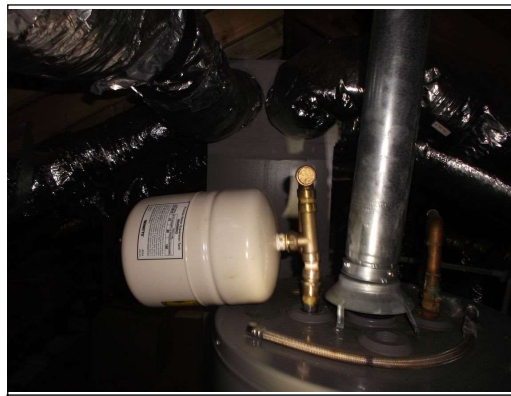
Expansion tank supported with water pipe

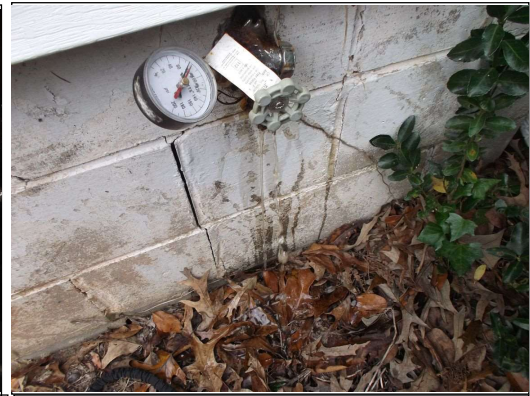
Verify if hose faucet leaks at the handle

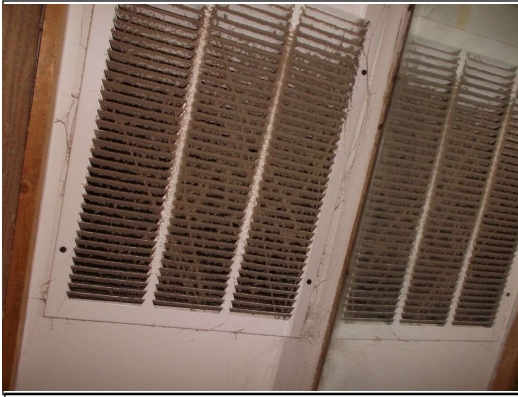
Return dusty

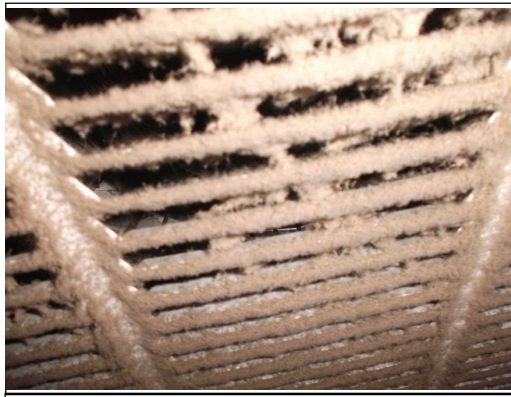
It is advised to have the HVAC system checked for service and maintenance. The air ducts appear to be very dusty. The filter door is not in place at the plenum near the furnace in the attic.

Air ducts dusty

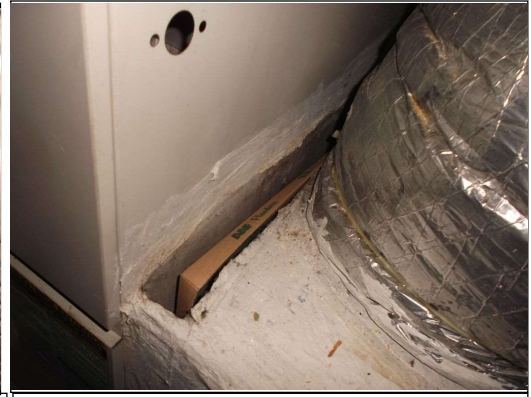
Missing filter door

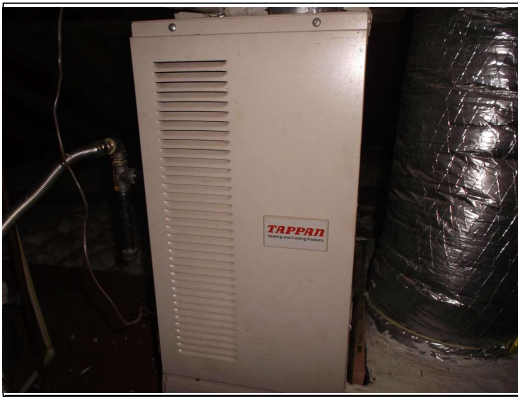
Furnace is aging

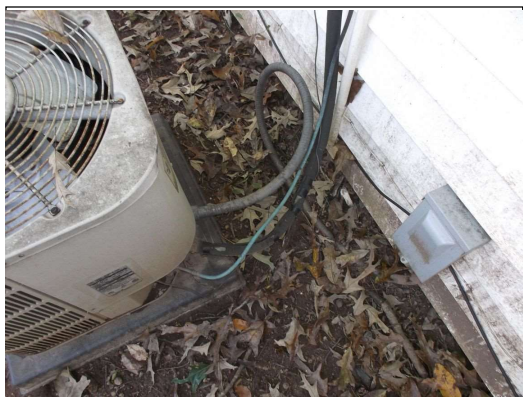
Refrigerant line insulation deteriorated

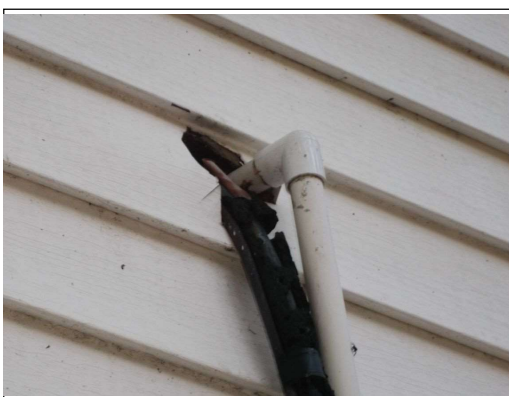
Refrigerant line insulation damaged

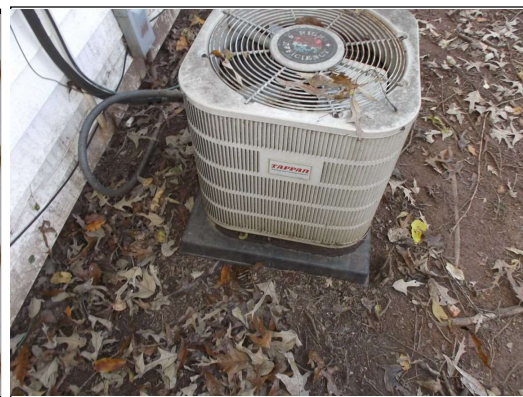
Unit needs cleaning and service

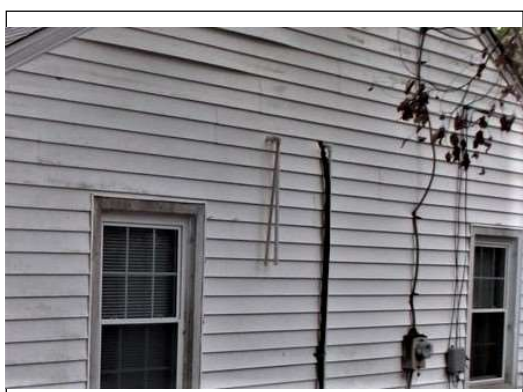
Condensate pipe not routed away

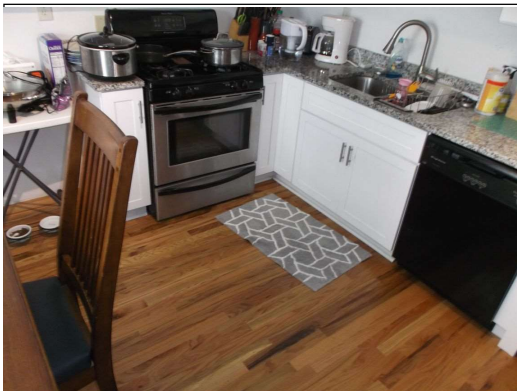
The kitchen floor slopes to and or sinks at the stove and sink area (may be damaged or defective floor system).

Floor slopes towards stove and sink

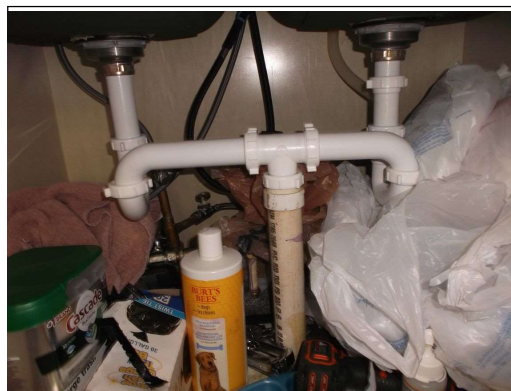
The sink drain pipe system is a S-Trap which can let sewer gas, methane gas and radon gas into the house under certain conditions.

Improper and unsafe drain pipe system

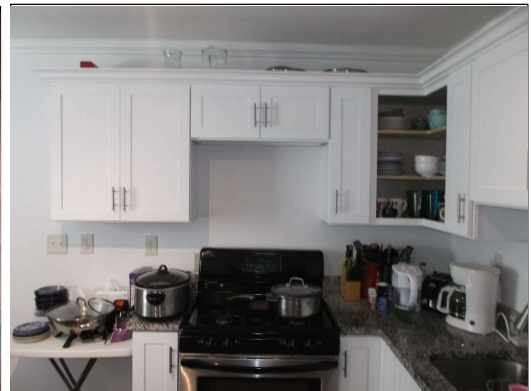
There is no anti tilt device connected to the stove. There is no exhaust fan over the stove. It is advised to verify all outlets within 6 feet of the kitchen sink be protected with GFCI outlets.

Missing exhaust fan

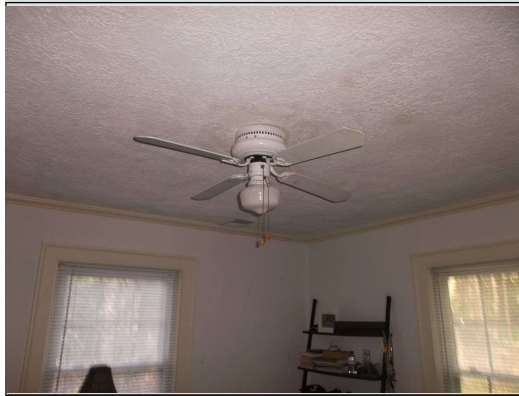
Rear bedroom ceiling fan has excessive humming while operating.

Fan excessive hum

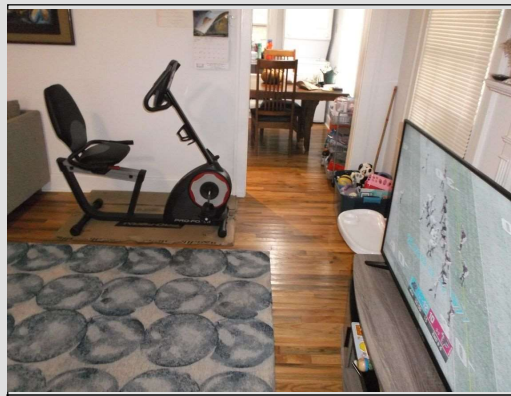
Living room floor slopes to the hall to the bedrooms area. Living room floor slopes to the center wall of the house as the kitchen floor slopes to the center wall area also (may be defective floor system, foundation settling, damaged floor system and or defective repairs to the floor system).

Floor slopes to dining room wall

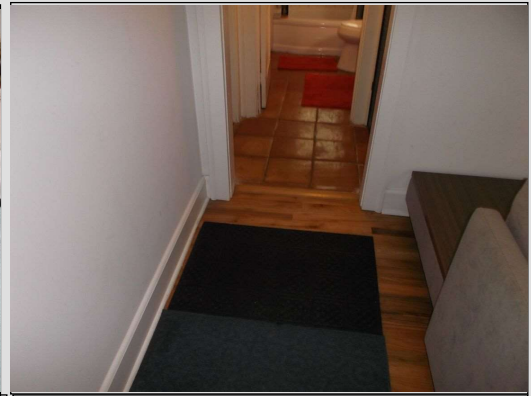
Floor slopes to hall wall

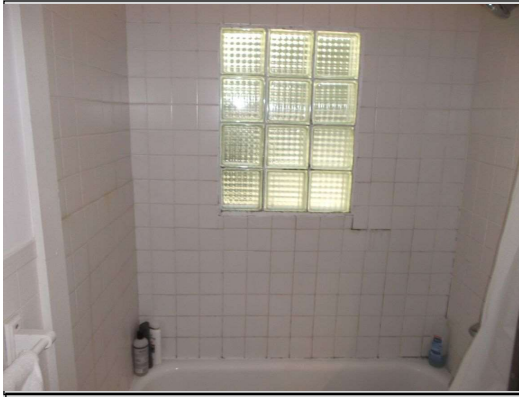
The shower exterior wall may have water damage. There appears to be bulging in the wall and tiles defective.

Wall defective and may have water damage

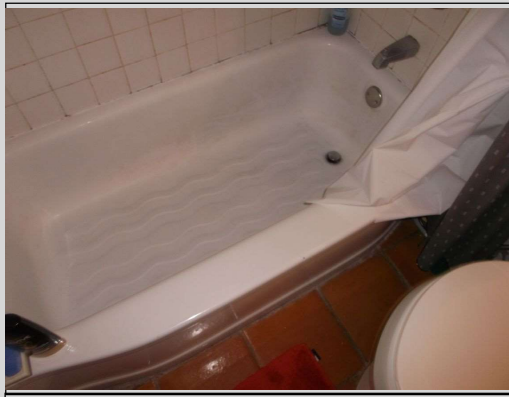
Tub finish soiled.

Tub finish soiled

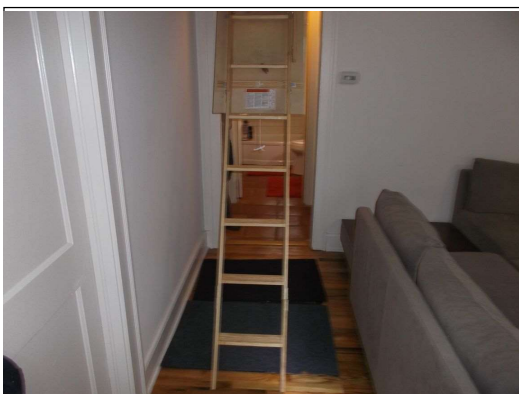
The attic ladder is slightly too long.

Attic ladder slightly too long

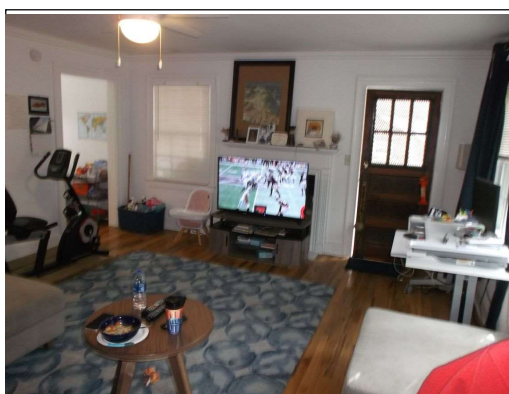
TV block access to fireplace

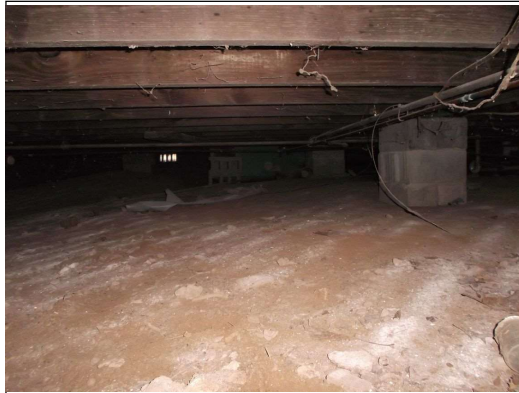
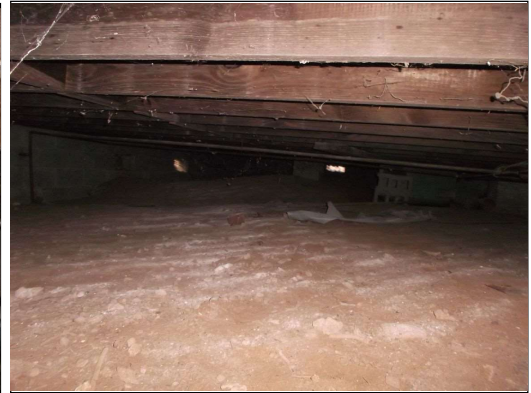
Missing moisture barrier over crawlspace dirt floor. Can see slight fungus like substance on floor framing at some areas in the crawlspace. Damaged, defective and missing foundation vents.

Missing moisture barrier

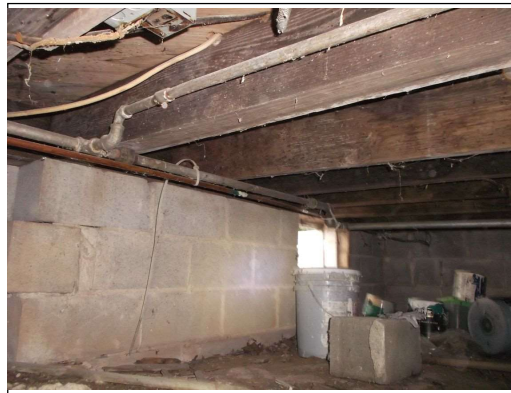
Slight fungus like substance on floor joists

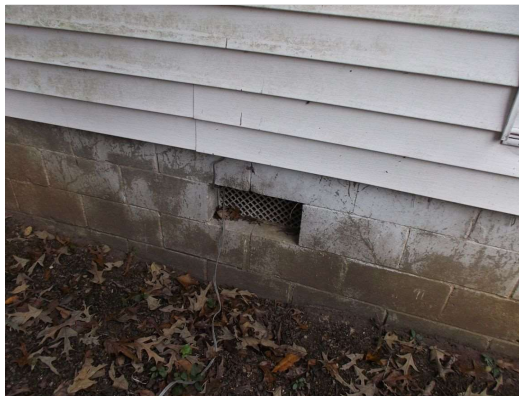
Defective foundation vents
