Property Inspection Report

117 Scarlett Dr. Jonesboro, GA.

Dec 19, 2020

1599

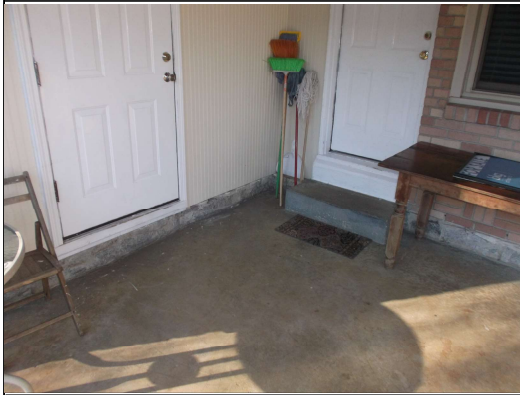
Steps up to the house door at carport and up to the utility room too high (more than 7.5 inches) can be a trip Hazard.

Steps up to doors too high at carport

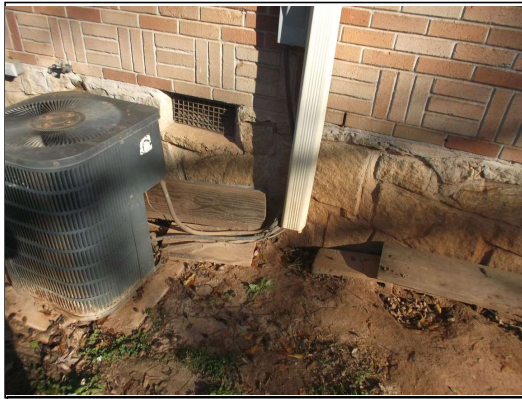
The HVAC system compressor was operating outside but system was no warming interior while operating. It is not advised to operate AC unit in cold weather can cause damage. Refrigerant line insulation missing at exterior. Condensate drain pipe drips at foundation. Foundation vents damaged and missing screens and defective, missing doors (replace). There is daylight at bottom of the kitchen door to the carport. Water damage to carport ceiling.

Refrigerant line insulation missing

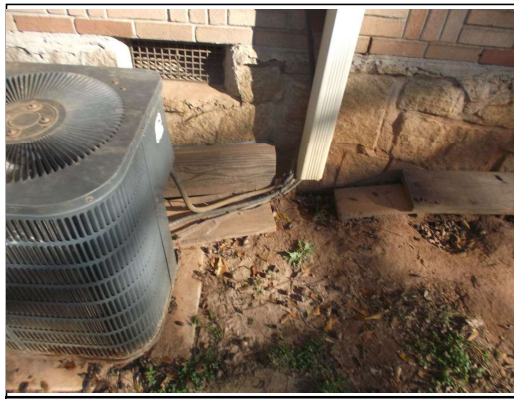
Condensate pipe pour at foundation

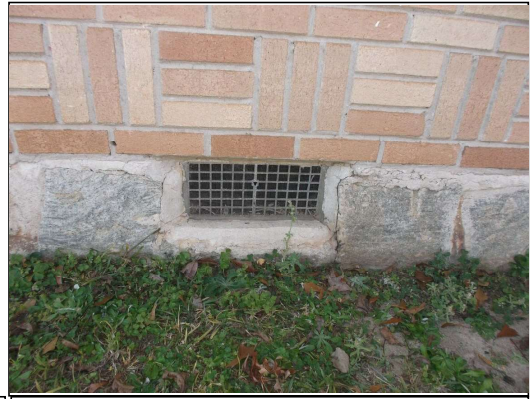
Foundation Wall Concrete block Poured concrete Post-Tensioned concrete Not Visible Other Stone
Condition Satisfactory Marginal Monitor Have Evaluated Not Evaluated
Concrete Slab N/A Not Visible Satisfactory Marginal Monitor Have Evaluated
Comments Foundation vent screens and doors defective and or missing (install new foundation vents).

Foundation vents screen and doors missing

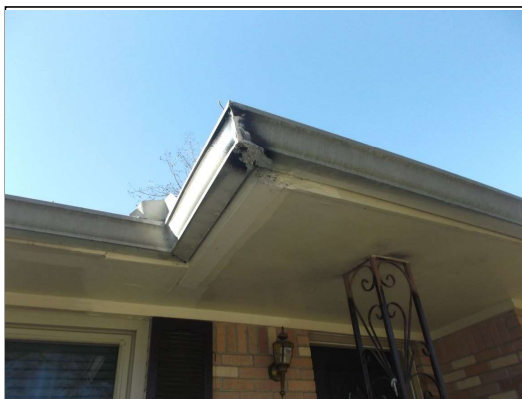
Comments Water damage to wood soffit at the front porch (repaired roof valley with sheet metal placed where shingle should be.)

Comments wWter damage to fascia boards at the front porch (leaking gutter)

Water damage to fascia and plywood soffit

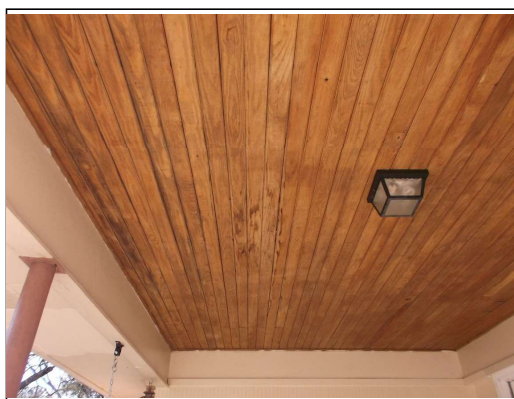
Water stains, damage to carport ceiling wood

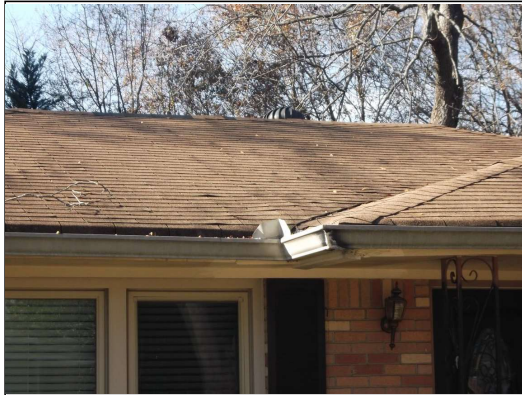
Roof covering appears to have lifting shingles and defective wood decking at the front roof near the porch valley on the left side of the front porch roof. Some shingle tabs are lifting at various areas. Shingles have begun to show signs of wear. Pipe and vent flashing have been installed on top of shingles and face nailed (can cause leaks). Shingles different colors at repairs. TV dish bolted to the roof deck can cause leaks over time.

Defective shingles and roof decking at valley

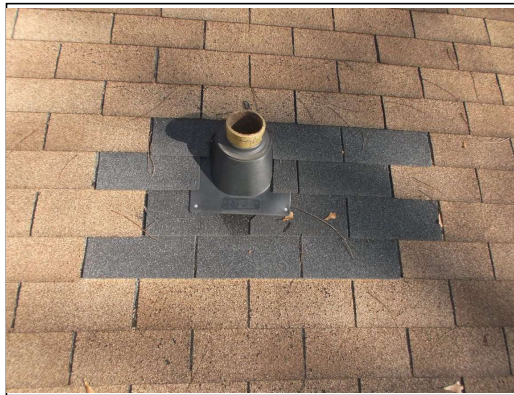
Flashing on top of shingles and face nailed

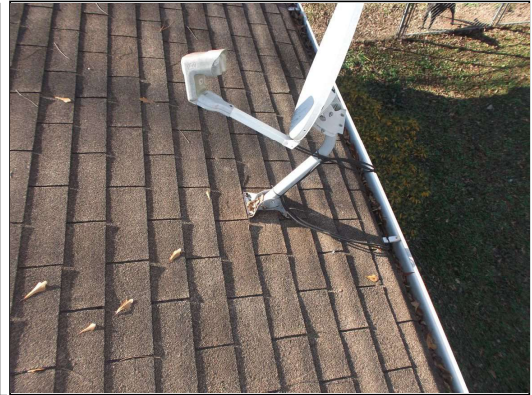
TV dish bolted to the roof can cause leaks

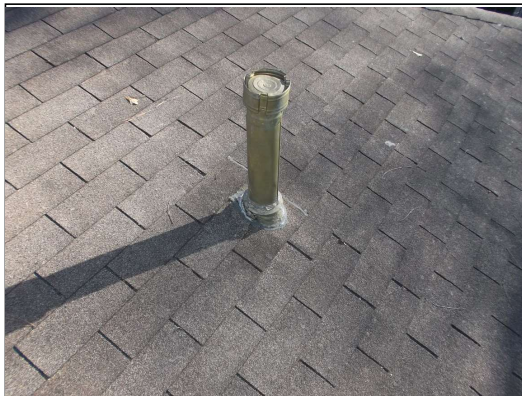
Shingles install all the way around pipe wrong

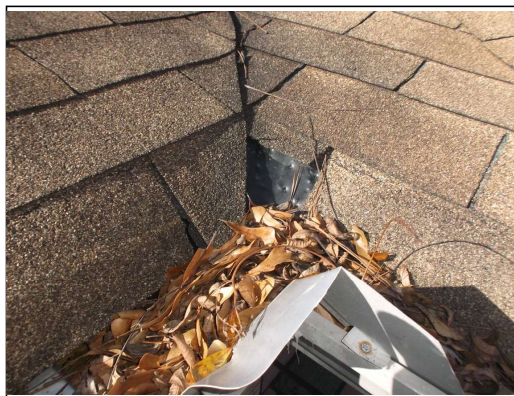
Broken flashing in porch valley with metal

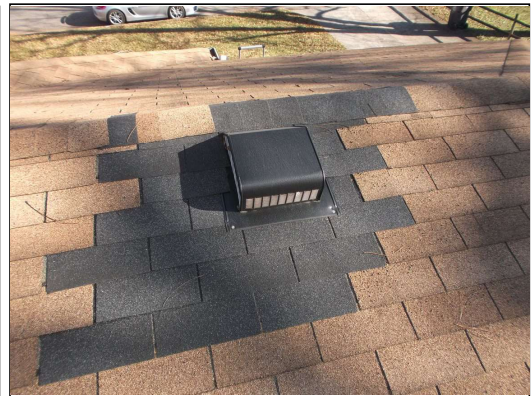
Wrong color shingles/flashing on top shingles

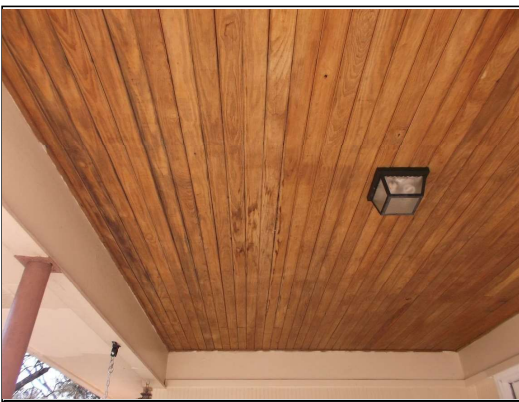
Maintenance:
 Water stains and water damage to the carport wood ceiling. Carport steps up to the house door and utility/laundry room door are too high and can be a trip hazard for some.

Carport ceiling wood has water damage

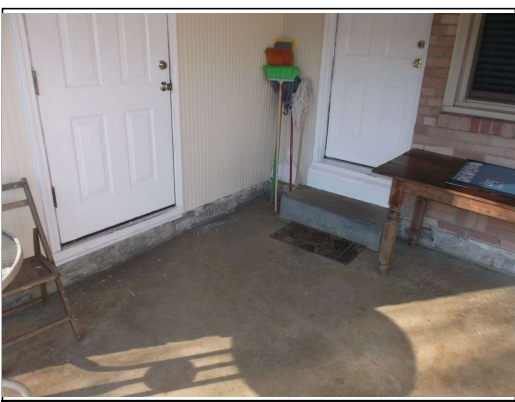
Steps up to the house & utility too high

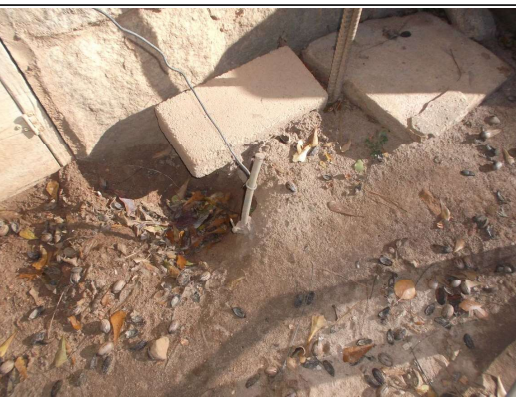
There is a ground wire detached from the ground rod at the rear yard near the foundation; there are openings in the distribution panel with cables entering contacting sharp metal edges. The holes in the distribution panel box walls can let sparks escape. There is too much gap between the distribution panel box and the sheetrock (can let sparks escape into the wall space). Interior outlets are no grounded (two holes instead of 3);

Ground wire poorly attached to ground rod

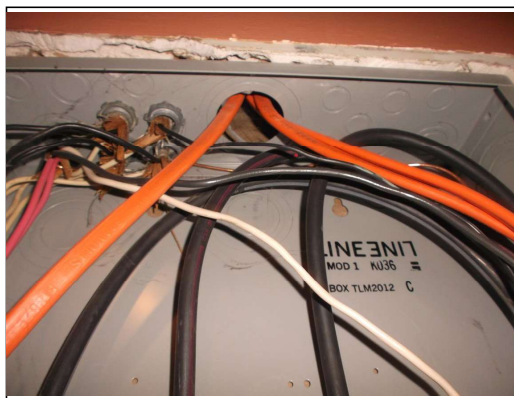
Electrical cables contact sharp metal at hole

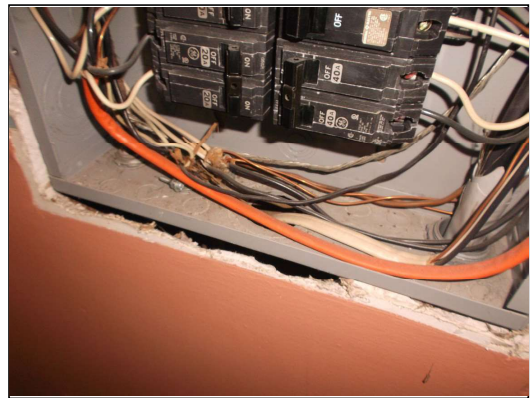
Excessive gap at panel box and sheetrock

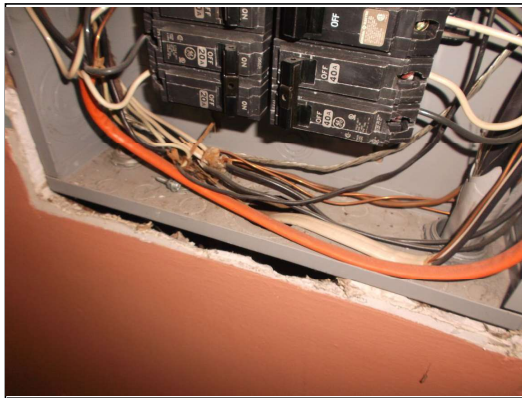
Cables pass through hole in bottom of panel

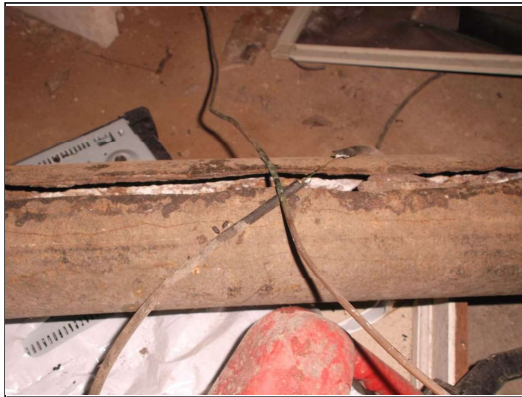
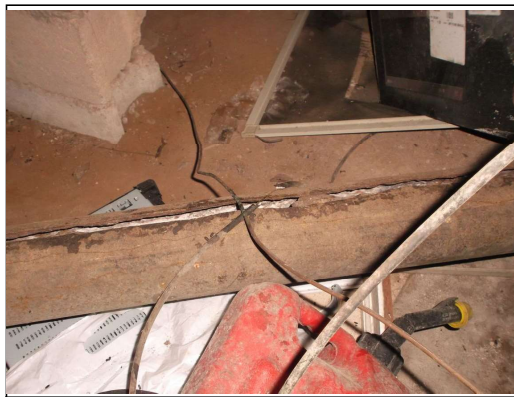
Cast Iron waste pipe has a split in a section in the crawlspace (check all waste pipes in the crawlspace for damage. There is some kind of material wrapped around some copper water pipes in the crawlspace (verify no leaks and verify not Asbestos).

Split waste pipe in the crawlspace

Split in waste pipe

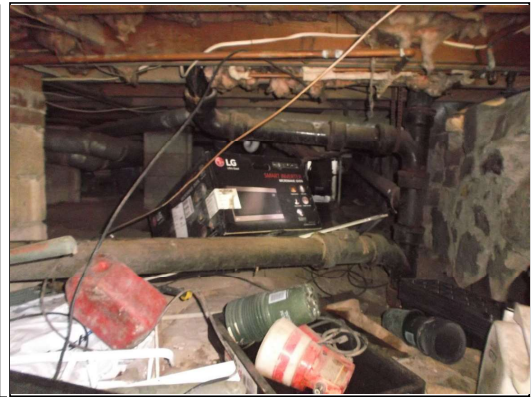
Unknown material wrapped around water pipe

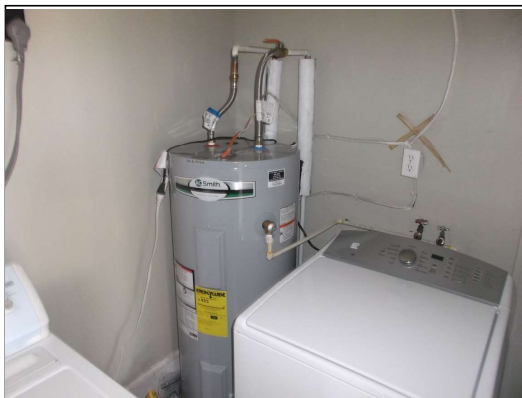
No expansion tank above the water heater; water pressure was slightly high at the exterior hose faucets; rear hose faucet leaks at the handle;

No expansion tank above water heater

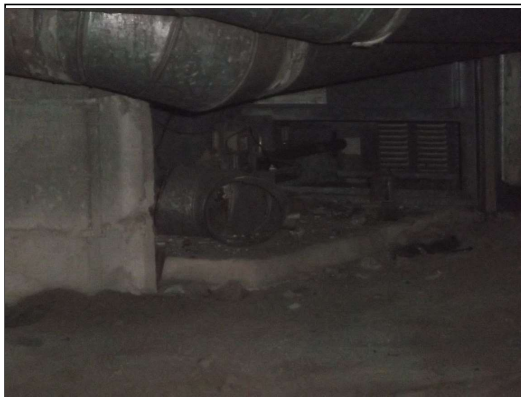
Old furnace still in crawlspace

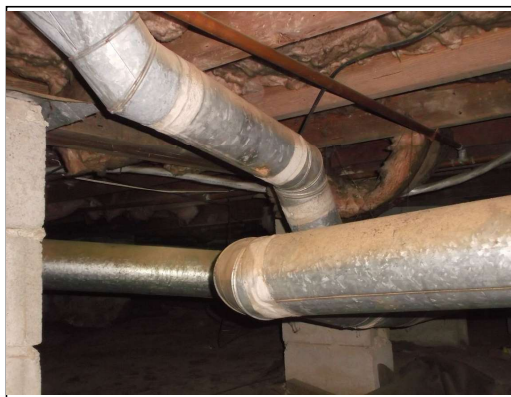
Asbestos like materials appear to be wrapped around old metal pipes in the crawlspace (some Asbestos tape damage, loose, removed and detached).

Asbestos like tape on old metal air ducts

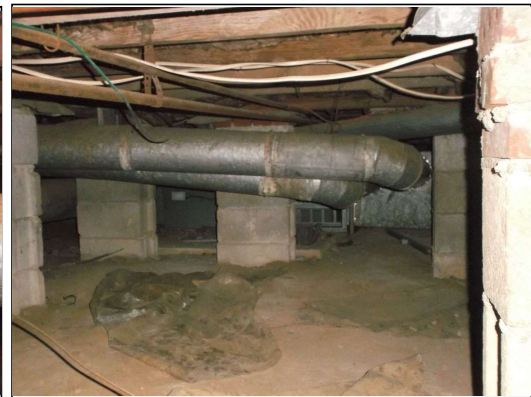
Damaged, loose, deteriorated Asbestos tape

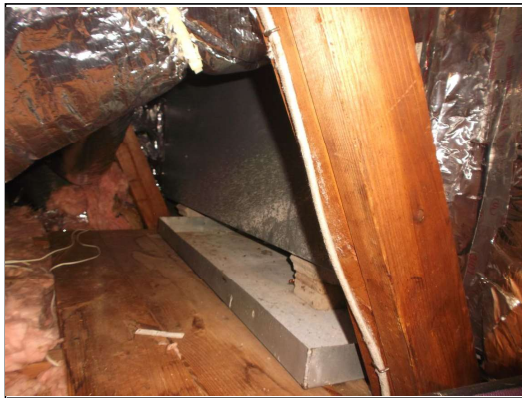
The AC compressor at the exterior was operating and the furnace blower was operating but air flow was low at registers and the system was not heating the house fully. Air flow was very low at air registers at several rooms. Some air vents of the last system installed were not installed near the exterior walls. It is advised to have a certified HVAC person or company check and service the system for operation. Old furnace still in the crawlspace and another furnace has been installed in the attic in a very cramped space.

Furnace located in tight space attic access

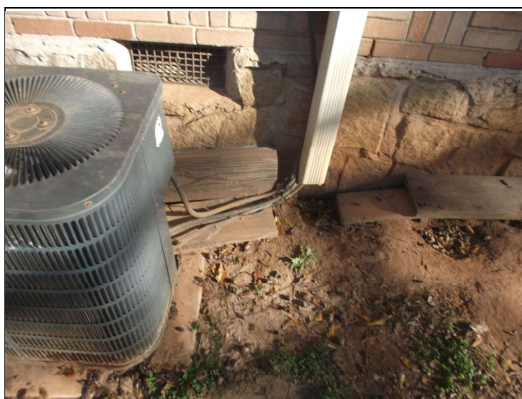
Refrigerant line insulation missing at the exterior; condensate drain pipe drains at the foundation; AC compressor was operating at the time of the inspection but poor heating at the air registers. It is not advised to operate the AC unit when the outdoor temperature is less than 60 (can damage system).

Refrigerant line insulation missing

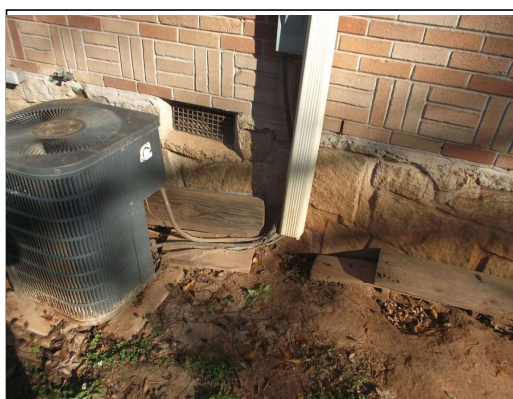
Condensate drain pipe pours at foundation

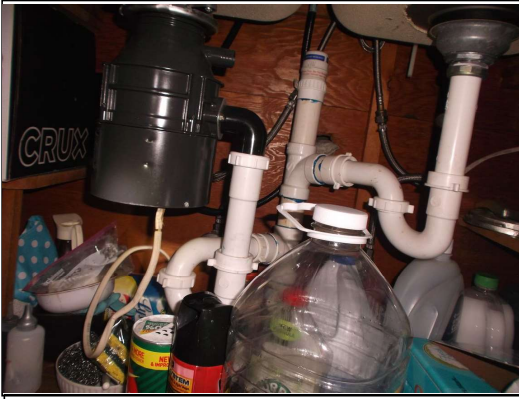
Disposal blades frozen (motor hums). Exhaust fan motor has excessive noise and is at end of use. Drawer tracks have rough rollers or rough tracks. kitchen floor slightly slopes to the sink wall. Improper electrical cable leading to the disposal (not protected in conduit).

Improper electrical cable for disposal

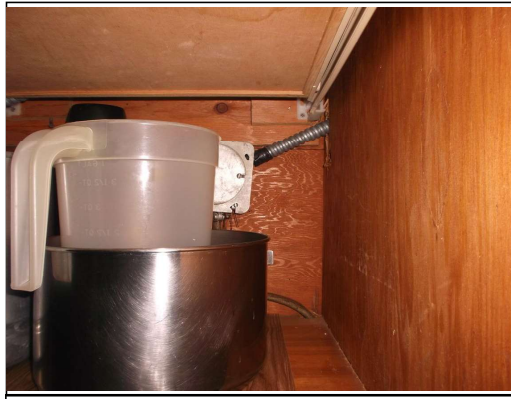
Electrical cables conduit leading from the cook top to the junction missing bushing and can be a shock hazard and short.

Missing bushing at conduit into box (tape)

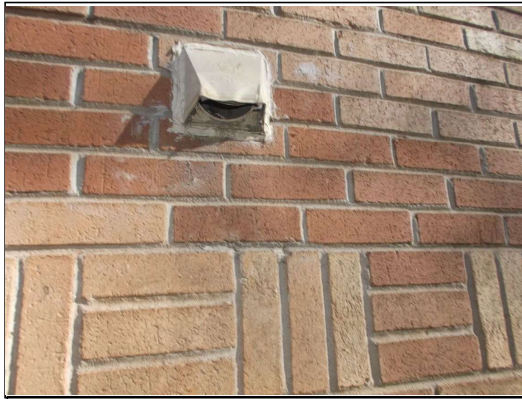
Maintenance: Dryer vent door stuck open at the exterior wall; outlet behind washer was not energized

Dryer vent door stuck open

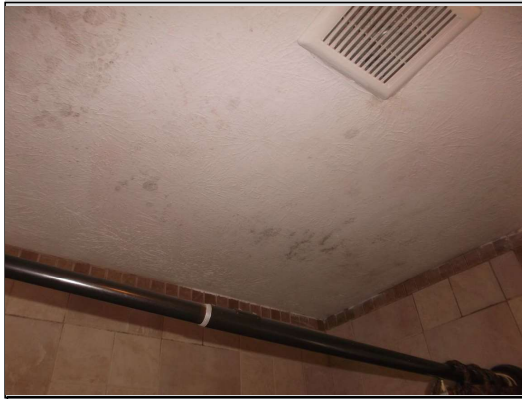
Defective ceiling repair at living room; mold like substance and sagging at hall bathroom ceiling over tub; ceiling fan not operational at rear bedroom; ceiling fan wobbles at master bedroom; some floors slightly slope to exterior walls (bedrooms, kitchen...). House was furnished at time of inspection and could not see all walls, floors, electrical outlets... Smoke alarms not operational, smoke alarms missing at bedrooms. Couple of door locks no striking; some door stops missing

Ceiling sagging and mold at the hall bath

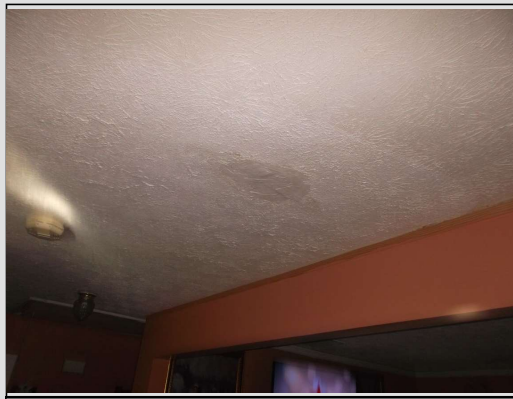
Defective ceiling repair at the living room

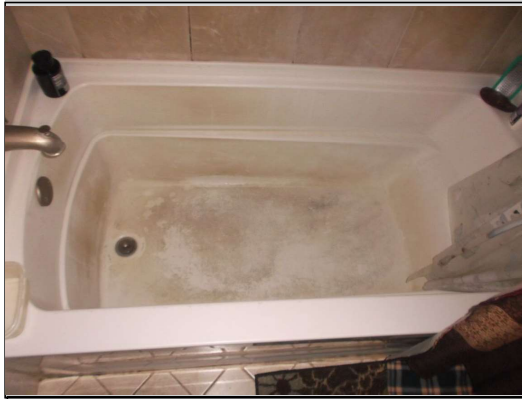
Maintenance: Hall bath tub soiled, shower head pipe loose in the wall, mold on ceiling and ceiling sagging over tub, toilet loose at the floor (can cause water damage to the wood sub floor below); sink faucet handle detached;

Tub soiled

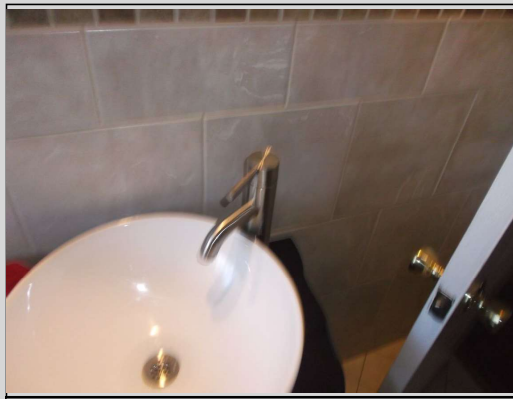
Sink faucet handle detached

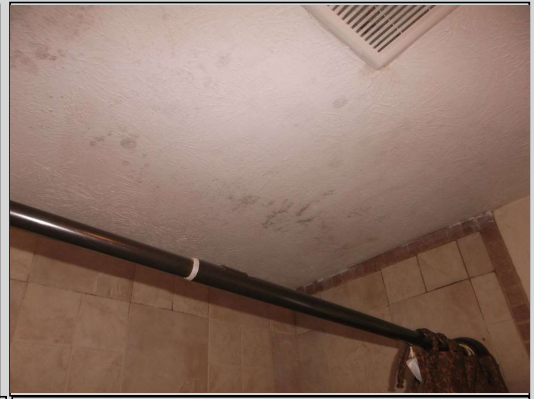
Bath ceiling has mold and sagging

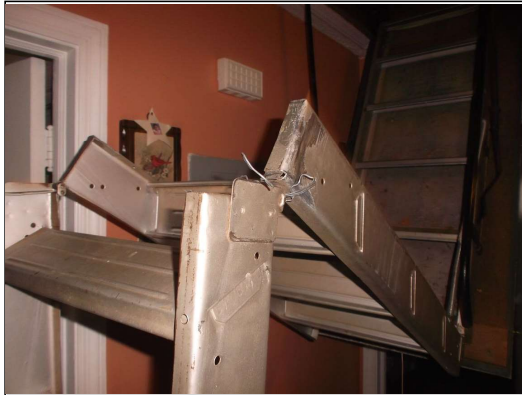
Attic ladder damaged and needs repair or replacement; light in attic missing switch near entry is a safety hazard.

Attic ladder broken at the hinge (hazard)

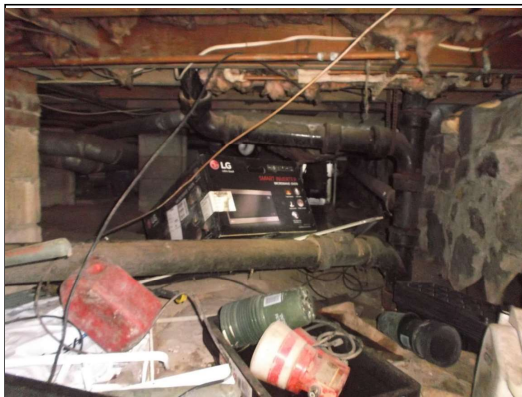
Moisture barrier missing at some areas. Belongings stored in crawlspace. Old metal air ducts appear to have damaged, torn, loose and detached Asbestos tape). Where there is damaged, loose and detaching Asbestos materials there can be particles on the crawlspace, soil, plastic and other materials.

Belongs and debris in crawlspace

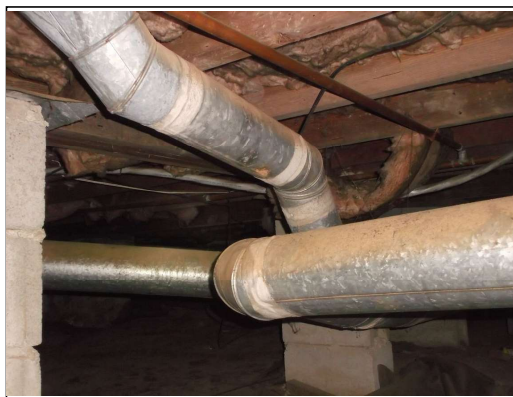
Asbestos tape on old metal air duct pipes

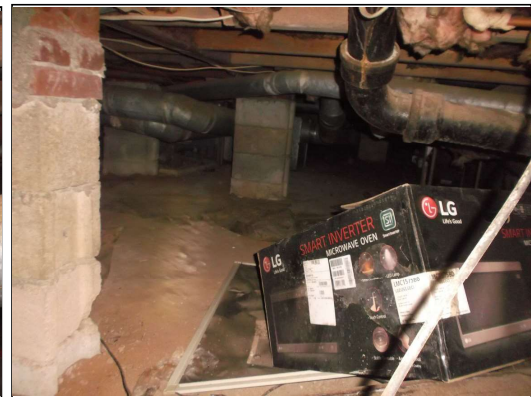
No plastic covering soil at areas in crawlspace
