PROPERTY INSPECTION REPORT

2950 Duke of Gloucester, East Point, GA.

Jun 4, 2021

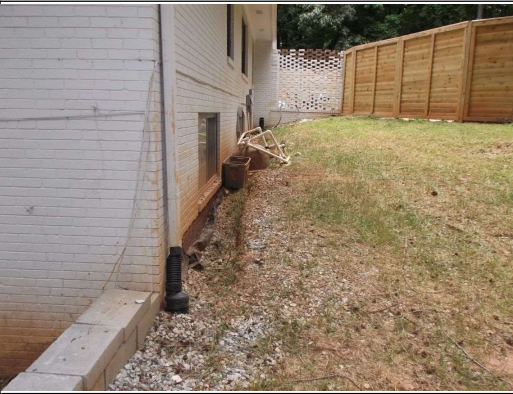
Ditch dug at foundation can hold water

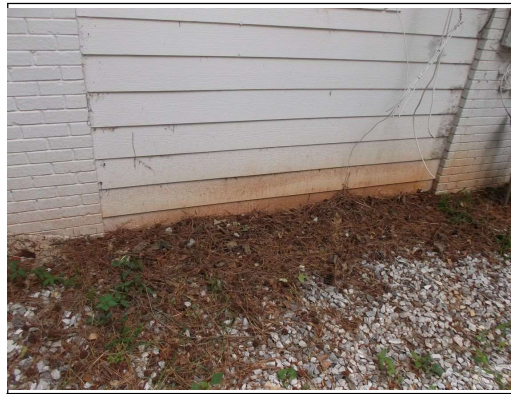
Siding touch ground right side of house

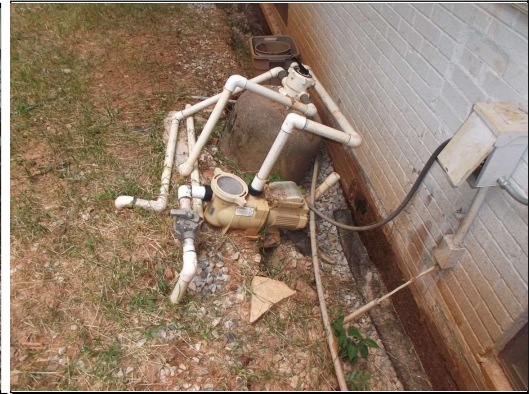
Pool equipment collapsing, stress on pipes

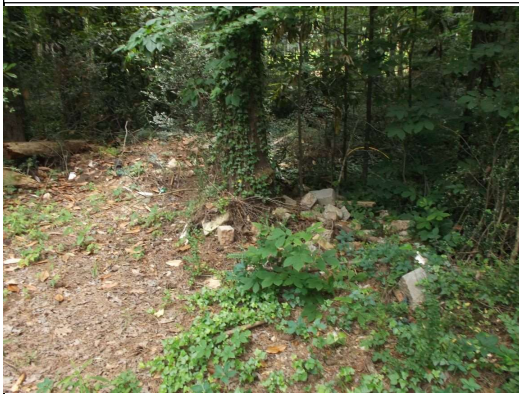
Debris in backyard several areas

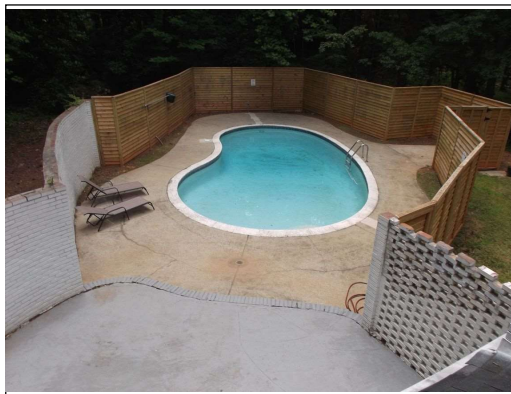
Pool soiled, gate defect, open joints @ cope

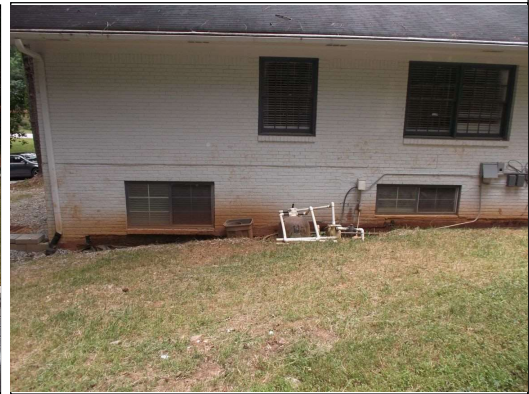
Ground sloping to the house

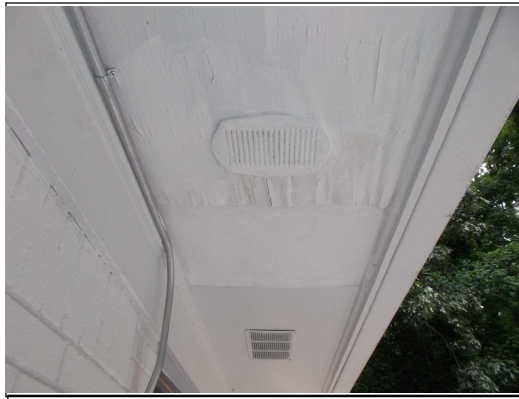
Water damage at soffit painted

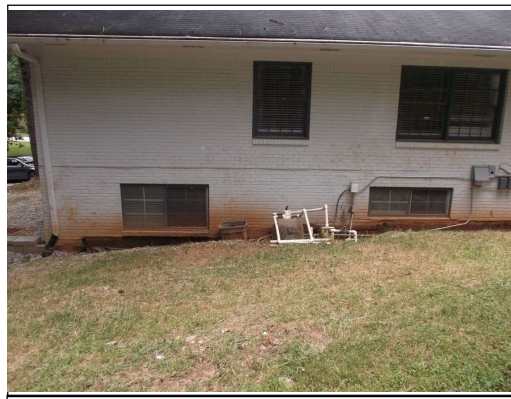
Mud on brick/gutter overflows

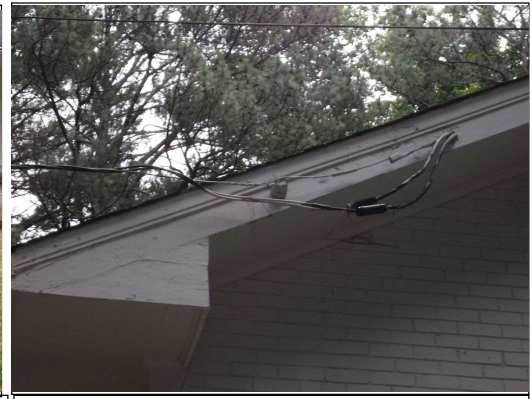
The electrical cables from the street to the house are poorly secured to the house soffit fascia board (can pull loose, needs l-bolt);

Service cables poorly anchored to fascia

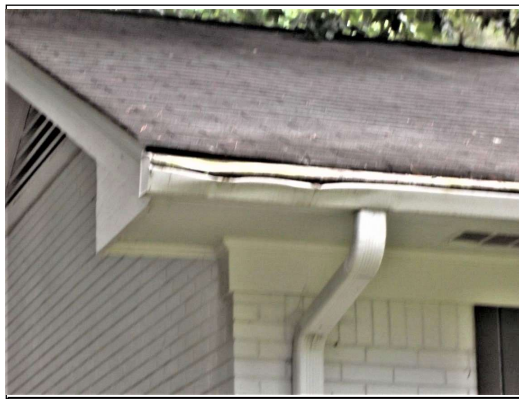
Garage gutter bent

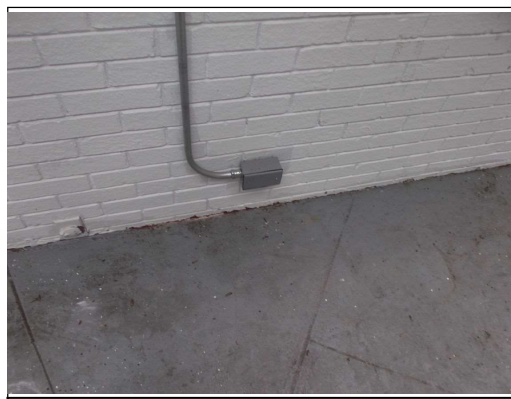
No outlet at the rear door to patio

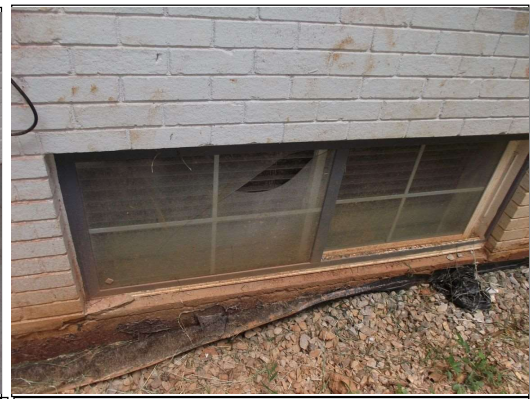
basement window broken not closing

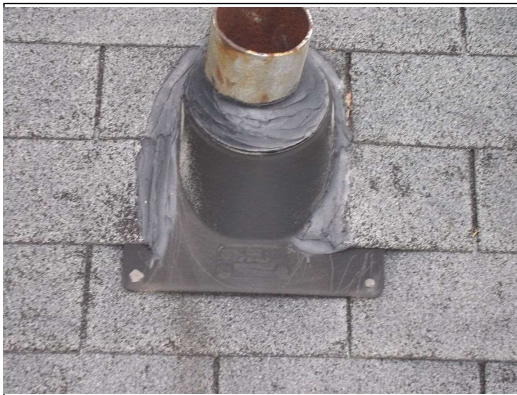
Flashing on top shingles face nailed

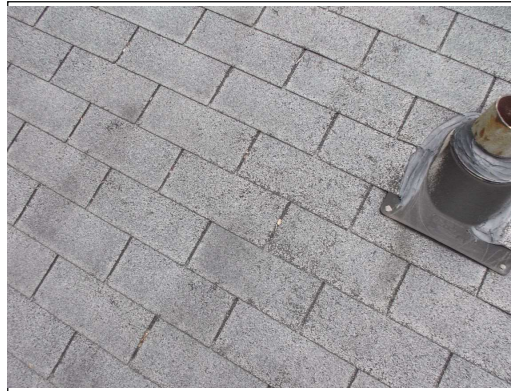
Shingles worn several areas

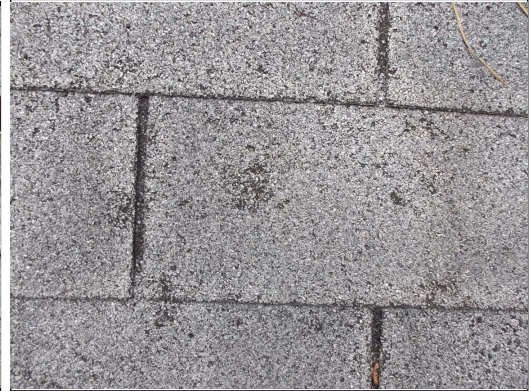
Nails pushing through shingles

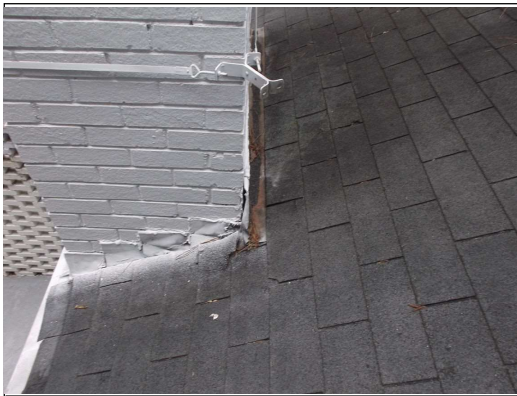
Flashing detaching at the back of chimney

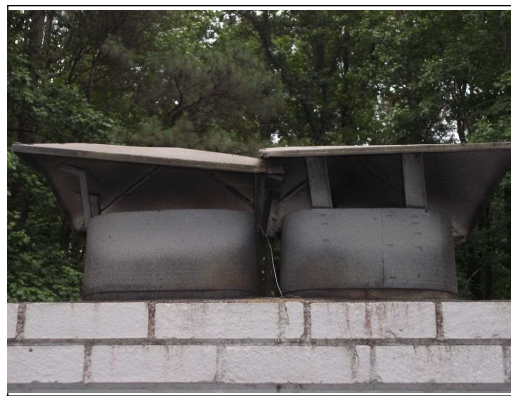
Chimney cap on left drain under right one

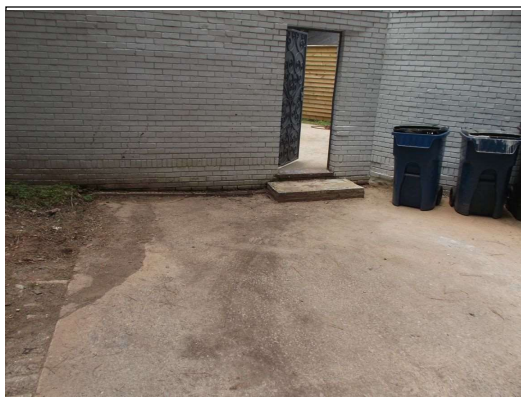
Driveway slopes to pool door

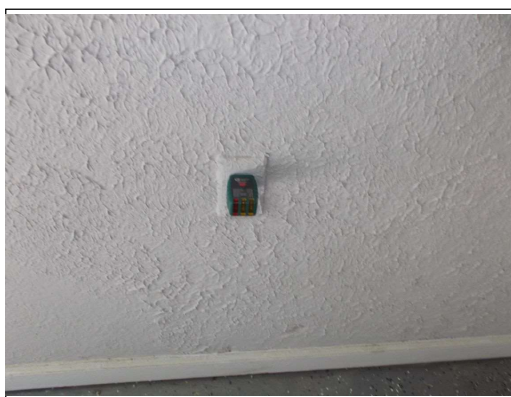
Garage outlet defective, not energized

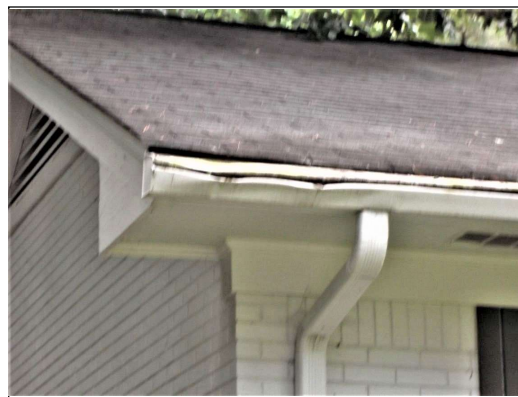
Gutter bent at the front of the garage

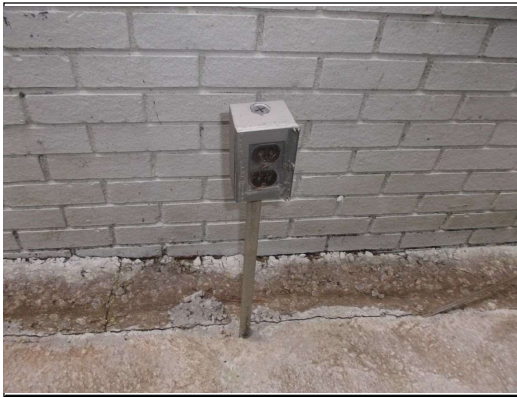
Defective receptacle at front porch

It is advised to have a certified electrician service and repair the electrical system and wiring;

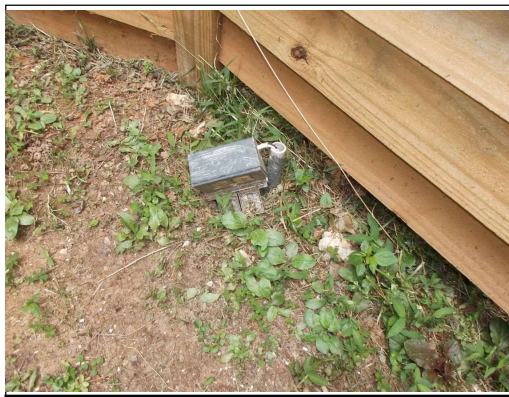
Pool side receptacle and box damaged

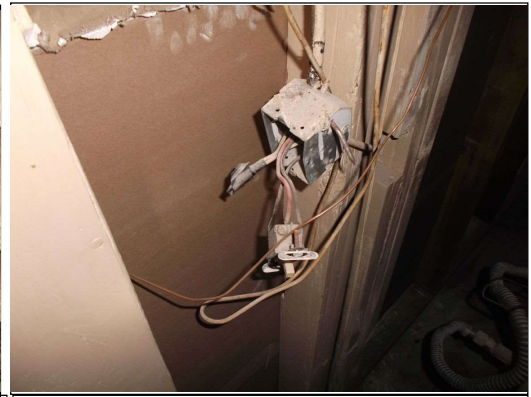
Several exposed wires utility room basement

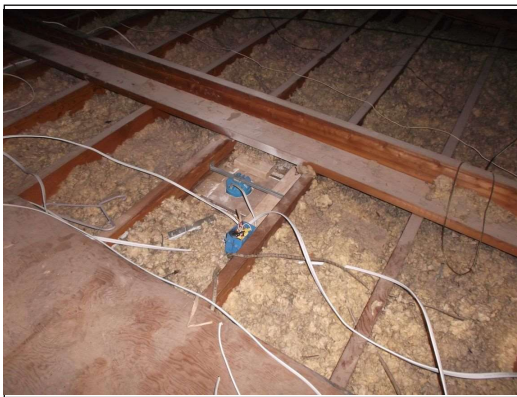
Exposed wires in attic several areas

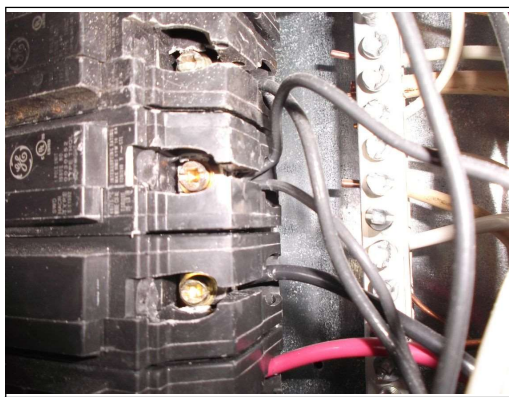
2 hots to one breaker some breakers

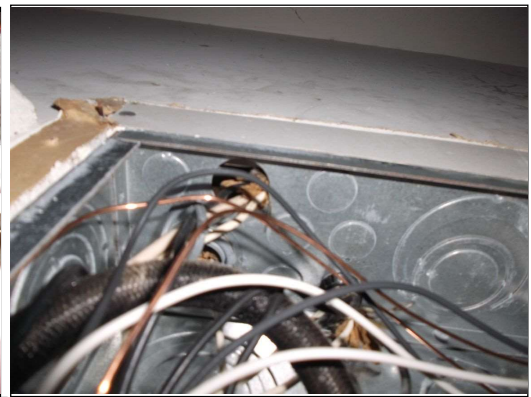
Wires enter panel hole contact sharp metal

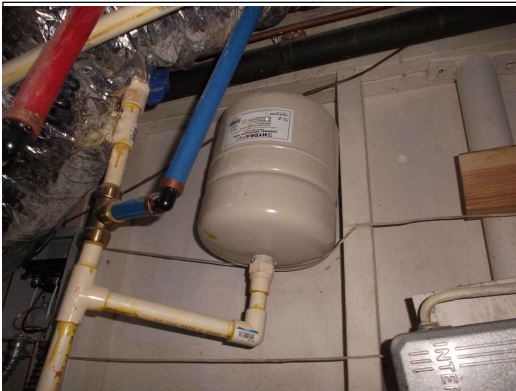
Expansion tank rest on the water pipe

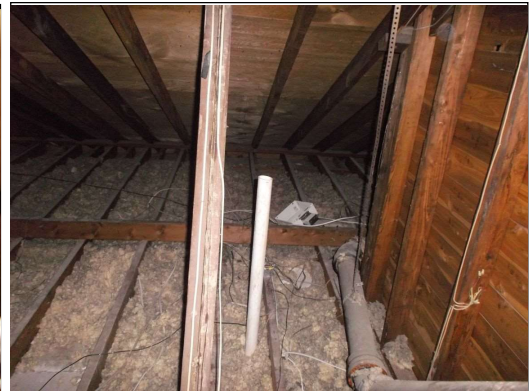
Plumbing vent pipe ends in attic shall pass through roof deck and to open air;

Vent pipe discharge in attic route out roof

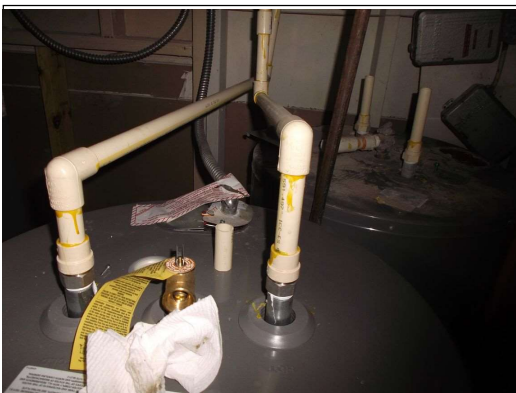
Water pipes not supported above water heater

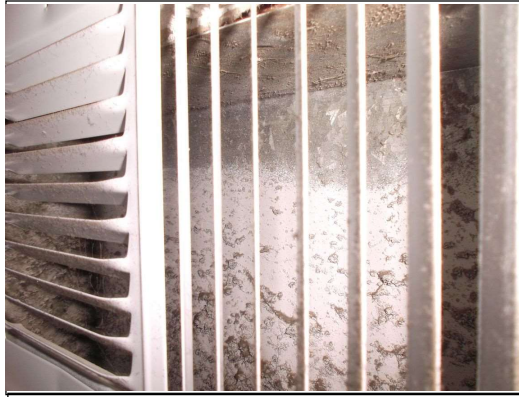
Dust in air ducts

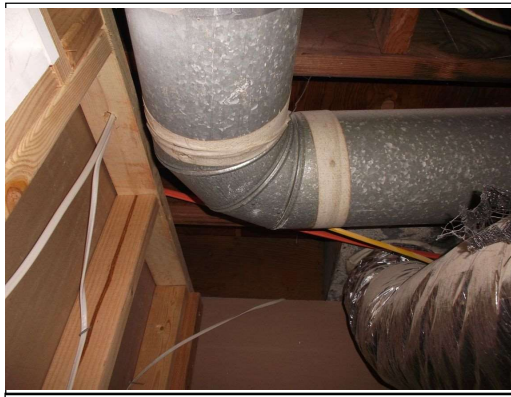
Asbestos tap wrapped on ducts

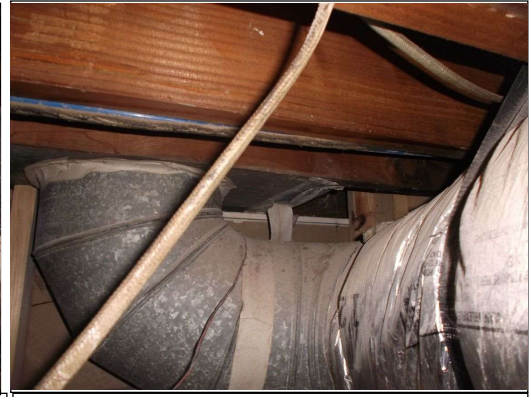
Loose and peeling Asbestos tape

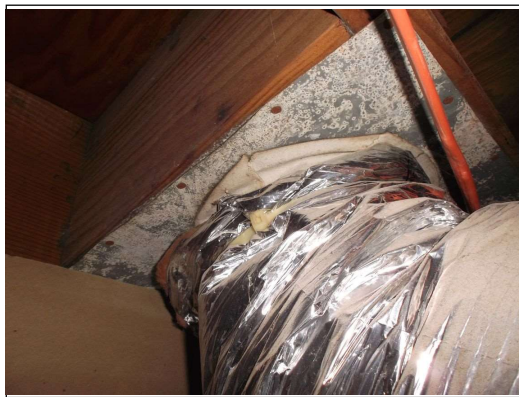
Detaching Asbestos tape

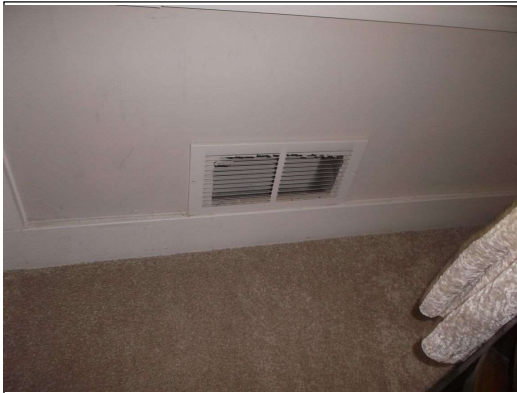
Air return grill at air register

It is advised to have a certified AC technician service and repair HVAC system;

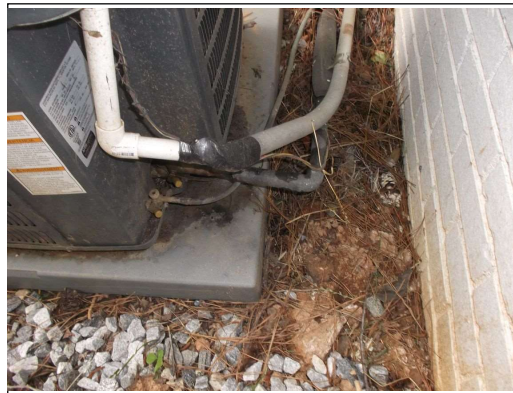
Refrigerant line insulation missing at AC

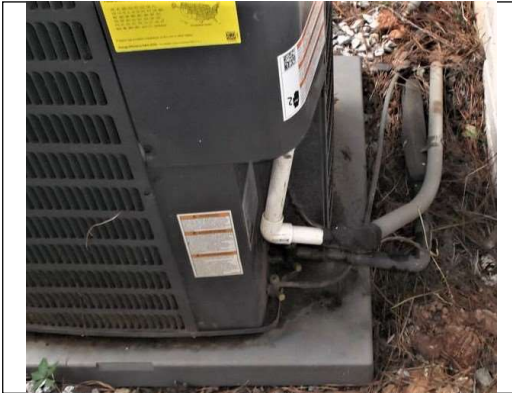
Water pipe for electrical conduit at AC

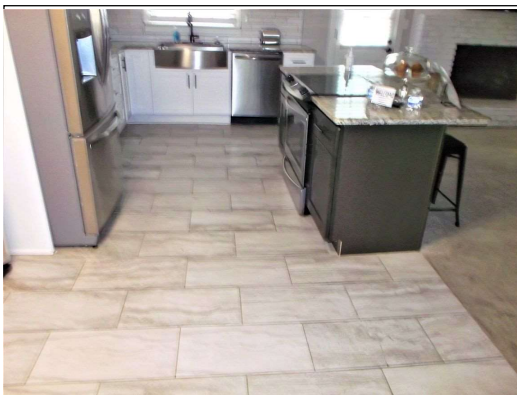
Floor sags and slopes to island

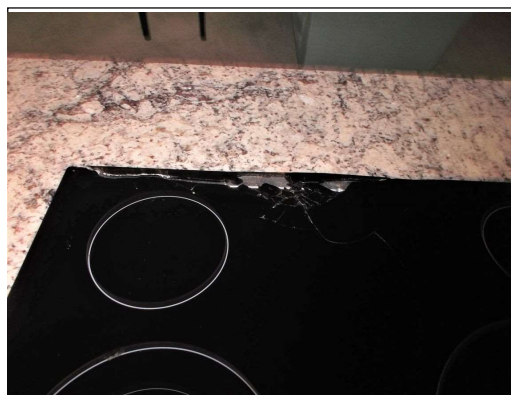
Cook top glass broken

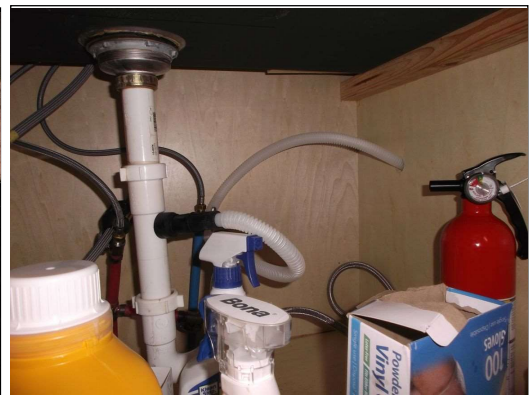
Dishwasher drain pipe not high looped

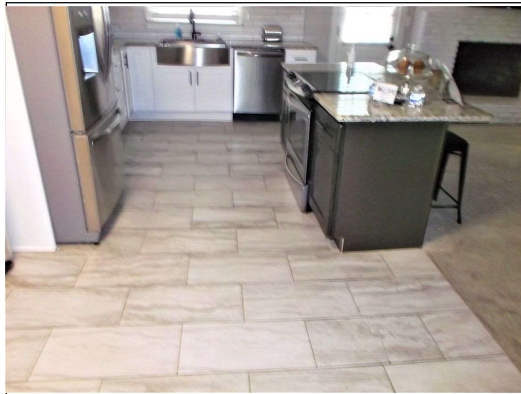
No exhaust fan above stove/ no light

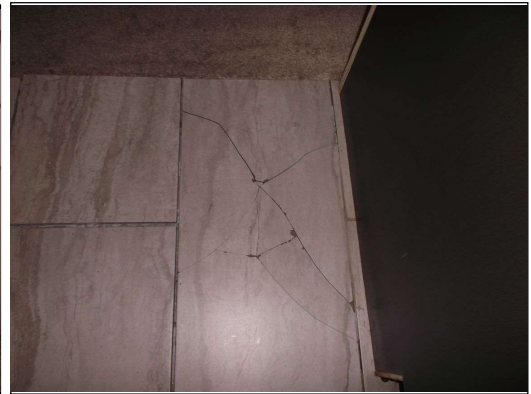
Floor tiles broken several areas

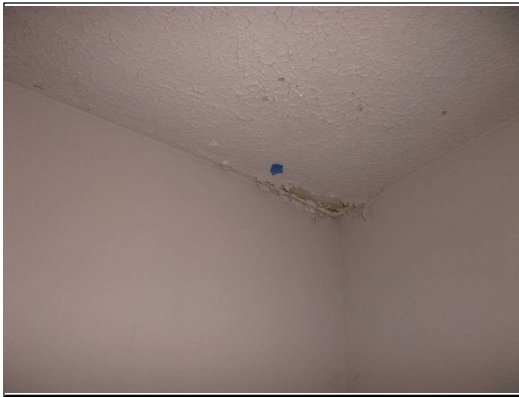
Water damage to popcorn ceiling at the rear corner near the wall may indicate a leak;

Water damage at laundry ceiling

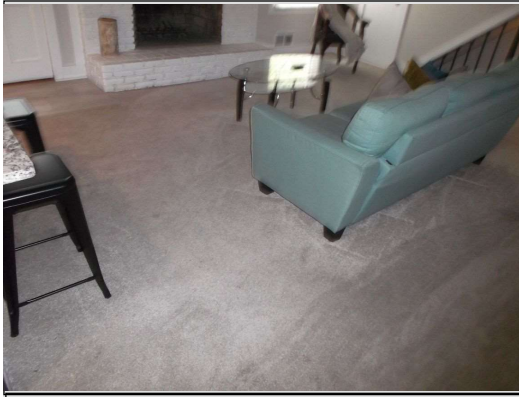
Floor sagging and carpet soiled

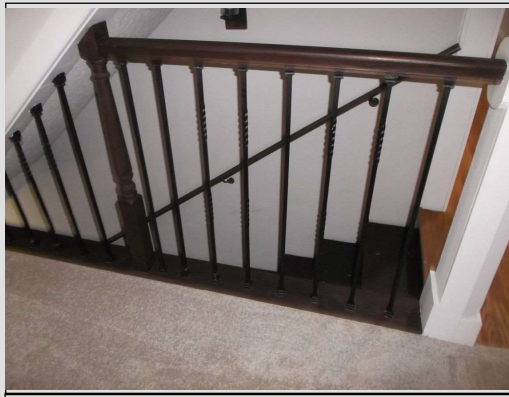
Great room rail guards at stairwell spaced more than 4 inches apart can be a child safety issue;

Great room stairwell guards space too wide

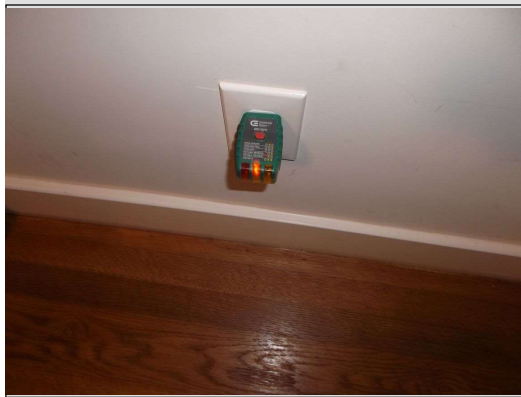
Outlet tested open ground

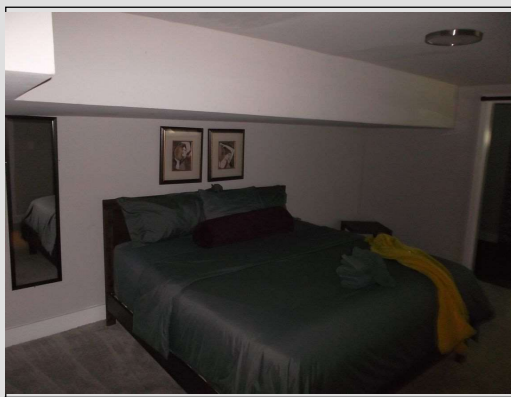
Basement bedroom ceiling too low over bed

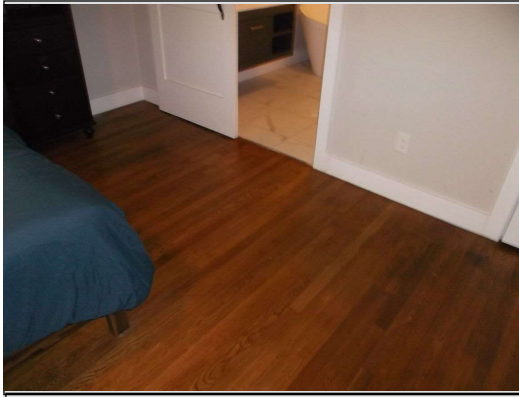
Master floor slopes to bath door

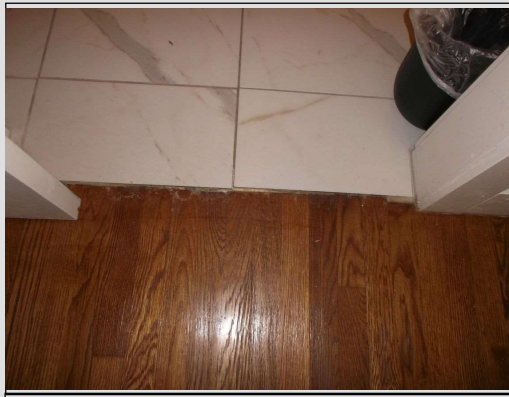
Missing transition strip at bed and bath door

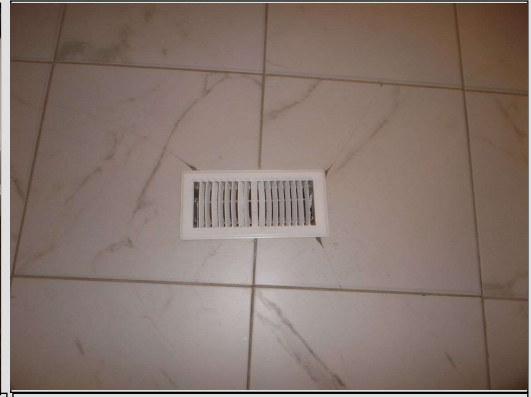
Cracks in master bath floor tile

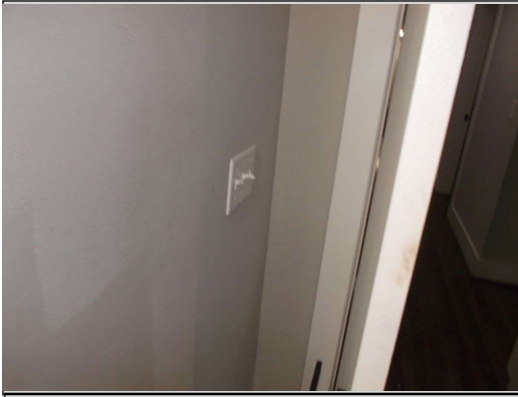
Light switches behind door

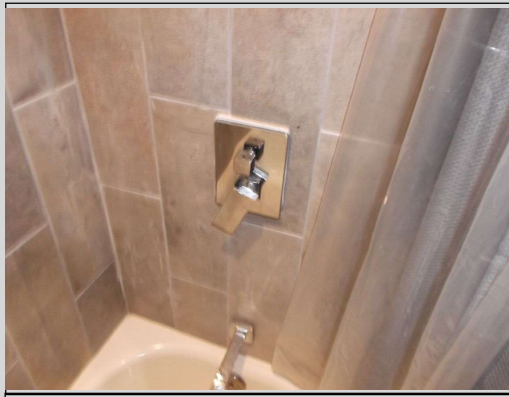
Tub faucet loose in the wall

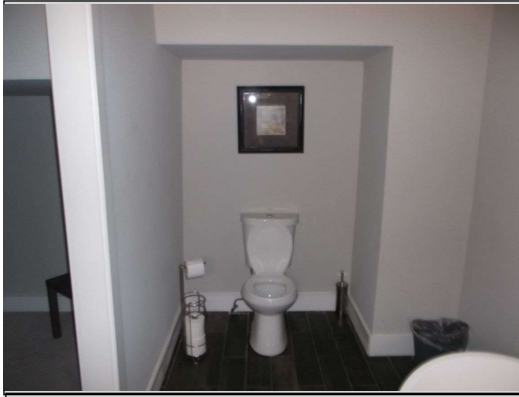
Low headroom over toilet

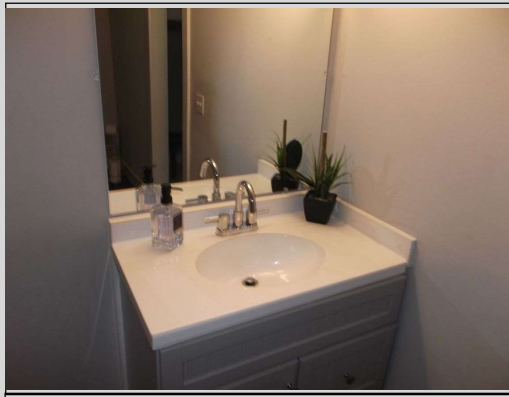
No outlet at sink

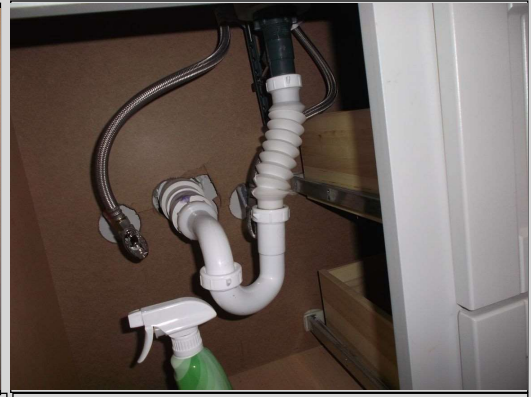
DIY drain pipe

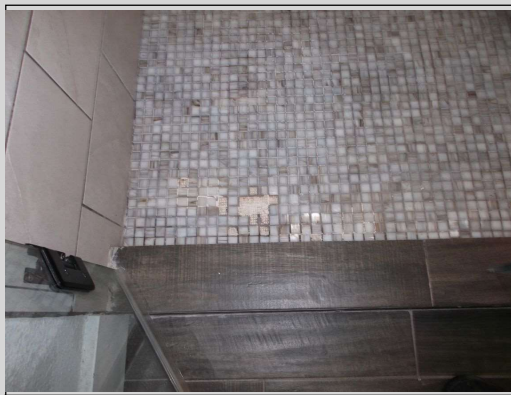
Missing and broken tiles at shower floor, wall

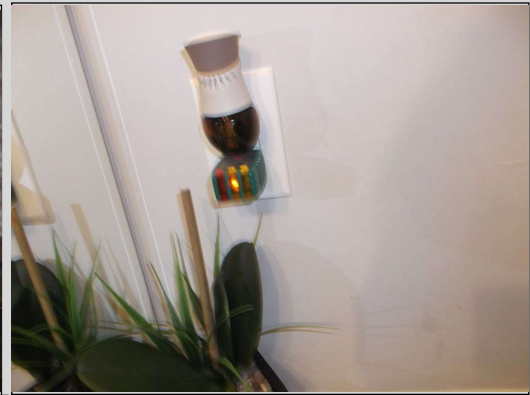
Outlet tested open ground

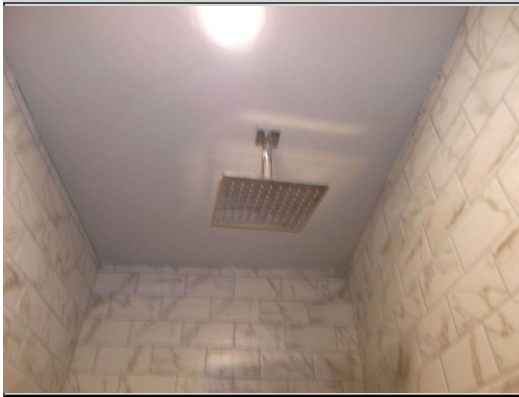
Shower head loose

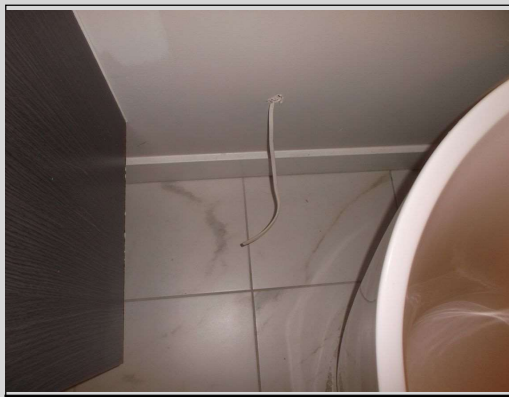
Exposed electrical cable

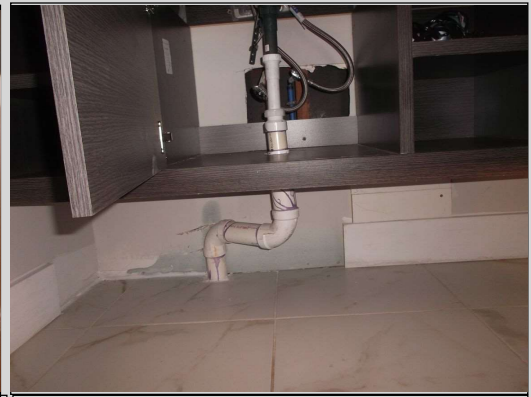
Improper drain pipe

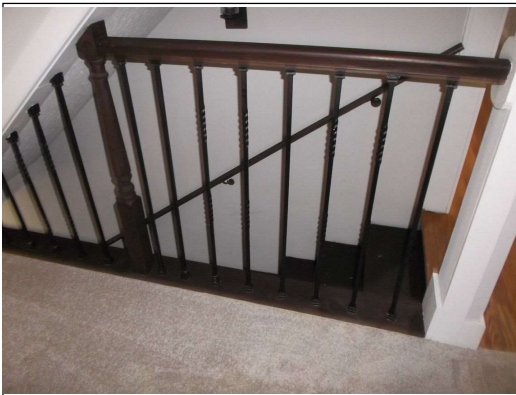
Guards spaced too wide

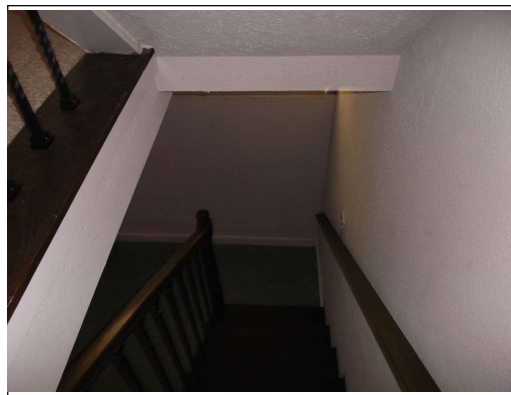
Low headroom at stairs

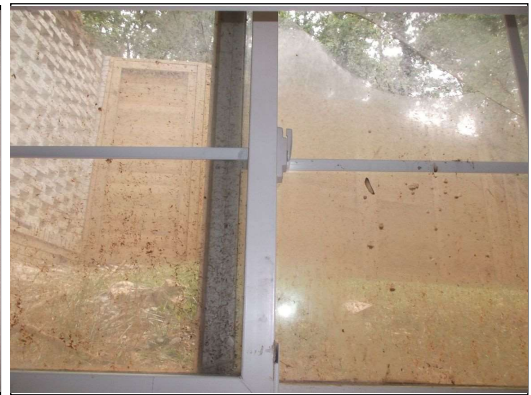
Window glass broken and wont close

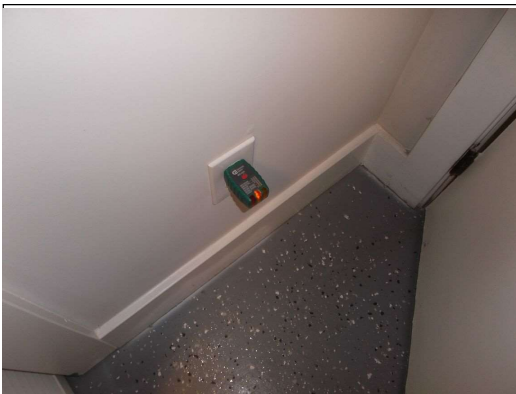
Outlets tested open ground several areas

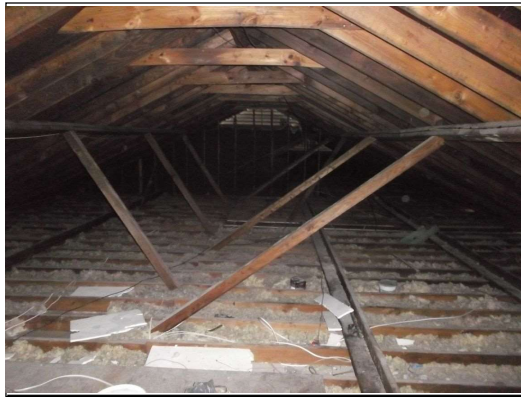
Debris in attic

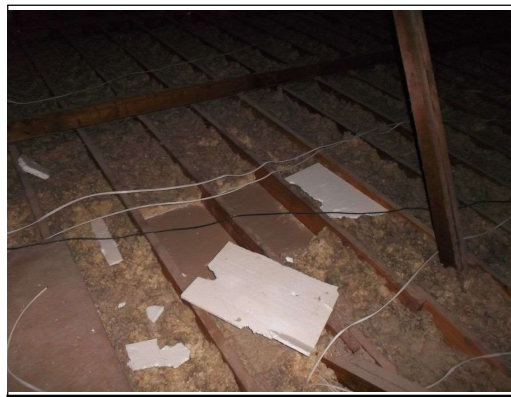
Missing and poor insulation coverage

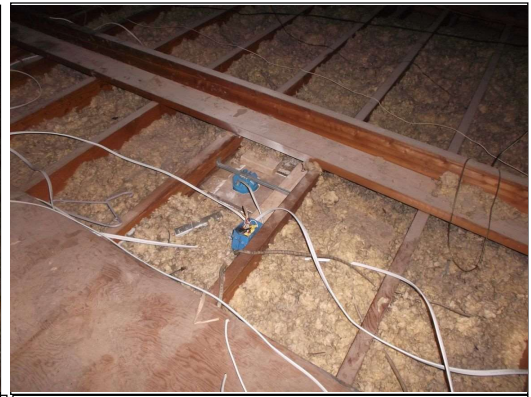
Exposed wire connections

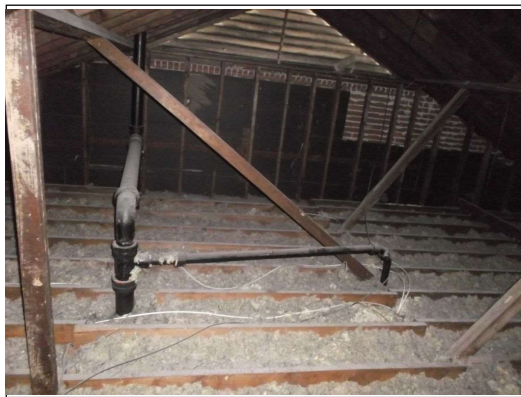
Poor insulation coverage

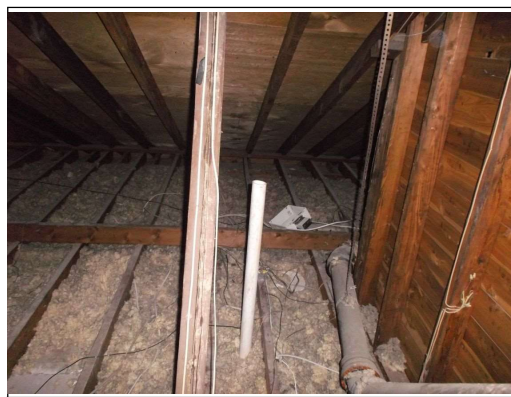
Plumbing pipe ends in attic
