# PROPERTY INSPECTION REPORT

2479 Peachtre Rd. NE, #617, Atlanta, GA.

**Inspection Date:**

May 20, 2021

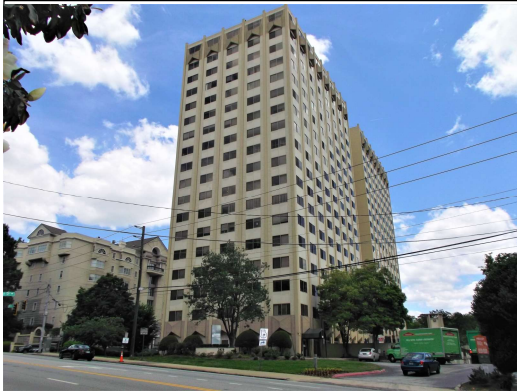
Building exterior needs pressure wash; missing window screens; windows worn;

Building needs pressure

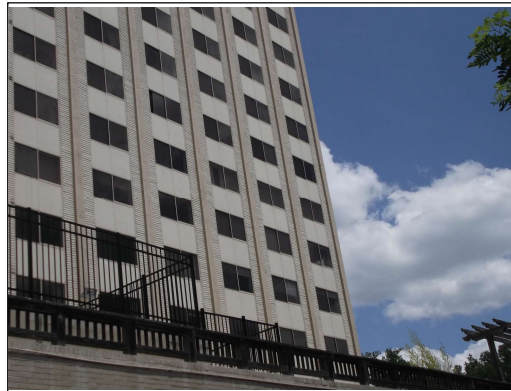
Screens missing and windows worn

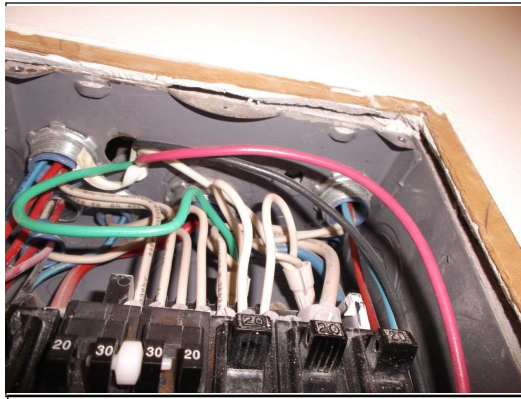
**Major Concern:**  
 There are electrical wires entering a hole in the top of the distribution panel in contact with sharp metal (can be a shock hazard, close with a bushing); there is a gap between the sheetrock and the bottom of the distribution panel box that can let sparks escape into the wall space (fill gap with caulk);

Wires contact sharp metal at hole

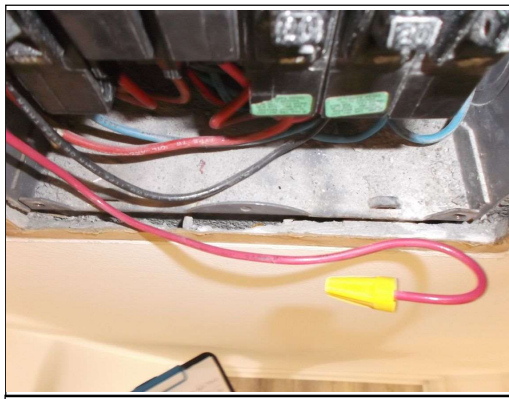
Gap between sheetrock and panel box

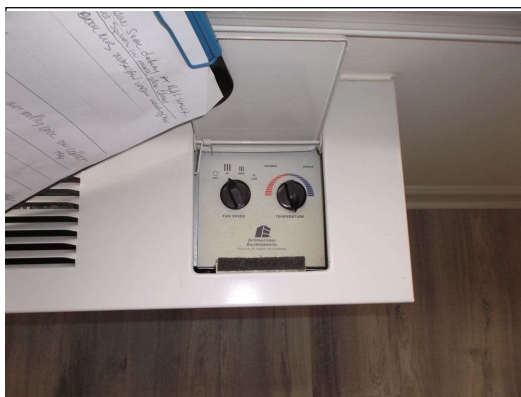
Wall unit for left bedroom

The HVAC system is made up of zone wall units in each room. At the time of the inspection the cooling systems were not cooling the condo fully. Seller verify the heating system will provide enough heat to evenly warm all rooms properly in the winter.

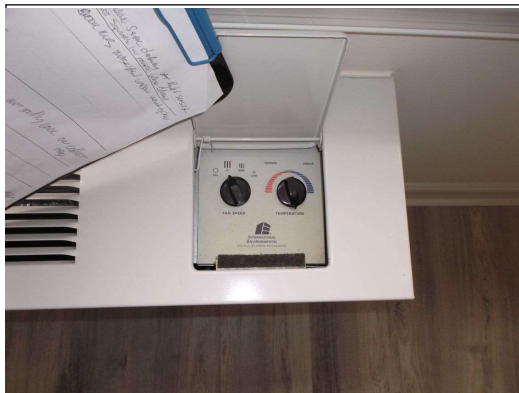
The cooling system is building supplied and is called a chiller system. There is no refrigeration cooling only water cooling. The condo cooling is supplied through the wall units which are water cooled. This type of air conditioning is not lowering the temperature in the great room area and lowering the temperature in the bedrooms marginally. In the middle of the summer heating season, this unit may have excessive heating caused by solar radiation and facing the south. The building super stated that the cooling system is limited in how low the condo temperature can be. Condo remained warm during the inspection;

Bedrooms did not cool fully

Supplemental cooling can cost 1500.00 initial operation and can cost another 1500.00 in 4 to 5 years.

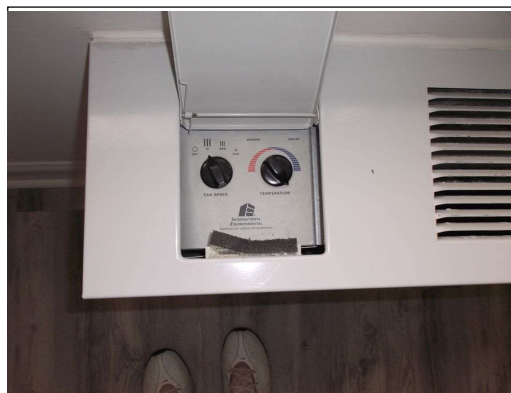
Great room stayed warm while cooling on

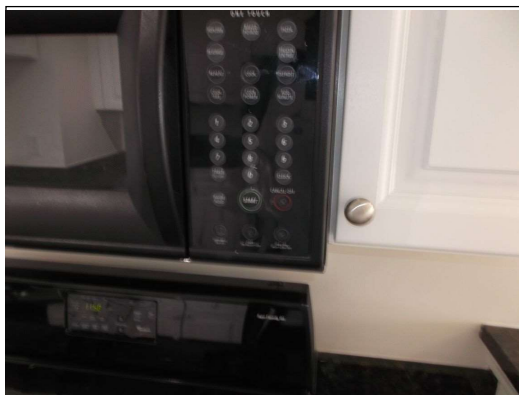
Microwave jell pad tarnished or soiled

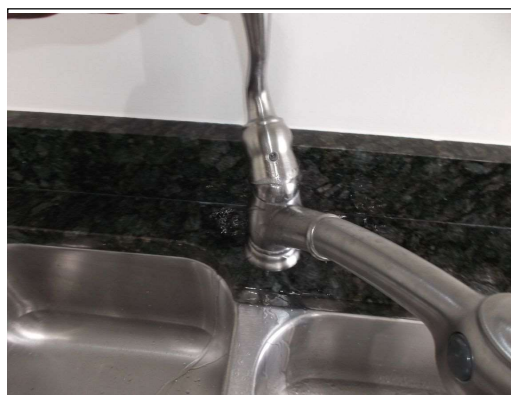
Sink faucet leaking water at the handle;

Sink faucet leaks at the handle

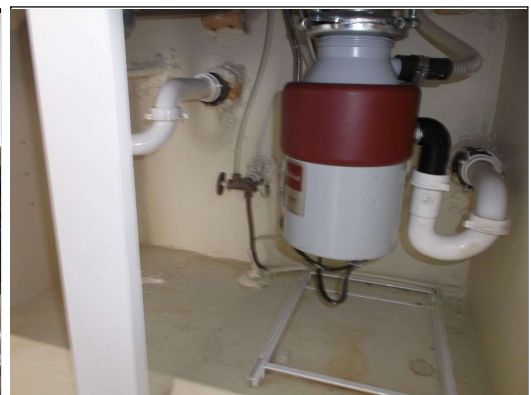
Sink cabinet has water damage painted over

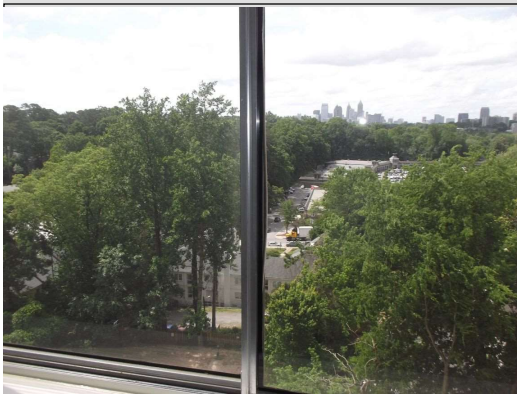
Windows are worn and defective in the great room; several windows cannot open and screens missing (windows poorly seal when closed and may be drafty when wind is blowing); great room did not cool down properly when the coldest temperature was dialed at the wall HVAC unit thermostat;

Glass weather strip detaching/window worn

The condo entry door does not fully self close and lock does not latch when closing (spring activated hinges weak); to repair windows to operate marginally can cost 400.00 each;

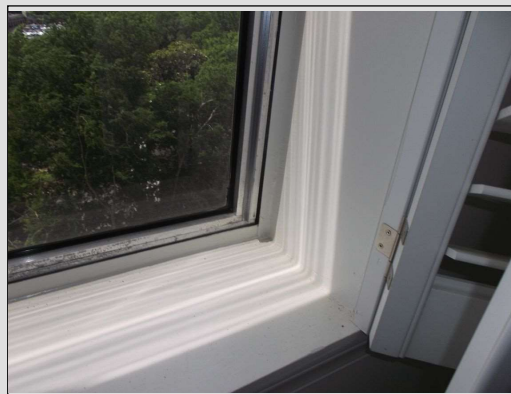
Windows wont open

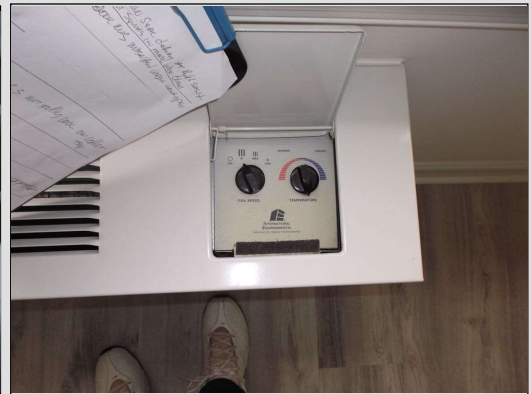
Poor cooling system in great room

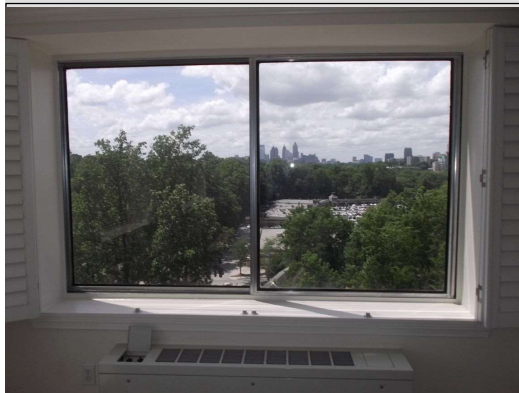
Bedroom windows do not open or very restrictive to open (worn, damaged...); bedroom windows are no square in the window frames (windows do not seal weather tight when closed and may be drafty when wind is blowing); rooms were slow to cool when AC dialed at wall units;

Window not opening

To repair bedroom windows to marginally operate or open can cost 400.00 each to adjust.

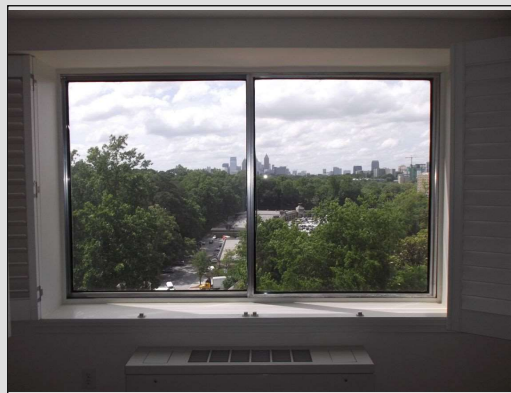
Window restrictive to open

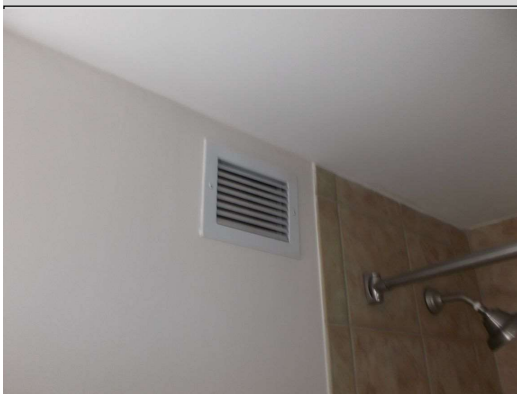
Master Bath: No exhaust fan in bath; bath became very steamy when hot water flowed at shower head; dry stains in cabinet floor; missing bead of caulk where bath floor tile marble threshold near the door frame;

No mechanical exhaust fan

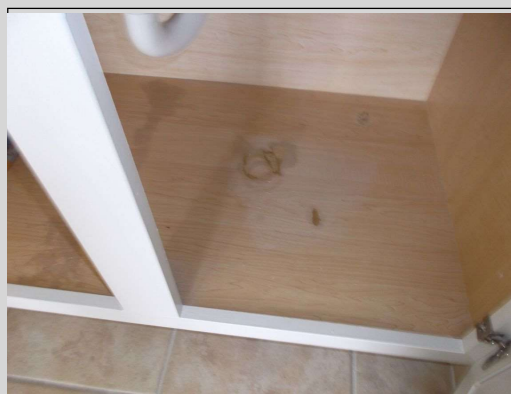
Dry stains on cabinet floor

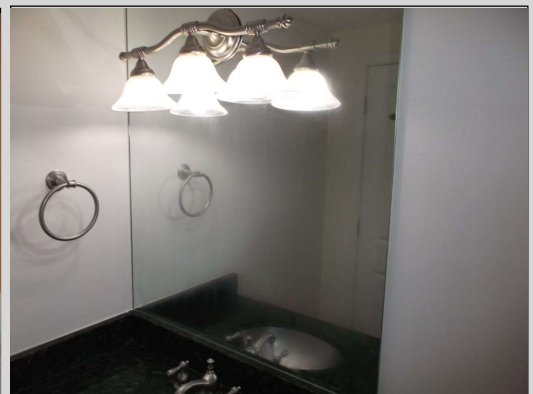
Mirror steamed when shower used
