PROPERTY INSPECTION REPORT

2161 Peachtree Rd. NE #102, Atlanta, GA.

Feb 5, 2024

1599

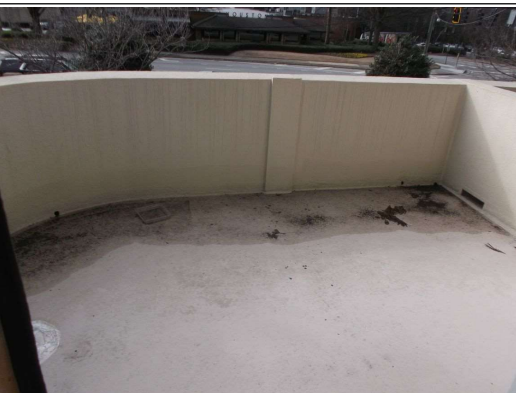
The balconies have poor drainage off the floors and the drain holes appear too small (heavy rains can cause water to rise up to the exterior doors). Verify the main entrance front portico or floor is not pouring too much surface water through the wall opening to the condo patio floor causing surface water to rise and flood the condo floor and rise up to the door threshold. The patio scupper holes appear to small to drain heavy rain water off fast enough during storms. It is advised to drill larger holes into the balcony walls. Debris are blocking some drain opening at the balcony walls which can cause poor drainage away during heavy or long rains.

Drainage holes too small for heavy rain, debris

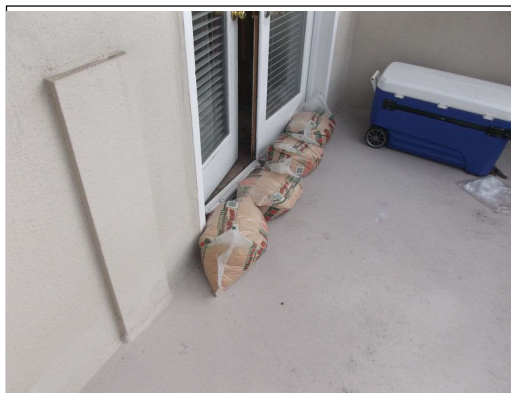
Tenant stated water rises up to doors

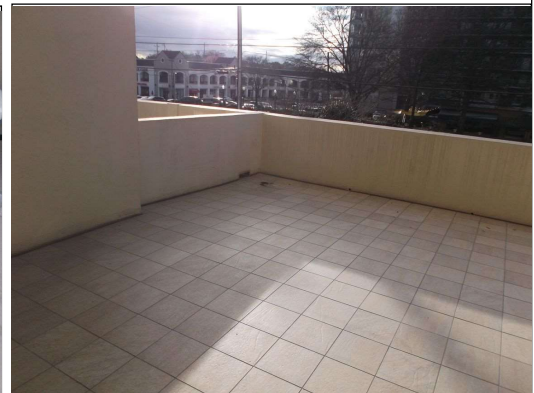
Drainage hole in condo balcony wall

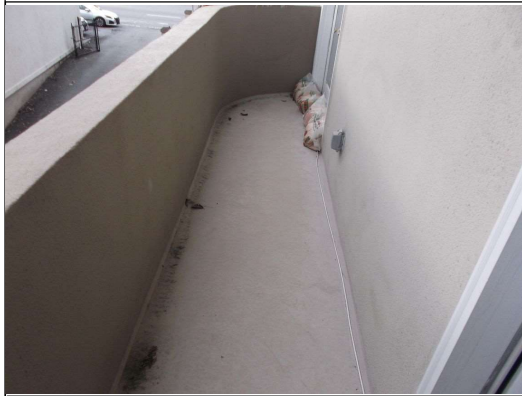
Drainage holes too small at side balcony

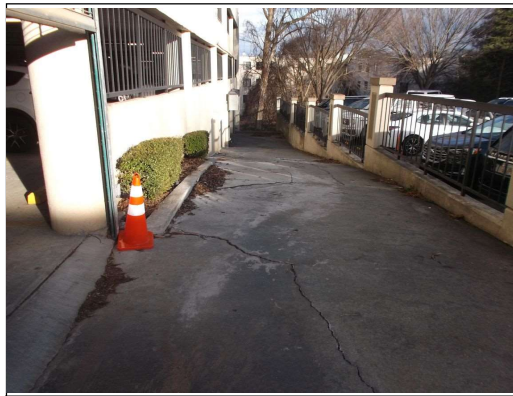
The driveway has major damage at the right side of the building, broken sections with defective repairs and settling.

Driveway major cracks and defective repairs

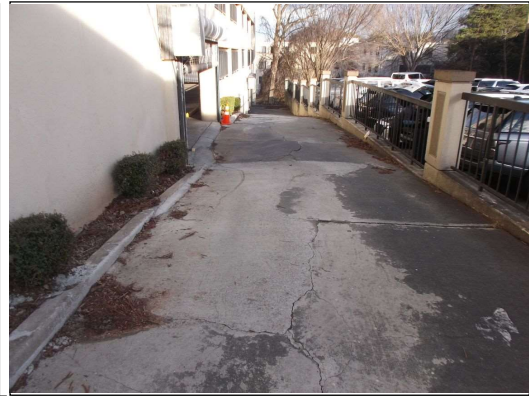
Driveway cracking and defective patches

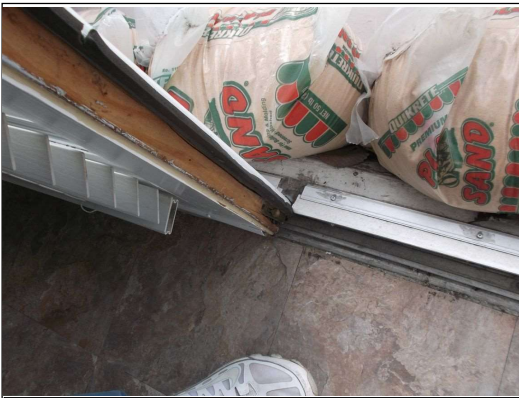
The front balcony patio door fixed door slab is split at the bottom latch and the door lock will not is not striking the plate to lock. The living room fixed door to the south balcony is split at the bottom lock, the door lock is not striking the plate properly. The weather strips appear worn. Missing weather strips a the the condo door to the lobby at the side frames and across the top. Verify proper sealing weather strips are under the bottom of all exterior doors.

Front fixed door slab split at the lock

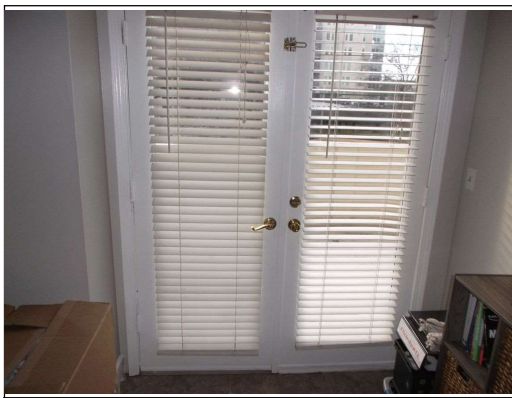
Liv. door not latch, not square in frame...

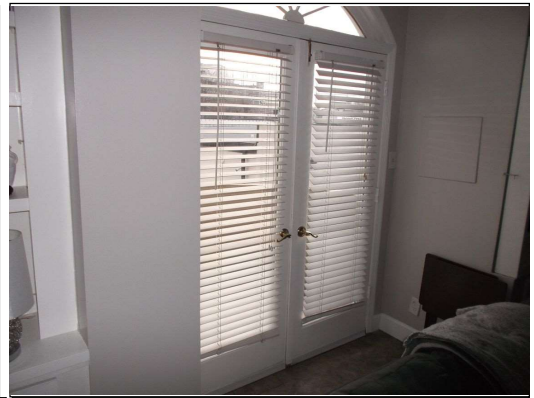
Front patio door damaged at the bottom lock

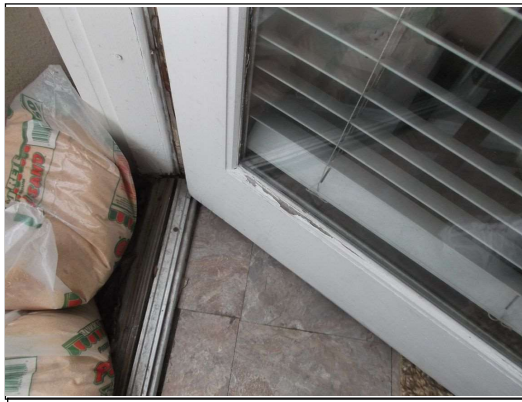
Exterior doors may need paint in near future

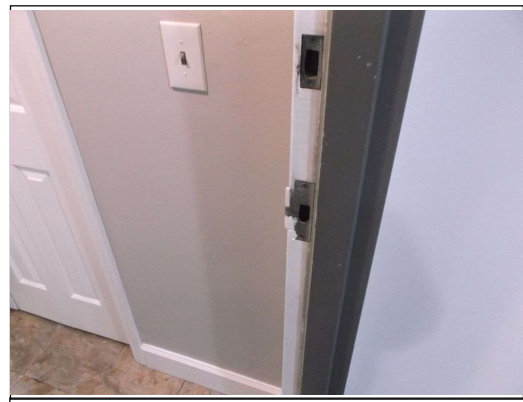
Missing and weather strips at condo door

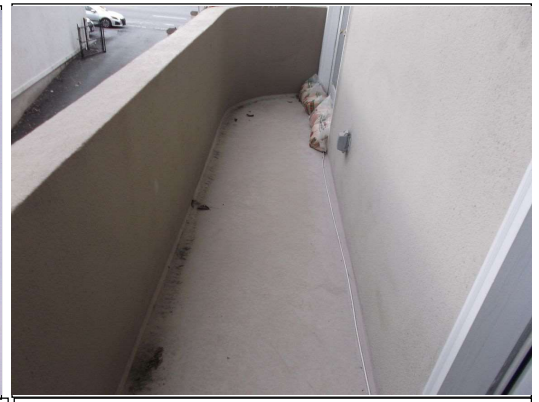
Verify proper holes for drainage at balconies

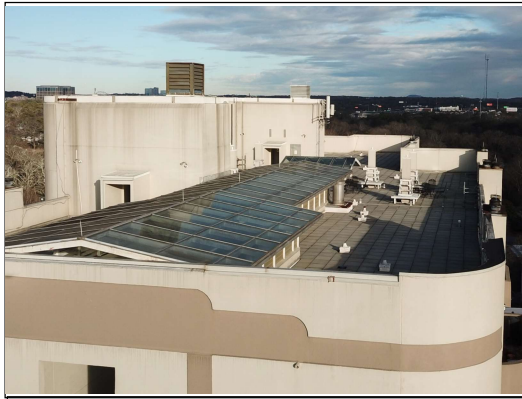
Maintenance:
 Roof is covered with a deck for activity use and people outings. Cannot verify the roof covering condition.

Roof covered with decking for pedestrians

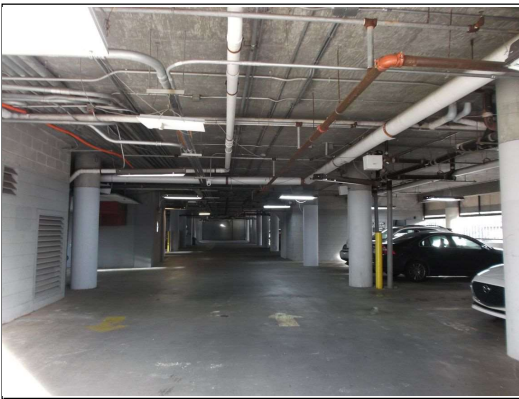
There is no foam insulation sprayed onto the garage concrete ceiling-condo floor to reduce condo energy consumption and heat loss. There was an infra red scan of the condo and the concrete floor, which is above the public garage, that shows low temperatures in the concrete slab. A concrete floor exposed to the weather can cause extreme heat loss in the condo through the floor and walls and heat gain in the summer that can cause higher energy bills. Without insulation covering the concrete, it can cause excessive energy use. All exterior walls and floors should be insulated.

The garage ceiling not insulated or sound pro

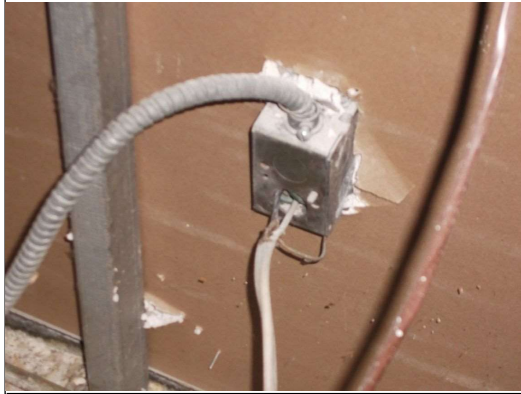
The dining room receptacle at the interior wall near the window was on and off when tested and loose in the wall. This receptacle is on the furnace closet wall. Can see electrical wires extending out the box (from in the furnace closet) which is a fire and safety hazard (wires should be wrapped in sheathing and clamped to the outlet box to prevent from pulling out of the box). Master bedroom receptacle not energized behind the bed. It is advised to have a certified electrician check system for service, safety and maintenance.

Wires pulling out the dining wall receptacle

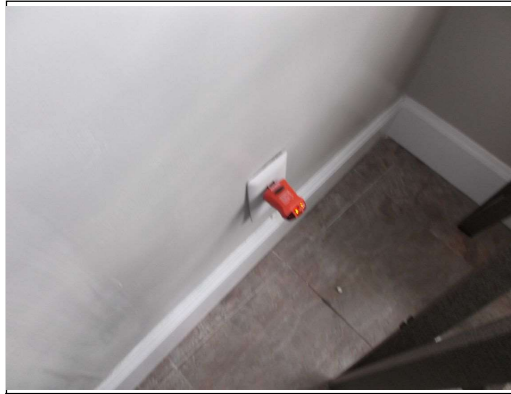
Dining receptacle on & off, pulls out wall

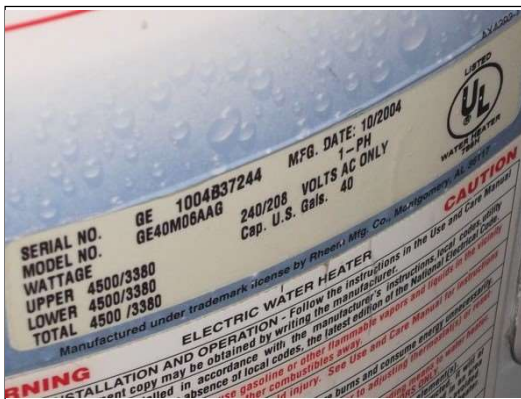
The water heater date is 2004. Water heaters have a good life of 10 to 11 years. Some have a good life of 8 years. After these dates rust can begin to accumulate as sediment in the bottom of the tank, the rod can corrode and the tank walls can become weak and leak.

Water heater date 2004

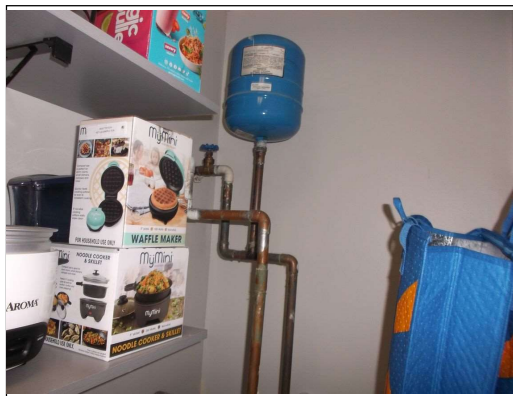
The expansion tank is resting on the water pipe above the water heater which can damage the pipes (should have independent support).

Expansion tank rest on the water pipes

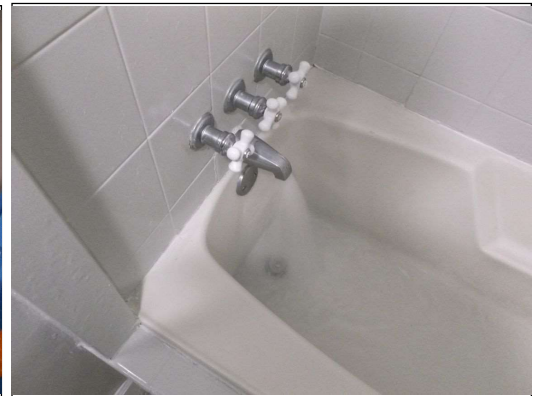
One bath tub spout had very high water flow and pressure. There was no way to check the water pressure in the condo because the washer was connected to the faucets. Water pressure over 80 psi is too high.

Water flow & pressure very high at front tub

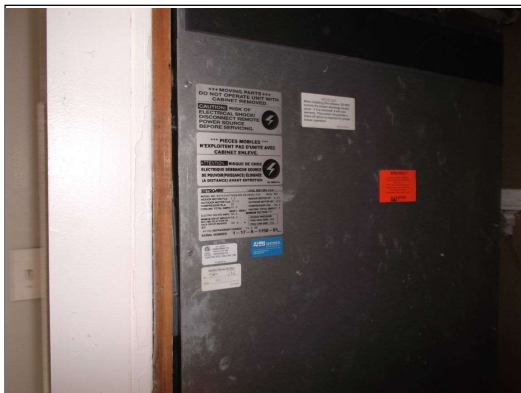
The occupant stated the electric bills are very high when trying to heat the home to a comfortable temperature. The HVAC system is a heat pump and/or electric. It is advised to have a HVAC contractor check for service and maintenance of the electric furnace before closing to verify operation and condition. It is advised to have a HVAC contractor do a heat output test for efficiency. Please be advised if there is poor insulation under the concrete floor, there will be heat loss via radiation and conduction through the floor. The furnace size and efficiency may cause excessive operation. The occupant had space heater in the bedroom.

Furnace electric in closet

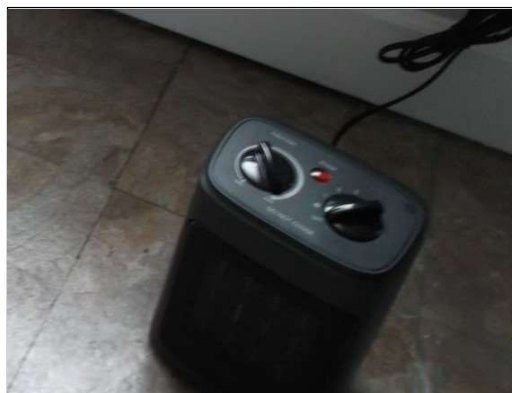
Space heater in bedroom

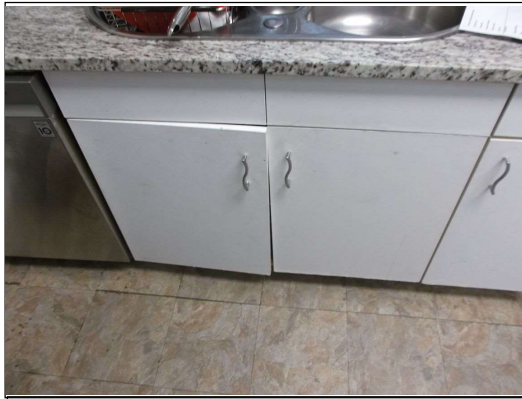
cabinet door hinges loose at areas

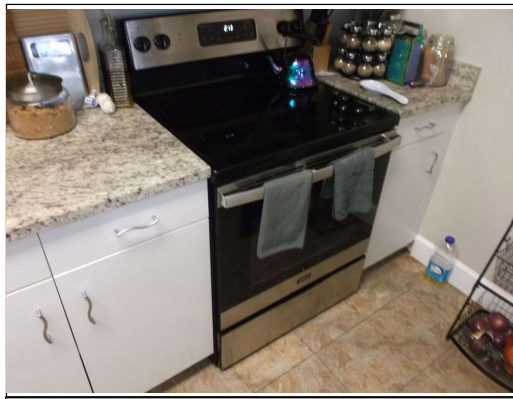
No anti tilt device connected to stove

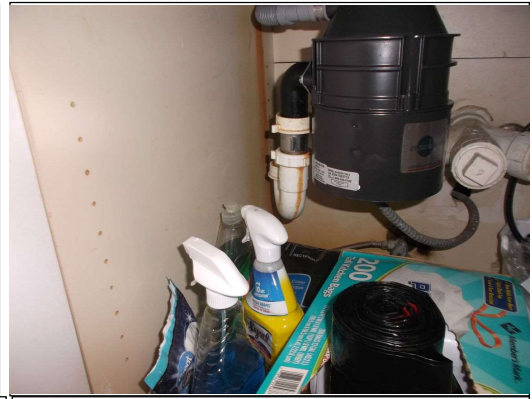
Stains on drain pipe to disposal

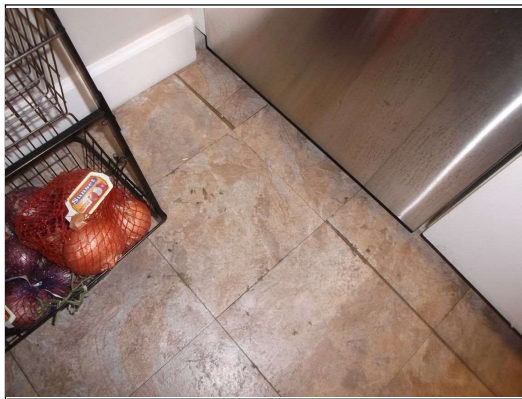
The floor vinyl or covering is defective at the dishwasher area and various areas.

Floor tiles moving and loose

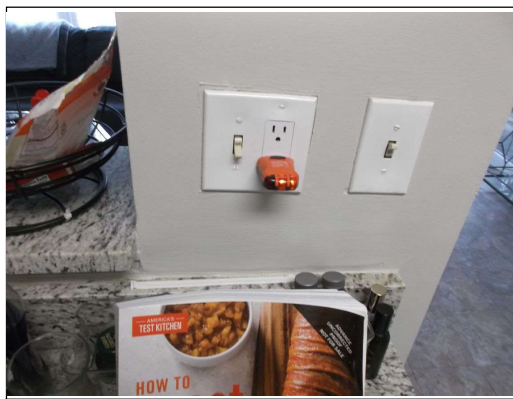
Receptacle did not trip when tested

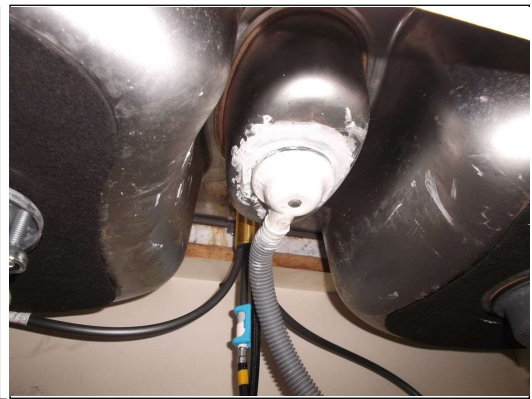
Improper drain assembly at center sink

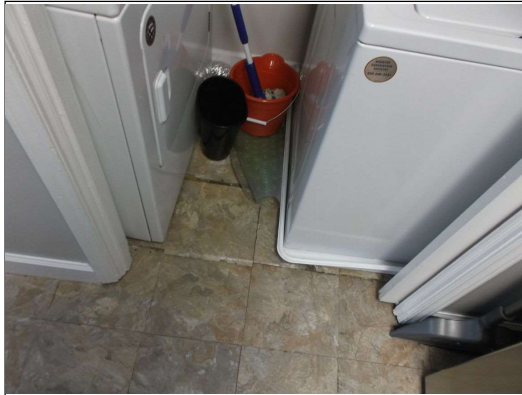
Floor covering at the laundry room are defective.

Defective floor tiles at laundry

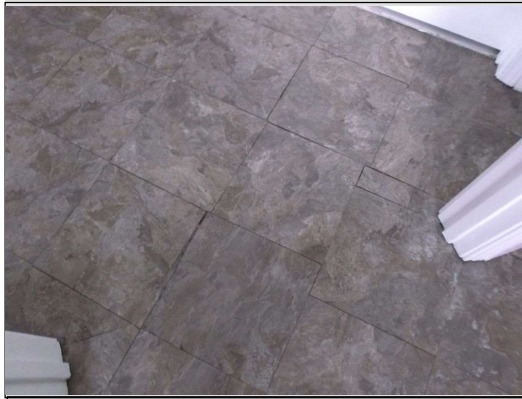
Floor tiles shifting at various areas throughout the condo. There are gaps at the baseboards and floor at the exterior walls (unconditioned air can come into the condo at open spaces, should be shoe molding on the baseboard at the floor and a caulk bead to seal air tight)

Floor tiles shifting at areas

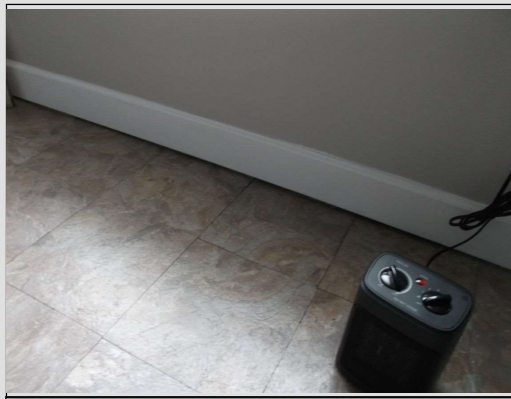
Gaps at baseboards near floor

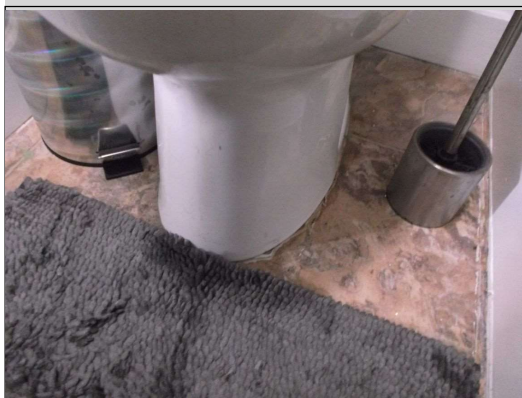
The front bed bath has defective bead of caulk where the toilet rest on the floor, the tub right or cold faucet need washer on the stem. Shower head pipe appears slightly loose in the wall. Do-it-yourself drain pipe in the sink cabinet (corrugated drain pipe can clog). The sink cabinet right bottom drawer bump when closing. Water flow very high at the tub faucet (verify water pressure to the condo is below 80 psi, verify there is a water pressure reduction valve at the main water pipe to the condo to reduce building pressure).

Defective caulk where the toilet rest on floor

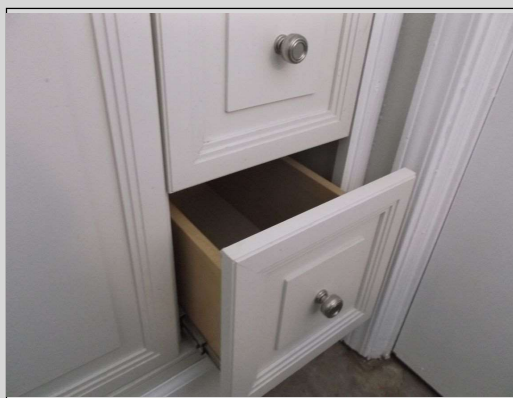
Drawer bump when closing

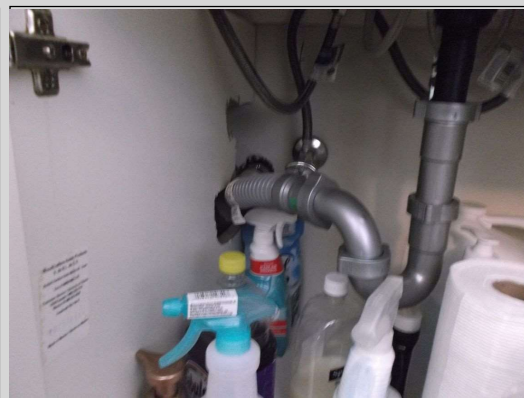
DIY drain pipe repair

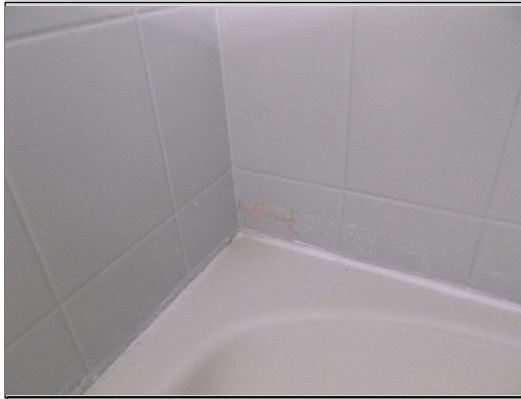
Left bedroom bath has defective caulk where the wall tile rest on the tub deck. The tenant says the tub floor is weak (some fiberglass tubs were supported with foam which compresses over time, a hole can be cut in the wall and cement or grout can be poured under the tub floor to support). Tub stopper not in place. The tub faucet nickel finish is stained of tarnished (verify can be polished or cleaned). It appears there is a paint or glaze on the wall tiles and peeling at the bottom tiles at the tub deck.

Defective glaze on tiles

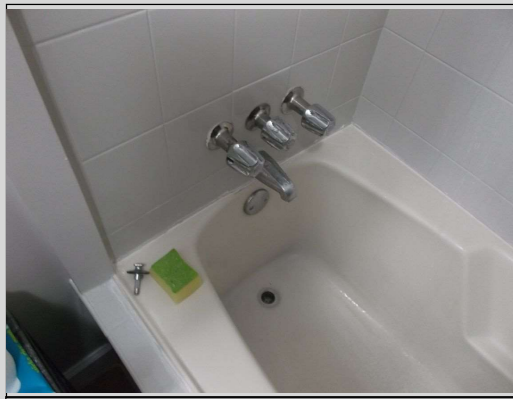
Stopper not in place/knobs loose

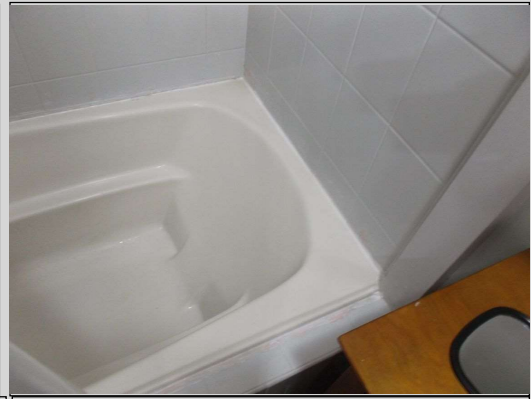
Defective caulk at tile and tub

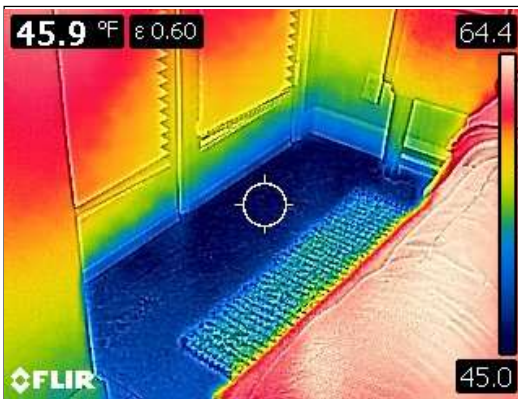
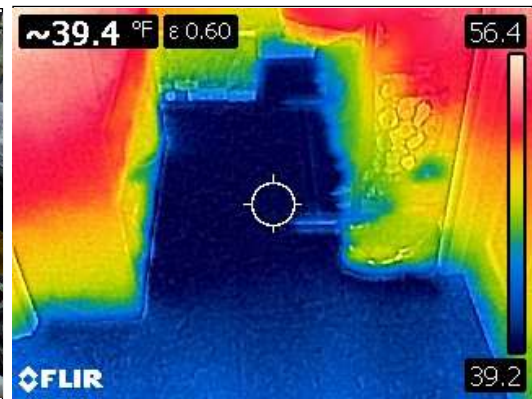
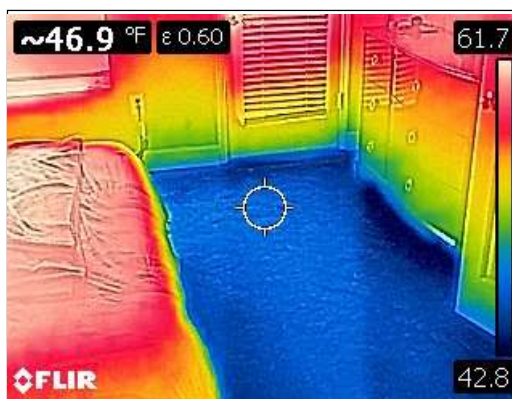
The color gradient shows the different surfaces' temperature. The blue color is the coldest surface and the red, yellow and white are warmer surfaces. White is the warmest surface.
