PROPERTY INSPECTION REPORT

1679 Riverlanding Circle, Lawrenceville, GA.

Jun 3, 2021

1599

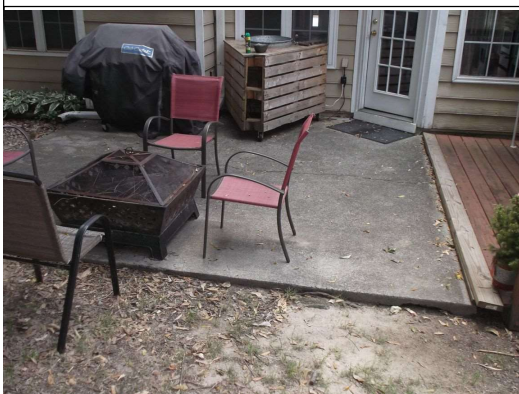
Patio cracked & settles/soil slope to patio

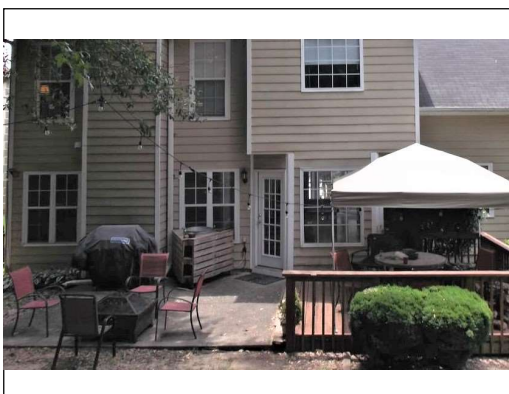
Soil slopes to patio-deck & wood block water

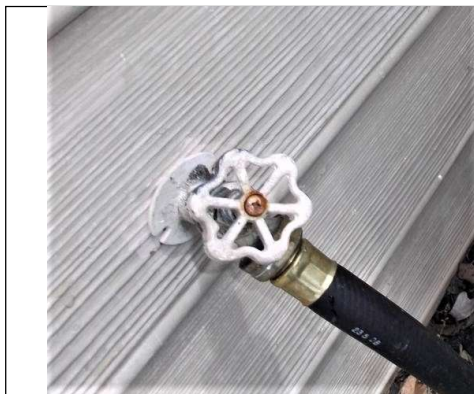
Missing anti siphon device at front faucet

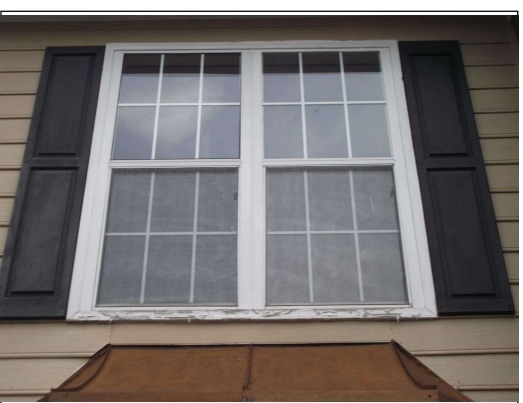
Screens rot

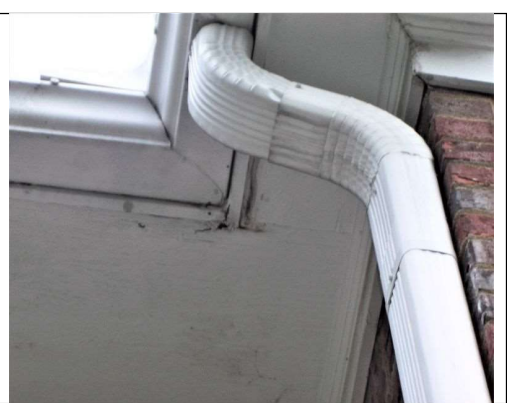
Water damage

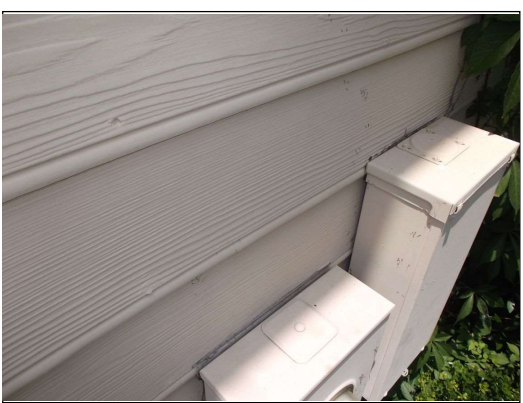
The electrical meter box and AC electrical boxes are missing a bead of caulk across the tops which can let water get behind boxes and into holes in the siding;

Missing caulk over electrical boxes

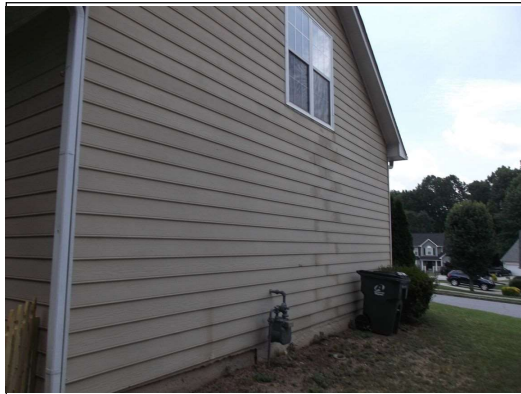
House needs painting

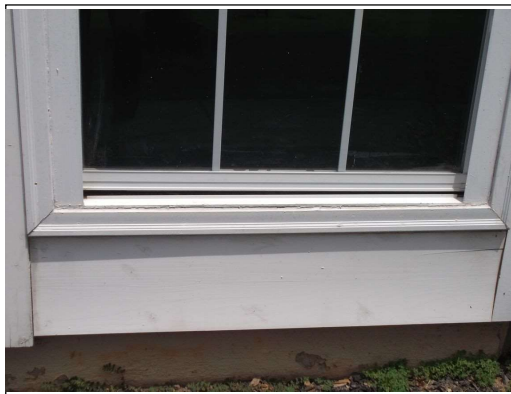
Bay window sash not square in frame

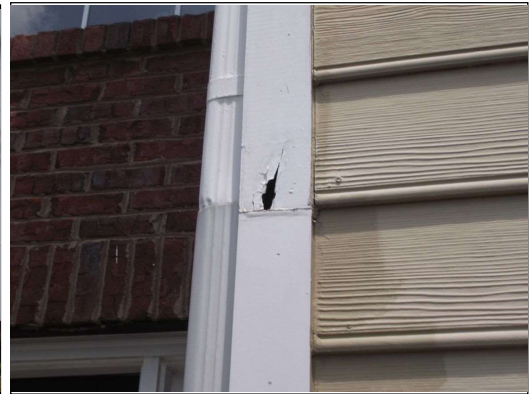
Rot at trim various areas on the house

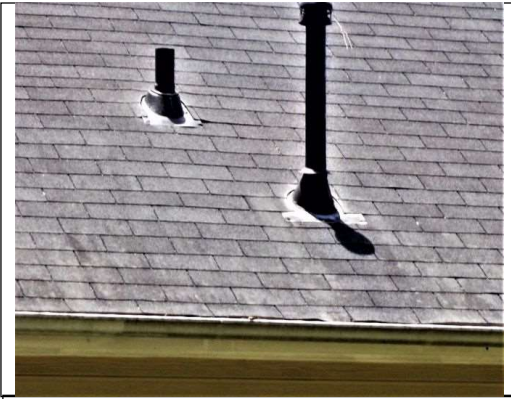
Pipe flashing on top shingles face nailed

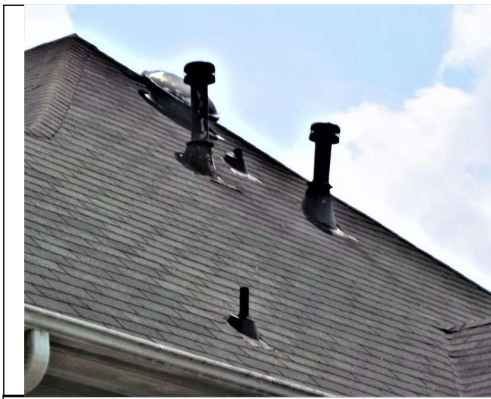
Pipe and vent flashing nailed on top shingles

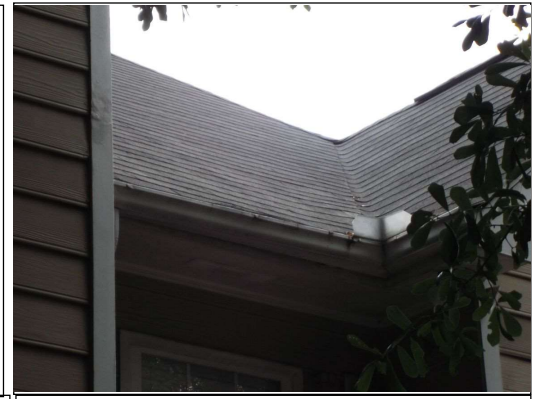
Slight dip in roof deck left of valley

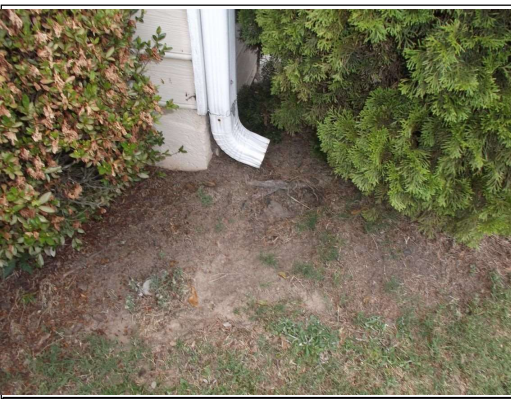
Downspouts pour at foundation

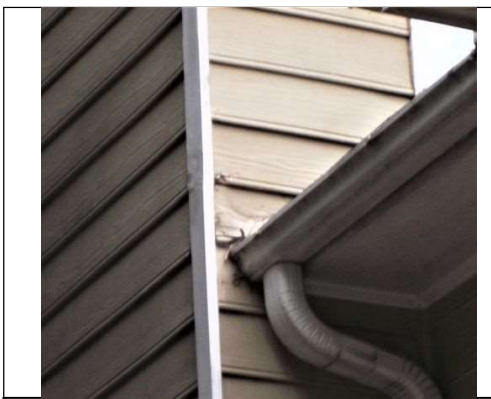
Siding has water damage on the side of the chimney near the roof; tree limbs touch chimney;

Siding rot near roof at chimney

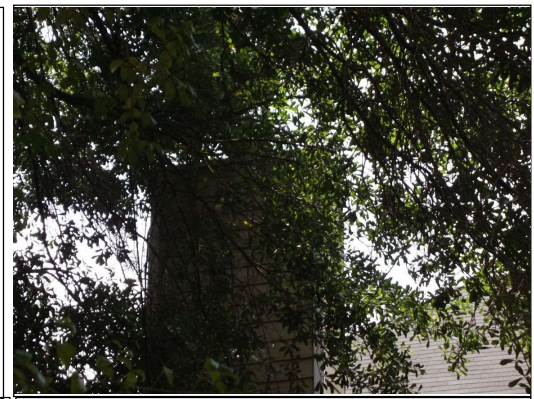
Tree limbs touch chimney and roof area

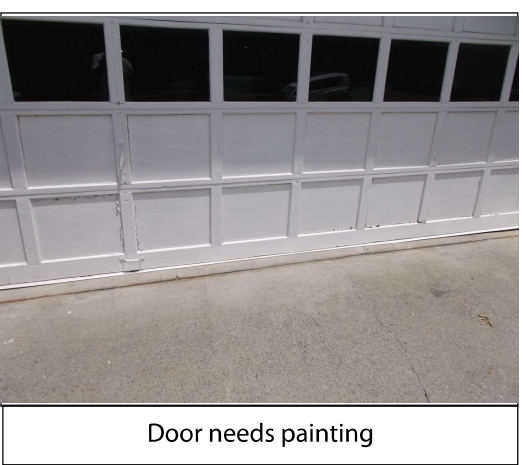
Door needs painting

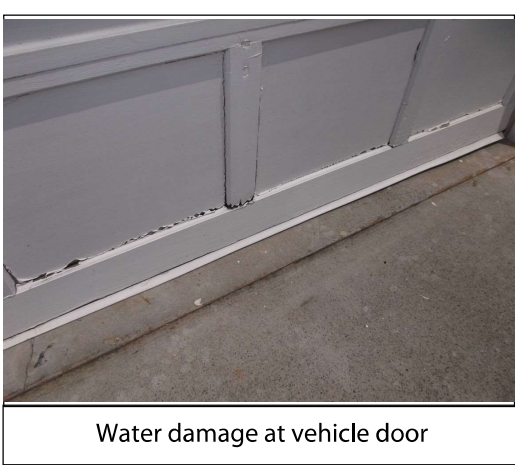
Water damage at vehicle door

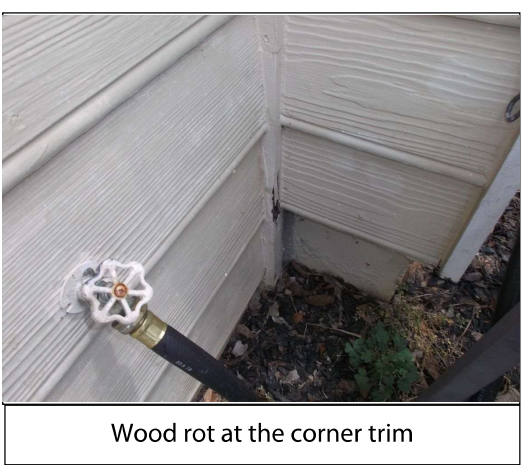
Wood rot at the corner trim

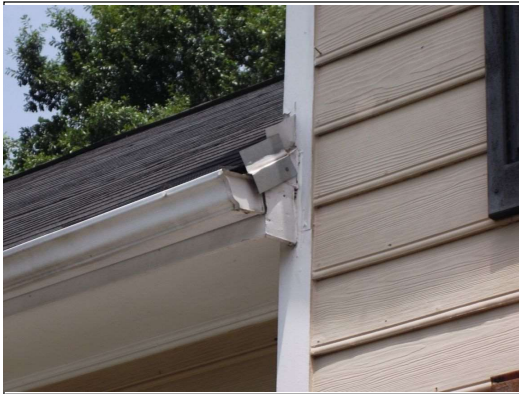
Rot and defective repair at soffit

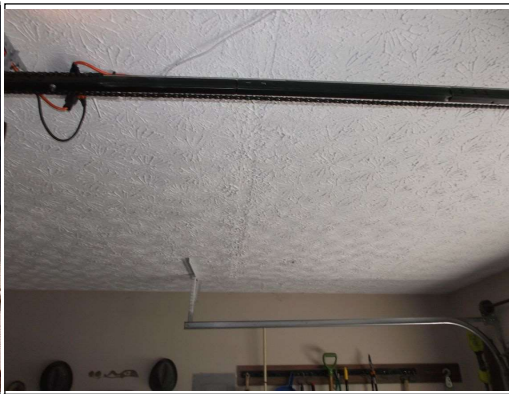
Defective ceiling repair at seam

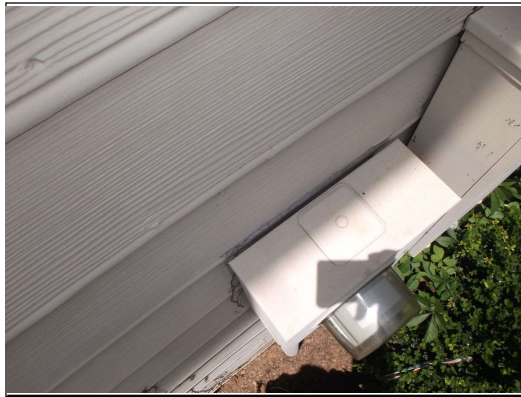
Meter box detaching from the wall/no caulk

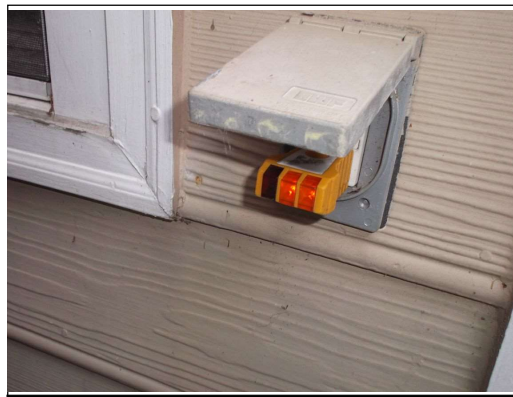
Front outlet not tripping

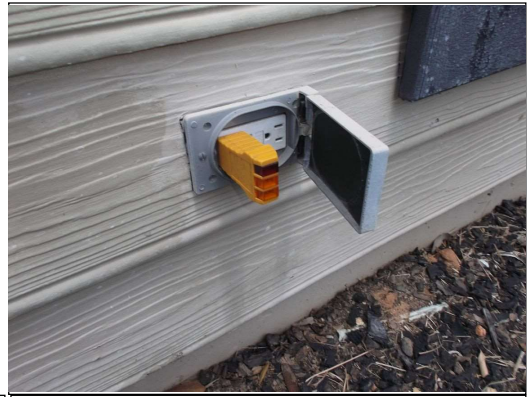
Rear outlet not energized and not reset able

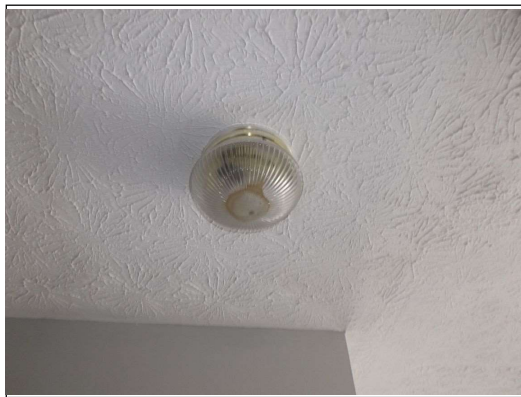
Water in 2nd floor hall light fixture

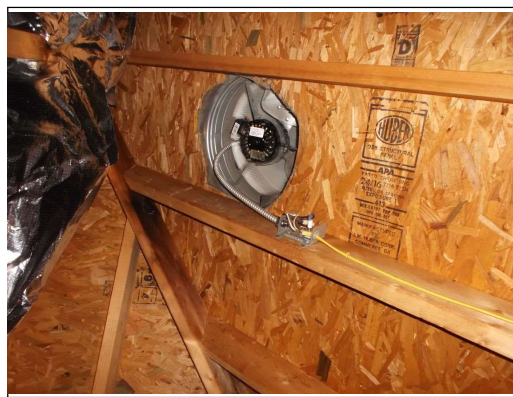
The attic exhaust fan electrical wires are exposed at the junction box nailed to the roof rafter (missing box cover)

Exposed wires at attic fan junction box

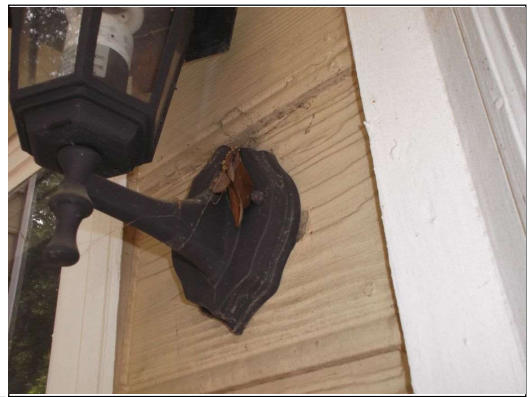
Missing caulk around light fixtures on siding

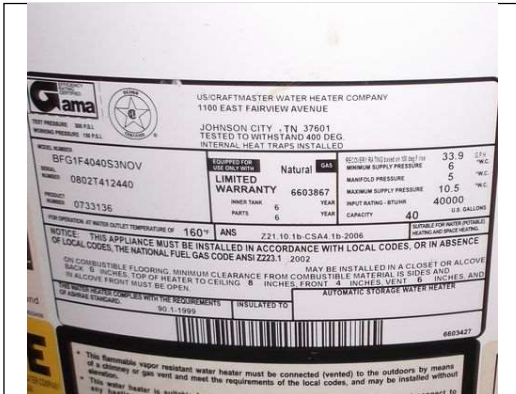
Water heater: near end of life (date 2008), water heaters have a good life of 11 to 12 years at the most; replacement needed;; there is no expansion tank above the water heater; missing anti siphon device at rear hose faucet;

Water heater date 2008/week 02

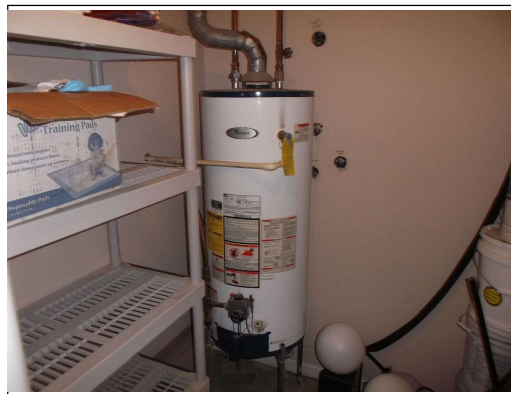
No expansion tank above water heater

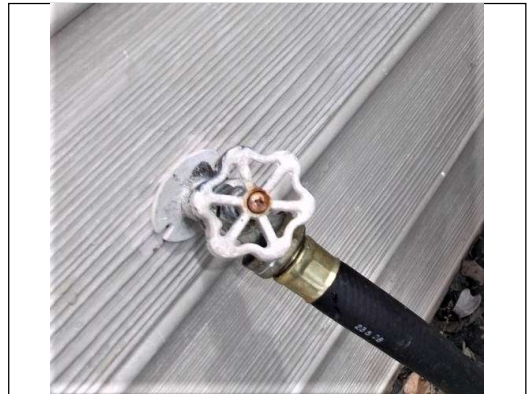
Missing anti siphon device at rear faucet

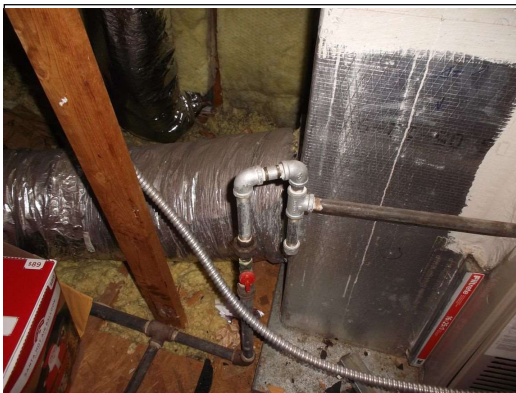
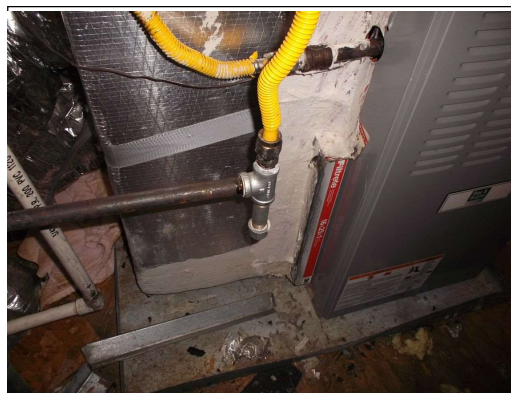
Water pipe for gas pipe

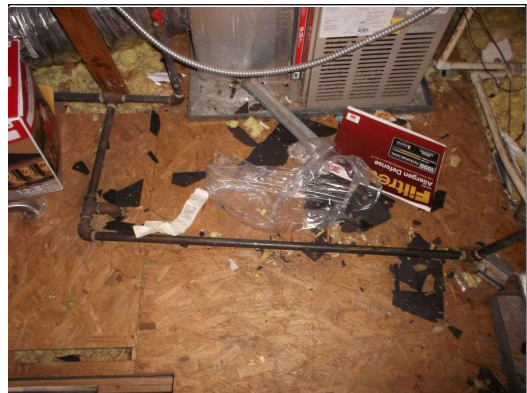
Gas pipe not secured to attic floor

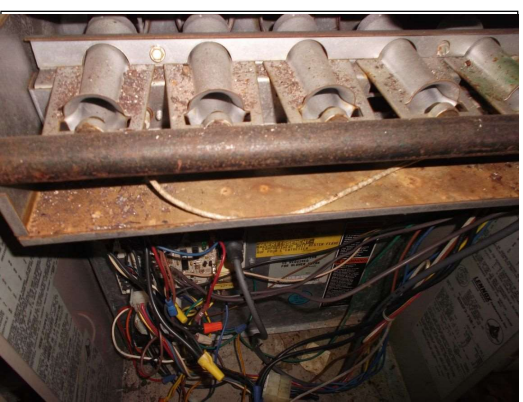
Major rust on burner heat shield

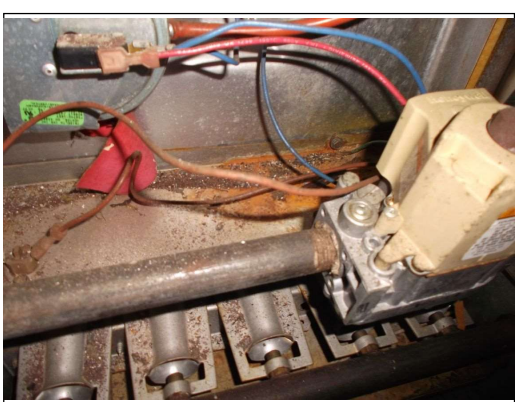
Maintenance:
Left furnace in the attic has rust inside the controls area and on the burner shield (may be from refrigerant line dripping above furnace); left furnace appears worn and may be in the last years of good use; there is a air duct the has sharp turns at the left side of the right furnace near the bottom (ducts with sharp turns can restrict air flow; there is a air duct on the left side of the right furnace that is detaching from the air handler column; missing air register cover in the laundry room; filter doors not in place at the time of the inspection;

Rust on left furnace burner shield

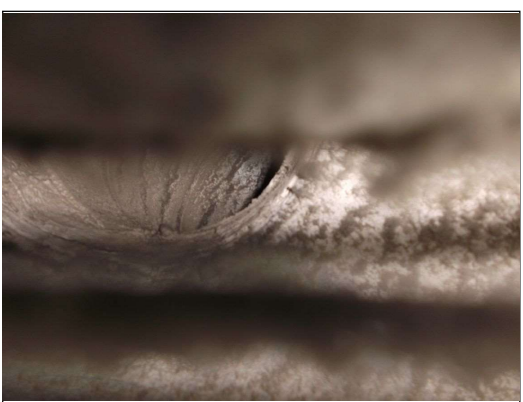
Air ducts rusty

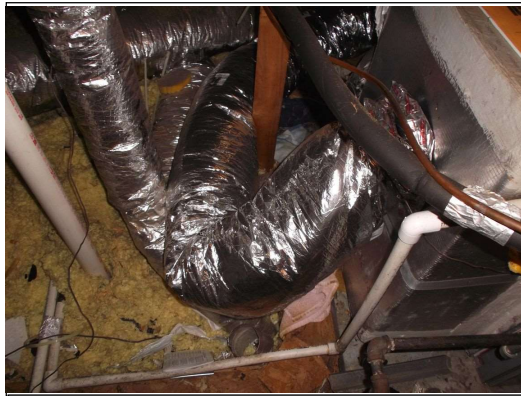
Air duct sharp turn

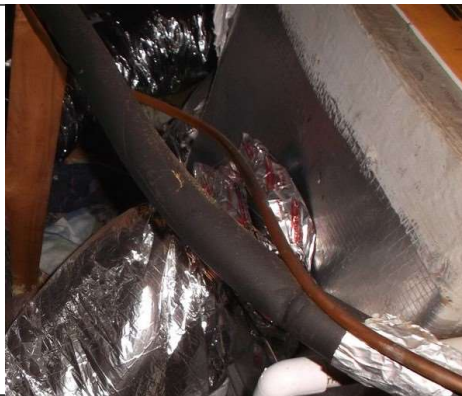
Air duct detaching from collar

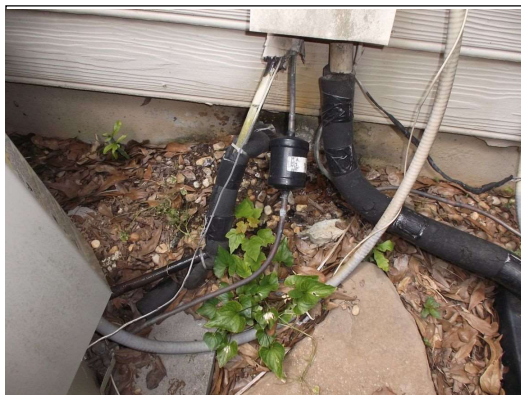
Refrigerant line insulation missing & damaged

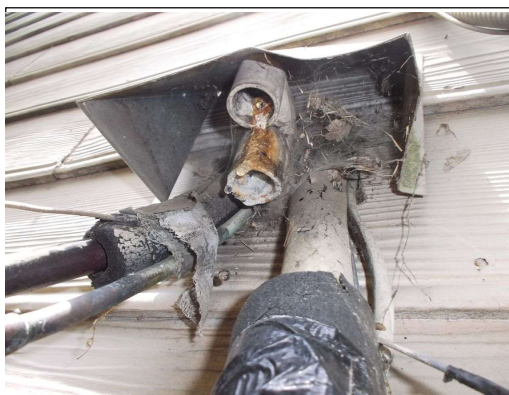
Condensate pipes drip at the wall

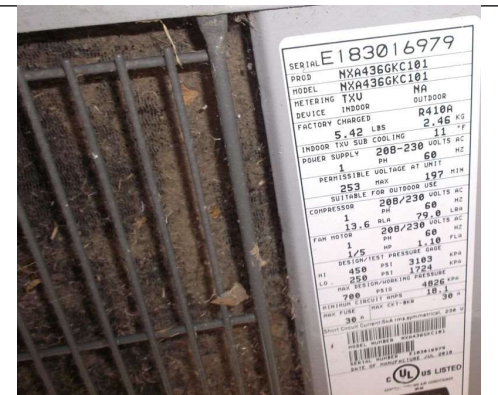
AC units fins need cleaning

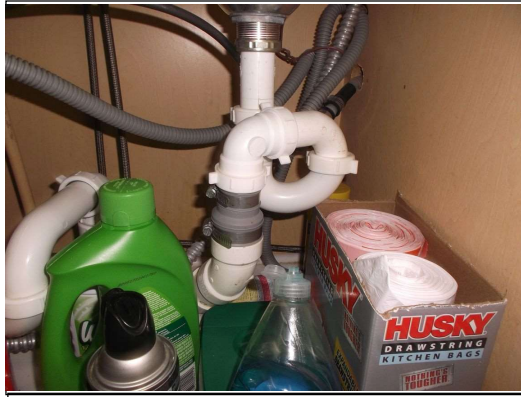
Drain pipe is a S-Trap

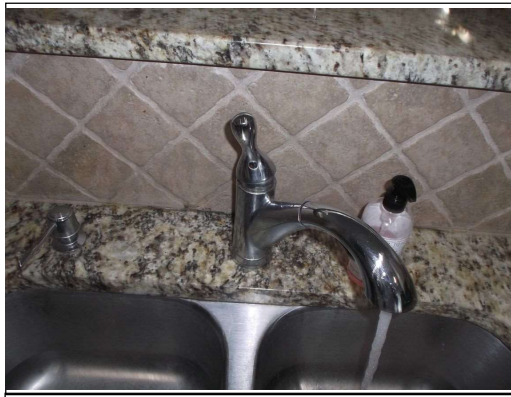
Faucet handle loose

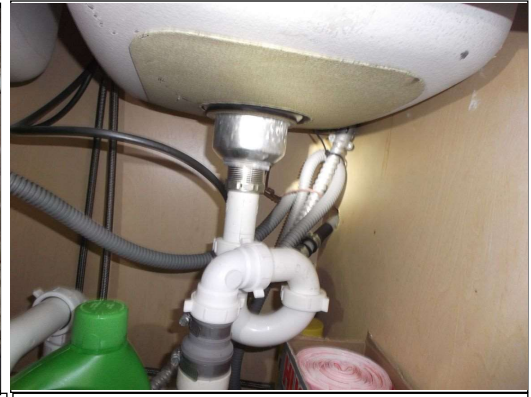
Dishwasher drain pipe not hi looped

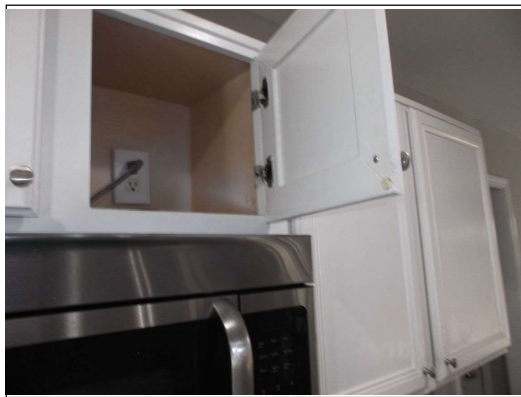
Cabinet door loose

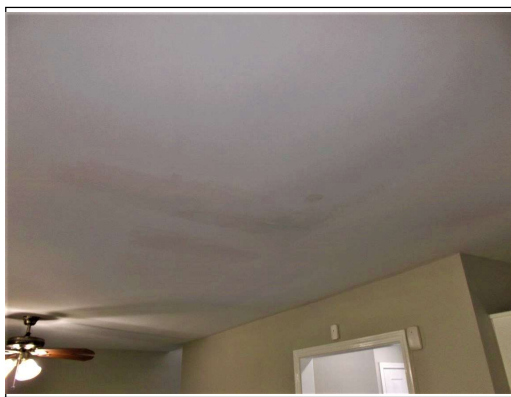
Dry stains in the ceiling over bar stools

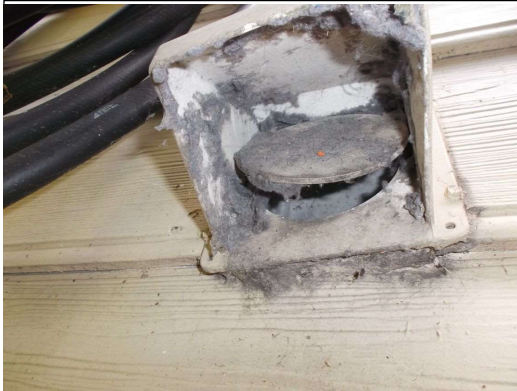
Dryer vent clogged and door stuck open

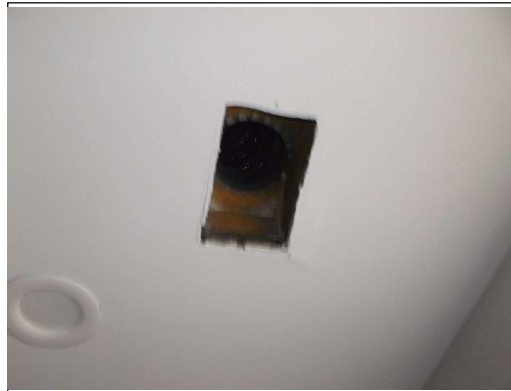
Missing vent register cover

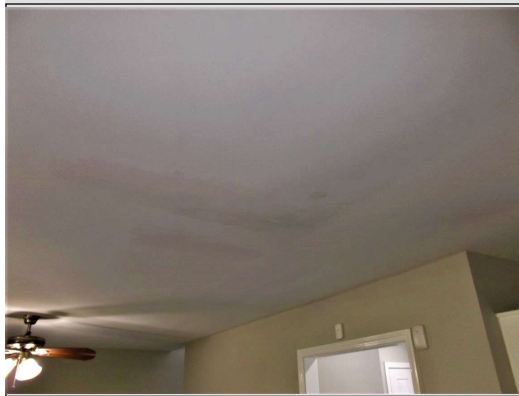
1st floor: There are major dry water stains in the ceiling above the bar stools (verify the cause by reseating toilets, checking plumbing, checking roof pipes and flashings above this area (if leaks cannot be determined by visual there should be a hole cut in the ceiling to see under the floor above to verify what is leaking)(seller verify the leak has been repaired);

Dry stains in ceiling above bar stools

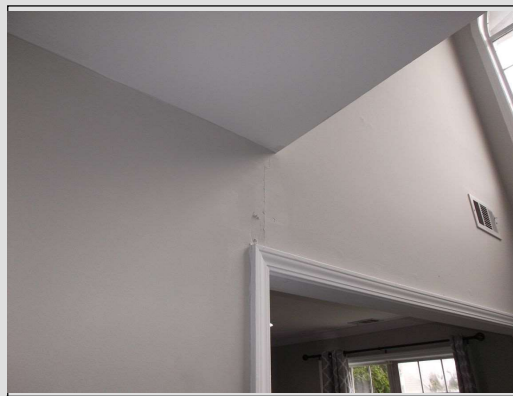
Settling crack in foyer wall above office door

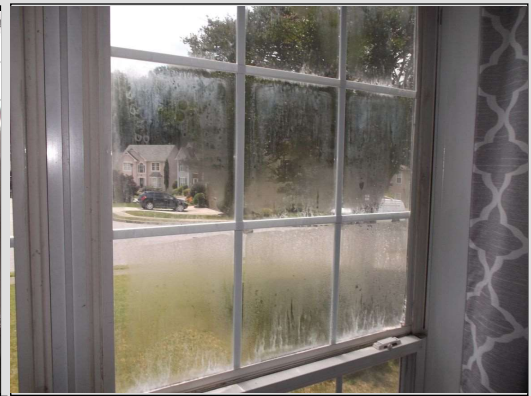
Glass fogged at the office

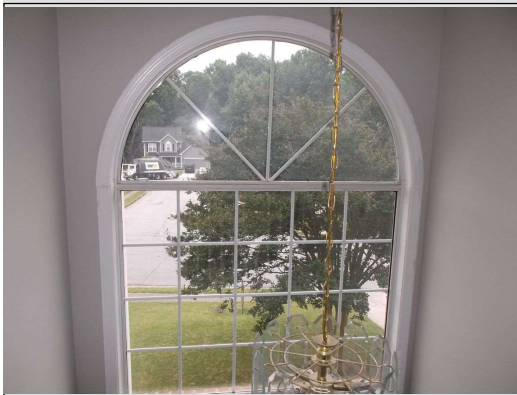
Arched window glass fogged

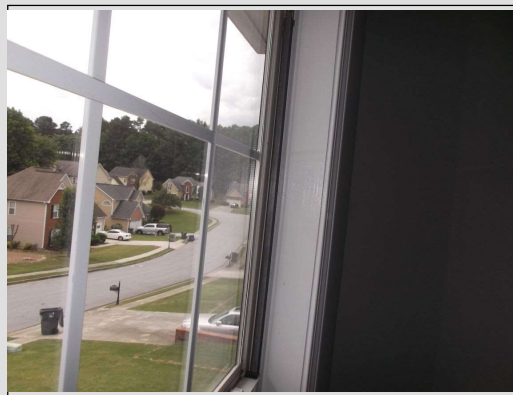
Defective sash cords at some windows

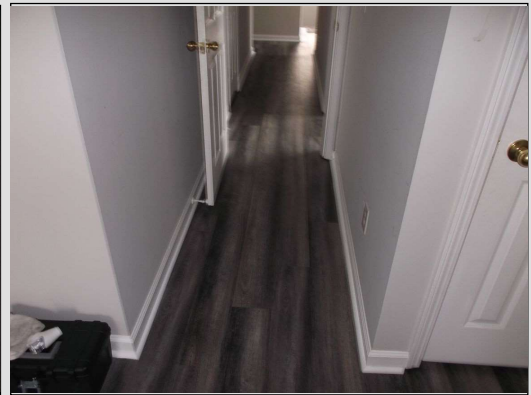
Hall floor dips at bonus room doorway

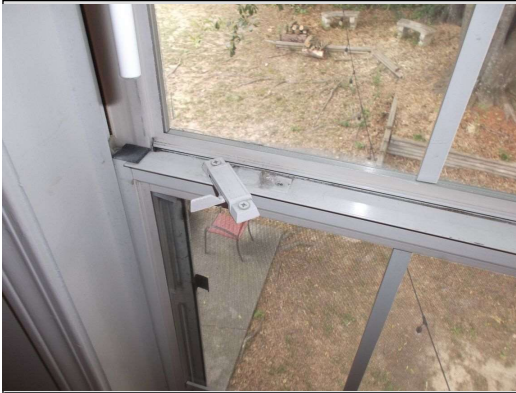
Master bedroom window lock detached at the right window;

Detaching window lock

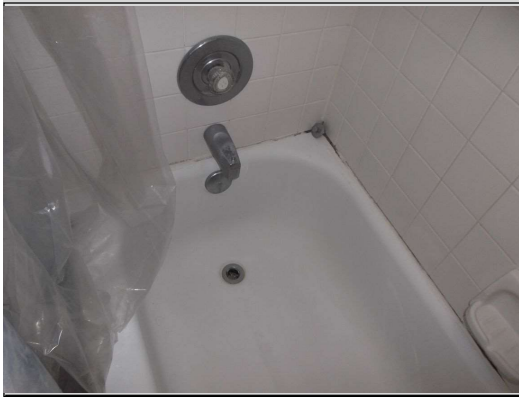
Stopper missing/mold on caulk

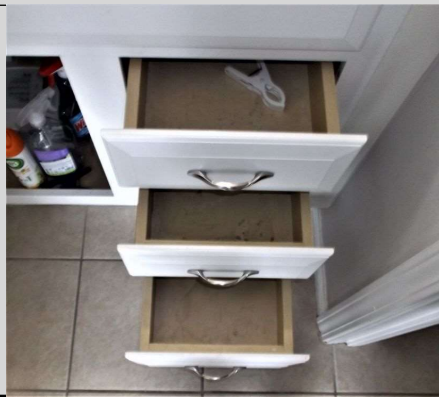
Drawers stained in bottoms

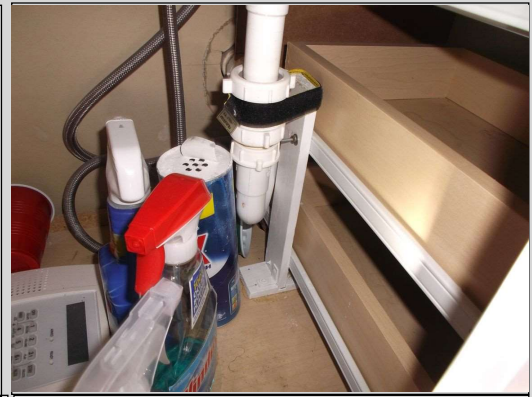
Strap around pipe attached to drawer track

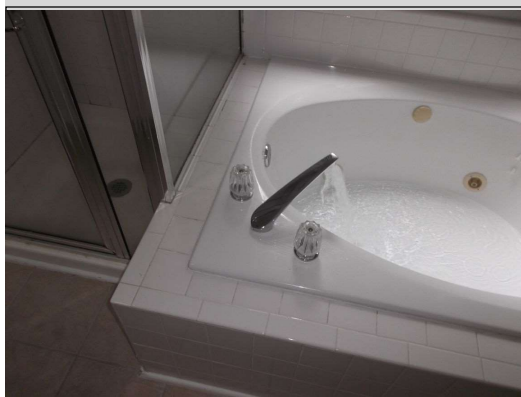
Tub spout loose, caps missing at knobs

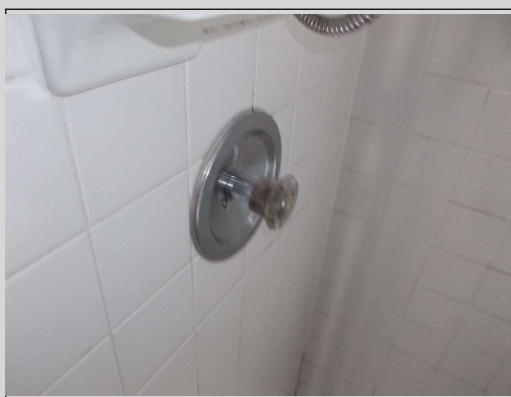
Shower knob missing cap

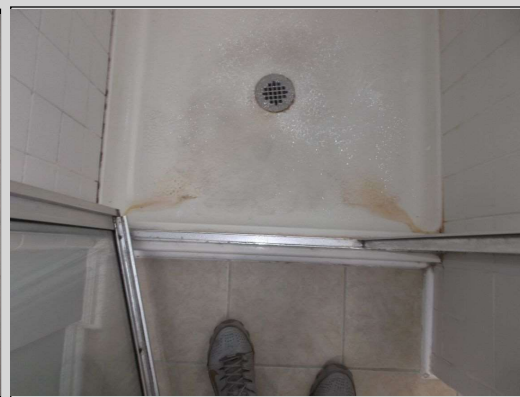
Rust stains in shower floor finish

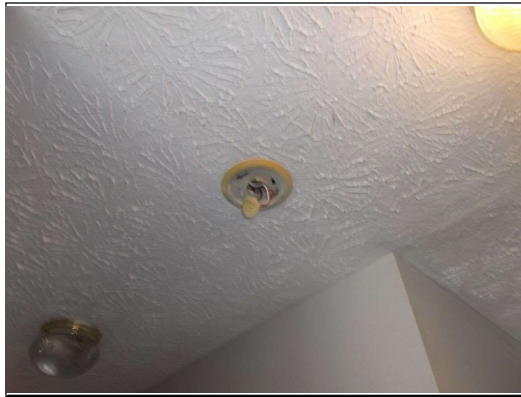
Missing smoke alarms and CO detectors (there should be a smoke alarm in all rooms for sleeping and in halls serving rooms for sleeping);

Missing smoke alarm

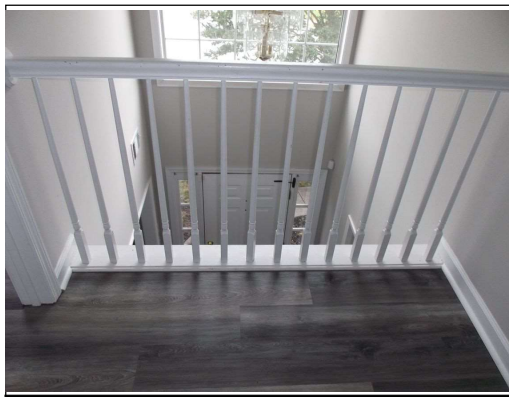
The rail guards at the 2nd floor balcony are spaced more than 4 inches apart (child and pet safety)

Guards spaced too wide at balcony

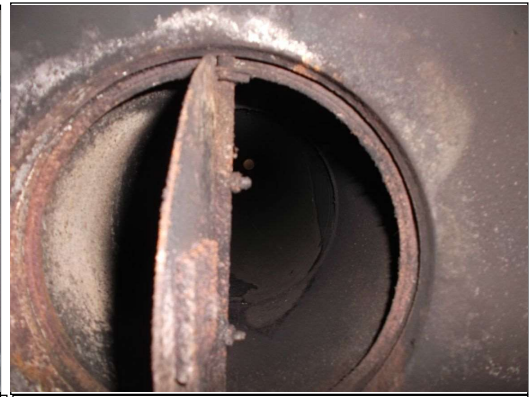
Creosote in chimney flue

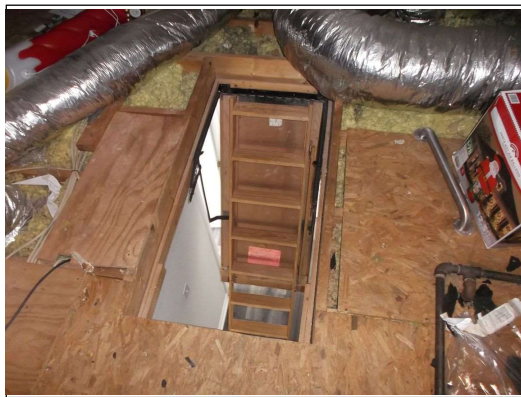
Attic ladder installed in the wrong direction and missing flooring around entry opening;

Attic ladder enters wrong way, missinf floor

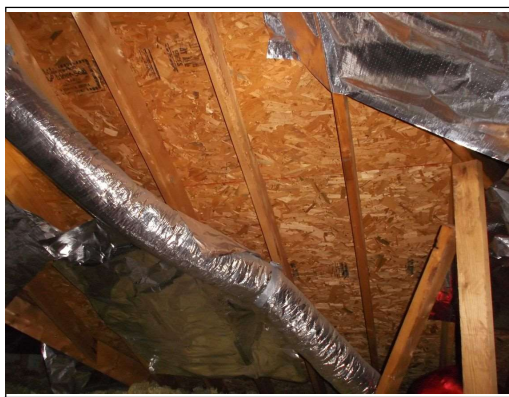
Missing spacer clips between roof deck panel:

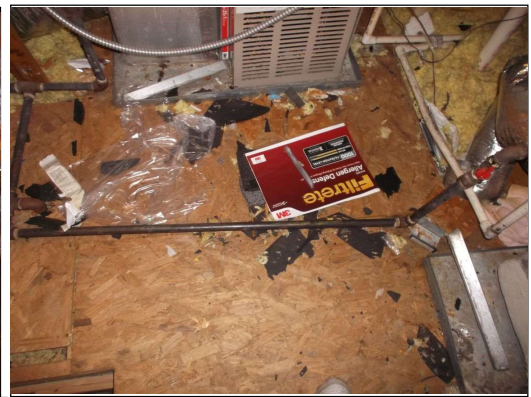
Debris in attic
