Property Inspection Report

65 Creek Breeze Way, Oxford, GA

May 7, 2021

1599

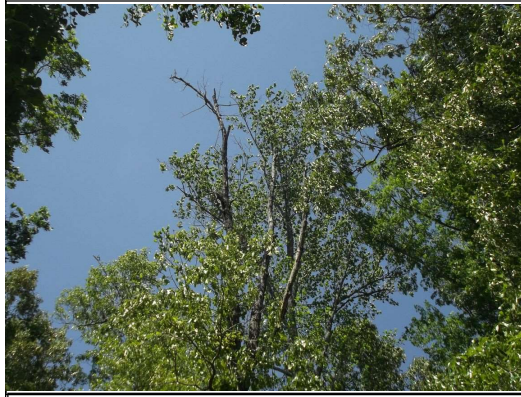
Dead tree limbs front yard

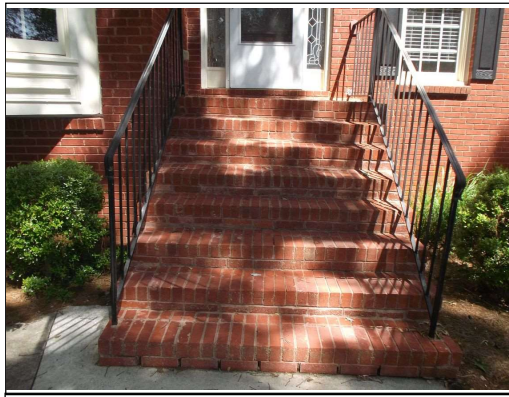
Front stairs and porch has settled some and cracks filled with cement at the house and under the entry door; missing mortar between bricks at steps and porch can allow water to enter and cause damage (fill open brick joints at stairs and porch); soil slopes to the foundation at the rear of the building (can cause water to flow to the foundation); driveway very steep;

Cracks in mortar at front stairs several areas

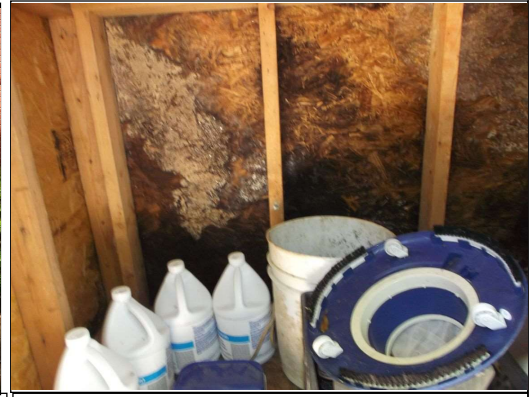
Rotted wood pool equipment house

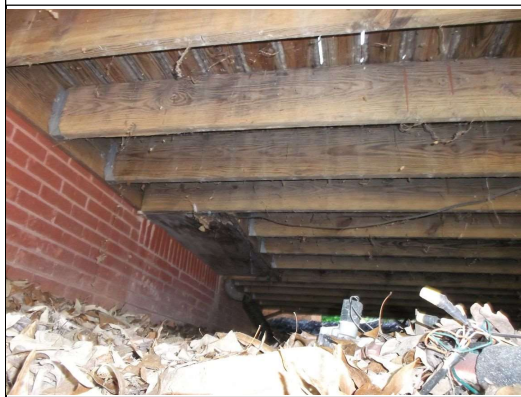
Deck bolted to brick and cantilever

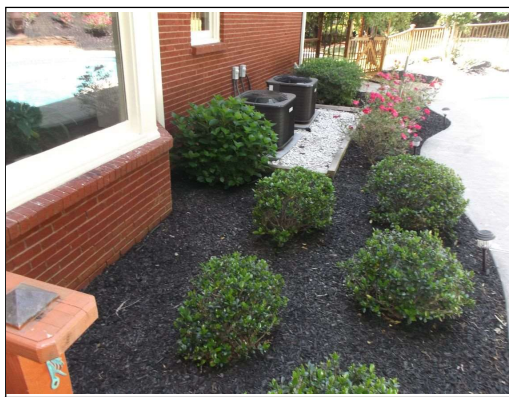
Soil slopes to the foundation at the rear of the building (can cause water to flow to the foundation); the rear wood fence has defective and damaged railing and is not safe to surround a pool); the wood deck or screened porch floor is bolted to the house through the brick (can damage brick veneer), connected to the cantilevered floor without supports, support posts are not notched and bolted to the floor rim joists, support posts in contact with soil; the pool equipment house roof slopes back to the screened porch, rotting walls inside, improper wood (OSB board) for walls; major cracking or broken area in walkway;

Ground slopes to the foundation

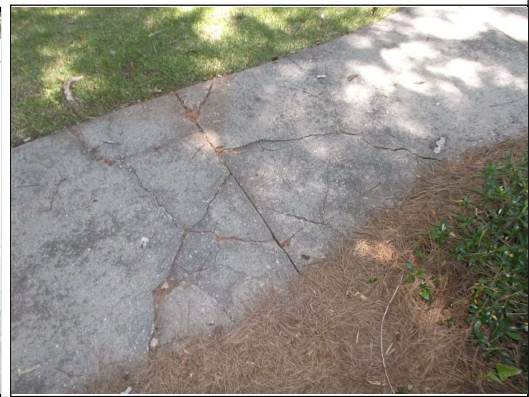
Major cracking in the walkway near driveway

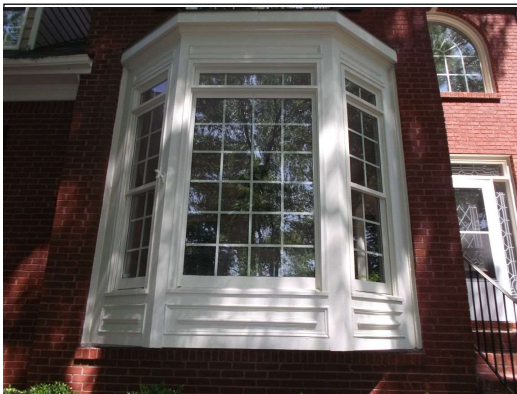
Water damage to wood painted over

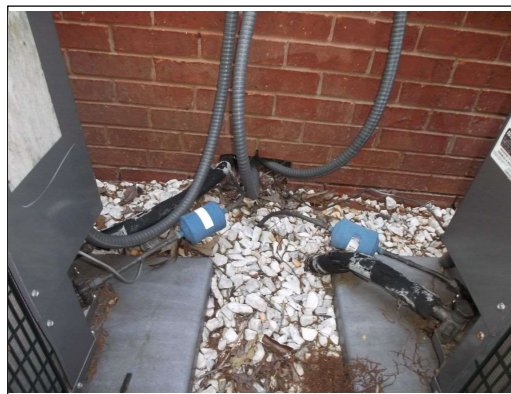
Verify if home on a septic tank or public waste sewer; there is a hole in the foundation where the AC pipes enter (close); there is a opening in the foundation vent where the AC pipes enter;

Holes in foundation wall

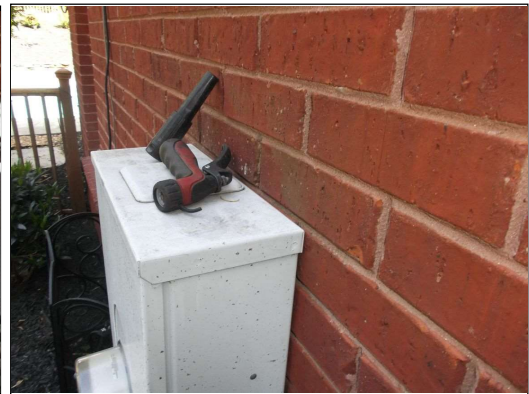
Missing bead of caulk across top of meter box

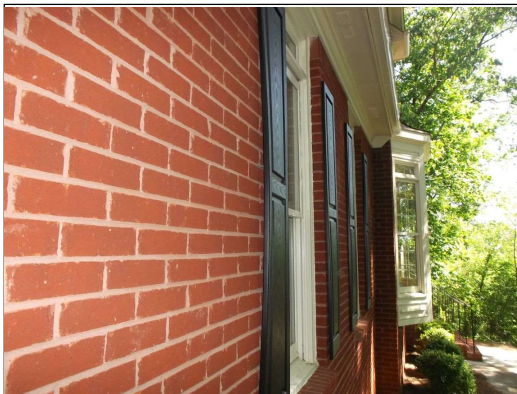
Shutter detaching

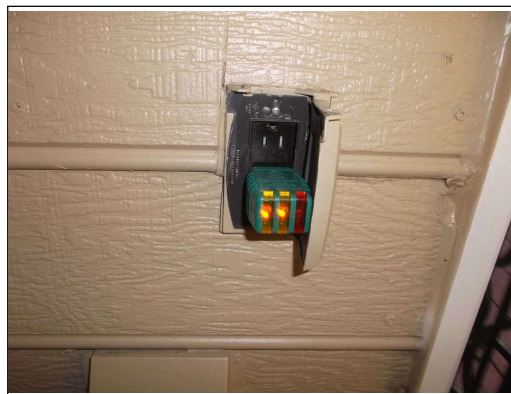
Screened porch outlet not GFCI unsafe

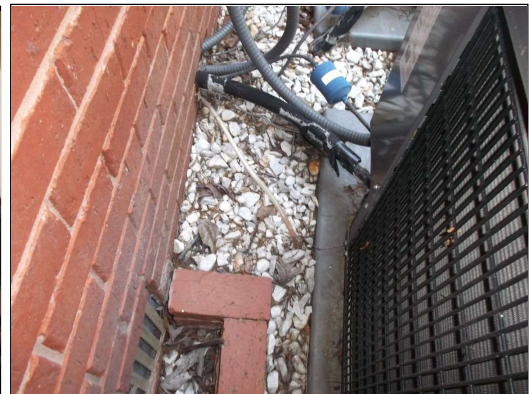
AC condensate pipe under soil

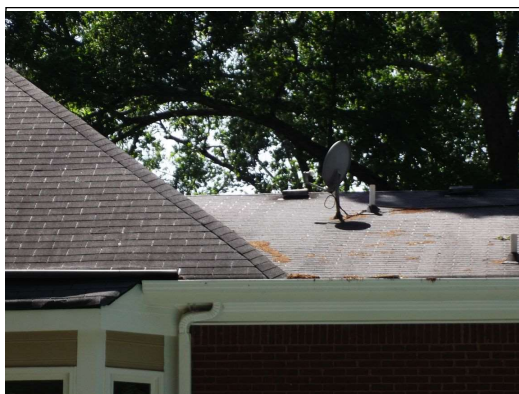
TV dish on roof/shingles show wear

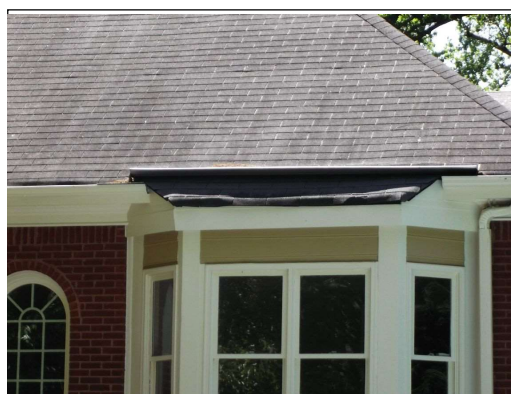
Bay roof defective & wavy shingles worn

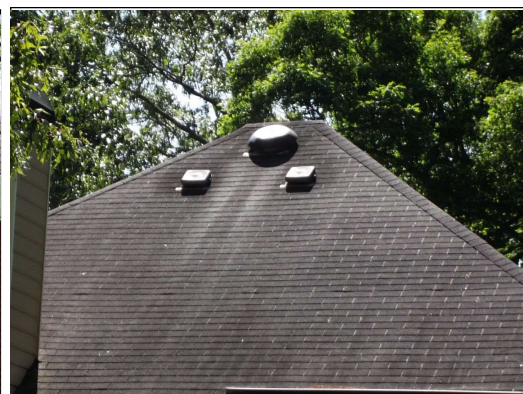
Roof worn, vent flashing on shingles nailed

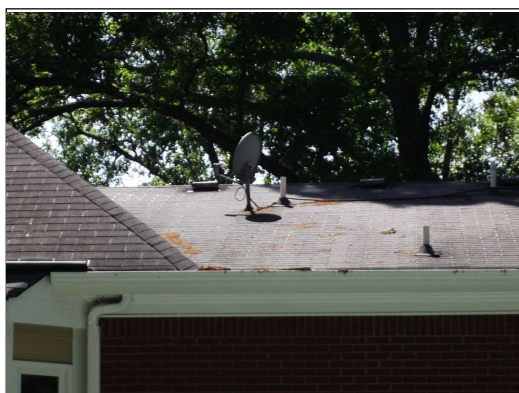
Pipe flashing on top shingles face nailed

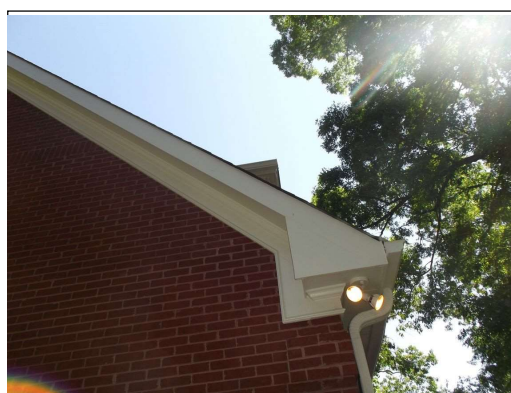
Missing drip flashing on top of gables fascia

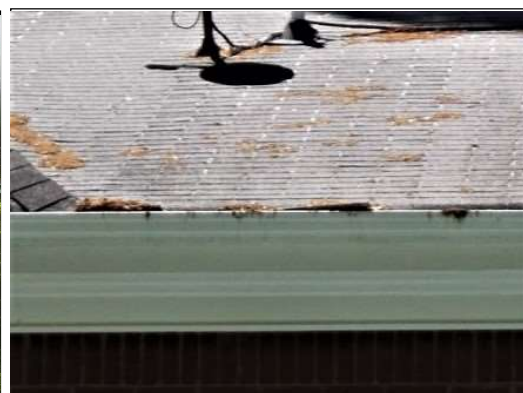
Debris in gutters

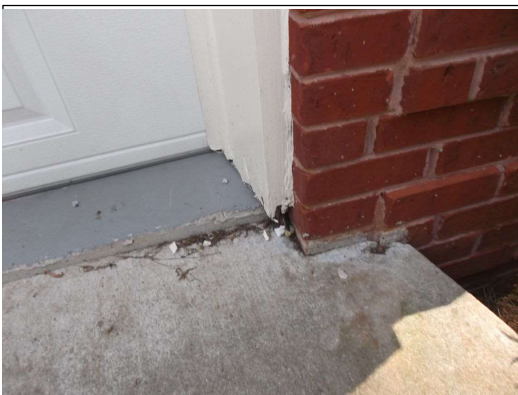
Water damage at the vehicle door frame

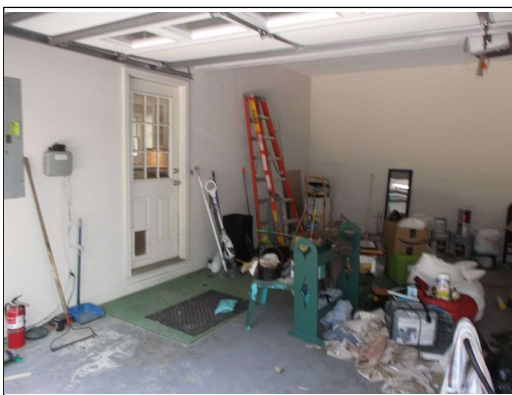
Door to the house has glass and is a safety hazard;

Door to house glass/belongings in garage

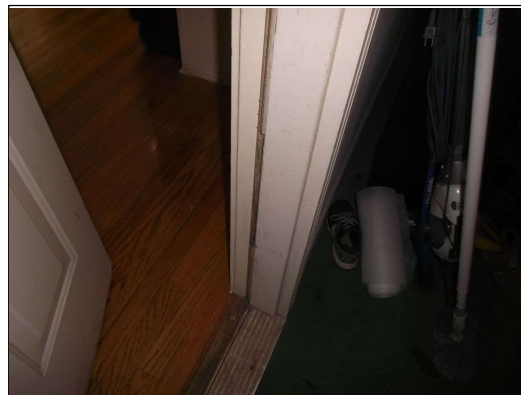
Damaged weather strip at door

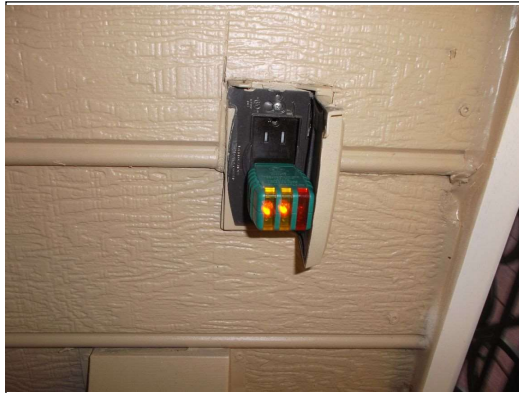
Screened porch outlet not GFCI protected

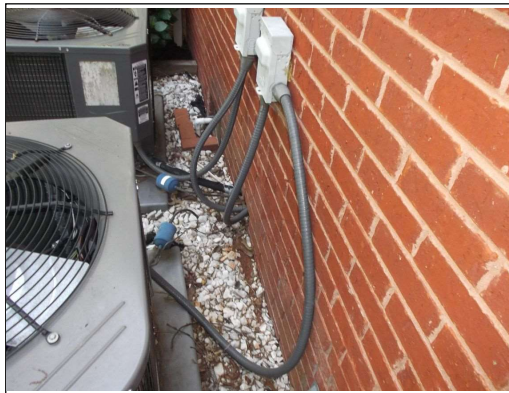
AC electrical conduit not clamped to wall

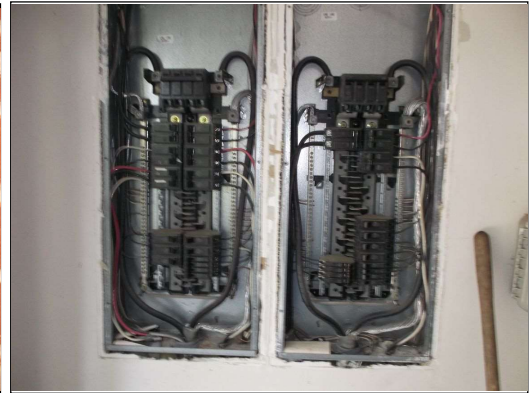
There are gaps between the sheetrock and the bottoms of the distribution panel boxes in the garage wall that can allow sparks from breakers to escape into the wall (fill gaps or holes); drop cords used for wiring in the attic, exposed wire connections in the attic are unsafe;

Openings at the bottom of the panels

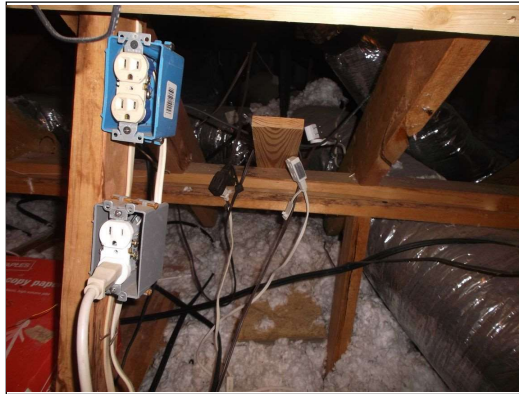
Drop cords for wiring in the attic

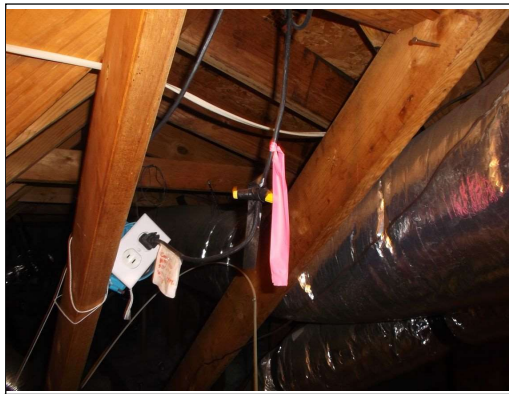
Exposed wire connections in the attic

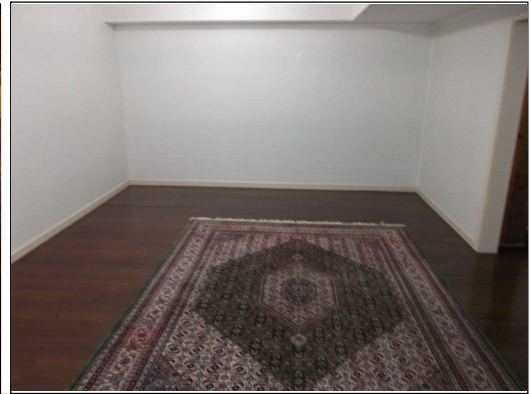
Missing outlets in basement rooms

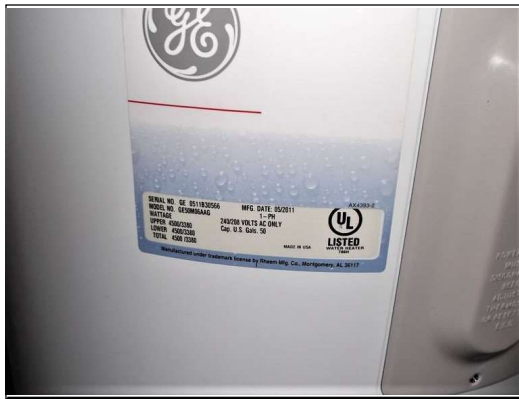
Water heater date 2011 and in the last years of good use (water heaters have a good life of 11 to 12 years); verify if the home is on public sewer or on a septic tank; can see where original water pipes were removed under sink cabinets and PVC pipes installed (seller very there is no Polybutylene pipe in the plumbing system);

Water heater 2011

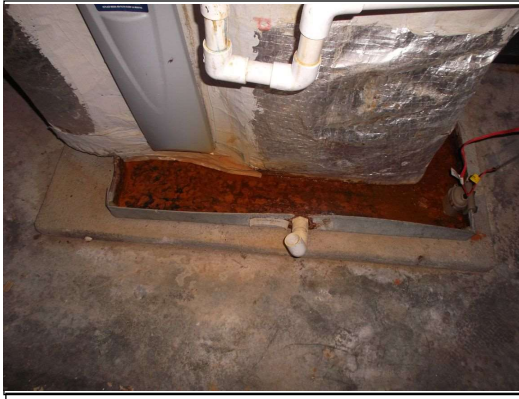
There is major rust in the furnace drain pans under the furnaces which may indicate defective, deteriorated or damaged evaporator coils and or condensate systems in air handlers (it is advised to have a certified HVAC company check, evaluate and service both systems to verify maintenance and operation before closing; furnaces may be in the last years of good use;

Major rust in furnace drain pan in basement

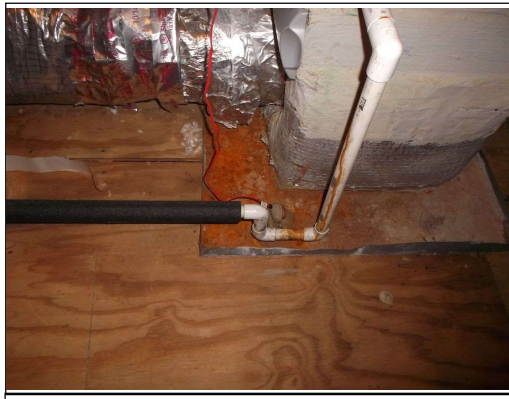
Major rust in furnace drain pan in attic

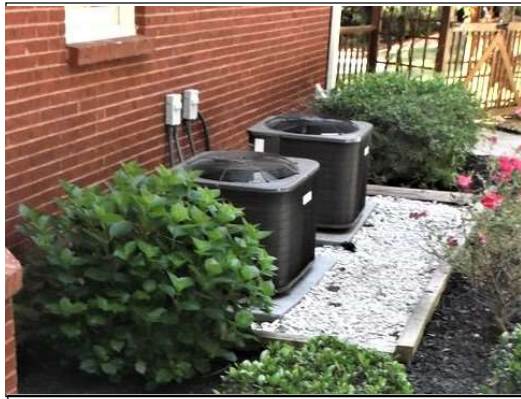
AC units aging

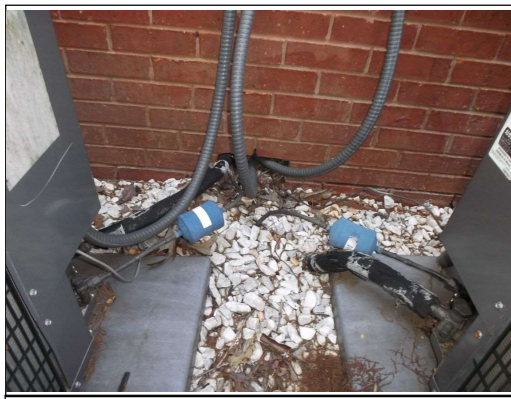
Refrigerant line insulation worn

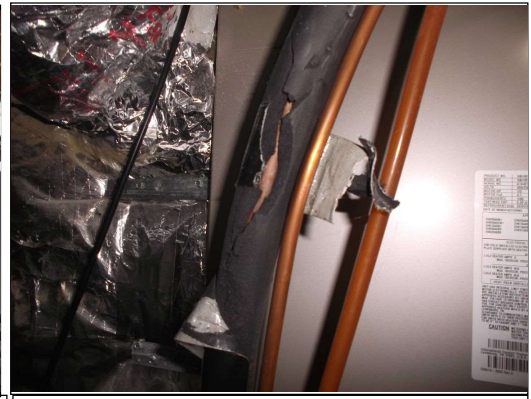
Torn Refrigerant line insulation basement

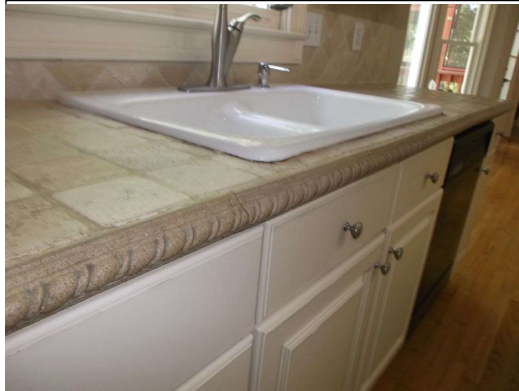
Missing bead of caulk at sink rim on tile

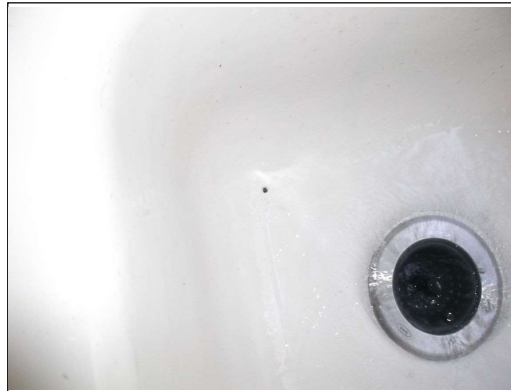
Hole in left sink bowl can rust through

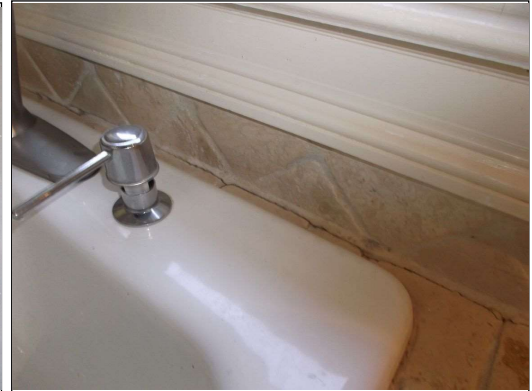
Cracks in grout at back splash

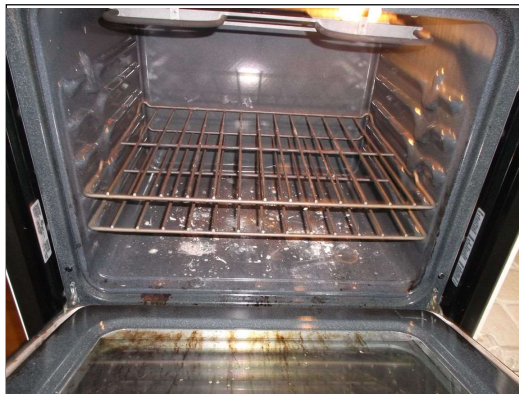
Oven soiled

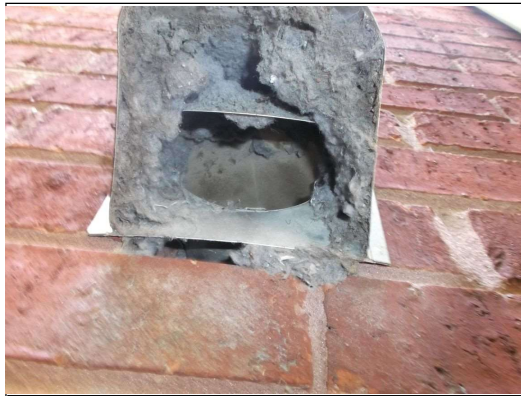
Vent terminal clogged with lint

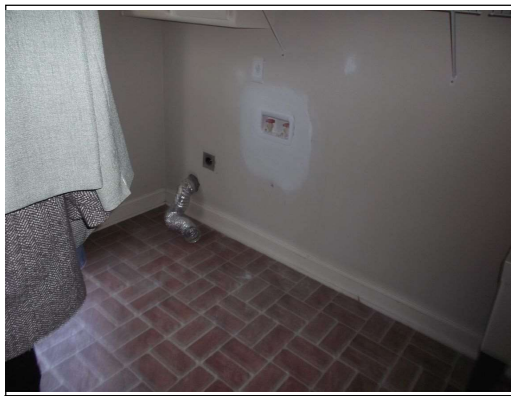
No washer drain pan

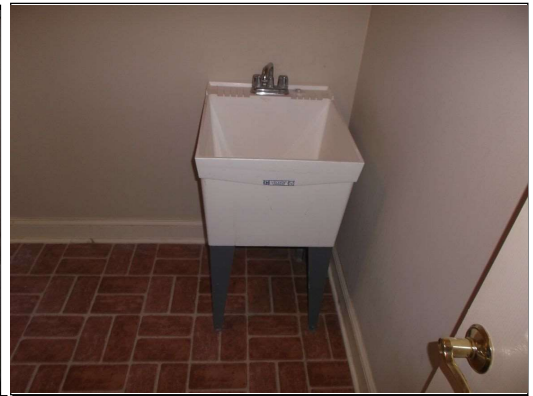
Wash sink not bolted to floor and wall

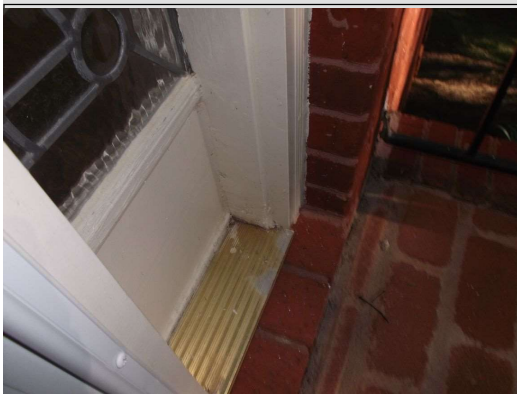
Water damage at front door frame

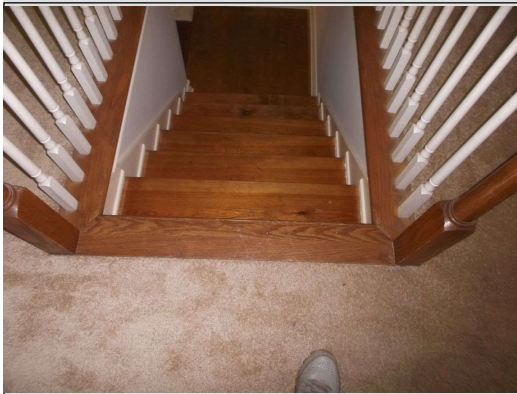
1st step rotates forward

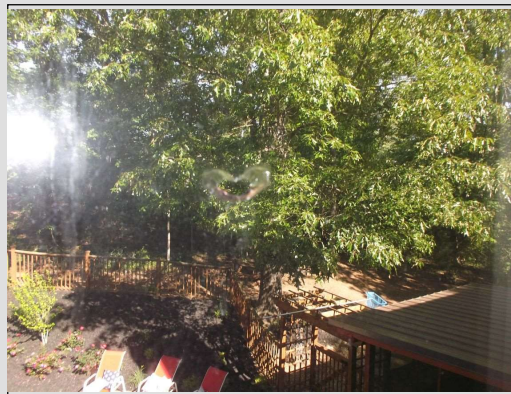
Hole in master bed window glass

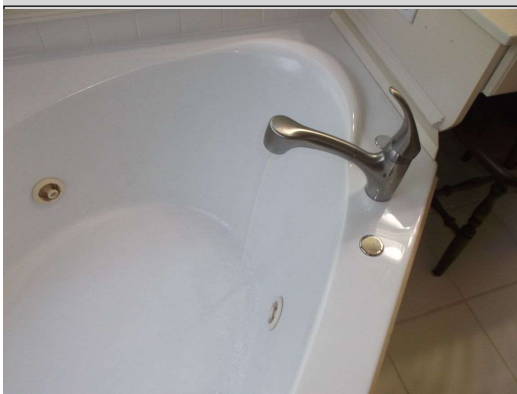
Low water flow at tub faucet

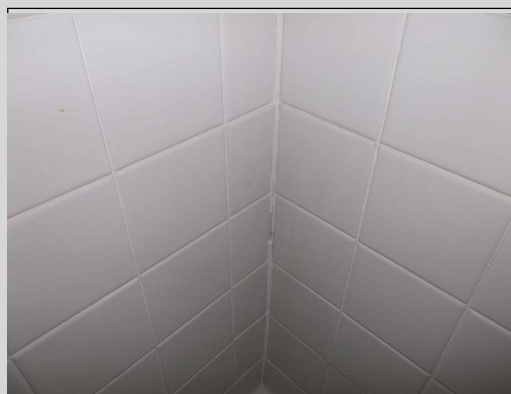
Missing caulk at shower corner

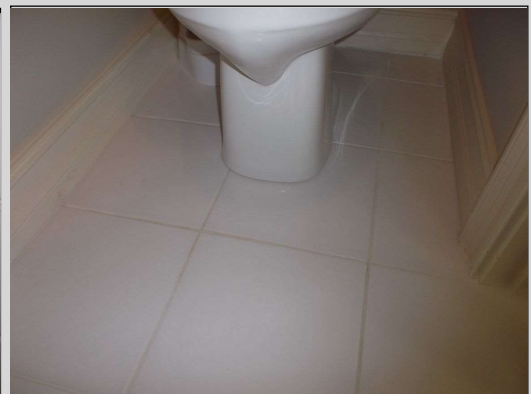
Missing caulk where toilet rest on the floor

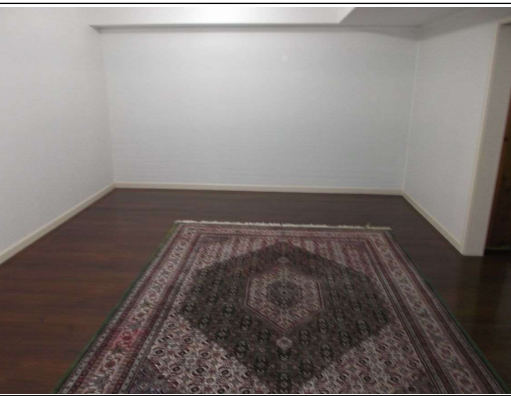
Missing outlets around room walls several rm

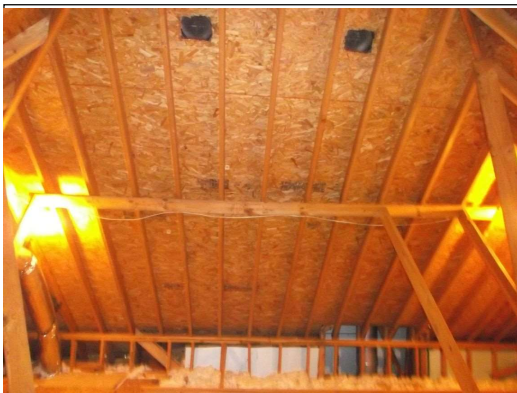
Missing spacer clips between OSB panels

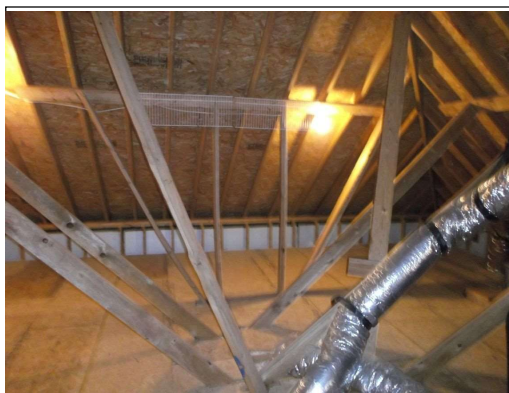
Single roof braces bending

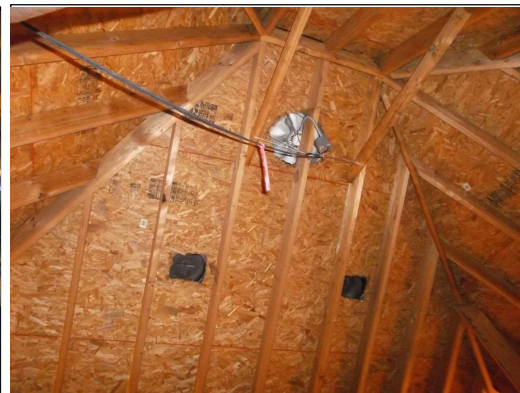
Missing spacer between OSB panels

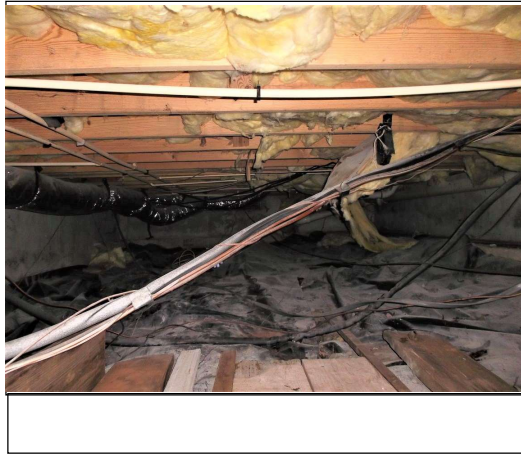
Insulation falling down some areas; vapor barrier installed loosely; damp soil noted at the rear wall (soil slopes to the foundation at the rear yard); cannot see floor due to under floor insulation;
