# PROPERTY INSPECTION REPORT

953 Hanover St. Lithia Springs, GA.

May 28, 2021

1599

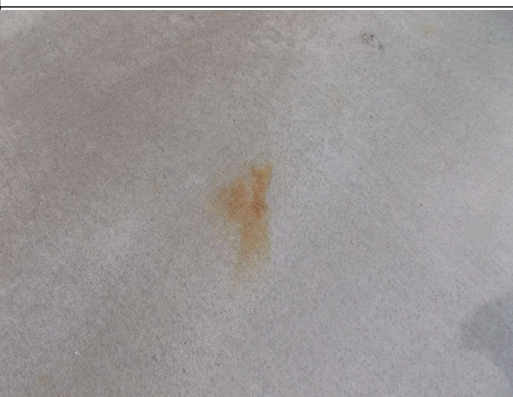
Stains in the driveway

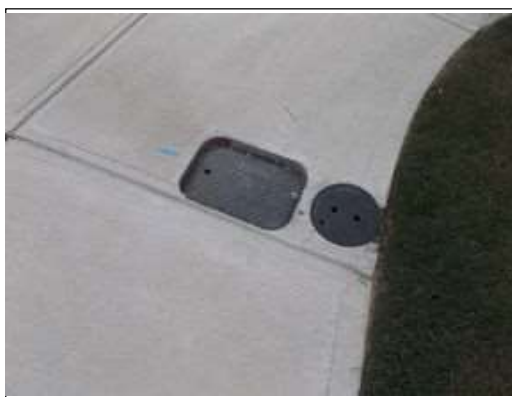
Water meter hole in sidewalk trip hazard

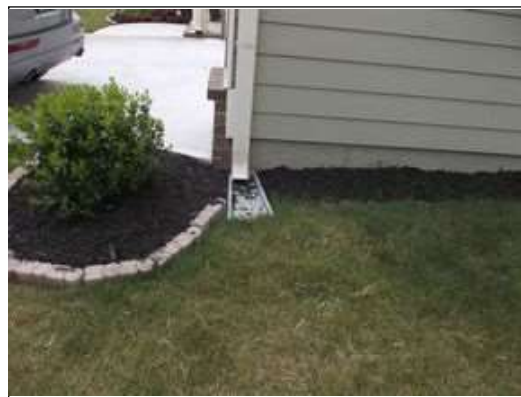
Poor soil slope away from side of garage

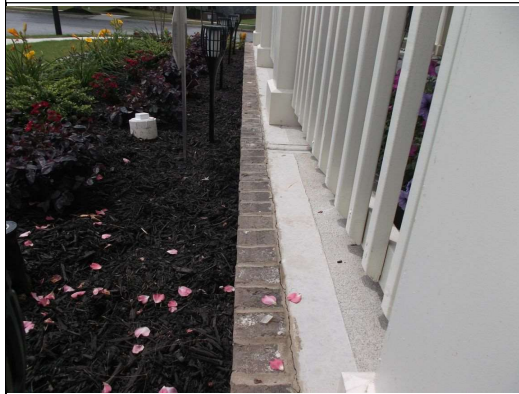
Brick mortar cracking at the front porch floor

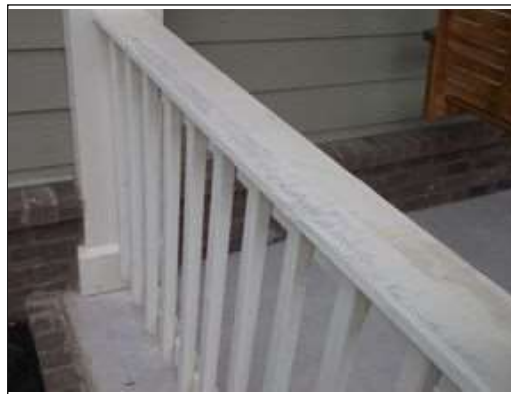
Defective paint

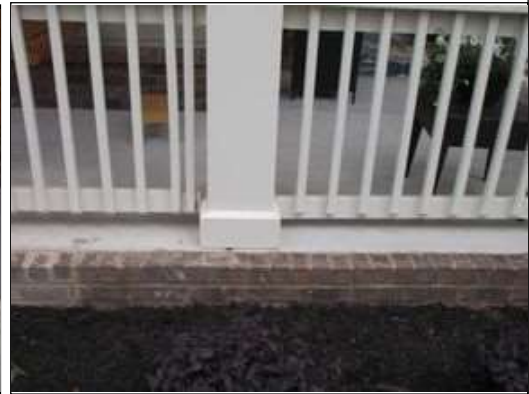
Railings not even at post connection

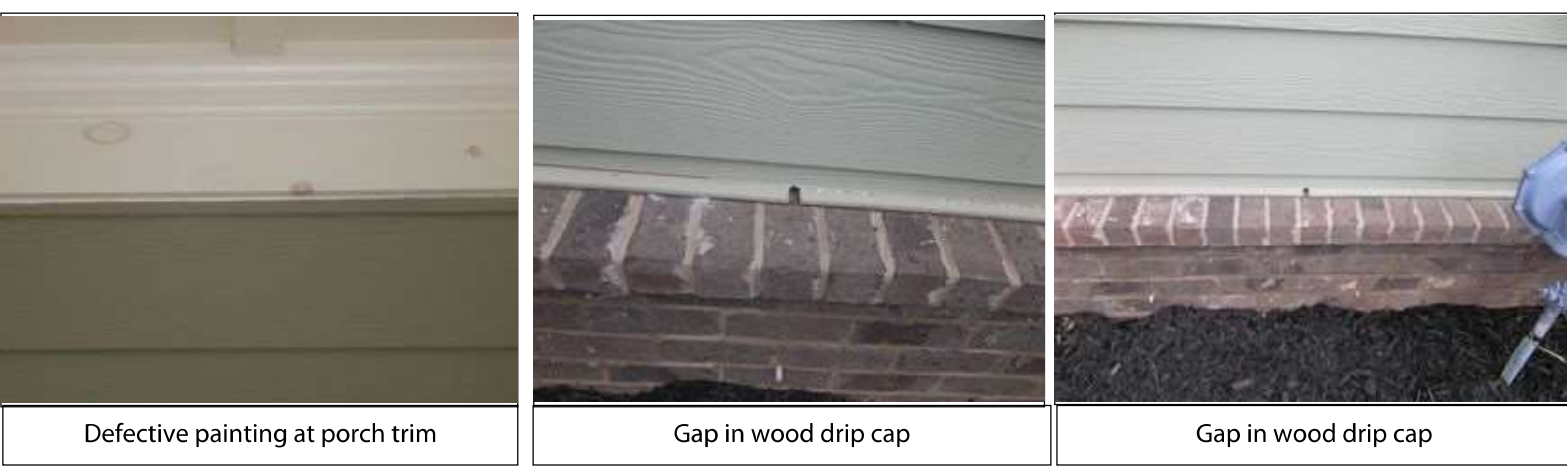
Defective painting at porch trim

Gap in wood drip cap

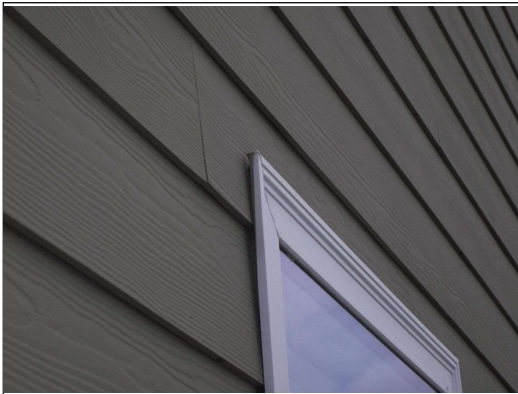
Missing flashing over windows

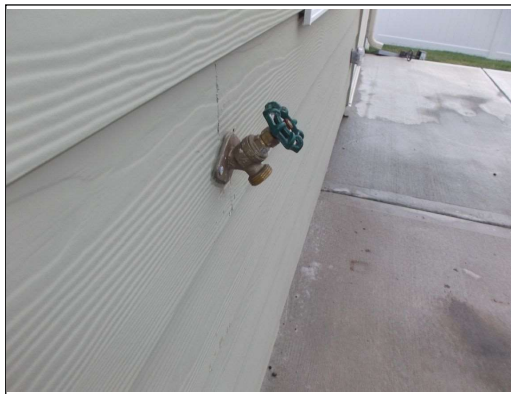
Missing anti siphon device

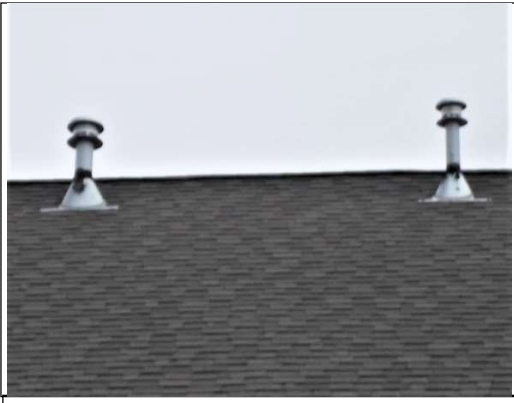
Missing rain collars on gas vent pipes & tar

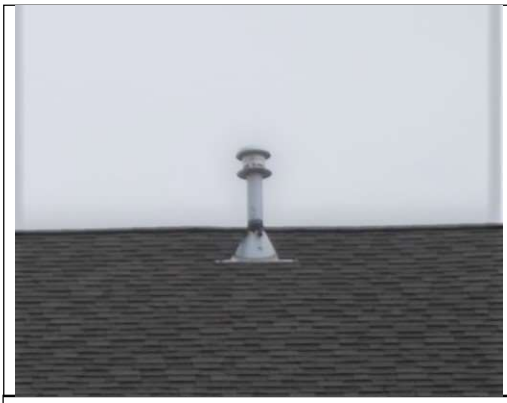
Flashing on top shingles face nailed

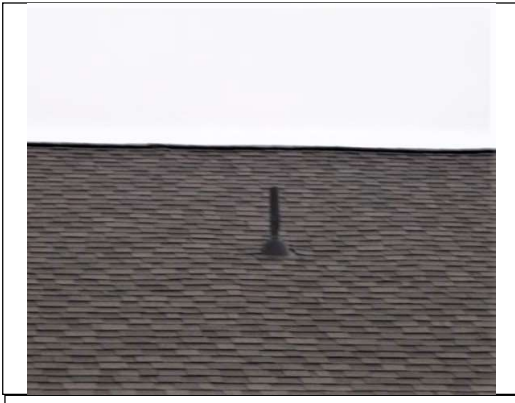
Pipe flashing on top of shingles face nailed

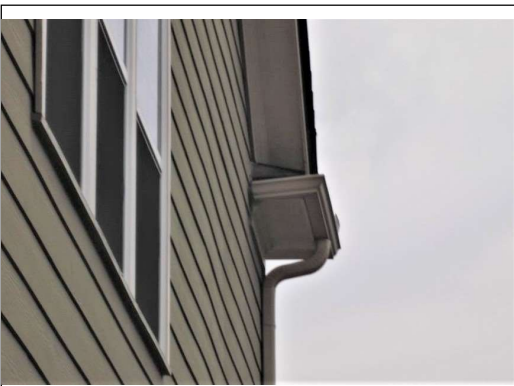
Gutter slopes away from outlet

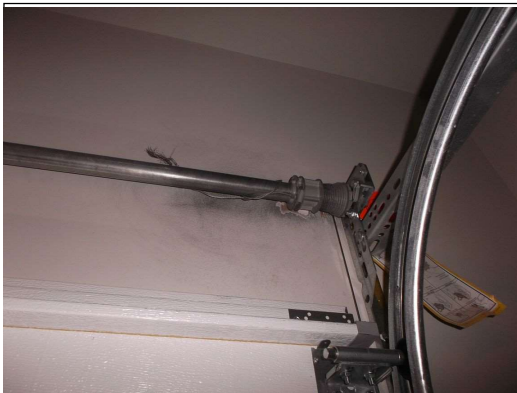
There is excessive vehicle door pulley cables loose at the wheel causing damage to the drywall;

Excessive door tension cable damaging wall

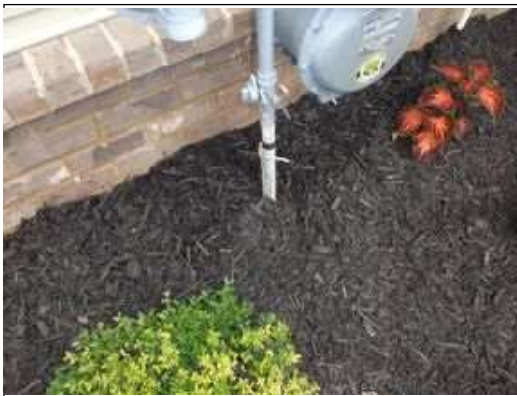
Ground wire not clamped to gas pipe

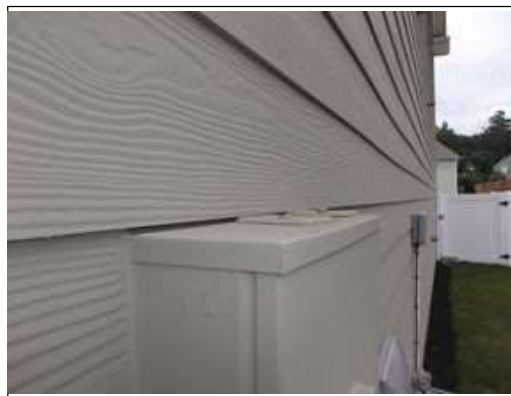
Missing bead of caulk across top of panel

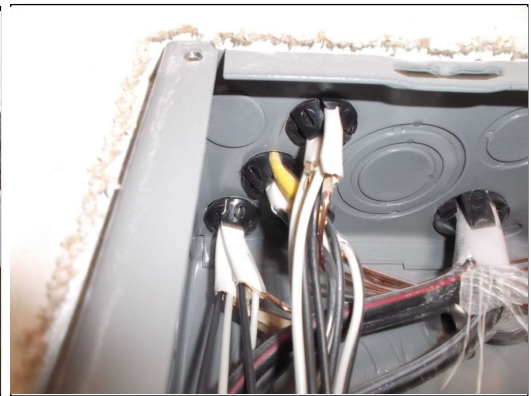
Cables touch sharp metal in bushing holes

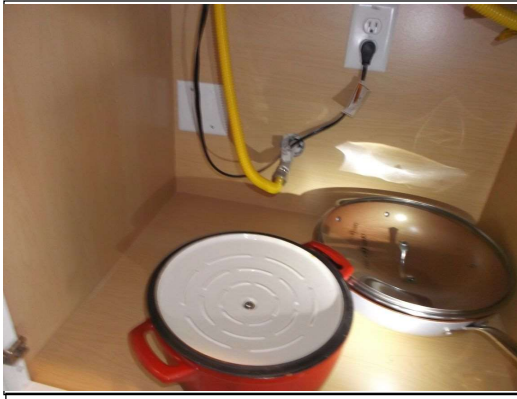
There is a gas pipe in the base cabinet under the gas cook top that extends too far into the storage area of the cabinet that can be damaged (should be a elbow on the pipe to cause gas flex line to stay near the rear cabinet wall as it travels up to the cook top;

Gas pipe extends into the storage area

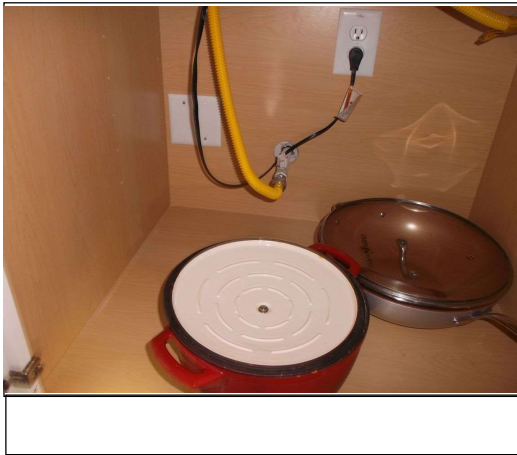
Gas pipe extends too far into the base cabinet storage area can be damaged over time if continued movement occur during continued storage (there should be a elbow on the pipe to send the gas flex line up the the gas cook top);

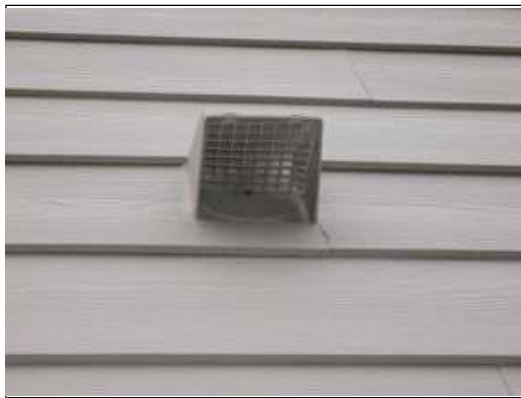
**Maintenance:**  
The vent terminal for the dryer at the exterior wall is for a bath vent (has a grill cover and grill cover blocking door flap is a fire safety hazard and can trap lint)(remove grill cover);

Dryer vent blocked and grill improper

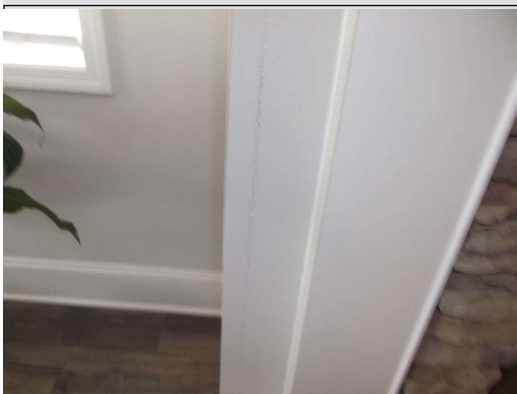
Corner tape detaching at fireplace

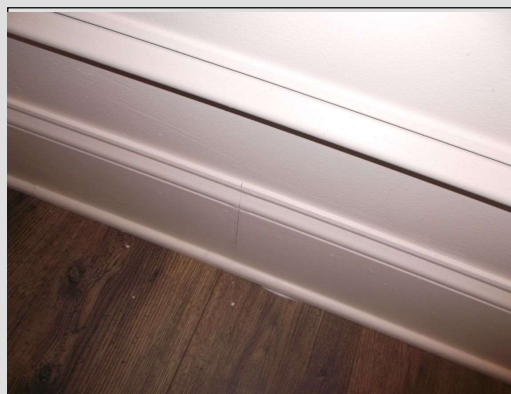
Missing caulk at trim various areas

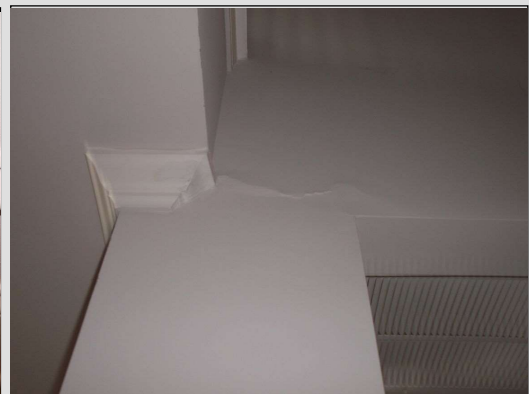
Sheetrock crushing at stairwell post

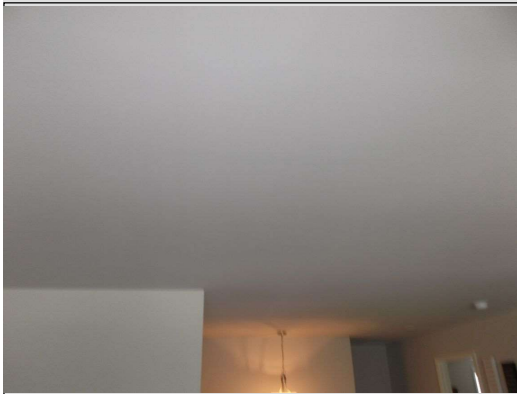
Can see drywall seams/incomplete finish

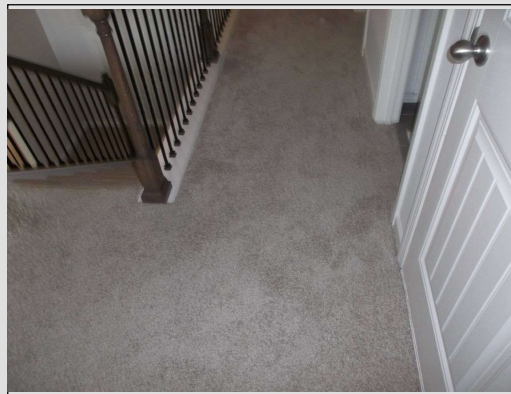
Floor dips at hall in front of bath

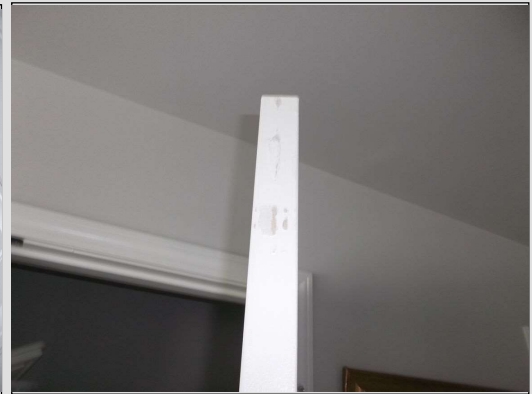
Double doors rub and defective paint

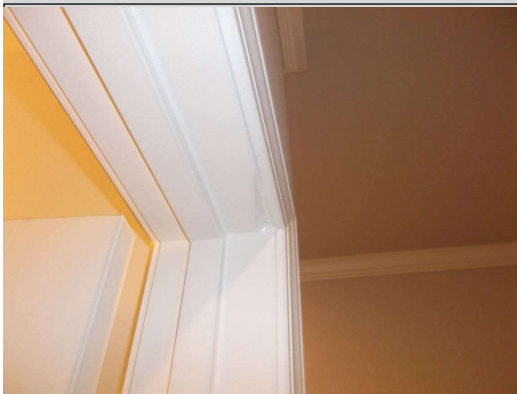
Damage to bath door frame at the top

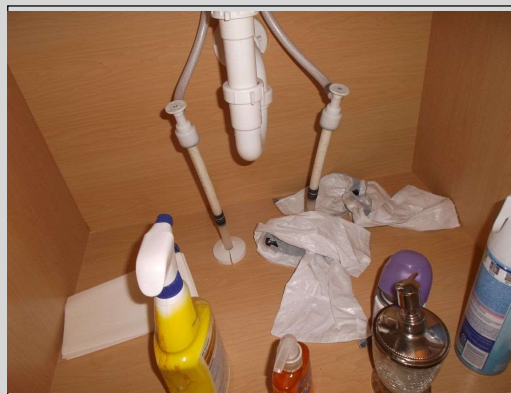
water pipes in storage area
