INSPECTION REPORT

Address: 310 Forestgate Ct. Sandy Springs, GA 30350

Inspection Date: 5-15-2026

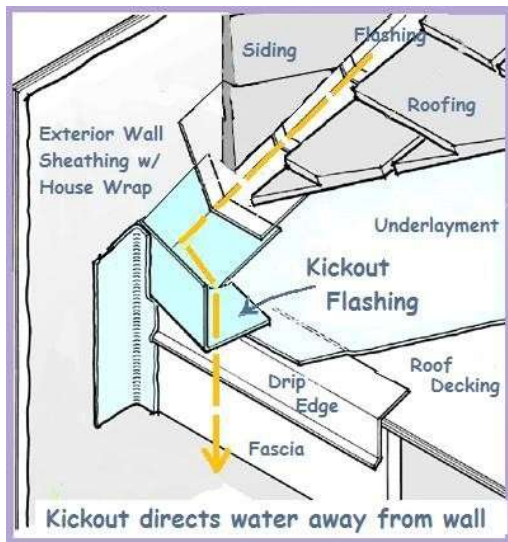
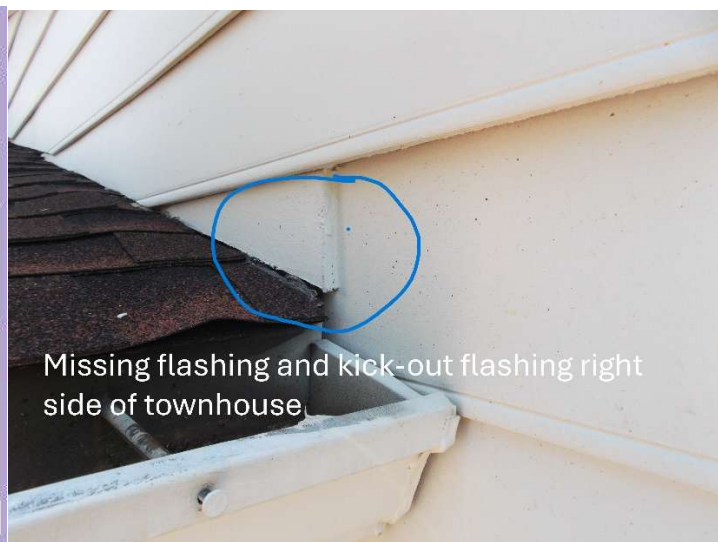
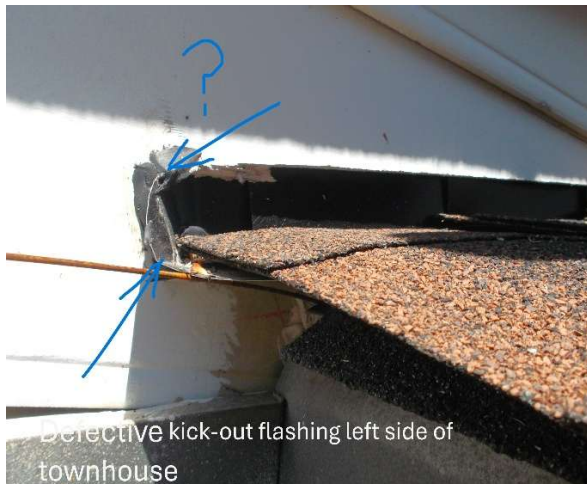
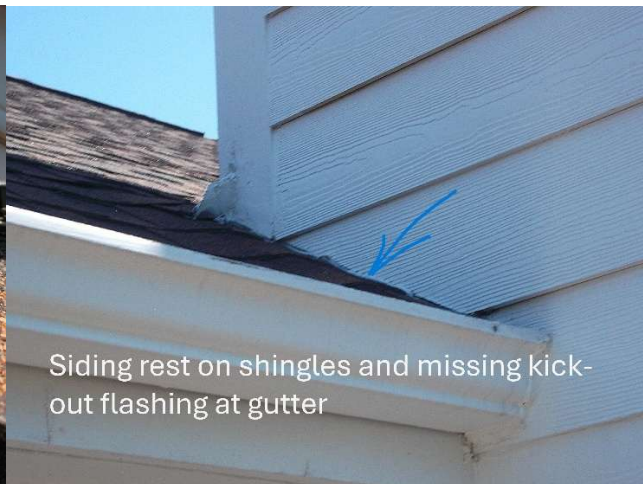
SIDING AT ROOF SHINGLES:

Cannot see roof-to-wall flashing (coming to daylight) at the townhouse wall siding on the right, connected to this townhouse when viewing from the rear yard. There should be roof-to-wall flashing coming to daylight and a 45 degree turn towards the gutter to flash the water away from the siding and wall junction and pour into the gutter.

The roof-to-wall flashing on the left side of the townhouse (over the sunroom) appears to be short, not high enough up on the wall and deformed (roof water may over shoot this side flashing, get into the roof soffit and into the wall space during heavy rains under certain conditions).

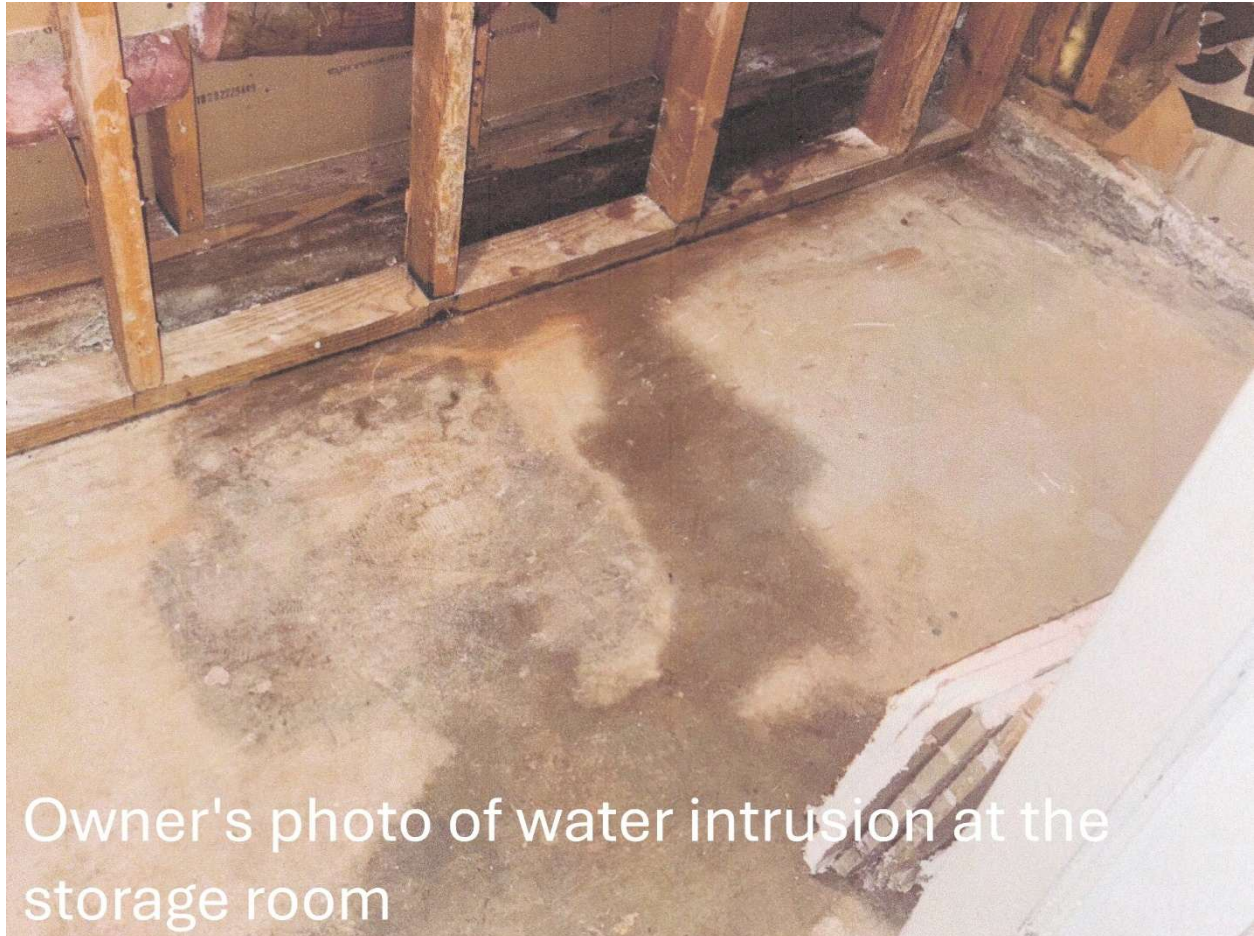
WATER INTRUSION: The owner stated and has photos showing there has been water intrusion after work was completed and water pouring between fire walls at her storage room. I have advised the owner to monitor these areas during rains and get a moisture meter to determine if drywall and insulation become damp or wet or still leaking. It is advised to verify the roof-to-wall assembly is complete and properly installed. This may require removing building materials and examining the envelope above this area.

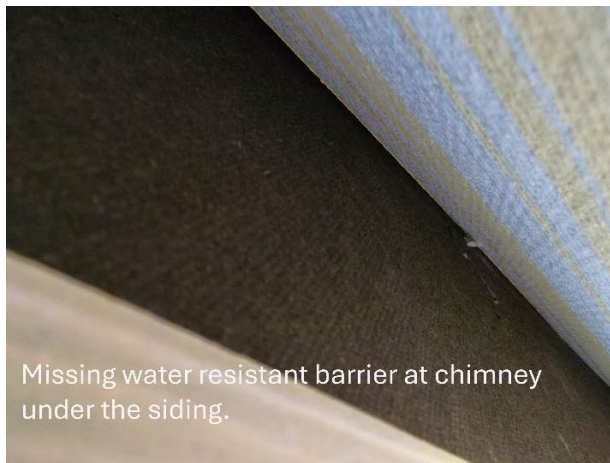
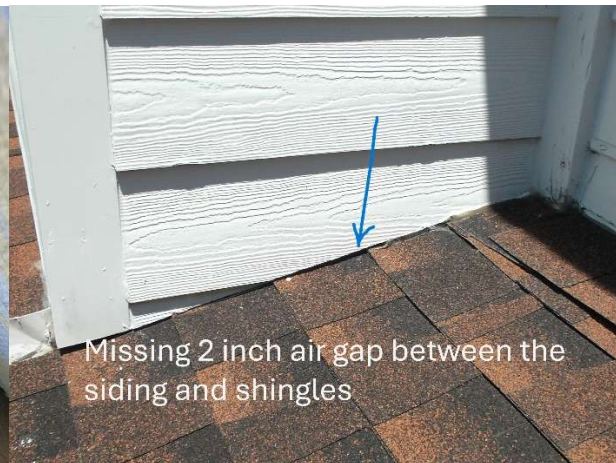
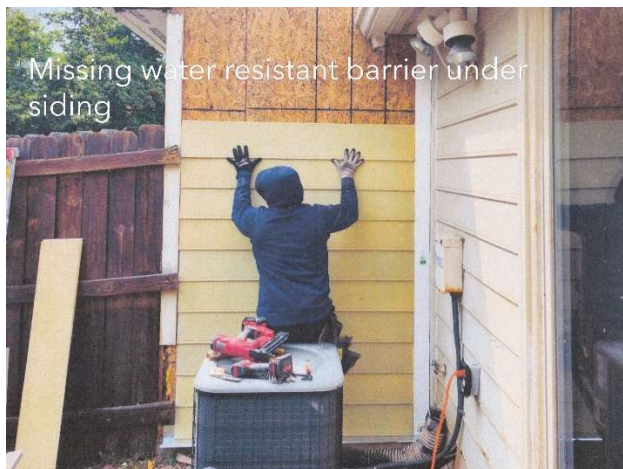
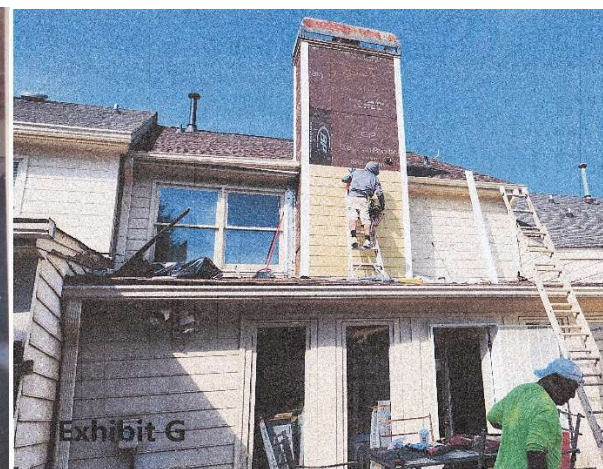
SIDING REPLACEMENT: The owner showed photos she took during the siding repair and replacement that recorded the work in progress. Some photos show siding contractors replacing siding and sheathing at some areas on the neighbor's townhouse on the left lower main level exterior wall, but did not appear to have a water-resistant barrier or house wrap installed before installing the siding.

The original asphalt-impregnated gypsum board on this townhouse chimney was repaired or replaced at some areas but it appears the siding contractors did not install a house wrap or water-resistant barrier before installing the new siding at this chimney structure.

Most or all of the siding on the chimney appears to have been replaced at the time of the inspection. The owner stated some of the siding was replace at the sunroom also. The IRC code R703.2 says that either a No.15 pound felt be installed, overlapped 2 inches horizontally or an approved water resistive barrier (house wrap) be installed over the sheathing before the siding is installed.

1. A section of the siding was lifted at the face side of the chimney and the inspector could not see a vapor retarder or house rap in place. Building code states if siding is replaced on a home that had only asphalt impregnated fiber board for the sheathing, it shall be wrapped with house wrap or a vapor retarder. IRC code R703.2
2. The cement fiber siding that was installed at the chimney and right-side wall is close to or in contact with the roof shingles. James Hardie and most cement fiber manufacturers says if their siding is installed without an air gap (a minimum of two inches) above the shingles, it will void the warranty (can absorb water). It is advised to have an air gap of two inches at all cellulose and or wood siding materials and roofs.
