Paris Pressley REI

3196 Church St. East Point, GA.

Page 3 KEY TO THE INSPECTION REPORT

Report #: 54

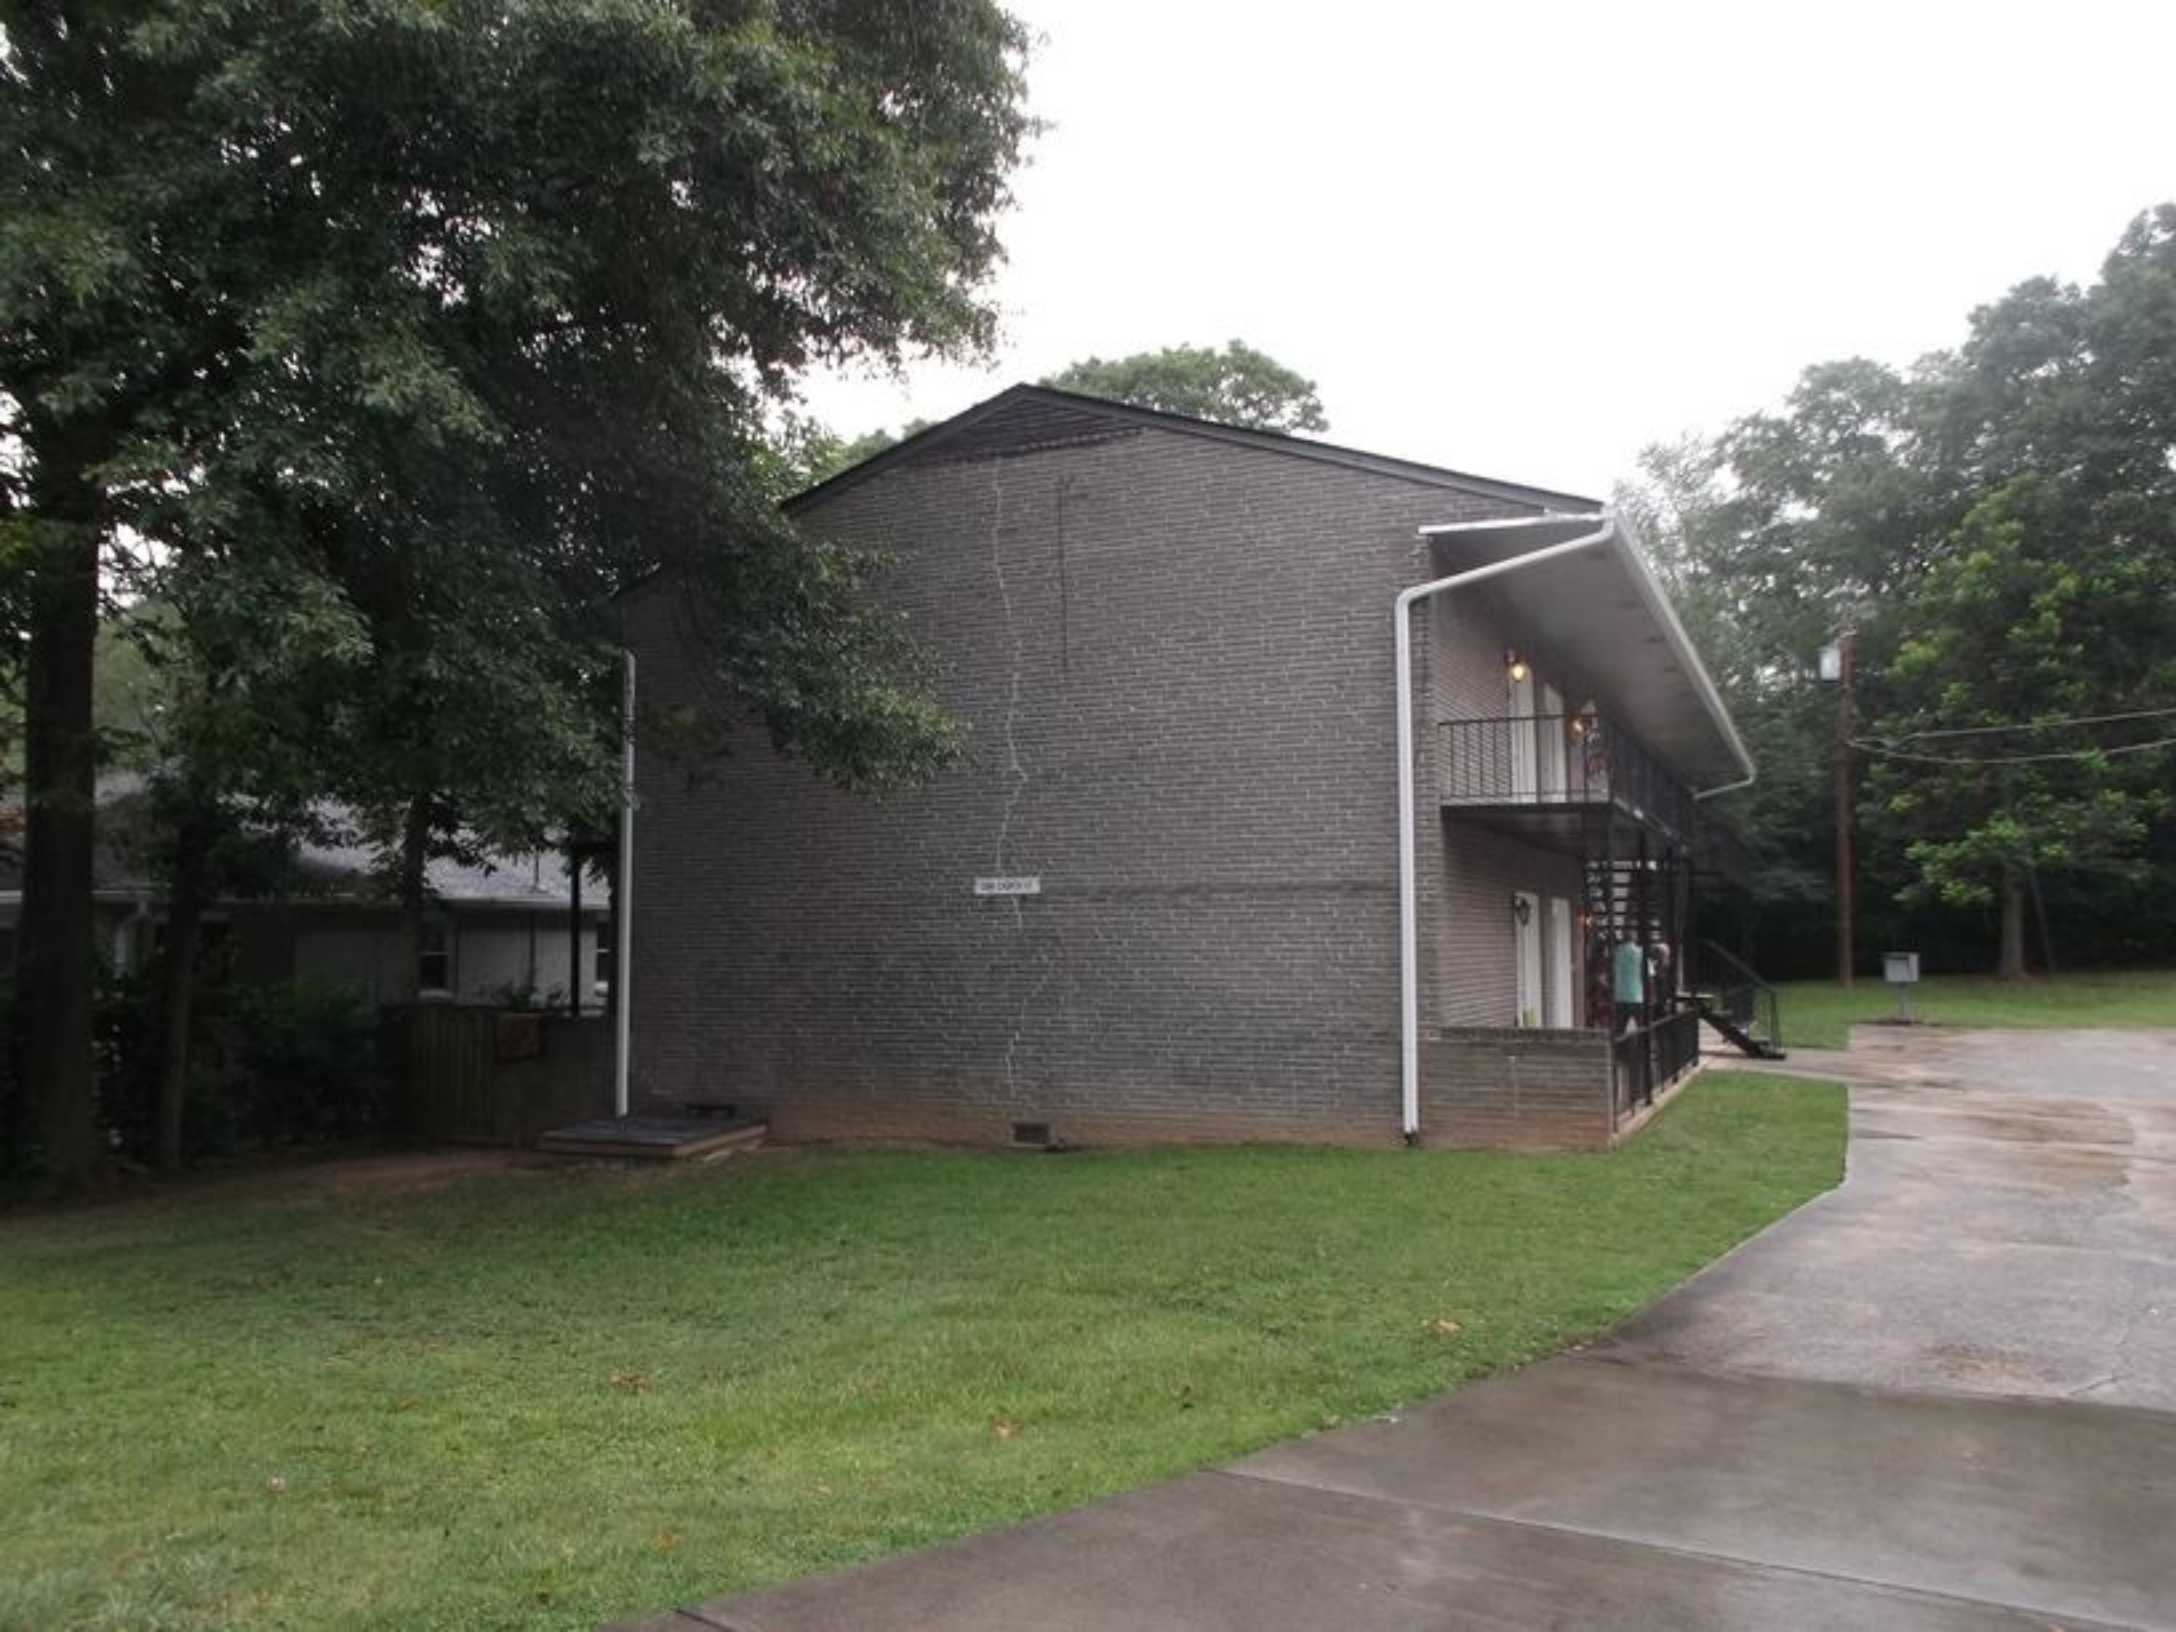
3196 CHURCH ST.

9 Exterior Walls N/A **Structure: WOOD FRAME**
Wall Covering is: Brick Veneer
 Appears serviceable Not Functional* Unsafe* Worn* Near end of lifespan* Not fully visible*
 No cracks found Common cracks* Major cracks (1) Cracks / openings need repair (2) Soil contact *(3)
 Moisture stains/damage Damaged Nailing defects * Weep holes missing
Comments: Moderate cracks at the west end of the building; settling cracks at various areas of the building (sides, front and rear)

A photograph of a brick wall with a vertical crack and a street sign. The wall is made of dark grey bricks with light mortar. A vertical crack runs down the center of the wall. A street sign is mounted on the wall, reading "3196 CHURCH ST.". The sign is white with black text and a black border. The wall is part of a building with a dark roof. There are green leaves visible in the top left corner.

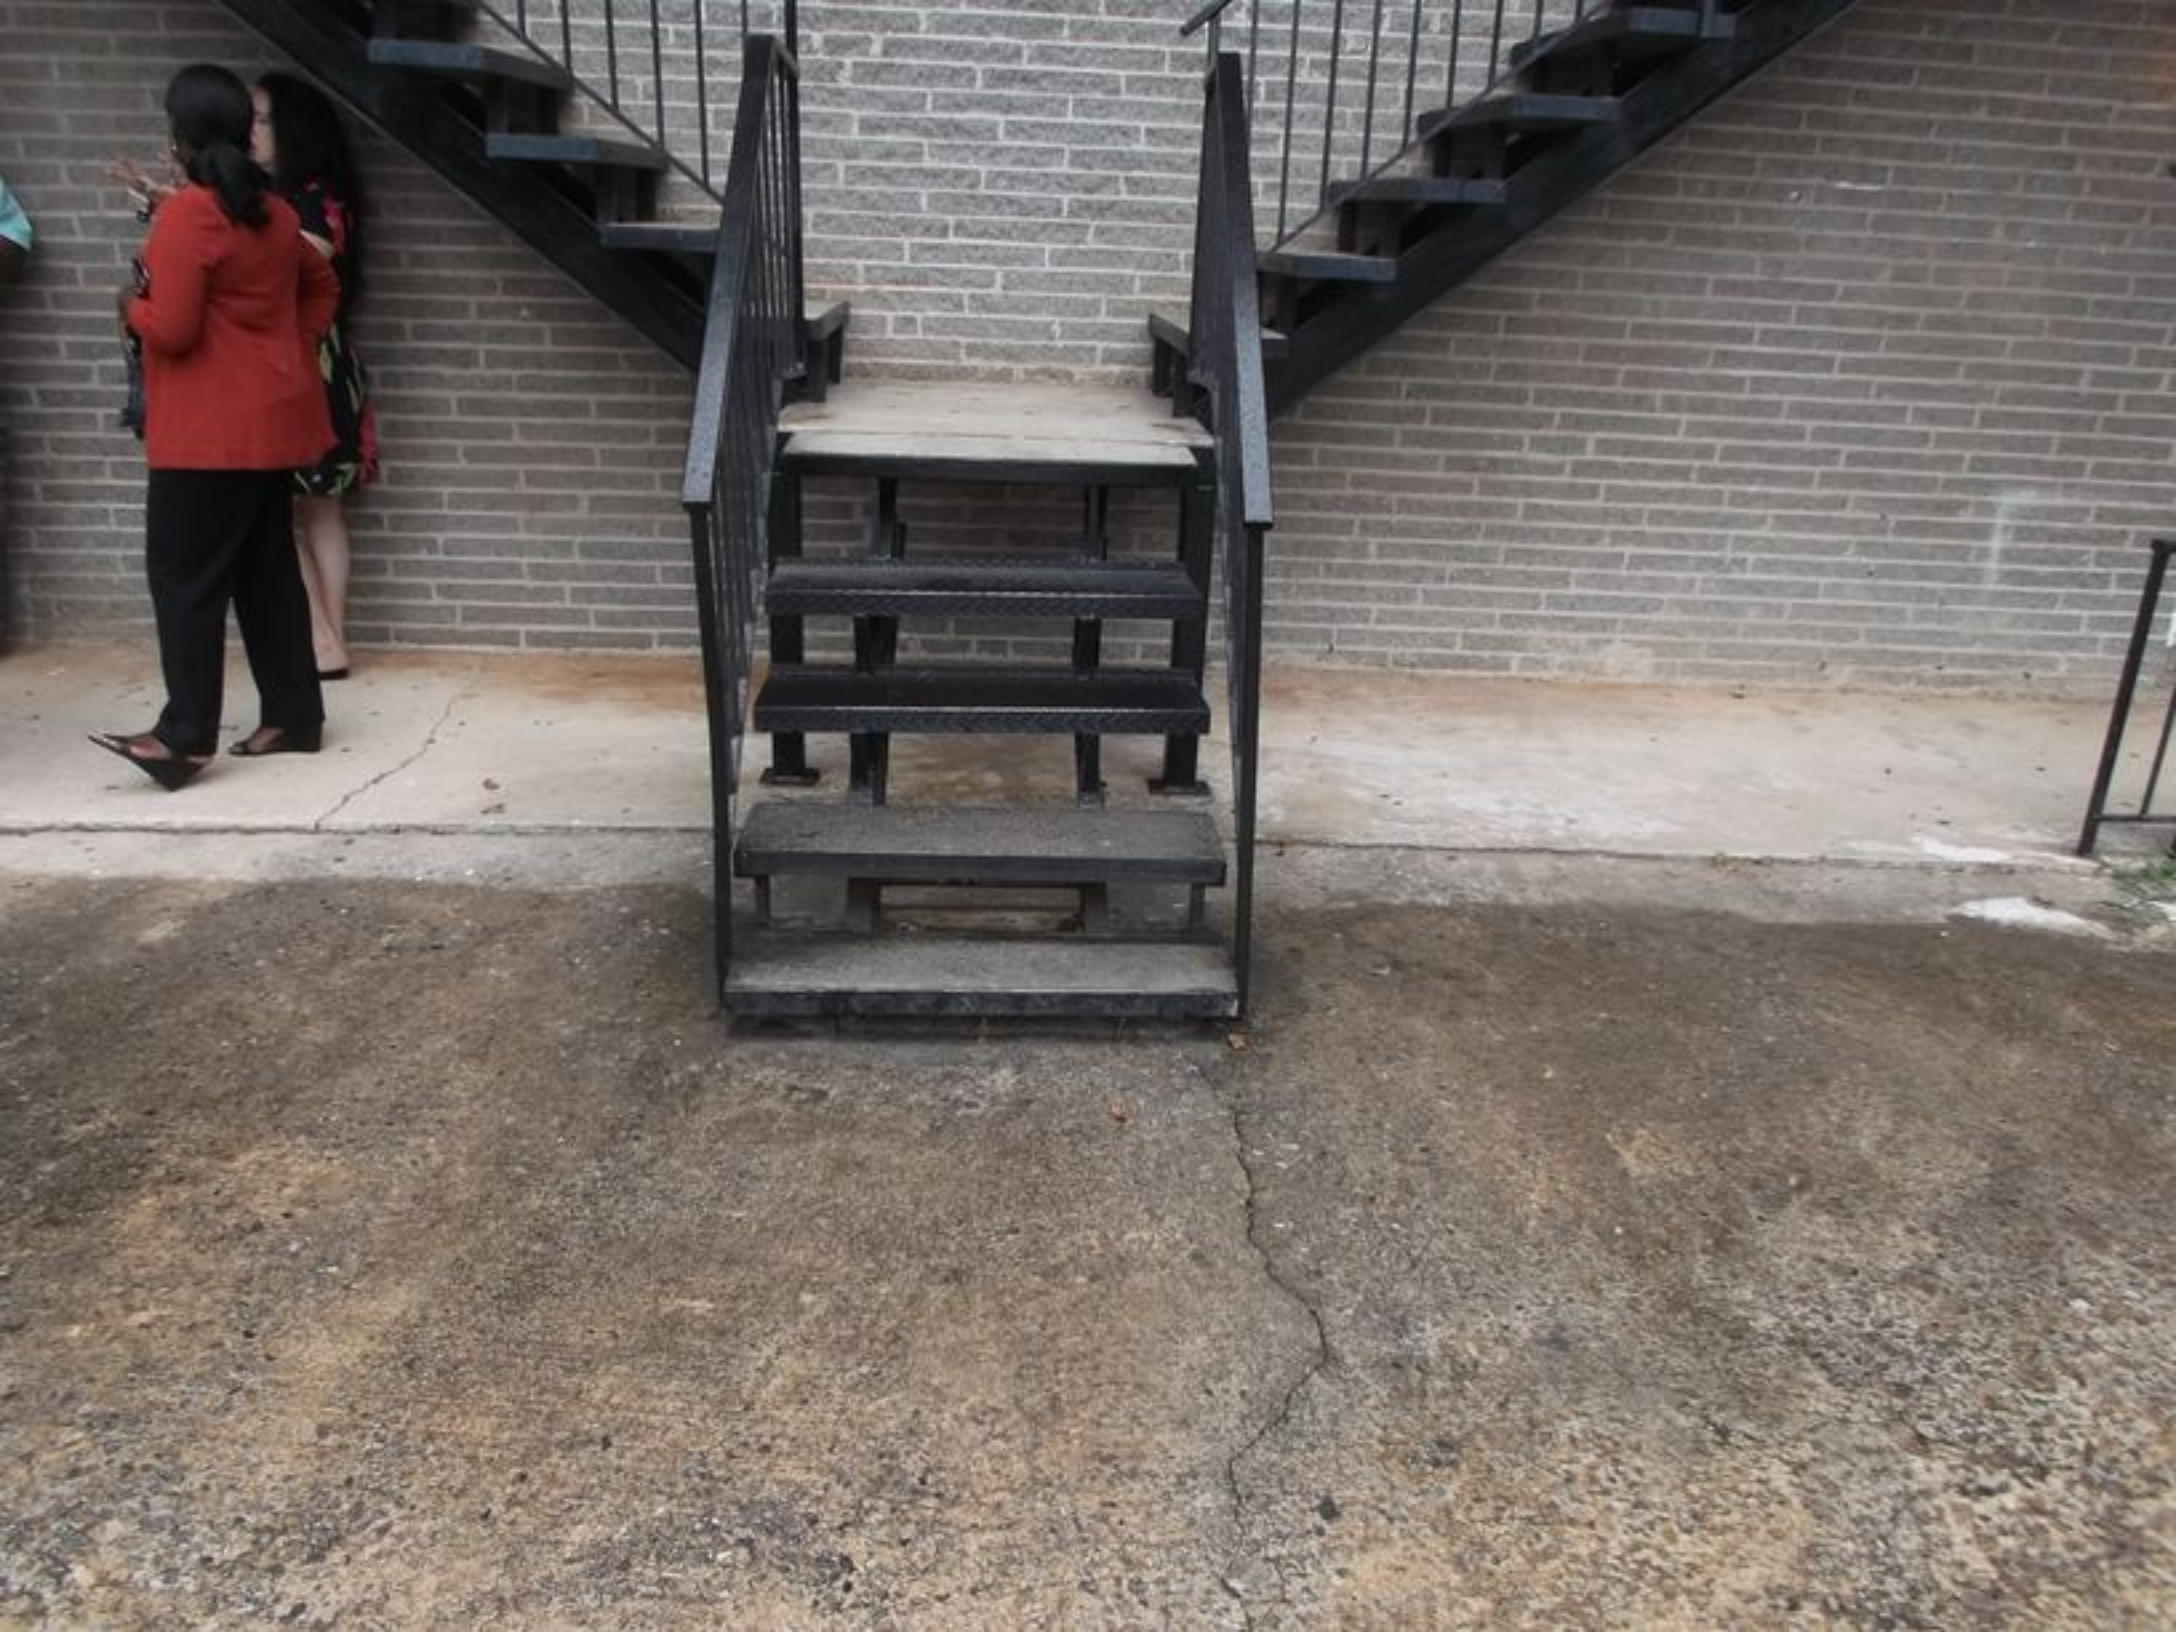
8 Exterior Stairs N/A **Type: Steel and Concrete** **Steel and Concrete**
Location: A Front B Rear C
 Appears serviceable Not Functional* Unsafe* Worn* Near end of lifespan* Not fully visible*
 Moisture Uneven N/A
 Railings serviceable Railings guards spaced too wide Openings in rails too large (5)
Comments: Front step too high and rotates forwards at the first stairs; concrete deteriorating at the rear stairs; space between stairs more than 4 inches; space between railing and stairs too wide; (2)(4)

WIDE
OPENING

30 IN

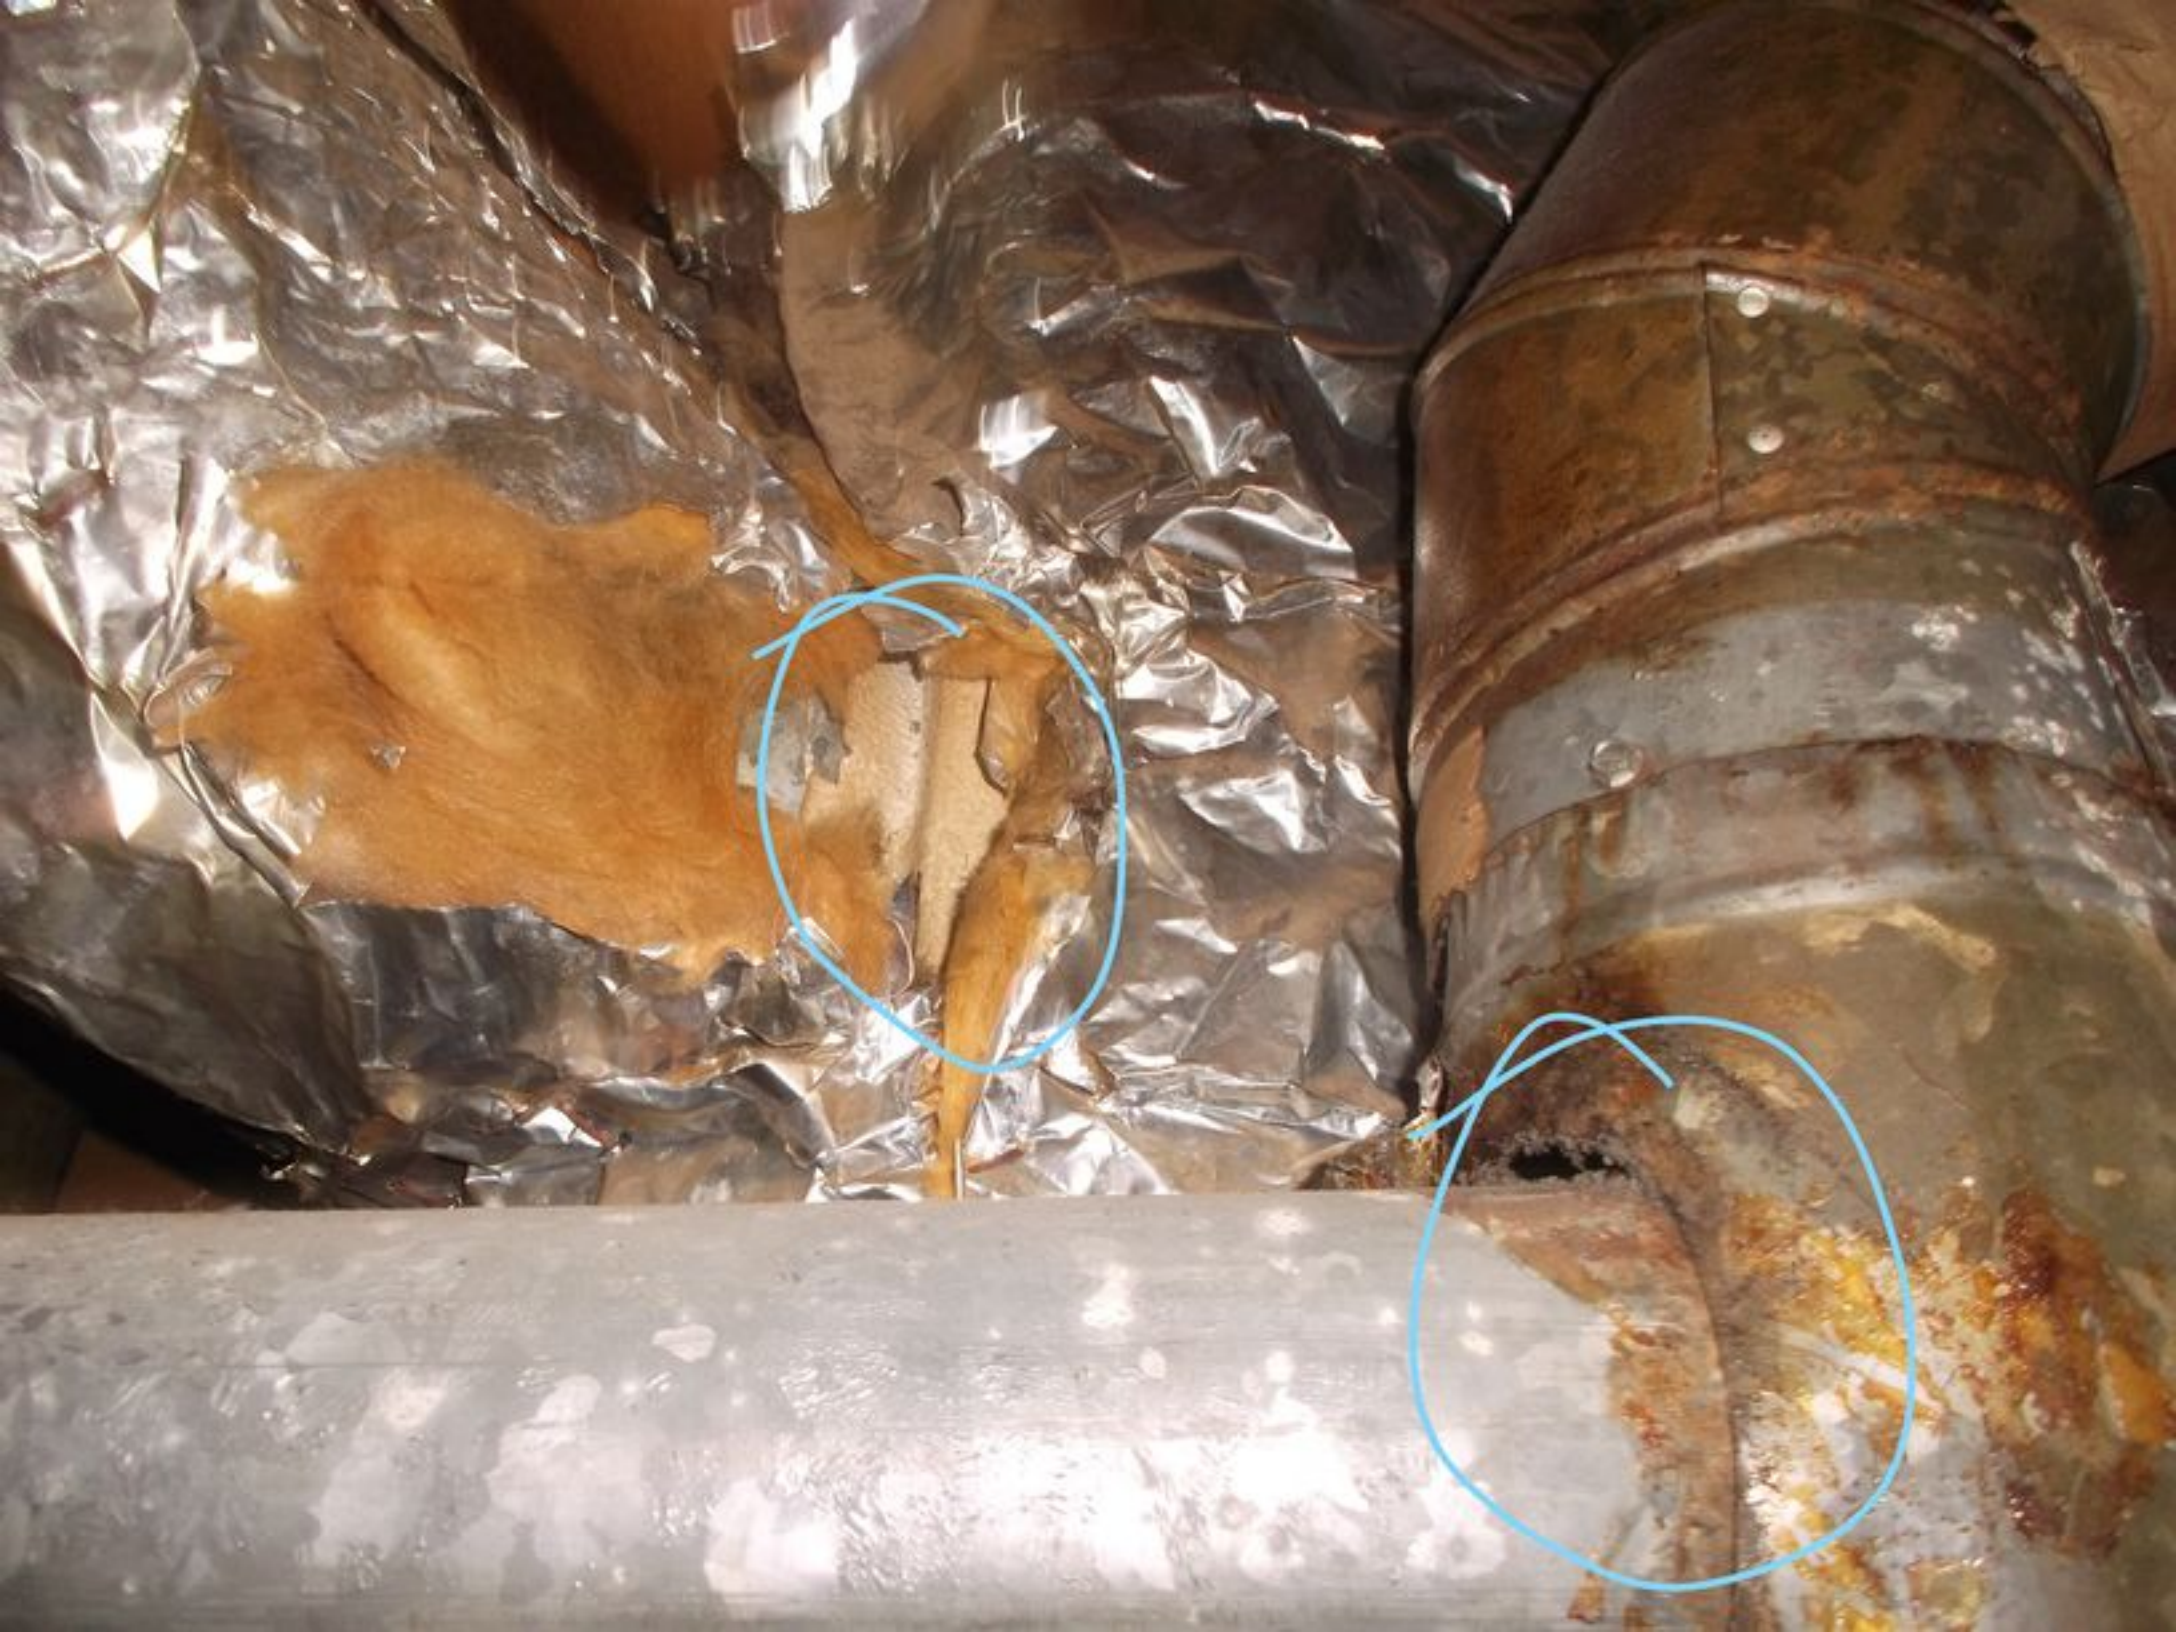
ASBESTOS

CORROSION
