# PROPERTY INSPECTION REPORT

390 Patterson Ave. SE Atlanta, GA.

Aug 21, 2021

1599

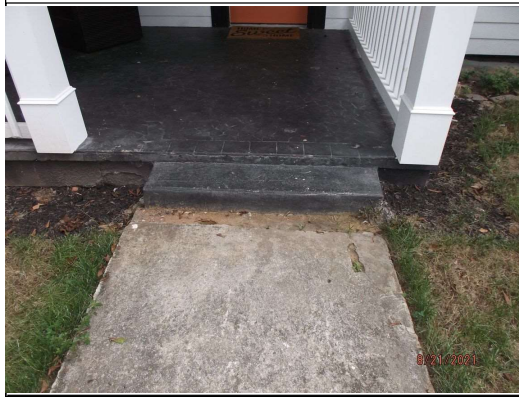
Front steps uneven and can be a trip hazard; no handrailing at the rear stairs; the wood deck stairs first step off the ground is too high can be a trip hazard; the retaining wall at the right side of the house has excessive leaning and could fall any time;

Front steps uneven and trip hazard

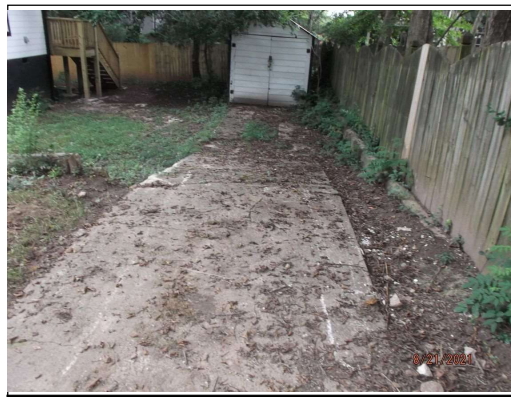
The driveway has major damage, broken sections and and steep at the incline to the street. Could not access the garage.

Driveway major damage and steep

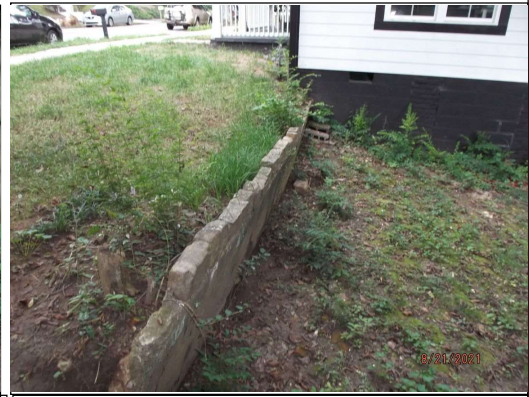
Retaining wall major leaning and no holes

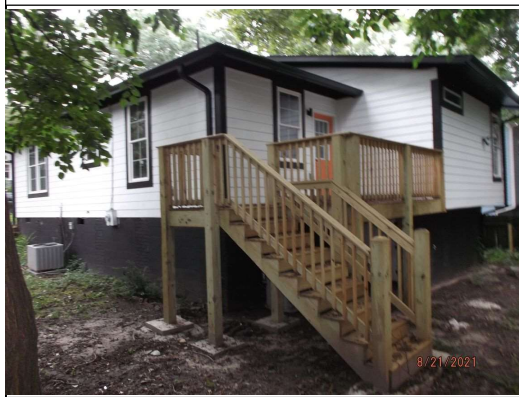
There is a missing support post at the deck floor where it attaches to the side of the house;

Deck missing bolts at house and missing post

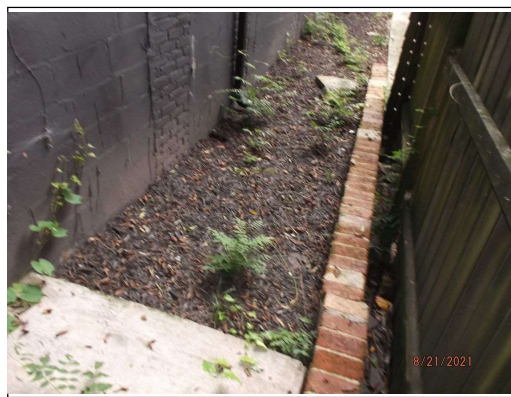
Foundation missing foundation vents and door to the crawlspace is not closing properly nor has a latch or lock; at the left side of the house the soil near the near the foundation is surrounded with retaining walls that can hold water that can get through the foundation and into crawlspace;

Retaining walls can hold water without holes

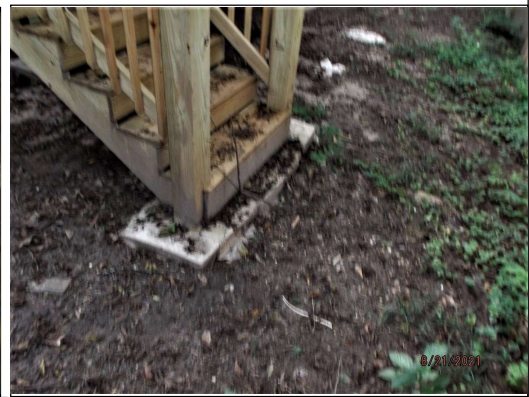
Missing stoop and no handrails

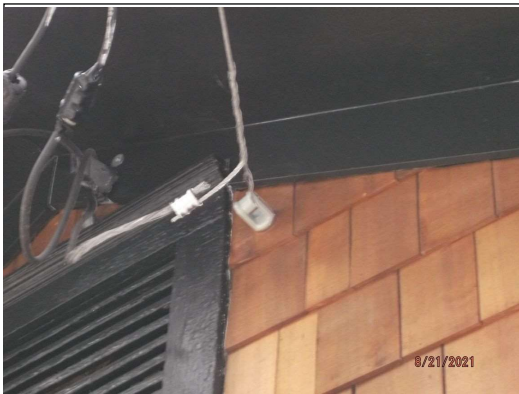
The electrical service cables from the street are attached to a glass knob in the siding can pull out and cause damage (should be a metal I-Bolt in the wall);

Improper anchor for service cables

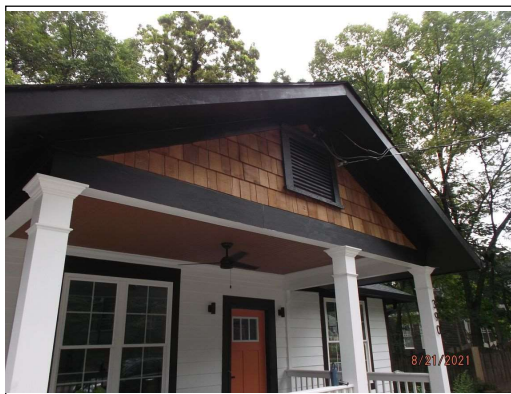
Missing drip edge flashing where the cedar shingles rest on the front porch beam; window screens not installed;

Missing flashing where shingles rest on beam

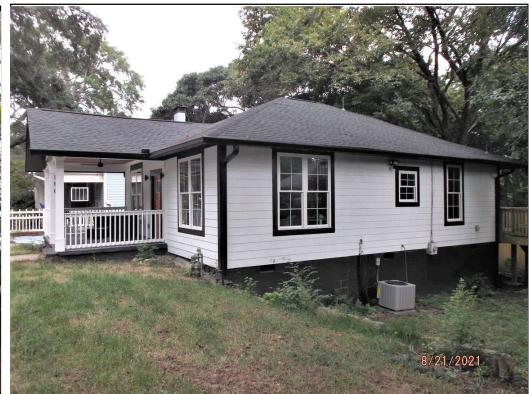
Window screens missing

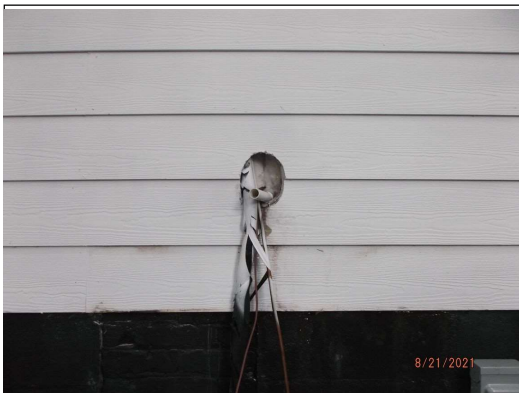
Hole in wall at AC pipes and no hood

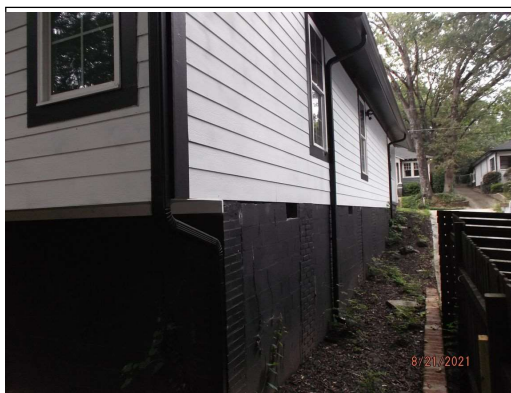
There is no lock or latch on the basement or crawlspace door; missing foundation vents;

Foundation vents missing at all sides

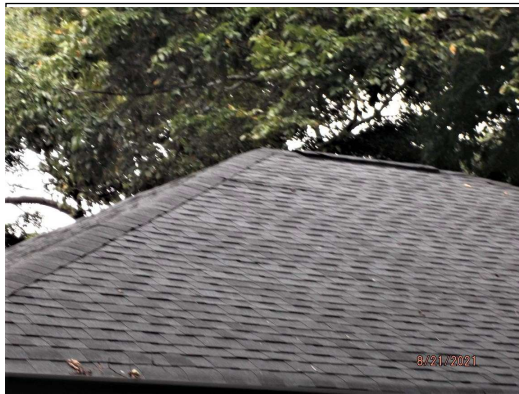
Missing soffit vents; main roof ridge vent not long enough to exhaust all hot air out the attic during extreme heat days; plumbing pipe flashing installed on top of shingles and face nailed can allow water to get under flashing and into holes (there should be no nails where flashing is not covered with shingles); there is a hump in the roof deck at the right side near the ridge; the roof shingles rise up near the gutter at the left side of the house; missing drip cap flashing on the fascia boards at the front roof gable;

Ridge vent too small/hump in roof shingles

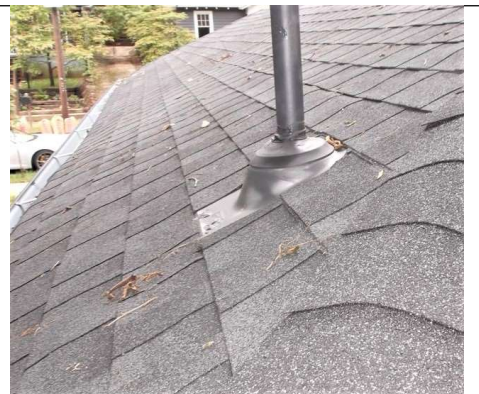
Flashing on top shingles and face nailed

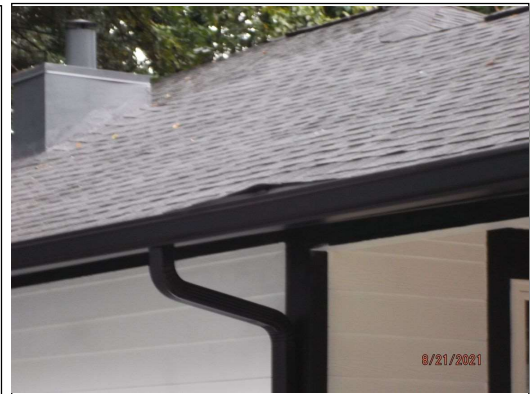
Hump in shingles left side

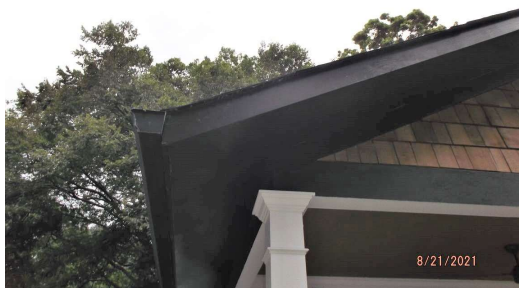
Missing drip cap flashing at fascia boards

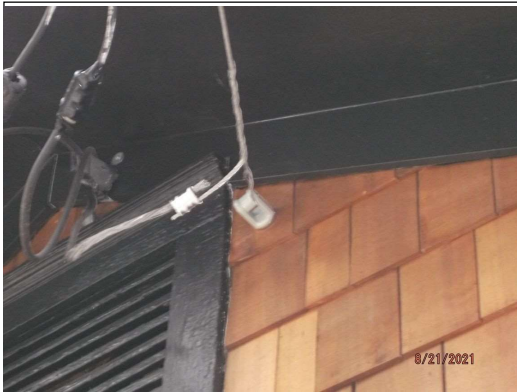
The electrical service wires from the street are anchored to the house with a glass knob that has a screw that can pull out of the wall (should be a I-Bolt with a nut. When a home has major electrical wiring the meter box should be replaced and service should have a disconnect at the outside (old meter still in place, verify there was a electrical permit issued and inspections passed)

Improper service cables anchor

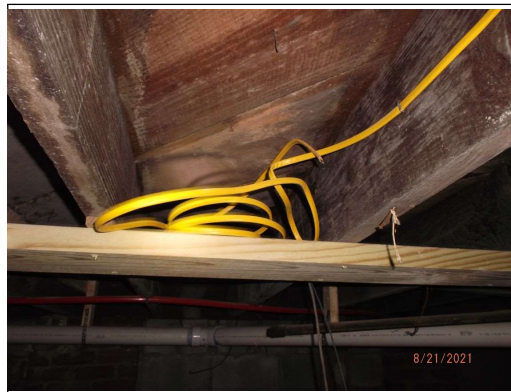
Exposed electrical cable not in box

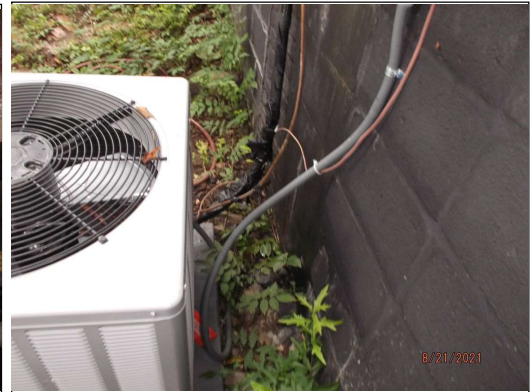
AC electrical conduit is not clamp to the foundation behind the AC unit at the right side of the house; missing switch and receptacle box covers in the basement ceiling;

AC conduit not clamped to foundation wall

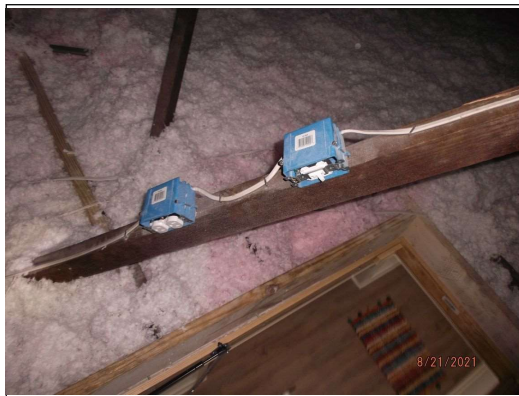
Missing outlet covers

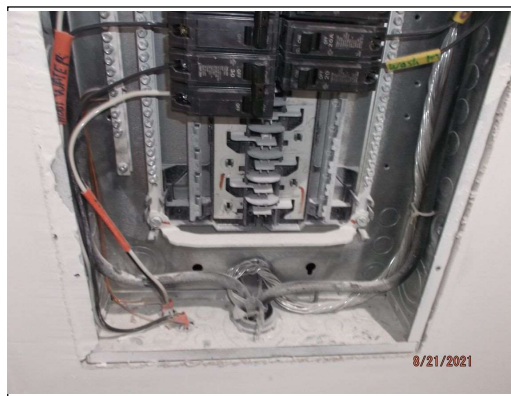
When the walls were spray painted inside the house the painters sprayed paint on the distribution circuit board components and breaker pins (all breakers shall be removed and all paint shall be cleaned on circuit board components, breakers can have poor contact with blades and pins); one screw is missing at the distribution panel cover;

Spray paint on circuit board at panel

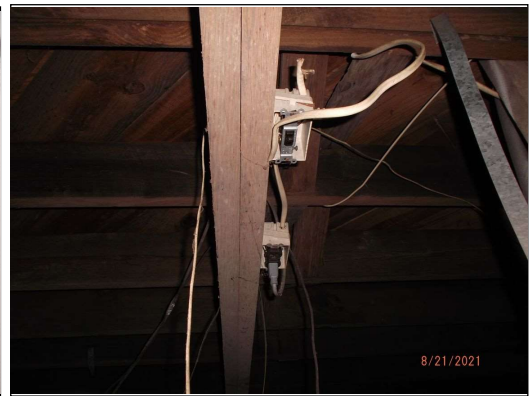
Missing box covers in the basement

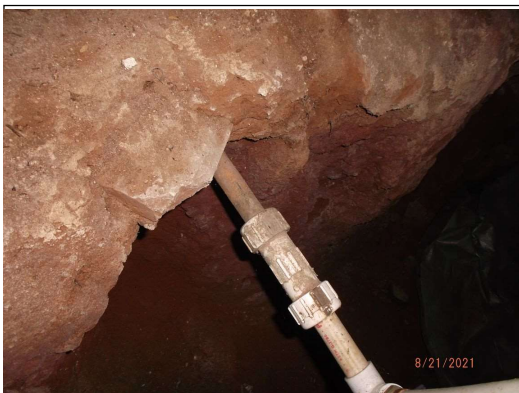
The gas meter has been shut off and a lock is installed (verify no outstanding gas bills); The water pipe to the street appears to be galvanized steel, seller verify (if main water pipe to the street is steel there may be rust at the inside walls if more than 13 years old); laundry room water pipes leaking into the basement and on the floor seals causing rot and mold;

main water pipe steel?

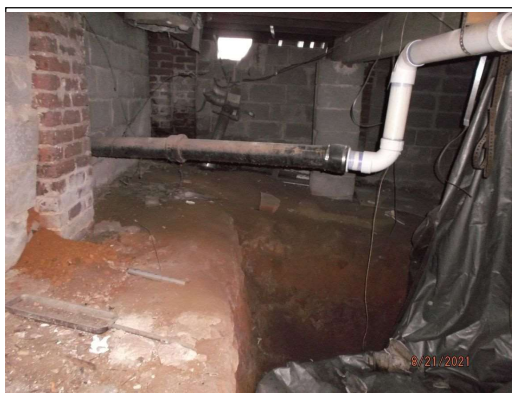
Original cast iron waste pipe

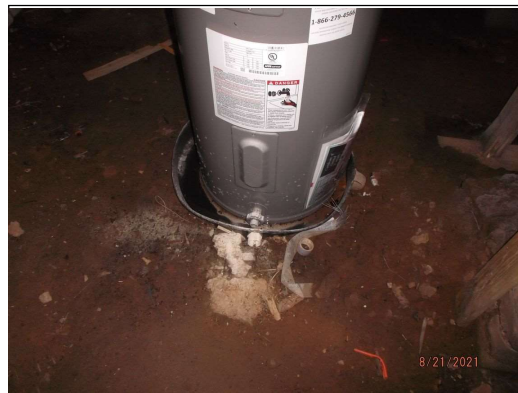
W/H rest in water in pan in soil

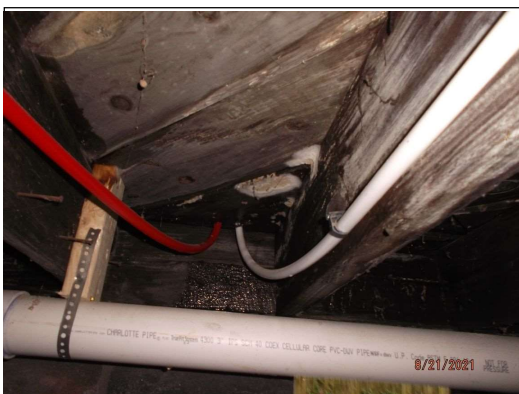
Laundry room water pipes leaking water

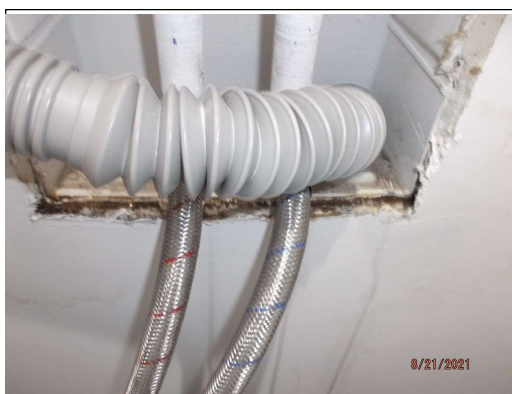
Pipes leaking at the washer hookup box (water leaking into the wall and floor below laundry room, water damage to wall, floor and floor framing);

Pipes leaking at the washer hookup box

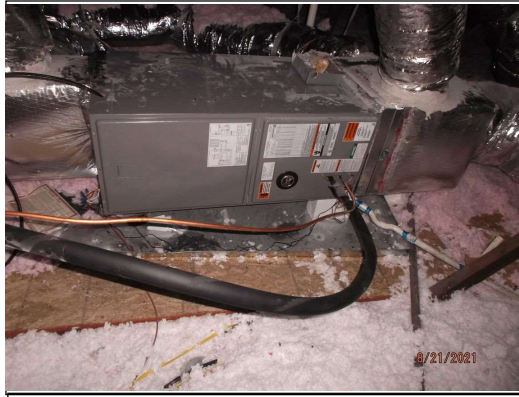
Furnace makes whistling noise operating

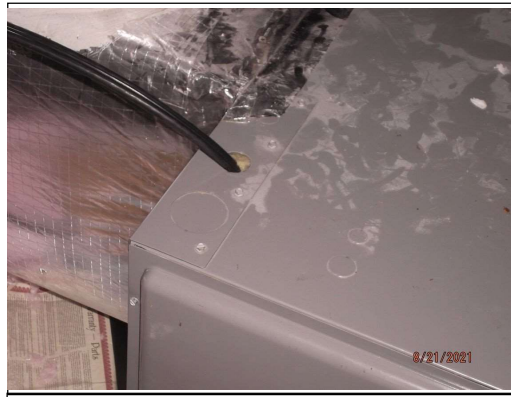
The electrical cable entering the furnace at the attic is contacting sharp metal where it enters the hole and can become a shock and safety hazard (hole should have a bushing in place);

Electrical cable contact sharp metal in hole

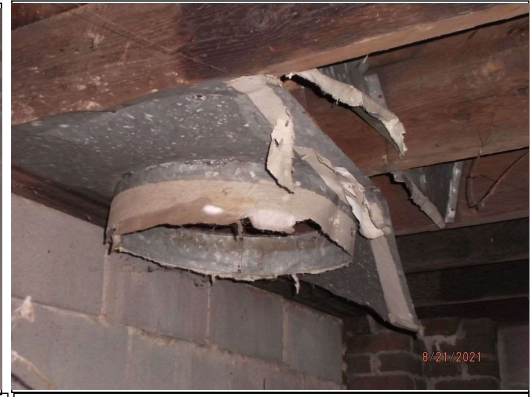
Damaged and deteriorated Asbestos materials remain on old metal air duct components in the crawlspace. It appears that old metal ducts with Asbestos tape may have been removed not according to EPD and EPA guidelines. Where Asbestos materials are removed improperly there can be particles in the crawlspace, in the basement, in the soil and in the house under certain conditions.

Damaged Asbestos remains on old metal duc

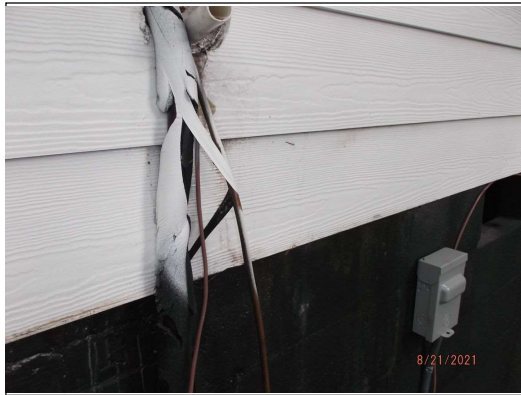
Damaged refrigerant line insulation

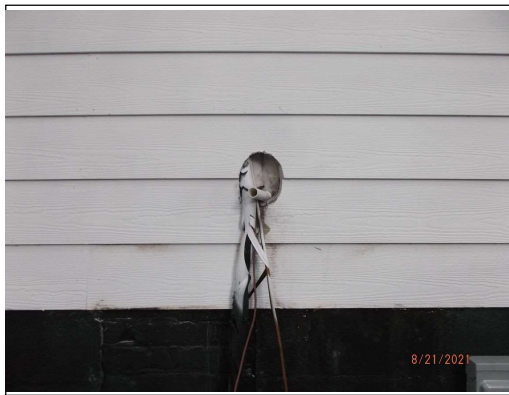
Condensate pipe at the exterior wall is not turned down to the ground and routed 3 feet away from the foundation. Condensate drain pipe draining water back into the wall cause water intrusion and water damage at the wall. Excessive hole opening in the siding shall be closed and a hood placed over the open where the AC pipes enter the siding. Refrigerant line insulation deteriorated at the exterior and missing at the attic. The AC electrical conduit is not clamped to the foundation wall can be damaged by movement.

Condensate pipe pour water into wall

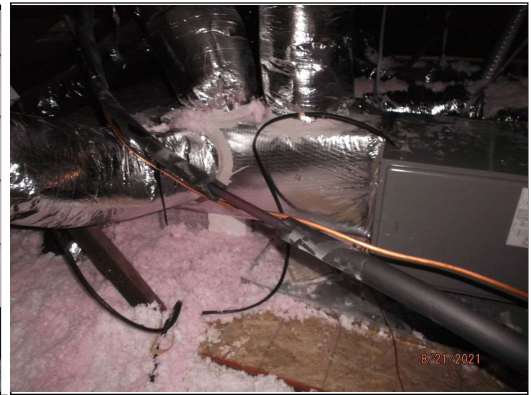
Missing refrigerant line insulation at attic

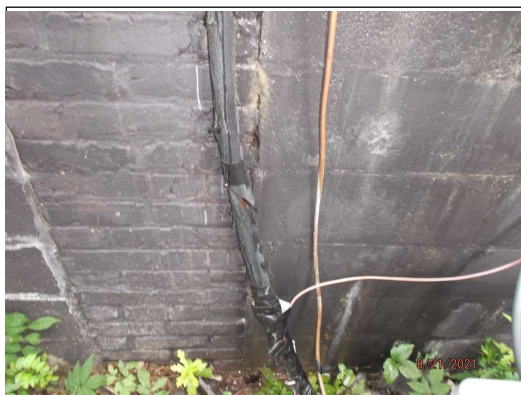
Deteriorated refrigerant line insulation

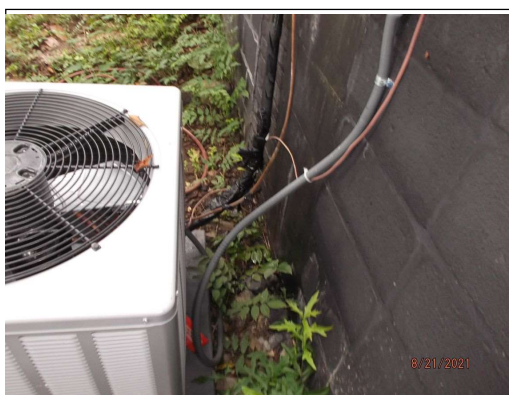
AC conduit not clamped to the wall

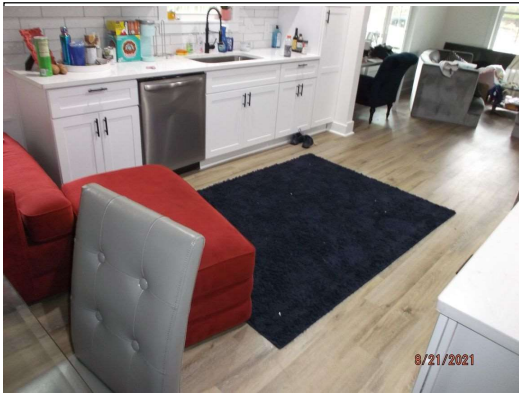
The kitchen floor is sagging in the center and slopes to the sink area; the dishwasher is not square under the counter; the stove is not connected to a anti tilt device; the dishwasher appears to still have the service tag inside (verify hooked up properly and operational)

Floor sagging and slopes to sink wall

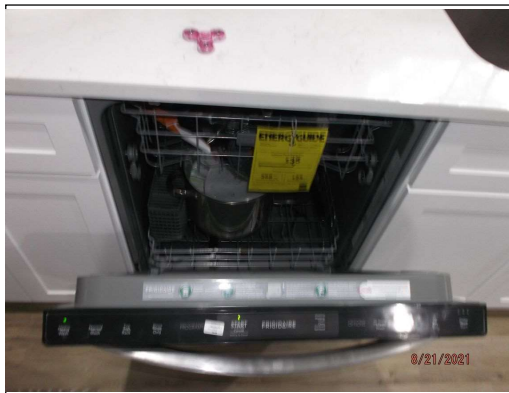
Dishwasher not used

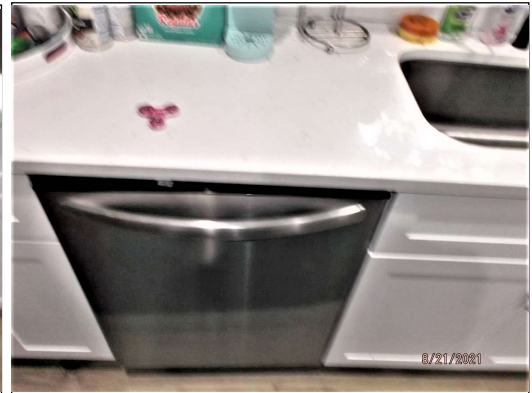
Not square under counter

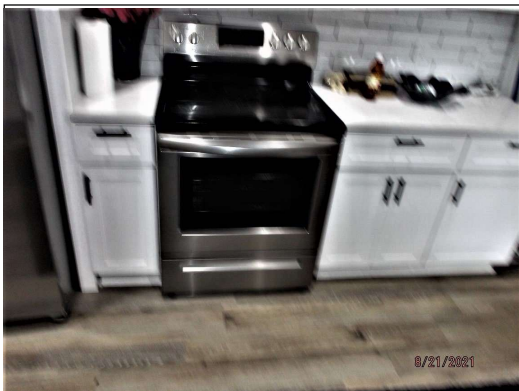
No anti tilt device connected to stove

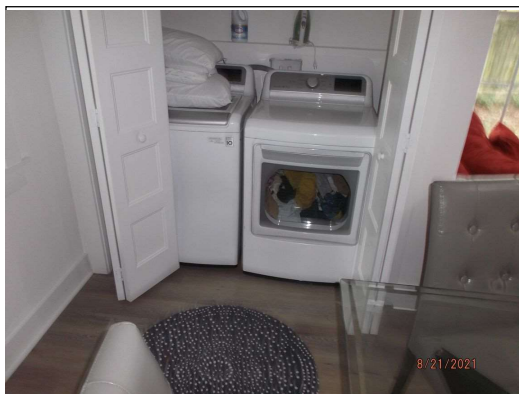
There is no washer drain pan in the laundry room and no drain pipe leading to the exterior;

No washer drain pan

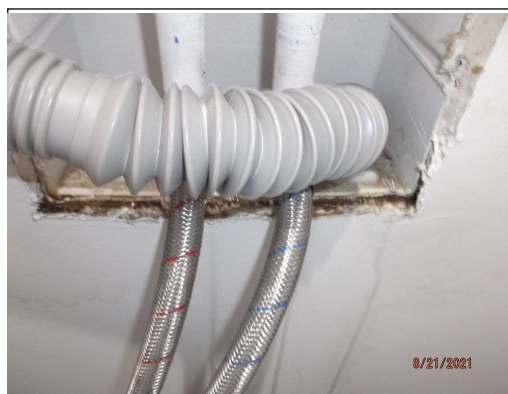
Pipes leaking into wall and floor

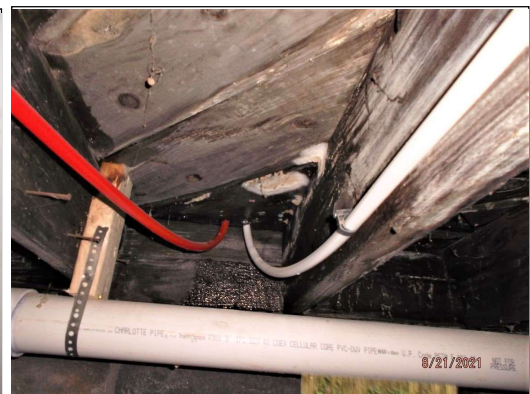
Water & water damage under laundry room

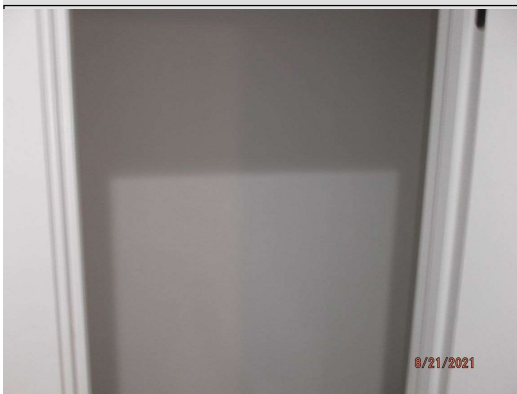
No shelves in the master closets

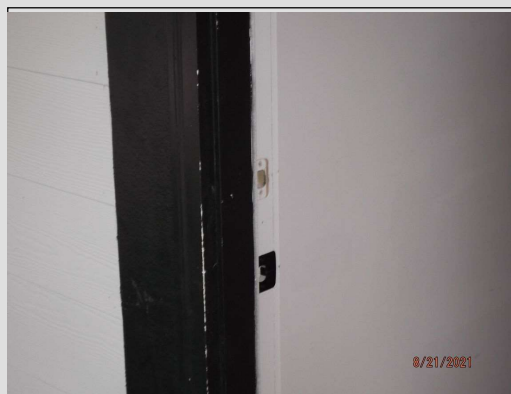
Rear door to the deck lock not striking plate; missing strike plate at the front door jamb;

Missing strike plate at the front door

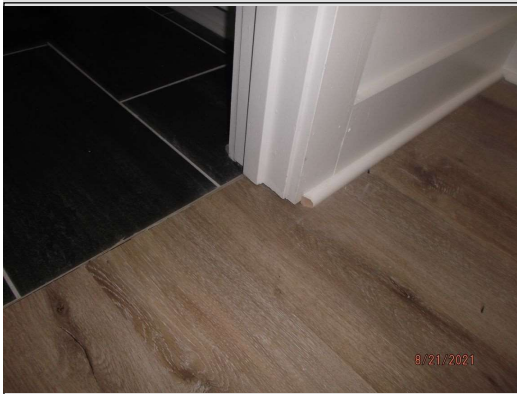
Missing bead of caulk

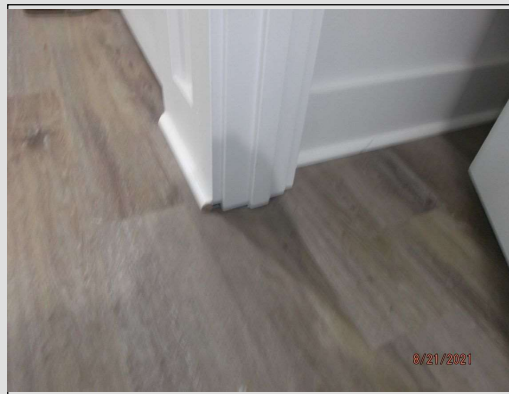
Missing caulk

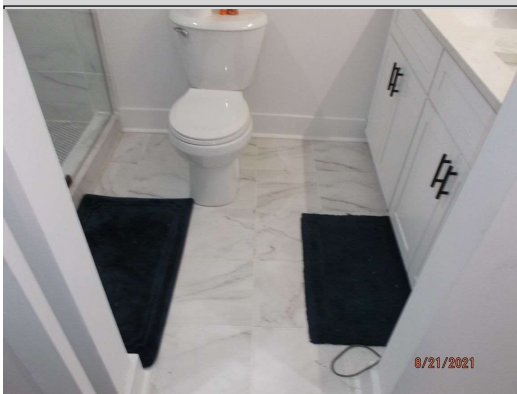
Master bath floor dips down when entering the door; missing caulk where toilet rest on the floor; shower head pipe loose in the wall; defective tile installation at the shower floor;

Missing caulk where toilet rest on the floor

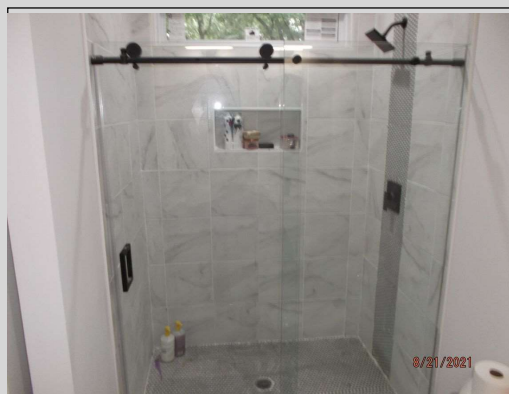
Shower head loose/poor floor tile installation

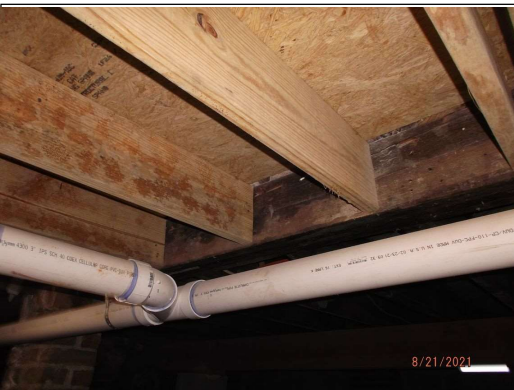
Missing joist hangers or 2 by 2 ledger at areas

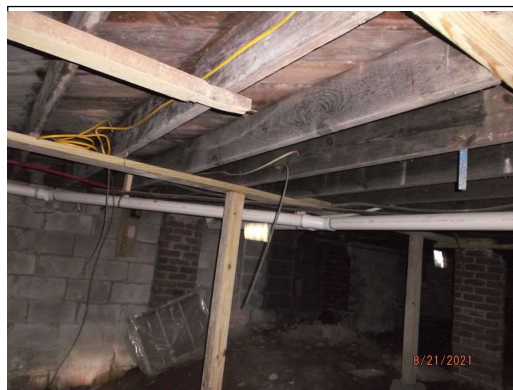
Fungus on floor framing

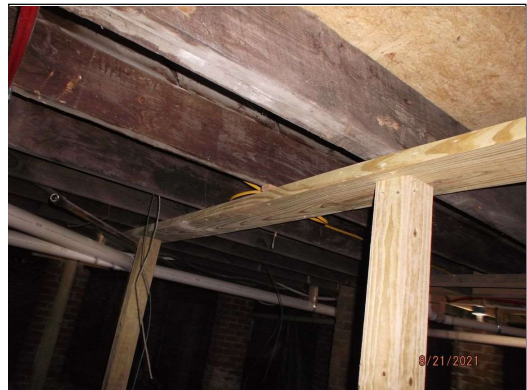
Improper wood for a beam

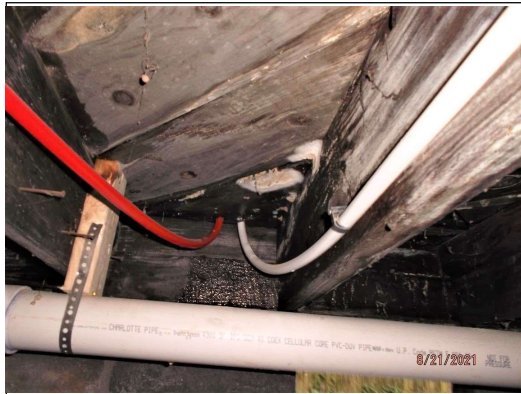
Water damage to floor framing and seals where the laundry and kitchen areas are above; Mold and fungus noted on floor framing; debris in the basement/crawlspace; soil wet in the crawlspace; missing joist hangers at several floor joists; Improper wood beams installation under floors at some areas (single 2 by 10 turned on the side)

Water damage, mold, fungus

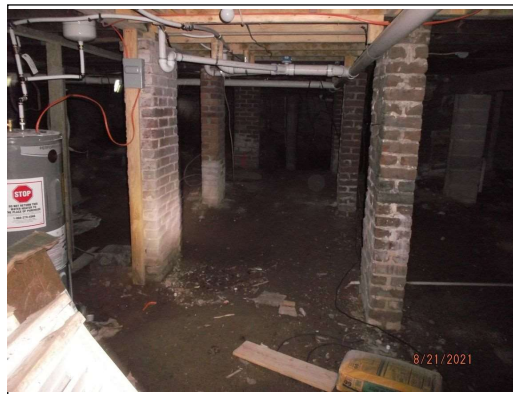
Soil wet, debris, no moisture barrier

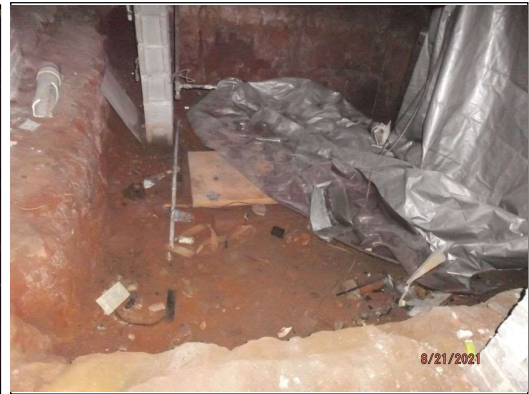
Debris and missing moisture barrier

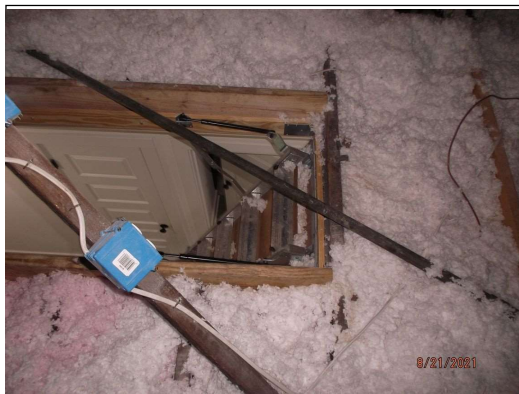
Pipe crosses over stair entry safety issue

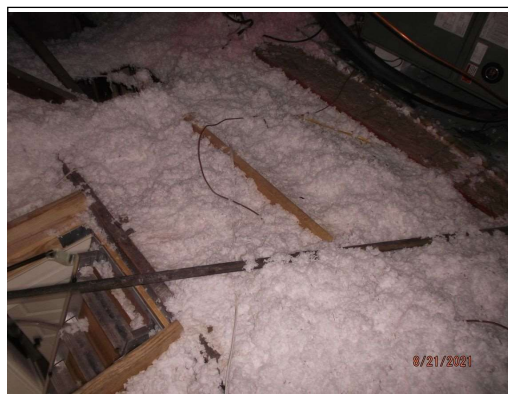
Missing service floor leading to furnace

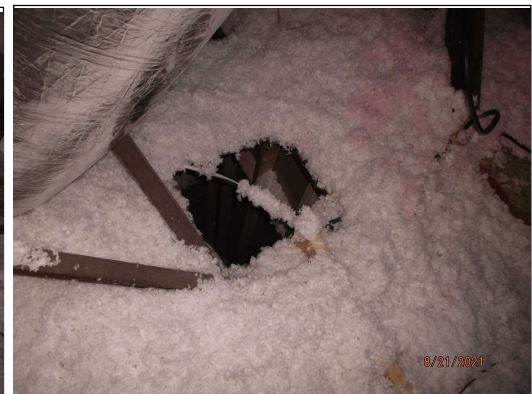
Open chase in attic floor

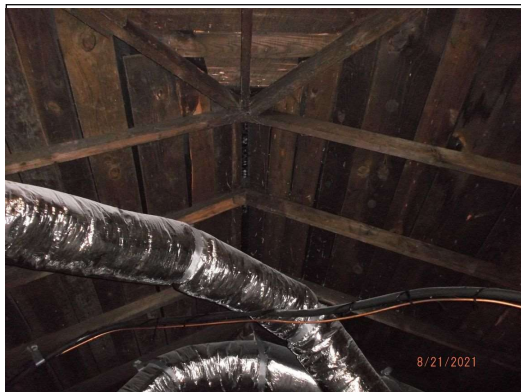
Not enough ridge ventilation

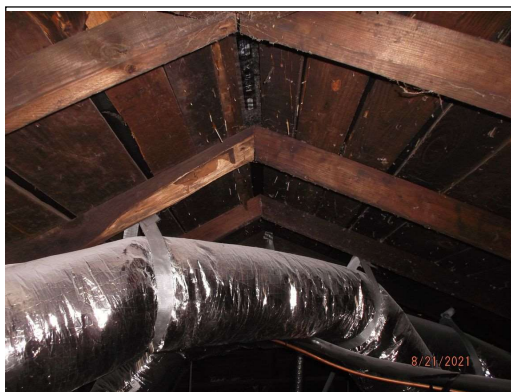
Missing collar ties

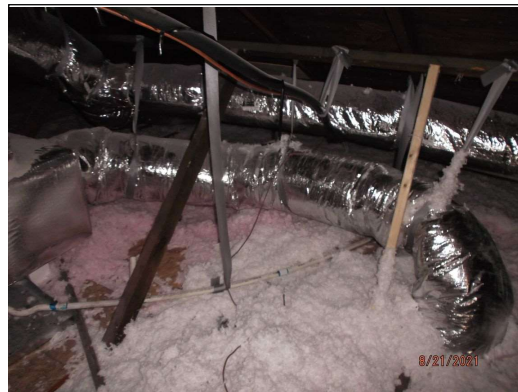
Roof structure supported with single 2 by 4 braces but should be 2-2 by 4s nailed together. Missing collar ties at main roof rafters. poor attic ventilation at the ridge and soffits (need additional roof ventilation and soffit venting). There is no service floor leading to the furnace is a fall and safety hazard. There is a pipe crossing over the attic door open that is a fall and safety hazard when entering and exiting the attic via attic opening. The attic door cannot fully close because the metal pipe cross over the stair resting place. There is an open chase leading from the main level into the attic (can allow a fire to get to the attic quickly and should be closed with insulation Batts. Outlet boxes missing cover plates.

Single 2 by 4s for braces should be two
