# PROPERTY INSPECTION REPORT

6177 Susan Lane, Doraville, GA.

**Inspection Date:**

Oct 1, 2026

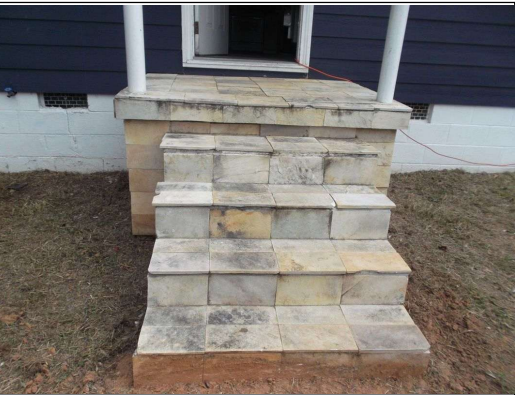
There are no handrails at the front porch (where there are 4 or more steps there shall be a handrail installed. The rear steps were rotted and broken but were being repaired at the time of the inspection. The front brick walkway has settling and sagging that needs the bricks relayed.

Need handrails/floor slope away/loose tiles

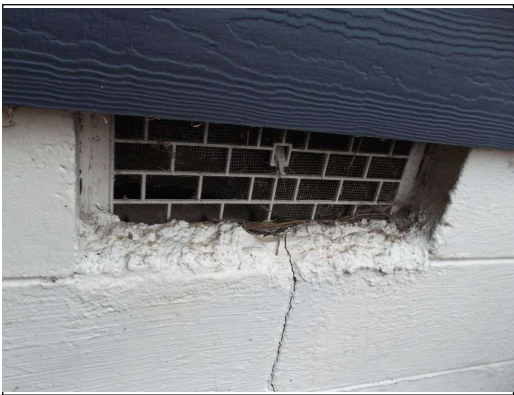
The soil slopes to the rear foundation and poor slope away from the left side of the house. Water can drain to the foundation and into the crawlspace during long and heavy rain. Foundation vents damaged, screens detached, vent doors missing. Common cracks in the foundation.

Vents damaged

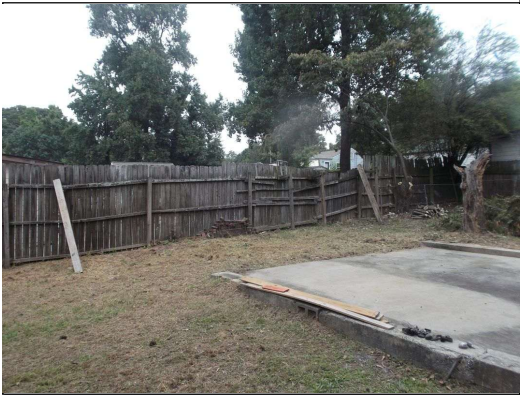
Wood fence damage at areas

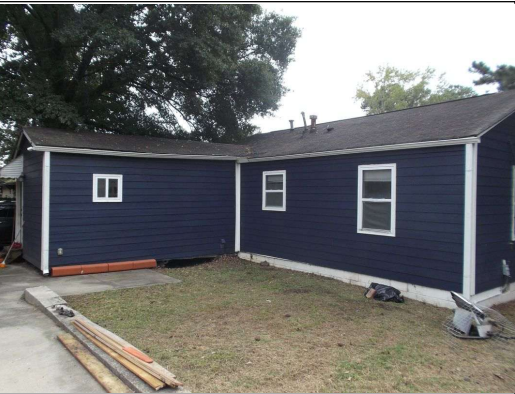
Soil slope to the foundation

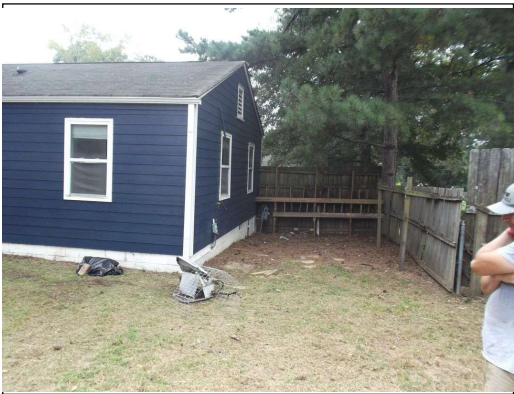
Poor soil slope away

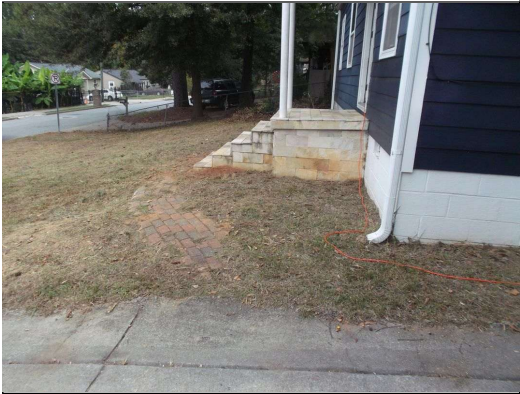
Walkway need relay/porch floor slope away

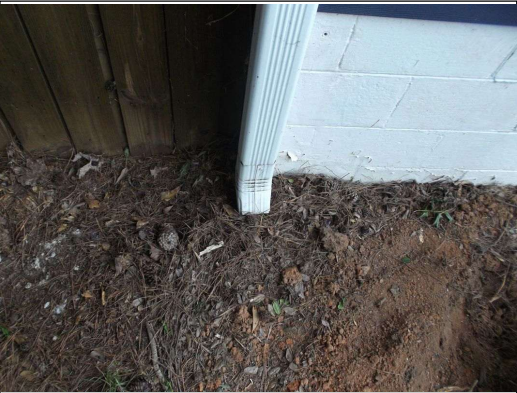
Downspouts pour at the foundation at several areas around the house should be routed away properly. Pine straw in the front gutters.

Downspouts pour at the foundation

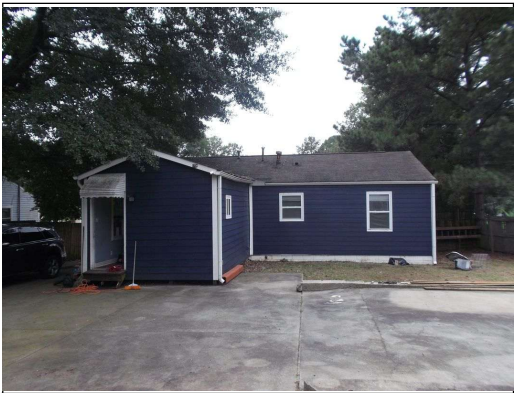
Verifique que la ampliación trasera tuviera per

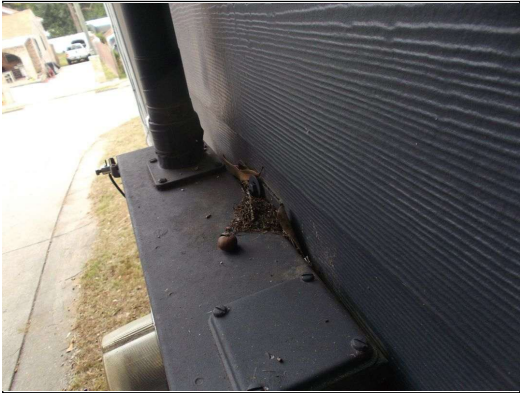
Missing bead of caulk over box

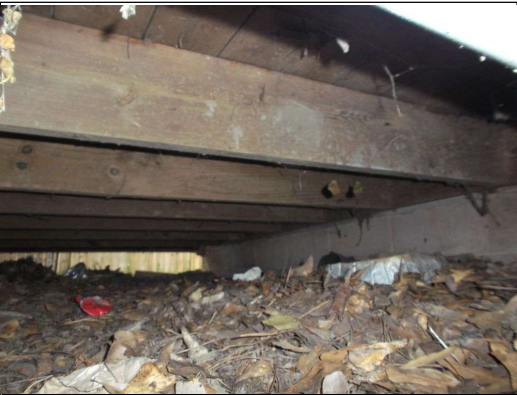
No se pueden ver los soportes de viguetas ni l

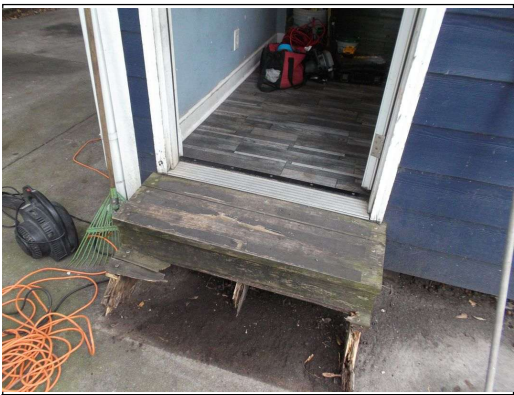
Some window screens have holes, fiber rotting and a few screens missing. There is a cracked window glass at the left side of the house. The rear entry door frame has water damage and rot at the bottom.

Podredumbre en el marco de la puerta

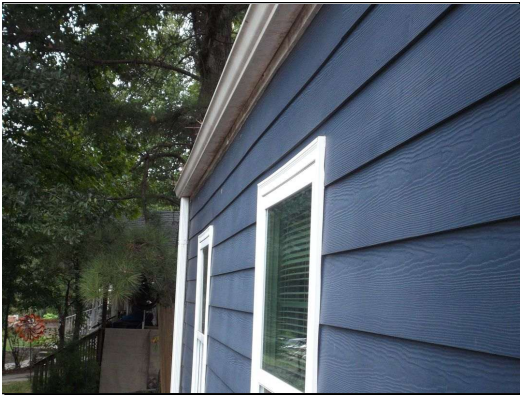
Missing flashing over the top of the windows. Some newer windows have built in flashing if they are installed properly and moisture barrier properly put on the house before the siding is installed.

Sin tapajuntas sobre las ventanas.

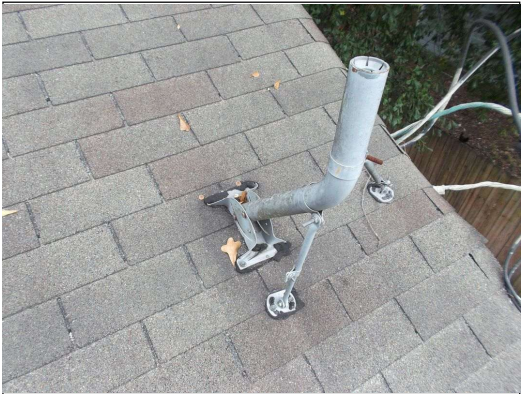
There is a TV dish bolted to the roof that can cause leaks over time and should be removed. Missing metal drip edge on the fascia boards under the shingles. Can see roof patches at the rear valley.

Dish pole bolted to the roof

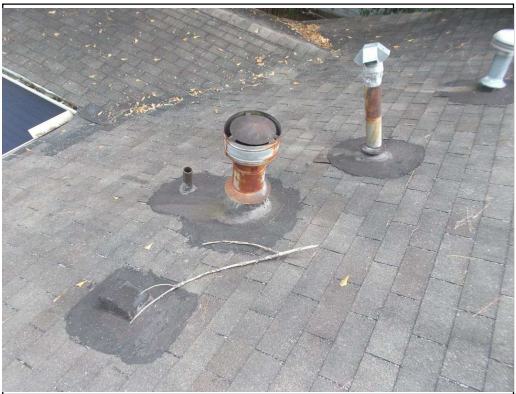
Pipe and vent flashing is installed on top of the shingles at the bottom flange and face nailed. Nails can extract, water can get under flashing and into holes in the roof covering and cause leaks over time. There should be no face nails in the flashing and where there are nails on the side flanges they should be covered with the shingles. Tar placed around the pipe flashing at several areas.

Tar around flashing and boots

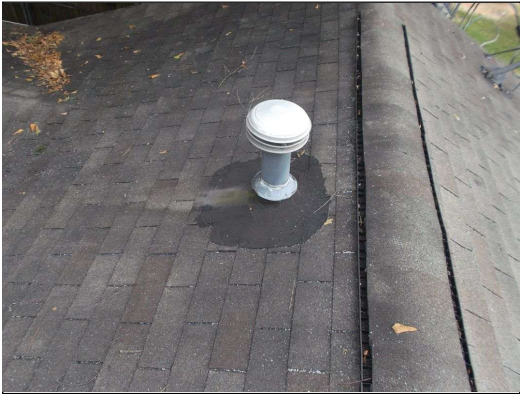
Tar around flashing and pipe

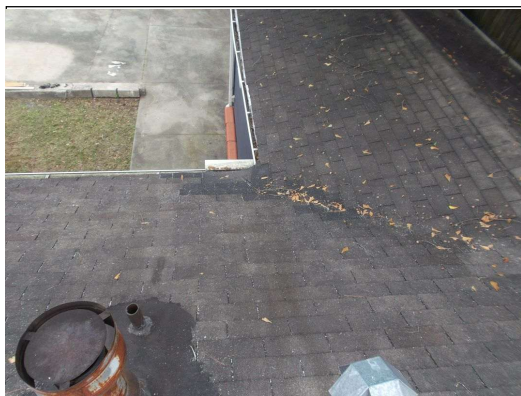
Roof patching rear valley

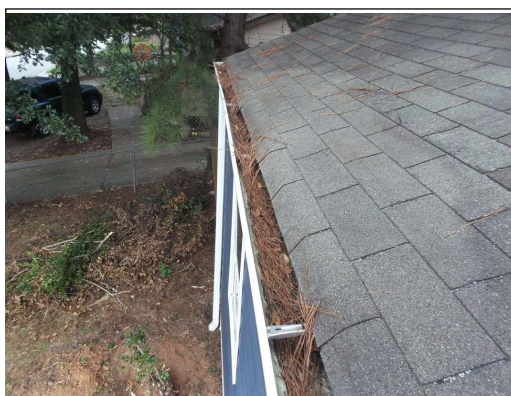
Pine straw in gutters

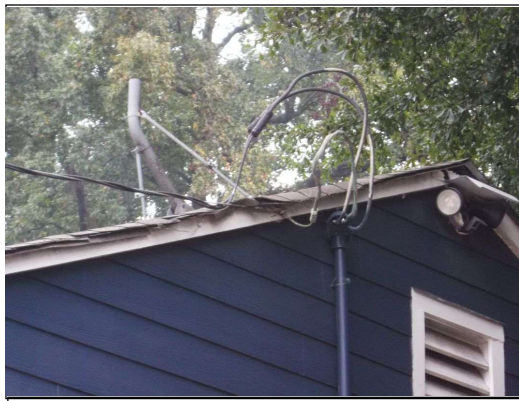
Cables not looped up to mast head

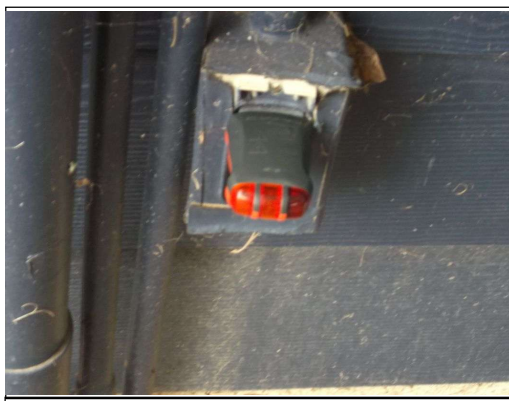
Receptacle not energized

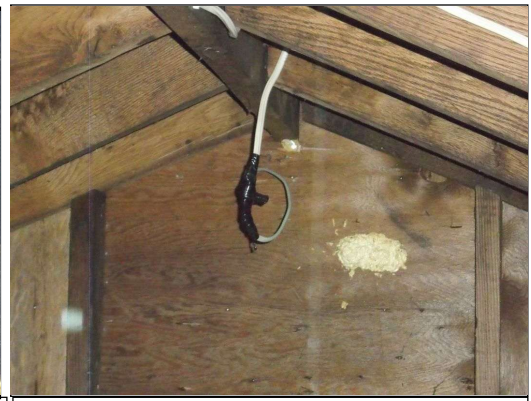
Wires tapped together in the attic

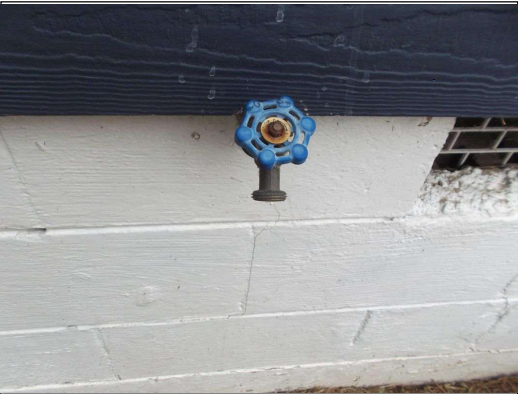
Missing anti siphon devices at hose faucets

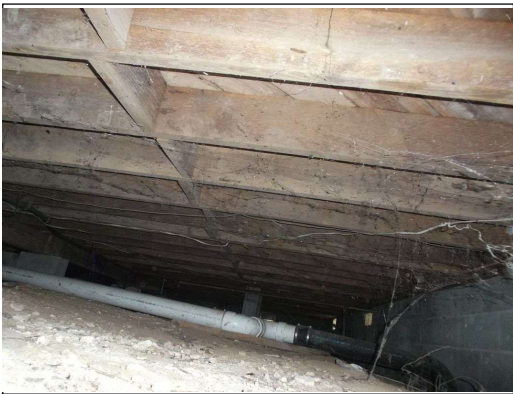
ABS black plastic waste pipe at foundation

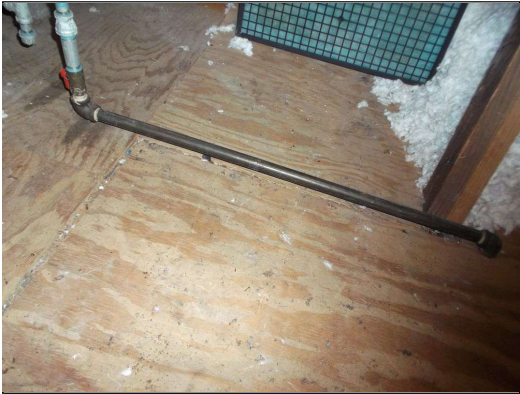
The gas pipe leading to the furnace in the attic is not secured and supported to the attic floor. Some of the gas pipe in the attic is water pipe. The water heater gas vent pipe in the attic touching insulation and wood.

Gas pipe not supported and secured to floor

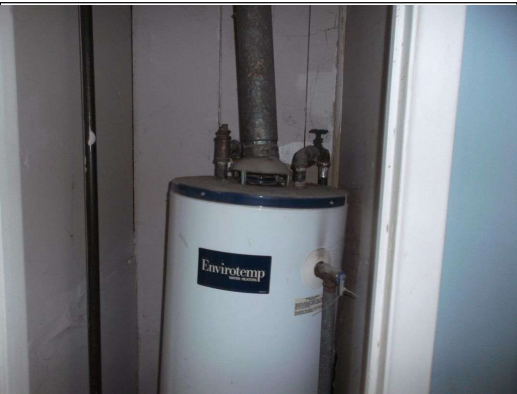
The water pipe system appears to be steel pipe. Steel or galvanized water pipe has a good life of about 40 to 60 years or so. These pipe can get rusty at the inner walls around 40 years.

Galvanized water pipes may have rust inside

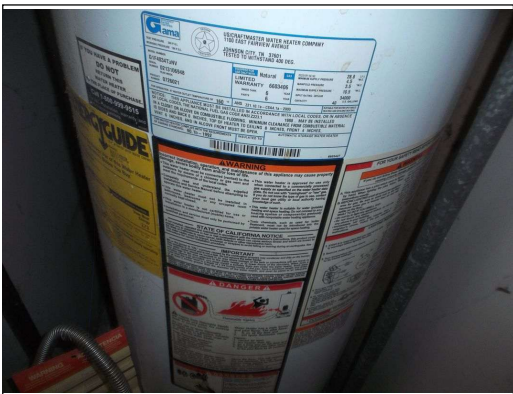
Water heater 2002 end of use

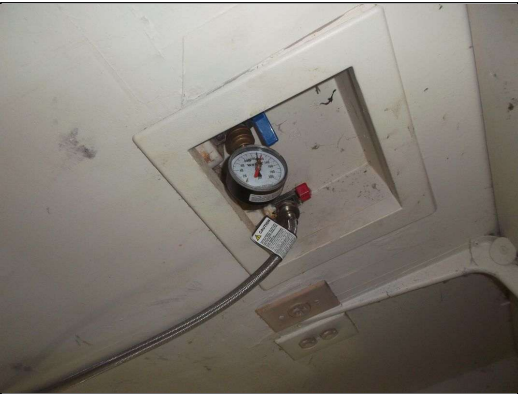
Water pressure over 80 psi

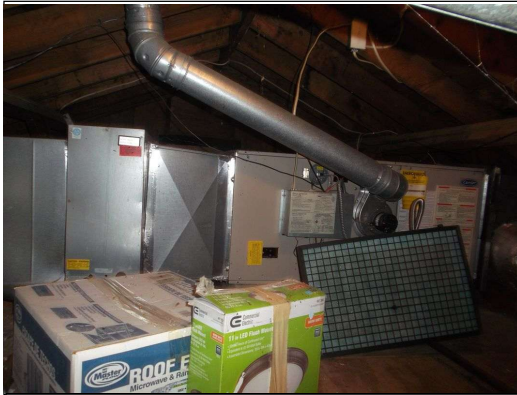
The industry average service design life for most forced air furnaces is 15-20 years, and the industry average service design life for most air conditioning condensing units is 10-15 years. 1998 date

Furnace may be at the end of use

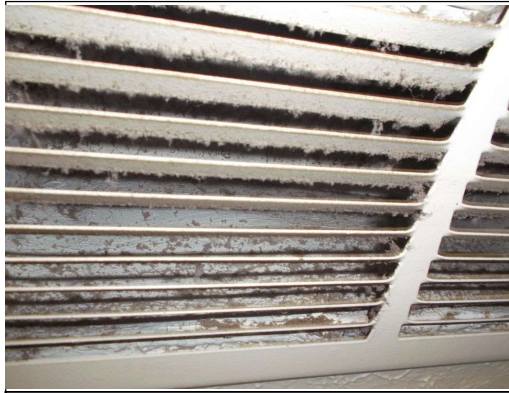
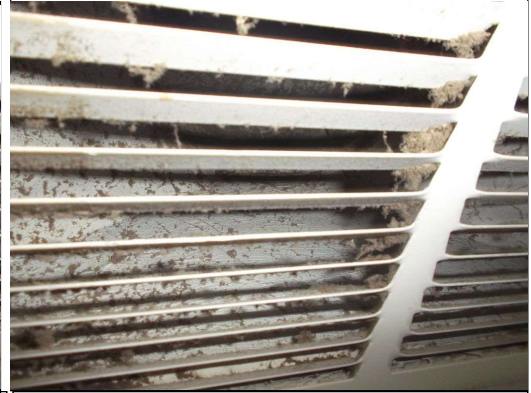
Conductos de aire polvorientos. Air ducts dusty.

Air duct dusty

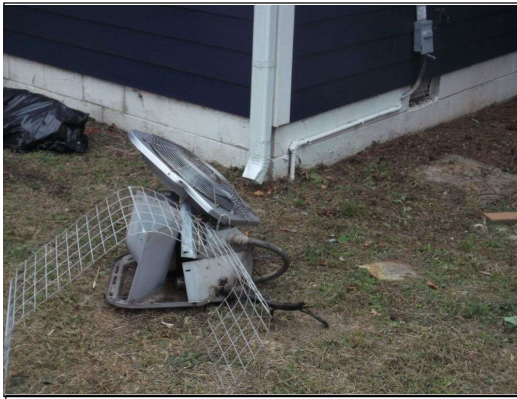
AC unit disconnected and damaged at the rear yard. Unidad de aire acondicionado desconectada y dañada en el patio trasero.

AC detached and damaged

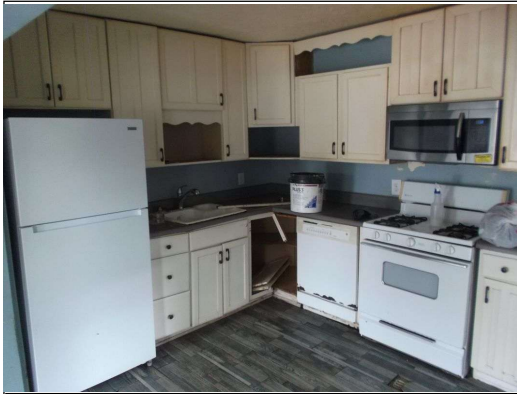
Cabinet damage, floor sinking

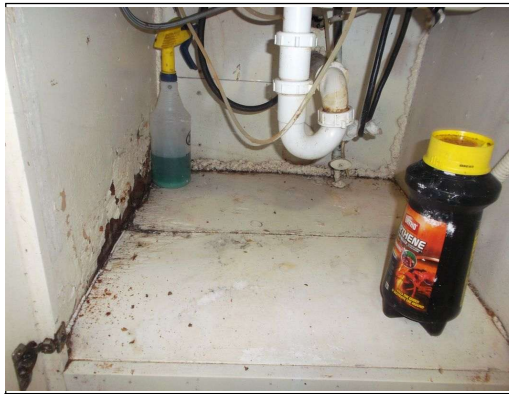
Water damage to cabinet

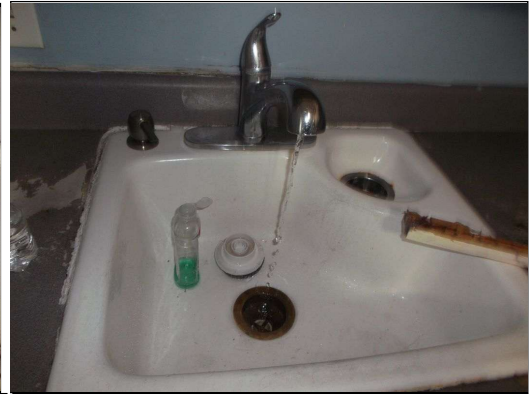
Low water flow at sink faucet

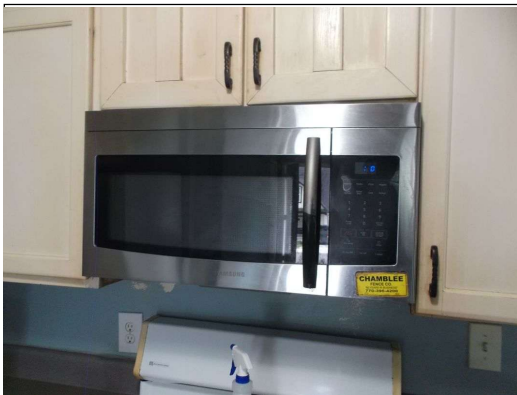
Microwave not working properly

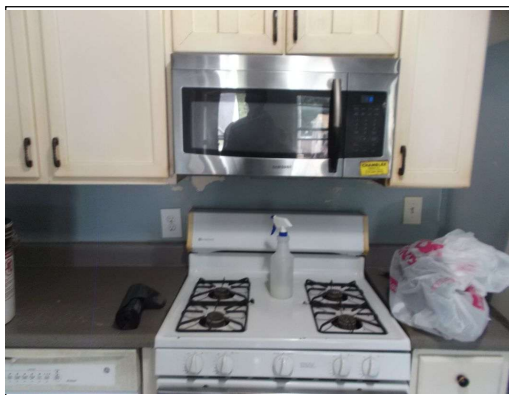
Stove end of use

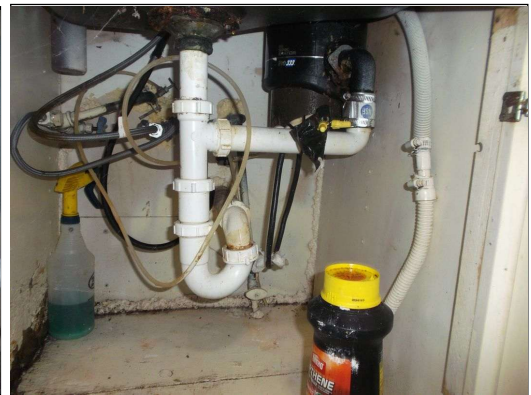
Exposed electrical wires

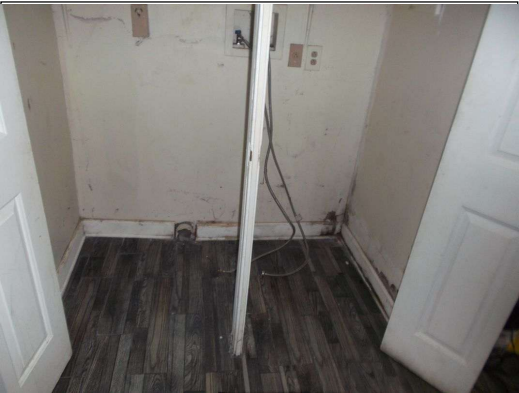
The laundry room floor is sagging, water stains and mold on the walls. No washer drain pan and drain pipe to the exterior.

Floor sink, mold on wall, no drain pan

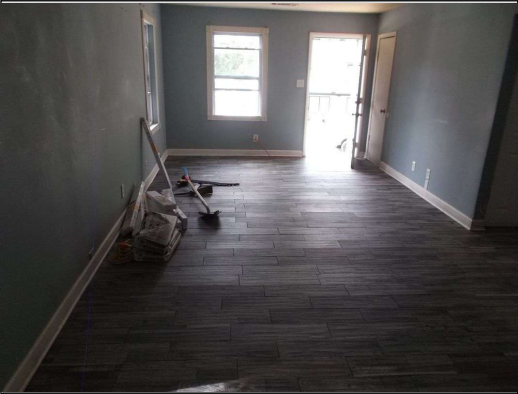
Floor slopes to left and exterior wall corner

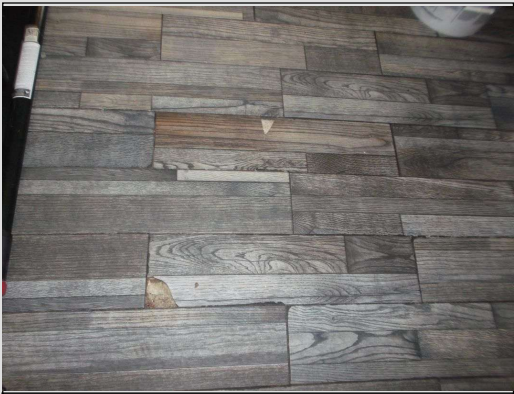
Broken and damaged tiles

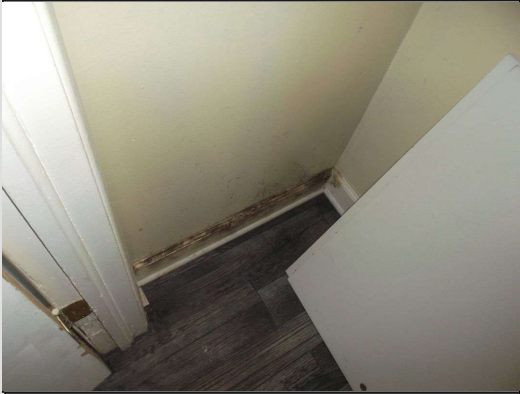
Mold in coat closet

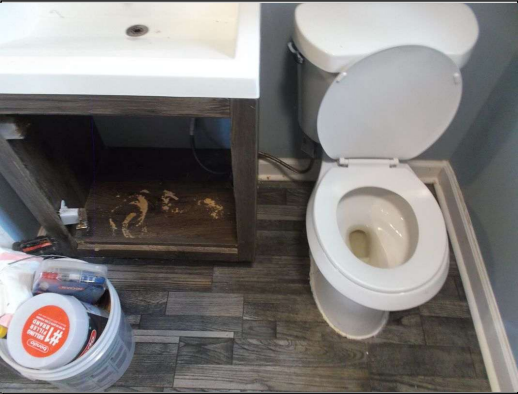
Cabinet door off

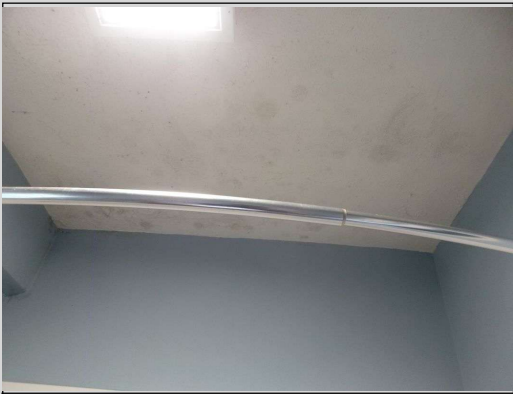
Stains in bath ceiling

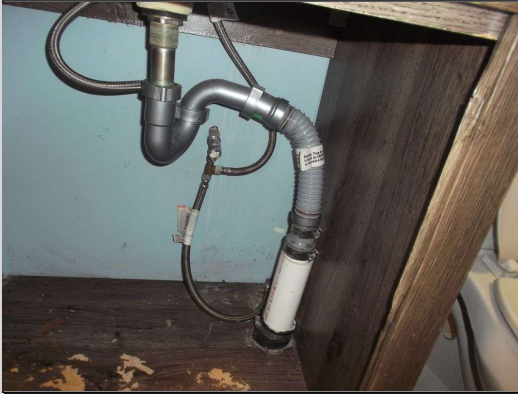
Sink drain pipe is a S-Trap unsafe

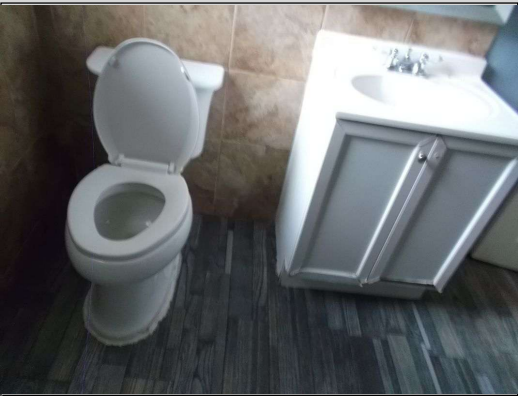
Cabinet water damage

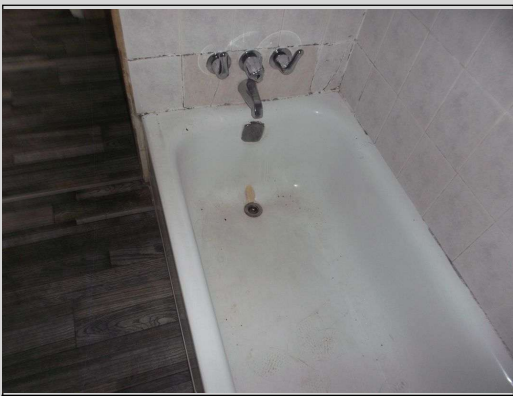
Stains in tub, broke tiles, faucet handles loose

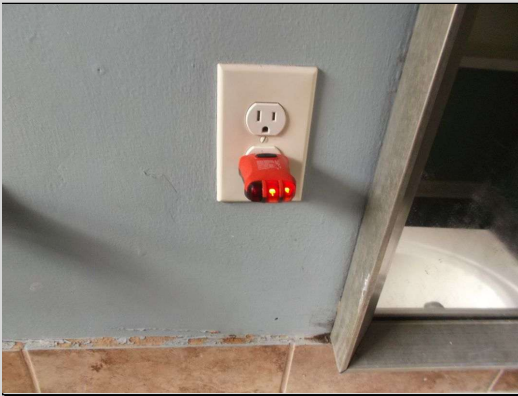
Outlets not GFCI protected

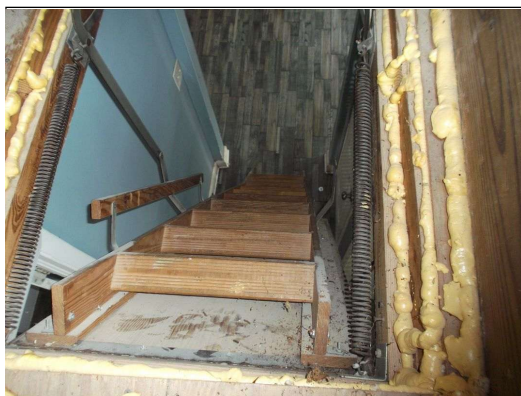
The attic ladder is too long and attic door does not fully close. Can see water stains under the roof decking around a roof vent pipe seen in the attic.

Ladder too long

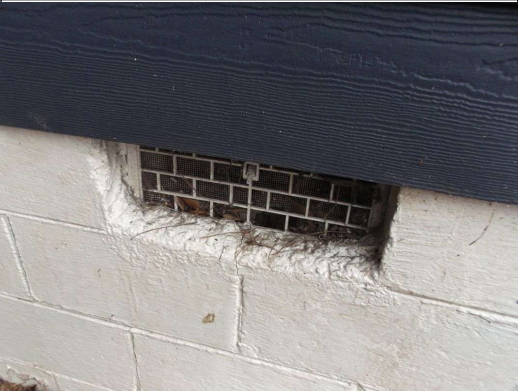
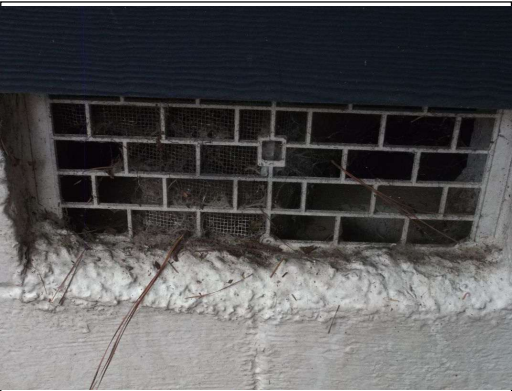
Vent need replacement

Vent needs replacement

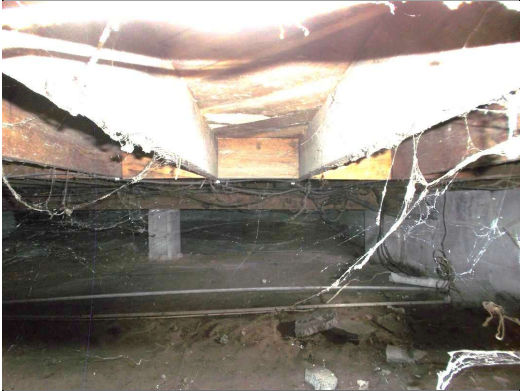
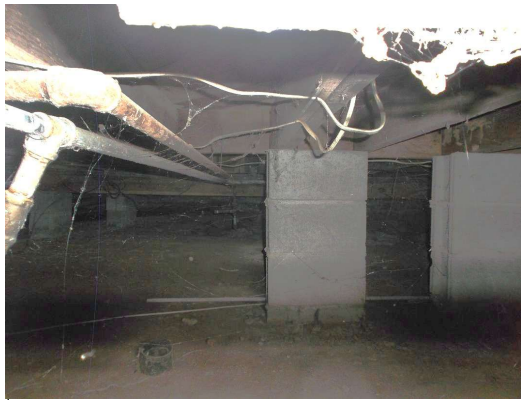
Missing moisture barrier on the ground in the crawlspace. Foundation vents damaged, missing screens and doors need replacements. The crawlspace door needs repair. Cannot see all areas of the crawlspace.

Missing moisture barrier plastic

No plastic on the ground

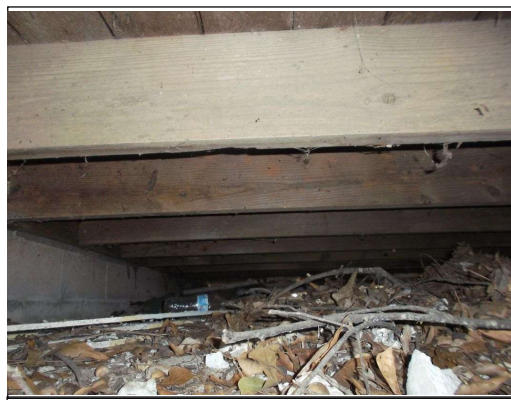
No insulation under room addition
