PROPERTY INSPECTION REPORT

1102 Grand Hill Dr. Alpharetta, GA.

1-21-2021

1003

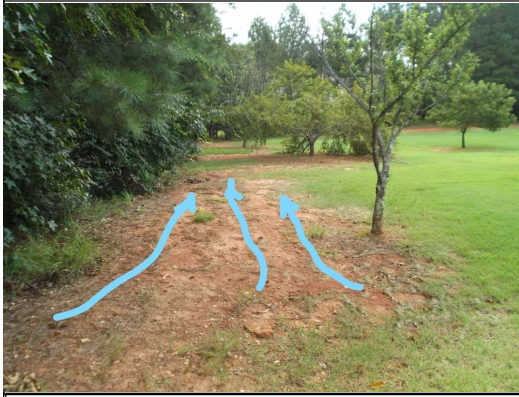
Soil erosion and missing ground cover

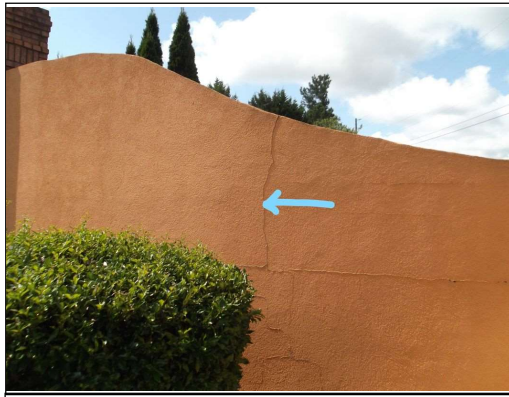
Settling cracks in masonry fence wall

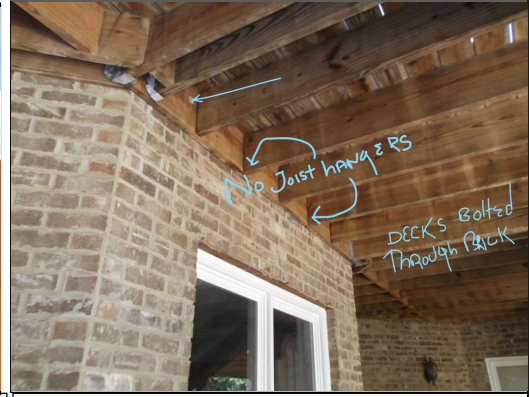
Wood deck has unsafe conditions (deck improperly connected to house, connected to the house through the brick, missing joist hangers), stairs poorly bearing on deck rim joist;

Wood deck unsafe, bolted through brick

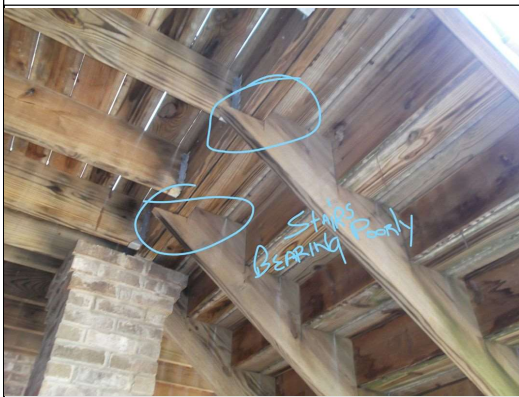
Deck stairs poor bearing on deck rim joist

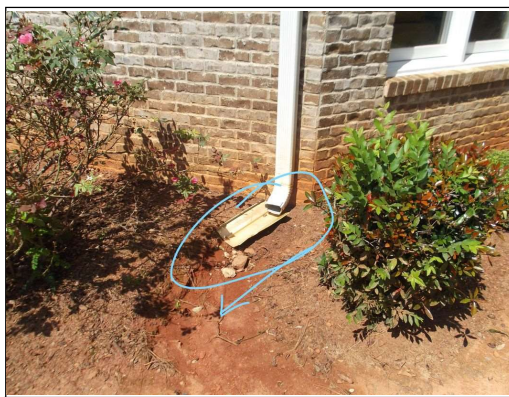
Soil erosion at downspouts

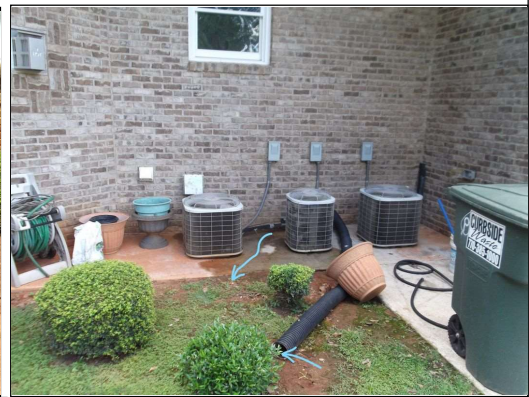
Poor soil slope and missing ground cover

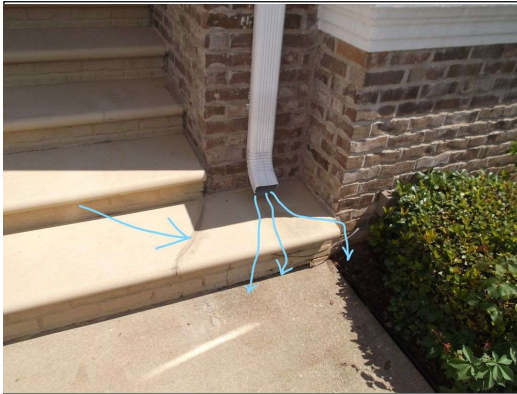
Settling crack front stairs, cause downspout

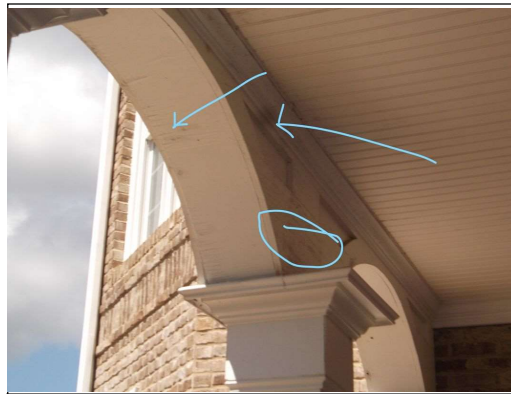
Front porch wood trim water damage

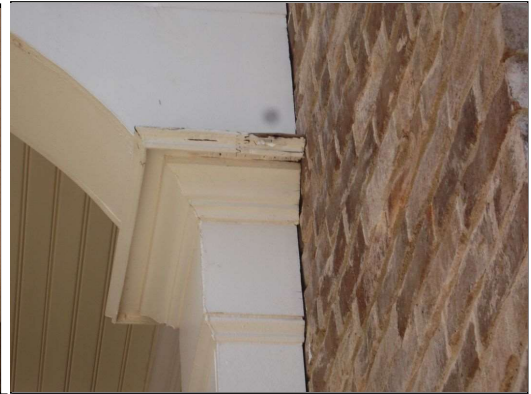
Front porch post water damage

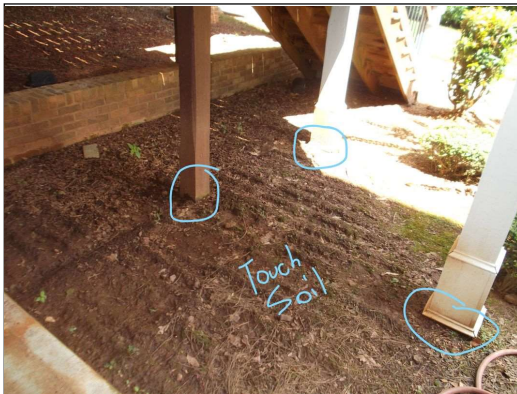
Wood deck support posts contact soil

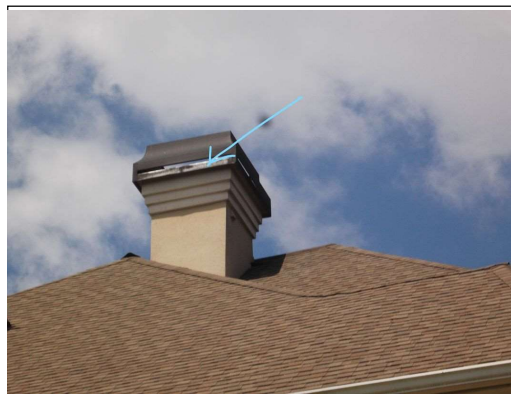
Paint peeling at chimney cap

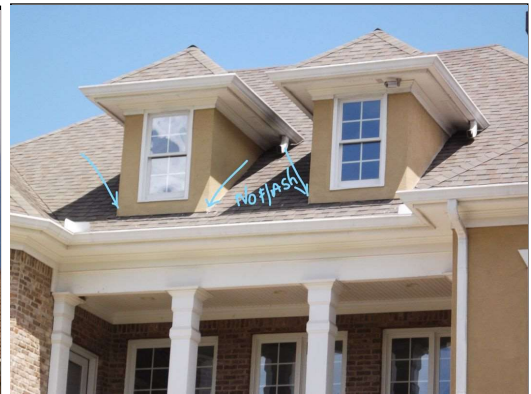
No flashing extending out of stucco

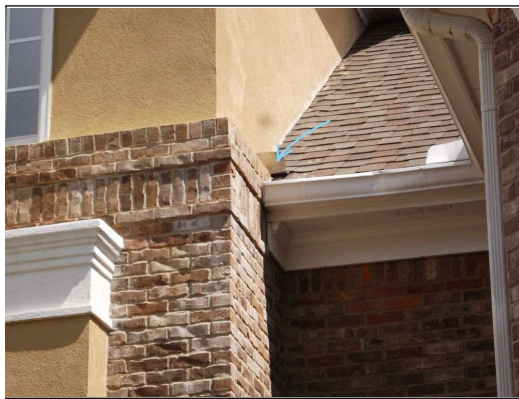
Improper kickout flashing at roof to stucco

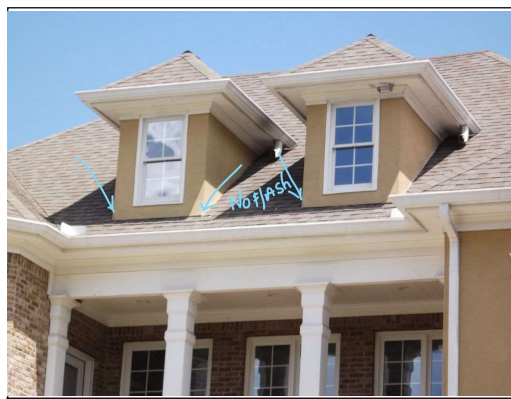
Cannot see flashing extending out stucco

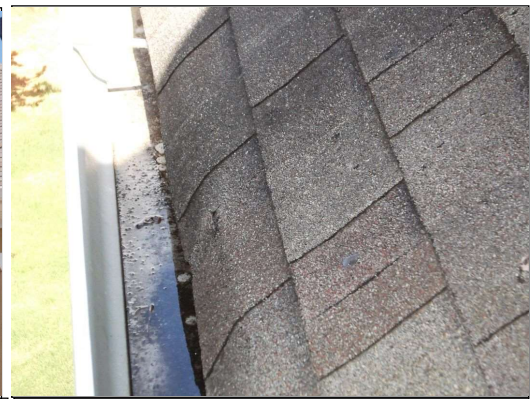
Shingle damage at the rear roof

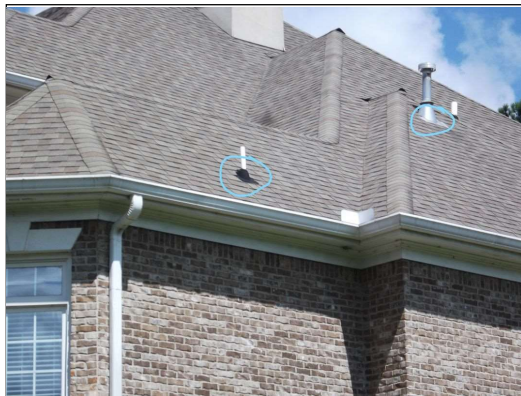
Pipe and vent flashing face nailed on shingles

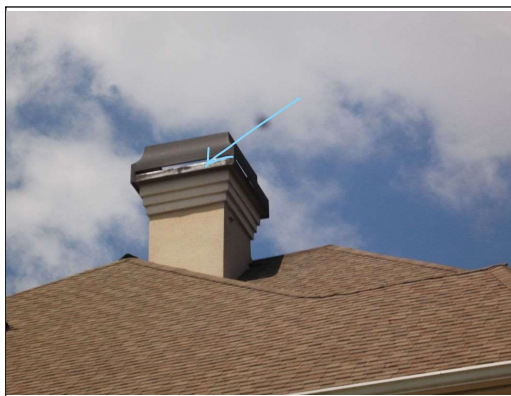
Chimney cap needs painting

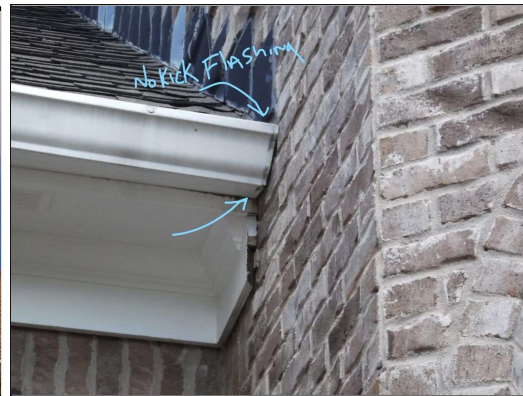
Roof water bypass flashing @ front of house

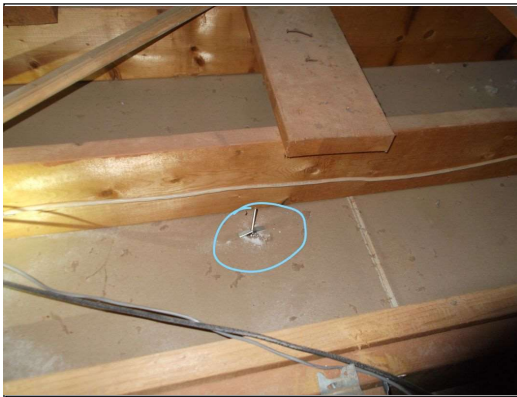
Garage ceiling lights attached to sheetrock

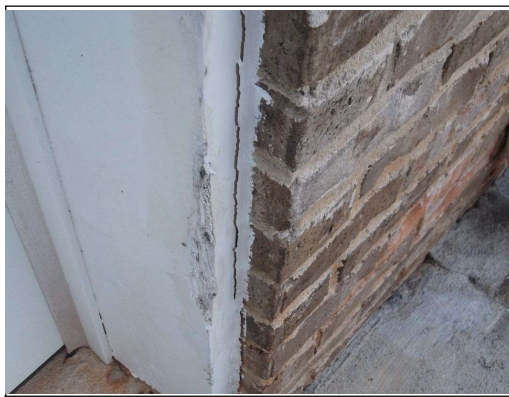
Damage to vehicle door frame

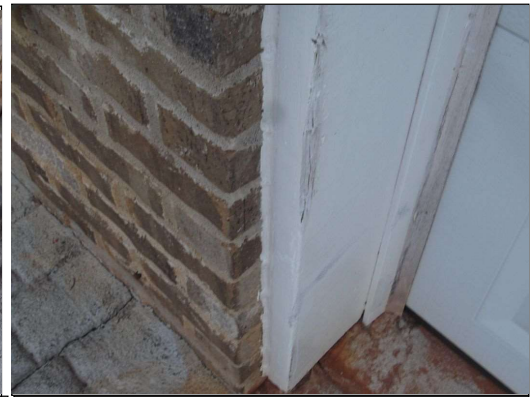
damage to vehicle door frame

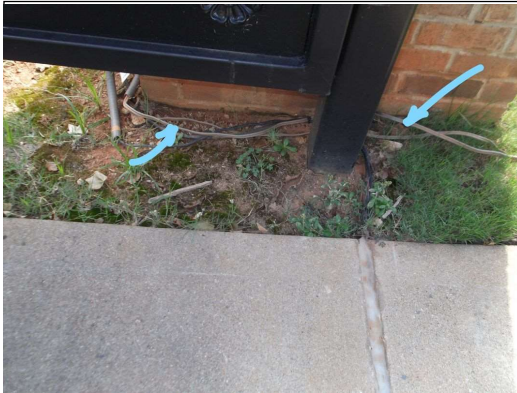
Electrical cables on top of ground at the gate

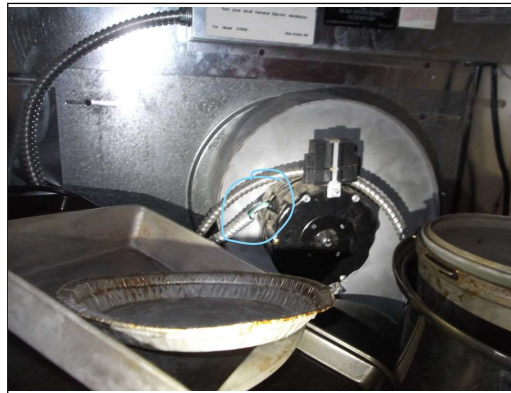
Damaged conduit at the stove exhaust fan

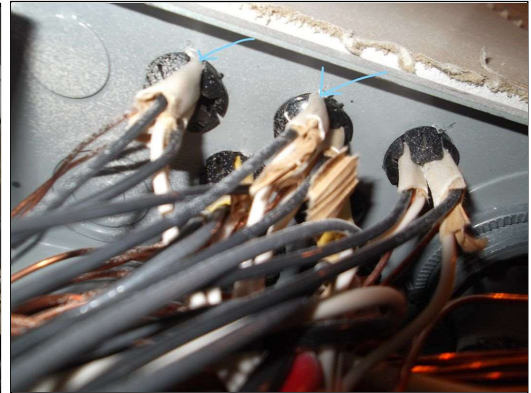
Electrical cables contact sharp metal in panel

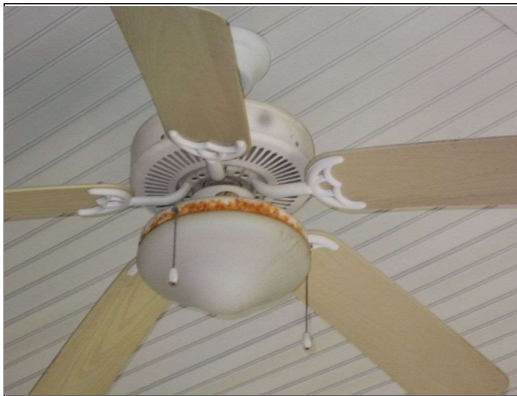
Deck ceiling fans have rust in finish

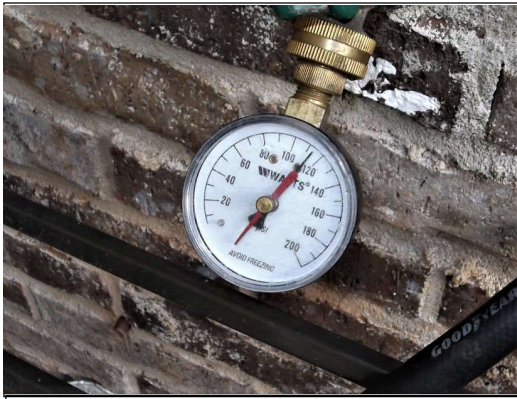
Water pressure 112 is too high

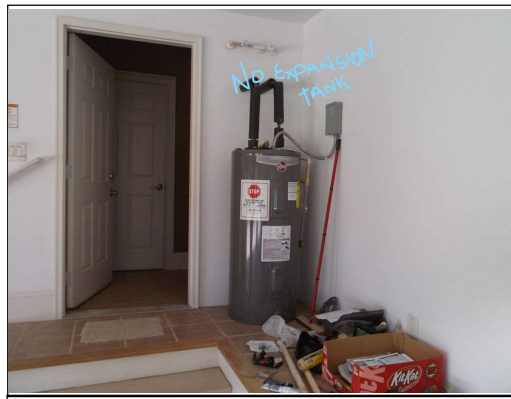
No expansion tank above water heater

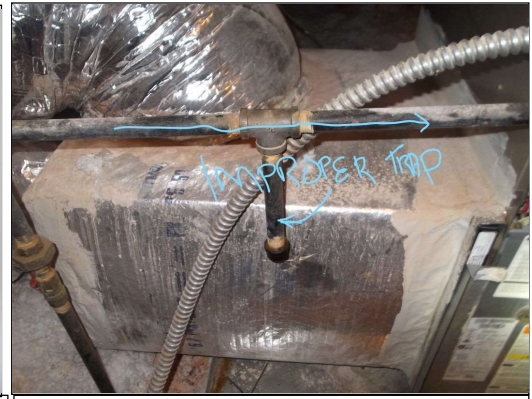
Improper sediment trap in furnace gas pipe

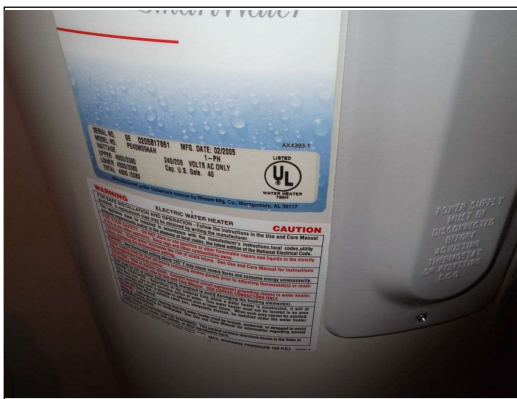
Water heater date 2005 is at end of use

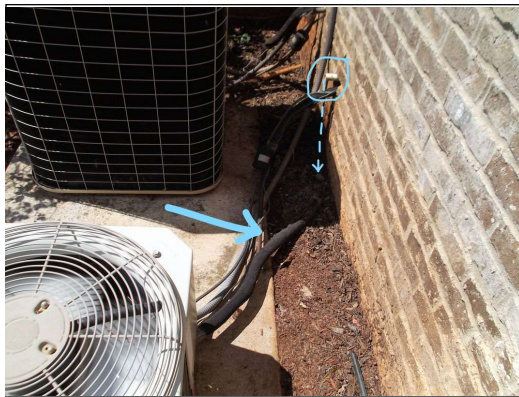
Refrigerant line insulation damaged

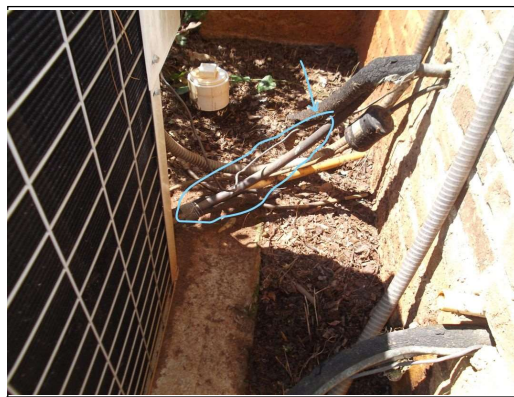
Refrigerant line insulation missing

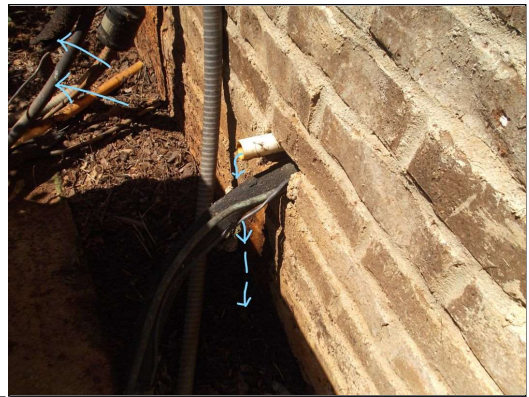
Condensate drain pipe pours at foundation

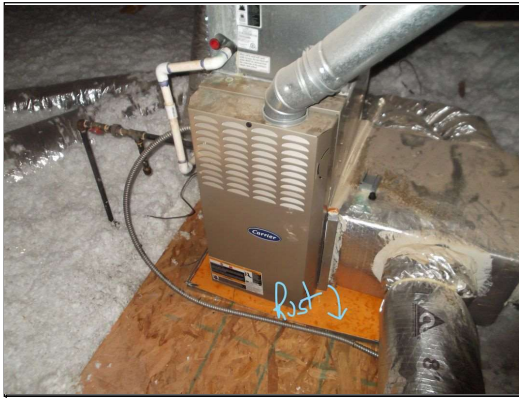
Rust in attic furnace drain pan

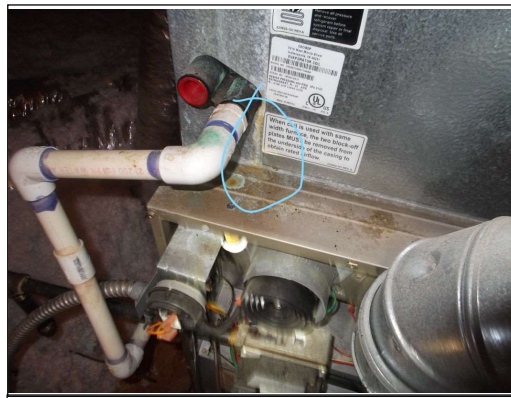
Rust at air handler at attic furnace

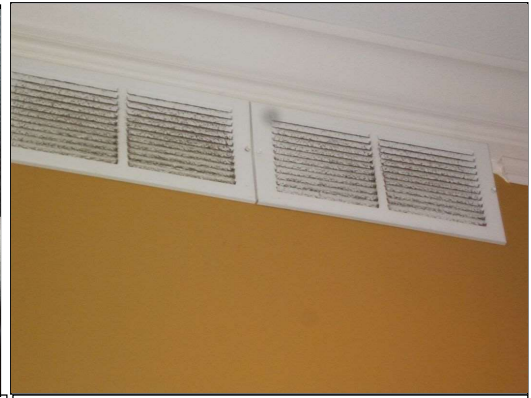
Air duct system dusty

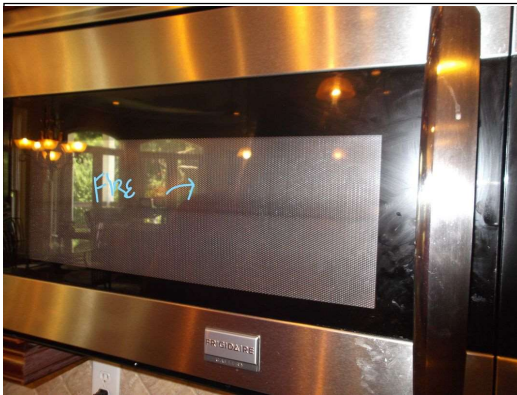
Microwave pops fire

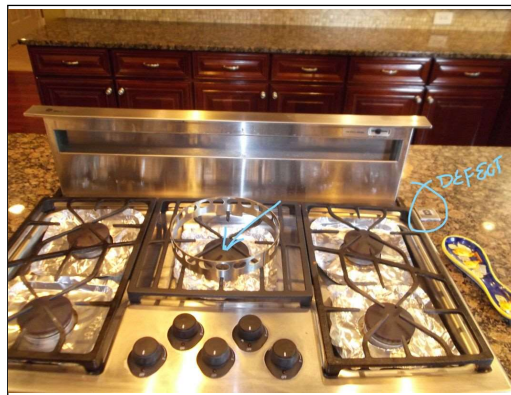
Gas stove center burner defective

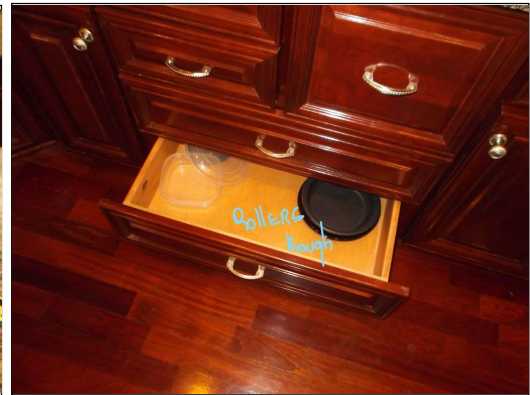
Some cabinet drawers have rough rollers

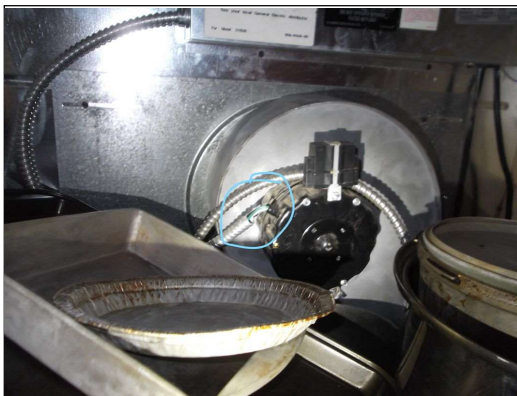
Exhaust fan electrical conduit broken

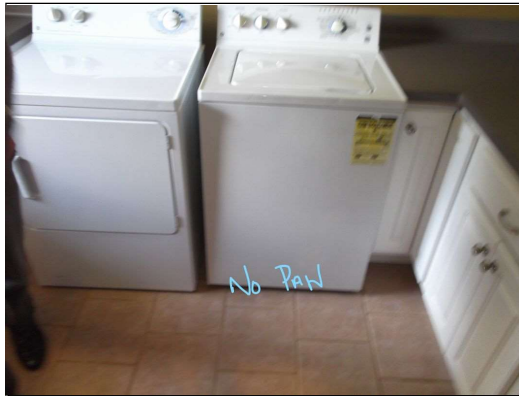
No washer drain pan

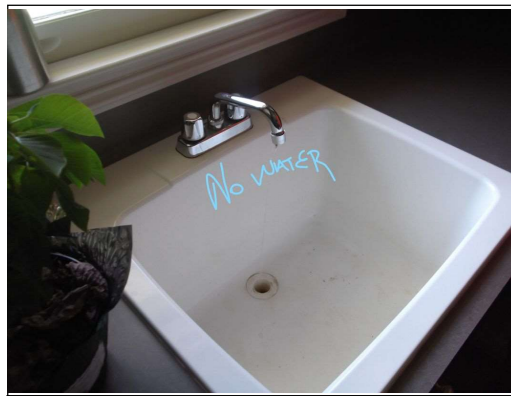
No water at the laundry sink

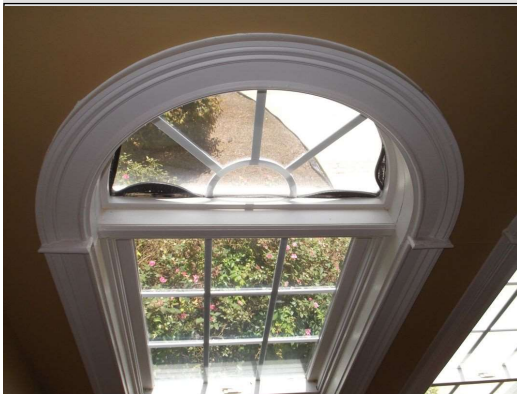
Stairwell window seal defective

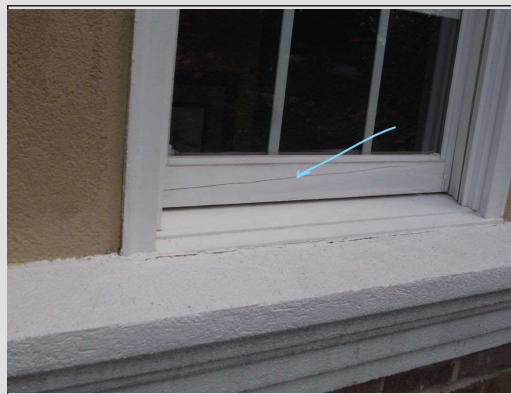
Split in window sash at the front right

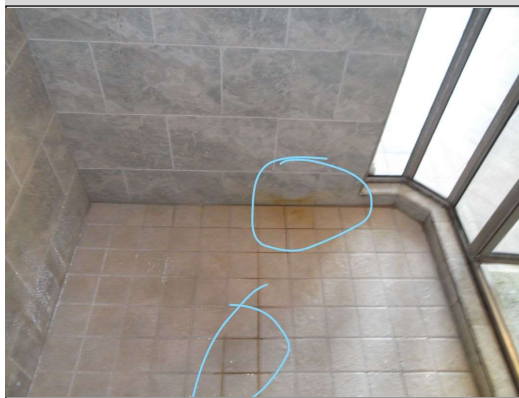
Rust stains in master shower tile

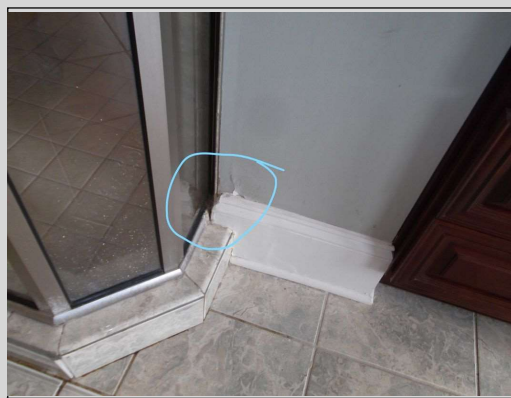
Slight water damage at master bath shower

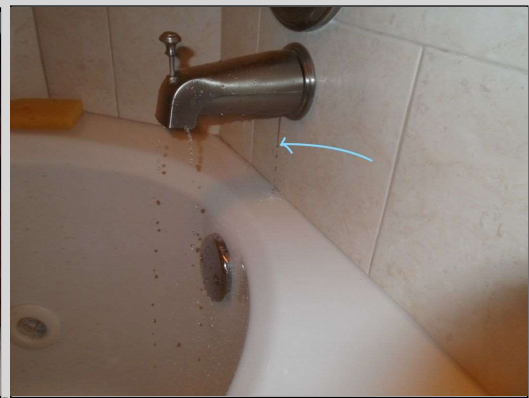
Tub faucet drains water back onto wall

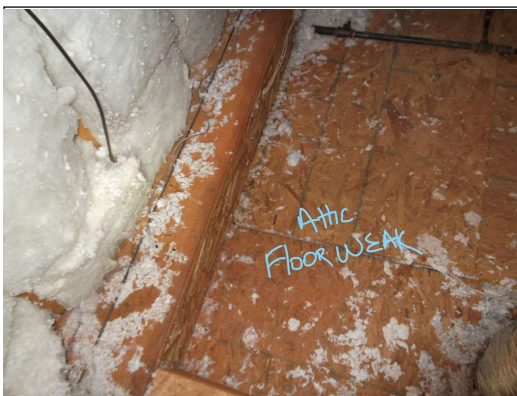
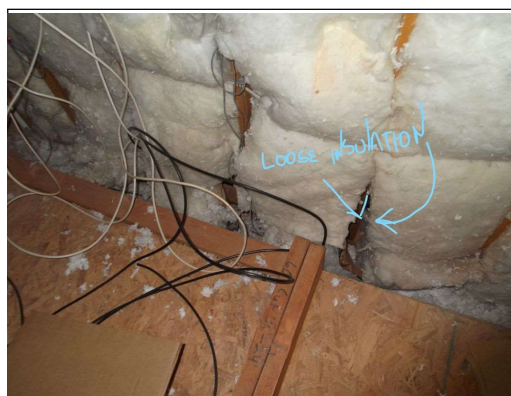
Bedroom door to the attic not insulated (hollow core); section of attic floor loose, not supported and weak; few pieces of wall insulation loose and detaching at the office wall;
