# PROPERTY INSPECTION REPORT

5600 Errol Place NW. Atlanta, GA.

**Inspection Date:**

Sep 10, 2021

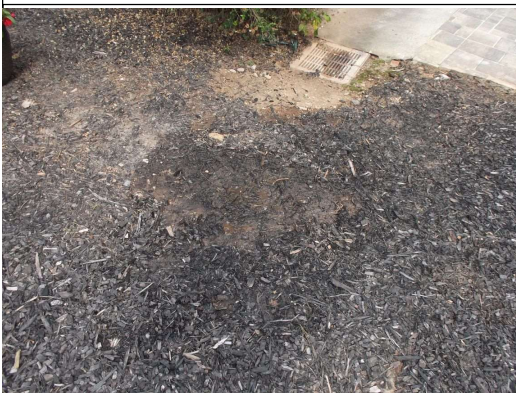
Water in the soil

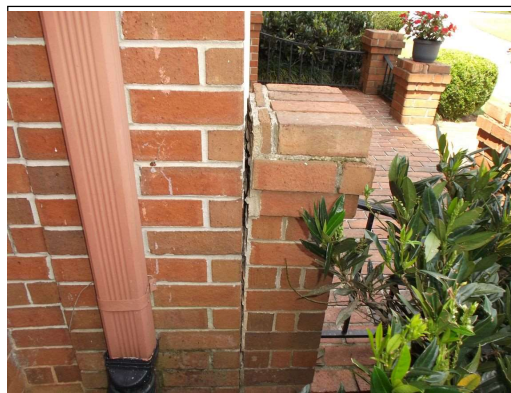
The front porch floor is rotating settling away from the front door. The front porch brick column is pulling away from the brick wall at the left side of the front door. There is missing mortar between the brick at the front porch floor.

Porch pillar rotating away

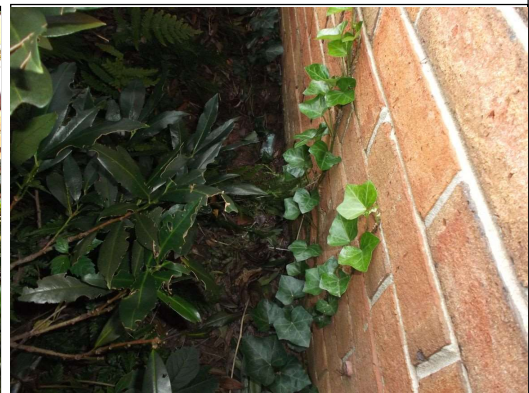
Sink hole at foundation right side of porch

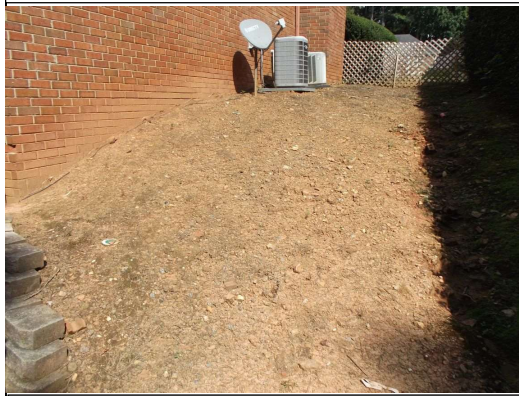
Major soil erosion at left side of house

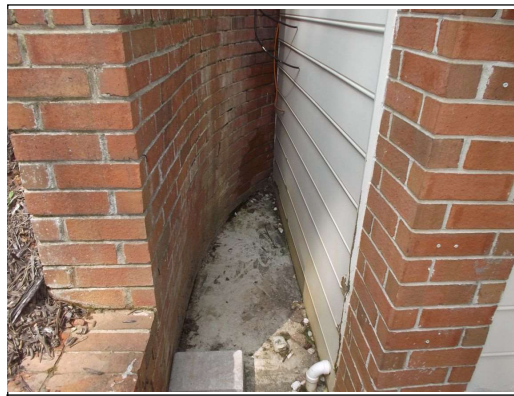
There appears to be wet stains on the brick retaining wall at the basement level where the wall joins the house.

Retaining wall wet?

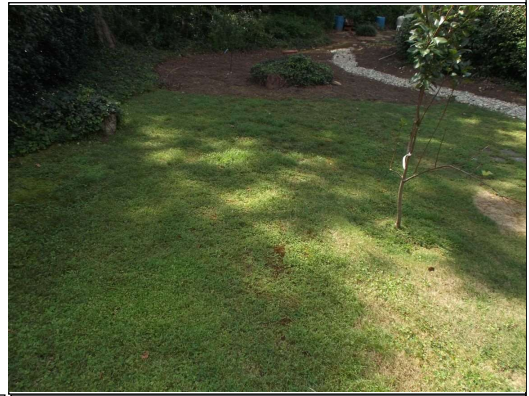
Ground water logged left side rear corner

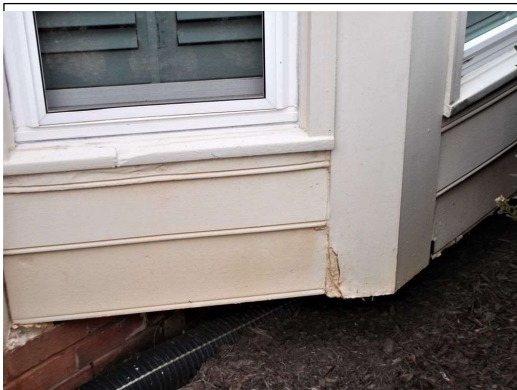
Water damage at front bay window

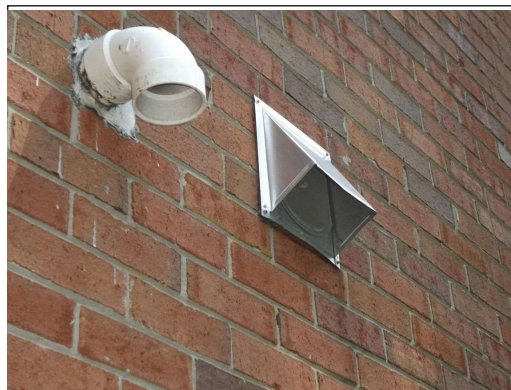
There is a missing bead of caulk around light fixtures and vents attached to the brick at several areas around the house (water can get behind lights and vents and into holes in the walls).

Missing caulk bead at terminals and fixtures

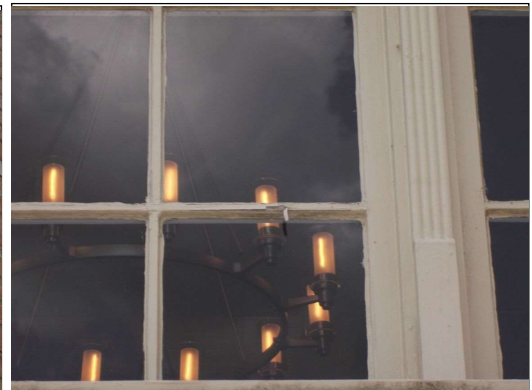
Front foyer window peeling paint and cracked glass at the bottom left. The paint is peeling at the picture window at the rear patio level.

Paint peeling and broken glass

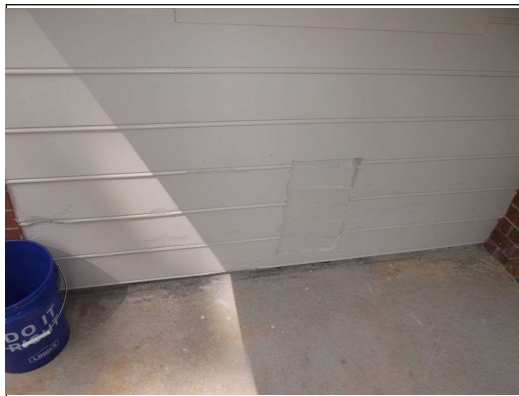
Siding damage at basement level

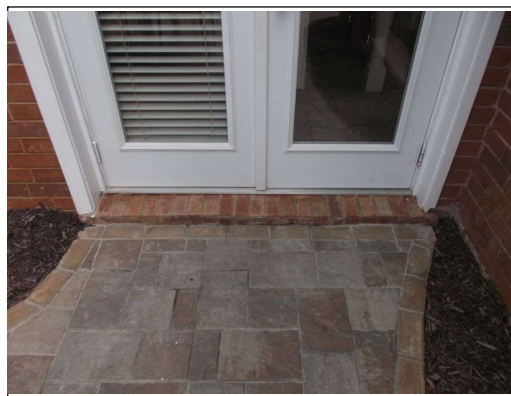
Doors: Missing bead of caulk under the exterior door's thresholds resting on brick and floors can allow air intrusion. The door to the patio has a defective deadbolt lock strike to the plate.

Missing bead of caulk at threshold on brick

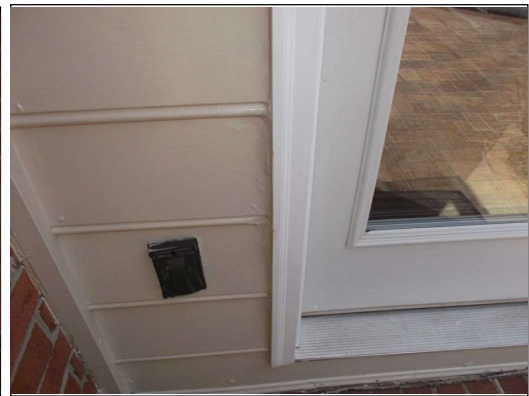
Damaged siding left side of patio door

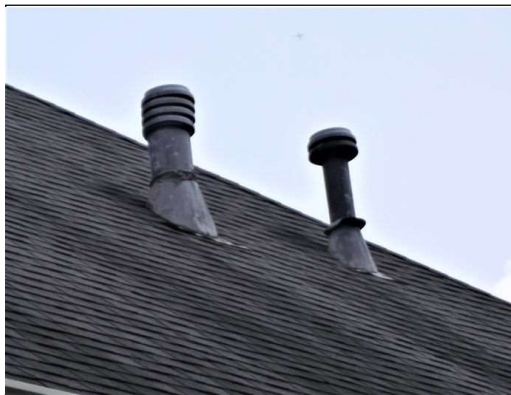
Missing rain collar left pipe/nails in flashing

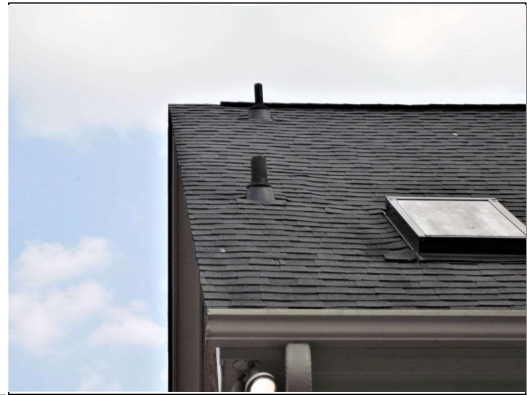
Pipe flashing has been installed on top of the roof shingles at several plumbing pipes (can cause water intrusion over time, nails can extract over time causing leaks, there shall be no exposed nails in the bottom flange of the flashing). Metal vent flashing is installed on top of the shingles at the bottom flange and face nailed. There is a missing rain collar at the gas vent pipe at the right side of the rear roof viewing from the rear yard.

Flashing on top shingles face nailed

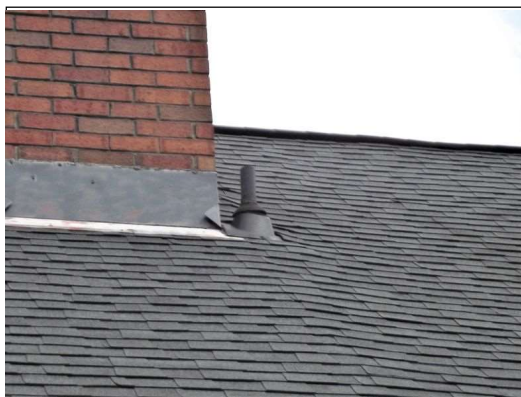
Flashing on side flashing face nailed

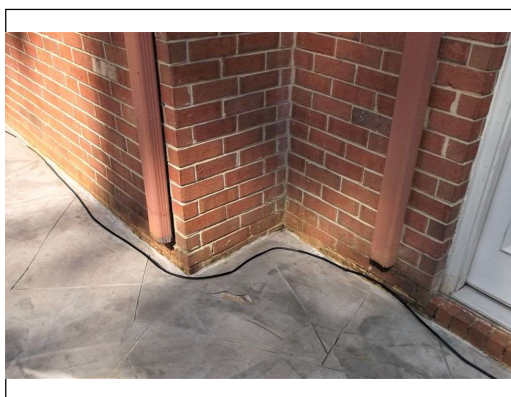
Missing downspout elbows

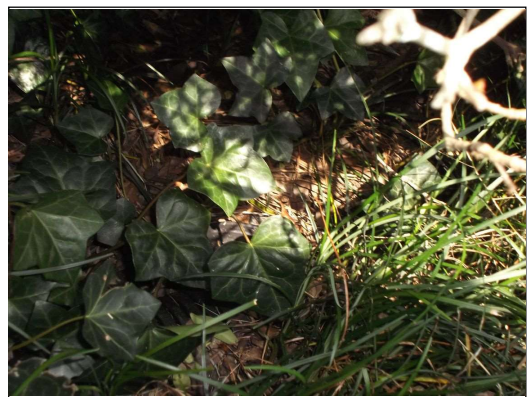
Spout pours in soil at front of house

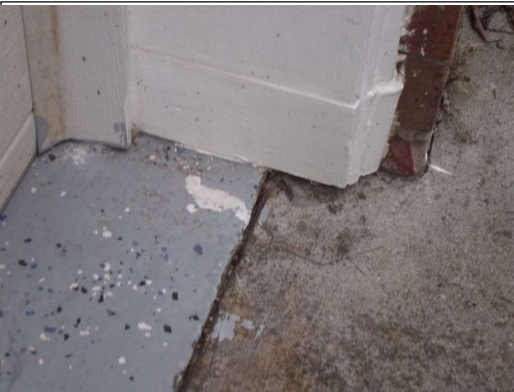
Wood frame contact concrete

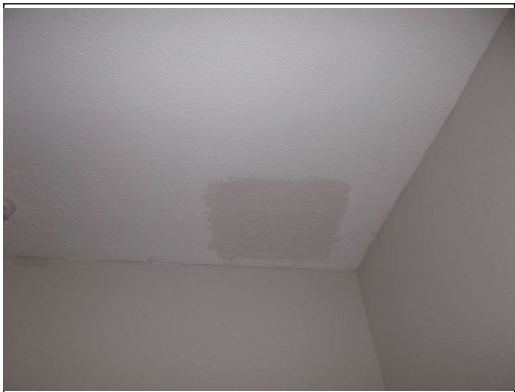
Incomplete ceiling repair

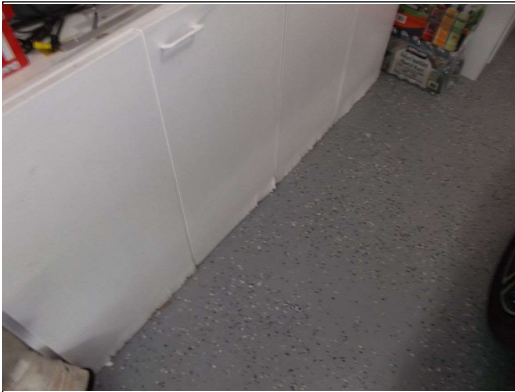
Water damage to cabinet doors

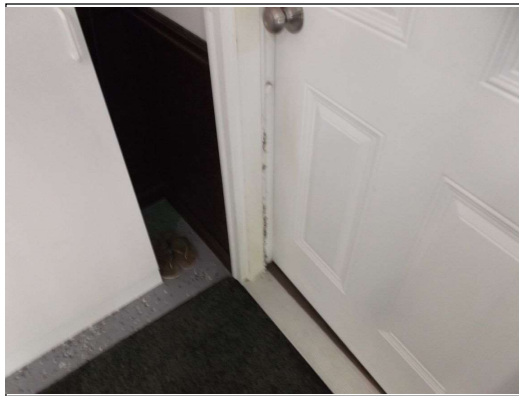
Pet damage at weather strip

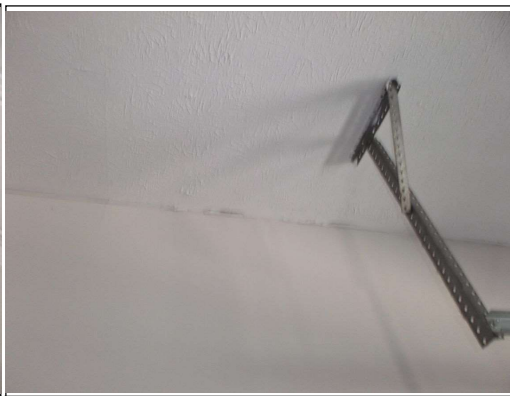
Tape peeling at ceiling to wall

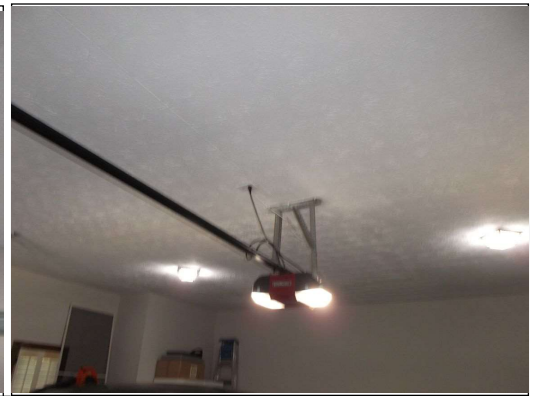
Can see drywall seam repairs in the ceiling at various areas (verify no water intrusion and no water leaks above ceiling)

Can see tape seam repairs

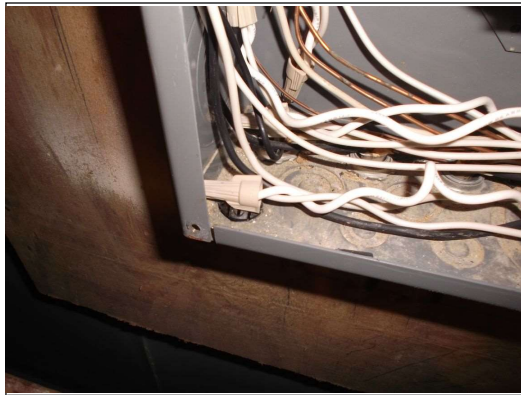
The main distribution panel has a opening in the bottom wall where a plastic bushing remains that can let sparks escape into the wall space. Could not access the small sub panel to the right of the main panel in the basement as the sofa blocked access. There are two hot wires twisted together and only wrapped with electrical tape inside the main distribution panel (should have a wire nut on the connections). At the bus bar in the distribution panel there are several ground and neutral wires grouped together under one screw (can lose contact or weaken contact under certain conditions).

Opening at black bushing in bottom of panel

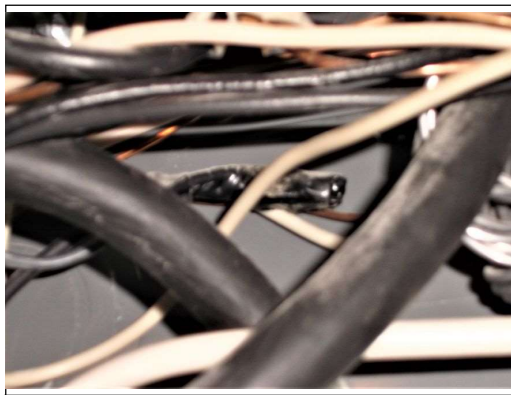
Hot wires joined &amp; wrapped with tape in pane

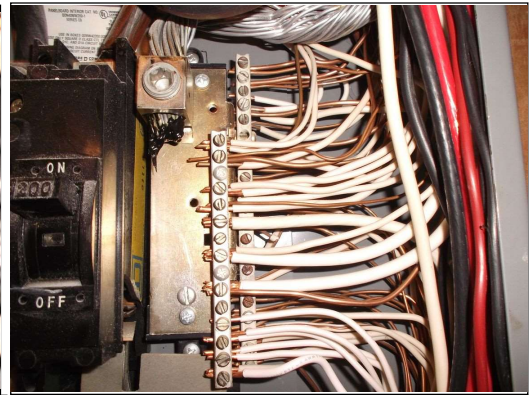
Conductors grouped together

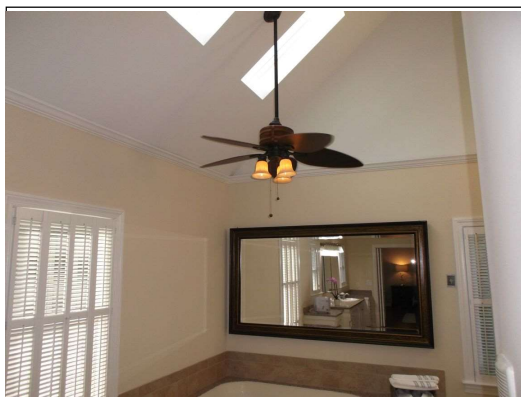
Master Bath: There is a ceiling fan installed over the jetted tub that is considered a safety hazard (luminaries or lights must be at least 8 feet above the tub area where the light is within 3 feet away from the tub).

Ceiling fan located over master tub too close

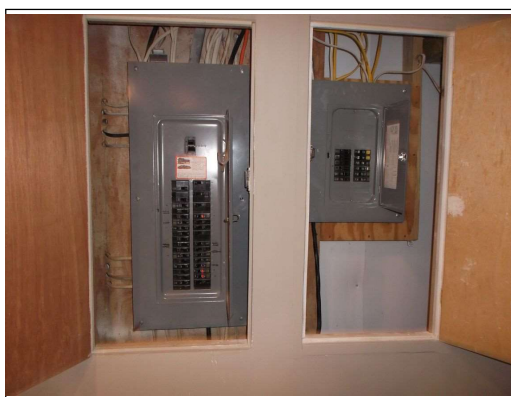
Sofa blocked access to sub panel in wall

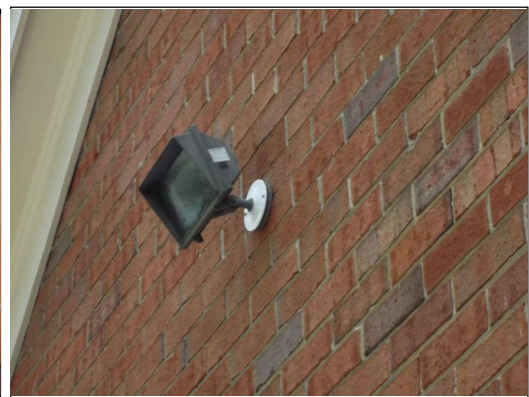
Several light fixtures attached to the exterior brick veneer are missing a bead of caulk and can let water get behind the fixture and into holes in the walls.

Missing bead of caulk around light fixtures

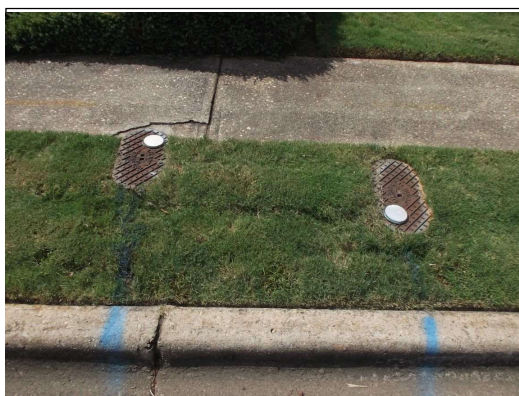
2 water meters at street

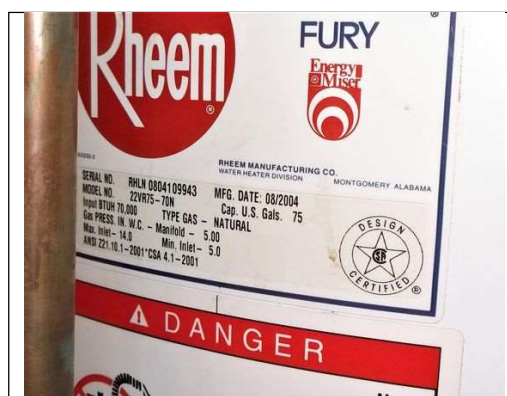
Water heater date is 2004 which would be at last years of good use (water heaters have a good life of 11 to 12 years depending on amount of hot water used every year. The expansion tank appears to be supported on the water pipe above water can cause damage to pipes under certain conditions and needs independent support.

Water heater 2004

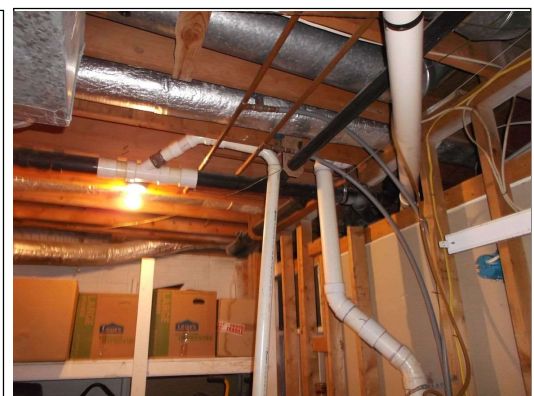
ABS black water pipe

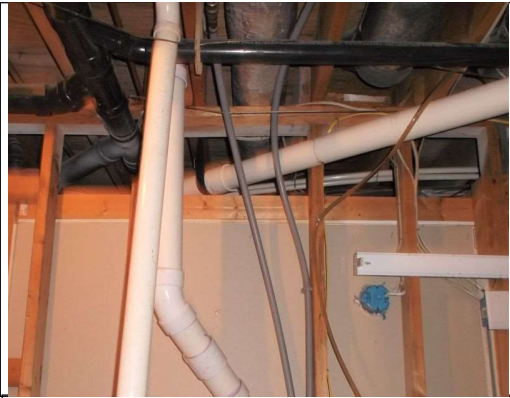
Polybutylene water pipe

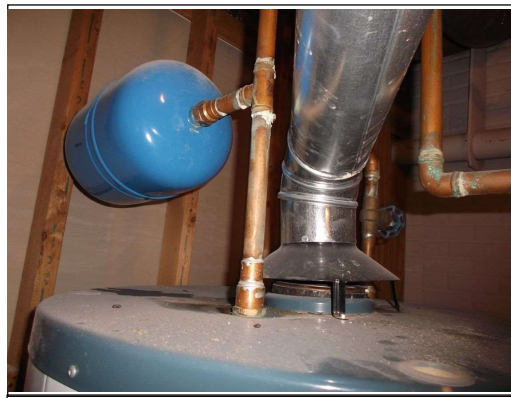
Tank rest on pipe/copper and steel join

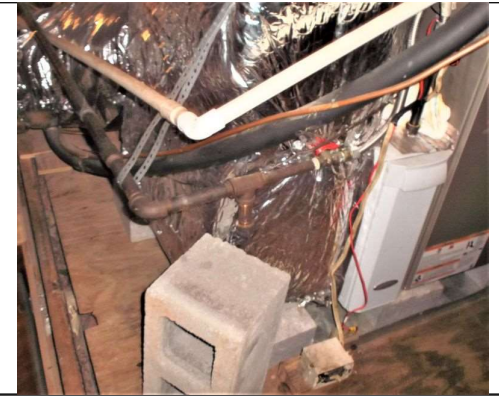
Improper sediment trap in gas pipe

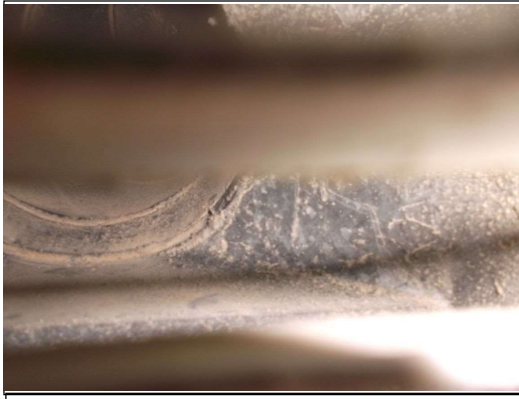
Air return duct dusty

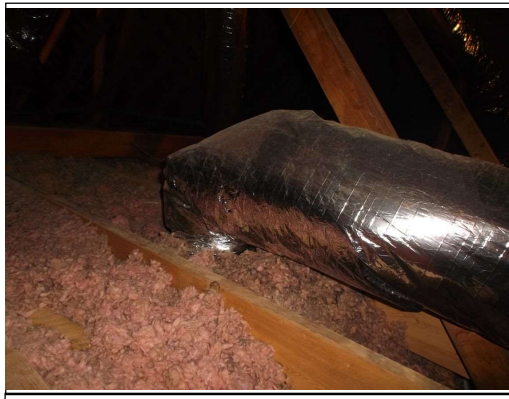
Partially twisted and crushed duct

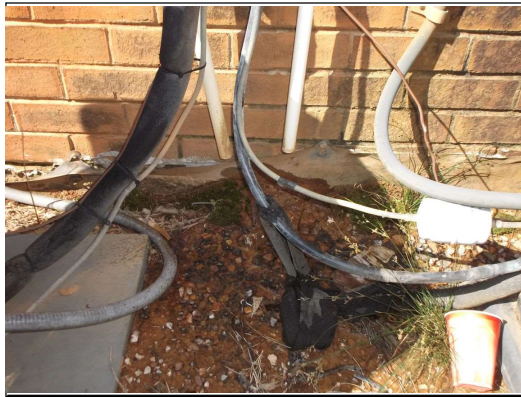
Missing refrigerant line insulation

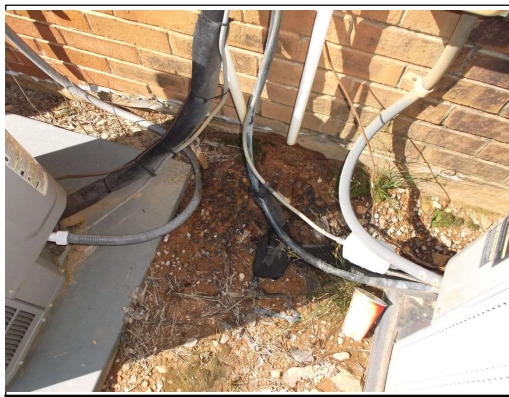
Condensate pipes pour at the foundation

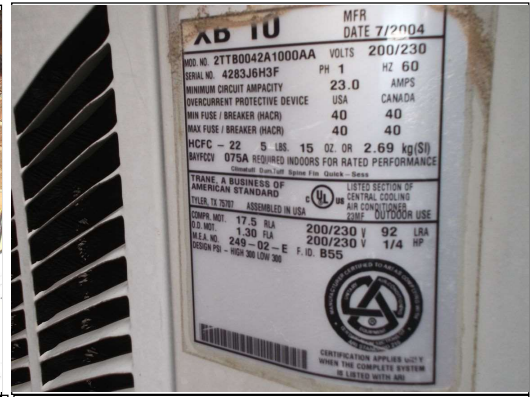
One AC unit older model 2004

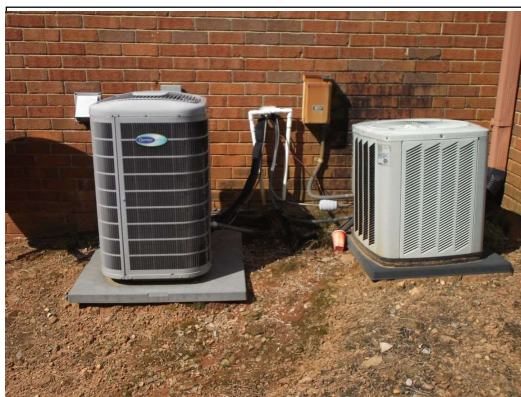
The AC units appear to have been originally installed on the sunny side of the house which can cause units to work harder in the hottest parts of the summer (AC units should be on the shade side of the house).

AC units located on the sunny side of house

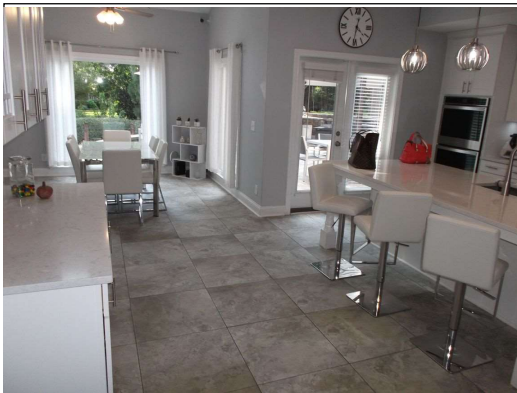
Floor slopes to rear exterior wall

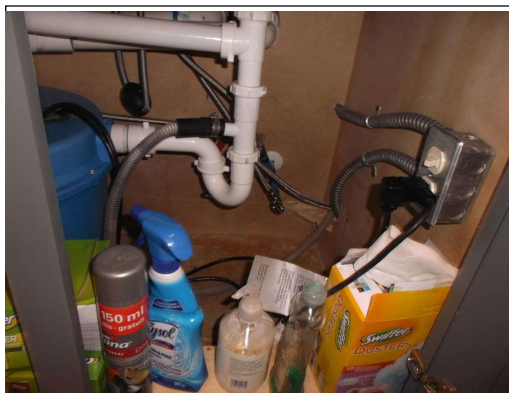
Basement kitchen washer drain pipe is not high looped up to the counter and back down to the sink drain pipe before connecting can let waste water back into the dishwasher drain pipe.

Basement dishwasher drain pipe improper

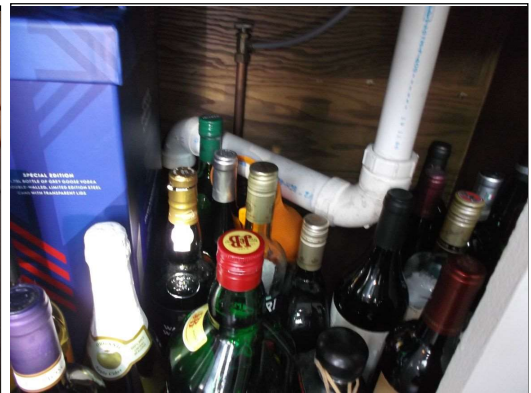
The main bar sink drain pipe has no trap and vent in the pipe system (can allow water vapor, sewer gas, methane gas and radon gas into the house under certain conditions

Main floor bar sink drain has no trap nor vent

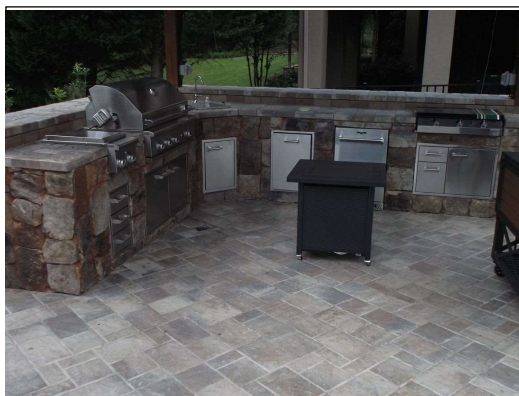
Floor sloping towards the cabinets

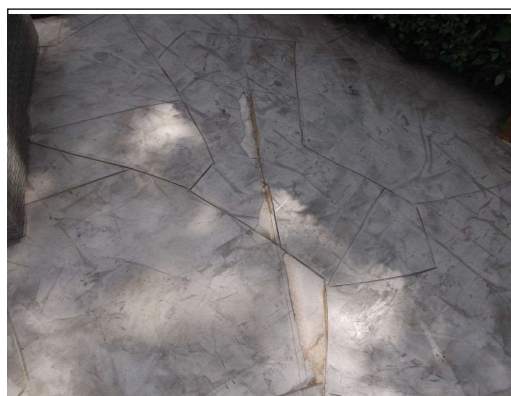
The outdoor kitchen floor slopes toward the sink cabinets and exterior retaining wall. The outdoor kitchen floor at the open area is rotating away and has movement cracks in the floor. The retaining wall appears to be rotating away also (verify there is a proper foundation under the outdoors kitchen floor, verify there is no soil erosion or movement issues under the floor)

Outer kitchen floor settling, cracking, rotating

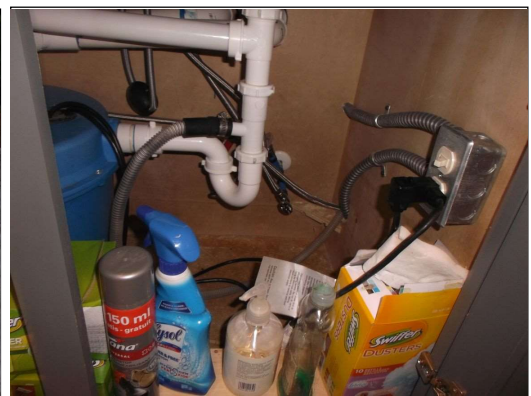
Basement dishwasher drain pipe not hi-looped

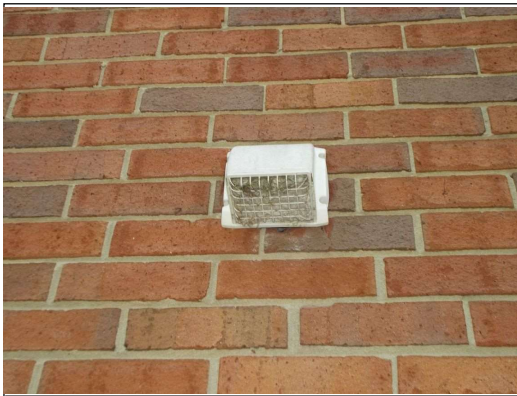
The dryer vent terminal is clogged with lint at the exterior wall above the garage can cause dryer to over heat (dryer vent terminals should have a metal terminal and no grill cover).

Improper dryer vent and clogged with lint

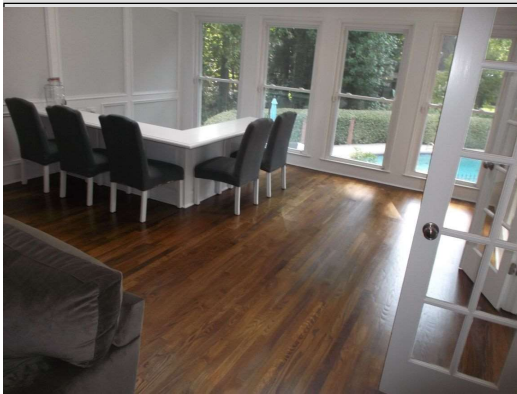
Floor slopes to exterior wall and left corner

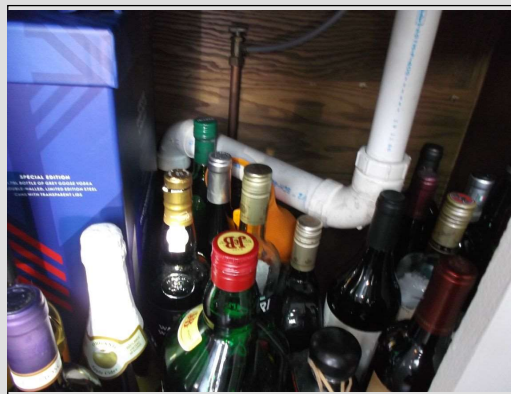
Improper bar sink drain pipe

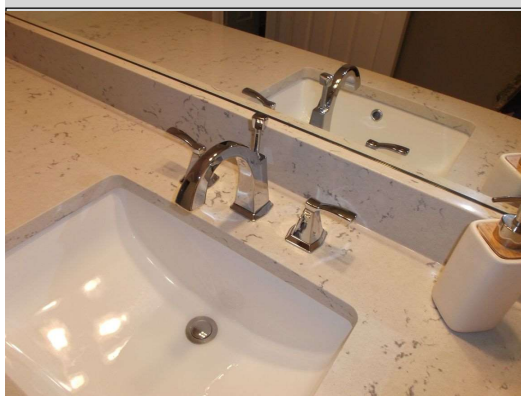
Sink faucet loose at the base

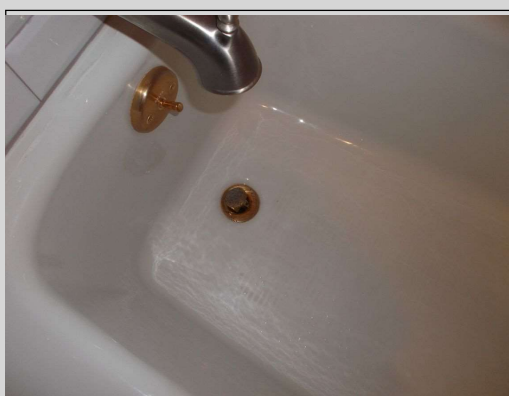
Tub stopper appears defective

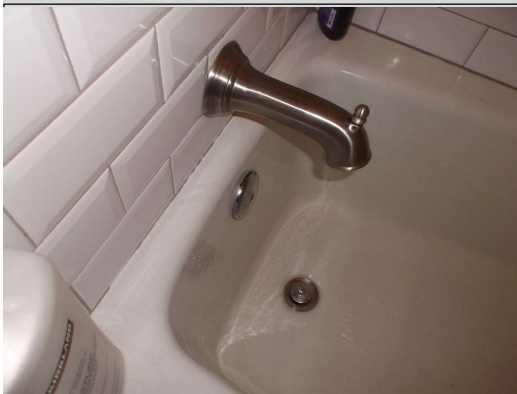
Tub overflow cap upside down

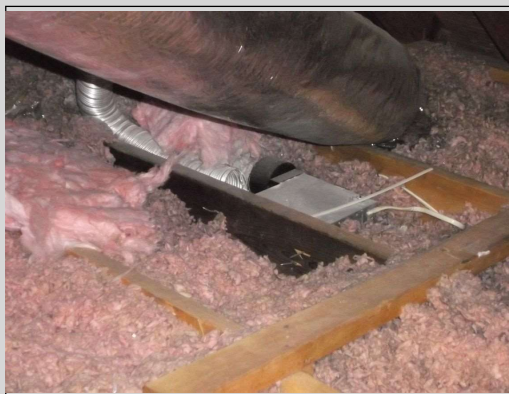
Exhaust fan duct disconnected

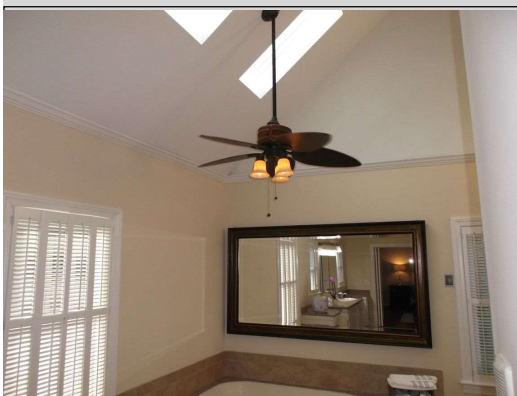
Ceiling fan closer than 8 feet from tub

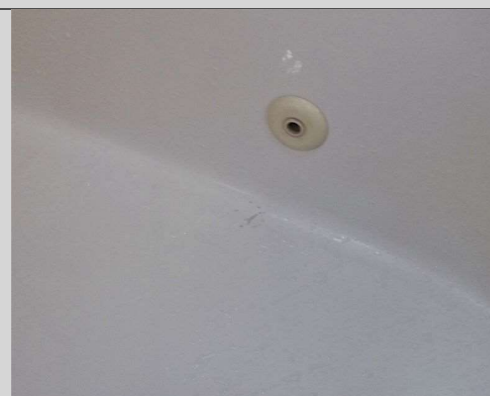
Master Bath: The jetted tub has cracks in the fiberglass finish (this condition can allow water intrusion and cause water damage to the sub structure of the tub walls). Exhaust fan has major vibration when operating over the toilet area. Toilet is not water saver.

Cracks in tub fiberglass at floor

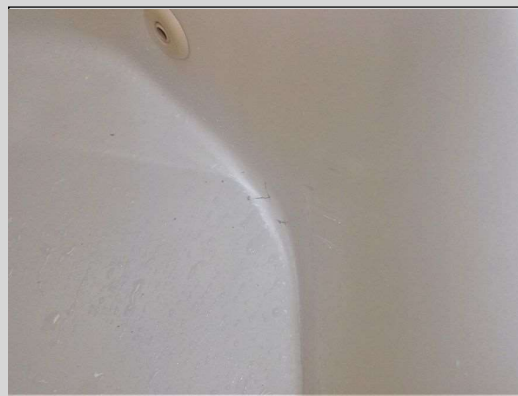
Cracks in fiberglass corner...

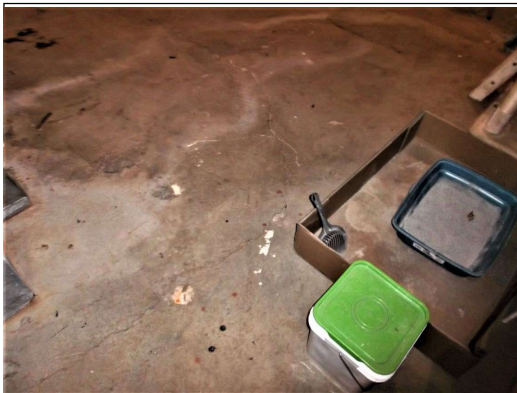
The concrete floor in the utility room has moderate cracking.

Moderate cracks in utility room floor

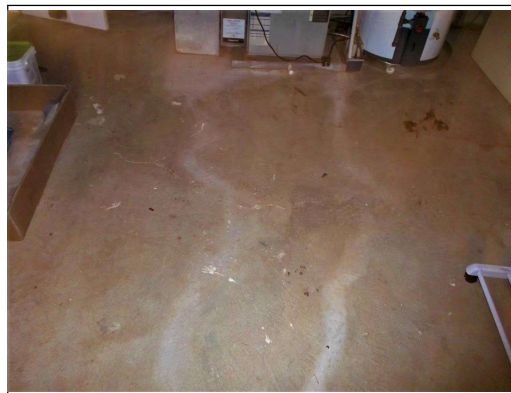
Stains on floor and cracking

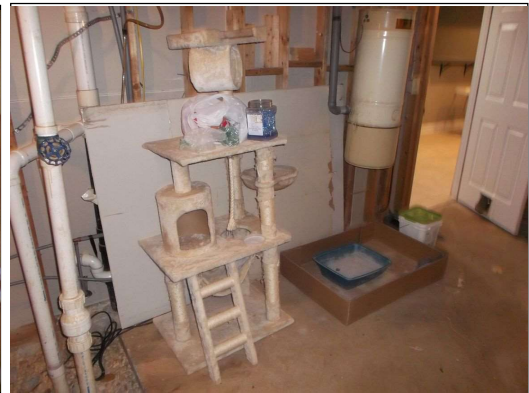
Cat play stand and cat litter box?

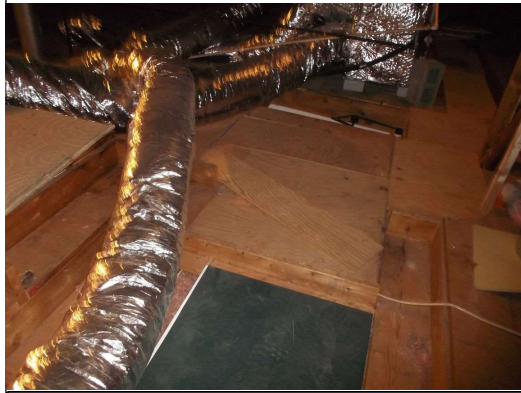
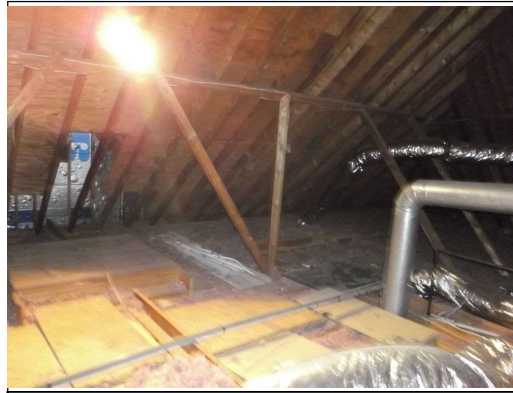
Flooring weak and poorly placed

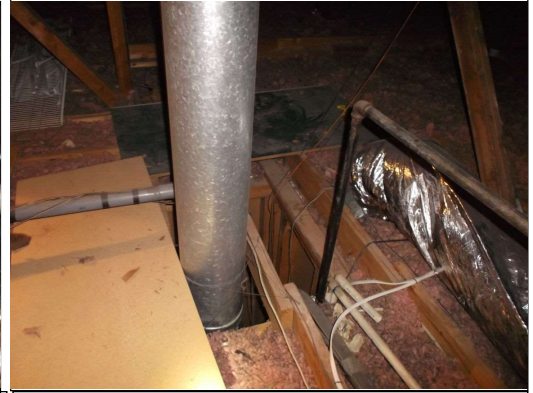
Open chase

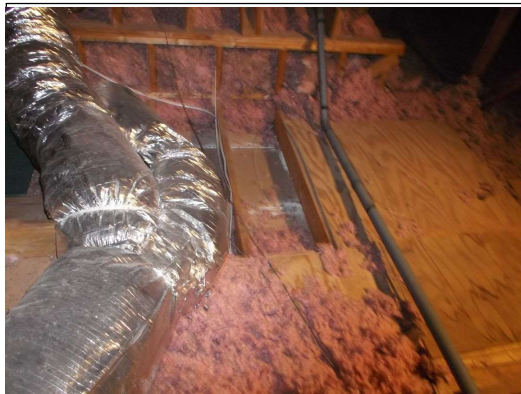
Missing ceiling insulation
