Property Inspection Report

7150 Lullwater Rd. Cumming, GA.

Inspection Date:

Apr 6, 2021

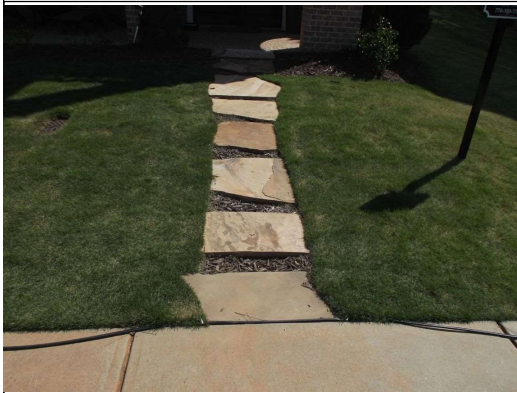
The walkway to the front porch is made of flat stones spaced apart and one is heaving near the public sidewalk can be a trip hazard for some. Main walkways shall have a smooth path to the house..

Stepping stones can be a trip hazard

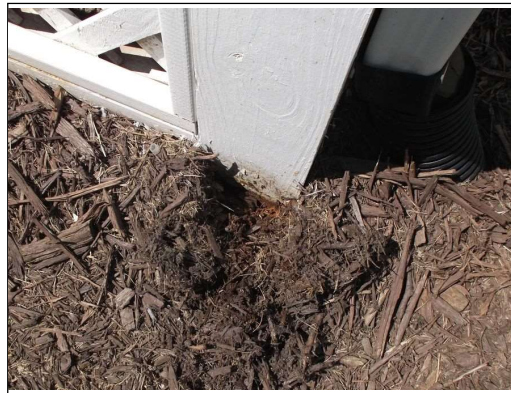
Front porches wood ceilings need pressure wash as a minimum. Rear wood deck support posts in contact with soil can rot (there shall be concrete around posts for protection from soil contact); the soil slopes to the rear of the house between the garage and the deck area; soil erosion at the rear yard;

Rear deck posts contact soil

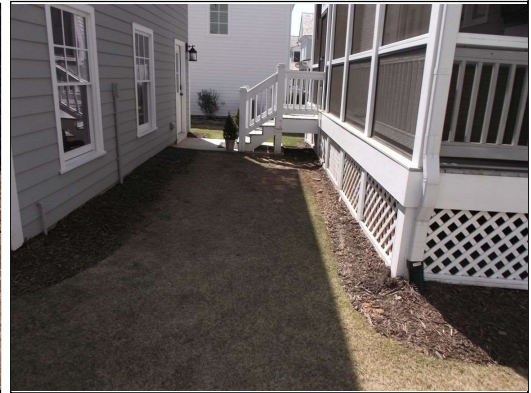
Rear yard slopes toward the rear porch

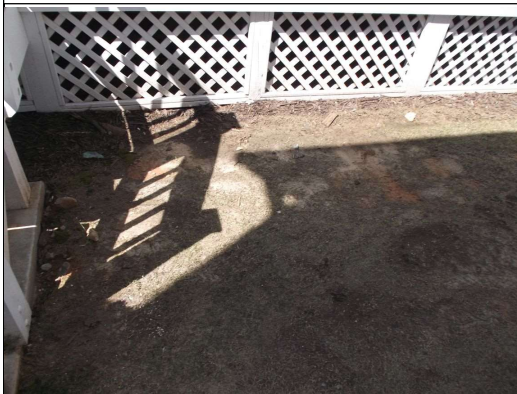
Soil erosion at the rear yard near the porch

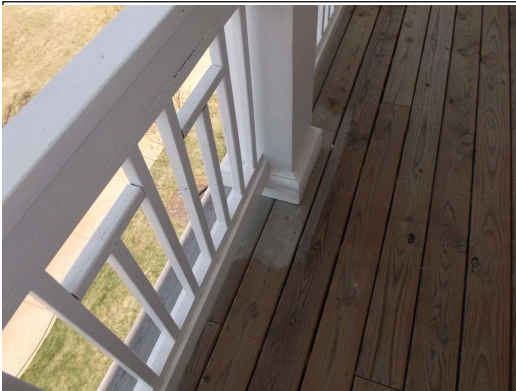
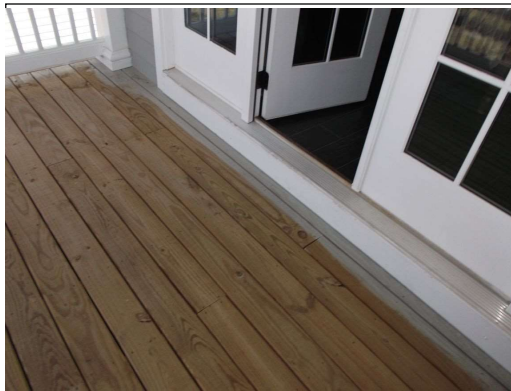
Painter's residue on 3rd level floor

Painters residue on 3rd level floor

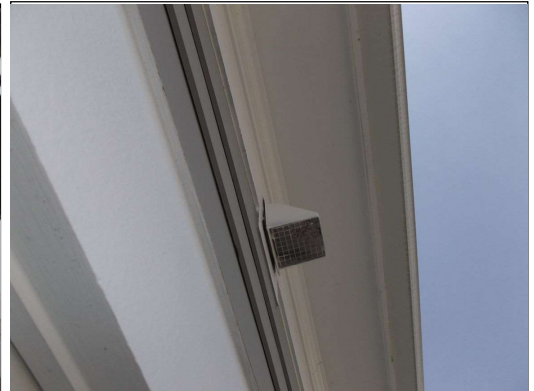
Missing caulk bead @ exhaust vents on wall

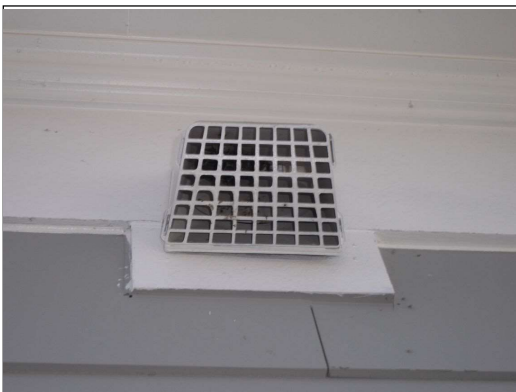
Wasp nest inside exhaust vent terminal

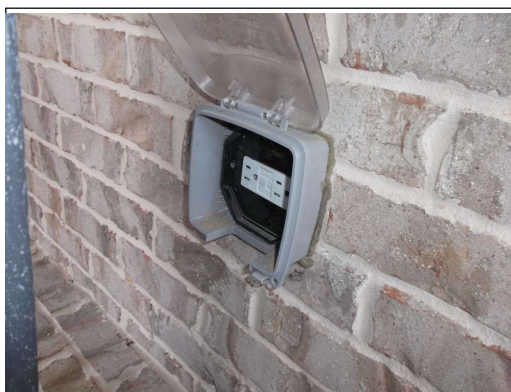
Could not plug into lower front ext. outlet

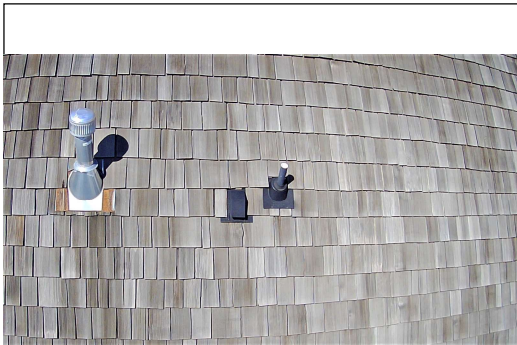
Pipe and vent flashing is installed on top of shingles face nailed (may or may not cause leaks over time)(there should be shakes or shingles on top the sides of flashing and nails covered with shakes or shingles);

Flashing on top of shingles face nailed

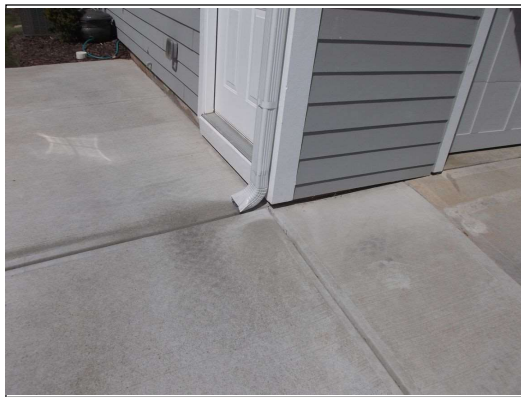
One garage downspout elbow crushed at the entry side corner and one downspout pour into the soil at the right side can cause floor settling (route downspout to not pour into the soil at the side of the garage; there is dust on the air return grill cover (verify air ducts do not need cleaning)

Downspout crushed left corner of garage

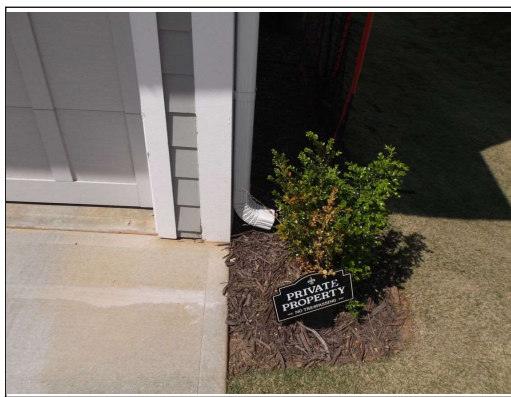
Downspout pour into soil right corner

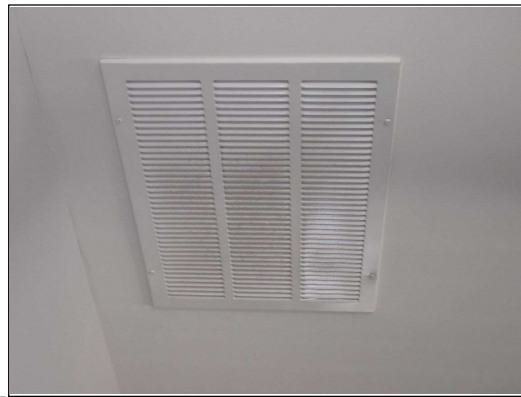
Return register grill cover has dust

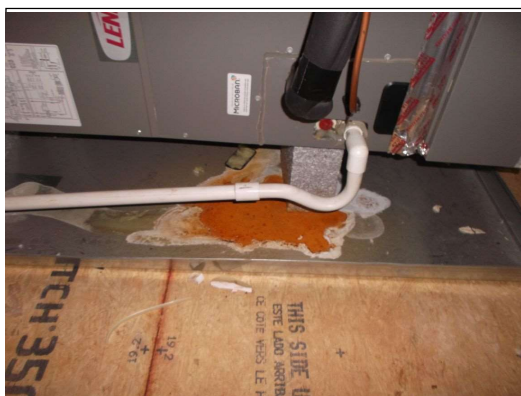
Calcium and rust in furnace drain pan

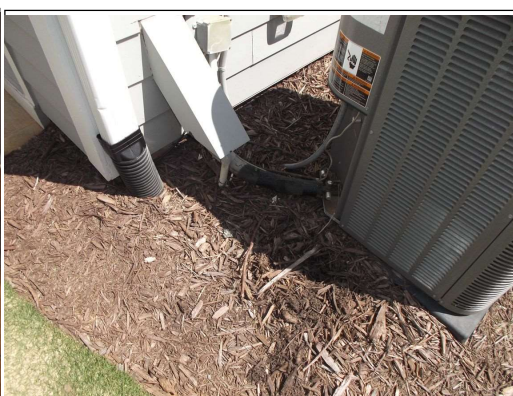
Condensate pipe under the soil and or mulch

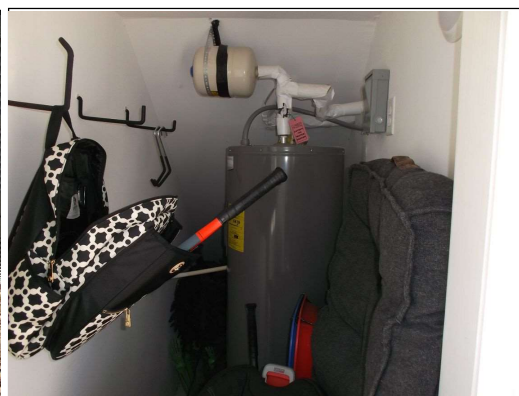
Access to water heater blocked/belongings

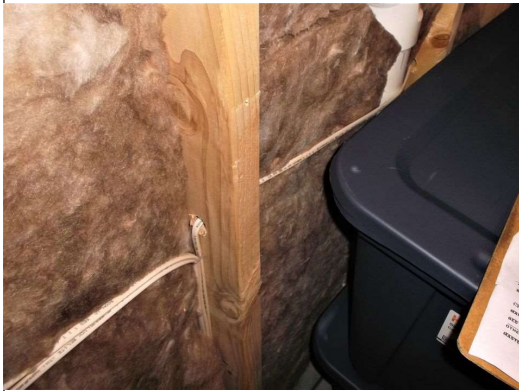
There is a electrical cable under extreme stress or pulled very tight through holes at the wall at the utility room in the basement below the distribution panel to the right; front lower porch exterior outlet was restrictive to plug into when tested;

Electrical cable under stress at utility room

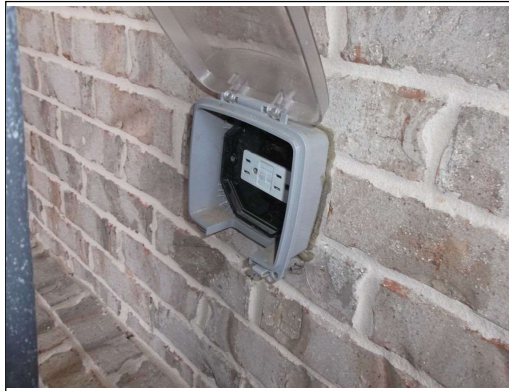
1st level exterior outlet restricts plug in

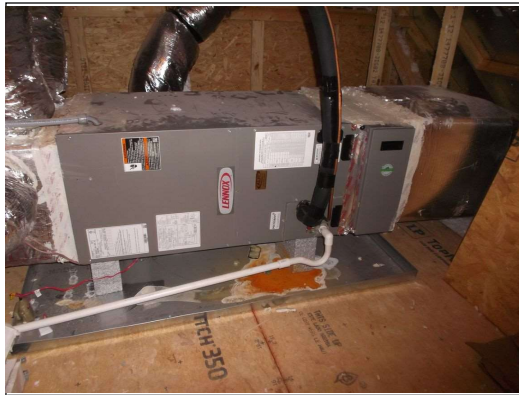
Garage furnace has rust in the drain pan (verify cause and repair if needed); basement furnace has rust and or debris in the drain pan(verify cause and repair if needed); there are water stains on the attic floor at the front corner of the furnace drain pan (verify cause). It is advised to have all furnaces checked for conditions and or have seller verify conditions have been addressed.

Rust in garage furnace drain pan

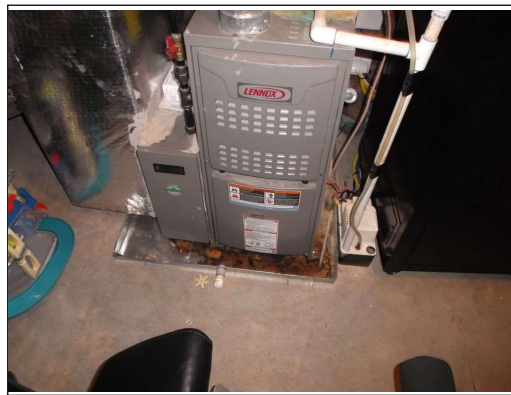
Rust or debris in basement furnace drain pan

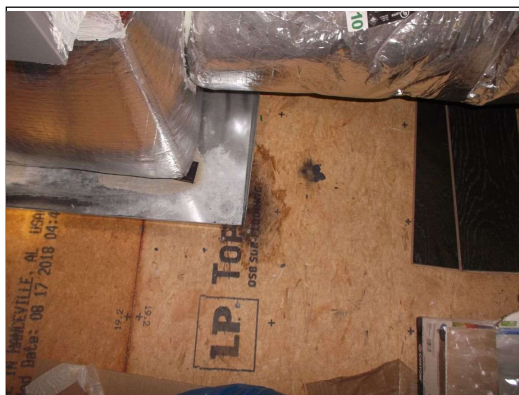
Dry water stains on attic floor at drain pan

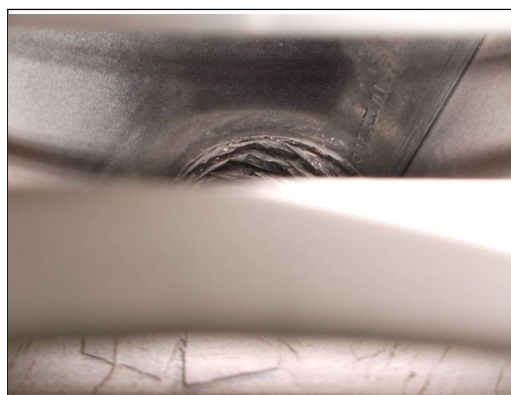
Slight dust in return air duct 1st floor

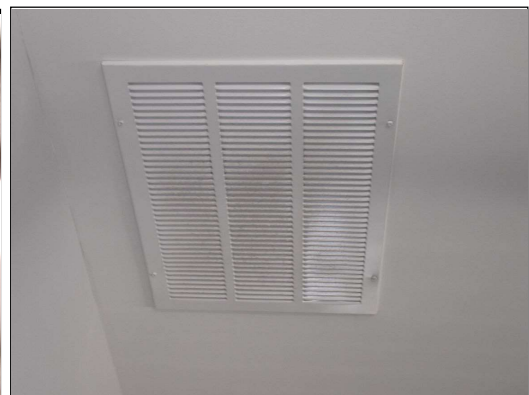
Dust on garage return register grill

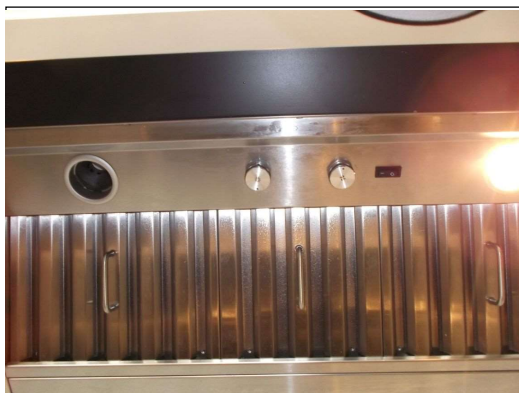
Left light out on the exhaust hood

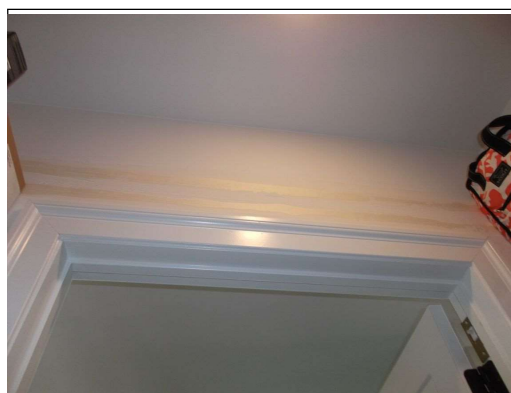
Incomplete finish at drywall over pantry door

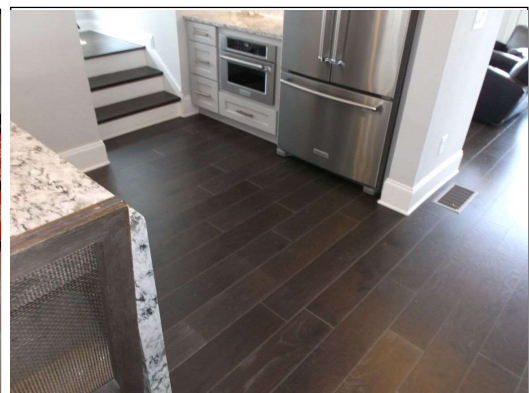
Kitchen floor has slight slope to microwave

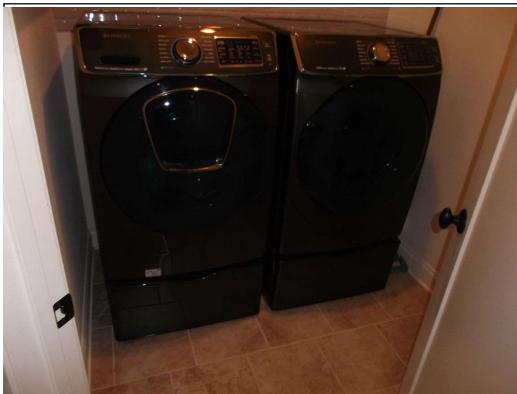
No washer drain pan installed at laundry room;

No washer drain pan installed

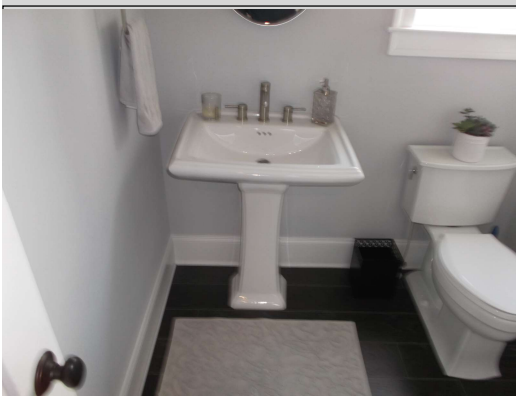
1/2 bath pedestal sink bowl slopes to the right slightly (seen when entering the bath door);

1/2 bath sink bowl slopes to the right

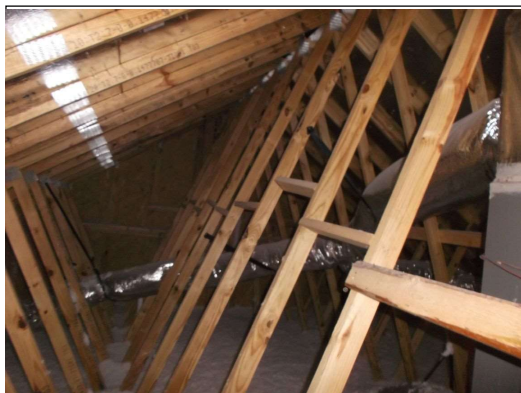
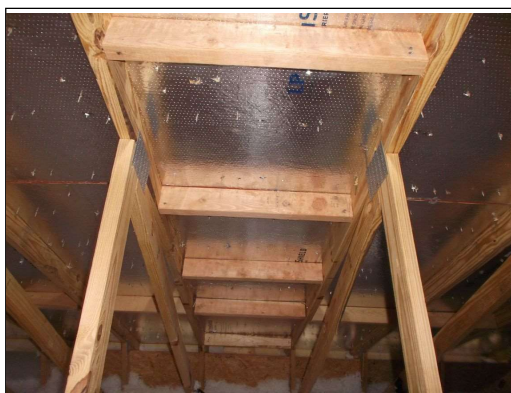
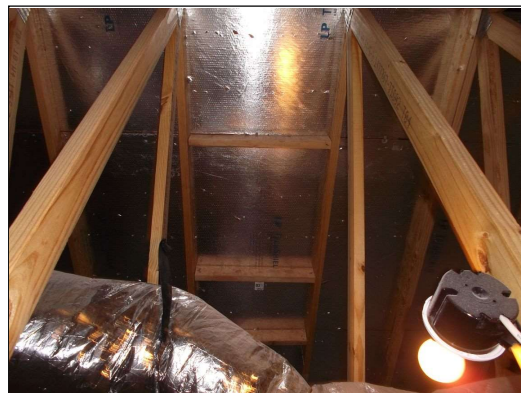
Bridging blocks have been nailed to the sides of some roof truss seen when entering the attic (truss manufacturers restrict nailing into the sides of truss web members or cords as this can cause damage and requires engineer approval to nail into the sides of roof truss)

Blocks nailed to the sides of roof truss

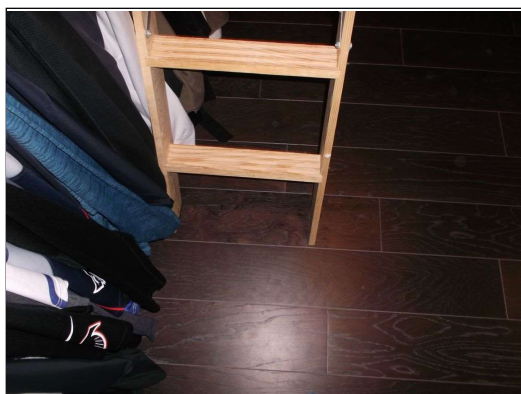
Attic ladder right leg longer than the left leg;

Attic ladder right leg longer than left

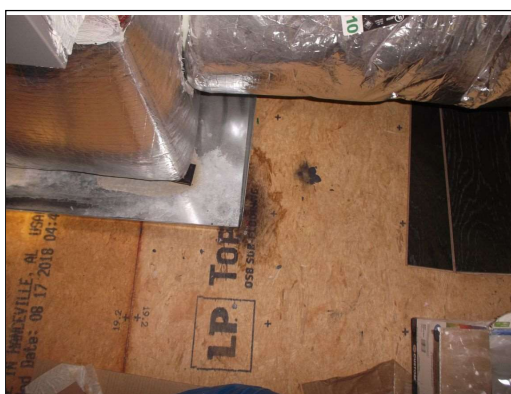
Dry water stains on the attic floor at the right corner of the furnace drain pan;

Water stains on attic floor
