Property Inspection Report

284 Wild Rose Cir. Holly Springs, GA.

Apr 13, 2021

Paris Pressley: R-5 Master Residential Building Inspector & State License Residential Building Contractor

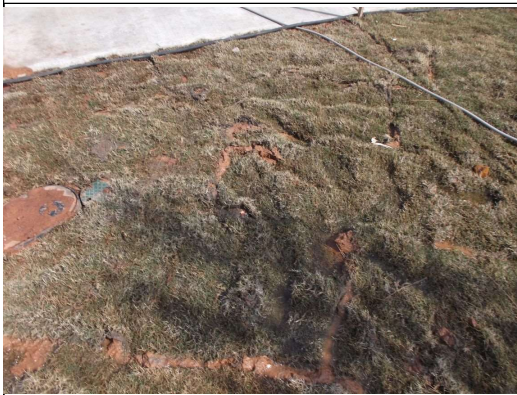
Driveway has some scuff marks in the concrete finish; soil under the sod has been trampled and sod gathered at several areas at the front of the house (ground not smooth); there is metal rebar rising out the ground at the front porch; the soil under the pine straw at the front porch has poor slope away and debris under the pine straw; the rear wood deck support posts contact soil and there are missing joist hangers at the bedroom deck floor joists; there are several nails that has been driven through the floor-to-wall flashing at the main deck; there is not enough pine straw under the rear deck;

Soil under sod trampled and sod gathered

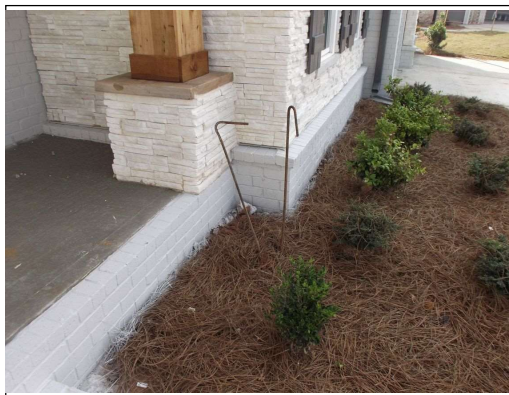
Rebar rising out the ground

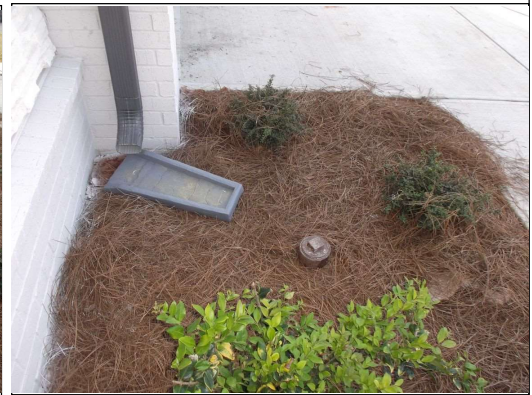
Poor soil slope away & debris under pine straw

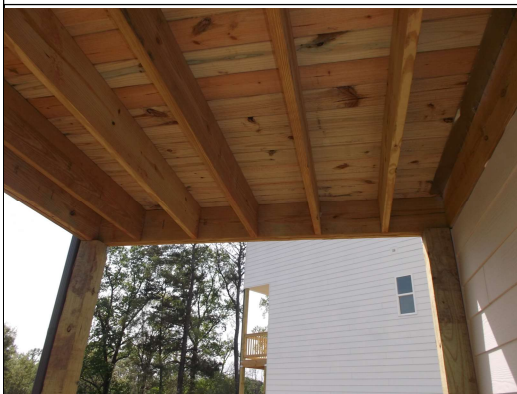
No joist hangers at bedroom deck floor

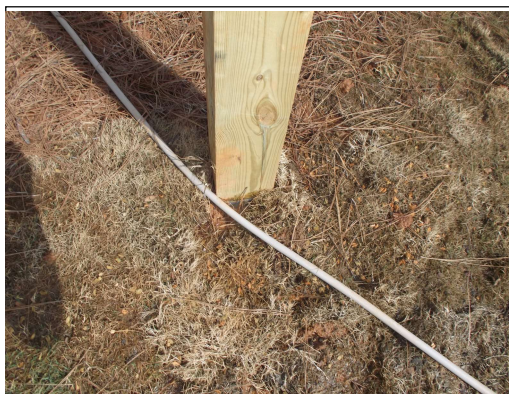
Deck posts in the soil/not enough pine straw

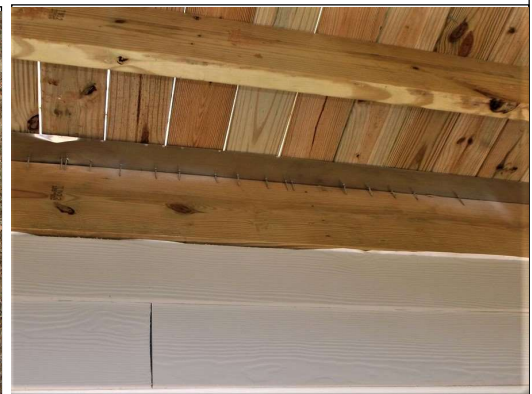
Many nails have punctured the flashing

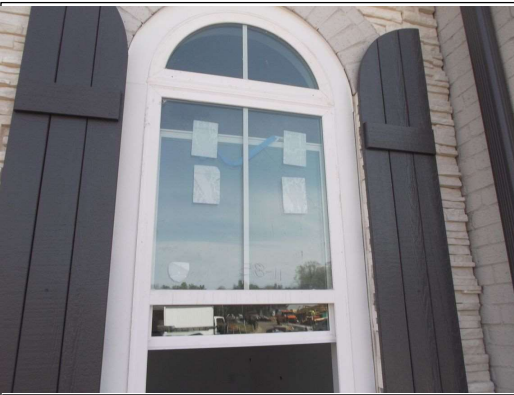
Broken glass

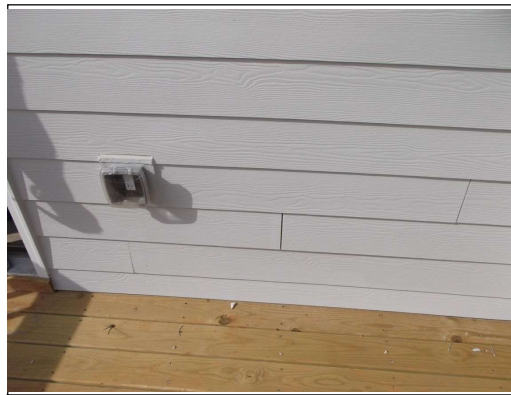
Gaps in siding at rear of house

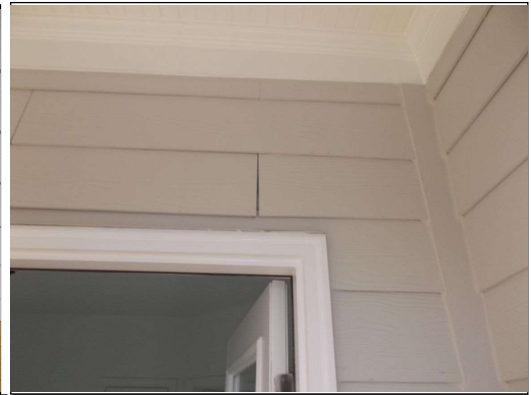
Excessive gap and siding not level

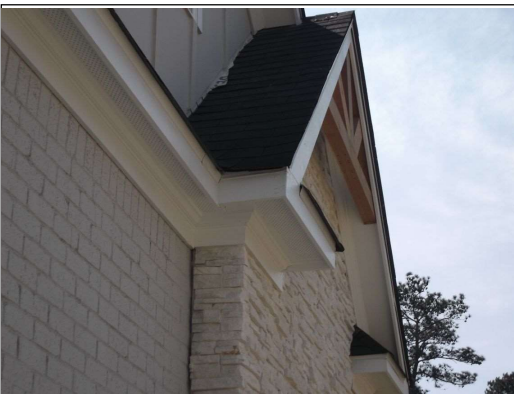
Missing short gutter front left side of garage

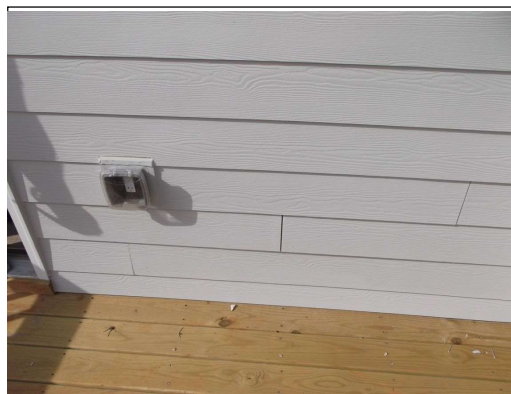
Excessive gaps between siding panels

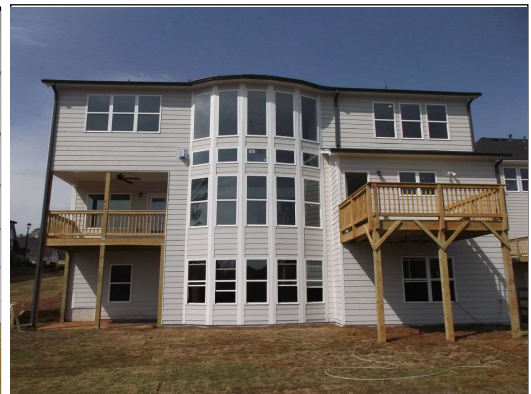
Gutter sagging at bay window & left side

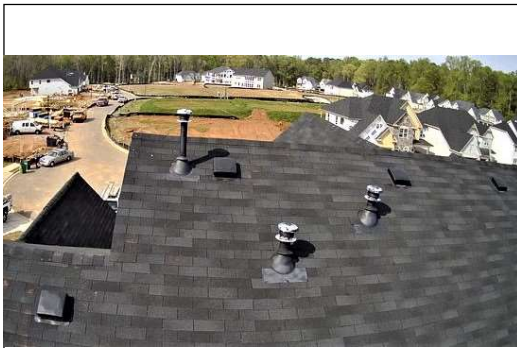
Plumbing and vent pipe flashing have been installed on top of shingles and face nailed (can cause leaking over time, shingles should be on top of the sides of flashing and no nails should be visible, nails can extract);

Pipe flashing on top shingles face nailed

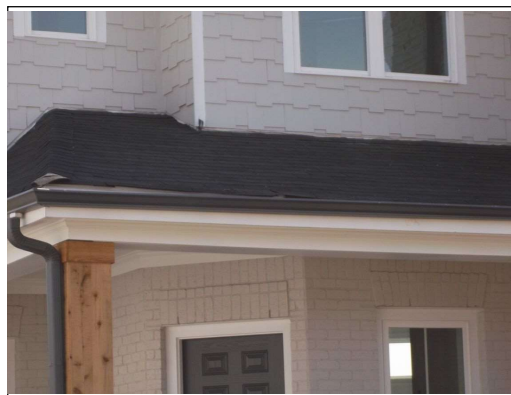
Shingle lifting at th front porch

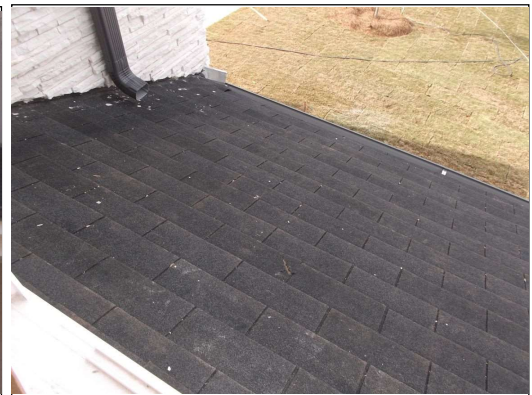
Workers residue & damage at porch shingles

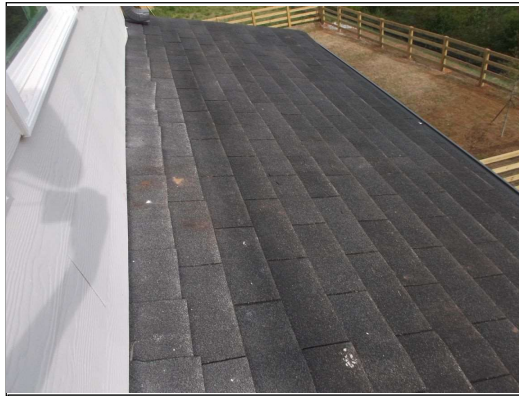
Workers residue on lower rear roof shingles

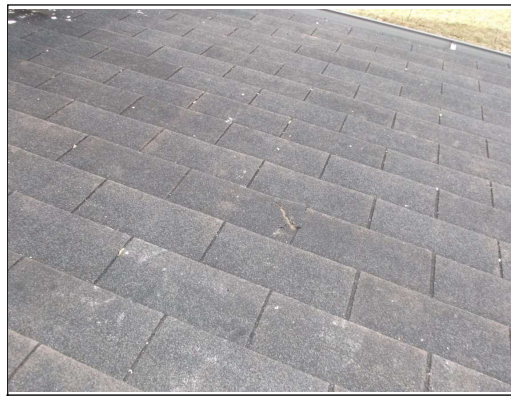
Damaged shingles at front porch roof

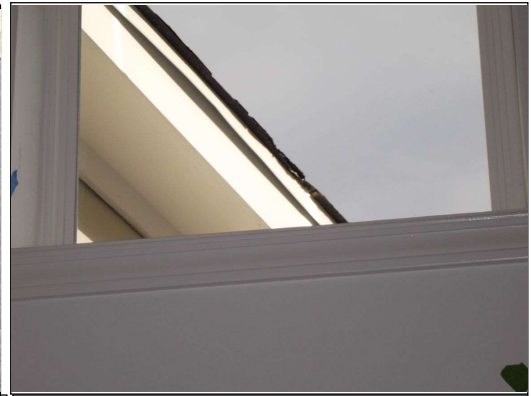
Damaged shingles at rear lower roof

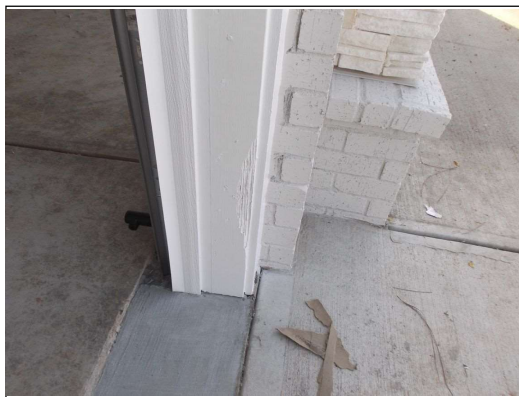
Damaged door frame

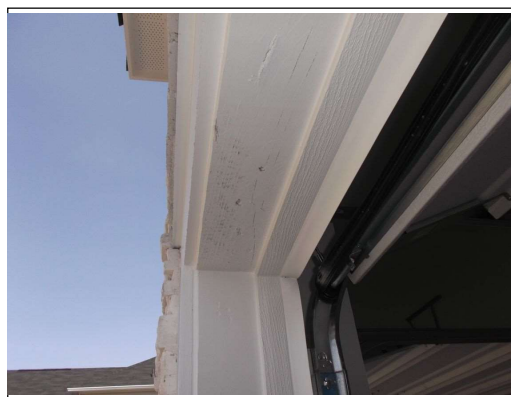
Defective door frame

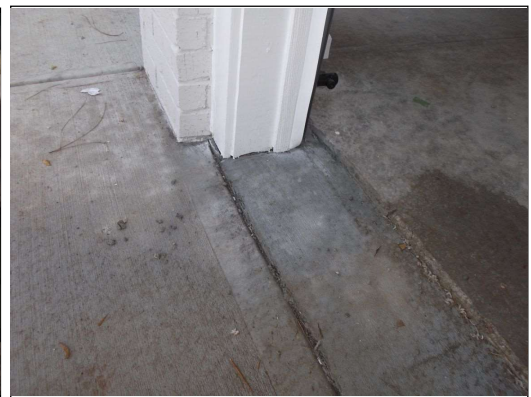
Not enough air gap at concrete

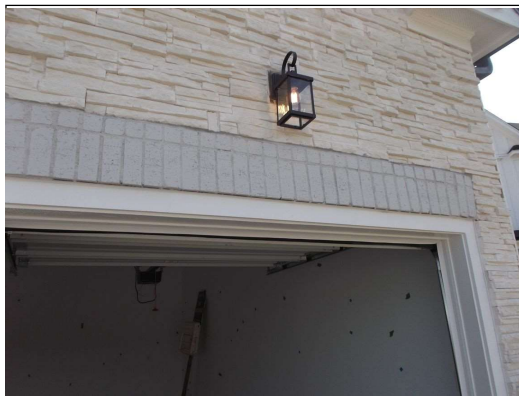
Missing weep holes?

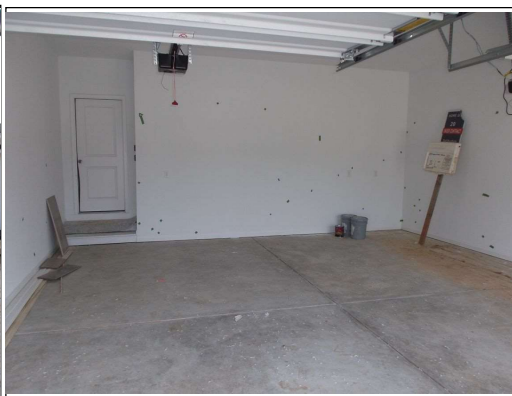
Tape indicating defective finish?

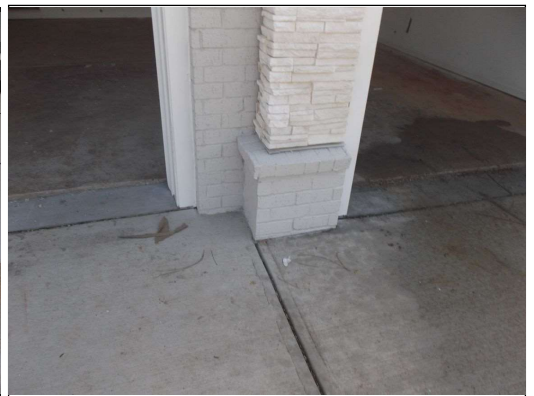
Weep holes not visible

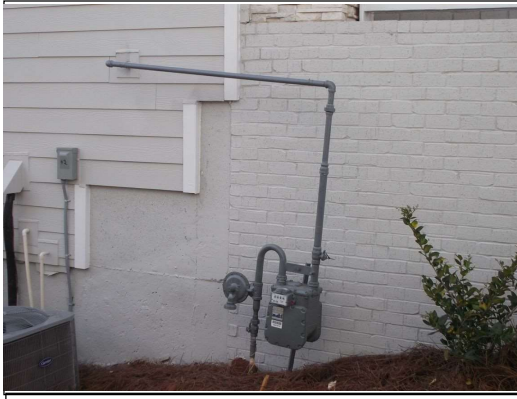
Main gas pipe from the gas meter to the house has excessive pipe lengths, pipes not level and plumb and meter was installed too far forward from the house wall and meter not plumb;

Gas meter to house pipes poorly installed

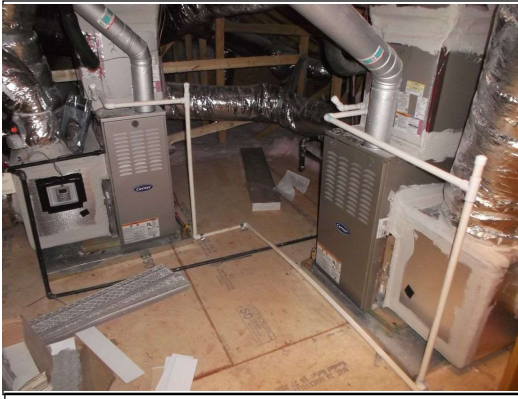
Right furnace has vibration when operating

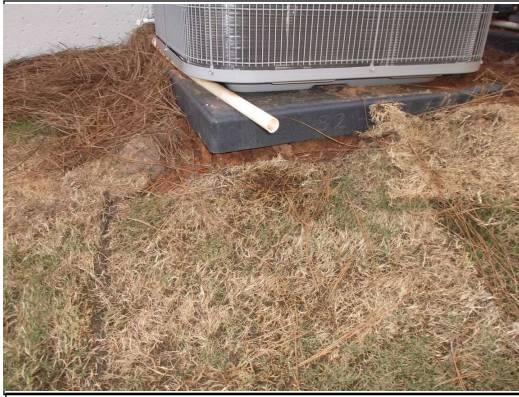
Missing soil under the left AC unit ground pad or base and left AC unit leaning to the left should be level;

Missing soil under left AC base

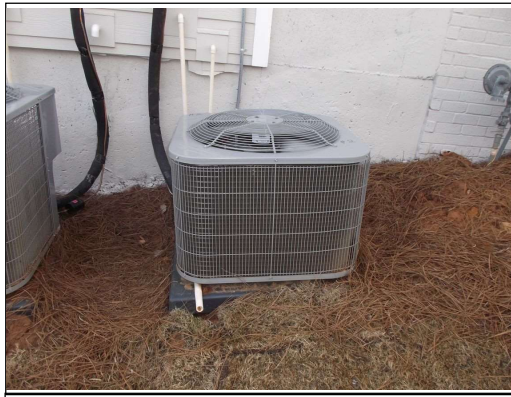
Right AC unit leaning to the left

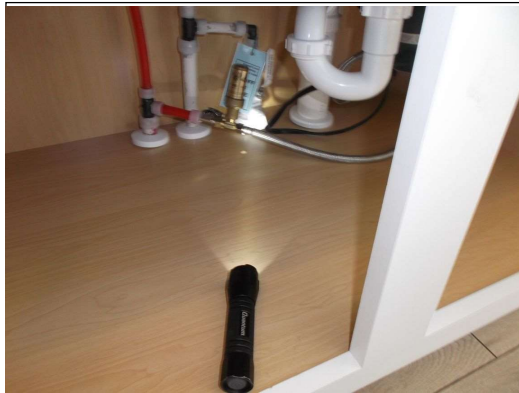
Drop of water on kitchen cabinet floor

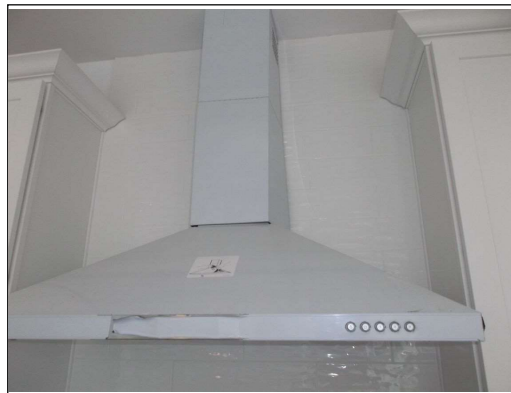
Stove exhaust hood shaft bent right side

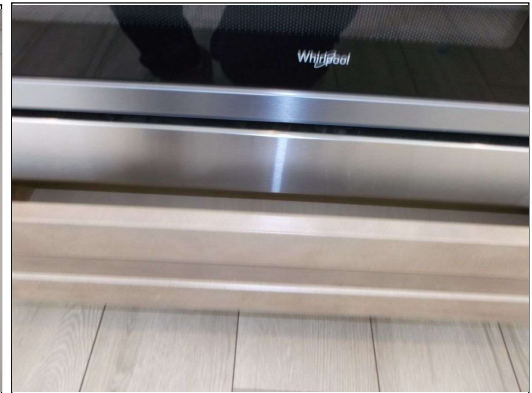
Drawer not closing under microwave

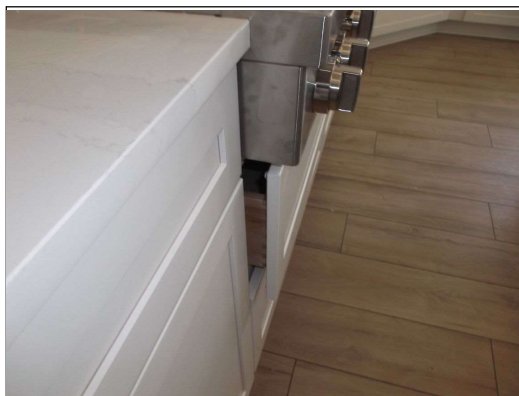
Drawer not closing under stove cook top

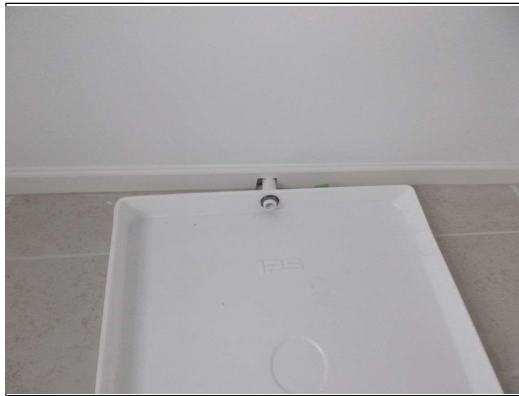
Missing caulk at hole in baseboard

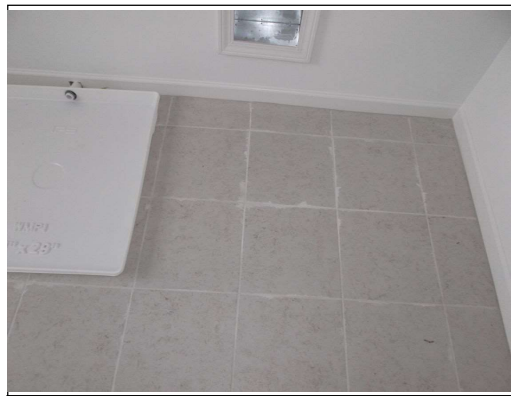
Grout spilled on floor tiles

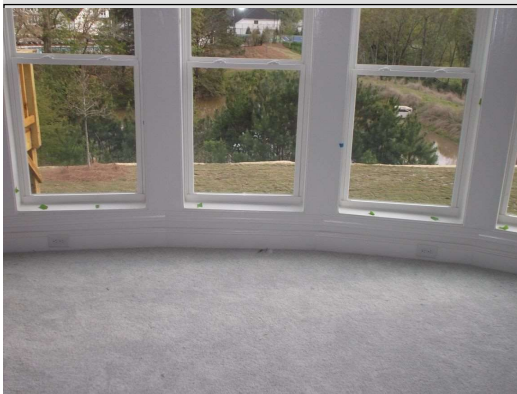
Windows not square in the wall

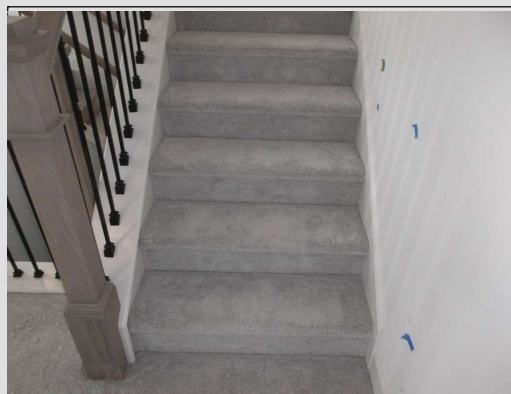
First steps rotate forward

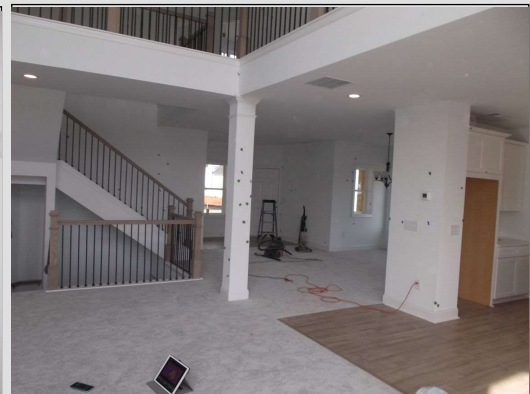
Tape placed on a lot of wall areas

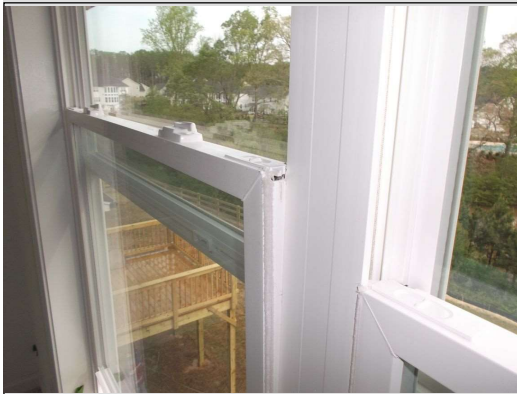
Master bed window will not snap in place

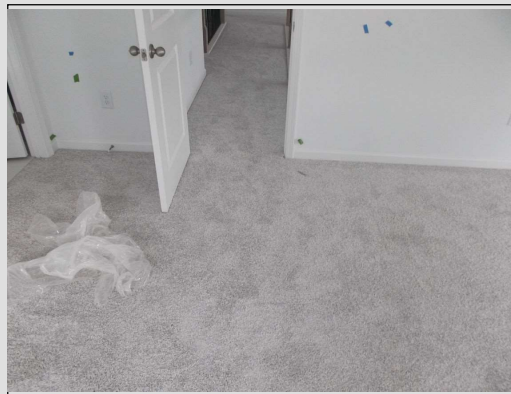
Hump in master bed floor near door

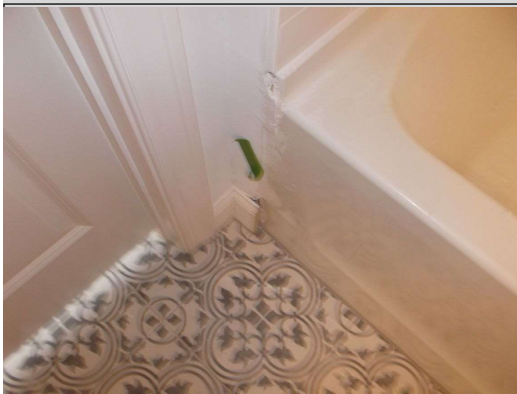
Defective baseboard and sheetrock finishing

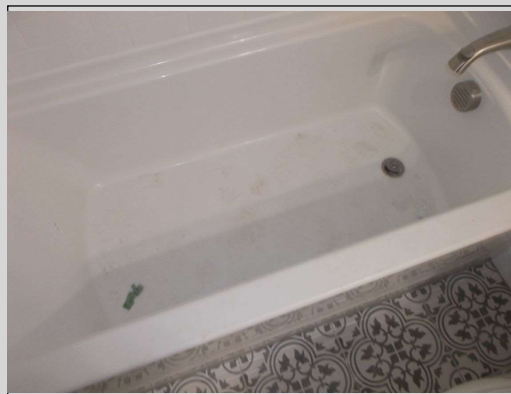
Tub soiled

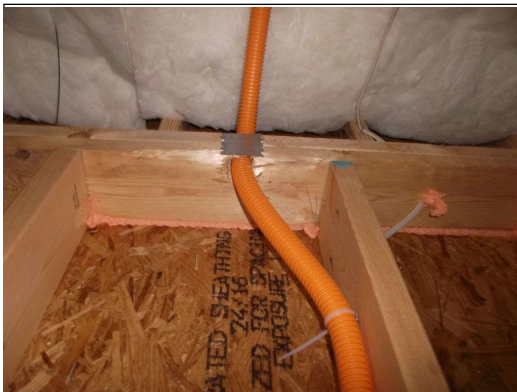
Missing caulk at top plate

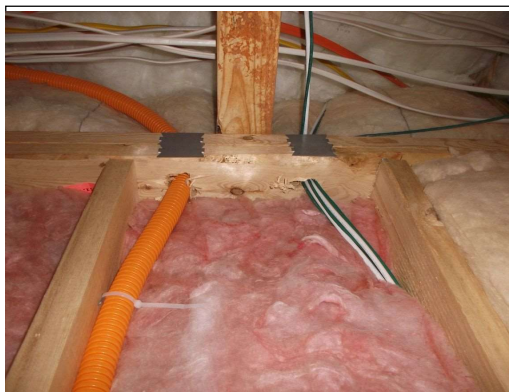
Missing caulk at top plate

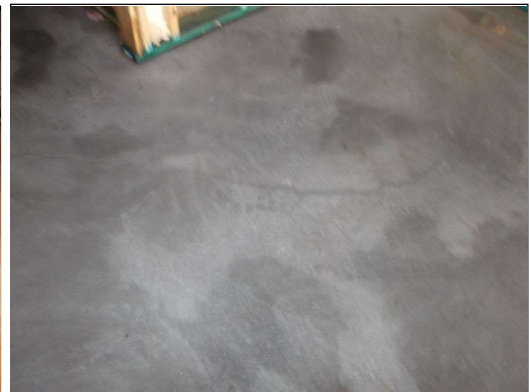
Hair line crack in floor

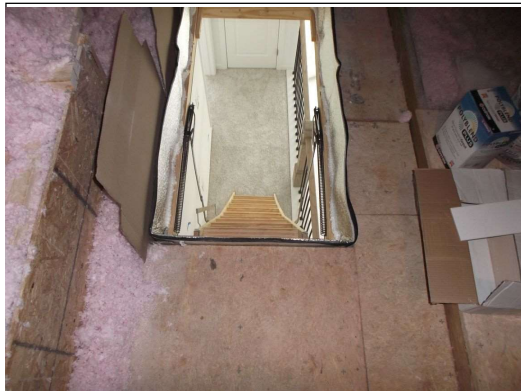
Attic ladder is too long can be damaged if legs not cut to proper length; furnace electrical cables clamped to the wood can cause damage to cables (there should be a clamp on the conduit for each furnace);

Attic ladder too long

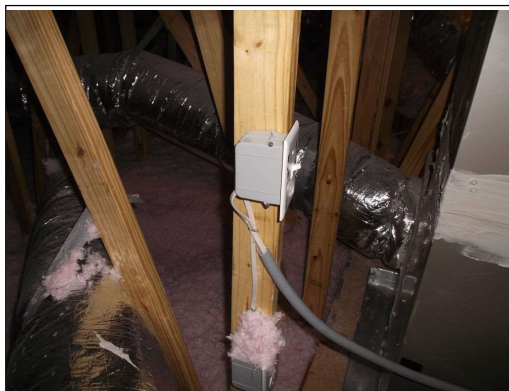
Electrical cable should not be stapled here

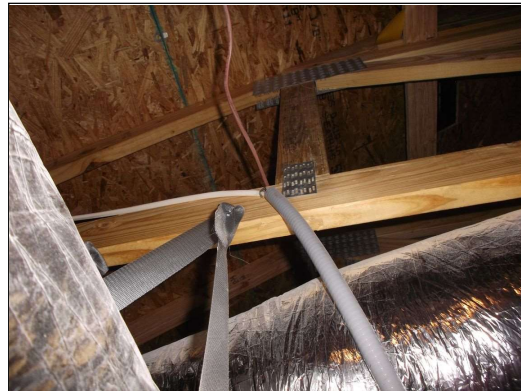
Electrical conduit should be clamped not cabl
