# PROPERTY INSPECTION REPORT

2595 Ridge Manor Dr. Dacula, GA.

Jul 29, 2021

1599

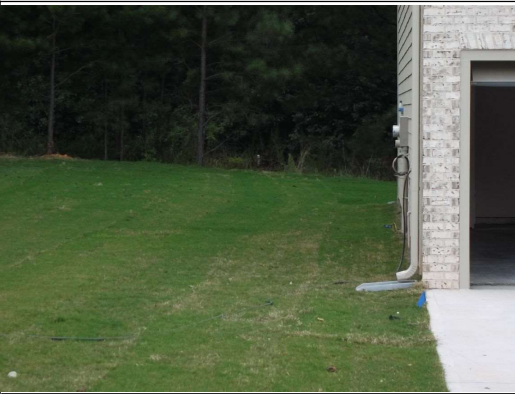
Soil has poor grading for drainage at the left side of the building and poor slope away from the foundation at the left side (can cause excessive water saturation in the soil at and under the garage side of the house and cause foundation settling over time if water does not drain properly away from this side of the house). Can cause support soils under the floor slab to erode which can cause differential settling and cracks in the floor slab.

Poor soil slope and grading

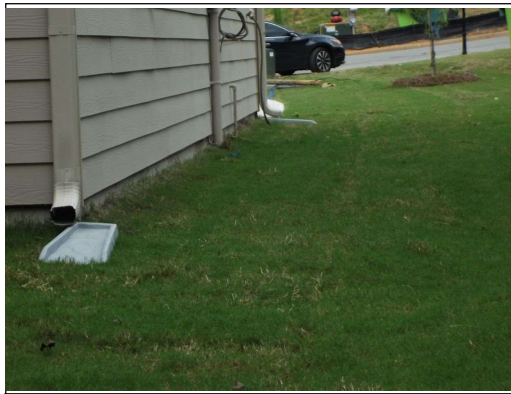
Poor soil grading

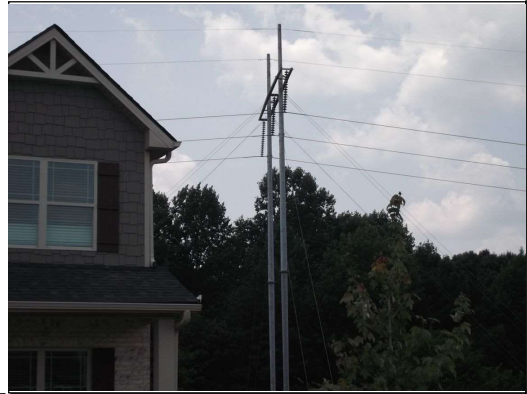
There is a electrical utility right-of-way bordering the rear property line of this property. It is advised to check the power company to verify if support trusses can be replace with bigger ones and high voltage cables could be increased in number and size. It is advised to do a research on living near power lines and utility right-a-ways.

High power utility lines

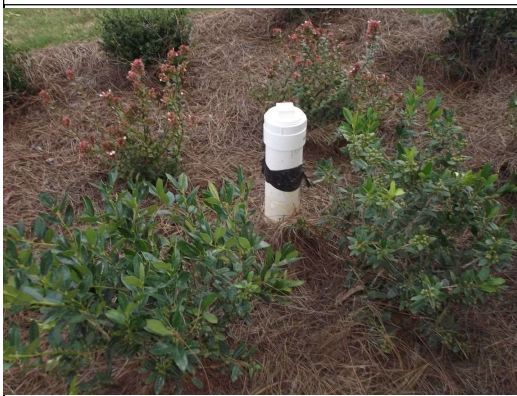
Pipe risers in the front yard

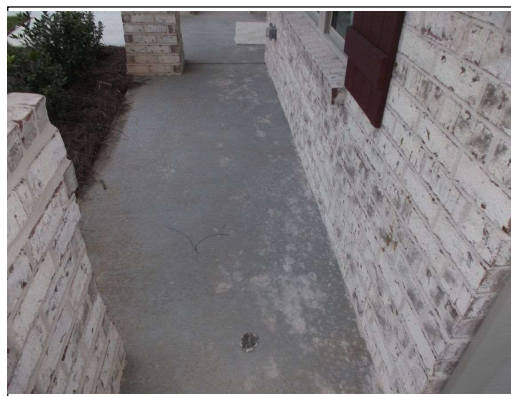
Stains in front porch concrete floor

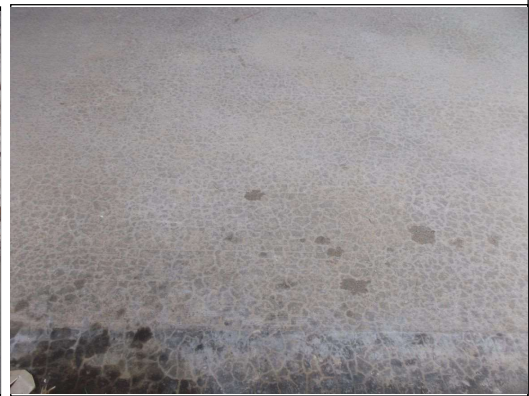
Spider cracks in patio floor

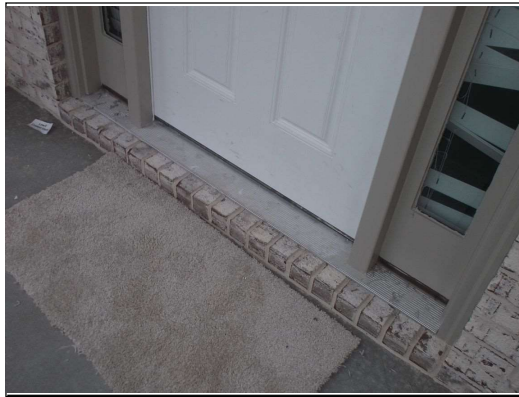
Front door threshold not supported

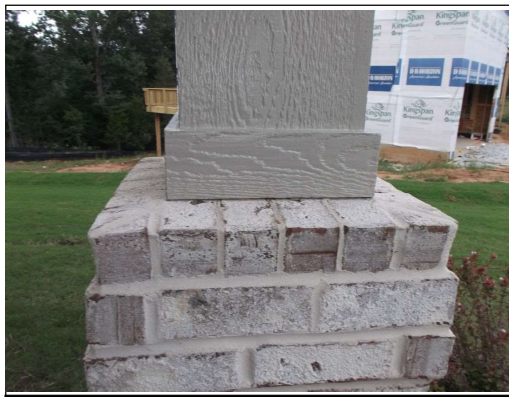
Missing bead of caulk at porch posts

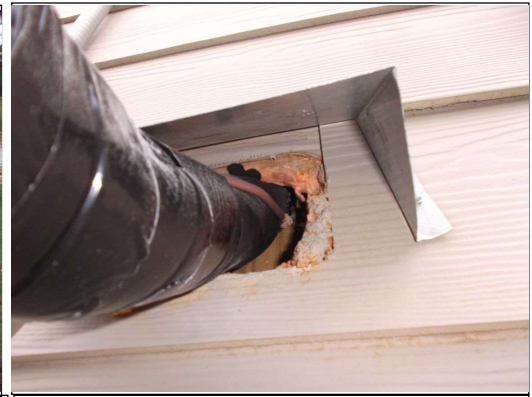
Opening in wall @ AC refrigerant lines enter

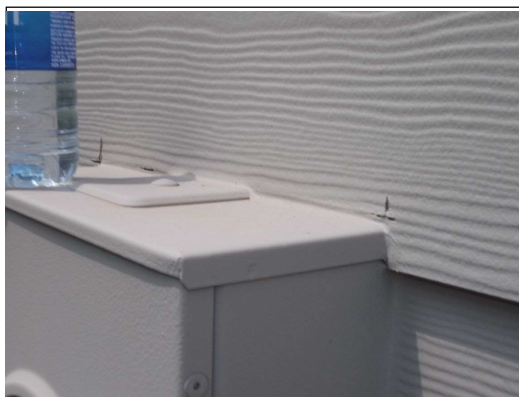
Missing caulk at the top of meter box

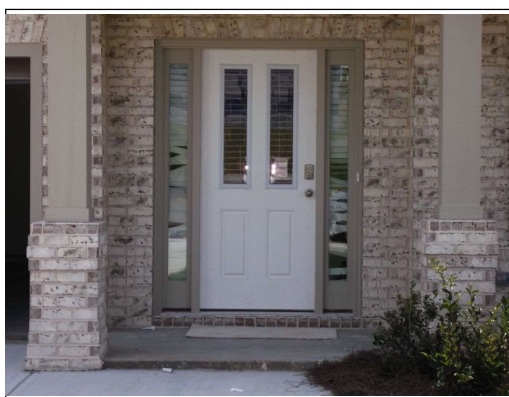
Front door appears to lean to the right

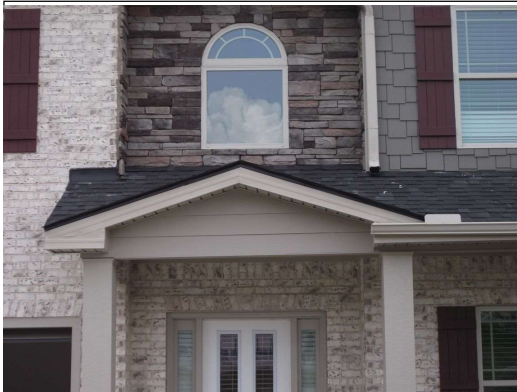
Painters residue on roof shingles

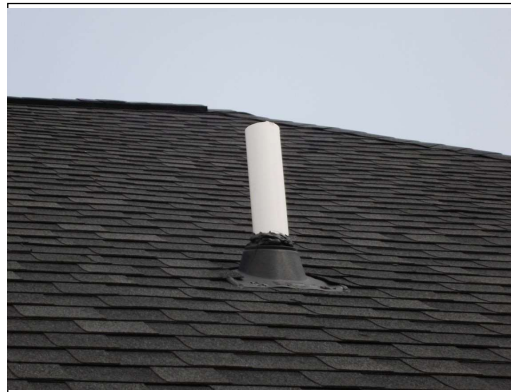
Flashing on top shingles, tar, nailed

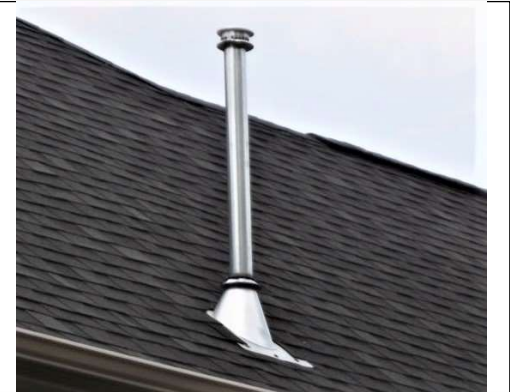
Pipe too tall/flashing on top shingles nailed

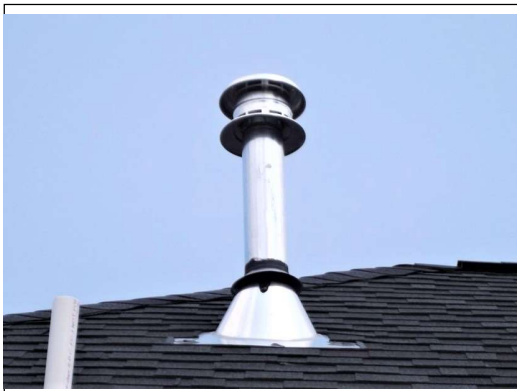
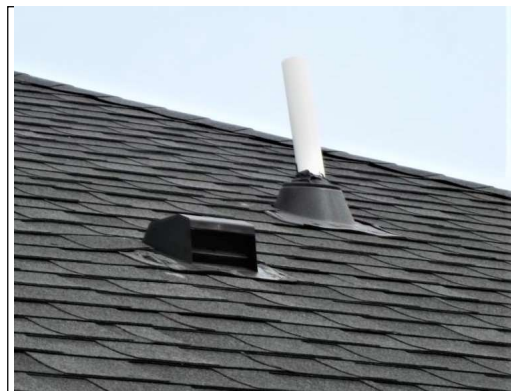
There is workers residue on the front porch roof shingles. There is plumbing pipe and gas vent pipe flashing installed on top of shingles and face nailed (water can get under flashing on the sides, nails can extract and cause leaks, there should be no nails across the bottom of the flashing and flashing shall be covered with shingles on the sides).

Flashing on top shingles face nailed

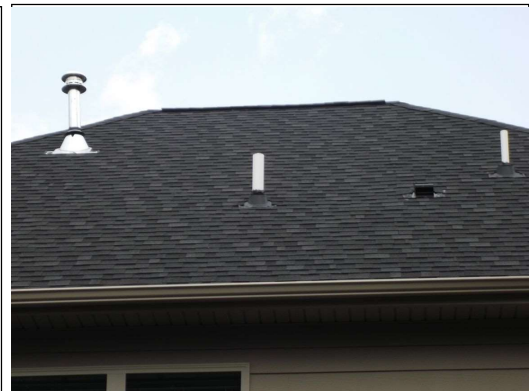
Wrong sealant @ metal pipes/sealant on pipe.

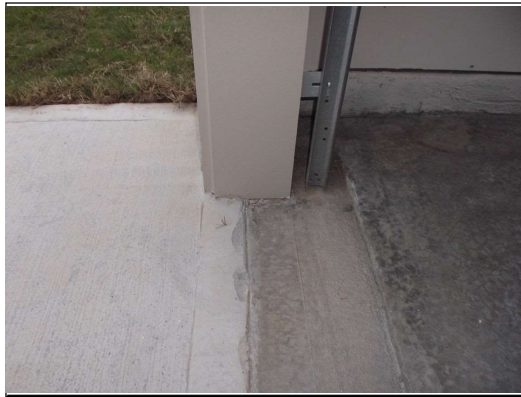
Door frame contact floor

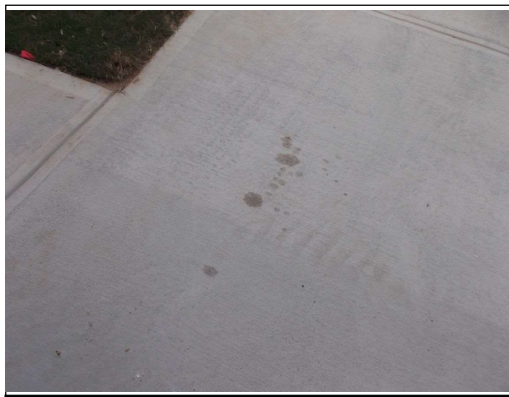
Oil in the driveway

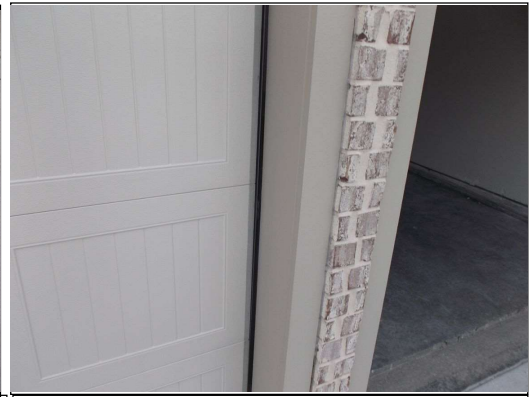
Missing weather strips

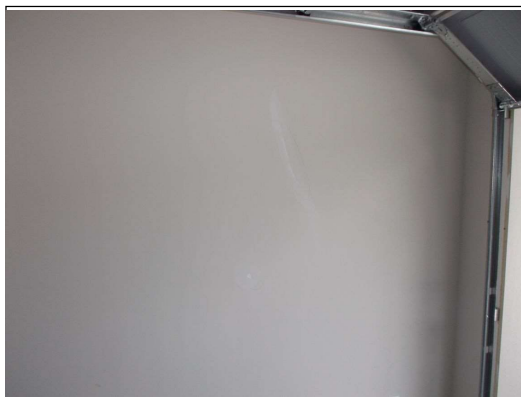
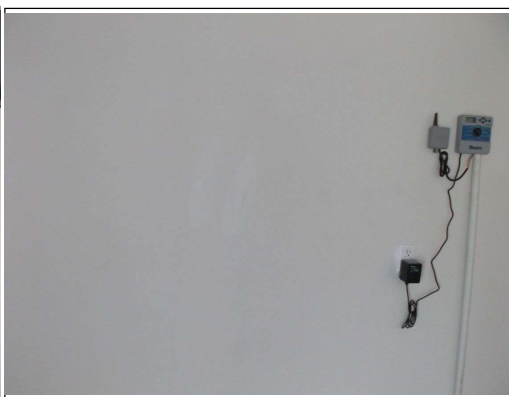
Wall needs painting

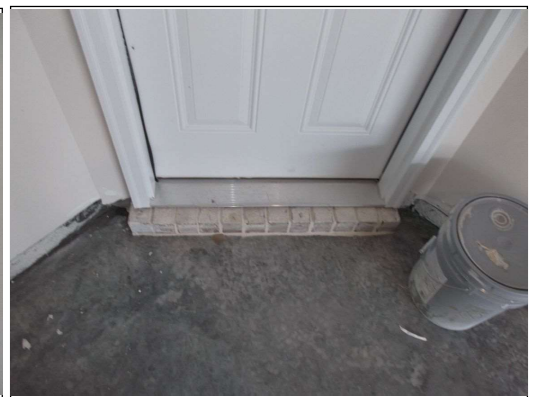
Threshold not supported

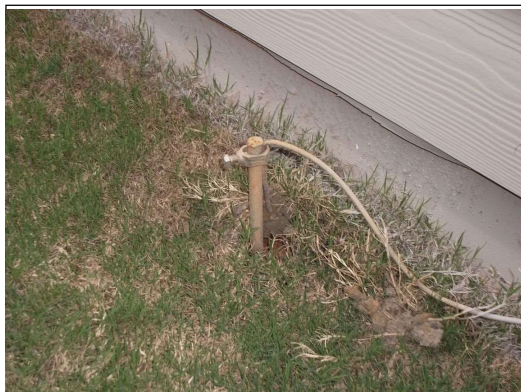
Ground rod too high above the ground

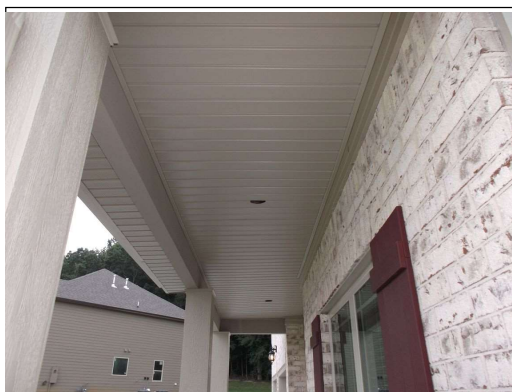
Missing light fixtures at front porch

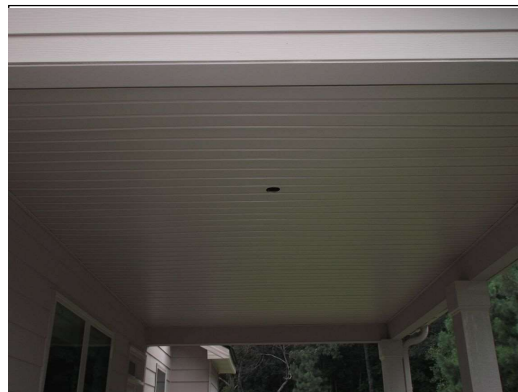
Missing light fixture at patio

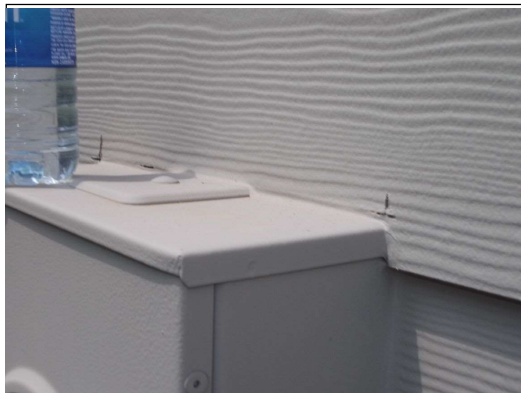
Missing bead of caulk across meter box

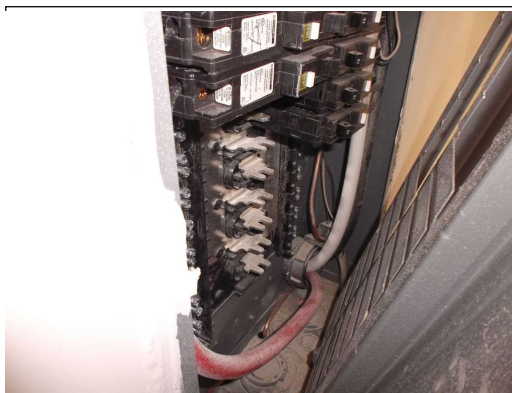
The electrode ground rod was not driven into the ground far enough (rod should be only 1 inch above the ground). There is painters residue sprayed on the distribution panel cover in the garage. There is spray paint on the bus bars inside the distribution (not allowed, clean off all paint or replace bus bars, considered defective). Spray paint on the main breaker in the distribution panel not allowed.

Spray paint on panel board components

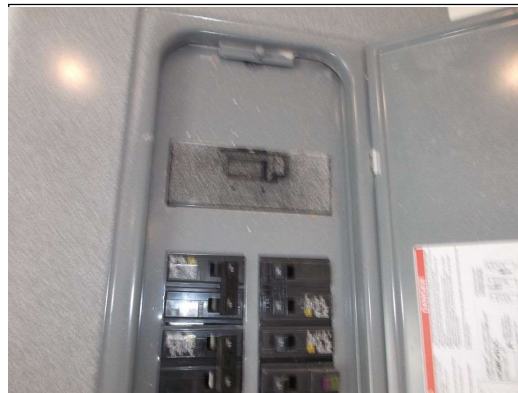
Paint on main breaker at panel

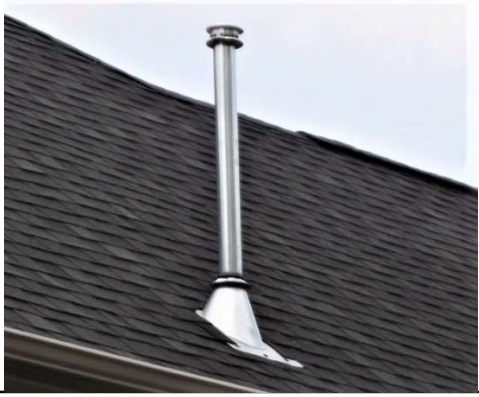
Water gas vent pipe rises too high above the roof.

Pipe too high above roof

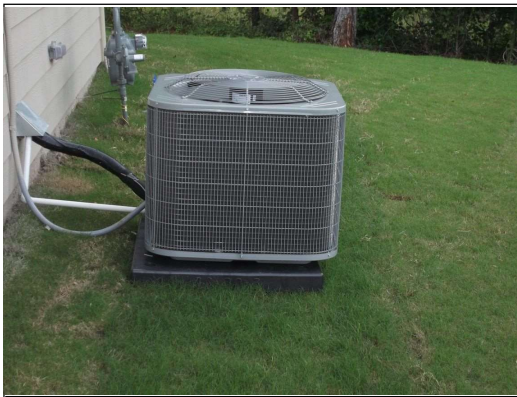
The AC unit at the side of the house is rotating away or leaning away from the building (can move off pad and cause damage, pad shall be made level). Contractor did not seal hole in the wall and siding where the refrigerant lines enter.

AC leaning away on the pad

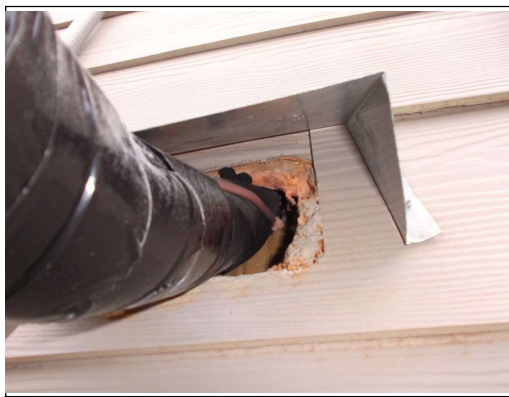
Open hole in the wall at AC lines

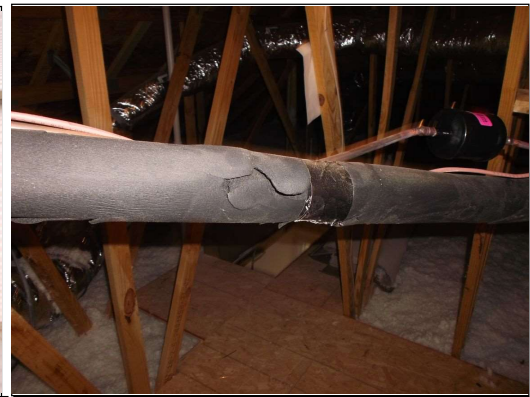
Damaged refrigerant line insulation on the backside of the line near the furnace can sweat and drip water, builder is advised to check complete line in the attic for damage a repair. Cannot verify there is refrigerant line insulation damage in the walls at the time of the inspection.

Damaged refrigerant line insulation at attic

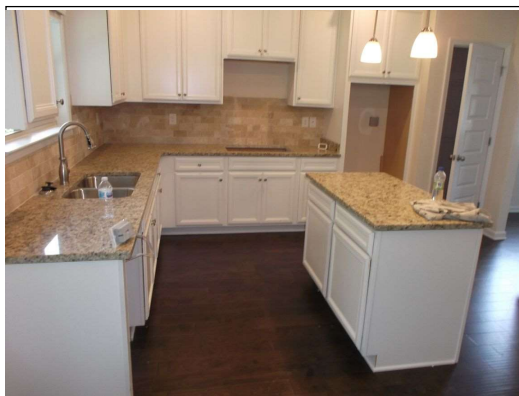
Appliances not installed

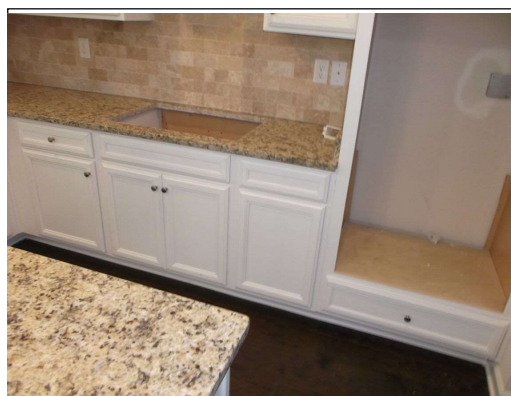
Missing cabinet knobs

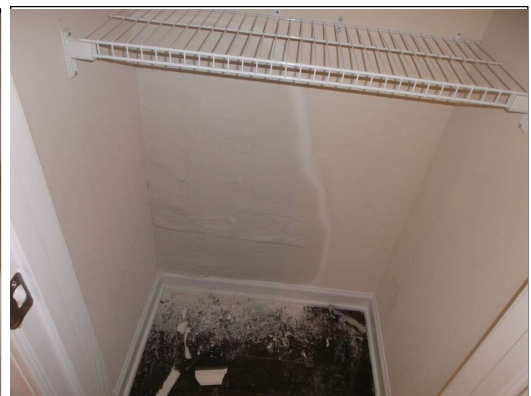
Defective drywall finishing in pantry

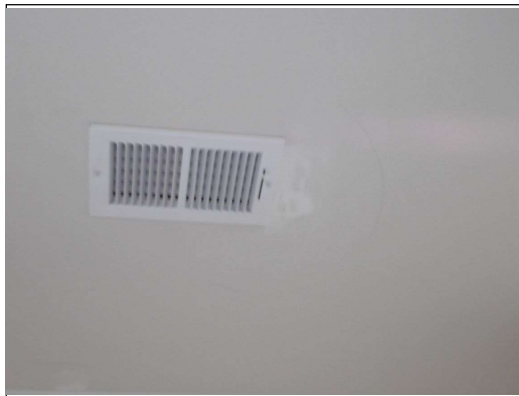
Unfinished ceiling

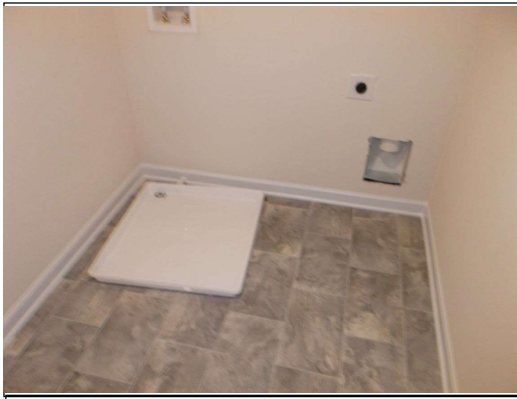
Washer drain pan not completely installed. Missing bead of caulk around the dryer exhaust pipe box in the laundry wall (can let unconditioned air into the living space).

Drain pan incomplete/gaps at dryer box

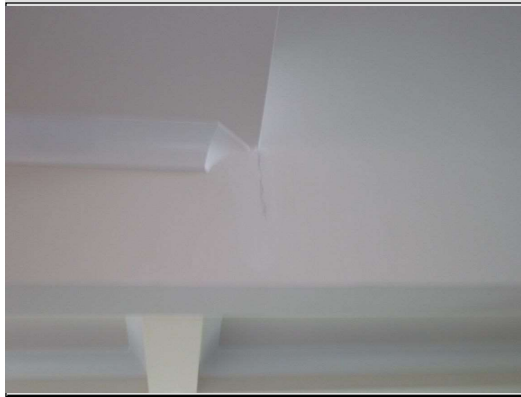
There is a movement crack in the foyer wall above the opening to the dining room (right over opening) that has been skimmed over with sheetrock mud (builder verify the crack will not redevelop after work is completed. Verify there is a bead of caulk installed where door frames end at the flooring).

Crack in wall above doorway

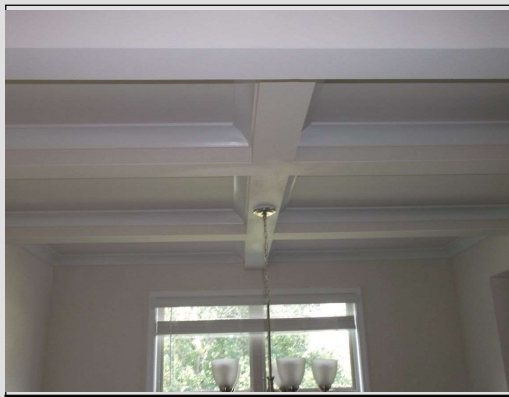
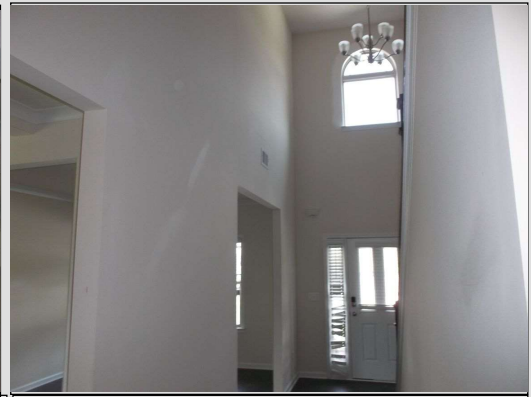
Incomplete finishing and painting

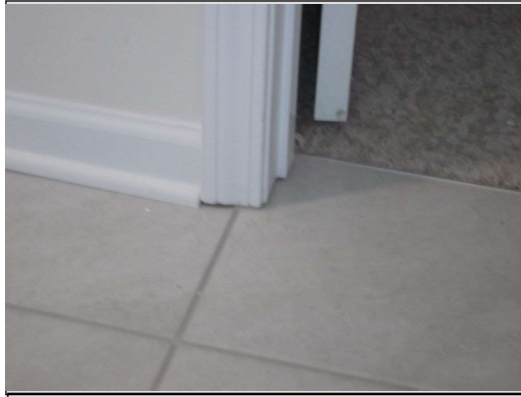
Gap at door frames and floor covering

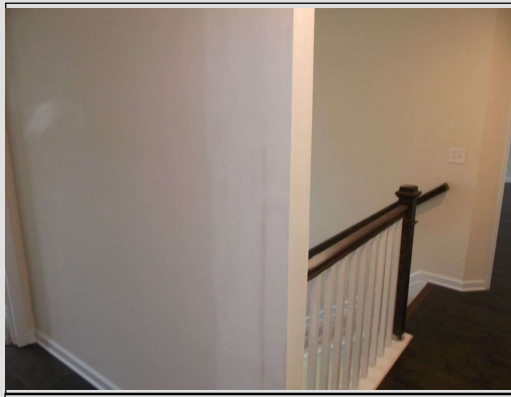
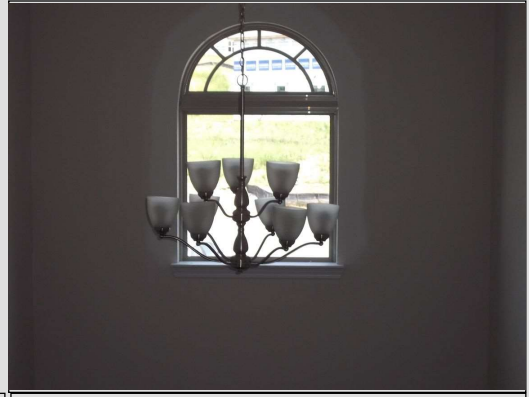
2nd level walls are not finished and painting incomplete (builder verify repainting will match and quality painting will be done when all walls painted).  
Missing caulk where door frames end at the flooring.

Incomplete finishing and painting

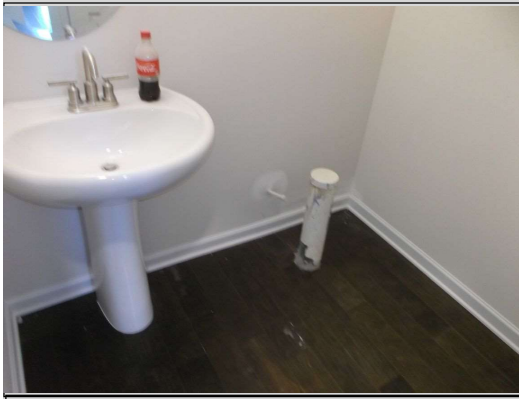
1/2 bath toilet has not been installed at the time of the inspection, there was no hot water at the faucet.

Toilet not installed

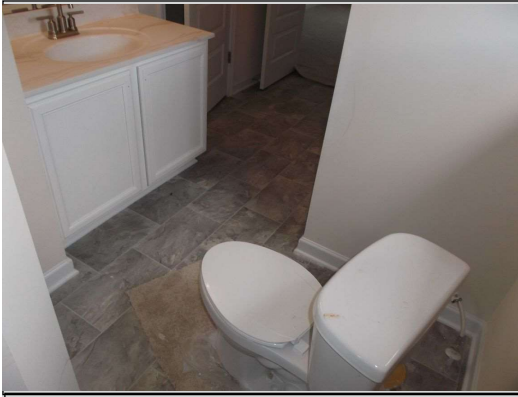
jack and Jill bath toilet and hardware not installed at the time of the inspection. Exhaust fan has a slight vibration noise when operating.

Toilet not in/hardware not installed

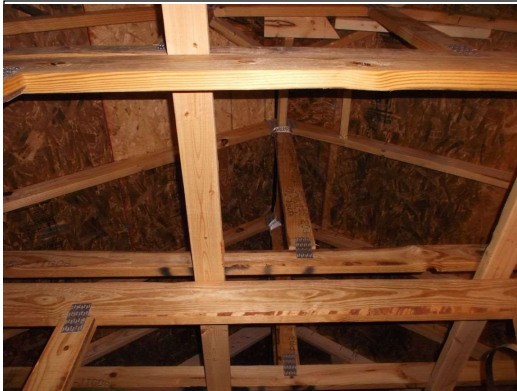
Ridge plywood not fully cut out at vent

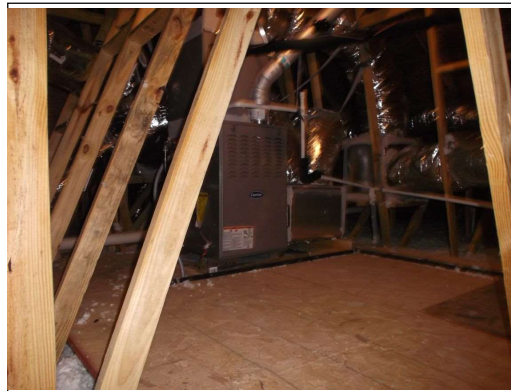
Attic was very hot and little air movement
