PROPERTY INSPECTION REPORT

1237 Lucile Ave. Atlanta, GA.

Sep 4, 2021

1801

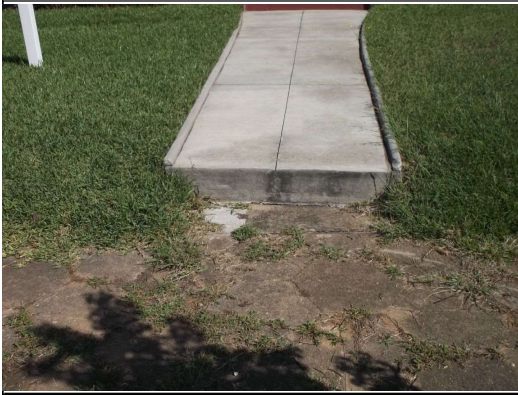
The walkway step up from the street sidewalk is too high and can be a trip hazard. The main front stairs at the front porch top step too high and can be a trip hazard.

Walkway step too high and trip hazard

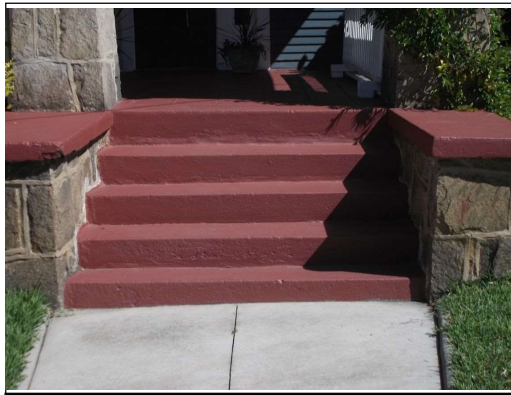
Top too high and trip hazard

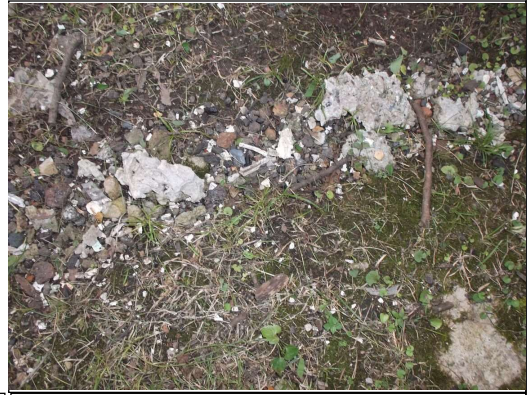
There are paint chips, glass putty and caulk noted in the soil at the right side of the house. Based on the age of this home the original exterior paint was lead based and EPD and EPA requires all lead based paint to be cleaned out of the soil.

Paint chips, putty, caulk debris in soil

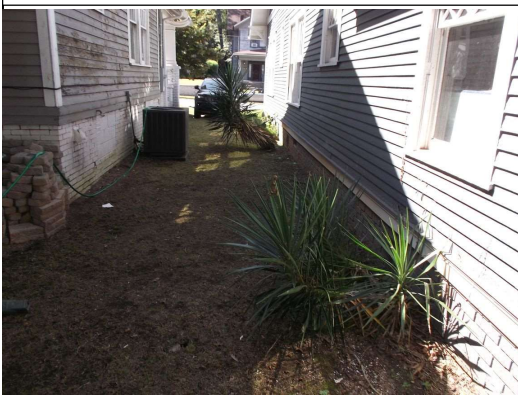
The soil grading at the right side of the house or the east side slopes to the foundation and has poor grading to drain water away from between the houses and to the street. The rear yard near the foundation has poor slope away from the foundation. Soil grading near the foundation shall be sloped 6 inches for the first 10 feet away from the foundation to drain water away from the building. Where there is poor grading or soils slope to a foundation water can cause damp basements and crawlspaces and cause water intrusion at the crawlspace or basement.

Poor soil grading and slope at right side

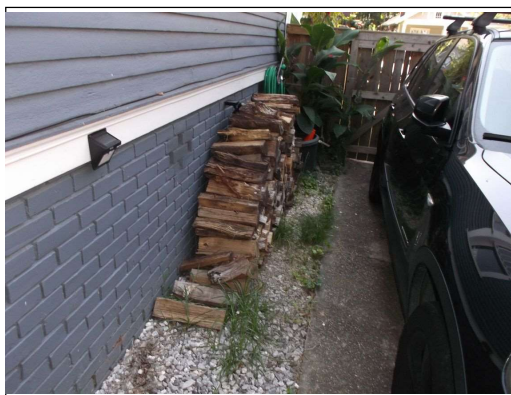
There is firewood stacked near the foundation at the west side of the house which can attract termites.

Wood stacked at the foundation

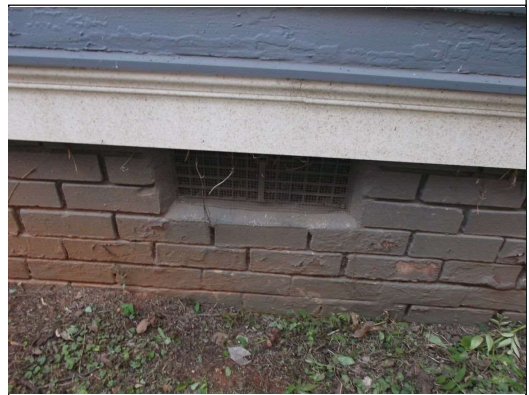
Foundation vents defective at some areas, some foundation vents missing doors or not operating properly. The exterior hose faucets do not have anti siphon devices which can let contaminants back into the fresh water supply. There is a exhaust fan placed in one of the foundation vents that was operating at the time of the inspection.

Foundation vents defective, damaged...

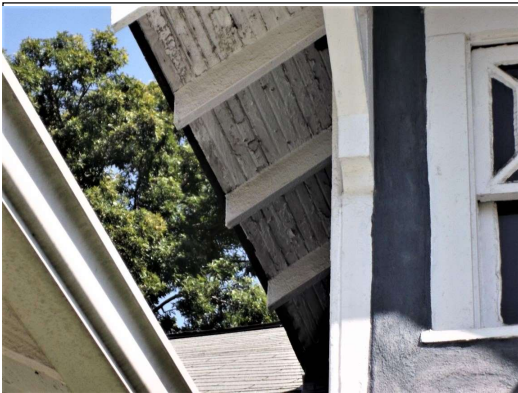
Paint peeling, rot at eaves

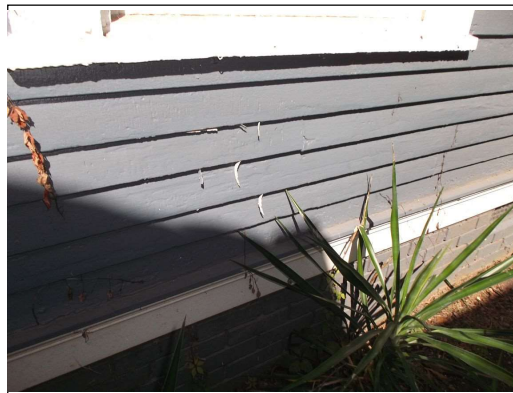
Paint peeling at siding

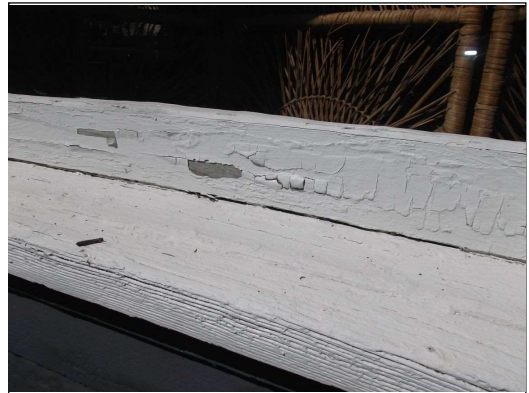
There is peeling and loose paint at some windows. many windows have been painted shut and sash cords broken. There are a few window glasses broken at the front dormer and at the left side.

Paint peeling at windows

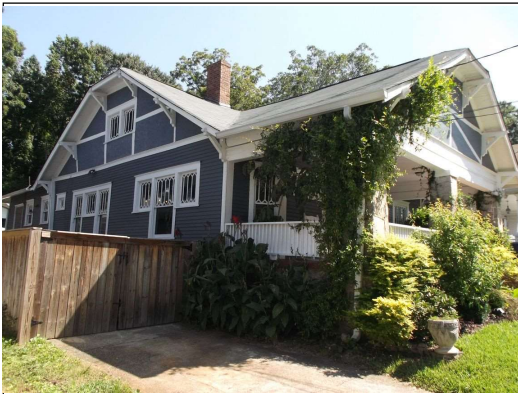
The front porch guard railings are too low and can be a fall hazard (current standards railing minimum height is 42 inches. There is no handrail at the front stairs and no hand rail attached to the stair railing at the wood deck stairs.

Railings too low, bushes need cut back

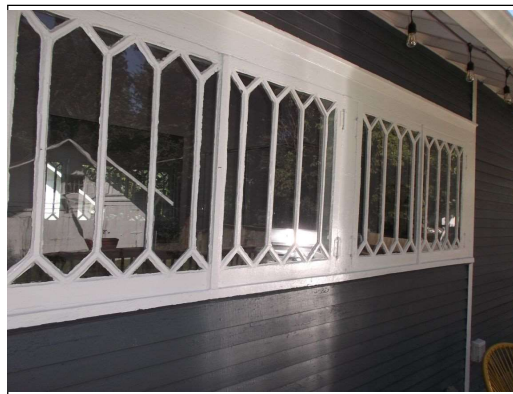
Several windows painted shut

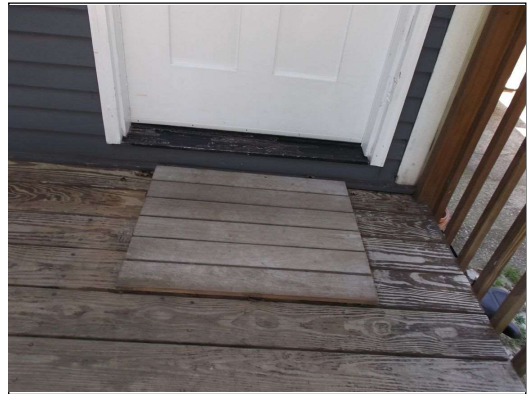
The front door threshold rubber weather strip is damaged. Rear door threshold is not fully supported and can see daylight at the bottom of the door corner when standing in the kitchen.

Rear door threshold not fully supported

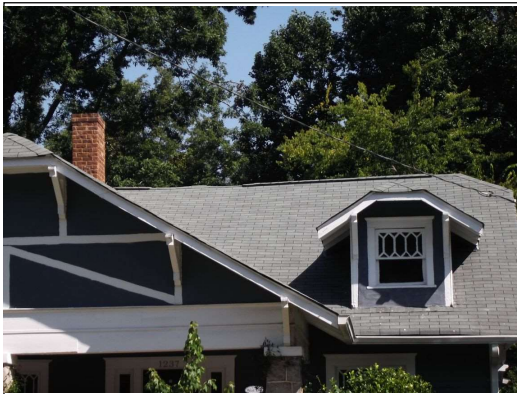
Main roof ridge sagging & slopes to left

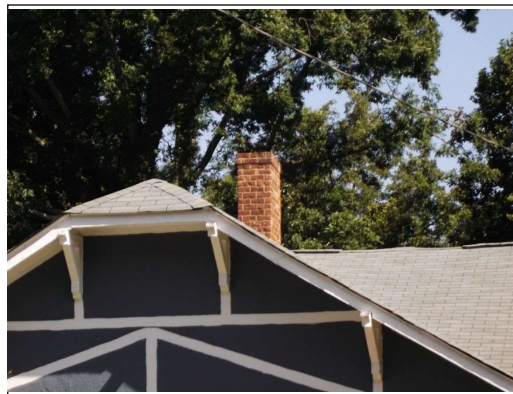
There is no spark screen not rain cap on the chimney.

No rain cap nor spark screen at chimney

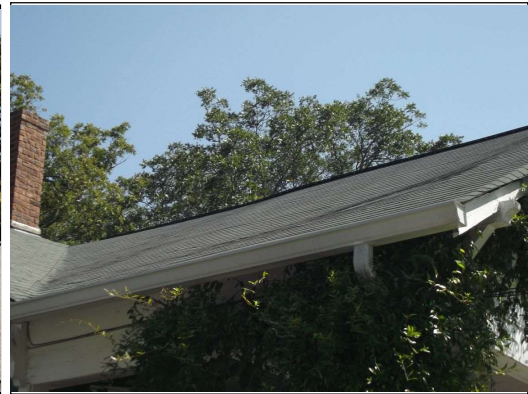
Dips at the roof deck at the left side

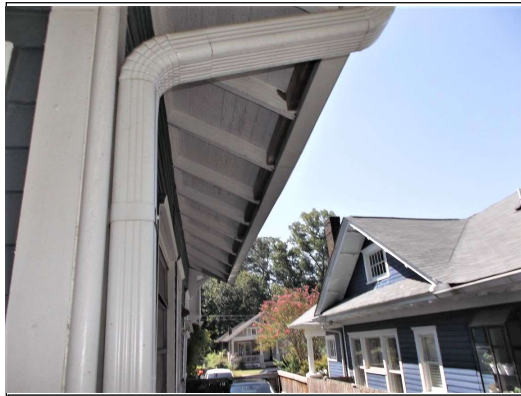
There have been wood blocks placed under the roof decking at the eave (behind the gutter) at the left side of the house near the kitchen (may indicate water damage to decking at the eave).

Blocks placed under the roof deck eave

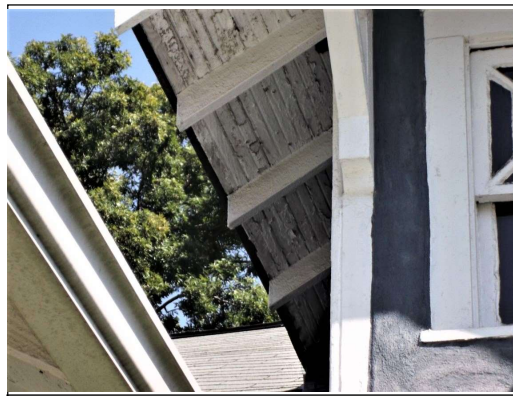
Water damage to roof deck eave boards

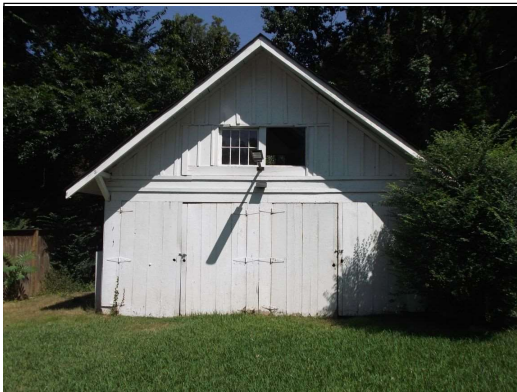
Doors need repair and adjusting

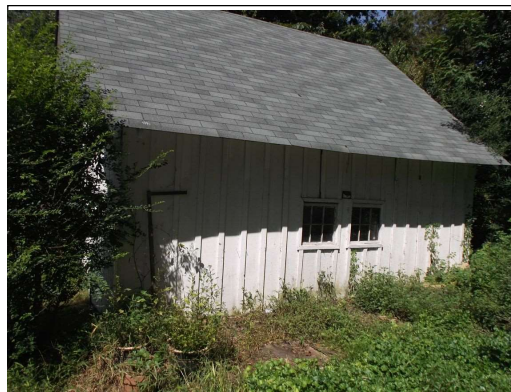
No gutters and downspouts at the garage can cause water to enter garage and wood siding rot under certain conditions.

The soil slopes to the garage foundation at the right side of the building. There is a dead tree at the right side of the garage.

Soil slopes toward garage/no gutters

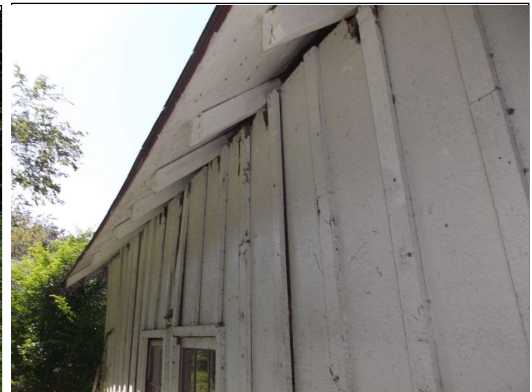
Defective and damaged

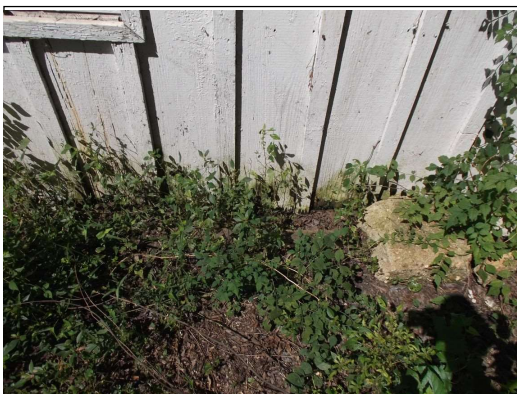
The garage wood siding rest in the soil and there is rot at the bottom of the panels at various areas. The wood siding has rot and or damaged at the top of some panels. The vehicle doors need repair. The exterior wall framing is utility type.

Soil contact siding and rot

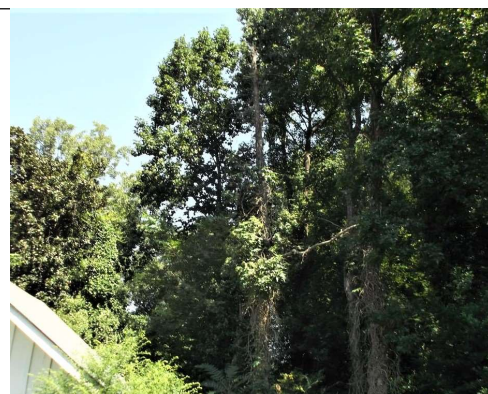
Dead tree standing right side of garage

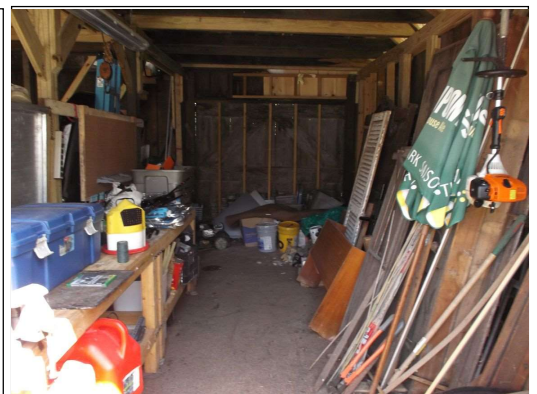
Do-it-yourself wall framing repair

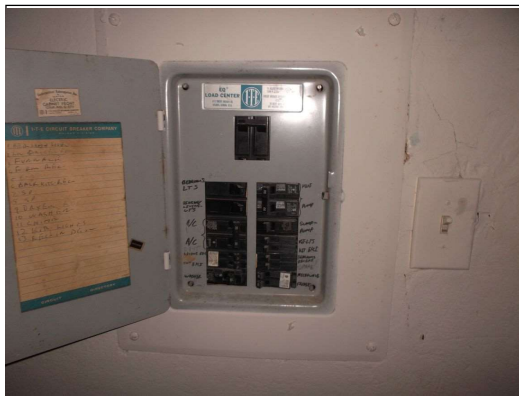
Panel too small for house

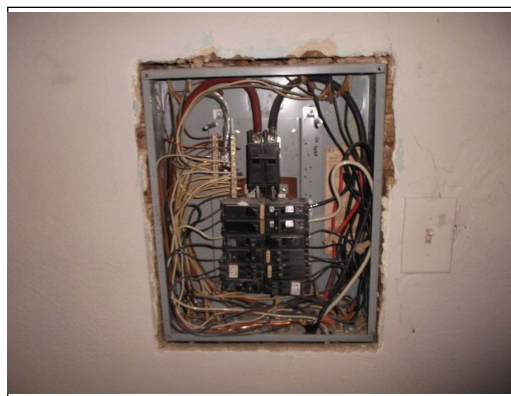
Gaps at plaster and panel box

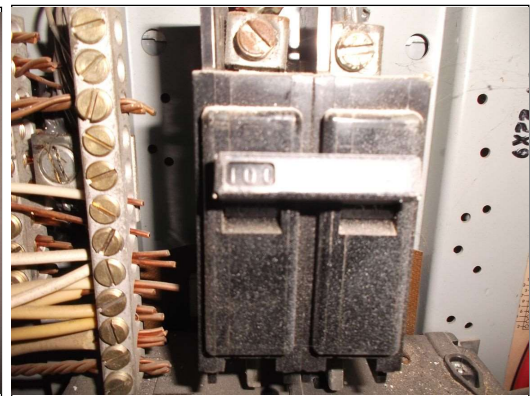
Only 100 amp service found/outdated

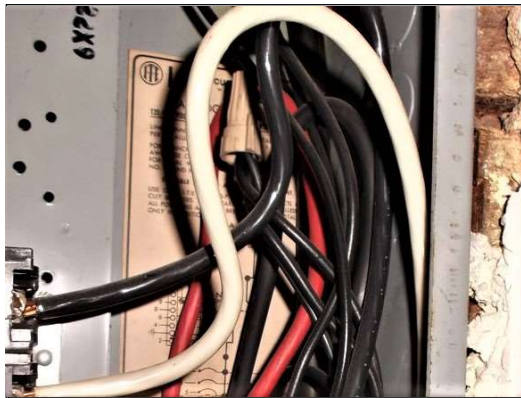
3 black or hot wires pigtailed at top of panel

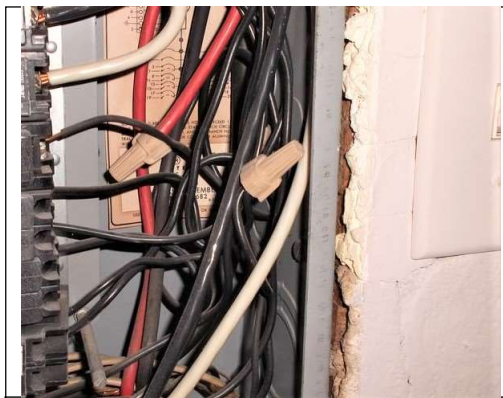
3 black or hot wires connected @ side of pane

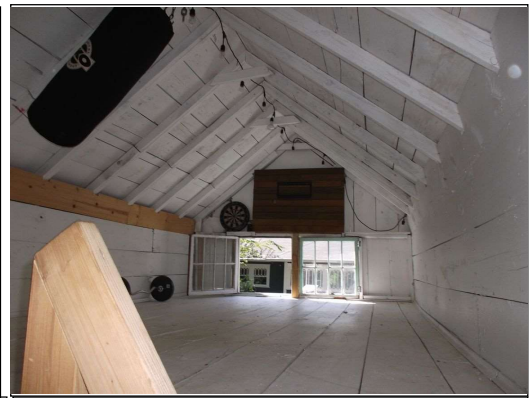
The exterior receptacle is loose at the siding. The garage has electrical wiring but cannot verify a sub panel and electrical is GFCI protected.

Cannot verify garage wired properly

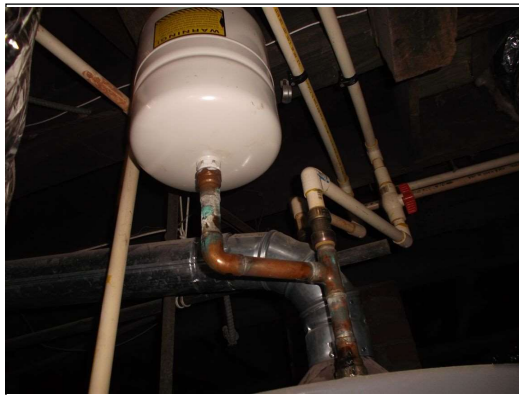
The water heater is resting on partial soil and gravel for the foundation but these materials are poorly installed and partially installed under the base of the water heater. The expansion tank is supported on the water pipe above the water heater and the floor joist above is pressing down on top of the expansion tank can damage the pipe or cause leaks (expansion tanks shall have independent support.

Expansion tank rests on water pipe

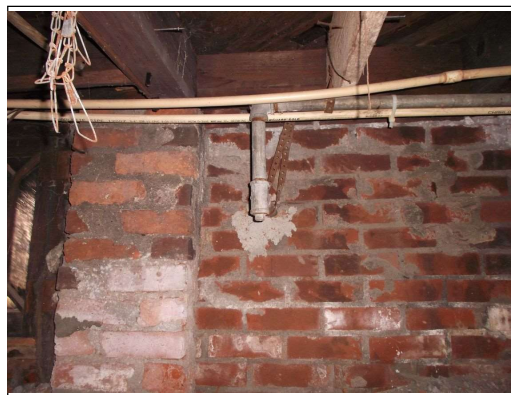
There is water pipe used for gas pipe visible in the crawlspace at various areas.

Water pipe for gas pipe in crawlspace

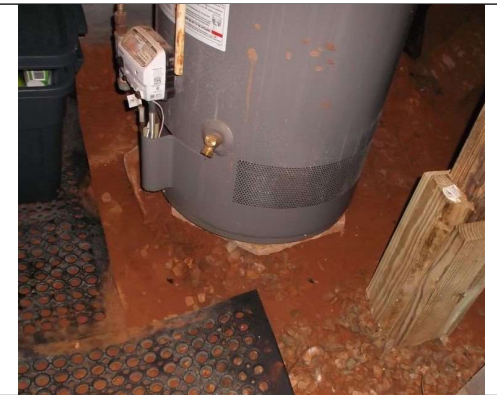
Water heater foundation/base defective

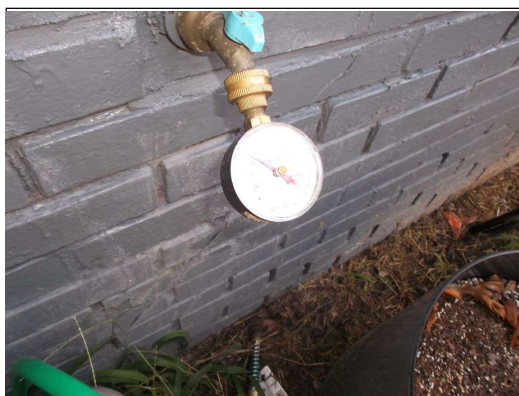
No anti siphon devices on hose faucets

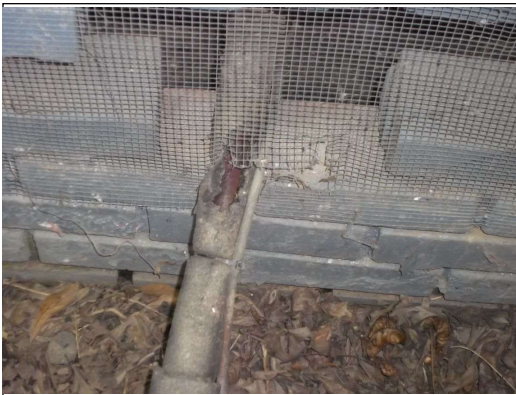
Refrigerant line insulation missing a section where pipe enters the crawlspace vent.

Missing refrigerant line insulation

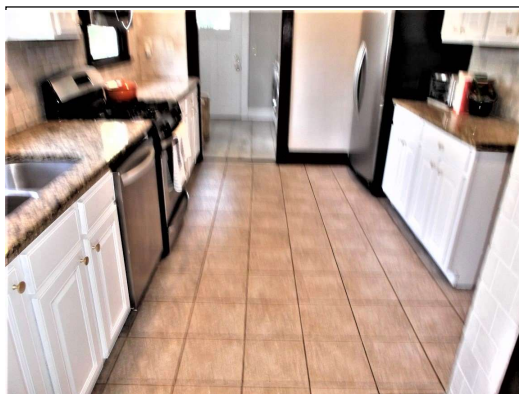
Floor slopes toward laundry

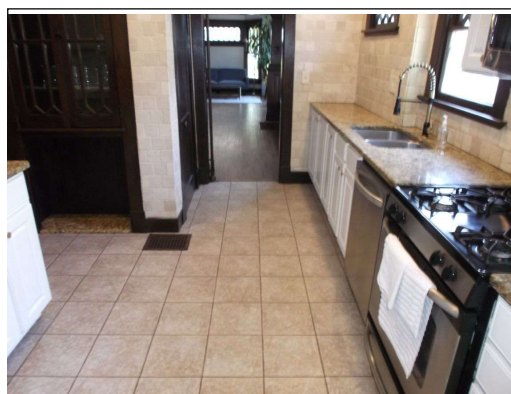
Floor slopes to dining and to center of house

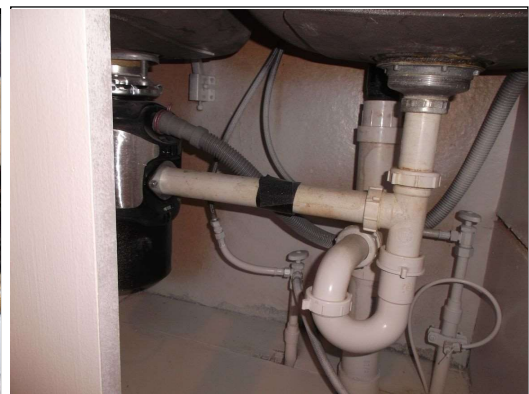
Tape wrapped around sink pipe

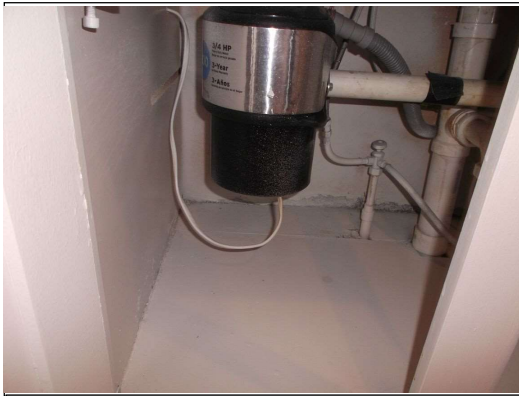
No conduit on disposal cable

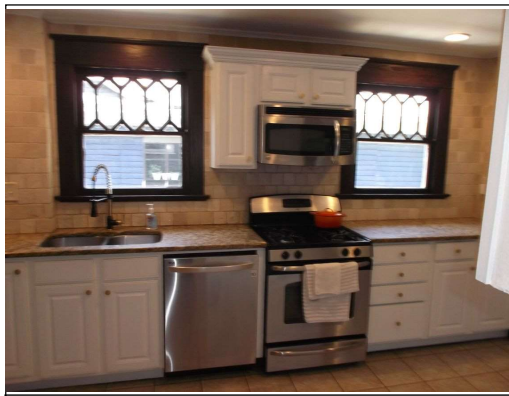
Not enough outlets on walls

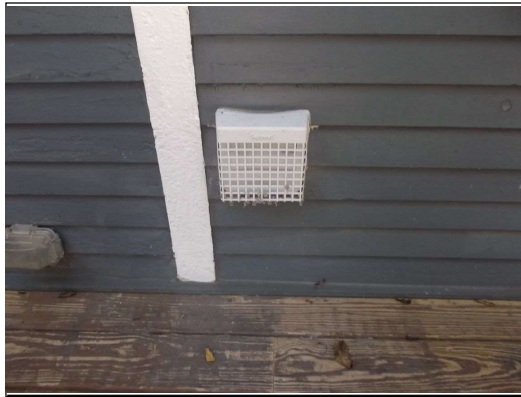
Improper dryer vent terminal

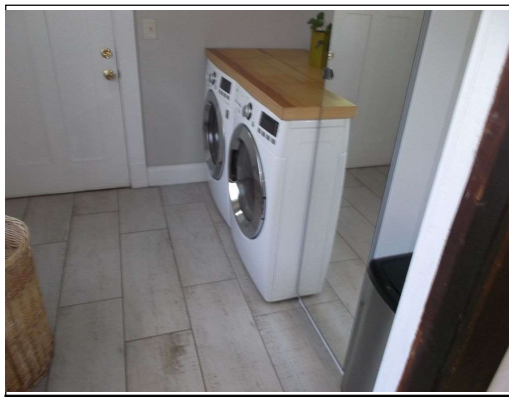
There is no washer drain pan installed in the laundry room.

No washer drain pan installed

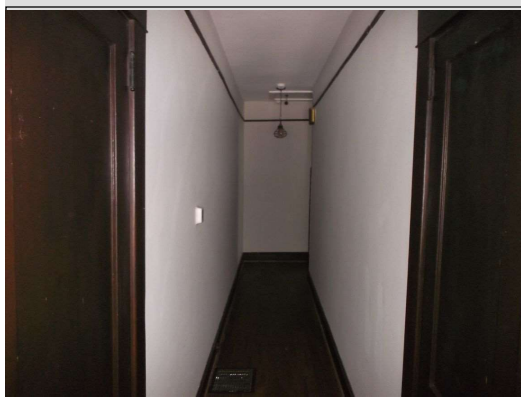
Hall & floor slopes to the center of the house

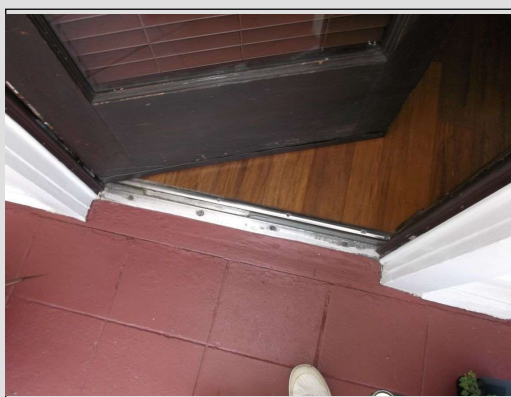
Front door threshold weather strip damaged

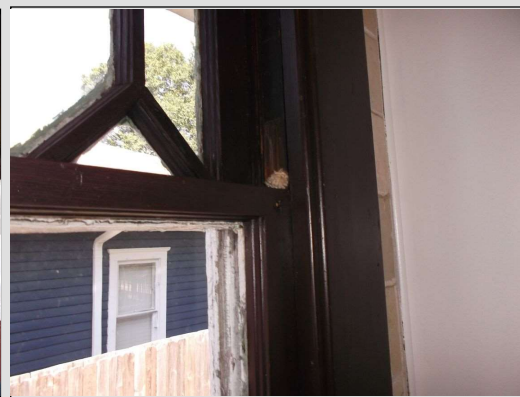
Broken window sash cords

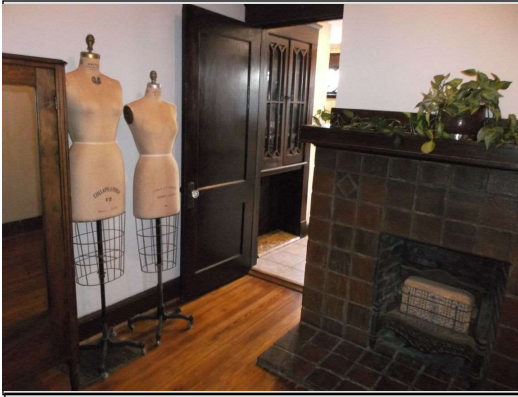
Master bedroom sitting room door to the kitchen rub the floor and door knob loose. Missing door stops at many areas in the house. Missing light globe at the master bed sitting room. Not enough electrical outlets around the walls.

Door drags on threshold, lock loose

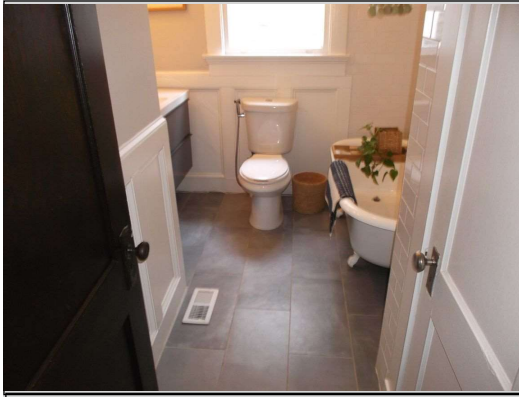
Tub reglazed

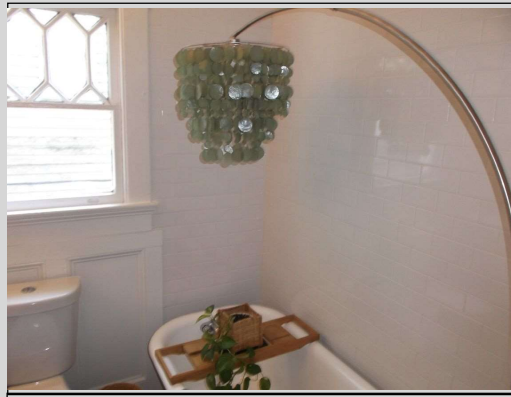
Hall Bath: There is a light fixture installed over the tub which is a serious electrical hazard.

Light over tub

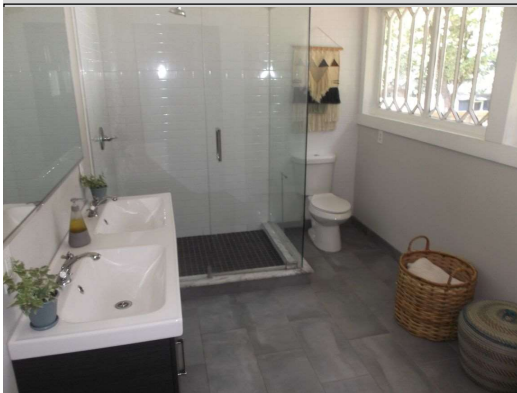
Floor slopes to toilet

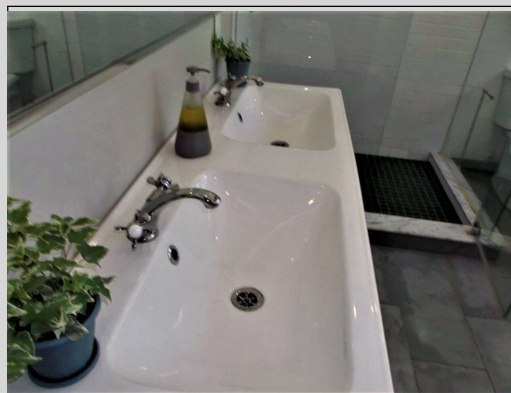
Little water flow from sink faucets

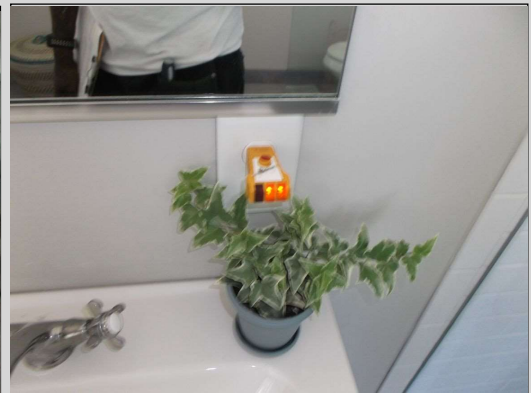
Outlet did not trip when tested

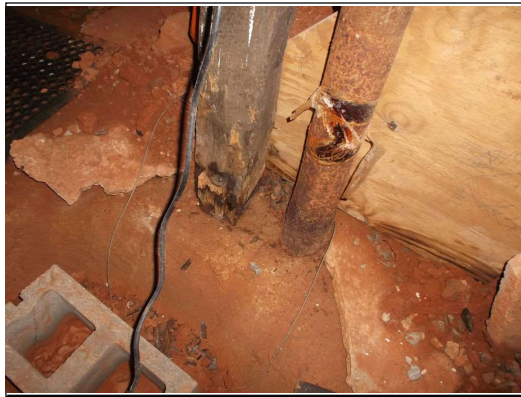
Missing moisture barrier, basement and crawlspace soils are wet. Belongings, discarded debris, wood... in the basement and crawlspace. Several wood support posts are resting in the soil at the basement and crawlspace. some steel support posts are in the soil and rusting through at the bottoms.

Wood posts rotting and steel posts in soil

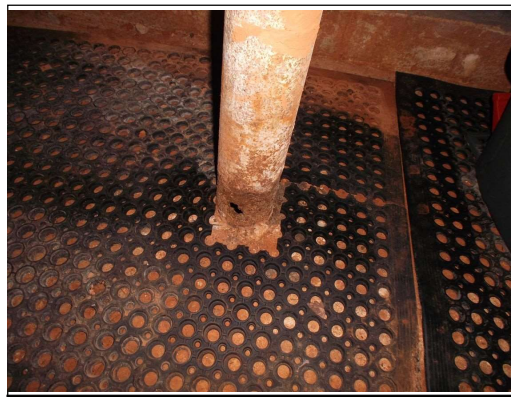
Steel posts rusting at the bottoms

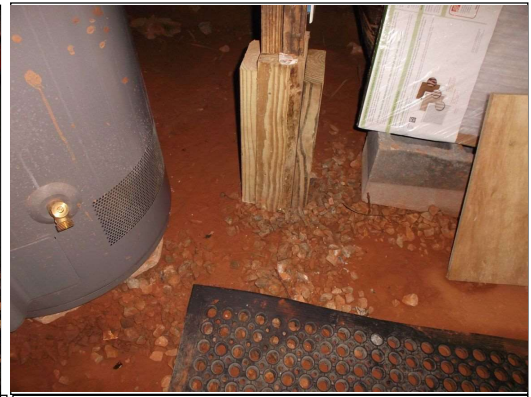
Wood posts in direct contact with soil

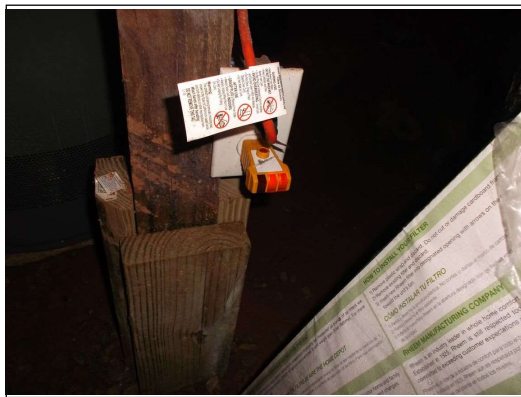
Outlet not GFCI protected

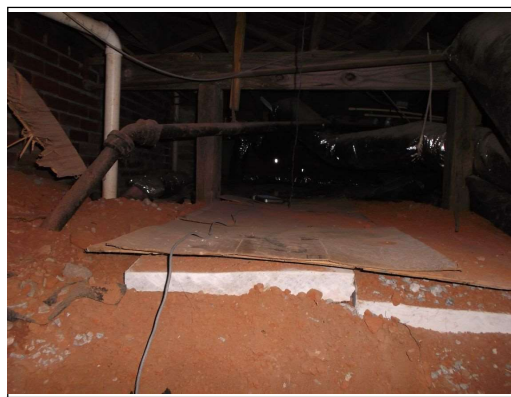
Missing moisture barrier and debris

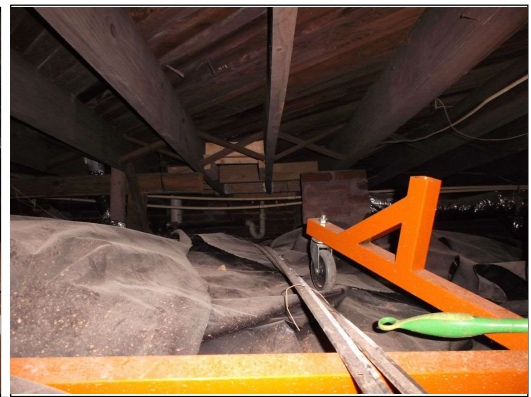
Floor system has patch repairs at the right

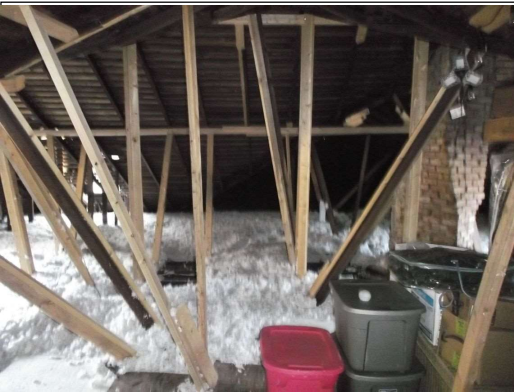
The roof framing structure has sagging and settling and support posts and bracing have been put in place but the roof structure was not jacked back up to original position. It appears that several roof braces and support bracing are improperly built and positioned. Based on the house floor and wall systems, it appears some of the roof settling may be caused by poor supports and posts in the basement, floors settling in the house and walls settling as a result. It is advised to review my findings and verify conditions and create a remedy for correct roof framing, roof support system and all bracing.

Defective roof brace supports/single 2x4s

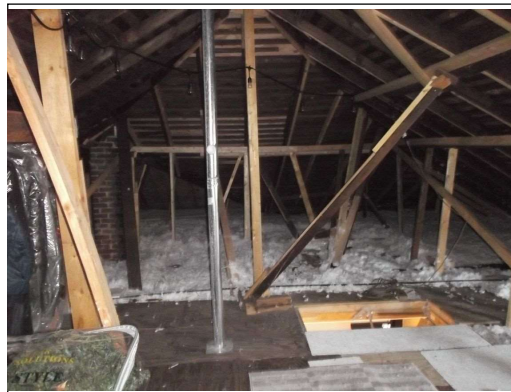
Defective roof brace supports

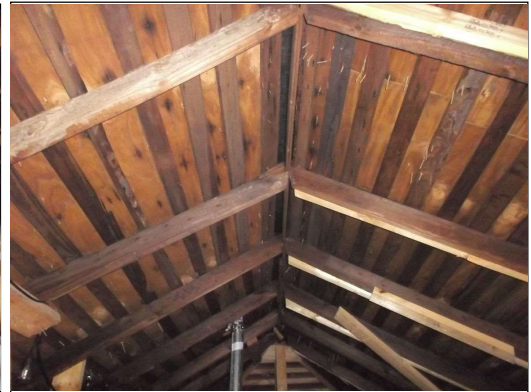
Defective rafter cuts to ridge boards

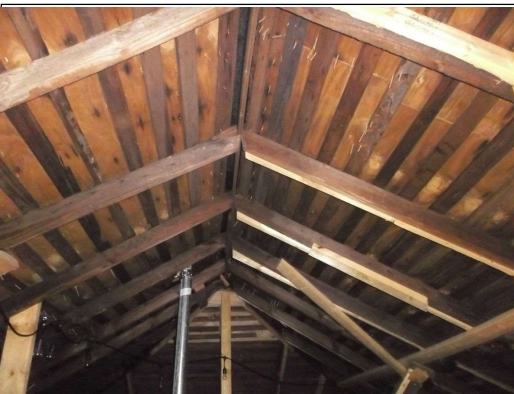
No collar ties on the rafters near the ridge

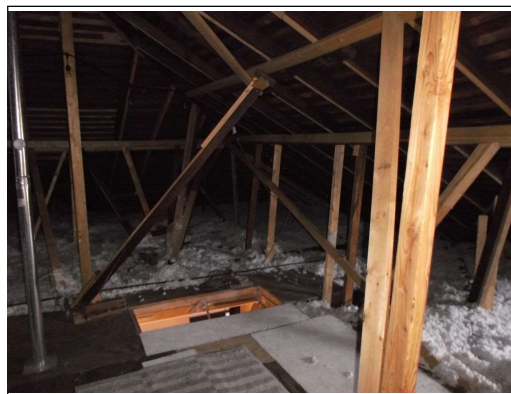
No eave venting

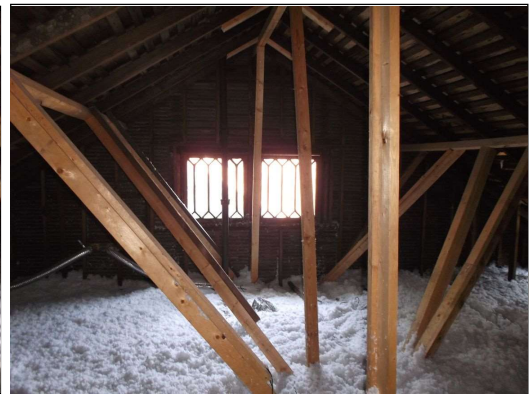
No gable venting

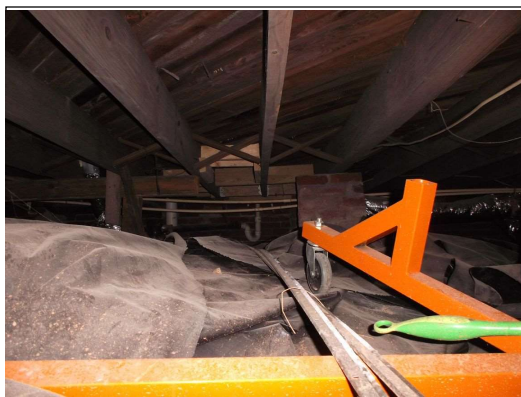
Floor repairs noted at right side of crawlspace

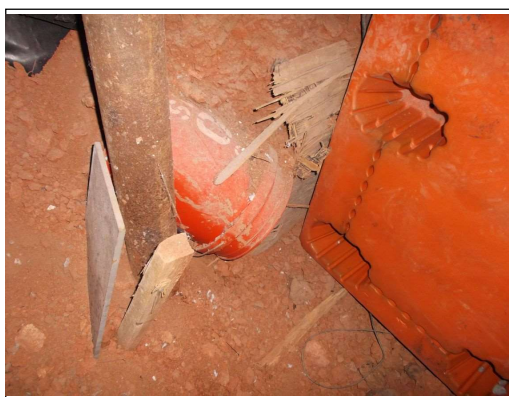
Debris in crawlspace; defective moisture barrier; soil damp. There is a fan that has been placed in the opening of one of the foundation vent locations that was running when the basement and crawlspace was inspected. It is obvious there is water intrusion at the crawlspace as the soil is damp. Can see some do-it-yourself floor repairs at some areas in the crawlspace.

Missing moisture barrier/wet soil

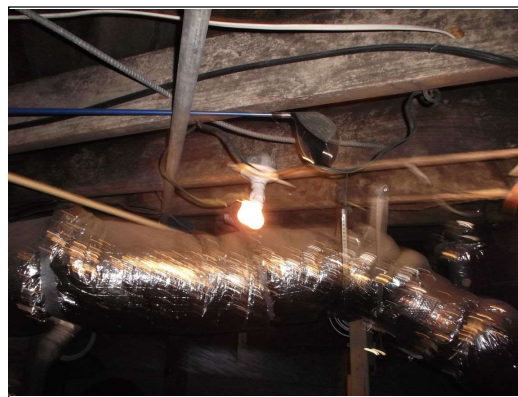
Mold like substance on floor joists
