# PROPERTY INSPECTION REPORT

521 Thomaston St. Barnsville, GA.

2-4-2020

2116

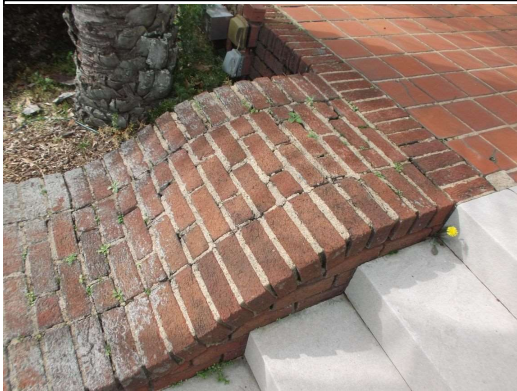
Deteriorated mortar at front porch step walls

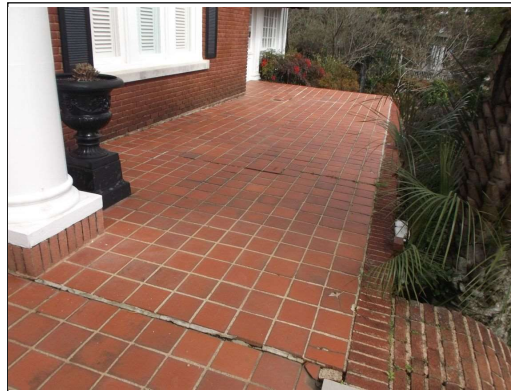
Front porch floor has settling cracks

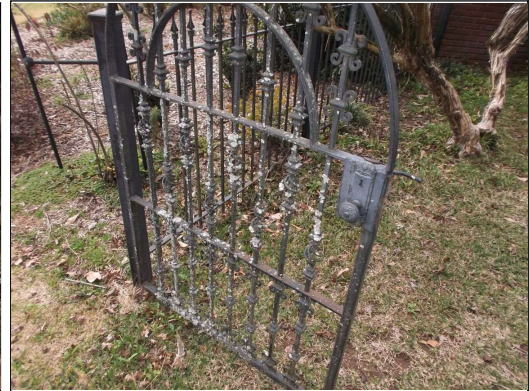
Wrought iron fence & gates need wash, paint

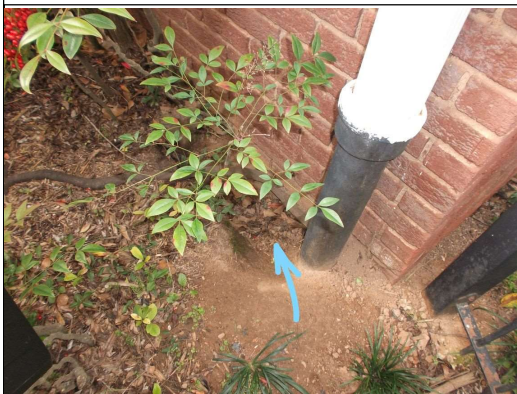
Hole in the soil at the foundation left side

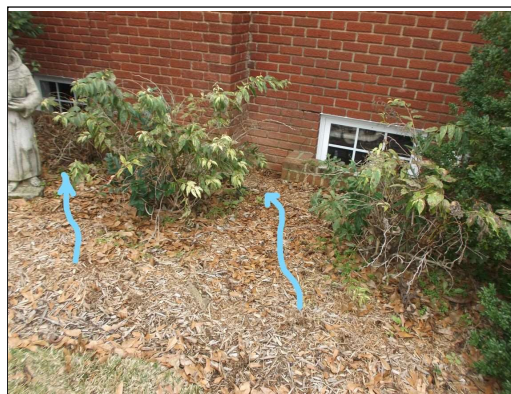
Soil slopes to the building at the right side

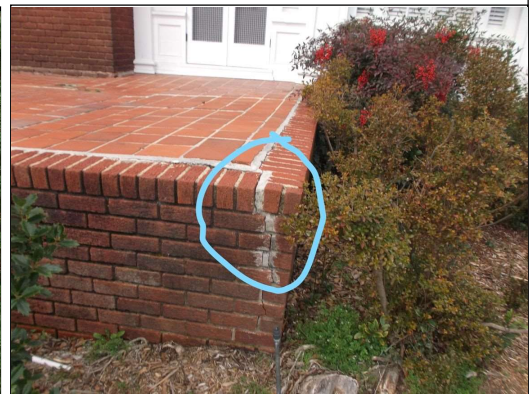
Front porch floor brick has movement cracks

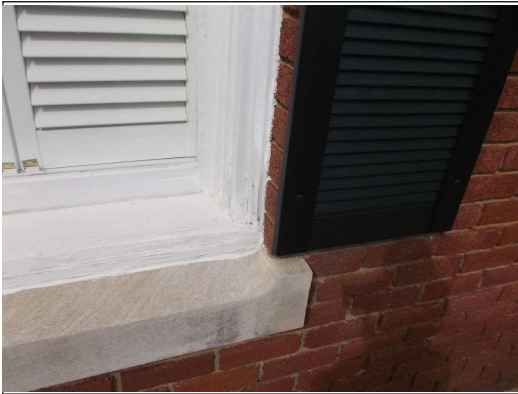
Window trim has water damage

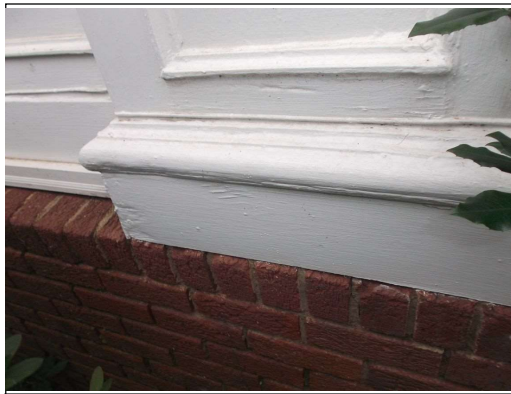
Water damage to wood trim

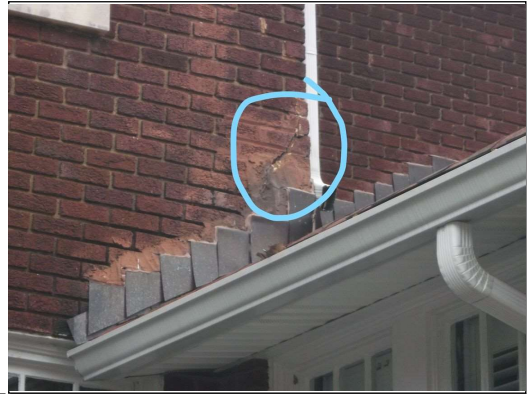
Settling crack in brick above sun porch roof

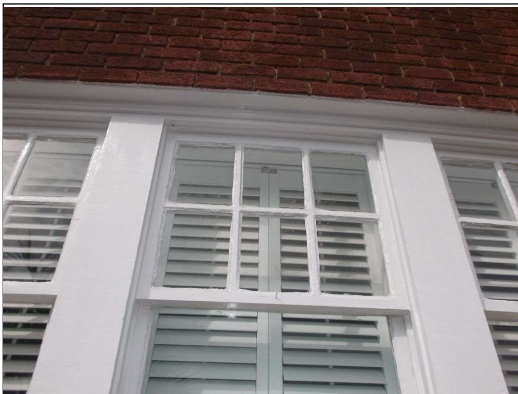
Window glass putty defective several area

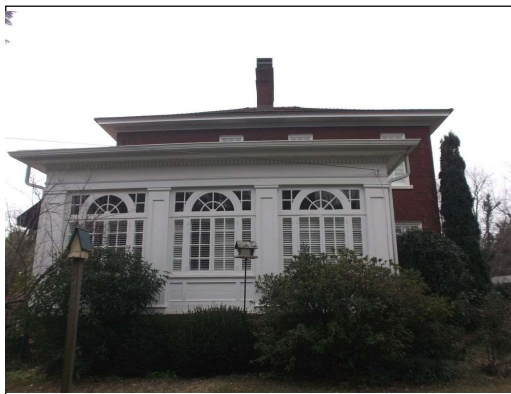
Defective paint at sun porch trim

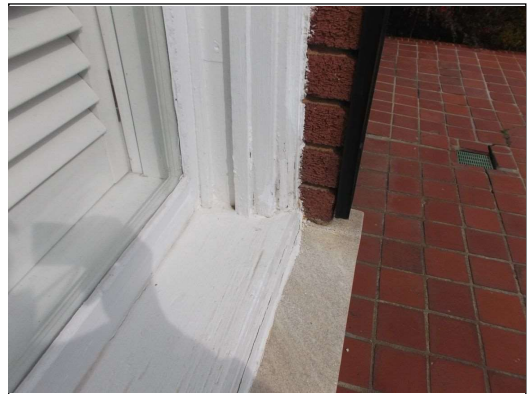
water damage to front window frames

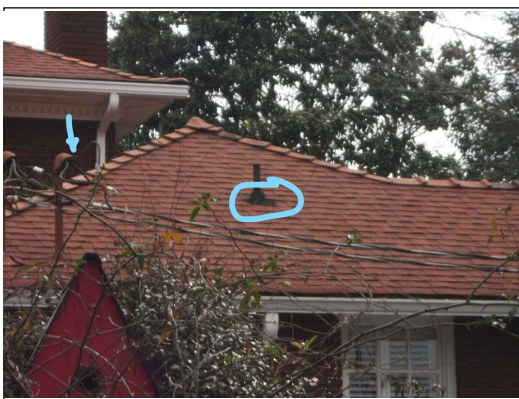
Flashing installed on top shingles face nailed

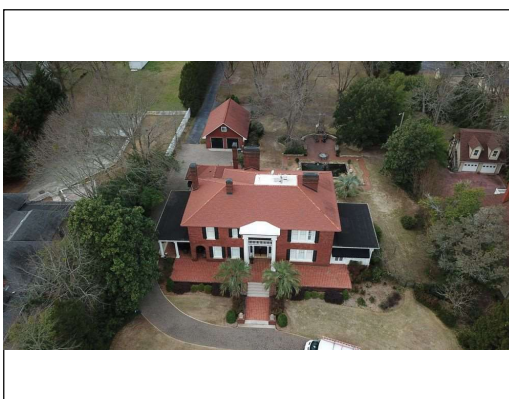
Roof deck system flat where it nears gutters

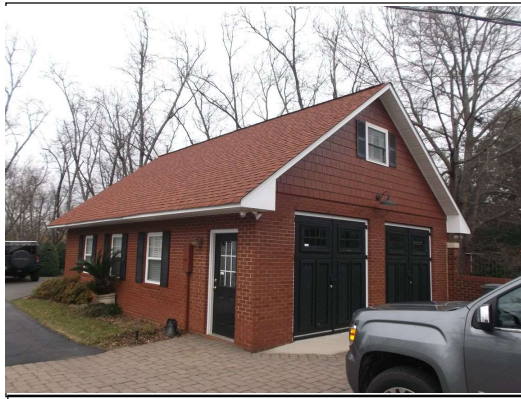
No gutters at main garage

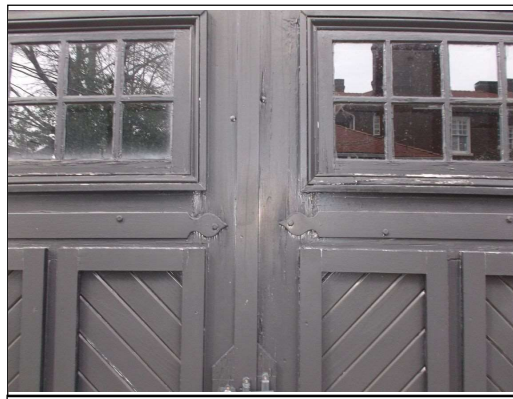
Garage doors have water damage

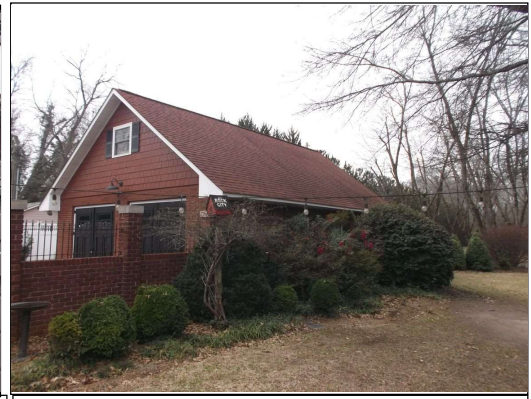
Bushes touching side of building

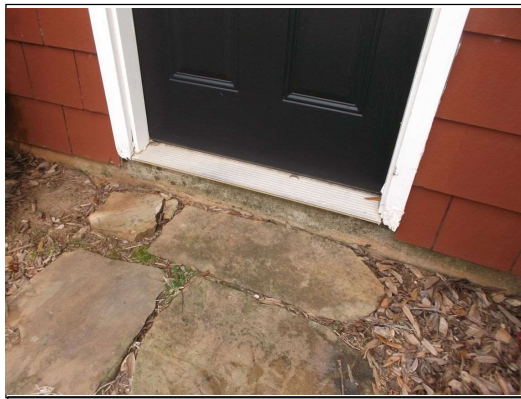
Water damage to storage house door frame

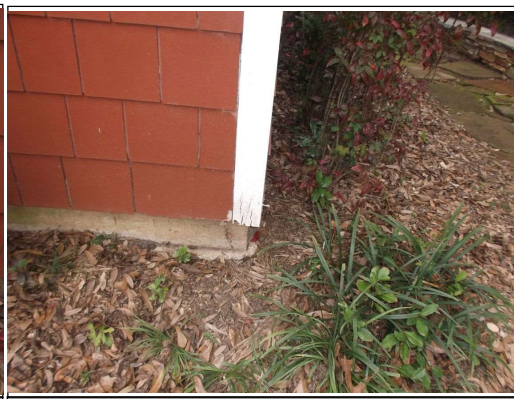
Water damage at storage house trim

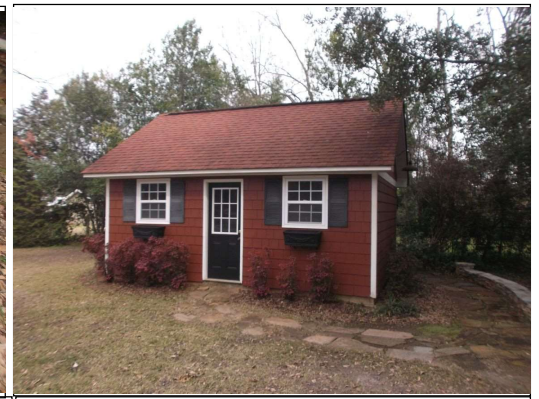
No gutters at storage house

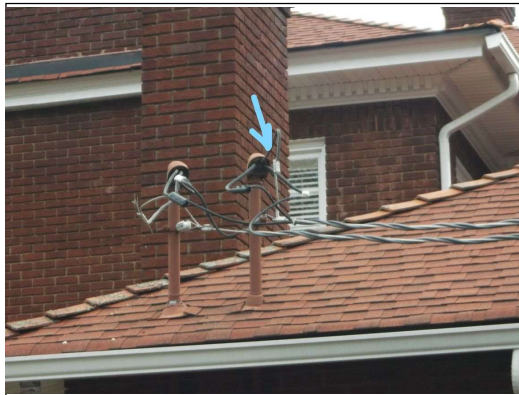
The service cables from the utility pole to the house has a poor drip loop at the mast head where they can allow water to drain from the cables into the mast head openings when raining under certain conditions;

Improper drip loop in service cables

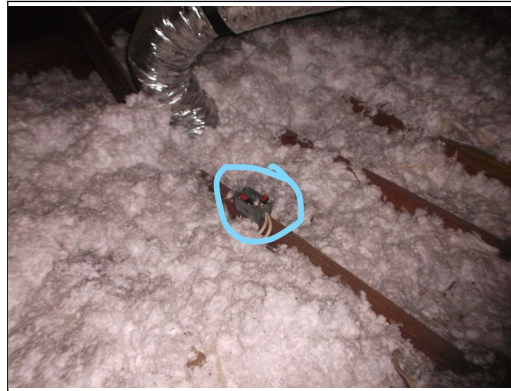
Open junction boxes &amp; exposed connections

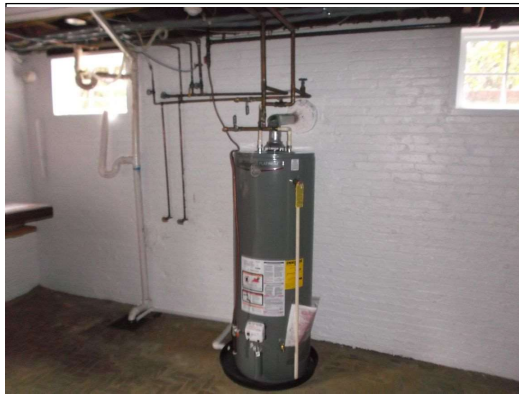
No expansion tank above water heater

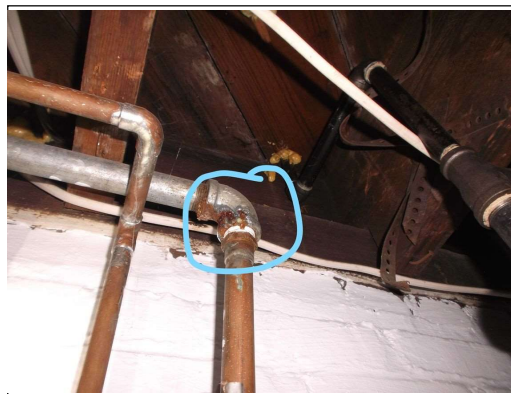
Copper and steel pipe join and rust

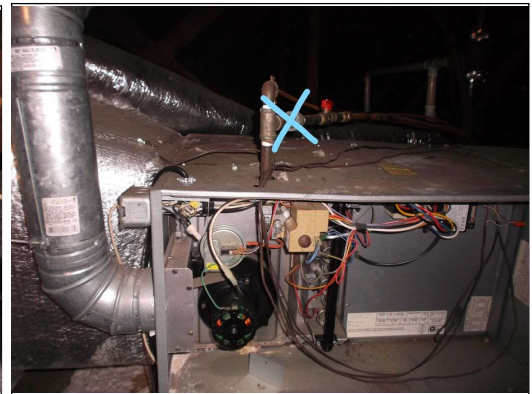
No sediment trap in gas pipe to attic furnace

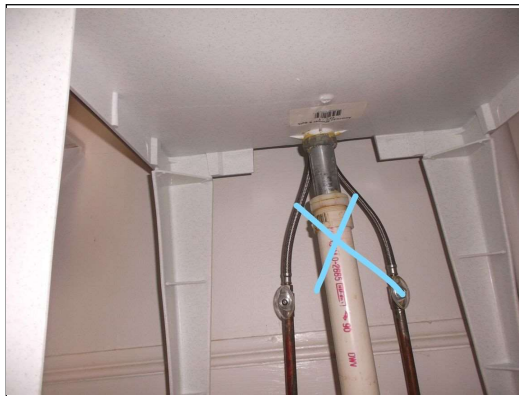
No traps in waste pipes under some sinks

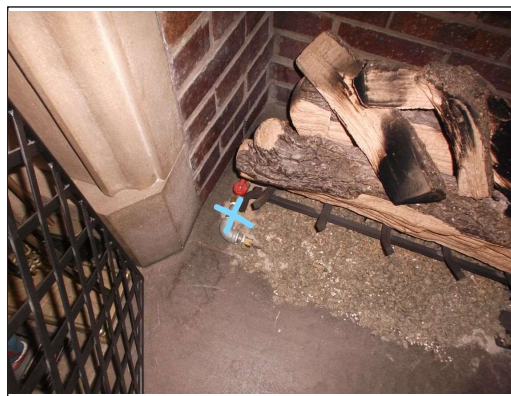
Water pipe for gas pipe at fireplaces

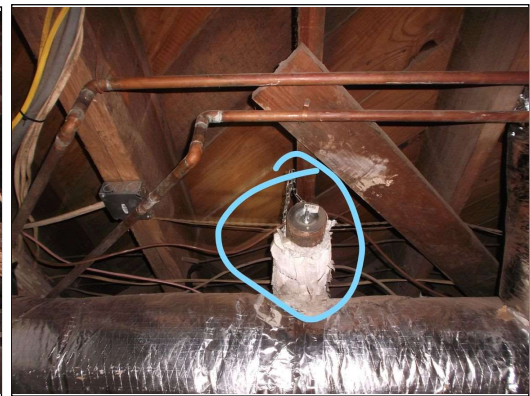
Asbestos tape noted on old steam pipes seen in the basement (damaged, deteriorating, detaching...);

Asbestos tape on steam pipes

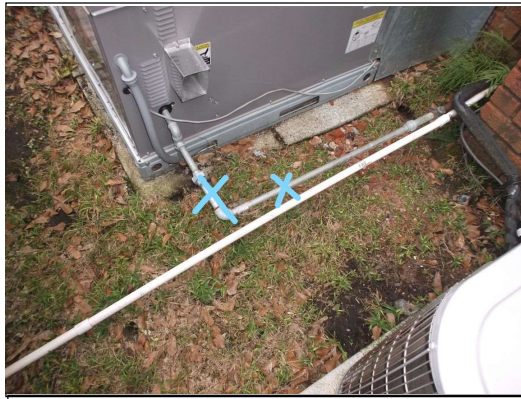
Water pipe for gas pipe 1st HVAC heat unit

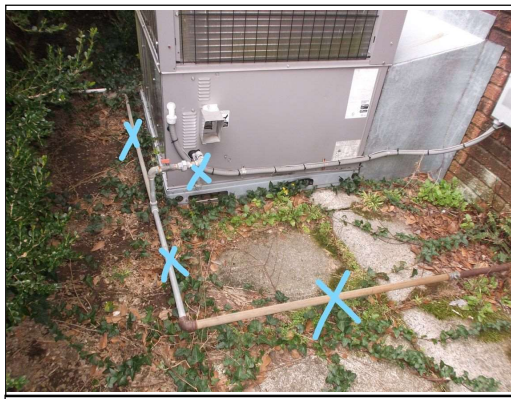
Water pipe for gas pipe 2nd HVAC heat unit

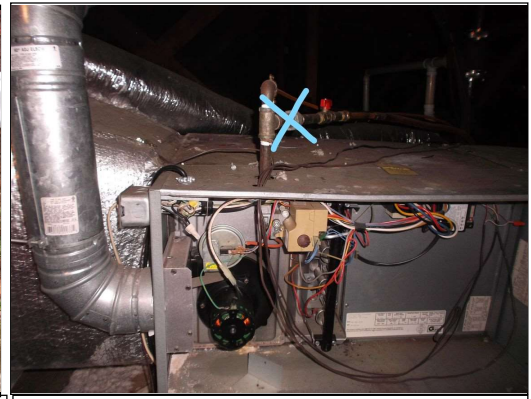
Missing sediment trap in gas pipe to furnace

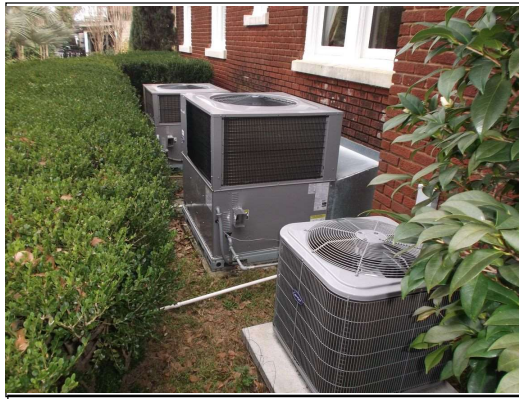
Bushes too close to HVAC units

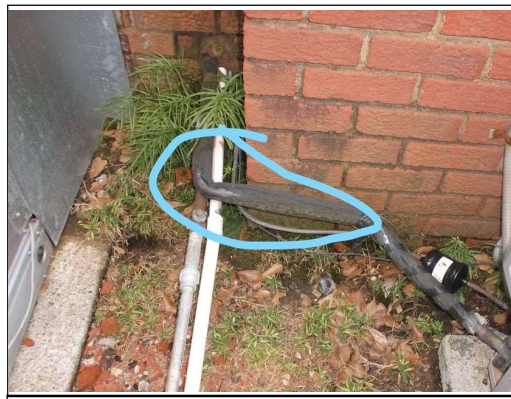
Refrigerant line insulation deteriorated

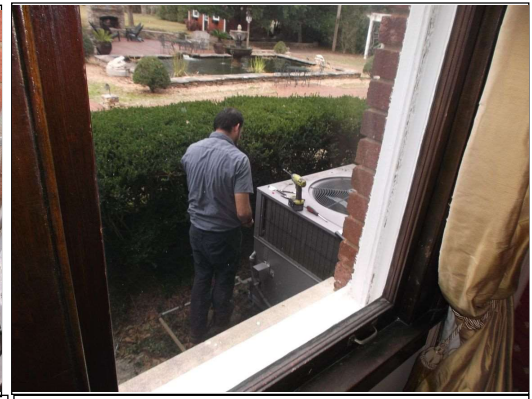
HVAC Tech was working on systems

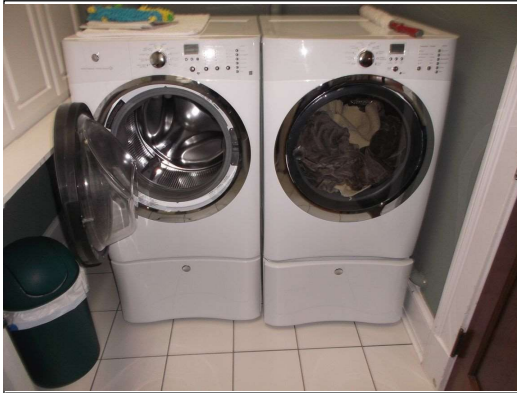
No washer drain pan installed

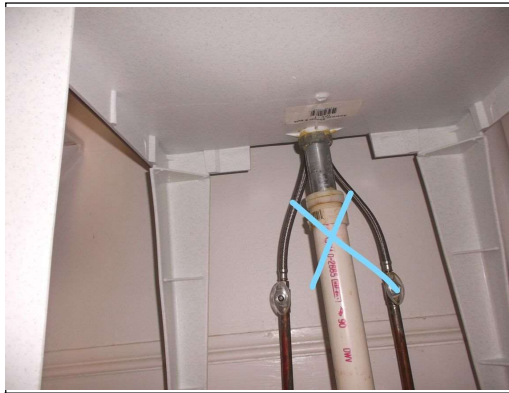
Washing sink drain pipe improper/unsafe

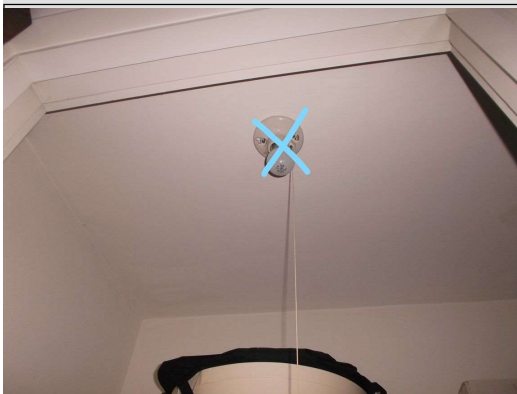
Exposed light bulbs in closets

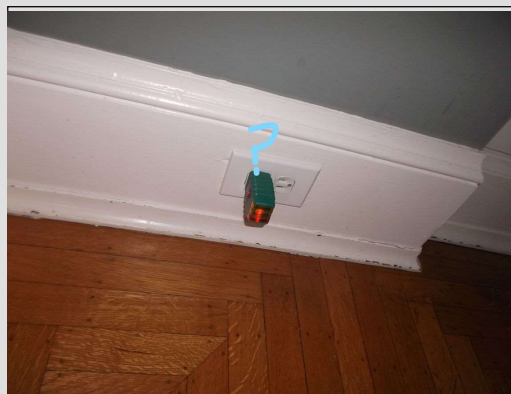
Hot and neutral reversed at bedroom outlet

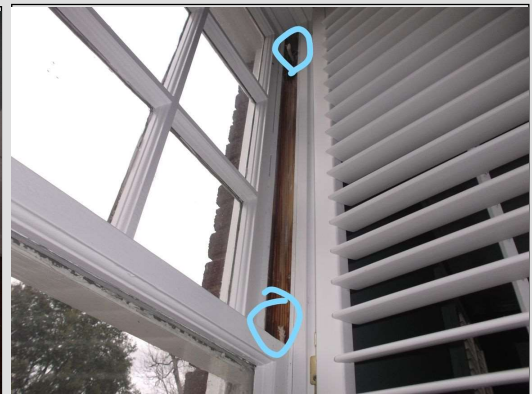
Sash cords and springs broken at windows

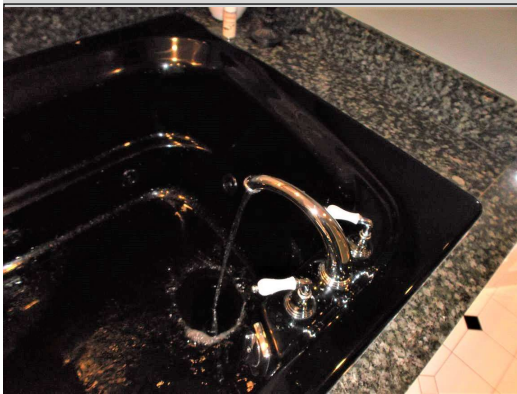
Low water flow at master tub faucet

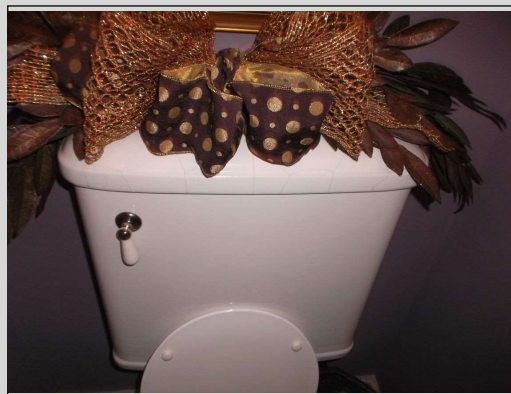
Toilet tank tops cracked several baths

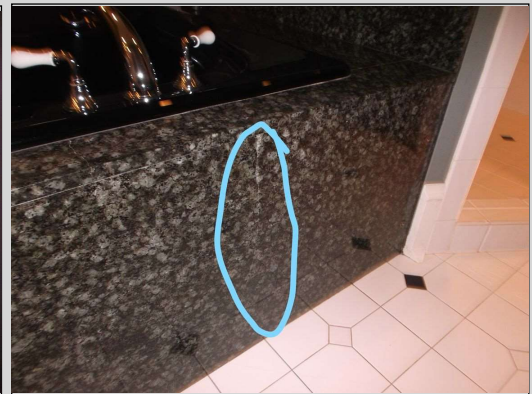
Crack in master tub granite wall

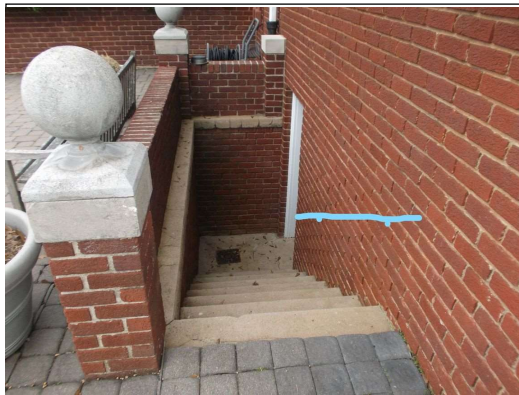
No hand rail at stairs to the basement

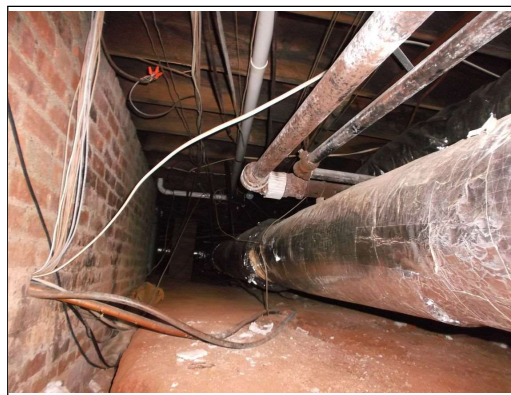
Missing moisture barrier in crawlspace

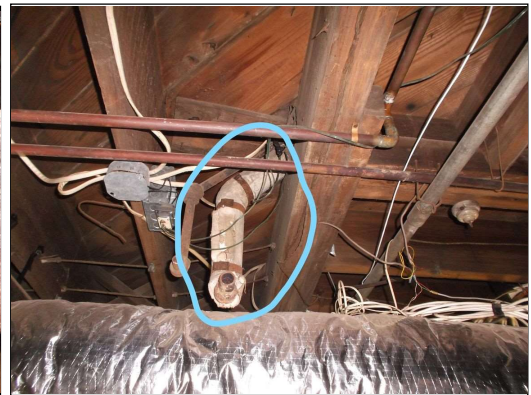
Asbestos tape

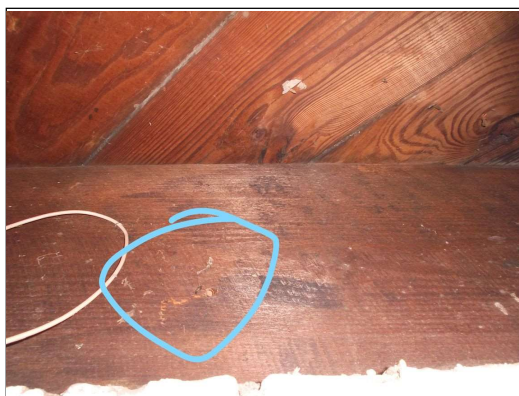
Termite trails in some floor joists & rim joists

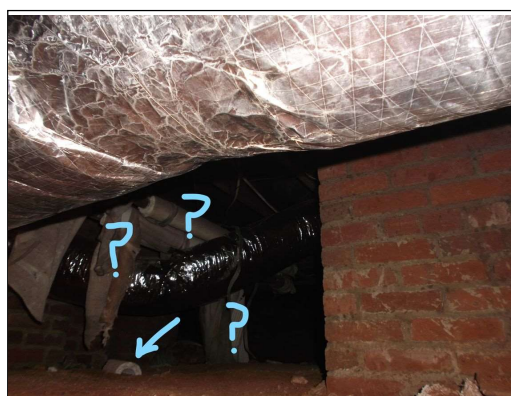
Damaged and loose Asbestos materials

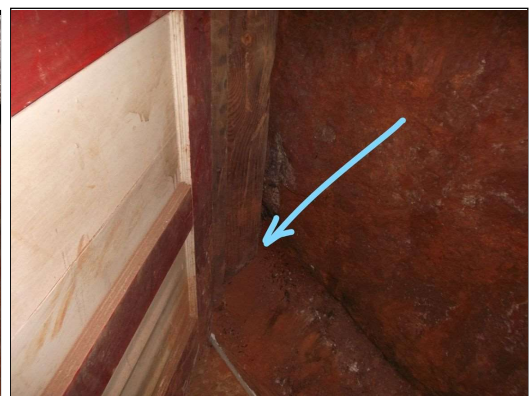
Wood wall framing in the soil

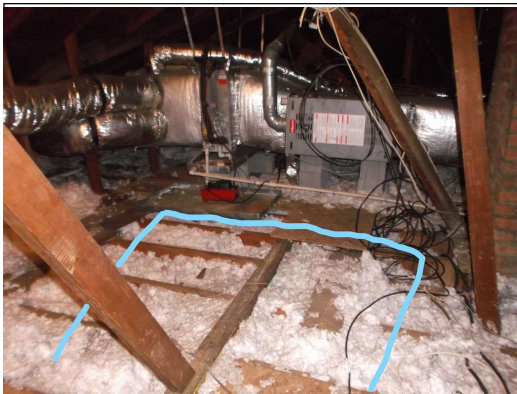
Missing flooring leading to the furnace

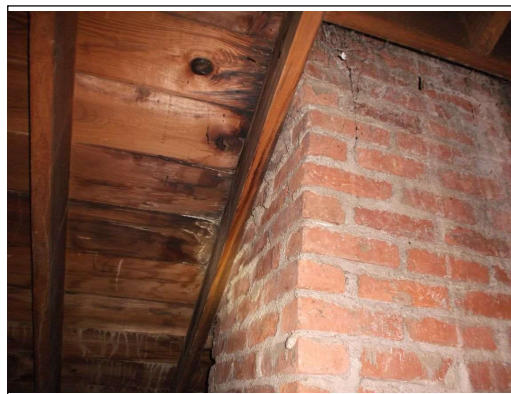
Dry water stains under roof decking

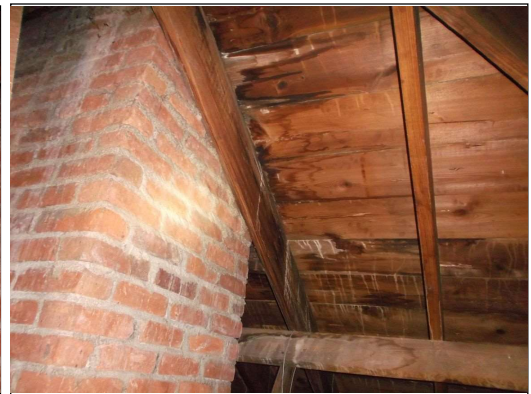
Water damage to roof decking at chimney

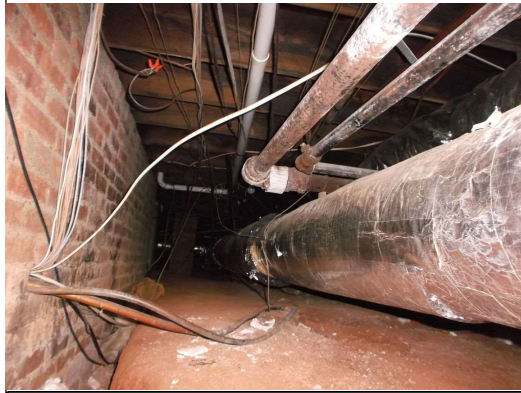
Missing moisture or vapor barrier

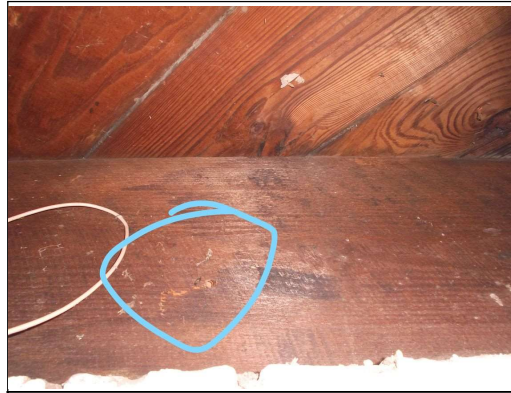
Termite trails in some floor joists
