Property Inspection Report

199 West Broad Street Monroe, GA.

Inspection Date:

March 17, 2020

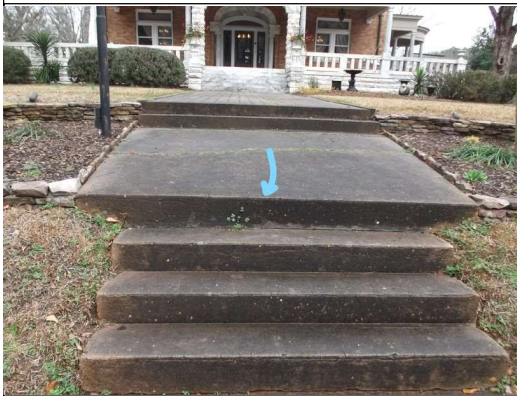
Rotting tree in front yard; front walkway rotates forward at the main stairs down to the street; retaining wall at the rear yard has tree root bulge, excessive leaning and may fail over time;

Front main walkway rotates forward at stairs

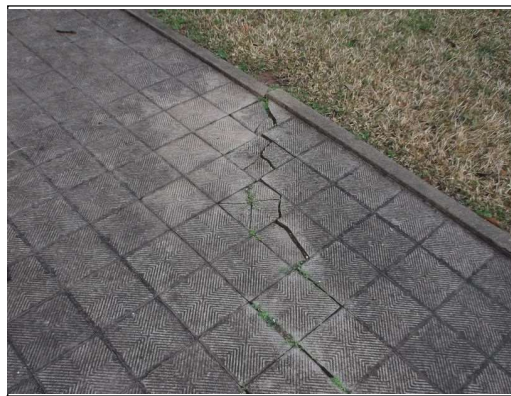
Front walkway has heaving sections and movement cracks can be trip hazards; rear stairs to the basement are cracking and broken;

Moderate cracks in front walkway

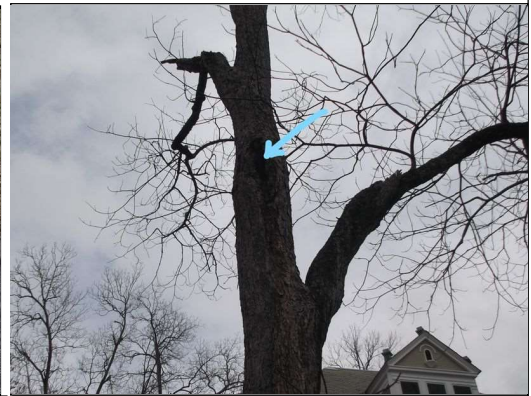
Rotting tree at the front yard

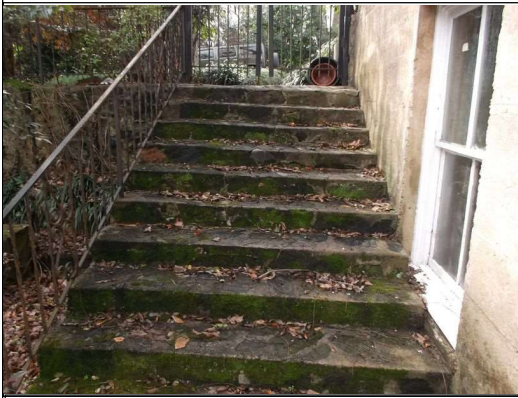
Rear stairs to basement cracking and broken

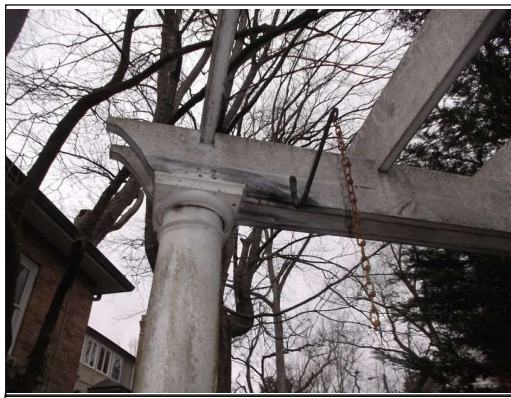
The courtyard wood trellis has rotted beams and joists and needs pressure wash and paint; the wood fence at the rear yard needs pressure wash and repair at some areas; the outhouse at the rear yard needs siding repair and painting;

Water damage to rear courtyard trellis wood

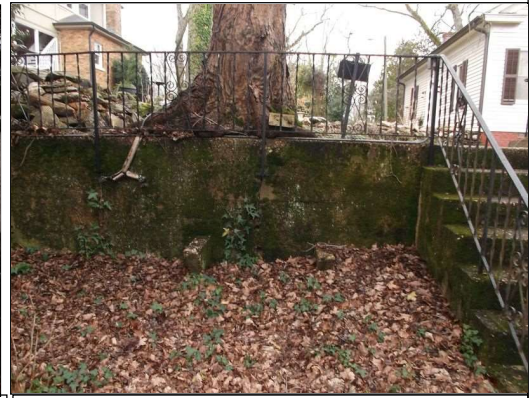
Rear yard retaining wall leaning and no holes

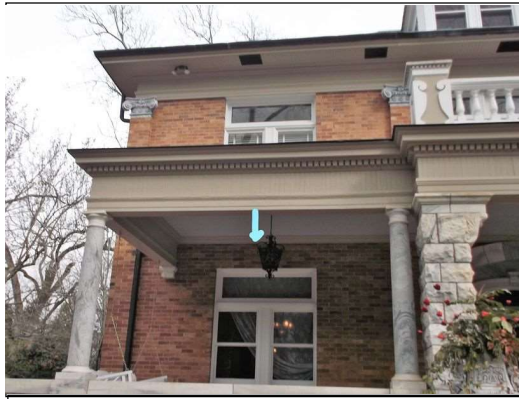
Front left porch beam sagging

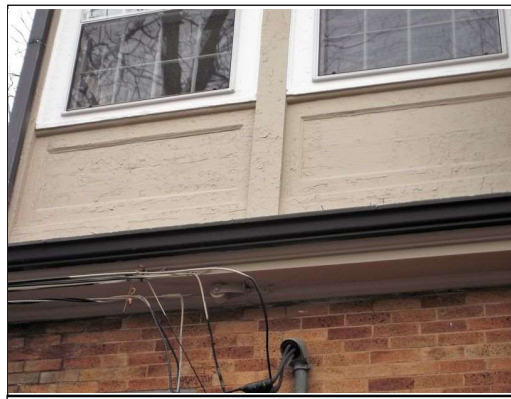
The original paint on the wood materials has a high possibility there is lead in the paint. EPD requires special procedures for repairs and painting this home. It is advised to note that a qualified contractor do all repairs and painting;

Defective paint at wood at box windows

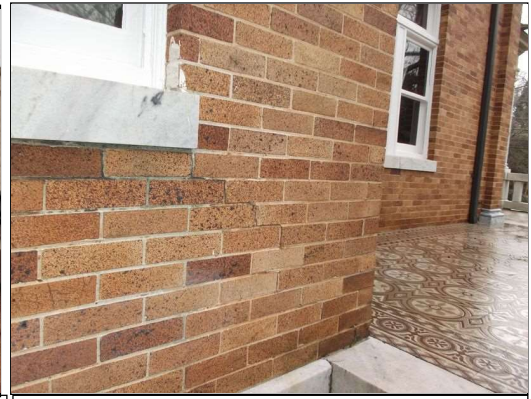
Settling crack in brick veneer at the left front

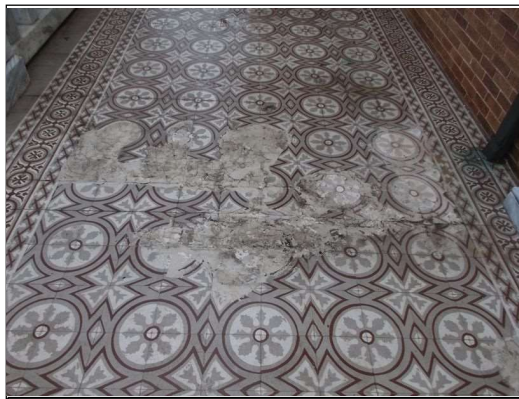
Front porch floor has water damage to tiles

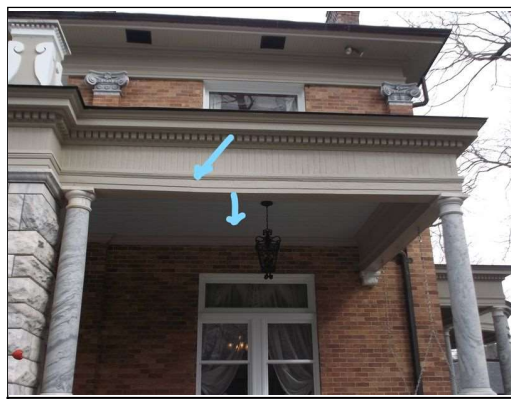
Water damage and sagging beam front porch

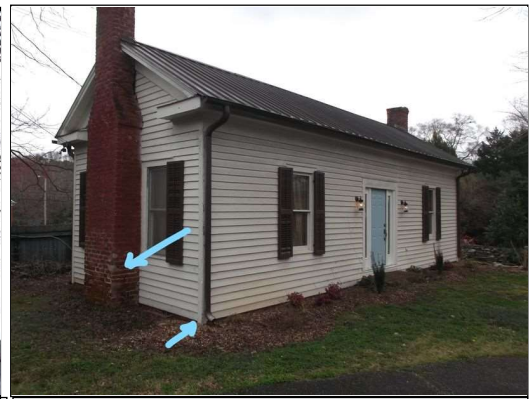
Damaged chimney brick @ guest house

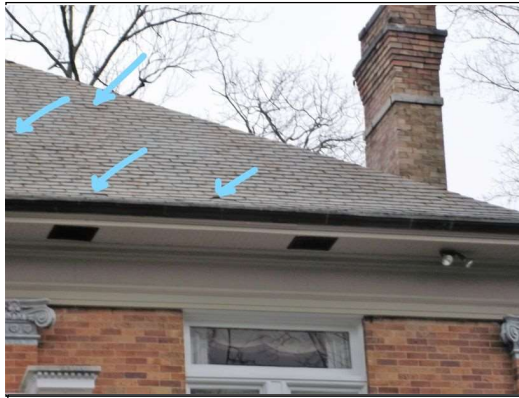
Broken and missing slate shingles

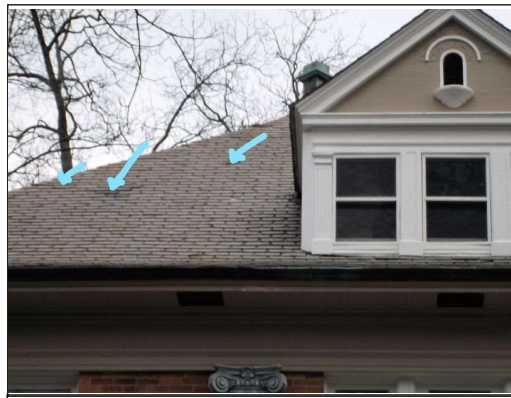
Broken slate shingles

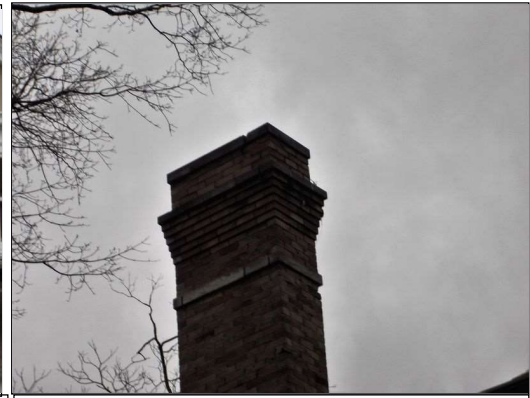
Defective & deteriorated mortar @ Chimney

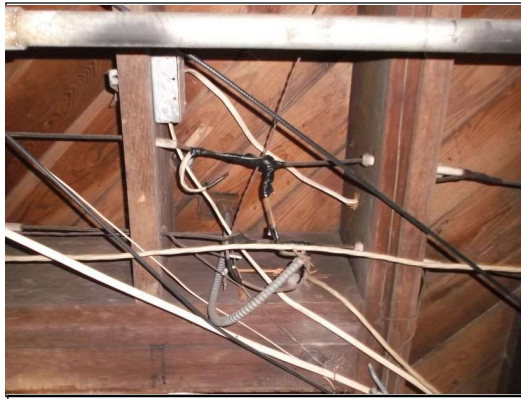
Exposed wire connections @ basement ceiling

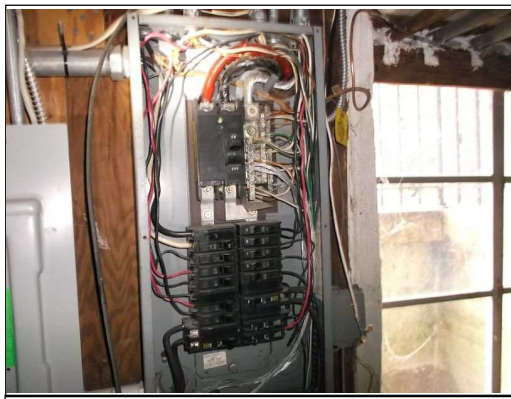
Sharp screws in panel box

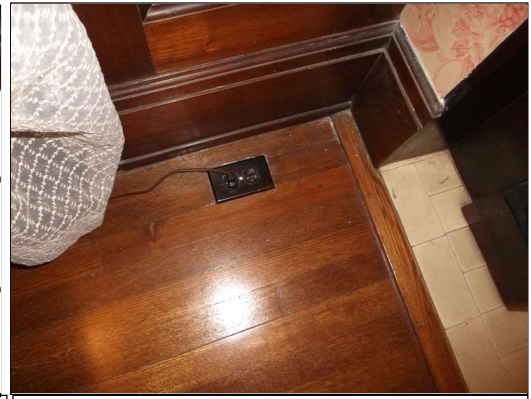
Improper receptacles in floors

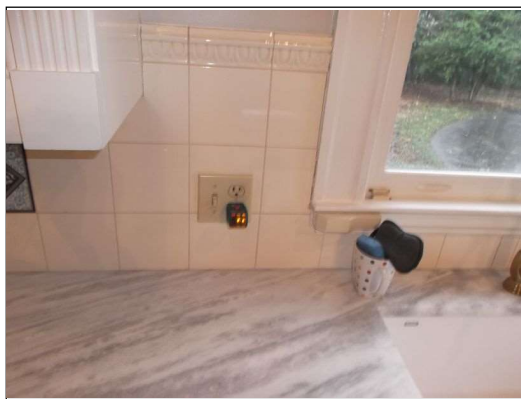
Kitchen outlets not GFCI protected

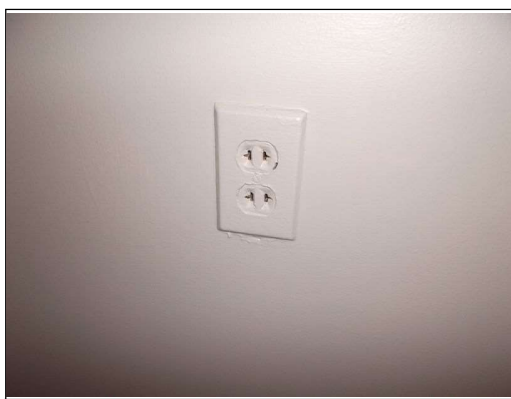
Outlets have no ground several areas

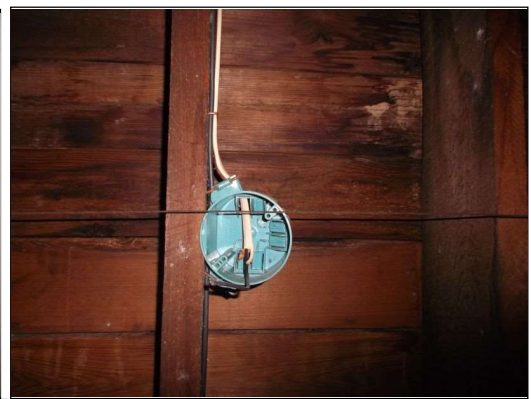
Open junction boxes/exposed wires @ attic

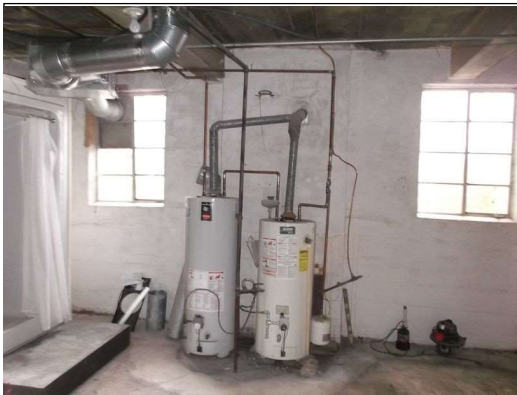
Water heaters at end of use

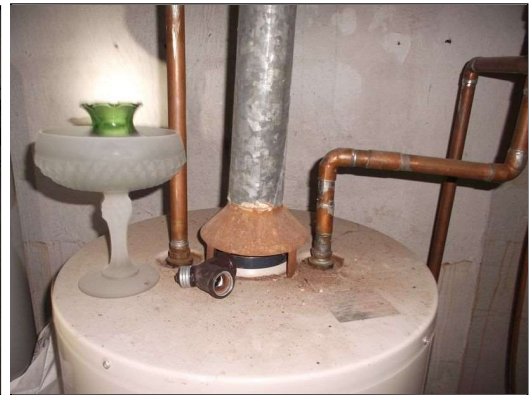
Copper & steel join without dielectric fittings

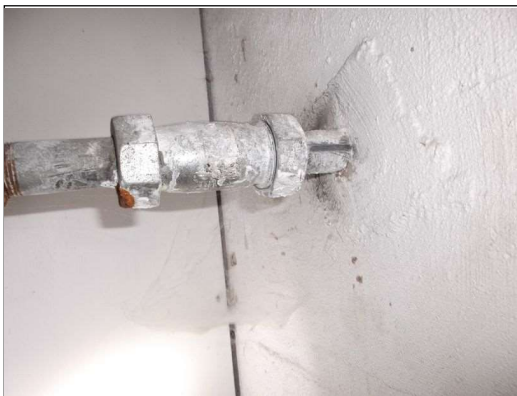
Main water pipe galvanized steel end of use

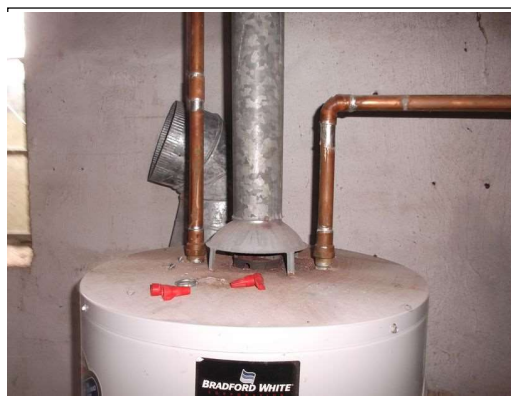
Copper & steel join without dielectric fittings

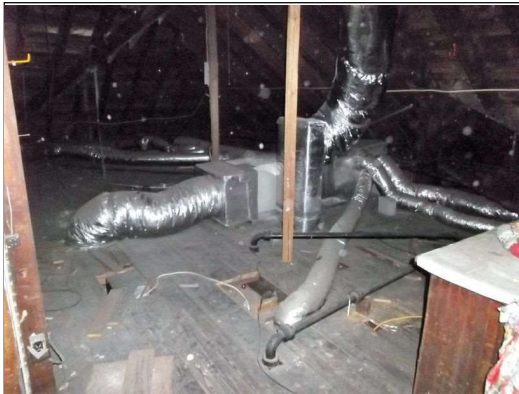
2nd attic furnace needs repair

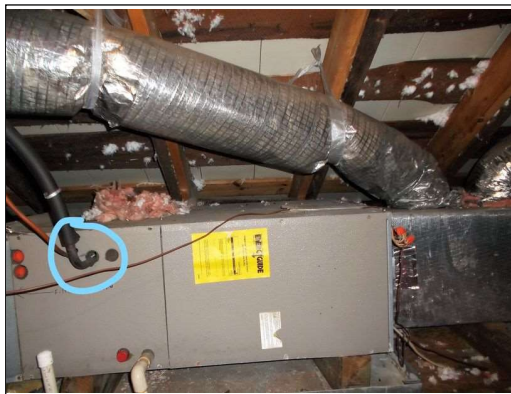
Missing refrigerant line insulation at out house

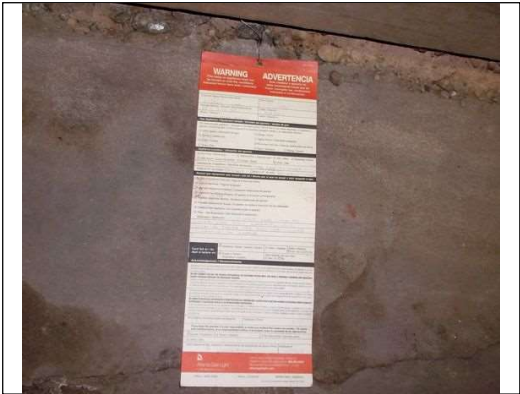
Furnace has been red tagged in basement

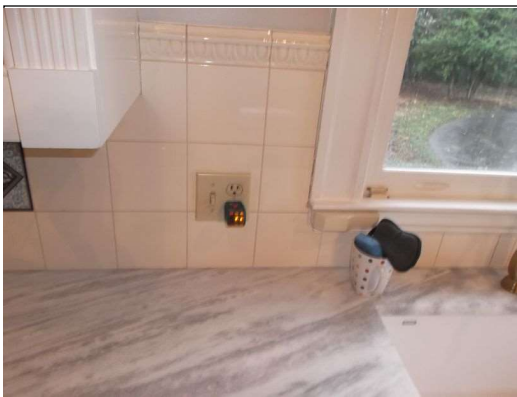
Outlet not GFCI protected

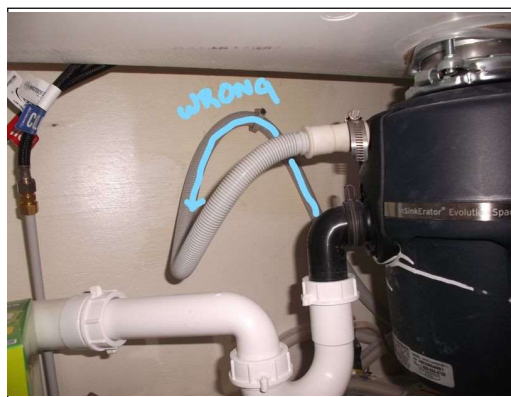
Dishwasher drain pipe not high looped

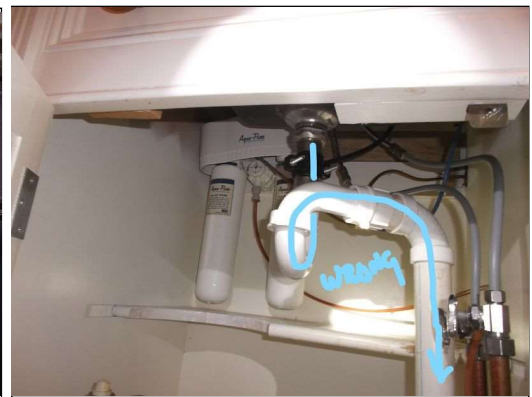
Sink drain pipe is a S-Trap

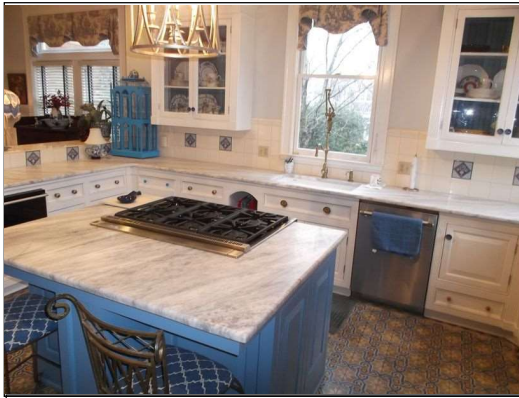
Kitchen outlets not GFCI protected near sink

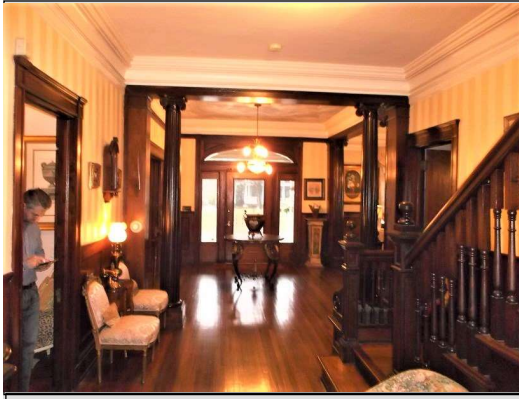
Hall floor slopes to the right

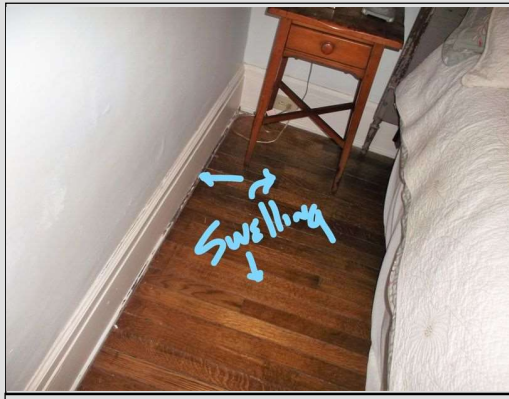
Swelling in left bedroom floor

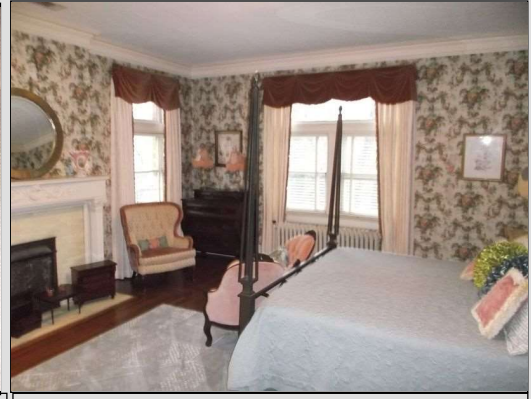
2nd bedroom floor slopes to exterior wall

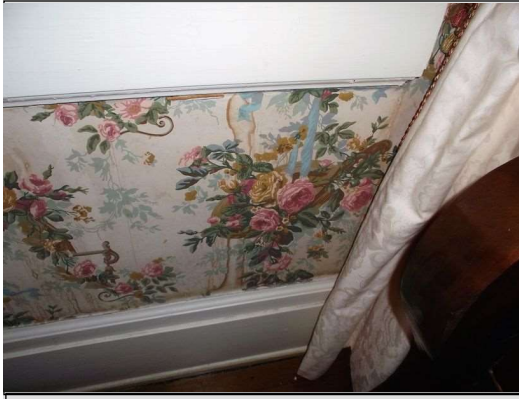
water stains in wal paper

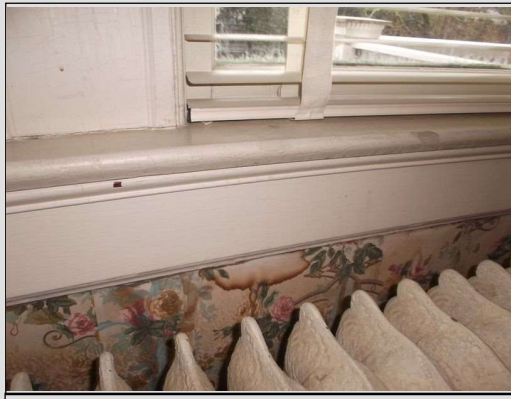
Water stains below windows

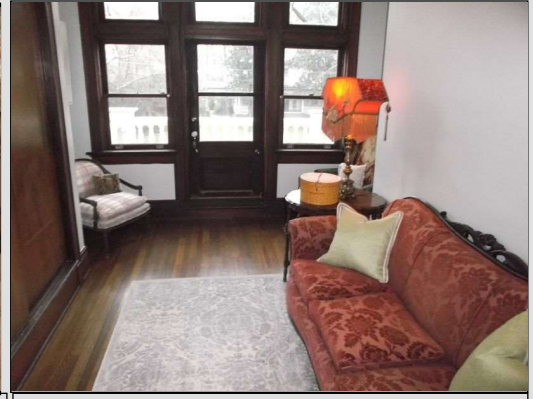
Hall slopes to front wall

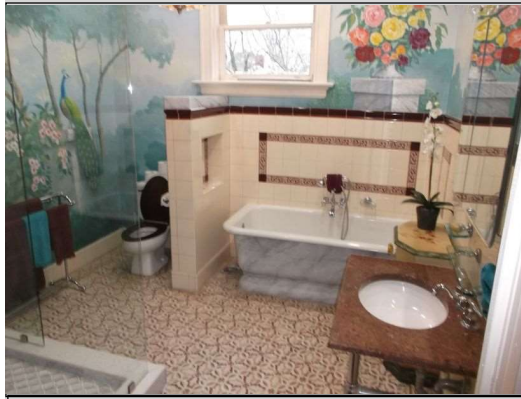
Tub faucet defective

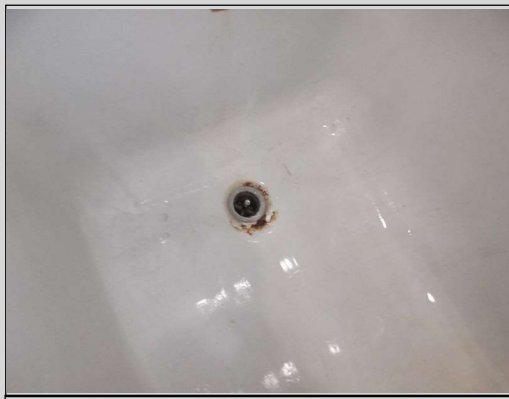
Rust in tub finish and stopper missing

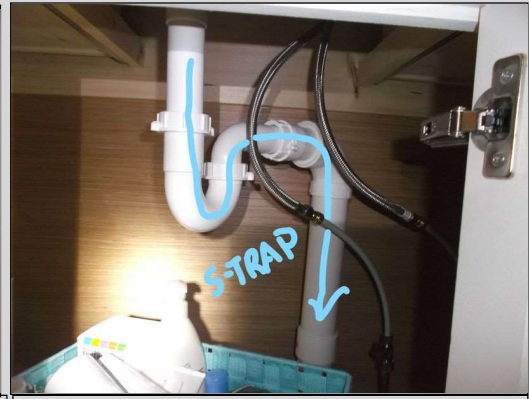
Sink has S-Trap

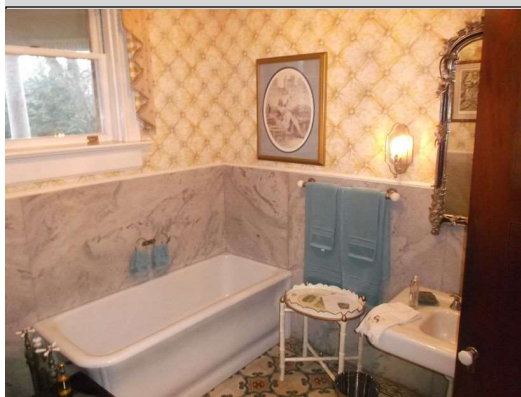
Bed bath floor slopes to tub

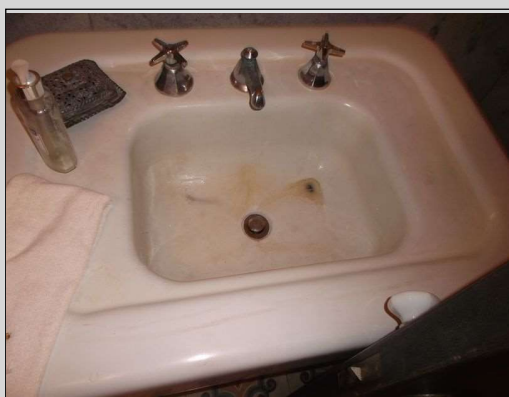
Sink bowl has rust in finish

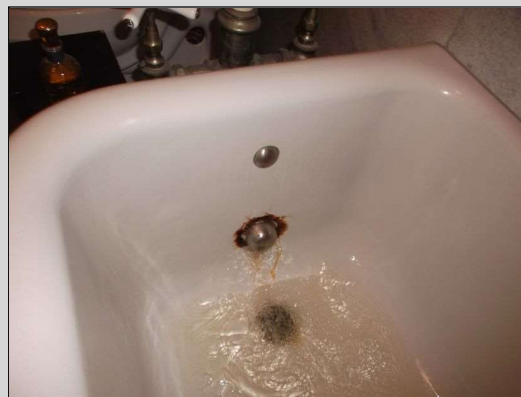
Rust in tub water

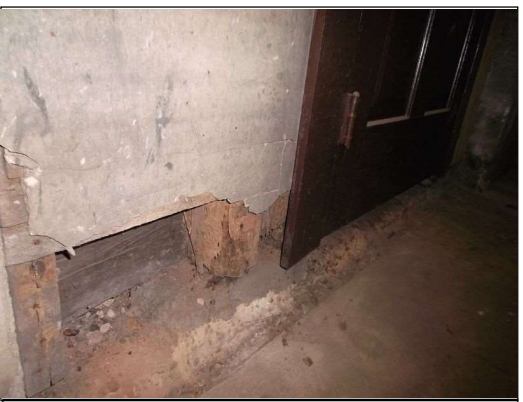
Basement wall framing dry rot several areas

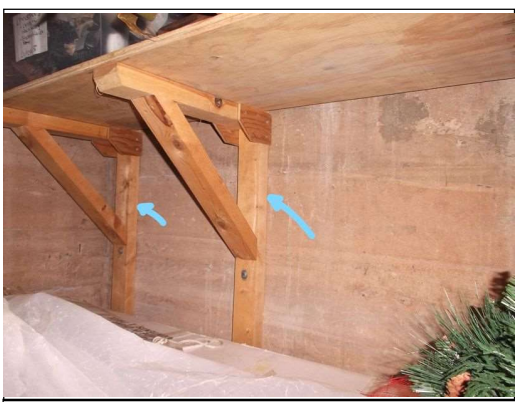
None treated wood attached to masonry

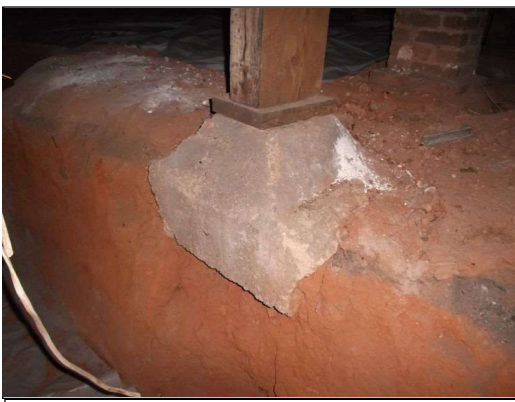
Foundation poorly rests on dirt

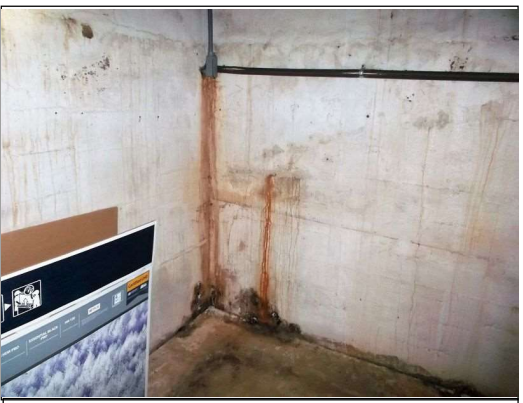
Water intrusion at front basement wall

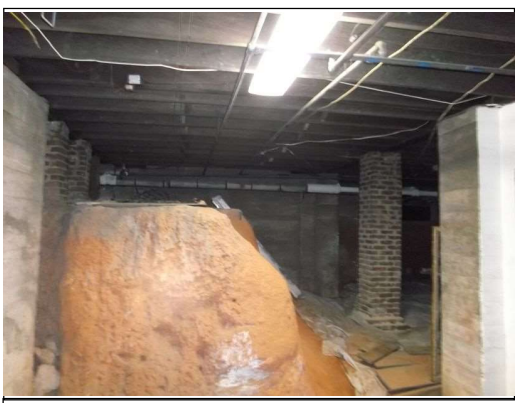
Exposed soil in crawlspace

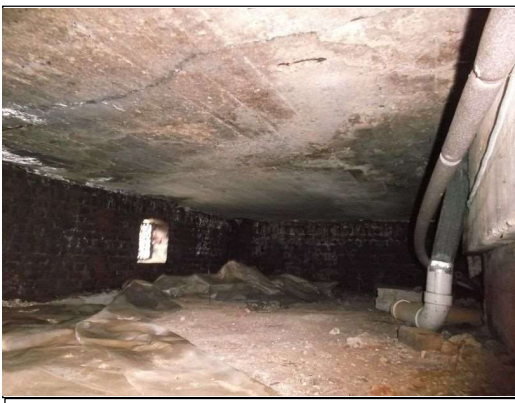
Exposed soil in crawlspace under porch

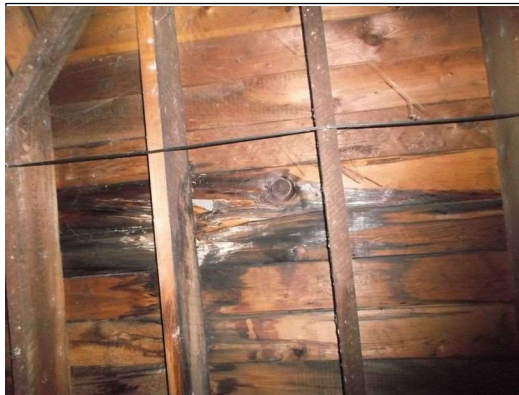
Mold and fungus under roof decking

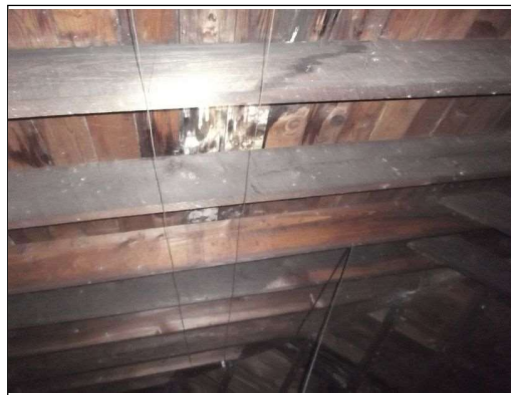
Mold, rot under roof decking

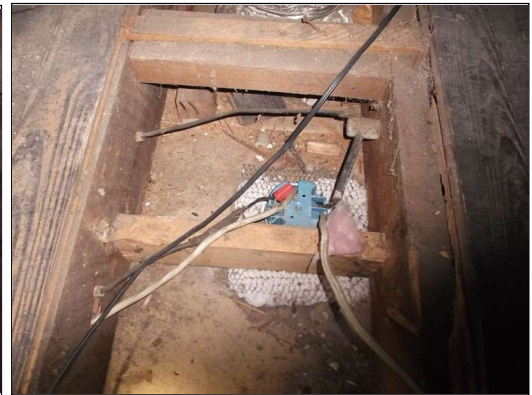
Exposed wire connections in attic floor

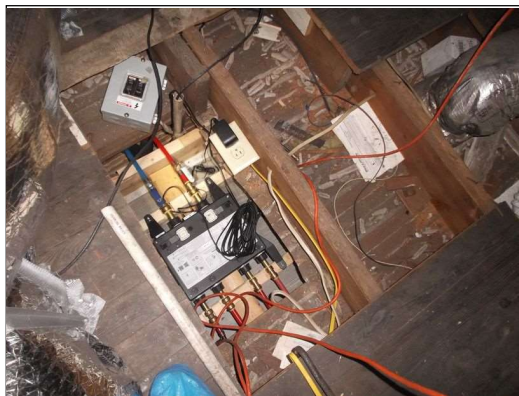
Missing ceiling insulation several areas

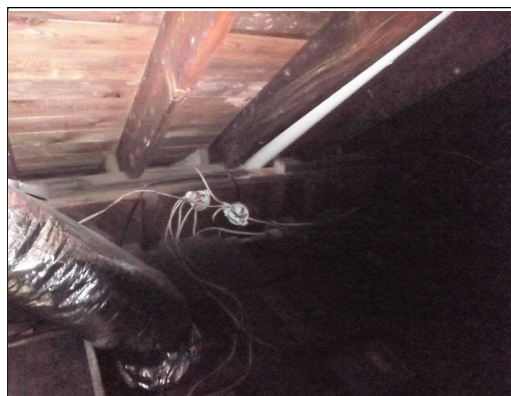
Exposed wire connections
