Property Inspection Report

400 Nolan Cherry Cir. McDonough, GA.

Apr 8, 2021

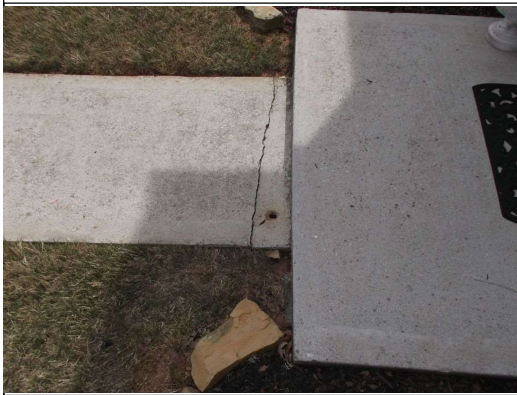
Porch settling and cracks in walkway

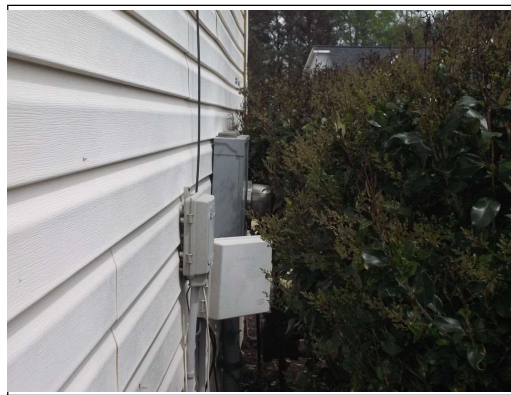
Bushes block meter and touch house

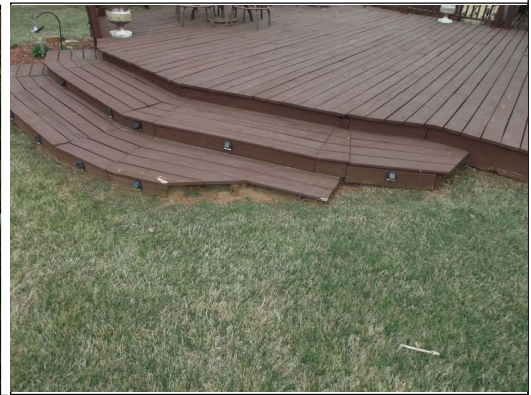
Deck wood resting in soil/dips & sags in floor

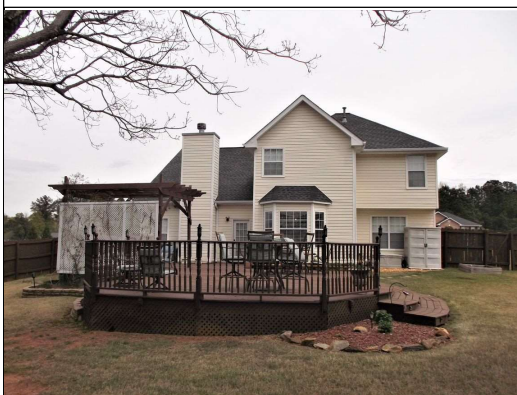
Wood deck guardrails are loose where the posts are bolted to the deck floor rim;

Wood deck railing loose/posts in soil

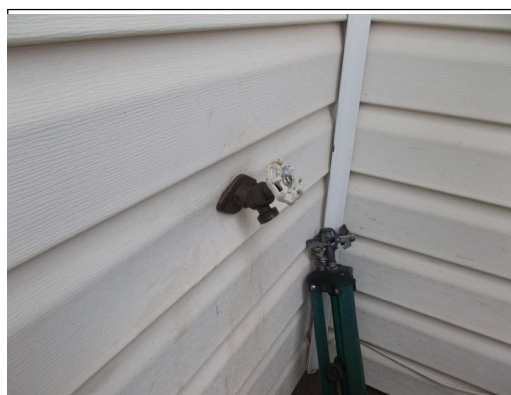
No anti siphon device on rear hose faucet

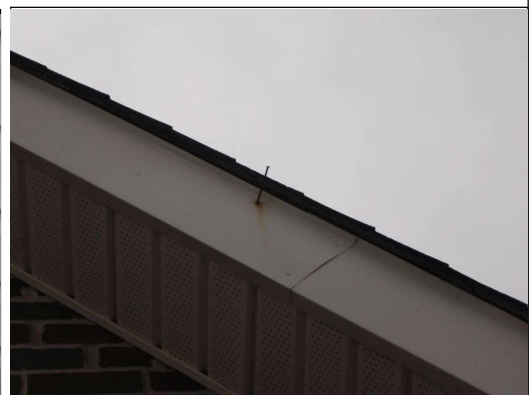
Nails rusting in front fascia

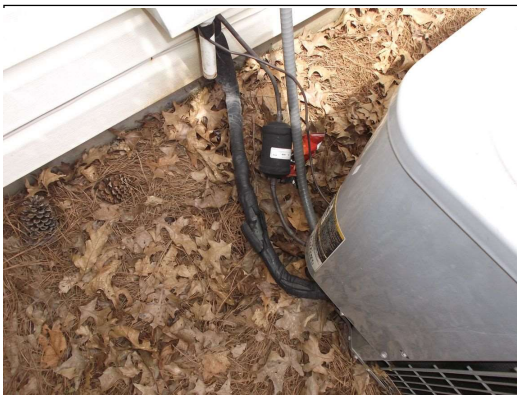
Refrigerant line insulation needs replacement

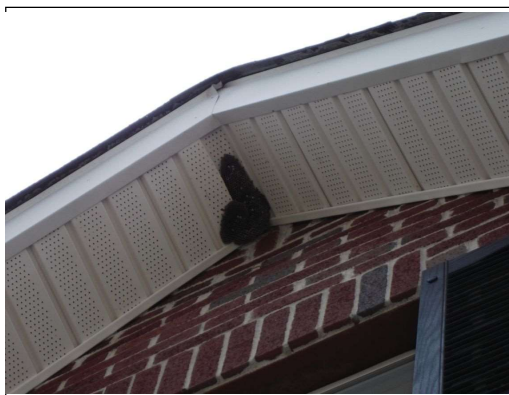
Wasp Nests at front gable peak

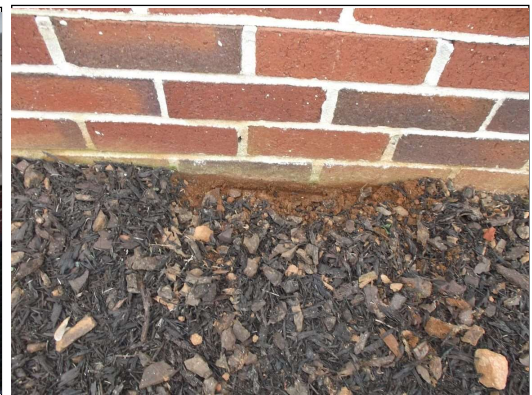
Soil contact mortar and brick

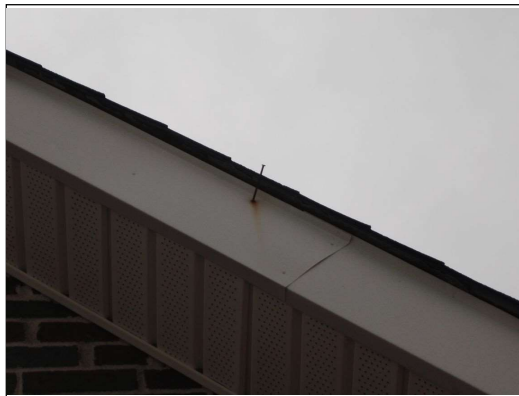
Nails rusting in metal fascia at the front

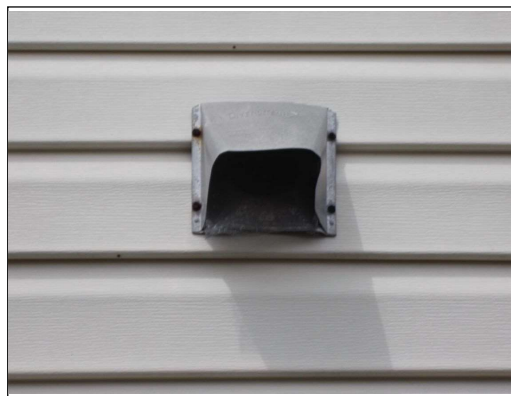
Exhaust vent door missing

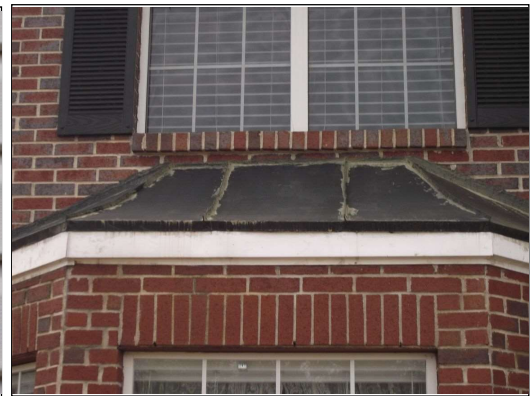
Wood fascia needs painting

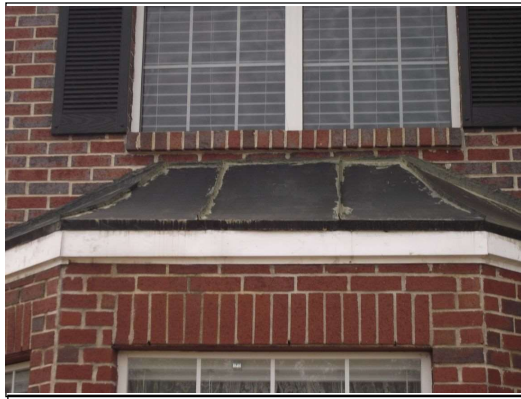
Caulk or sealant spilled on metal roof

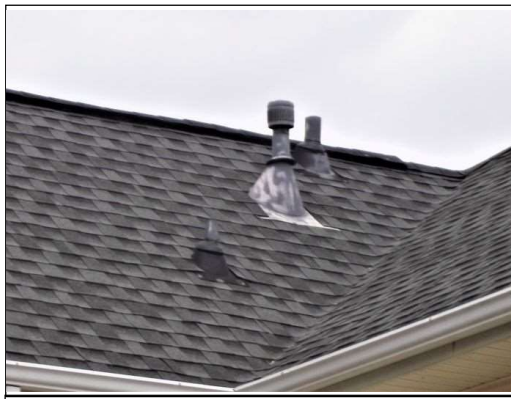
Pipe/vent flashing face nailed on top shingles

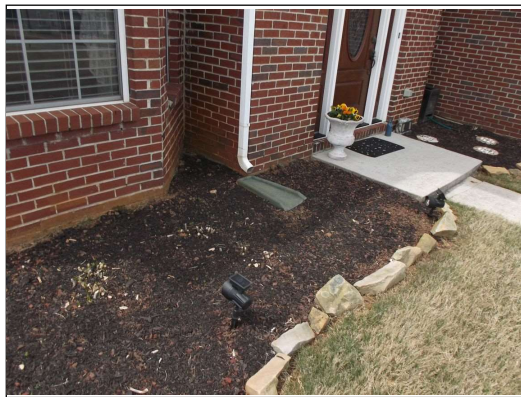
Downspout pours in plant bed

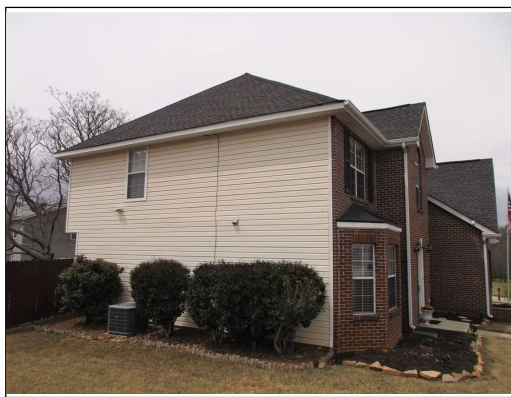
Missing gutter at right side of house

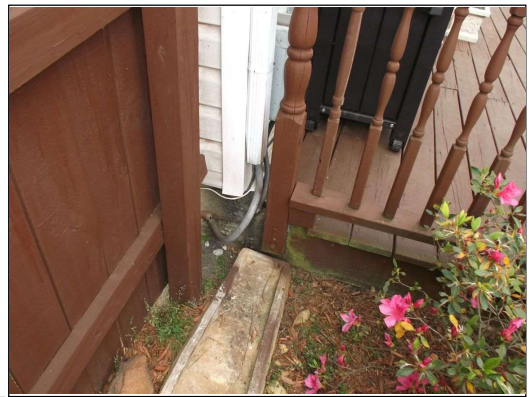
Missing elbow on rear right downspout

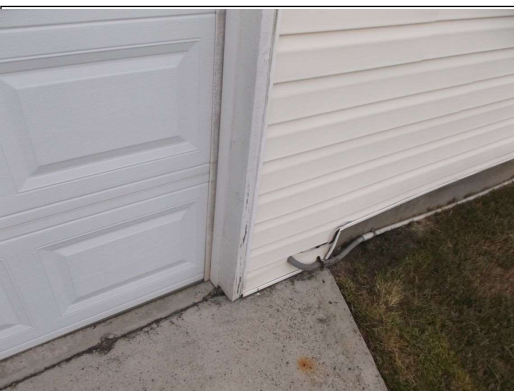
Door trim need paint

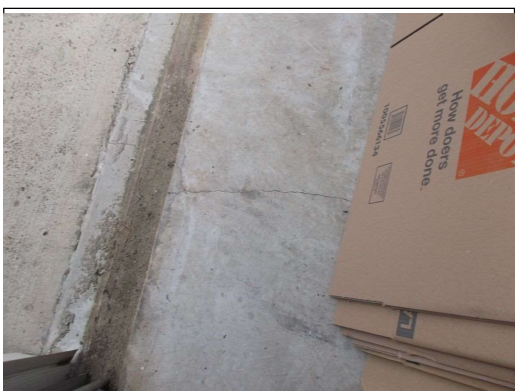
Crack in floor near door

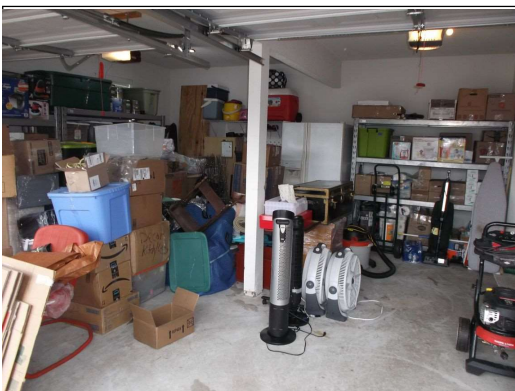
Belongings in garage cannot see all areas

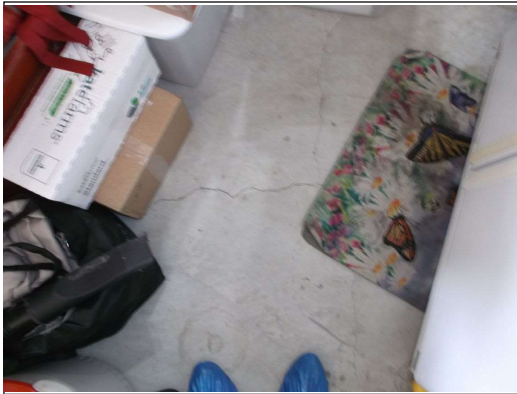
Cracks in floor near refrigerator

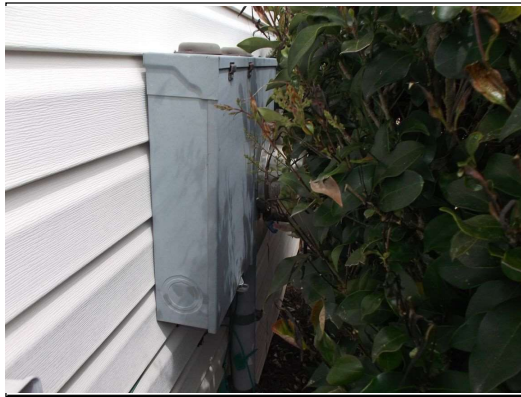
Bushes block access to meter and panel box

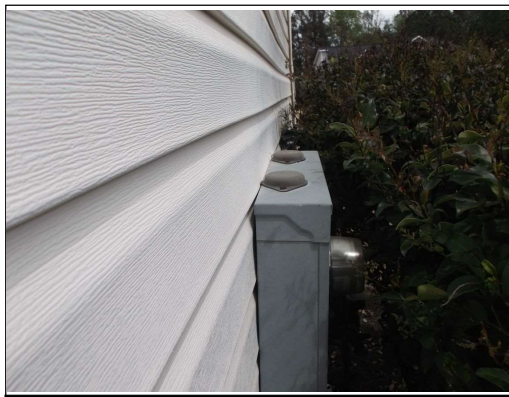
Missing bead of caulk over top of meter box

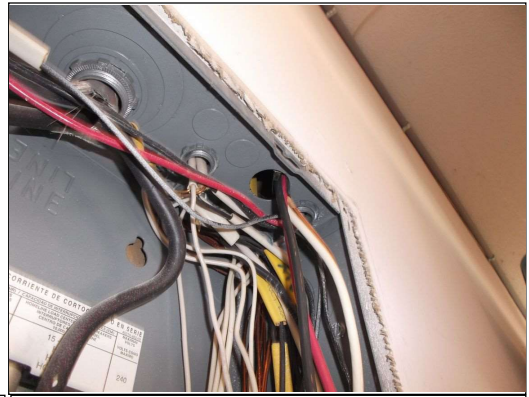
Cables touch sharp metal @ hole in top of par

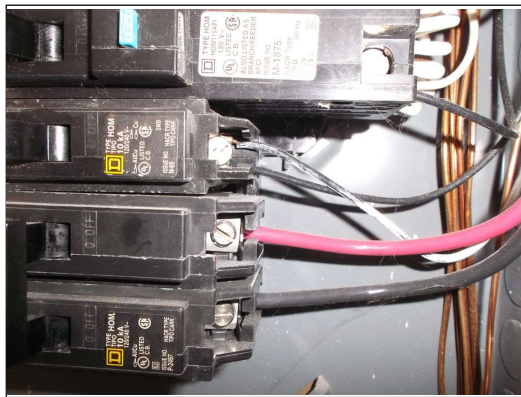
2 hot wires connected to one breaker

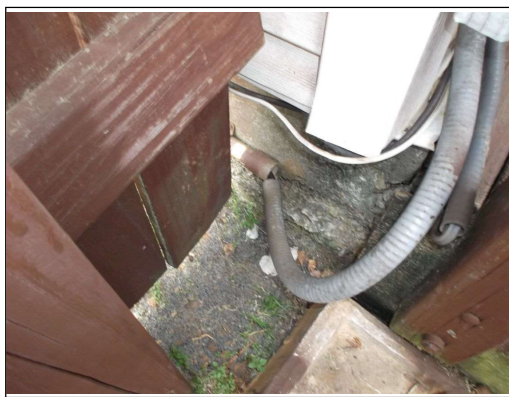
Detached conduit @ right rear corner of house

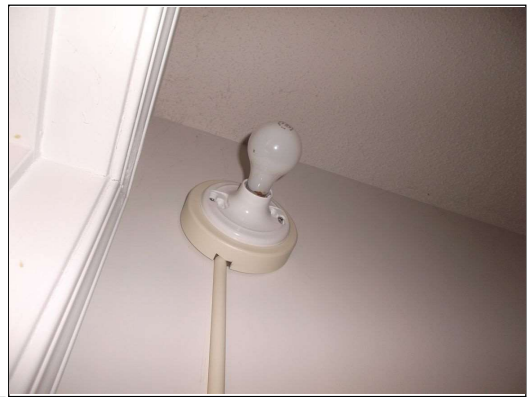
Light bulbs have no globes at closets

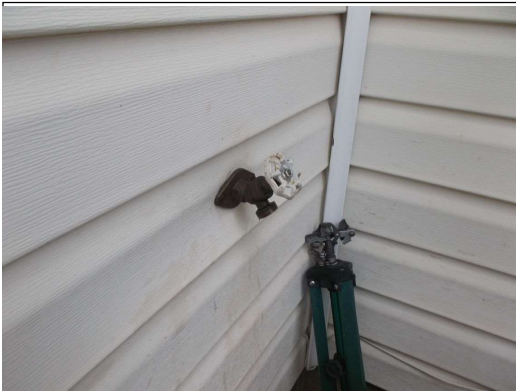
No anti siphon device on rear faucet

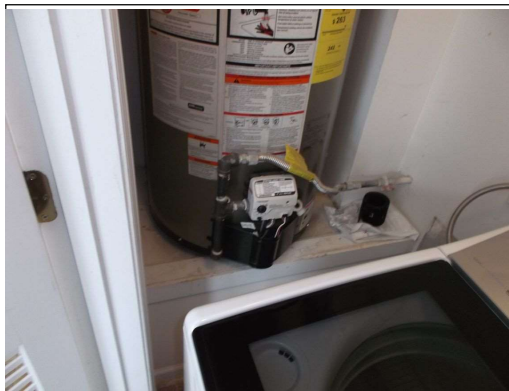
Water heater not in a drain pan

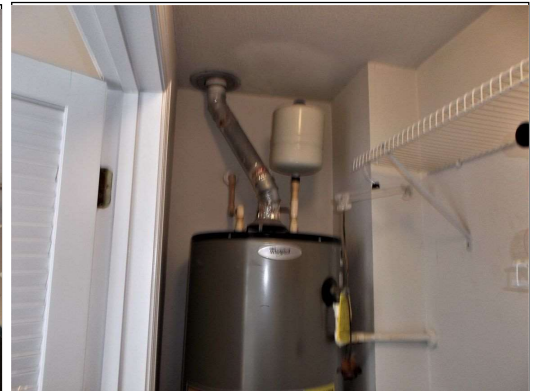
Expansion tank not braced from the wall

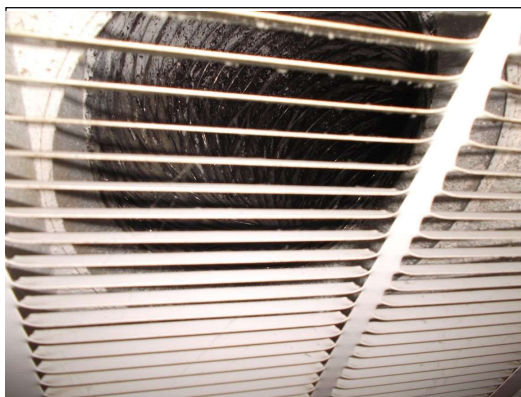
Dust inside air duct returns

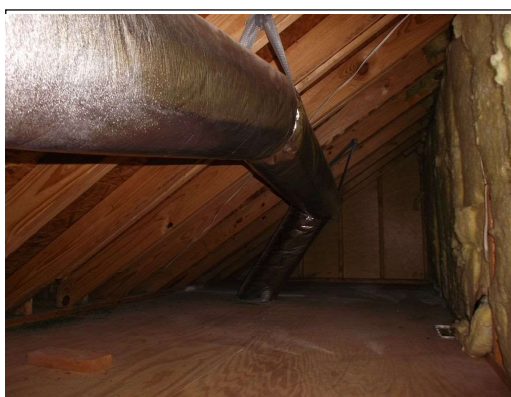
Duct has sharp turn at rear attic crawlspace

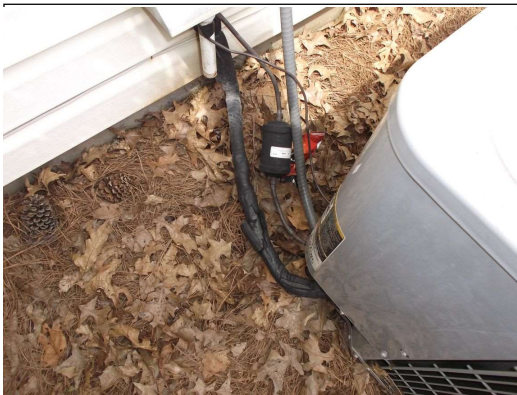
Refrigerant line insulation needs replacement

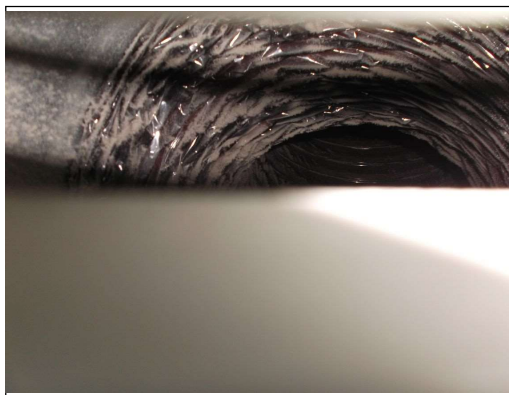
Dust in air return pipe

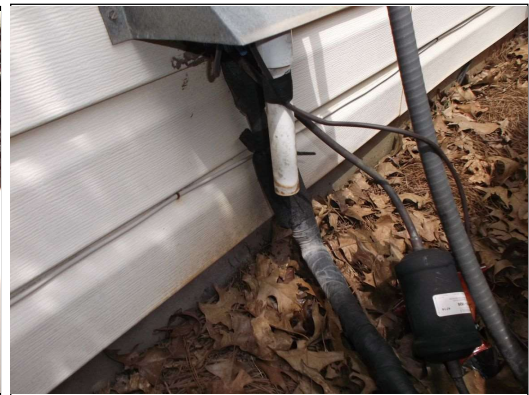
Condensate pipe drains at foundation

AC condensate drain pipe pours at the foundation shall be routed 3 feet away from the foundation at the AC unit;

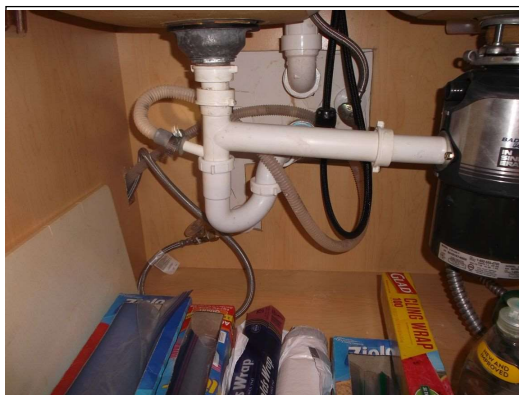
Dishwasher drain pipe not high looped

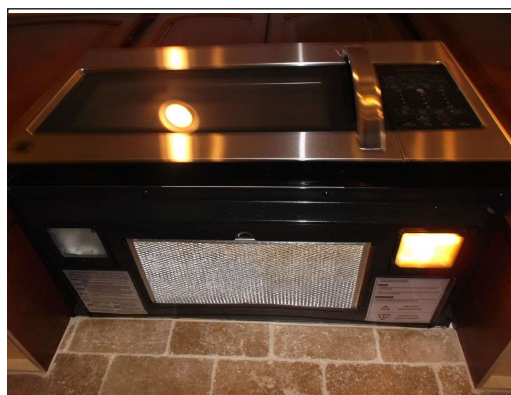
Left light out at exhaust hood

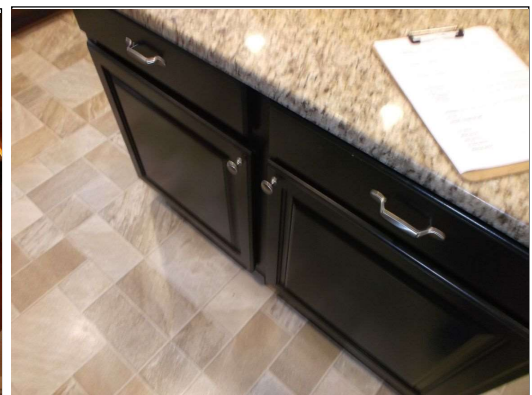
Island left cabinet door not closing

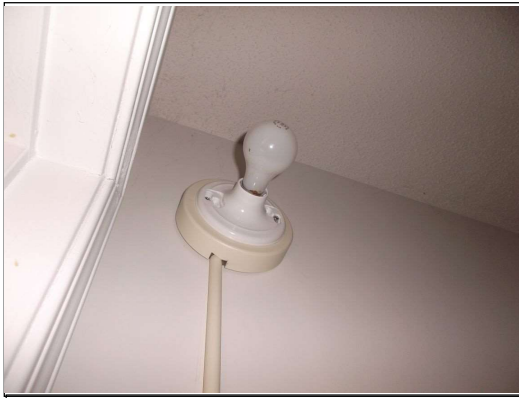
Exposed light bulb in pantry (needs globe)

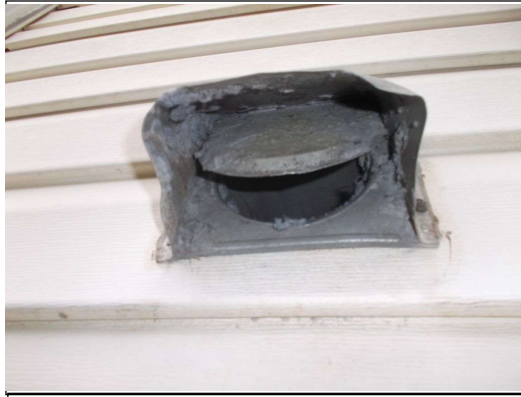
Dryer vent door stuck open

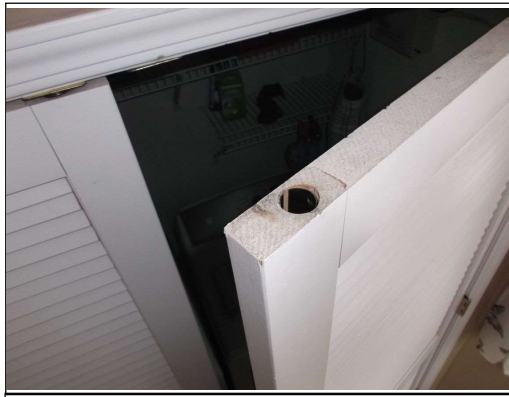
Missing snap hardware at top of laundry door

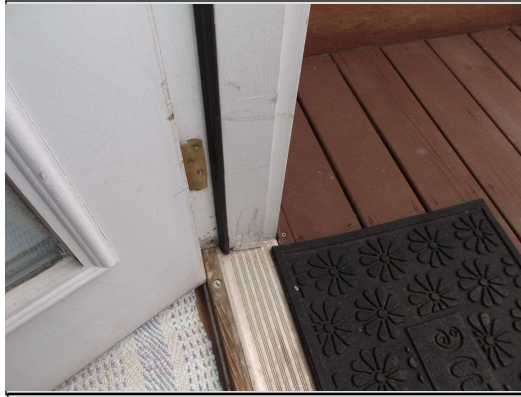
Rear door frame has water damage

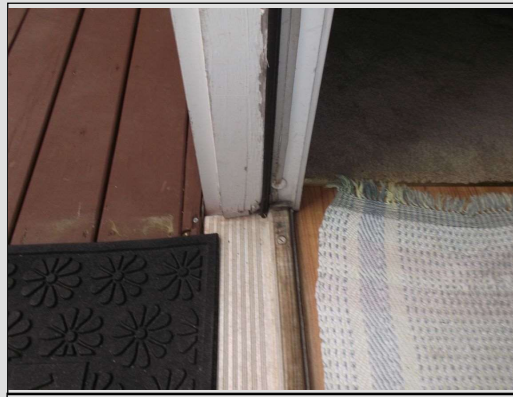
Water damage at rear door frame

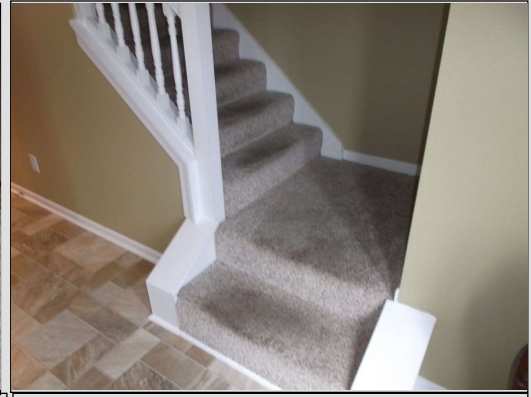
Carpet soiled at the stairs

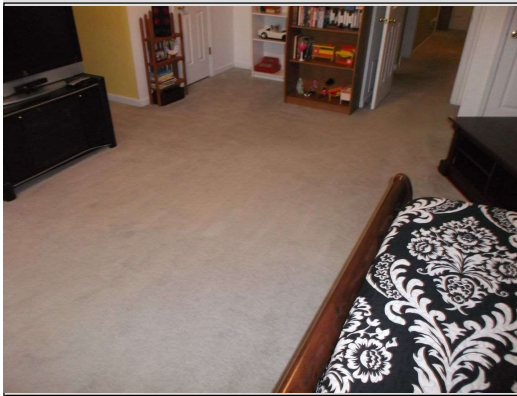
Hump in bonus room floor

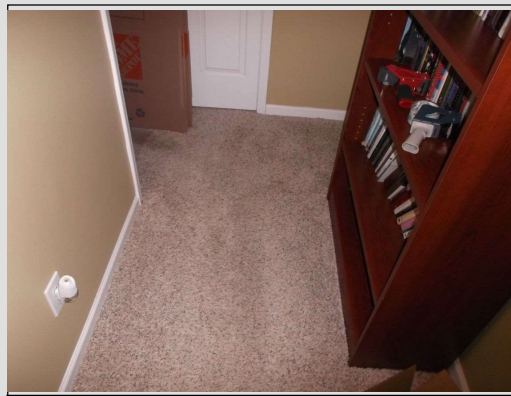
Hump in hall floor bedroom side of house

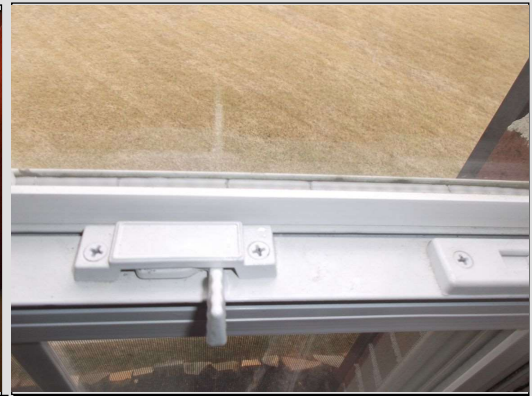
Seals between glass are cracking

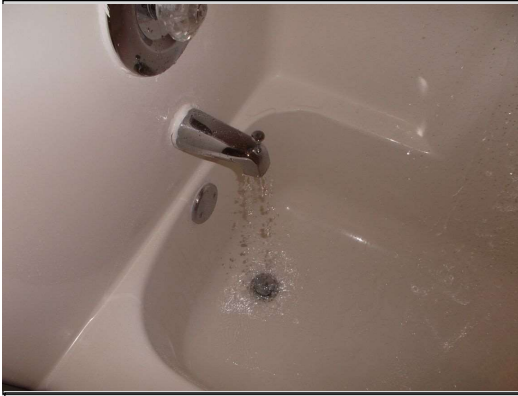
Water bypass when shower water flowing

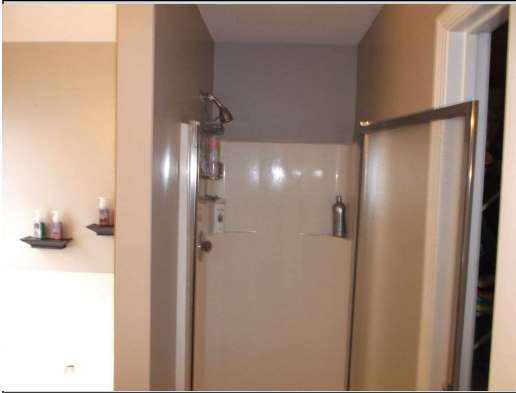
No light over shower (dark)

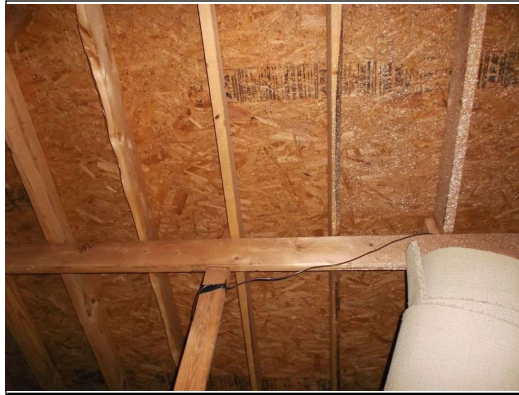
No spacer clips between roof deck panels

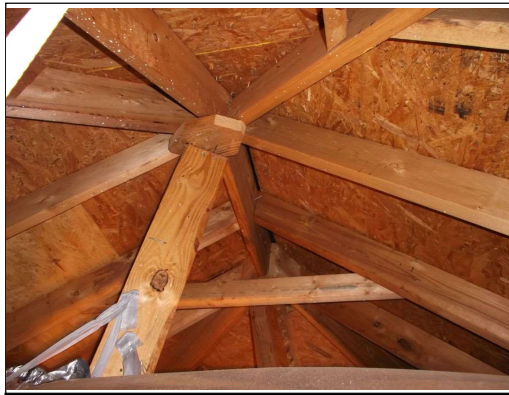
Plywood not cut wide enough for ridge vent

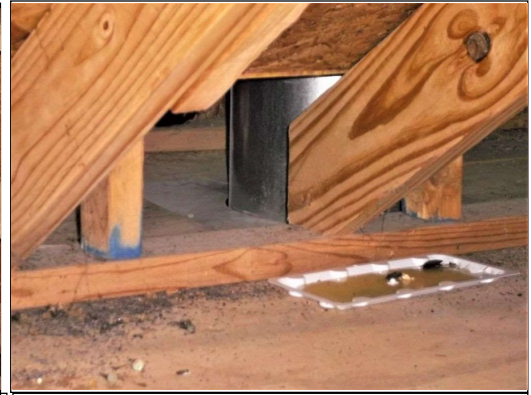
Chimney pipe too close to wood in attic;

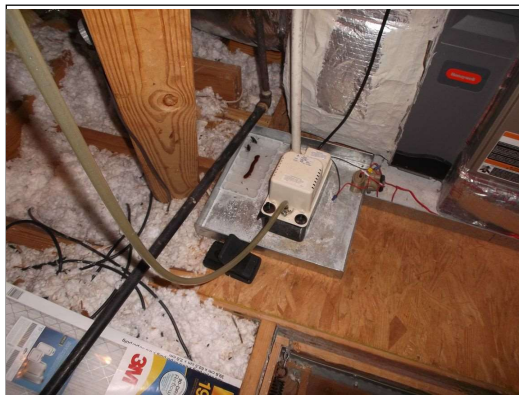
Bugs in bug traps in attics

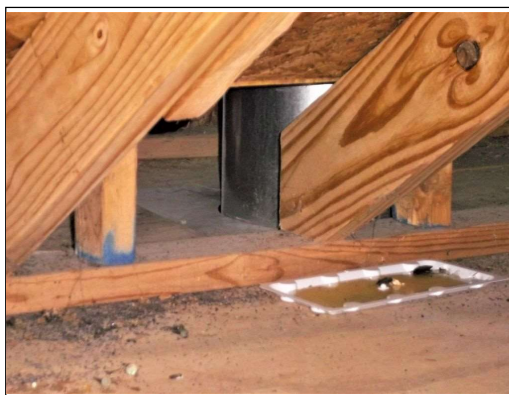
Bug traps in attics (roaches)
