# PROPERTY INSPECTION REPORT

9620 Cedar Grove Rd. Fairburn, GA.

2-23-2017

1477

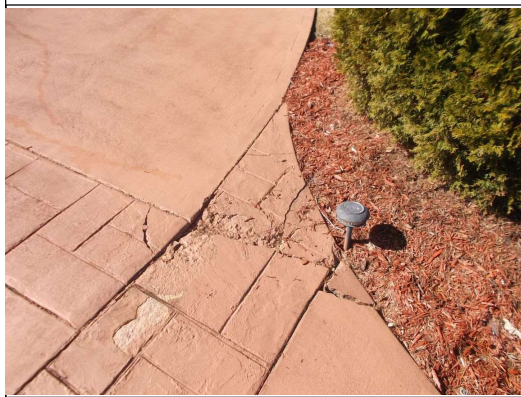
Cracks and damage at the driveway

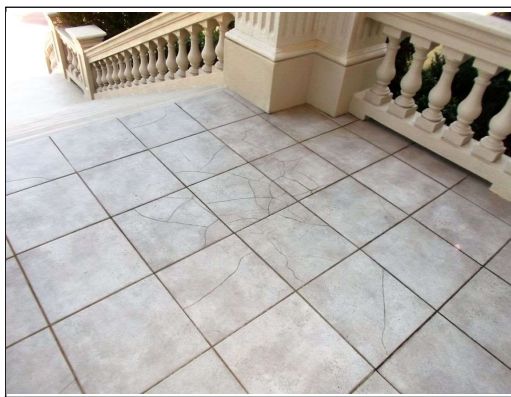
Cracks in the front portico floor tiles

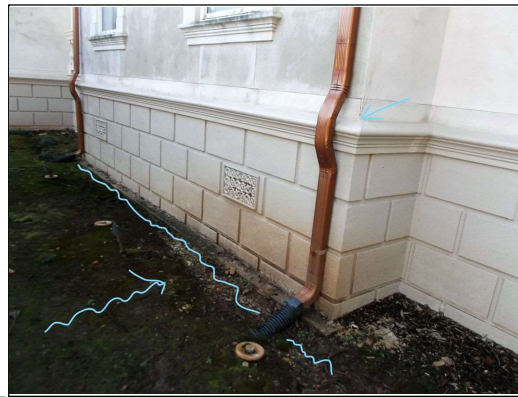
Poor soil slope and erosion at areas

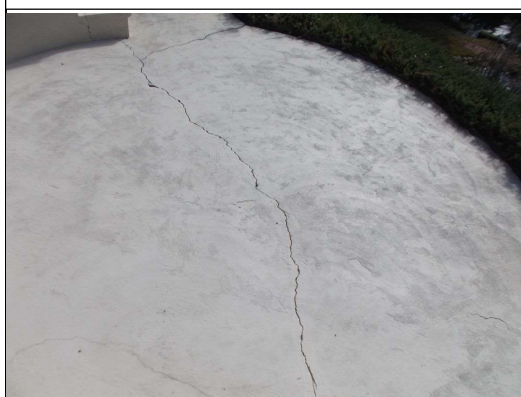
Crack in walkway

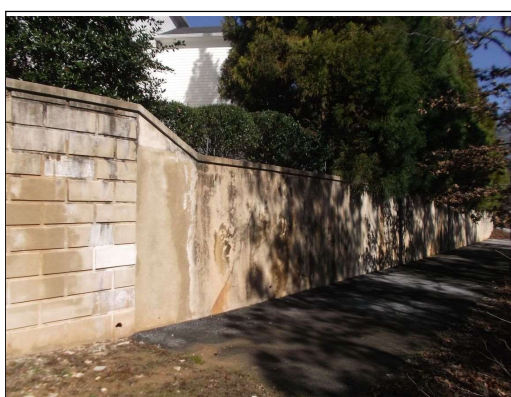
Retaining wall cracking at the back driveway

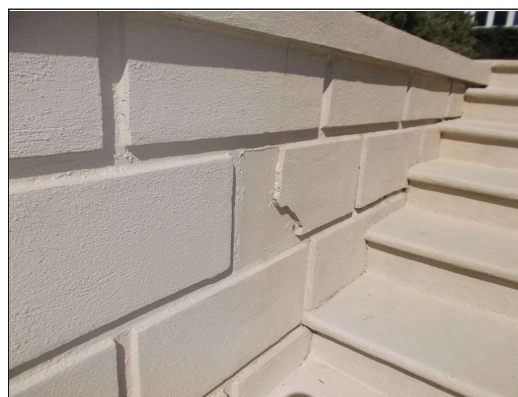
Damage at wall to the pool level

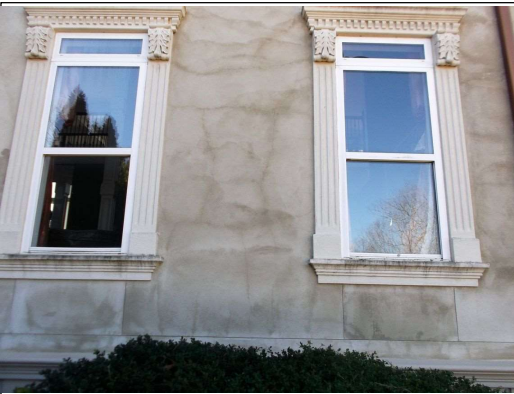
Stucco cracks may indicate water intrusion

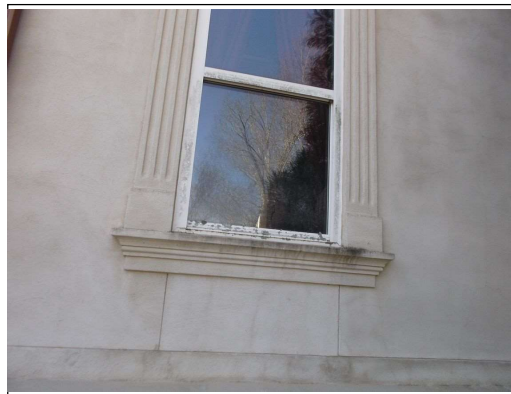
Some window sash are rotting

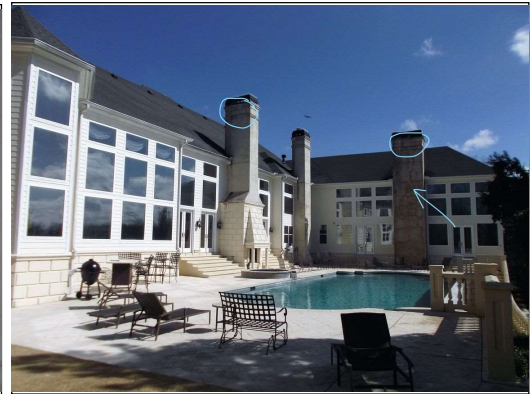
Water intrusion at chimneys

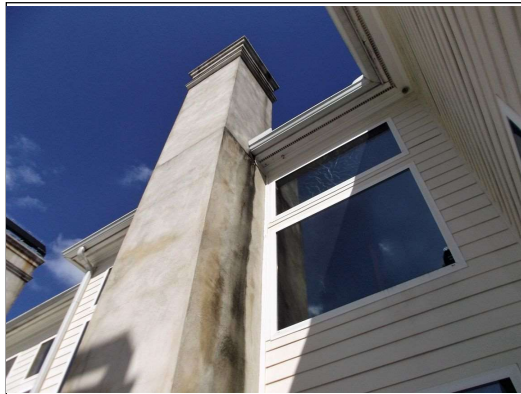
Missing flashing where roofs meet chimneys

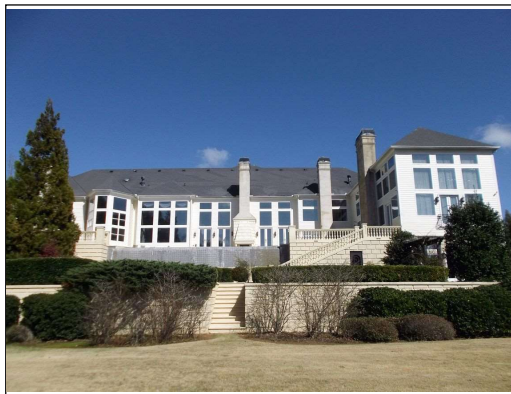
Stucco needs pressure wash

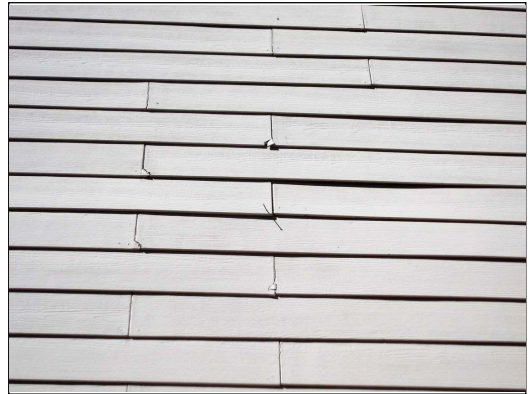
Siding damaged and nails extracting at areas

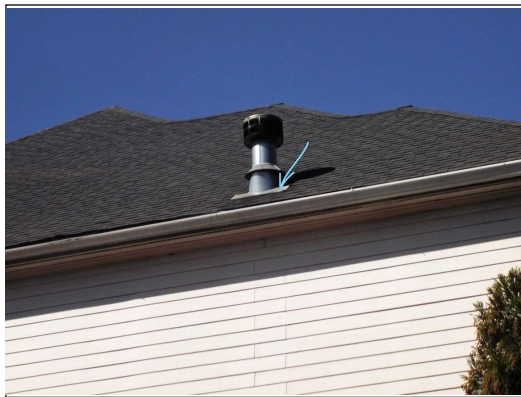
Pipe flashing on top shingles face nailed

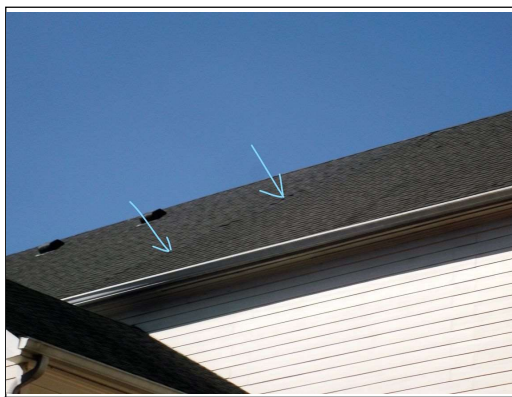
Humps in roof shingle surface

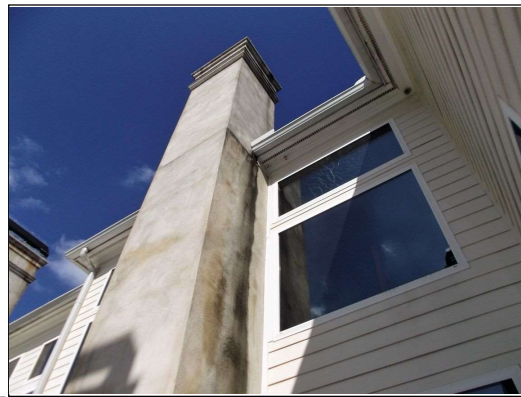
Missing or defective roof-to-chimney flashing

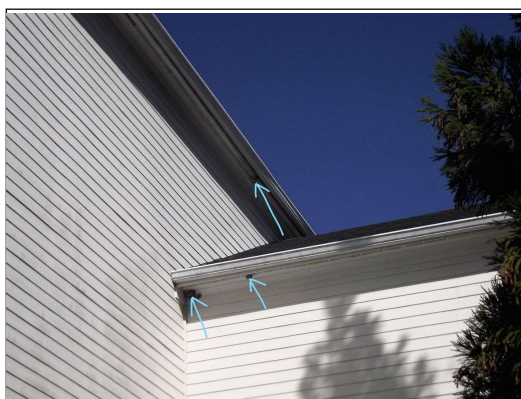
Water damage to wood soffits at areas

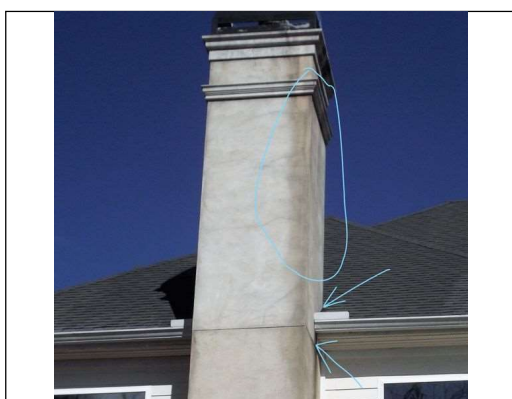
Defective flashing at chimney

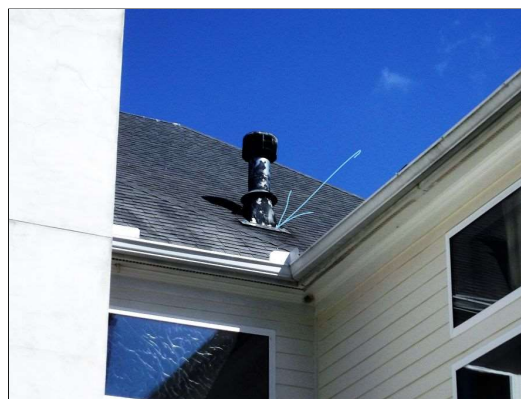
Vent pipe flashing on top shingles face nailed

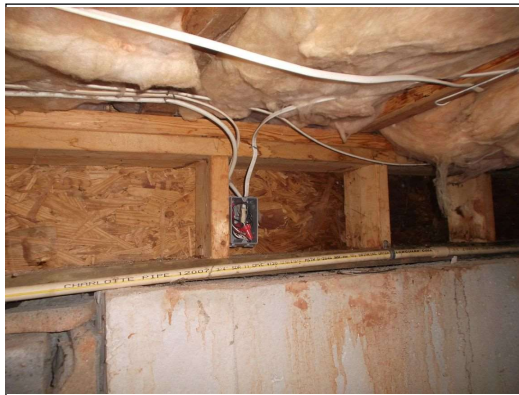
Open junction box in crawlspace

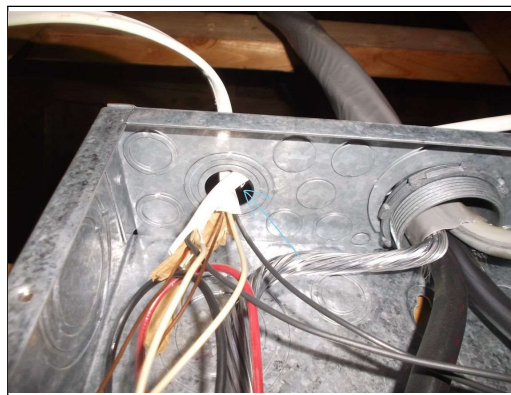
Wires contact sharp metal at panel

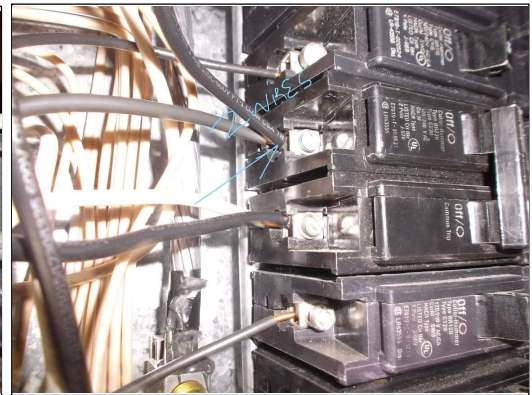
Two hot conductors to one breaker

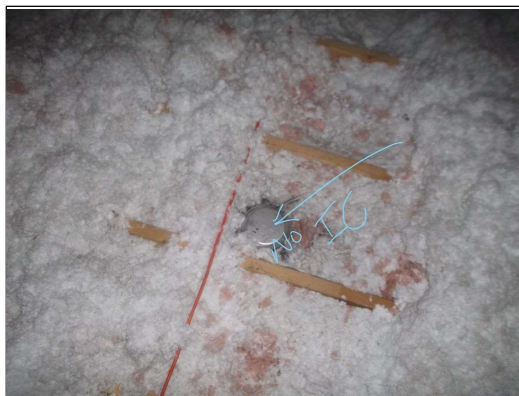
Recessed light do not have IC stamp on back

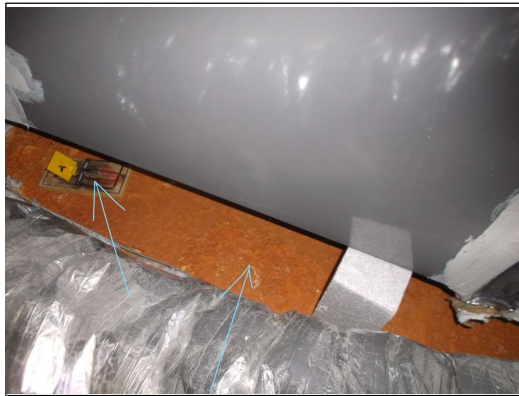
4 furnaces have water and rust in the drain panes may indicate defective condensers or condensate issues;

Rust and water in one attic furnace drain pan

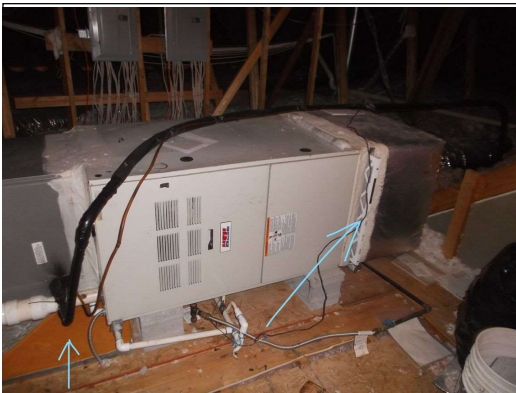
Rust in attic furnace drain pan

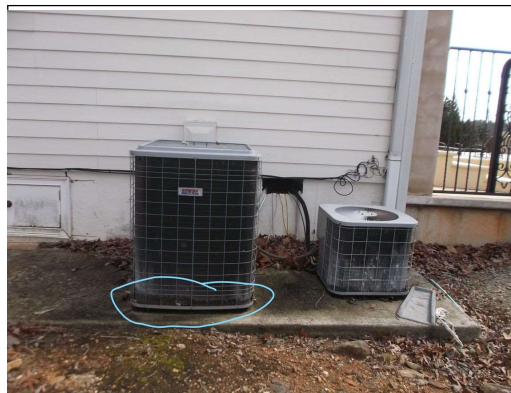
Debris and corrosion at the bottoms of ACs

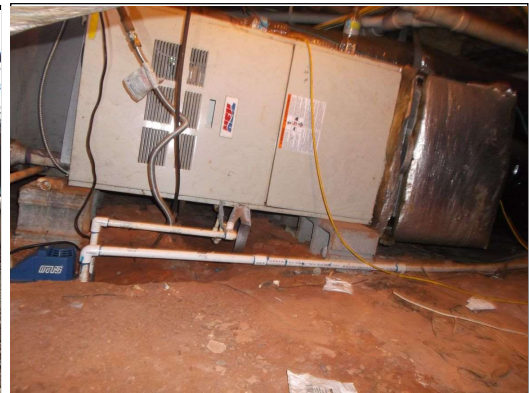
Furnace in the crawlspace defective

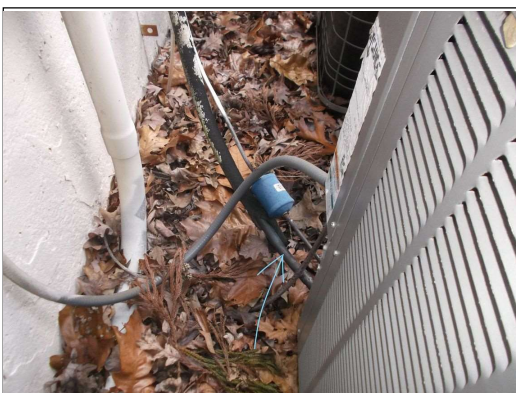
Missing refrigerant line insulation

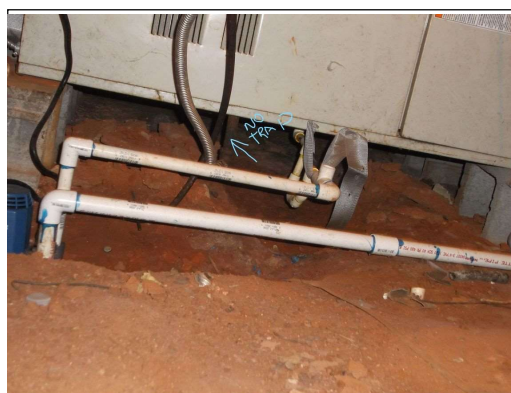
No sediment trap in gas pipe to furnace

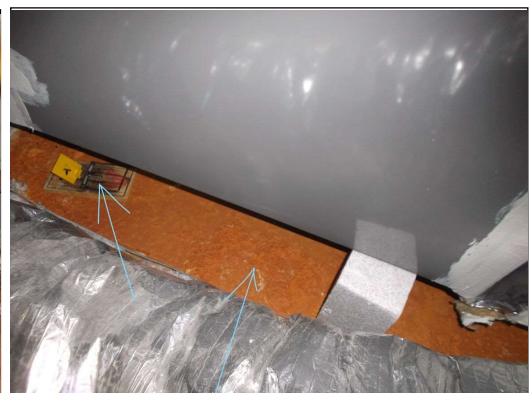
Major rust in attic furnace drain pan

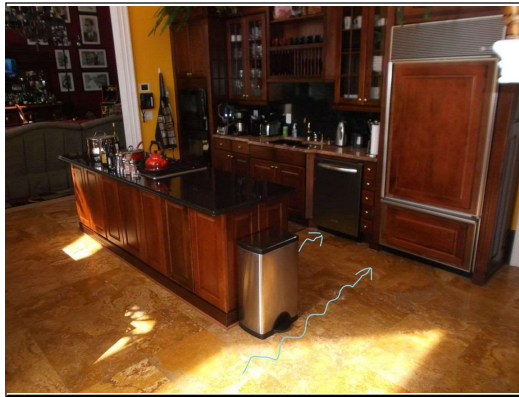
Kitchen floor slopes to refrigerator wall

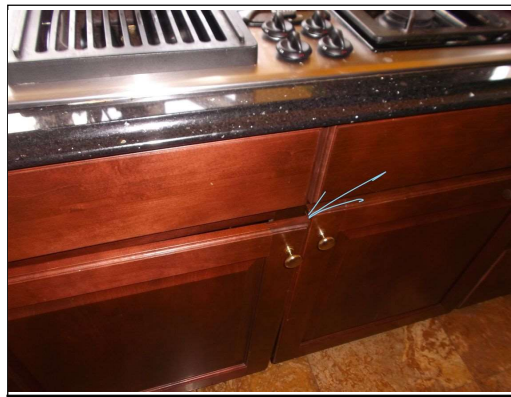
Base cabinet door bowed at cook top

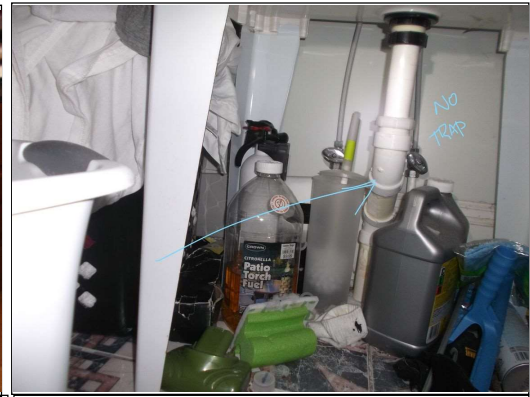
Sink waste pipe has no J-Trap

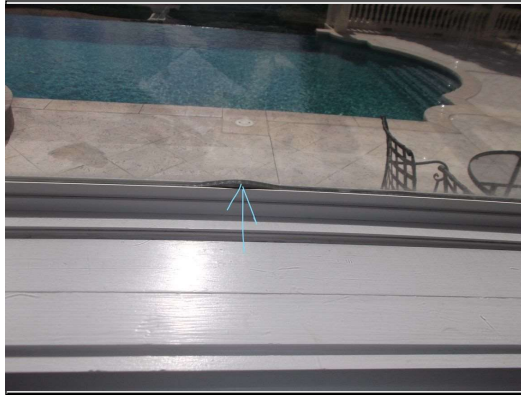
Glass sill defective

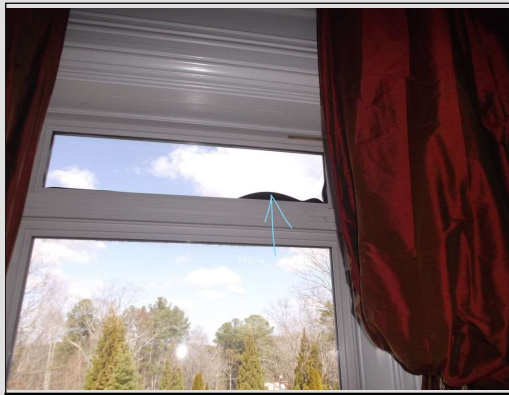
Window seals spill into glasses at areas

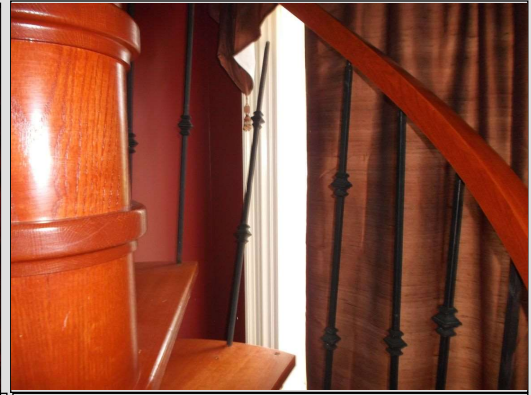
Detaching guards in main stair railing

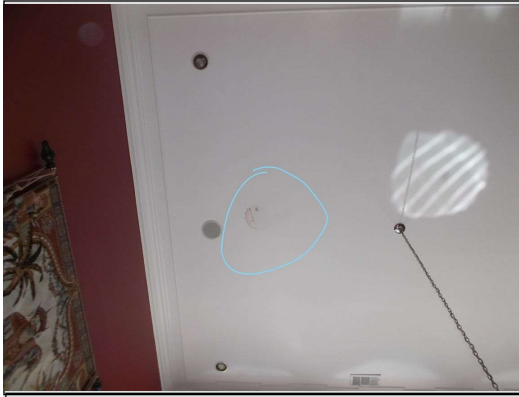
Dry water stains in ceilings

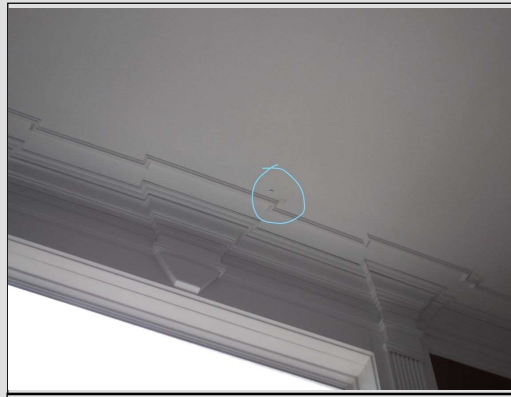
Nail pops in ceilings

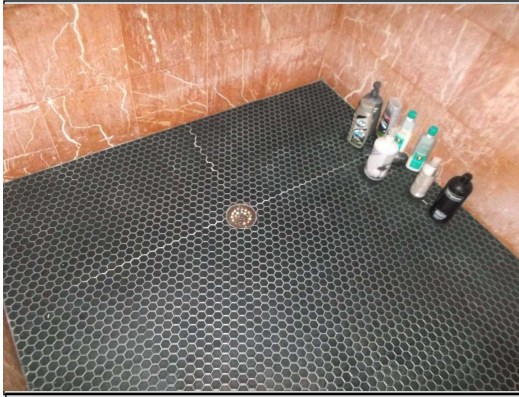
Defective grout in cracks at master shower

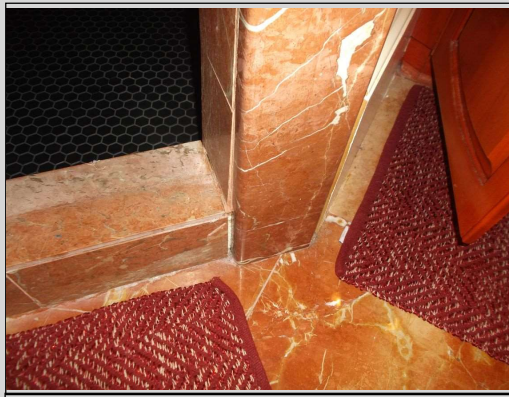
defective grout at master shower curb

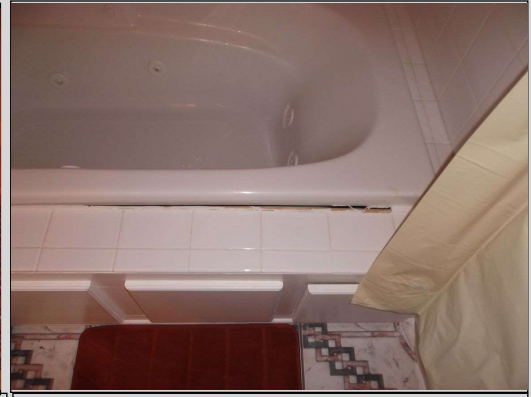
Tub movement at deck tile indicate settling

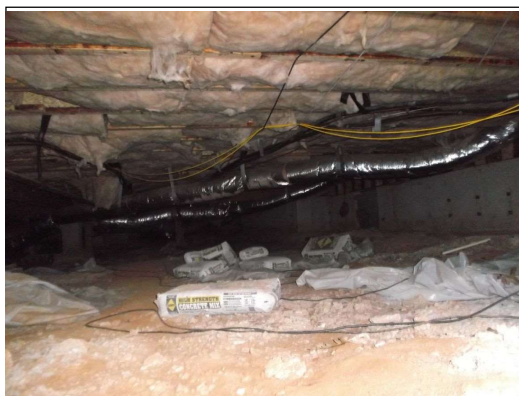
Concrete debris throughout crawlspace

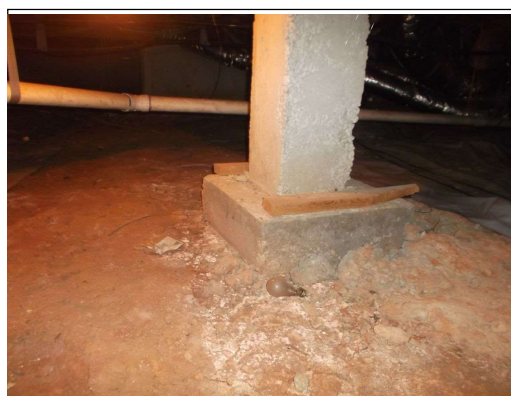
Foundation supports installed on top of soil

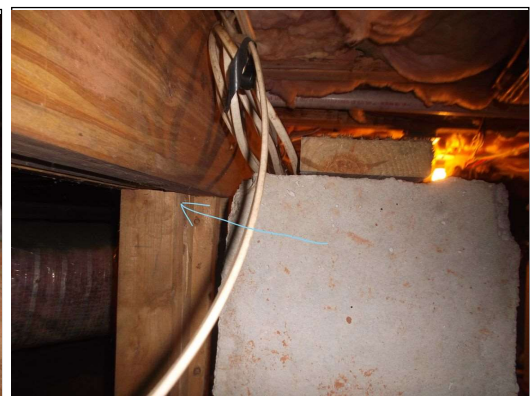
Several original concrete columns were installed in the wrong locations in the crawlspace for floor beams and wood post were installed offset afterwards; some wood support posts have concrete foundations installed on top of the soil;

Original concrete columns in wrong place

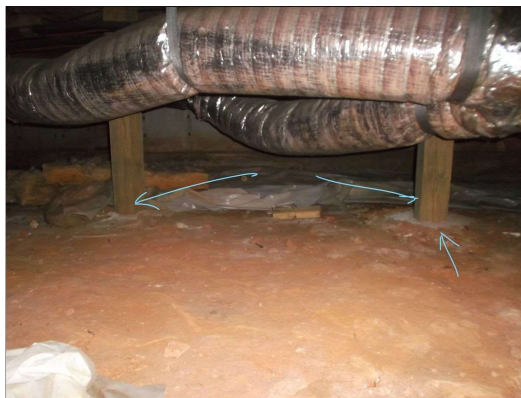
Wood posts alternates placed for masonry
